WADC TECHNICAL REPORT 59-87
PART II

**DETERMINATION OF FACTORS
GOVERNING SELECTION AND APPLICATION OF
MATERIALS FOR ABLATION COOLING
OF HYPERVELOCITY VEHICLES**

*Chicago Midway Laboratories
The University of Chicago*

JULY 1959

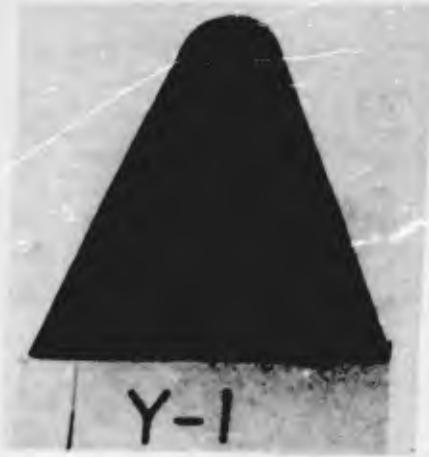
Remarks: Immediately after the start of heating, some liquid began to flow up the side of the sample. No cracking of the sample was observed.

Figure 11. Sample No. Y-1 after testing.

Figure 12. Silhouettes of sample No. Y-1 before and after testing.

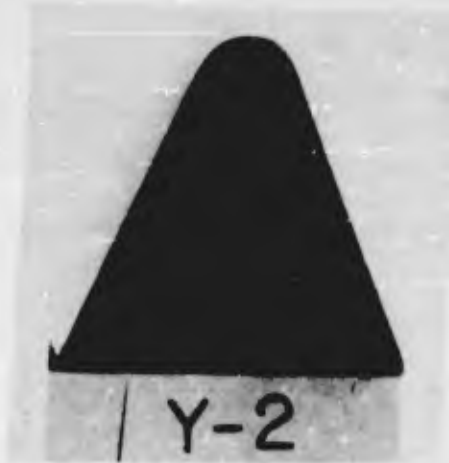
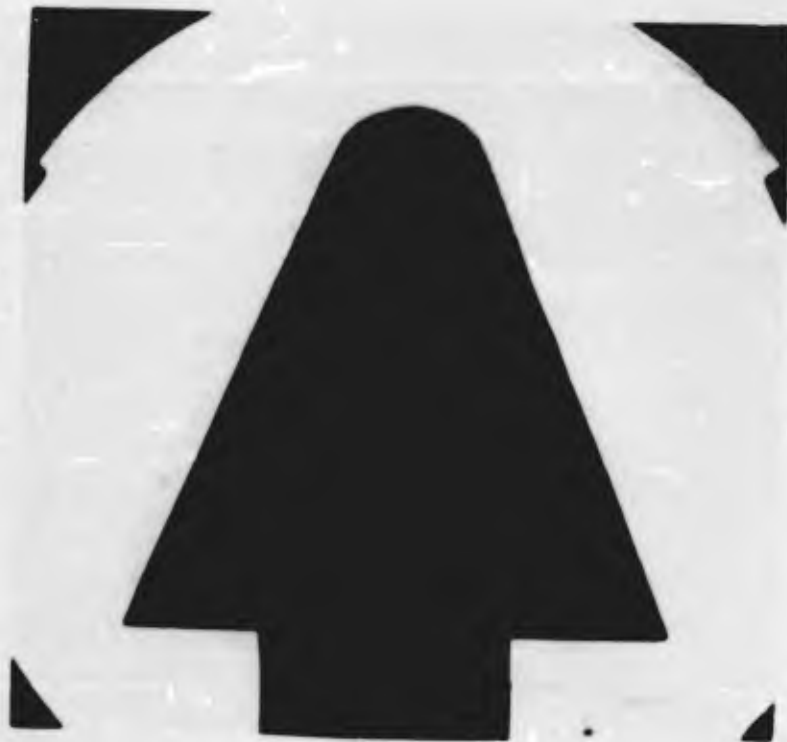
Remarks: Immediately after the start of heating, some liquid began to flow up the side of the sample. No cracking of the sample was observed.

Figure 13. Sample No. Y-2 after testing.

Figure 14. Silhouettes of sample No. Y-2 before and after testing.

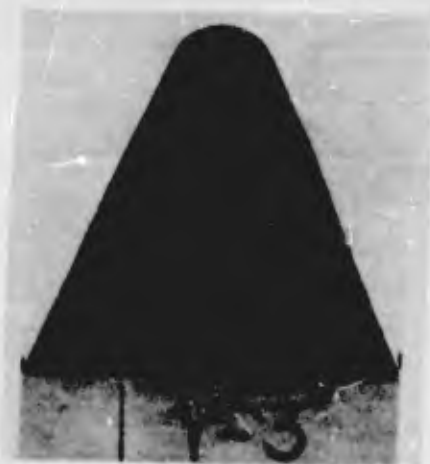
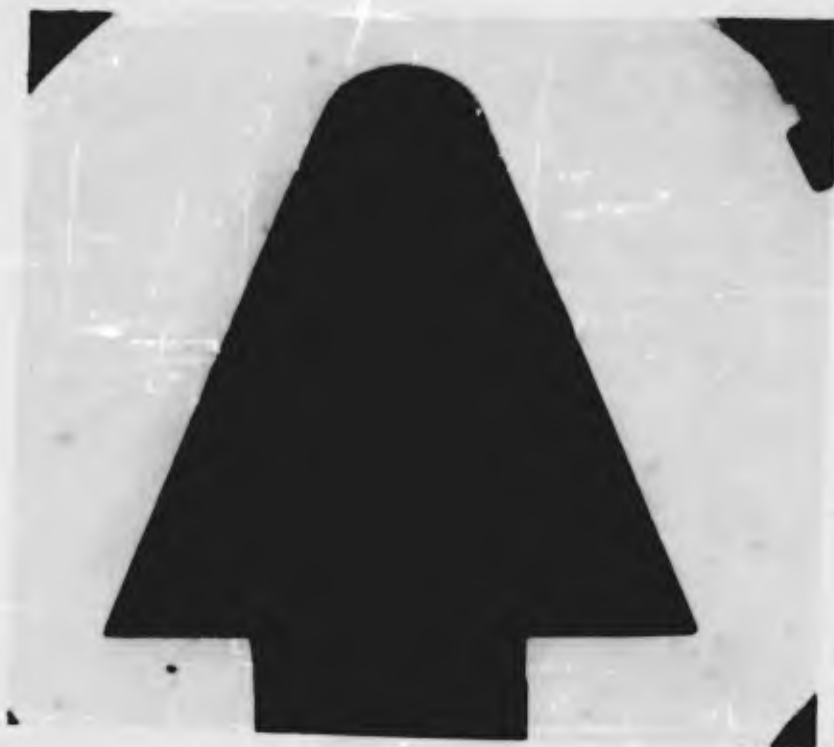
Remarks: The flow field is slightly asymmetrical although the condition is not serious. Again, liquid is seen leaving the hot nose zone. In addition, there are definite isotherms along the body, corresponding to possible phase changes. No cracking of the sample was observed.

Figure 15. Sample No. Y-3 after testing.

Figure 16. Silhouettes of sample No. Y-3 before and after testing.

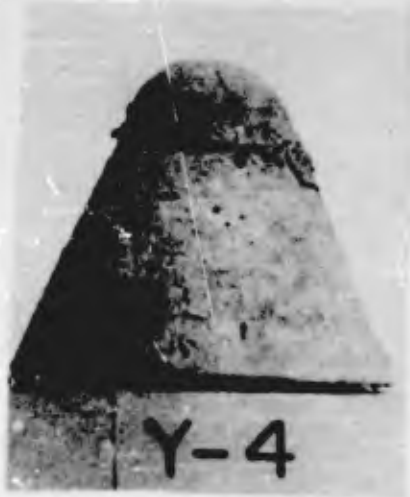
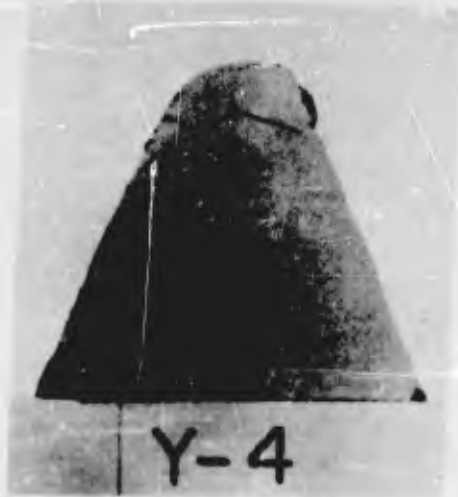
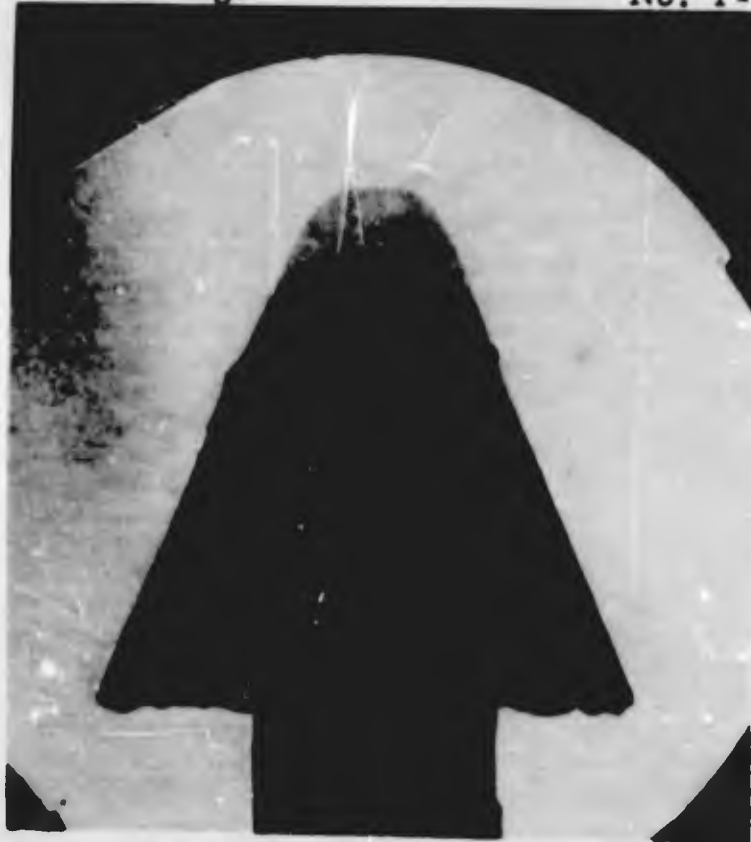
Remarks: Due to a malfunction of the arc, this sample was subjected to two stepwise heatings, of 10- and 26-second durations. Figure 18 shows the depths of penetration of the melted zone at the nose, and also indicates a probable thermal stress failure in the interior. During the early part of the test there was some spalling at the nose.

Figure 17. Sample No. Y-4 after testing.

Figure 18. Sectional view of sample No. Y-4 after testing.

Figure 19. Silhouettes of sample No. Y-4 before and after testing.

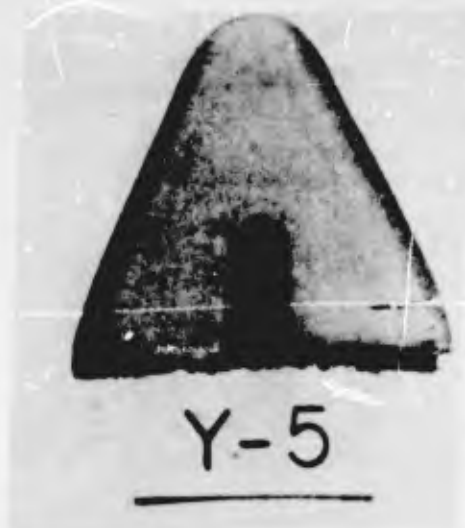
Remarks: During the run, much liquid was stripped away from the surface of the sample. The laminar failure near the base occurred during the latter portion of the test.

Figure 20. Sample No. Y-5 after testing.

Figure 21. Sectional view of sample No. Y-5 after testing.

Figure 22. Silhouettes of sample No. Y-5 before and after testing.

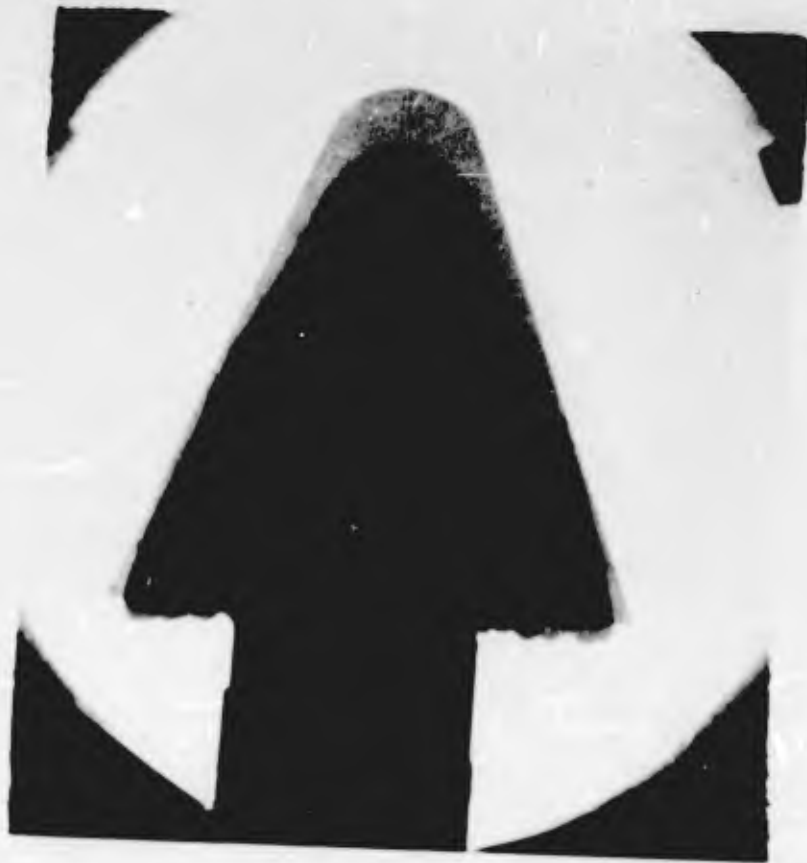
Remarks: Much spalling occurred over the entire area of the sample during the early part of the test. Later, liquid spilled over the base of the cone. There is definite evidence that the boundary layer in Y-6 is much thicker than in Y-5, which may account for the slower ablation rate.

Figure 23. Silhouettes of sample No. Y-6 before and after testing.

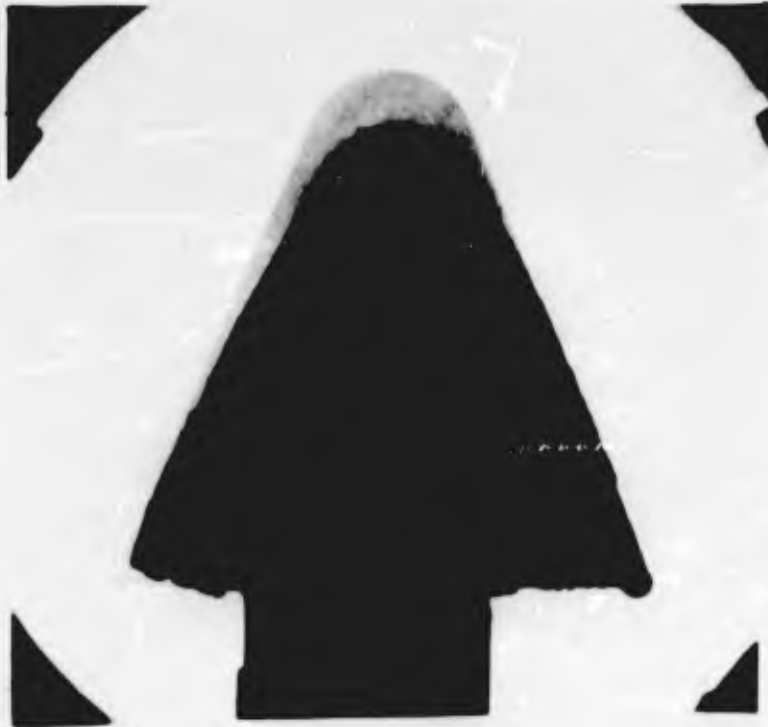
Remarks: Some liquid being stripped off and a slight amount of spalling occurred. The surface after test was somewhat roughened.

Figure 24. Silhouettes of sample No. Y-7 before and after testing.

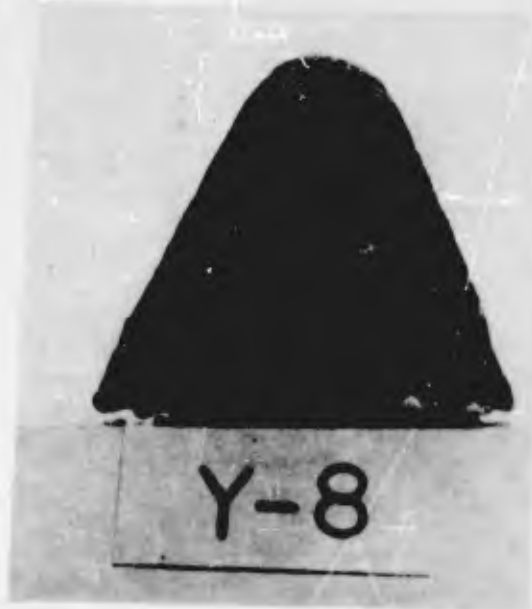
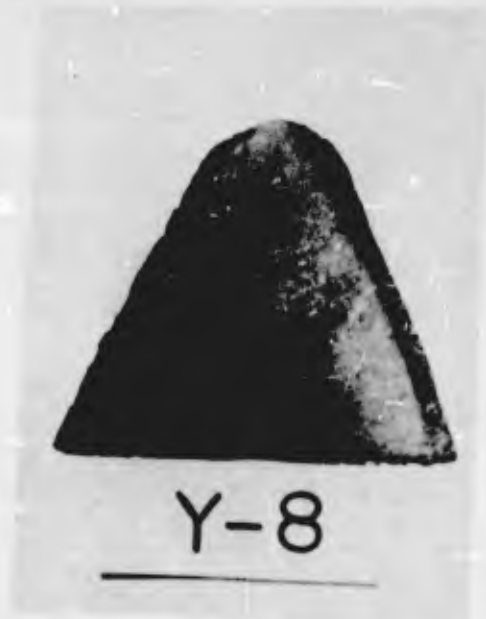
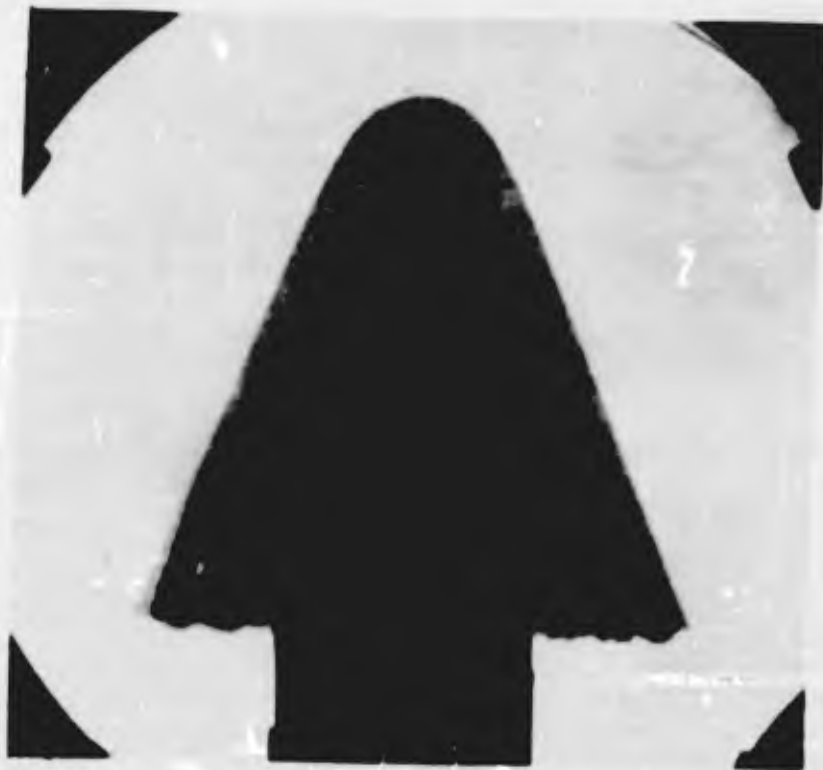
Remarks: Again, some liquid left the base of the cone. Little or no spalling occurred, but there was some surface roughening. The boundary layer seems to be fairly thin.

Figure 25. Sample No. Y-8 after testing.

Figure 26. Sectional view of sample No. Y-8 after testing.

Figure 27. Silhouettes of sample No. Y-8 before and after testing.

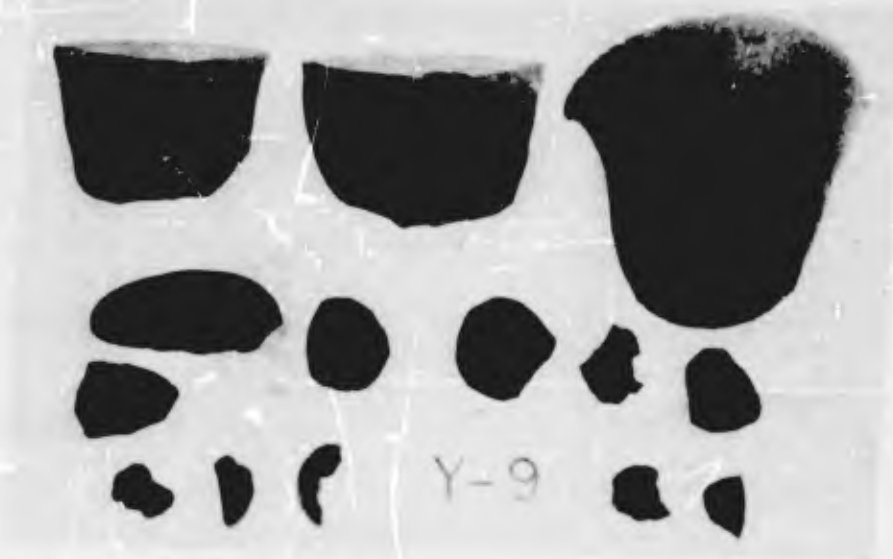
Remarks: Both samples failed similarly. The shattering of each was almost of an explosive nature, and the pieces were found over an area about 12 by 20 feet, indicating the forceful disintegration. Each test was stopped when the sample had disappeared.

Figure 28. Sample No. Y19 after testing.

Figure 29. Sample No. Y-10 after testing.

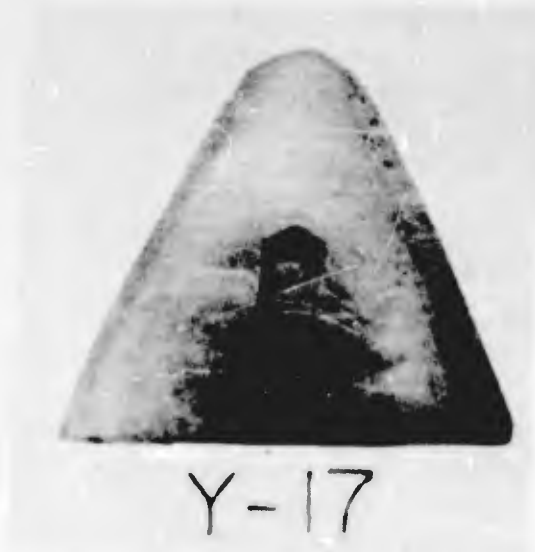
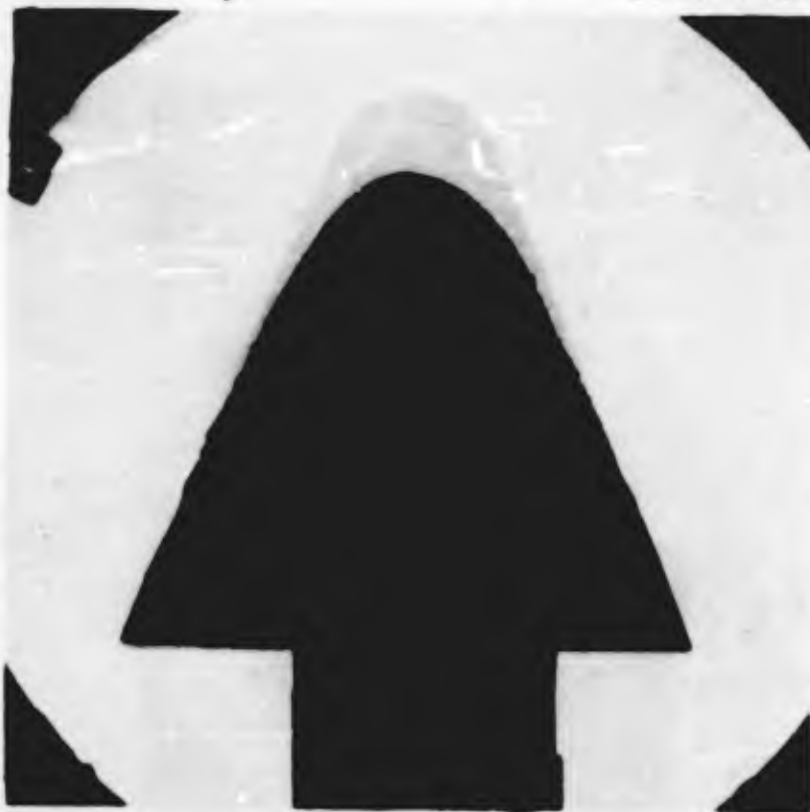
Remarks: The color motion pictures show little liquid leaving the surface of the sample. There is considerable roughening of the surface.

Figure 30. Sample No. Y-17 after testing.

Figure 31. Sectional view of Sample No. Y-17 after testing.

Figure 32. Silhouettes of sample No. Y-17 before and after testing.

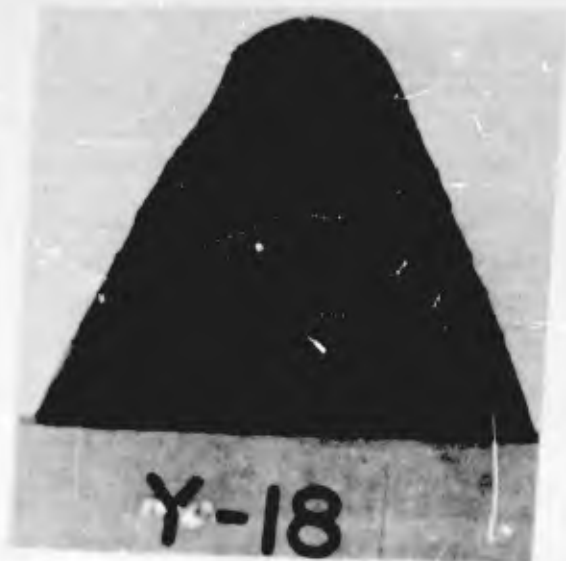
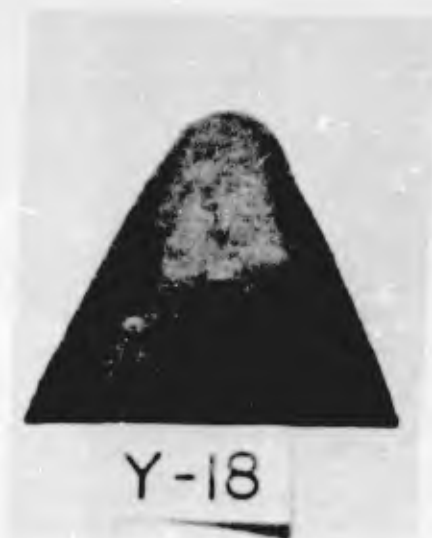
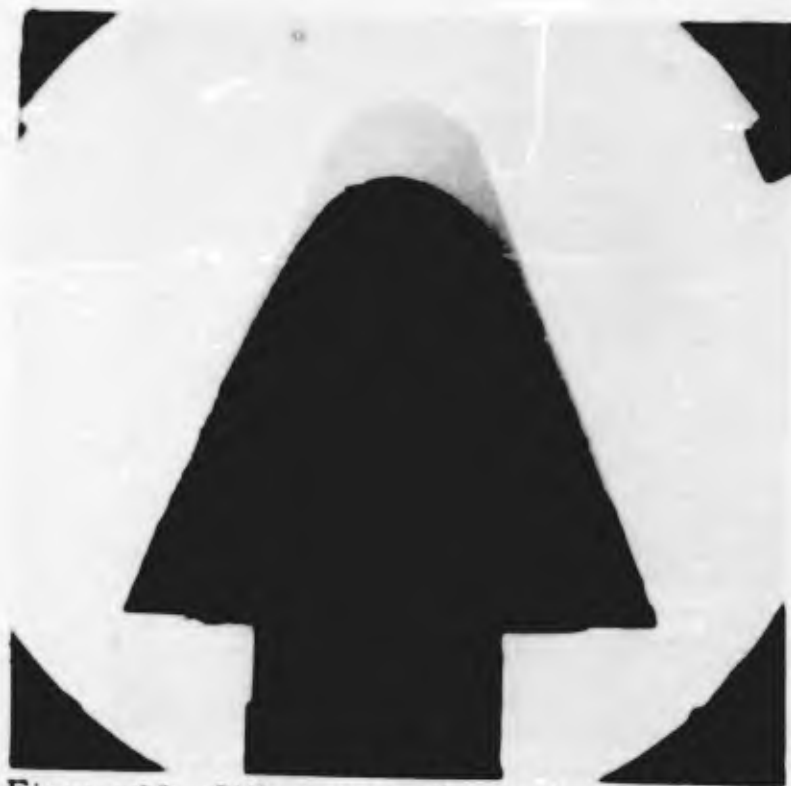
Remarks: This sample was identical to Y-17 except for a routed out section to relieve stresses which might cause delamination. It behaved similarly in all respects to Y-17. Neither sample cracked or delaminated. Although the weight loss percentage is somewhat higher, the actual loss of weight is comparable.

Figure 33. Sample No. Y-18 after testing.

Figure 34. Sectional view of sample No. Y-18 after testing.

Figure 35. Silhouettes of sample No. Y-18 before and after testing.

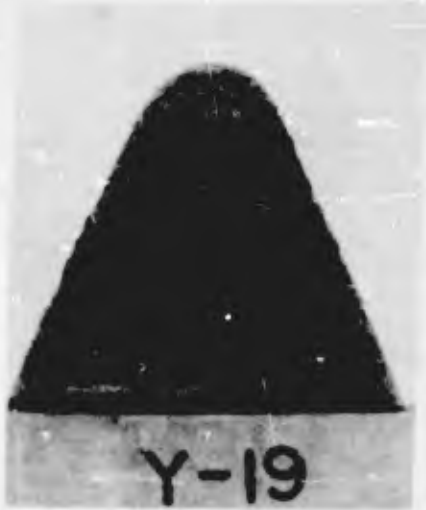
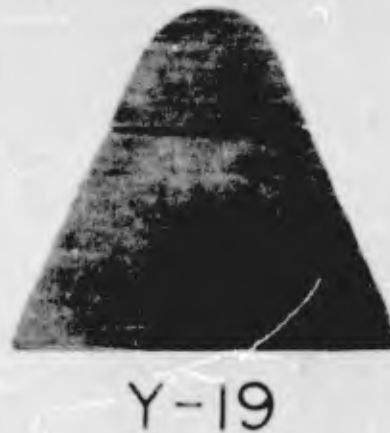
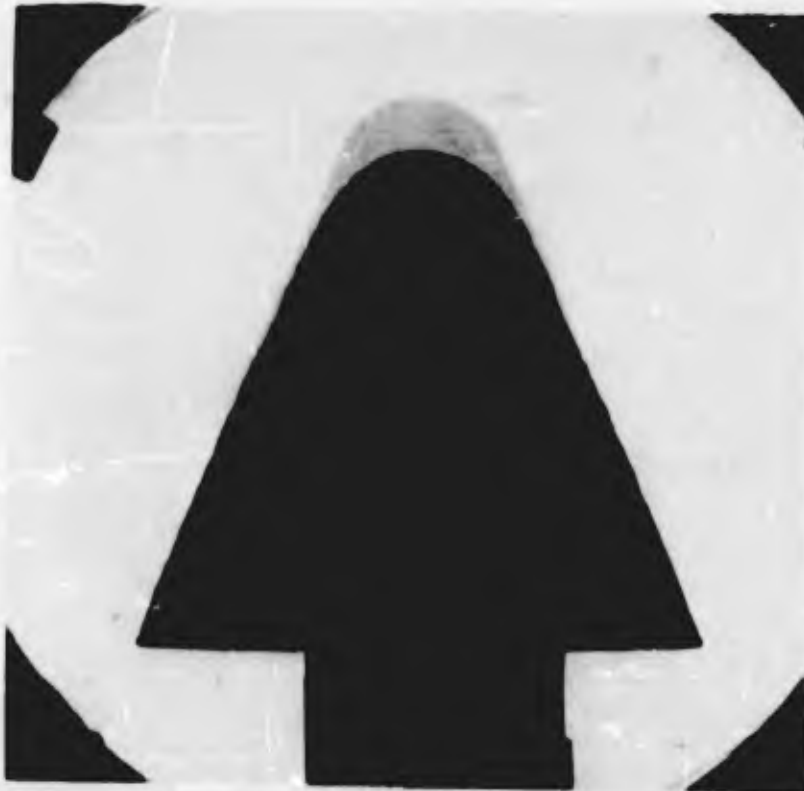
Remarks: This sample shows some degree of surface roughening. During the test a small amount of liquid could be seen leaving the base of the cone. This sample was of a laminar structure, but no delamination was noted during testing. However, a delamination was noticed 1-1/8 inches from the stagnation region upon sectioning of the sample, as shown in Fig. 37.

Figure 36. Sample No. Y-19 after testing.

Figure 37. Sectional view of sample No. Y-19 after testing.

Figure 38. Silhouettes of sample No. Y-19 before and after testing.

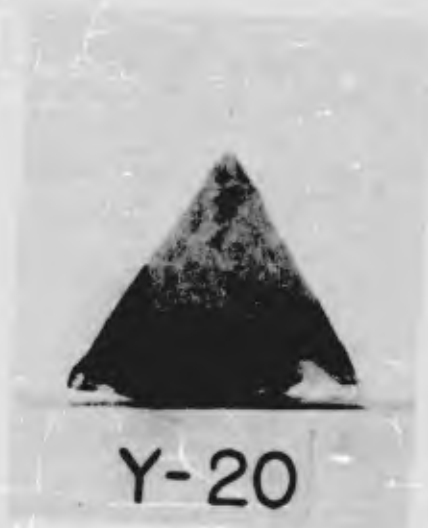
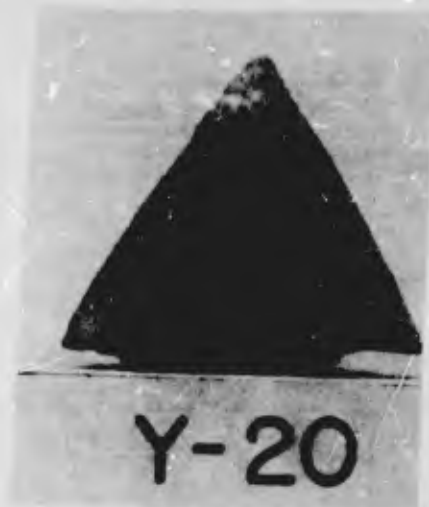
Remarks: Immediately after the start of heating of the sample thin sheets of material began flying off, and this phenomenon continued during the test. The sample very rapidly lost its hemispherical nose and assumed the pure conical shape illustrated by the after silhouette.

Figure 39. Sample No. Y-20 after testing.

Figure 40. Sectional view of sample No. Y-20 after testing.

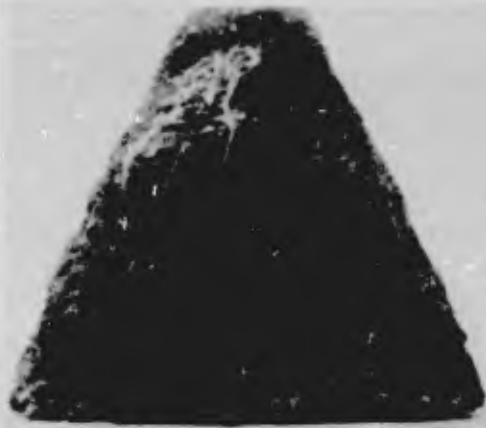
Remarks: The surface of this sample became pockmarked early in the test. Some liquid was noted leaving the base of the cone, and the surface of the sample was left in a considerably roughened condition after the heating.

Figure 42. Sample No. Y-21 after testing.

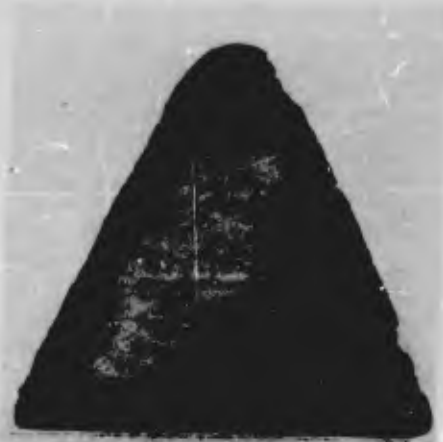
Figure 43. Sectional view of sample No. Y-21 after testing.

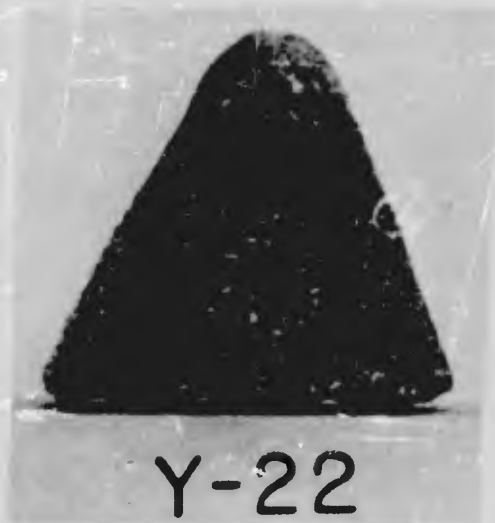
Remarks: A slight amount of pecking was noted early in the heating period, followed by considerable liquid loss from the base of the cone. The surface was left in slightly roughened condition.

Figure 45. Sample No. Y-22 after testing.

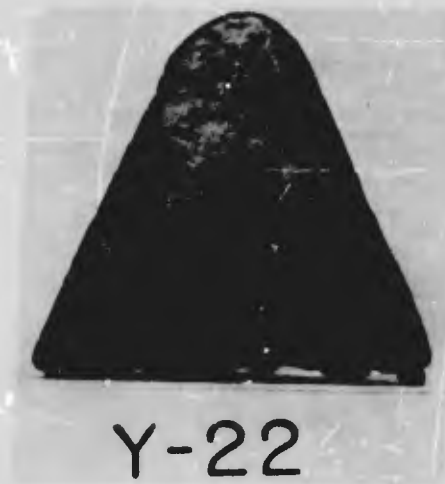
Figure 46. Sectional view of sample No. Y-22 after testing.

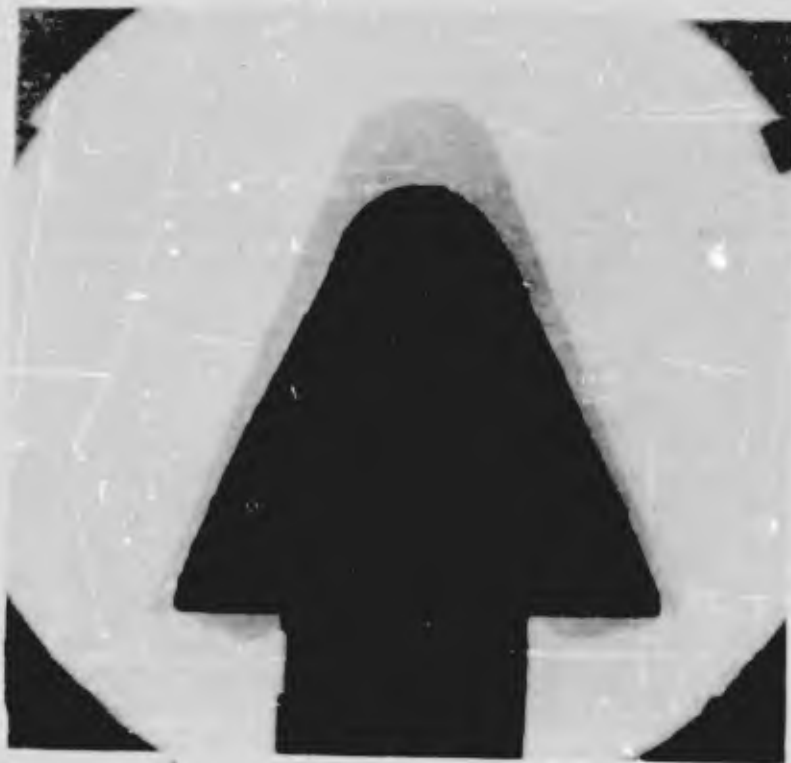
Figure 47. Silhouettes of sample No. Y-22 before and after testing.

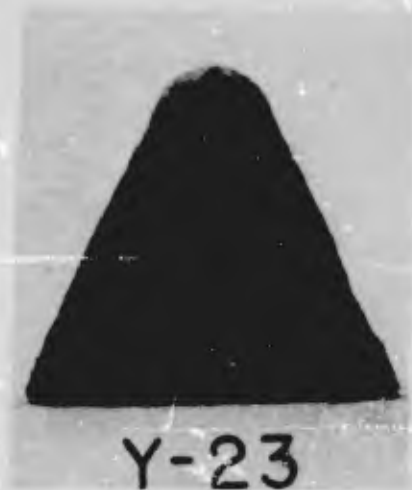
Remarks: This sample evidenced much more pocking, as though internal pressures were causing small pieces of the surface to be popped out. Little liquid was lost from the base of the cone, and the surface was left in somewhat better condition than that of the previous sample.

Figure 48. Sample No. Y-23 after testing.

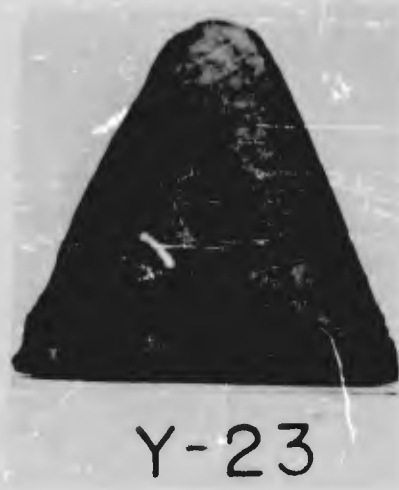
Figure 49. Sectional view of sample No. Y-23 after testing.

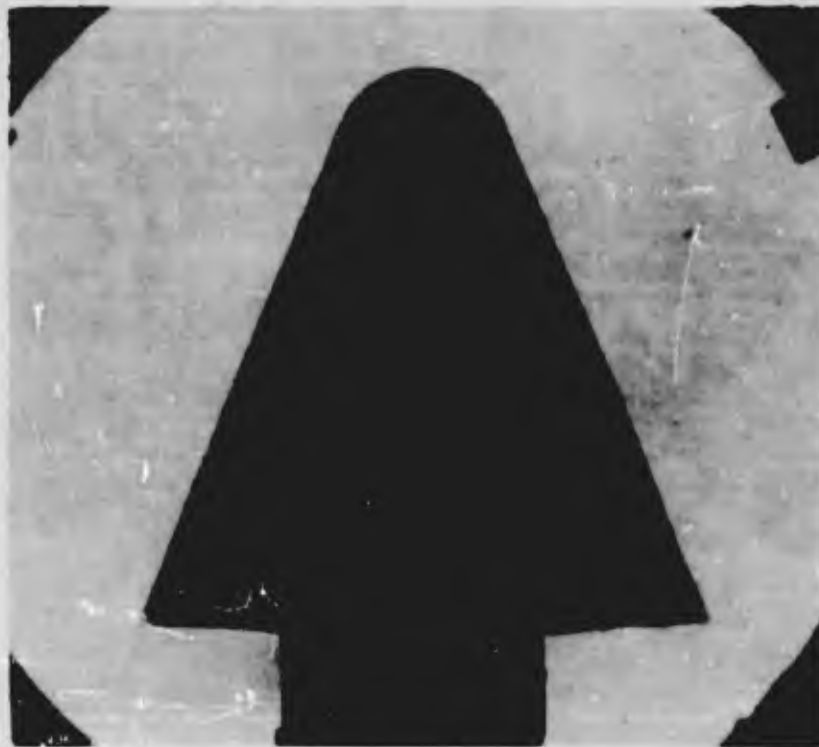
Figure 50. Silhouettes of sample No. Y-23 before and after testing.

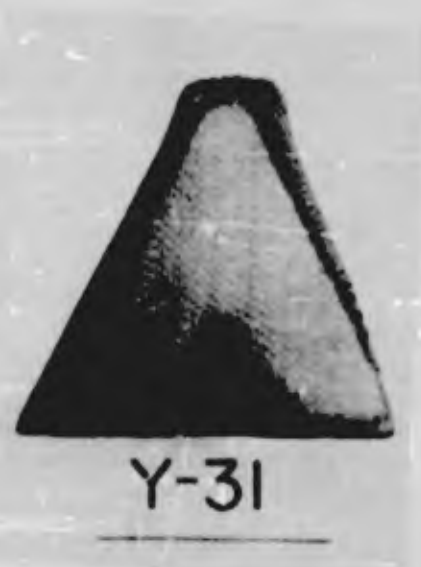
Figure 52. Sectional view of sample No. Y-31 after testing.

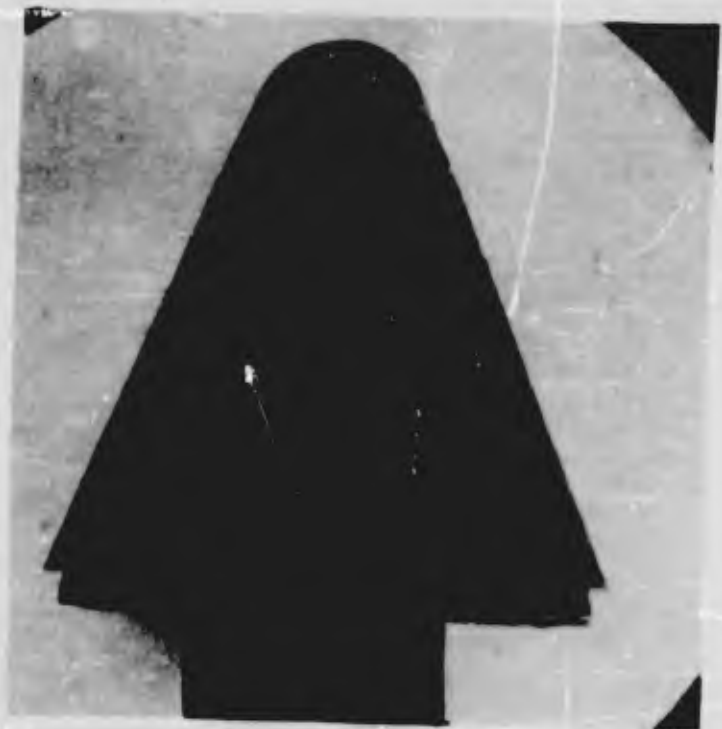
Figure 53. Silhouettes of sample No. Y-31 before and after testing.

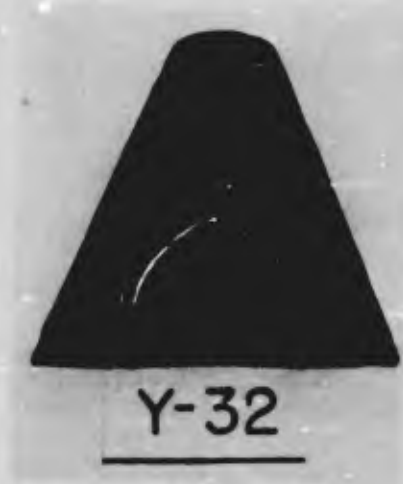
Remarks: Little information is available from the motion pictures because the film was inadvertently overexposed. The view of the sectioned sample shows that a relatively thin outer shell came loose during handling after the test.

Figure 55. Sectional view of sample No. Y-32 after testing.

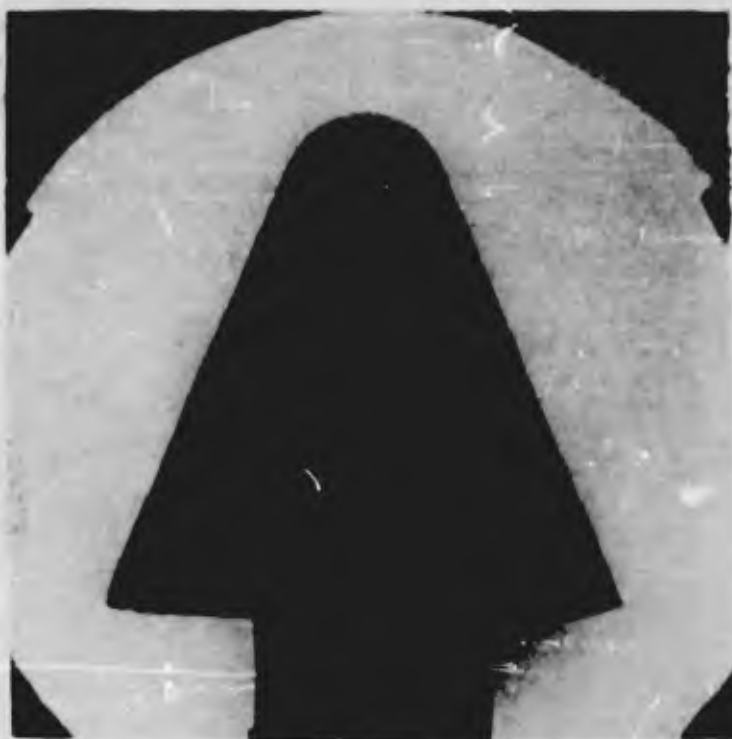
Figure 56. Silhouettes of Sample No. Y-32 before and after testing.

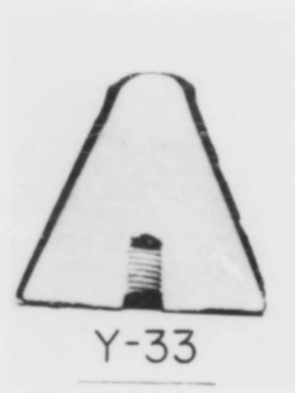
Figure 58. Sectional view of sample No. Y-33 after testing.

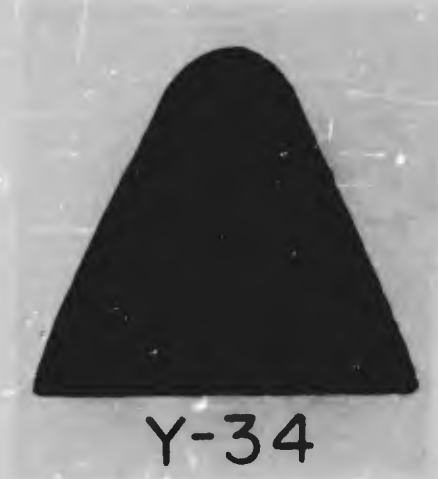
Figure 61. Sectional view of sample No. Y-34 after testing.

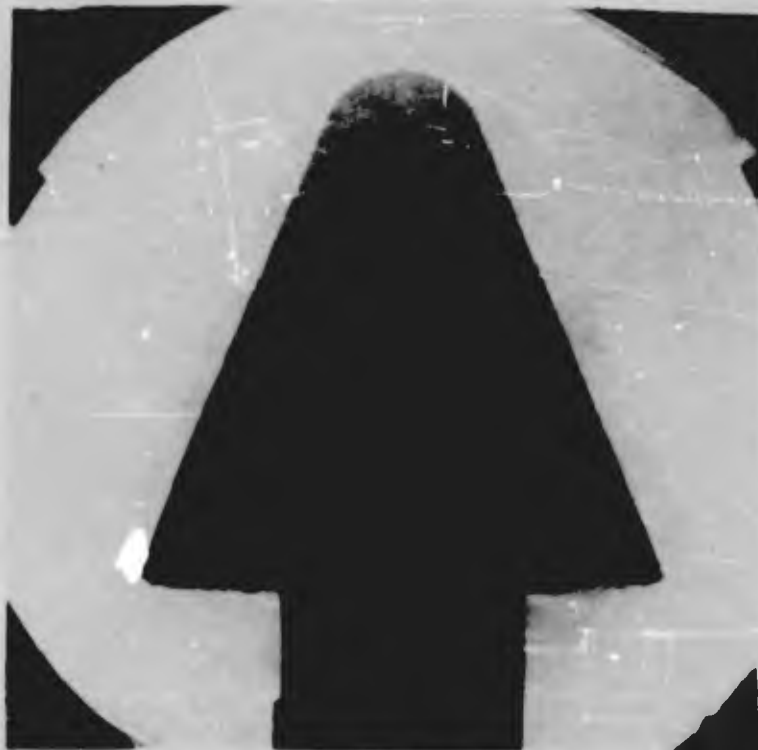
Figure 62. Silhouettes of sample No. Y-34 before and after testing.

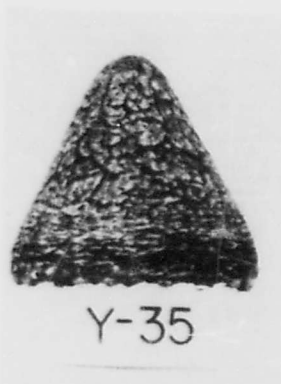
Remarks: The motion pictures show that some liquid was lost from the base of the cone and a relatively thin boundary layer. The surface shows considerable roughening.

Figure 63. Sample No. Y-35 after testing.
