AEDC-TR-67-179

QUALIFICATION TESTS OF
THIOKOL CHEMICAL CORPORATION
TE-M-364-3 SOLID-PROPELLANT ROCKET MOTORS
TESTED IN THE SPIN AND NO-SPIN MODE
AT SIMULATED ALTITUDE CONDITIONS
(PART I — INITIAL PHASE)

D. W. White and J. E. Harris

October 1967

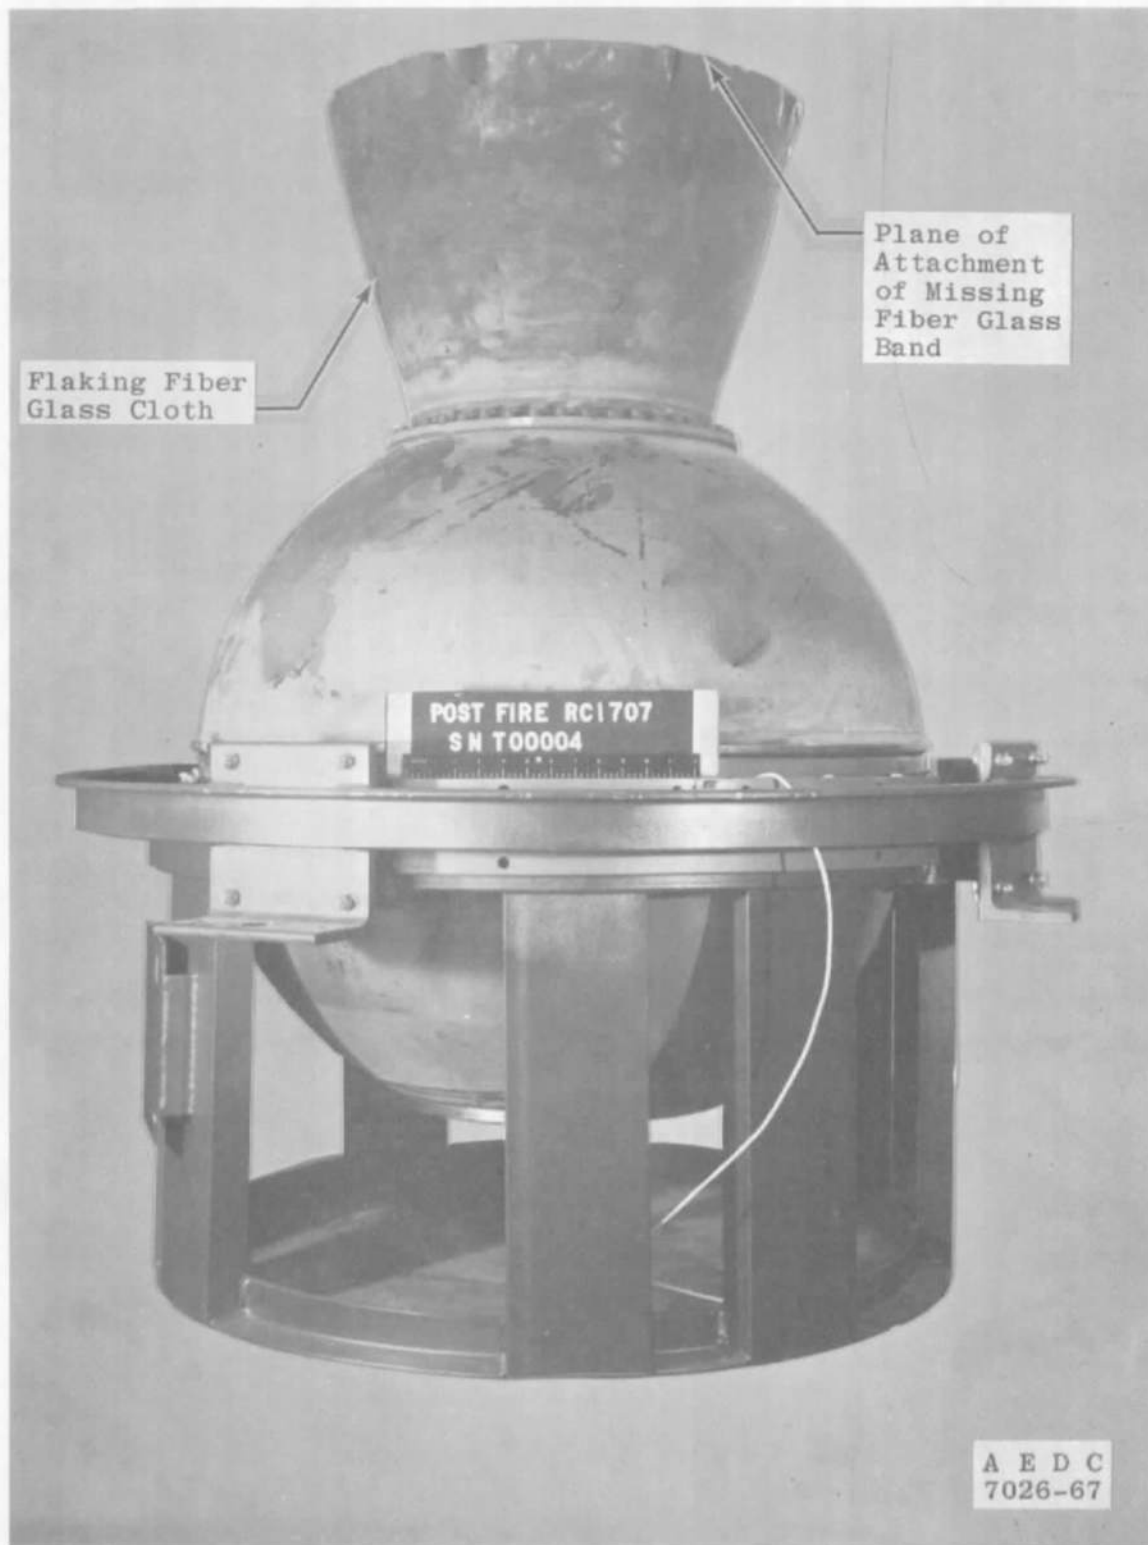
a. Motor S/N T00004

Post-fire photographs of motor S/N T00004 and T00005 are presented in Fig. 16. Post-fire examination of motor S/N T00004 did not reveal any distortion or evidence of thermal damage to the motor case. Post-fire examination of motor S/N T00005 revealed that several hot spots were located on the forward hemisphere just forward of the motor equator on the uninsulated section of the motor case. One small depression was also noted on the motor case in the uninsulated area.

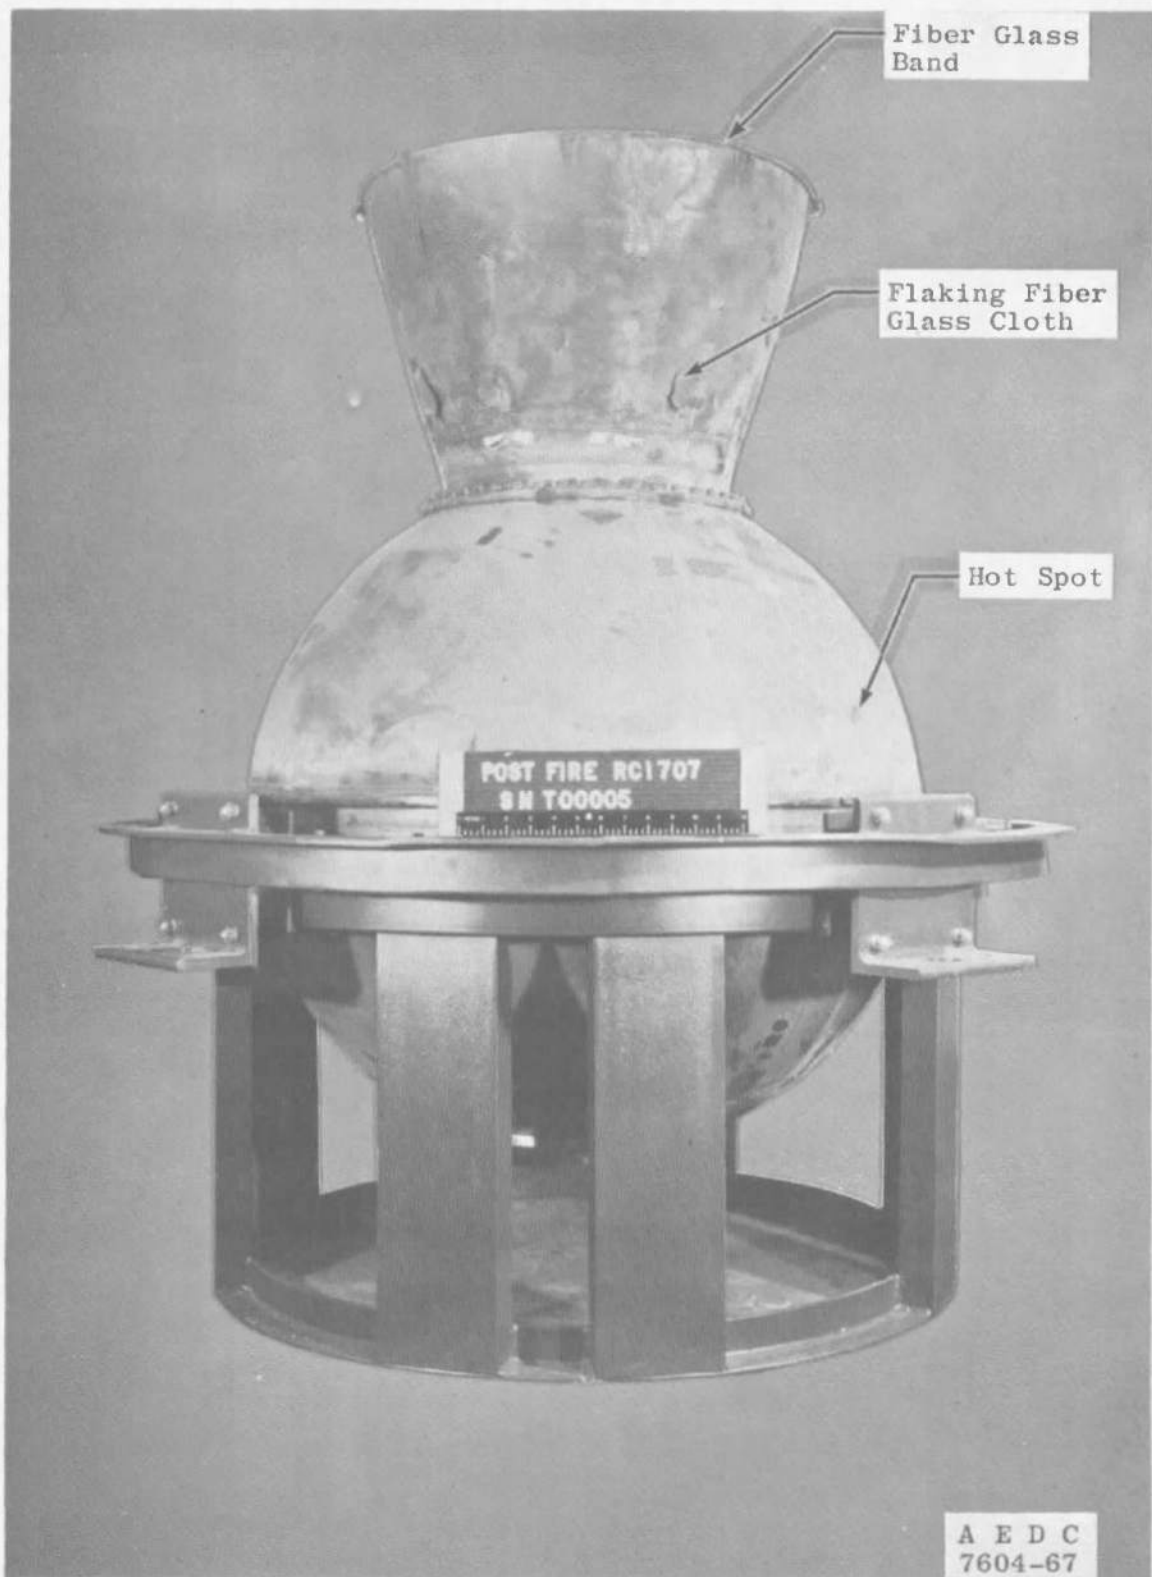
b. Motor S/N T00005

5. Post-fire examination of motor S/N T00005 did not reveal any distortion or thermal damage to the motor case. Post-fire examination of motor S/N T00005 revealed one small depression and several hot spots on the forward hemisphere of the motor case on the uninsulated area. Both nozzle exit cones experienced cracking of the inner layers of carbon cloth phenolic and flaking of the outer layers of glass cloth phenolic.

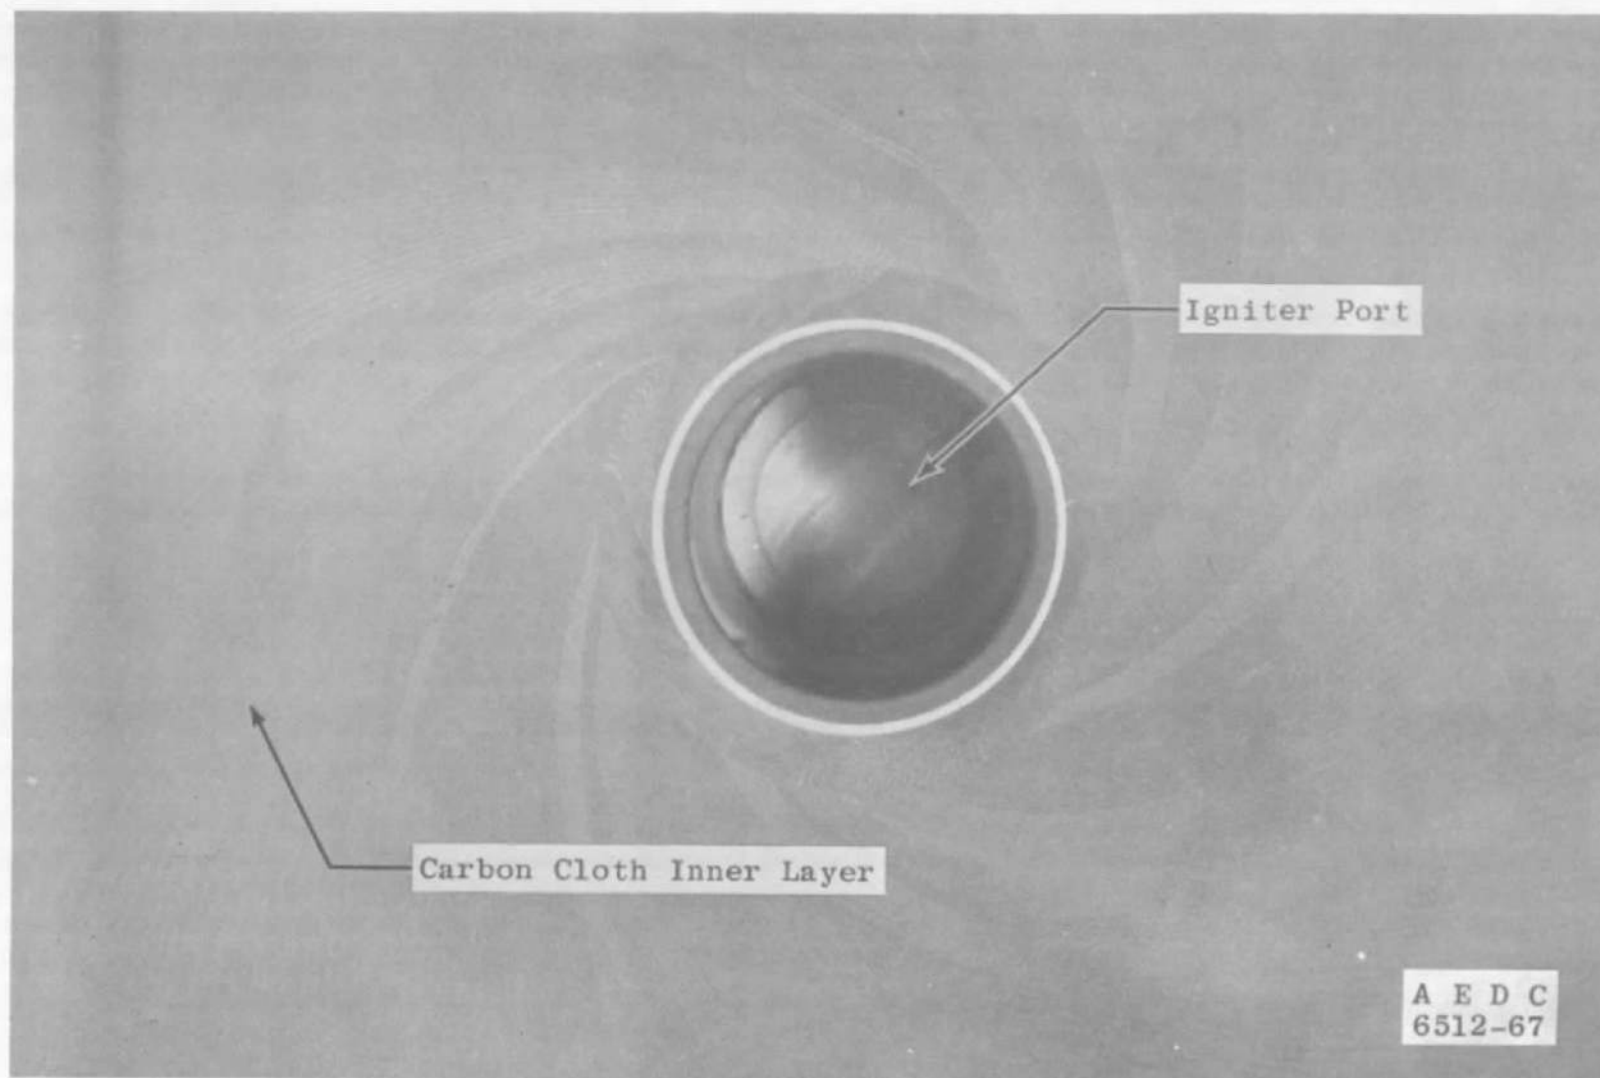
a. Typical Pre-Fire

Both nozzle exit cones experienced thermal damage as was evidenced by cracking of the inner layers of carbon cloth phenolic (Fig. 17) and flaking of the outer layers of glass cloth phenolic (Fig. 18). Nozzle throat measurements indicated that erosion had caused an area increase of 11.4 and 8.96 percent from the pre-fire areas of motor S/N T00004 and T00005, respectively.

Fig. 17 Nozzle Exit Cone Interior Condition
