NRL Report No. R-1452
BuEng. Prob. A2-5

Report of Test

Model RAM Receiving and

Model GN Transmitting Equipments

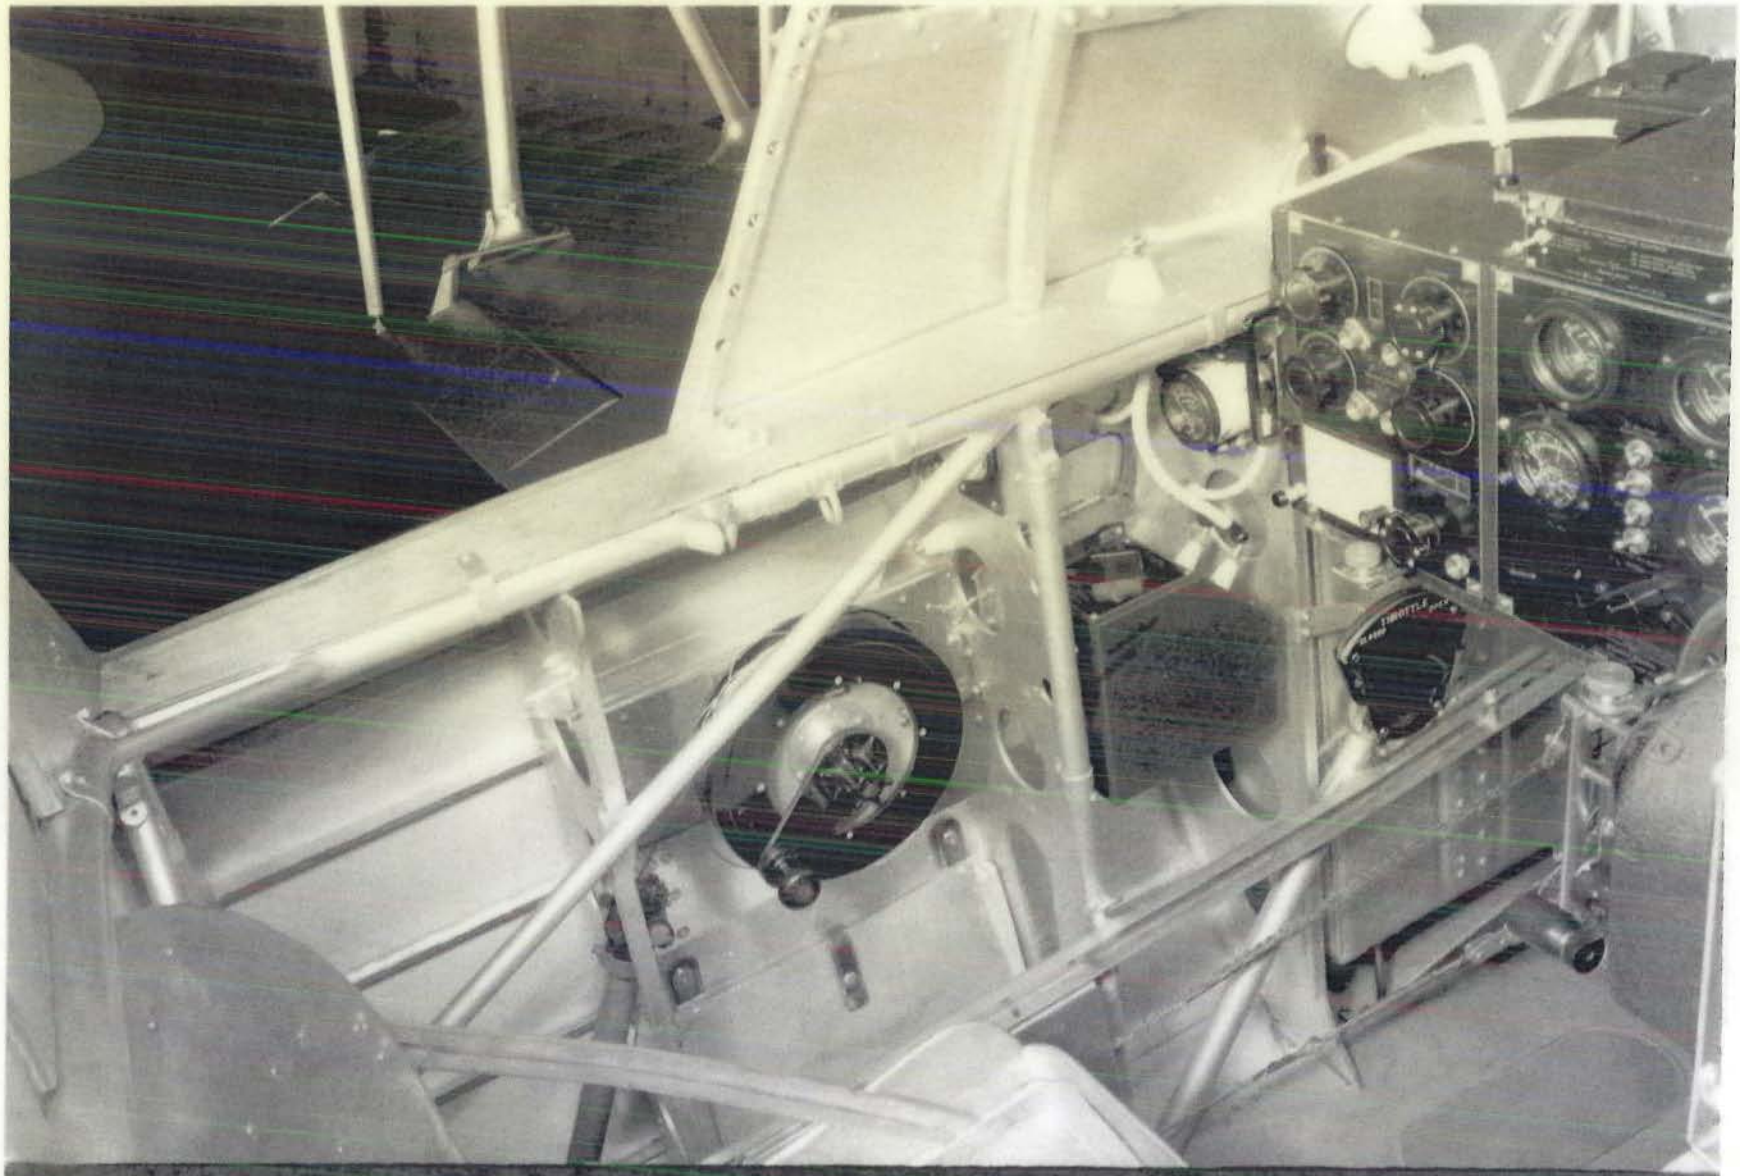
OFFICIAL NAVY PHOTOGRAPH
NOT TO BE USED FOR PUBLICATION
ENCLOSURE (K)

Model XGN Radio Installation in SU-2 Airplane #9104 - Antenna connections with added r.f. ammeter.

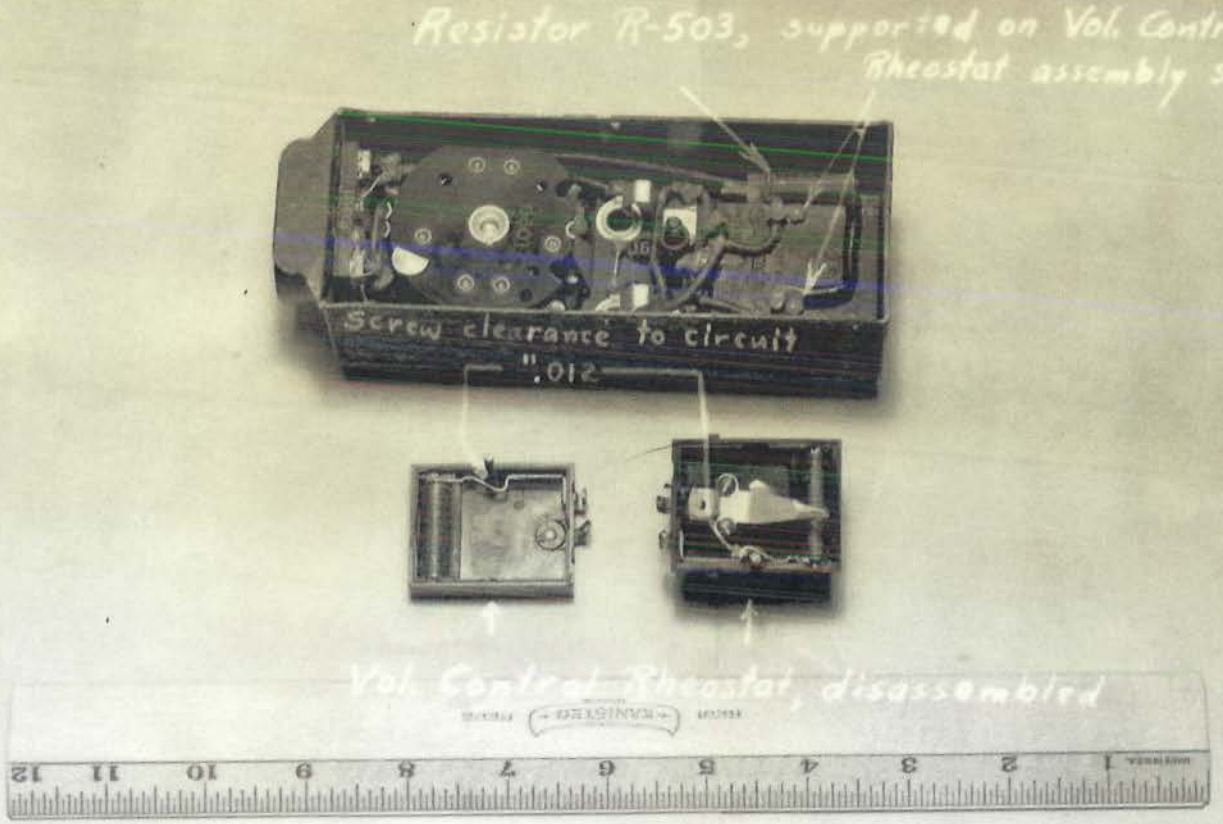
ENCLOSURE (WW)

(XX) Photograph #AN-50885 - Interior of XRAM Radio Receiver Switch Box, showing inadequate resistor mounting.

Interior of XRAM Radio Receiver Switch Box, showing inadequate resistor mounting.
