INTERIM RESEARCH REPORT NO. 15A
for
**HIGH-SPEED DATA PROCESSOR
SYSTEM RESEARCH**

Project LIGHTNING

This report covers the period of
May 31, 1962 to August 31, 1962

Prepared by
Engineering Department
Electronic Data Processing Division
Industrial Electronic Products
RADIO CORPORATION OF AMERICA
Camden, New Jersey

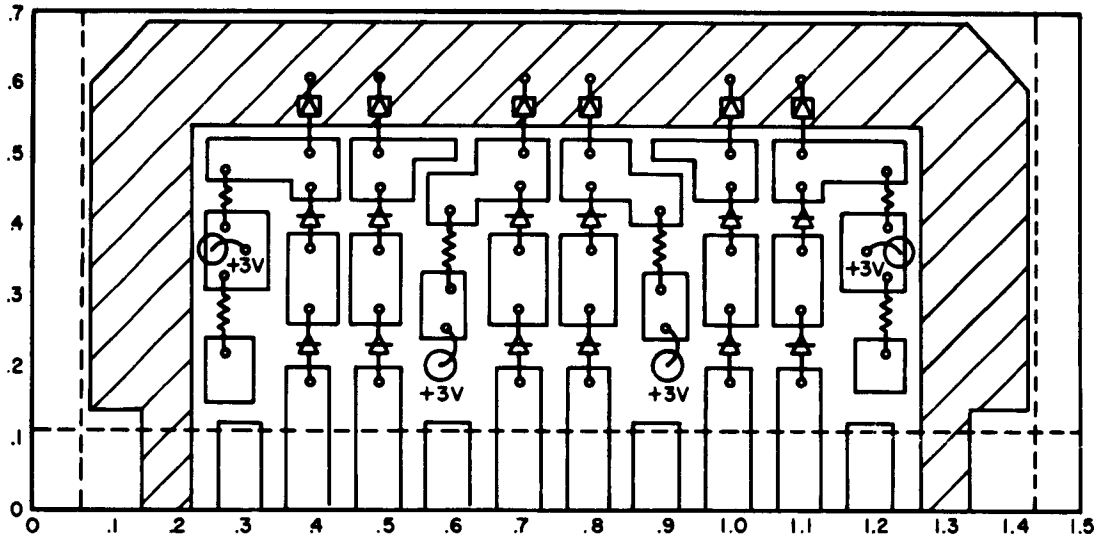
Figure 2-1. Memory Word Wafer

A wafer layout for one-half of a 12-bit word is shown in Figure 2-1. This wafer is now in the process of being built and will soon be under test. The wafer also indicates another step related to devices to increase the reliability of the tunnel diode memory. Since the GaAs tunnel rectifiers used for memory do not operate within specification, these may be replaced by two germanium rectifiers. The supply of germanium rectifiers are presently within the required tight tolerances for memory application. The positioning of the components for each memory cell can be seen in Figure 2-1. These components are two germanium rectifiers, one germanium tunnel diode and one resistor. This layout is such that the word line impedance of 10 ohms per 12-bit word is maintained across the wafer. Wafer frames have been built for the logic subsystem, as transmission line structures with extruded copper transmission lines. The memory will maintain that structure. The extruded copper transmission lines have been made between 3.5 ohms and 50 ohms which includes the values required for memory.

The entire tunnel diode memory is now planned to be built in two wafer frames with memory cells and peripheral circuits constructed on wafers.

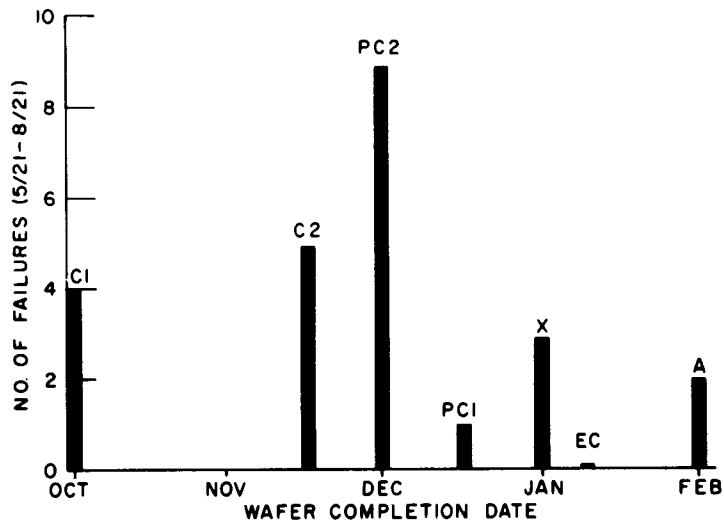
Figure 2-3. Logic Subsystem Failures

It is obvious from the results thus far that solder joints and diodes are the areas of greatest unreliability. Further inspection shows that the major portion of failures are occurring in the two control units and parity check unit #2. These were the first three units constructed. Figure 2-3 shows the number of failures during the period 5/21/62 to 8/21/62 plotted vs. time of wafer completion (the time when all wafers for that particular frame had been constructed and tested). There seems to be a definite break at December, or between the parity check #2 and #1 frames. This becomes more significant when the number of wafers in each frame are considered. The A and X registers are the largest frames, with 66 and 52 wafers, respectively. Next comes control #2 with 32 wafers, control #1 and parity check #1 with 28 each, parity check #2 with 24 and the error counter with 23.

Early in the program of subsystem construction, it was required that all OR rectifiers have a capacitance of 1.0 pf or less. This limit was subsequently changed to 1.5 pf due to the very low yield and fragile junctions which resulted from the 1.0 pf limit. This, then, is a possible answer to the situation since 8 of the 11 diode failures were of OR rectifiers.
