DSTR/501-M62B DYNAMIC INTERFACE CRITICAL SPEED PROBLEM

Detroit Diesel Allison
4700 West 10th Street
Indianapolis, Indiana 46206

Final Report for Period October 1976 - February 1977

4. TITLE (and Subtitle)	5. TYPE OF REPORT & PERIOD COVERED
DSTR/501-M62B DYNAMIC INTERFACE CRITICAL SPEED PROBLEM.	Final Rept October 1976-February 1977
	6. PERFORMING ORG. REPORT NUMBER
	DDA - EDR 9127

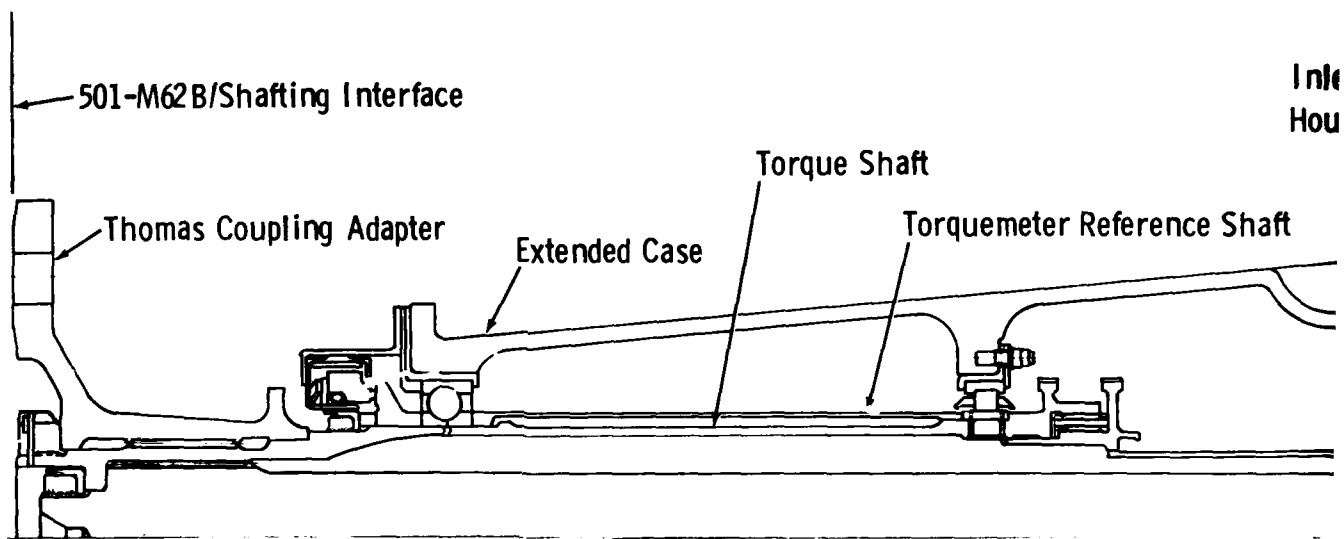
Figure 4. Layout of Modified 501-M62B Extended Torquemeter Configuration.

torquemeter configuration is shown in Figure 4. Structural analyses of the extended torquemeter configuration indicated the following end flexibilities:

This implies an end translational stiffness of 112,000 lb/in.

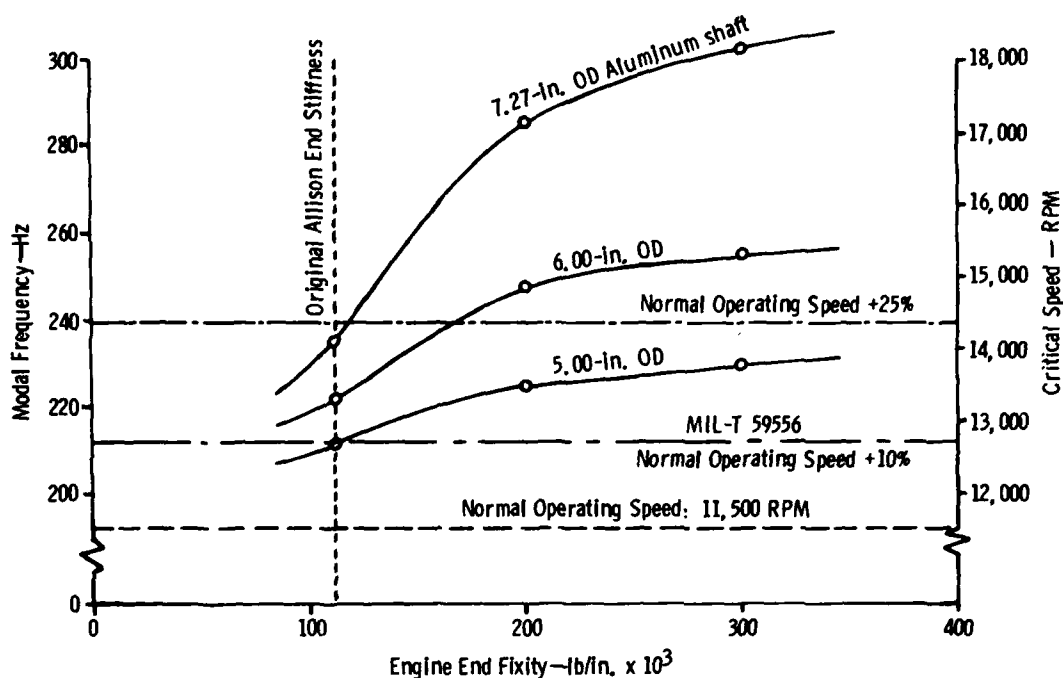
Figure 5. DSTR Shafting Trade-off Study Between Shaft Diameter and
Engine End Stiffness.

A reduction in shaft and Thomas coupling diameter was desired to further reduce the engine inlet airflow blockage and reduce weight. A preliminary study of alternatives was performed by BV in which critical speeds of the shafting were computed for various combinations of shaft diameter and total effective engine end fixity. The model used in the computations was basically a beam element representation of the shafting with local flexibilities included to account for the Thomas couplings. The shaft/engine interface end of the shafting was considered tied to ground with a translational stiffness equal to the engine end stiffness. The mixbox was modeled at the other shaft end. Results of this study are shown in Figure 5. It shows that an extremely high stiffness would be needed at the engine for a 5.0-inch-diameter shaft to have a sufficient margin above the 11,500 rpm design speed. A 7.27-inch-diameter shaft has acceptable critical speed margin with the original estimate of end stiffness, but this large diameter exhibits unacceptable inlet blockage. The compromise diameter of 6.0 inches would require an engine end stiffness increase from 112,000 lb/in. to 150,000 lb/in. This would increase the critical speed margin to 20 percent above the design speed. DDA agreed to modify the engine to achieve the desired end stiffness of 150,000 lb/in. by changing the torquemeter housing from aluminum to steel. A subsequent analysis with revised shaft adapters, Thomas coupling size, and shaft tube length; improved mixbox idealization, and 150,000 lb/in. effective end stiffness revealed that the critical speed was actually 15,300 rpm, or 33 percent above the design speed. The resulting critical speeds and associated mode shapes are shown in Figure 6. Although it is not entirely obvious from the mode shapes, the second shafting critical speed is the first mode which has significant participation of the torquemeter. This mode incorporates substantial whirl of the torquemeter housing and some shaft bending, and is very sensitive to output shaft coupling weight and unbalance. This is the mode with which the remainder of these discussions

are concerned. The true character of this mode will become evident as
the discussions continue. It is important to note that an analysis of the
shafting system was performed using engine data required by Military
Specification MIL-E-8593A. The analysis indicated an acceptable con-
figuration.

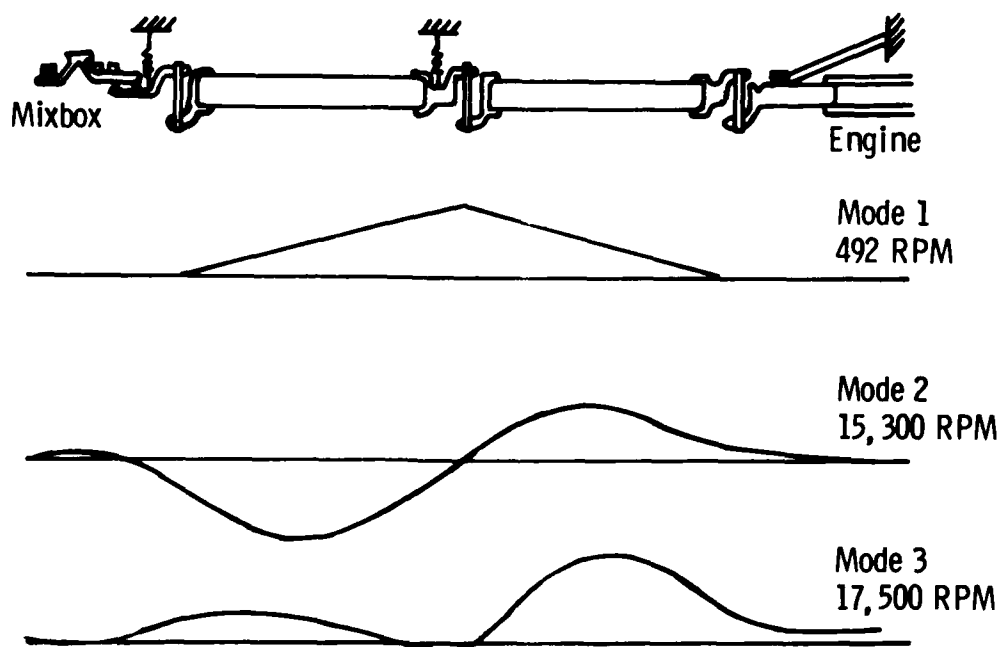
Figure 6. Critical Speed Analysis Results for Initial 6-Inch-Diameter
          Shafting Configuration—End Stiffness 150,000 Lb/In.

are summarized in Figure 7. Since the design speed was 11,500 rpm,
the results of this analysis indicated an unacceptable drive train when
coupled with the engine.

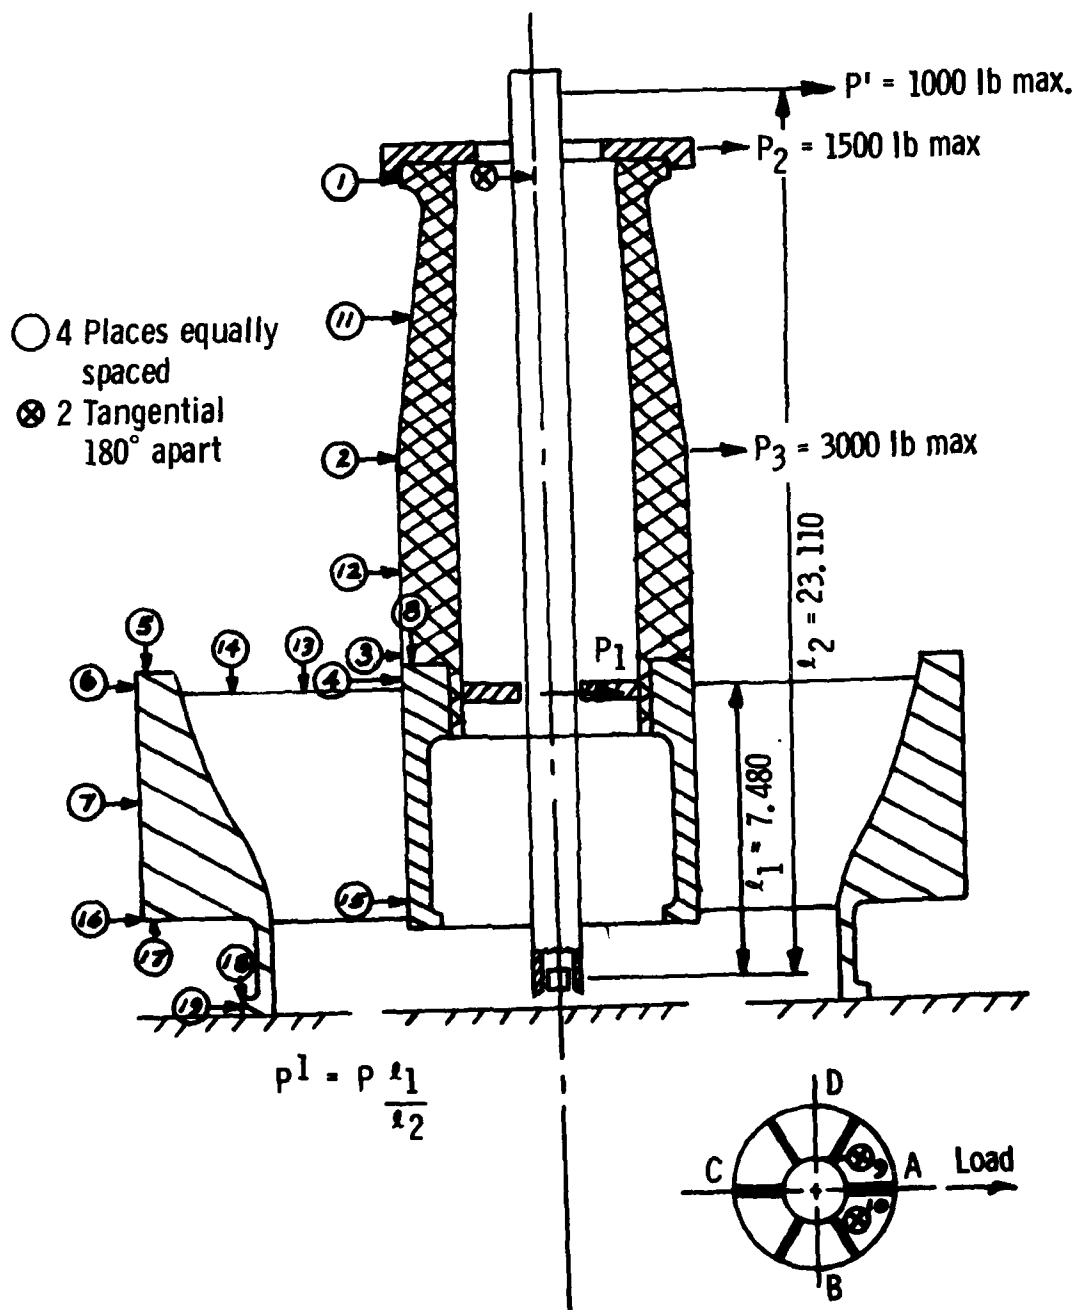
Figure 9.   Test Setup for Torquemeter Housing Static Load Test.

A sketch of the test setup is shown in Figure 9. Loads were applied using hydraulic rams at incremented load levels through 1500 pounds. Figure 10 indicates the deflections noted for a 1500-pound load applied at the forward flange of the housing. The resulting spring rate was determined to be 156,000 lb/in. The finite element model depicted in Figure 11 was used to compute the spring rate analytically. A rate of 167,000 lb/in. was computed, showing very good correlation. The finite element model was deemed sufficiently accurate to be used for further analysis. The original estimates of the engine end stiffness were based on front and rear torquemeter bearing spring rate estimates of 650,000 lb/in. and 750,000 lb/in., respectively. A subsequent analysis of these bearings, using a computer program provided by SKF Industries, Incorporated, indicated the rates to be closer to 1.6×10^6 lb/in. for the load range anticipated at the bearings. The newer bearing rates were incorporated in the analysis. Using the finite element model of the engine inlet housing and torquemeter housing, and coupling the torquemeter shaft through bearing flexibilities, the effective end stiffness translational spring rates were computed for the configurations listed in Table 2.

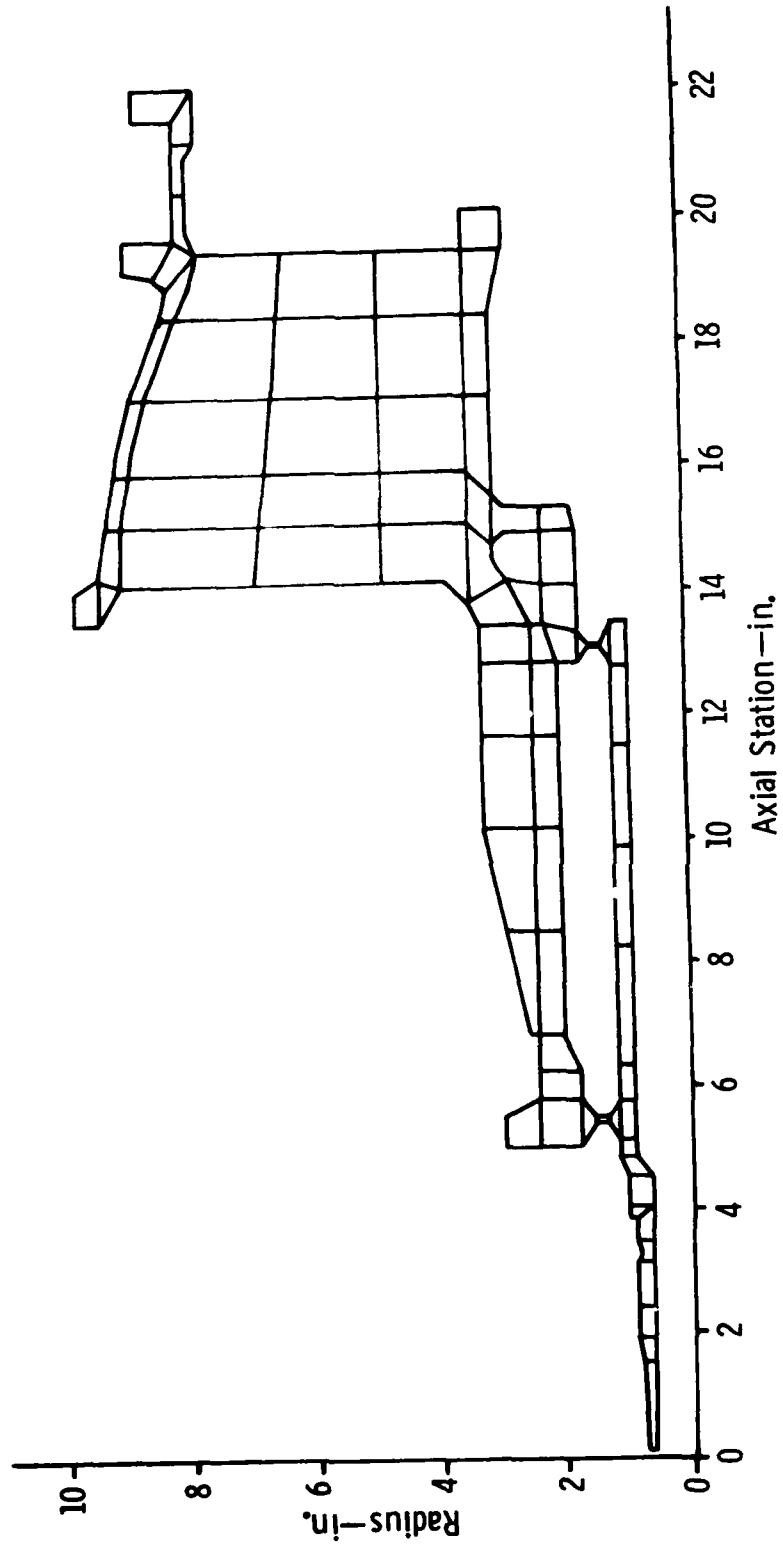
Figure 11. Finite Element Model of Engine Inlet and Torquemeter Housing.

The discovery of a dynamic interface problem was made after engine hardware was committed. The engine inlet frame and torquemeter extended case hardware was available. A static deflection test was ordered to verify some of the spring rates which were estimated and used in the foregoing analyses. In addition, a finite element idealization of the structure was performed for correlation purposes and to serve as a vehicle for evaluating structural design changes.

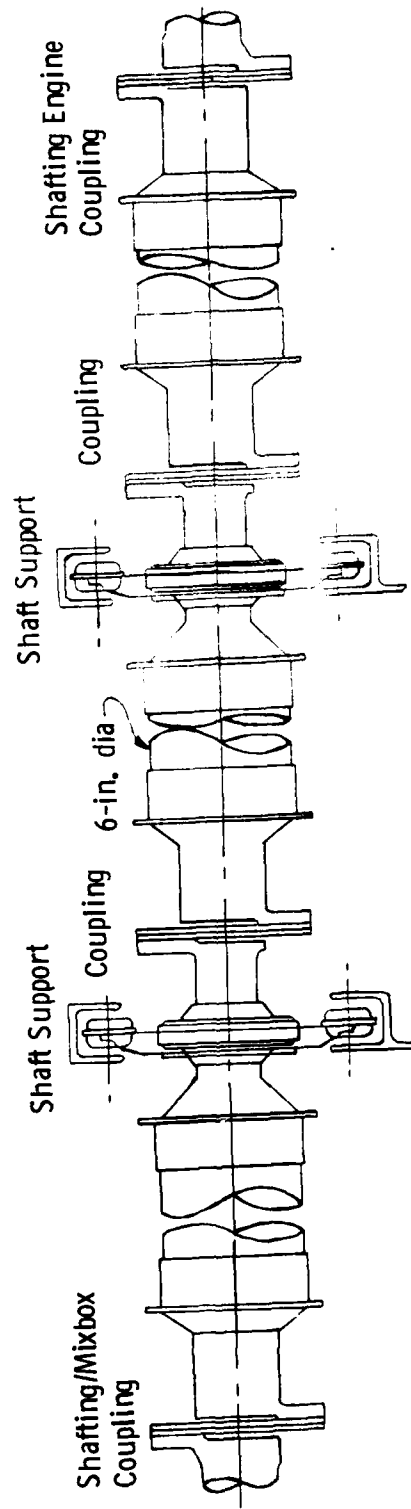
Figure 12. Sketch of Three-Section DSTR Shafting Arrangement.

2. Three-section shaft—This shafting configuration is characterized as having three equal 6-inch-diameter shafting lengths separated by Thomas couplings. A sketch of the design is shown in Figure 12.

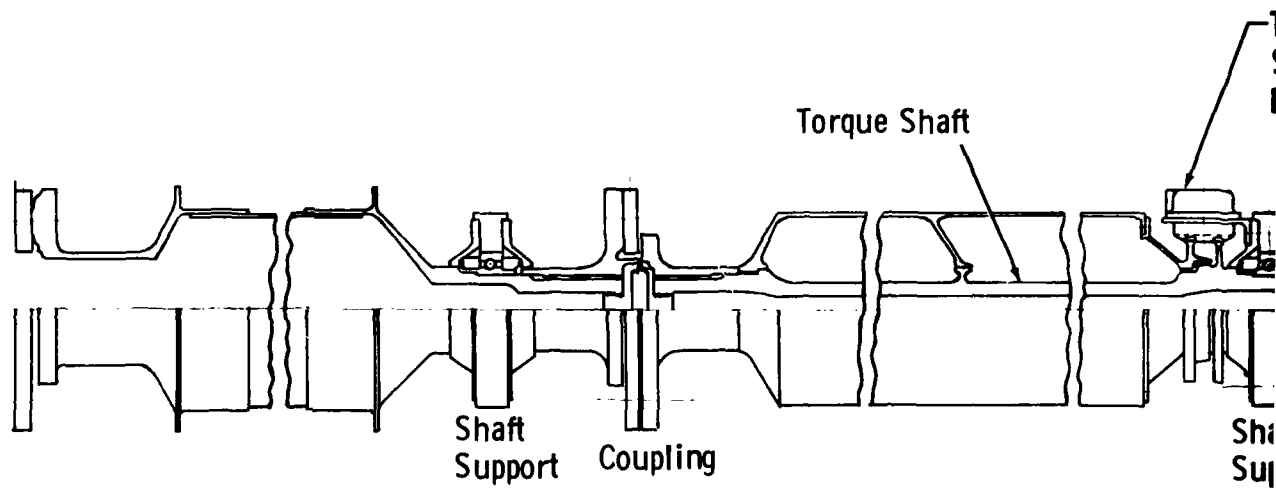
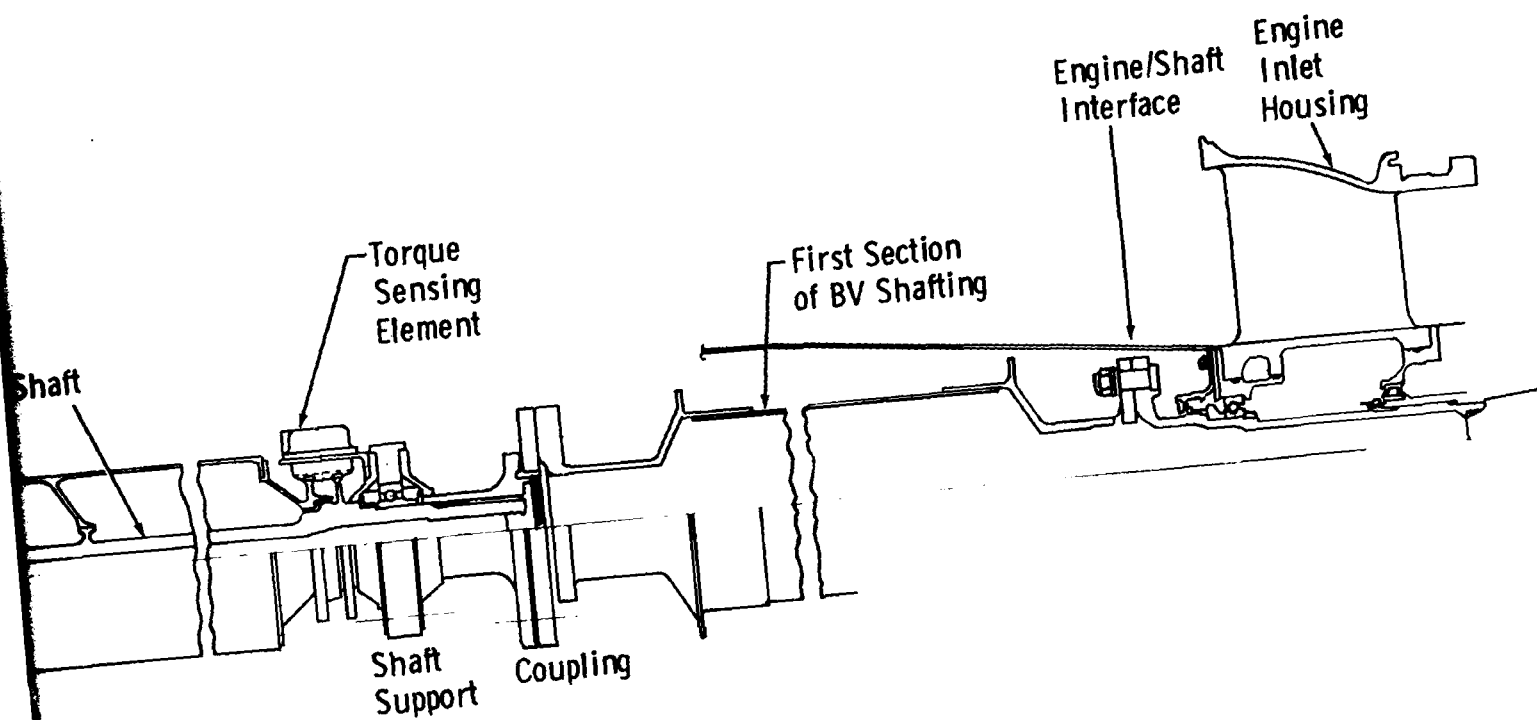
Figure 13. Layout of Shaft-Contained Torquemeter Configuration.

One approach which offered some promise was to include the torquemeter as part of the BV shafting. That allowed the engine/shafting interface to be moved as close to the engine as possible. A sketch of one of the designs considered is shown in Figure 13. This shows a three-section shaft with the torquemeter contained in the center section and a Thomas coupling overhang of 3.03 inches from the engine inlet. Analyses of this configuration were performed as a function of the amount of Thomas coupling overhang. One analysis showing promise featured an overhang of 2.4 inches.

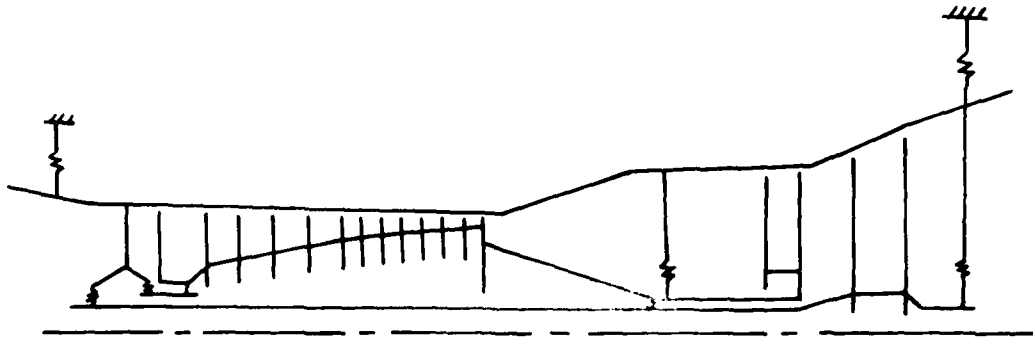
Figure 14. Geometric Representation of 501-M62B Engine Analytical
            Model.

A geometric representation of the analytical model of the engine is shown
in Figure 14 for reference. This sketch is presented to define the axial
datum. The calculated critical speeds and associated mode shapes are
shown in Figure 15. The first three modes are basically rigid body modes
of the shafting and engine. The fourth mode is one of HP rotor conical
whirl with the predominant motion occurring at the turbine. The next
mode is the critical mode showing large motion at the engine/shafting in-
terface with large LP rotor participation. This mode provides a margin
of 23.4 percent over the normal design speed. The effect of the Thomas
coupling overhang on critical speeds was determined and is shown in
Figure 16. This illustration shows that two modes are involved. For
large overhangs the critical mode is a simple cantilever mode of the ex-
tended torquemeter, which occurs near the normal design speed. An-

other mode, which is a coupled LP shaft and output shaft mode, occurs
near 15,000 rpm. As the Thomas coupling overhang is reduced, these

two modes (eigenvectors) approach the same frequency (eigenvalue). As

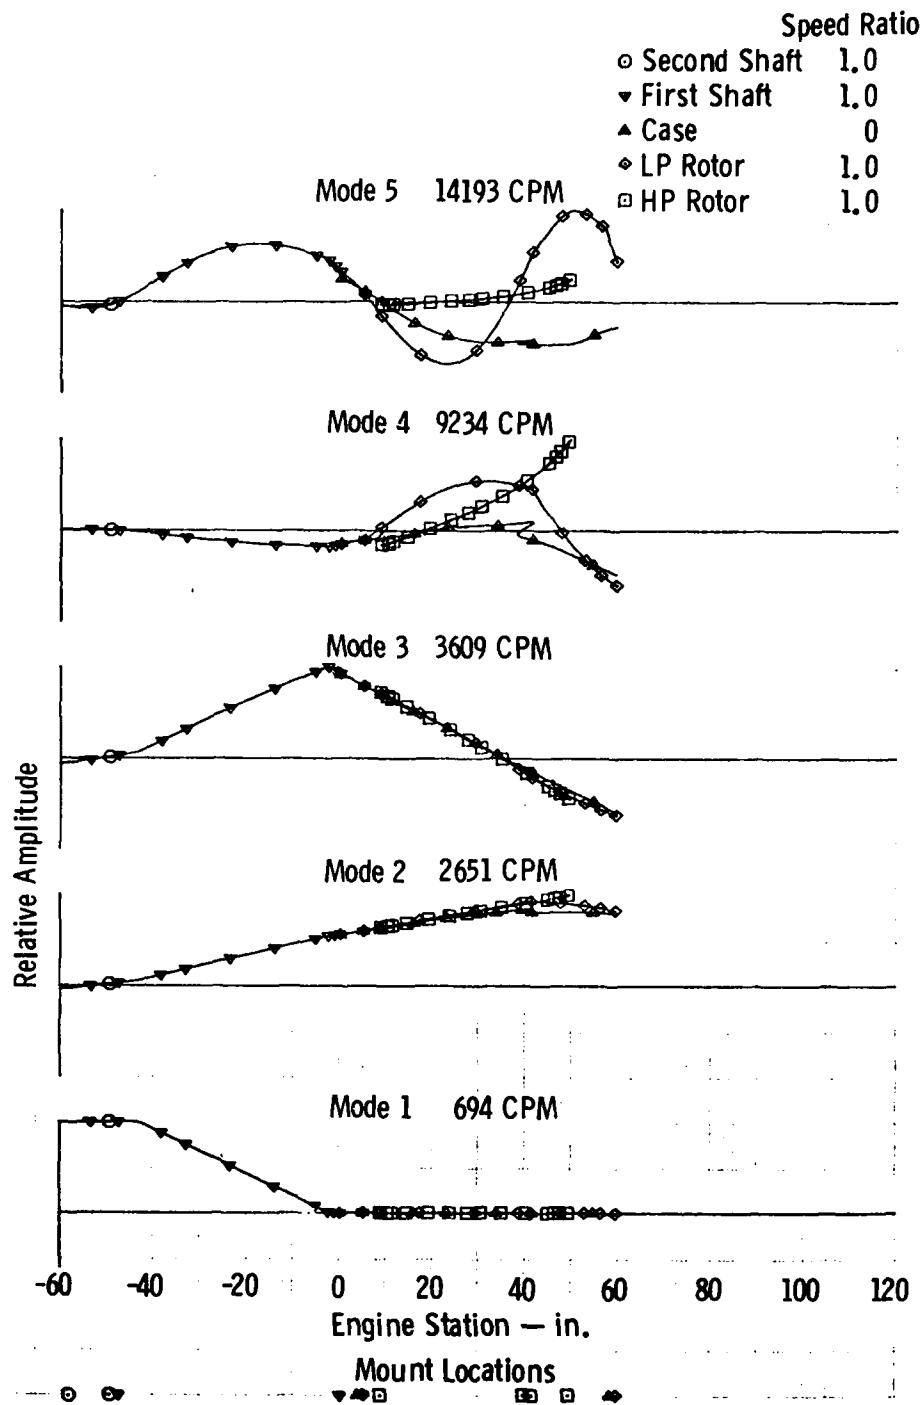
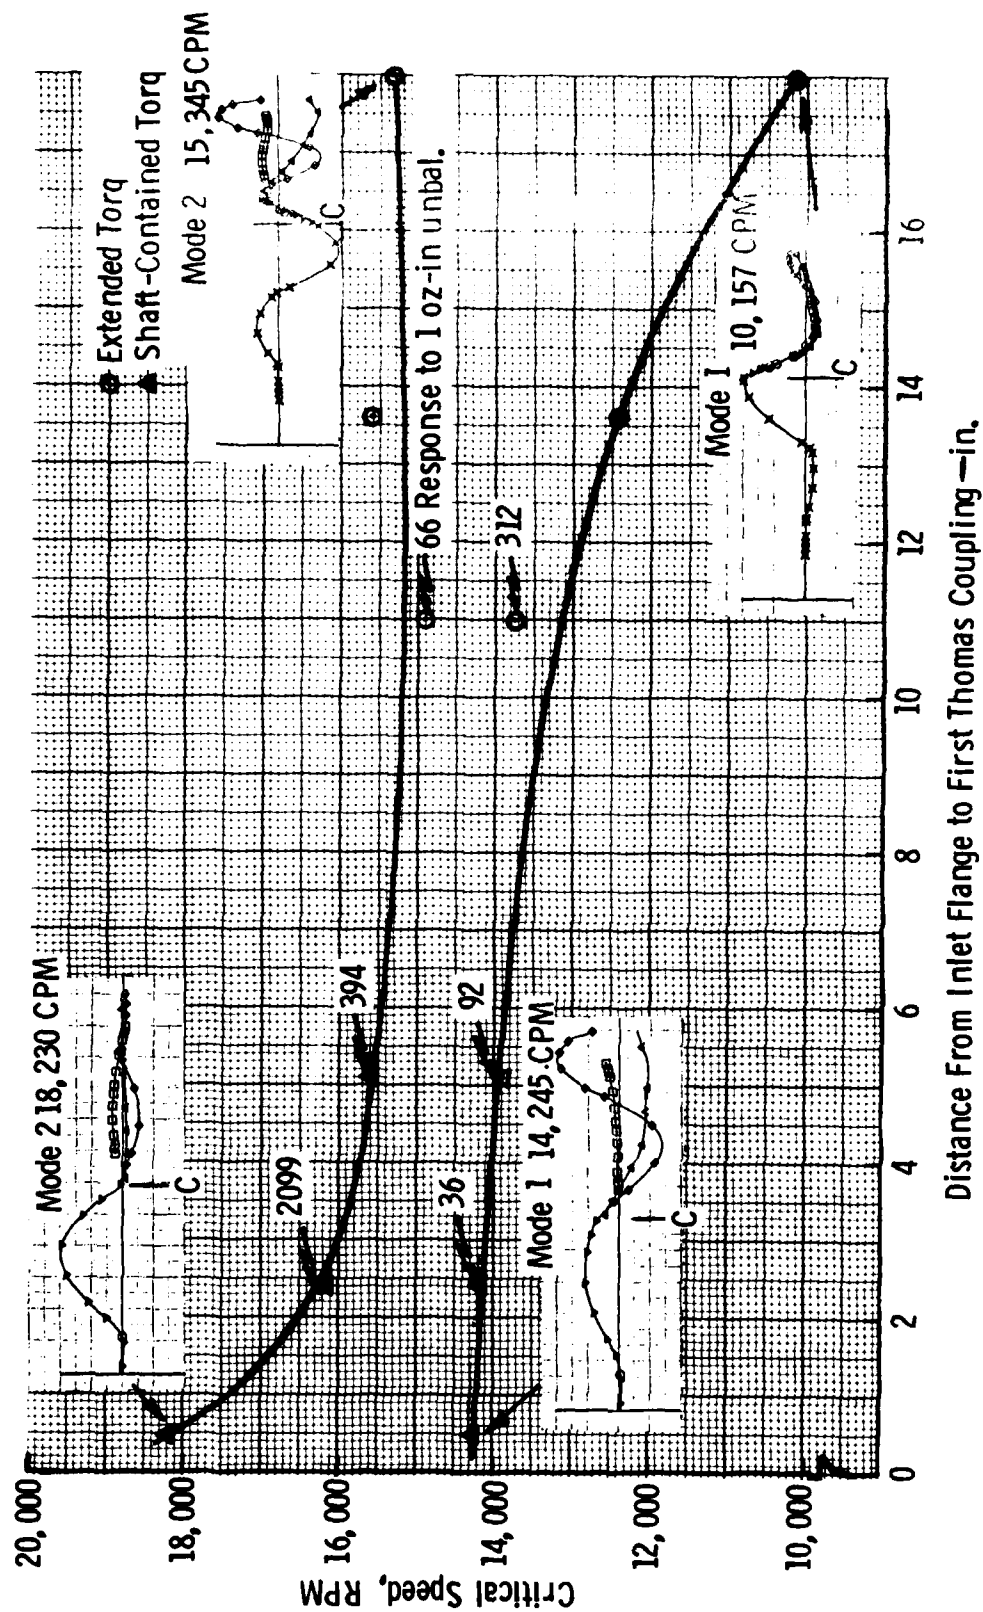
Figure 15. Critical Speeds for 2.4-Inch Thomas Coupling Overhang.

the overhang is further reduced, the eigenvalues exchange eigenvectors.
In this way the modes effectively cross. It can be seen that Mode 2 be-
comes Mode 1 as the Thomas coupling overhang is reduced from 17 inches
to 0.5 inch. Similarly, Mode 1 becomes Mode 2. This means that the
first critical speed above design speed cannot be raised above about
14,300 rpm by decreasing overhang alone. Some other design change
must also occur.

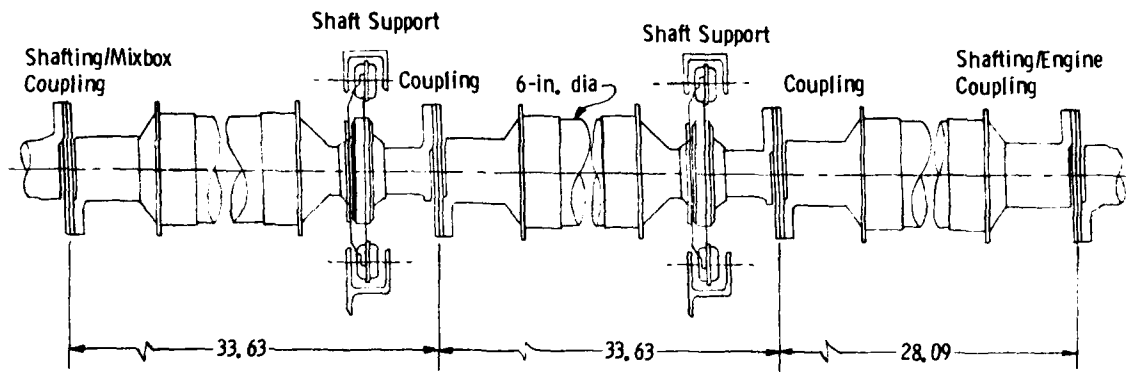
Figure 17. Final 501-M62B Design.

The results of the design investigations indicated a shortened torque-meter/three section shafting configuration would provide acceptable vibratory characteristics. An engine design was synthesized to minimize the overhang of the engine/shafting interface and still maintain sufficient torquemeter accuracy. This was accomplished by shortening the torque-meter and containing it within the engine. Figure 17 presents the final 501-M62B design. As can be seen, the Thomas coupling shaft adapter be-came an integral part of the engine assembly and is overhung 5.274 inches from the engine inlet flange. The BV shafting from the engine to mixbox is similar to the three-section design shown in Figure 12. The sketch of Figure 18 indicates the distribution of shaft lengths. The first section of shaft is 28.085 inches long (center-to-center of the flexible coupling) and is attached to the engine output flange which serves as the engine side of the first flexible coupling adapter.

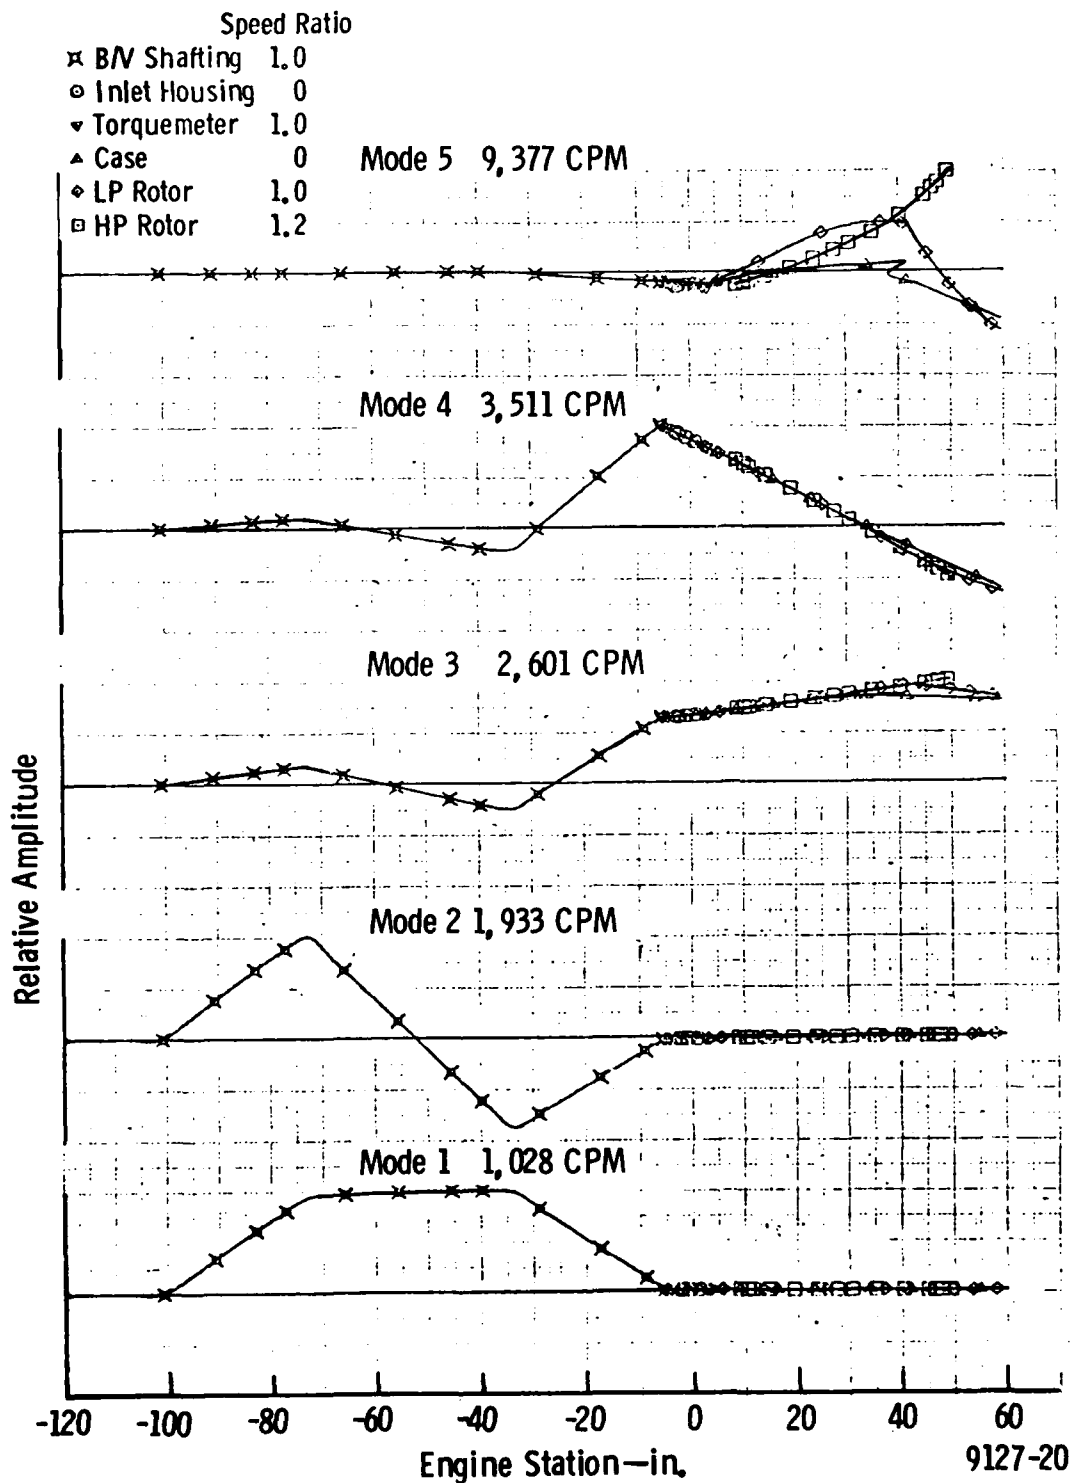
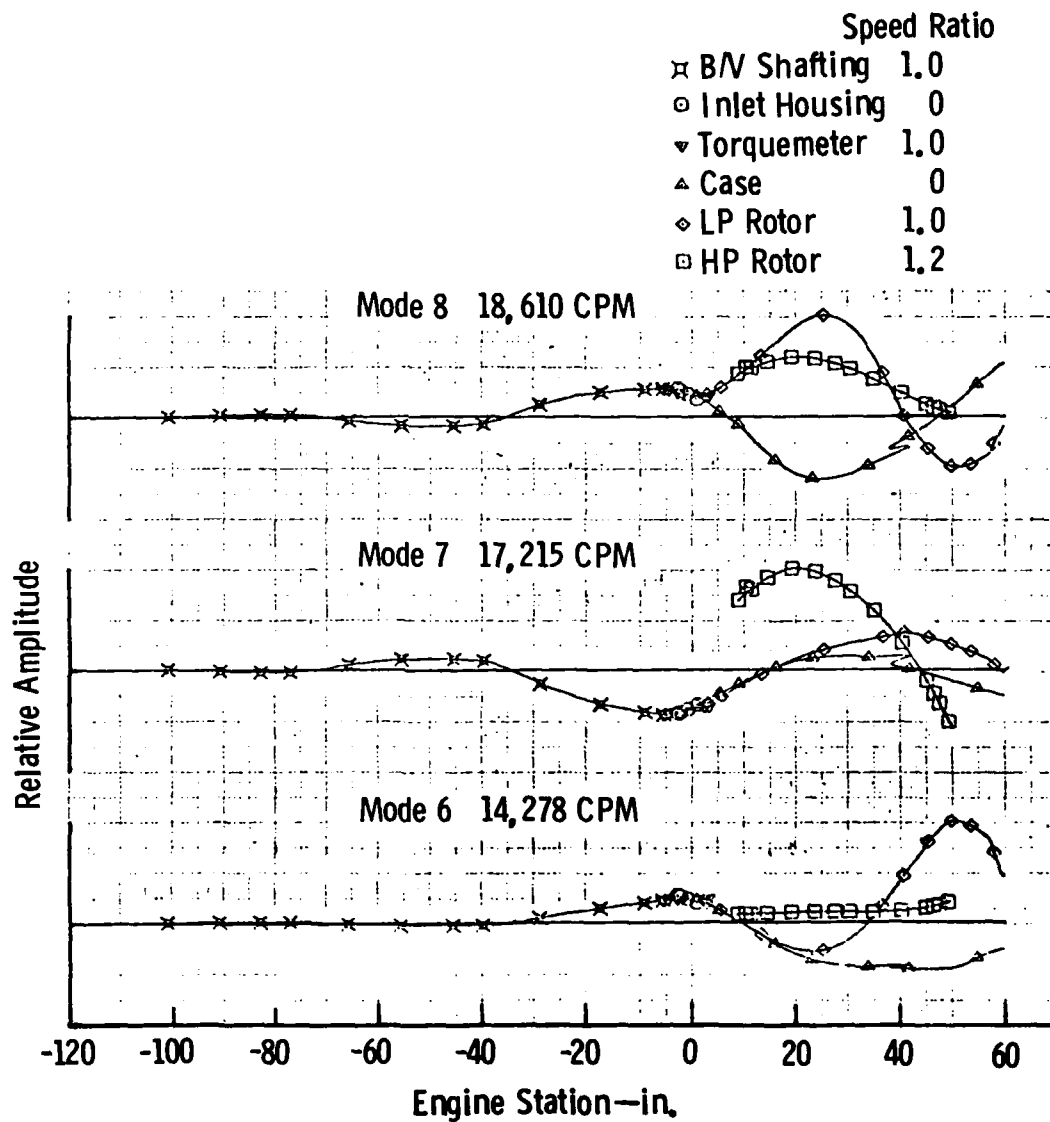
Figure 20. 501-M62B/Shafting System Dynamics (AL-18584)—Nominal Design. (Sheet 1 of 2)

A coupled engine/shafting analysis of the final configuration was per-formed. Figure 19 shows the geometric representation of the analytical model. Figure 20 shows the computed critical speeds and associated mode shapes. The first mode above design speed occurs at a critical speed of 14,278 rpm, providing a margin of 24.1 percent. The sensitivity of this mode to an unbalance of 1 ounce-inch at the Thomas coupling nearest the engine is shown in Figure 21. Less than 10 mils of double amplitude displacement is predicted at the resonance, which falls outside the operating range of the rotor system. This configuration is a viable design.

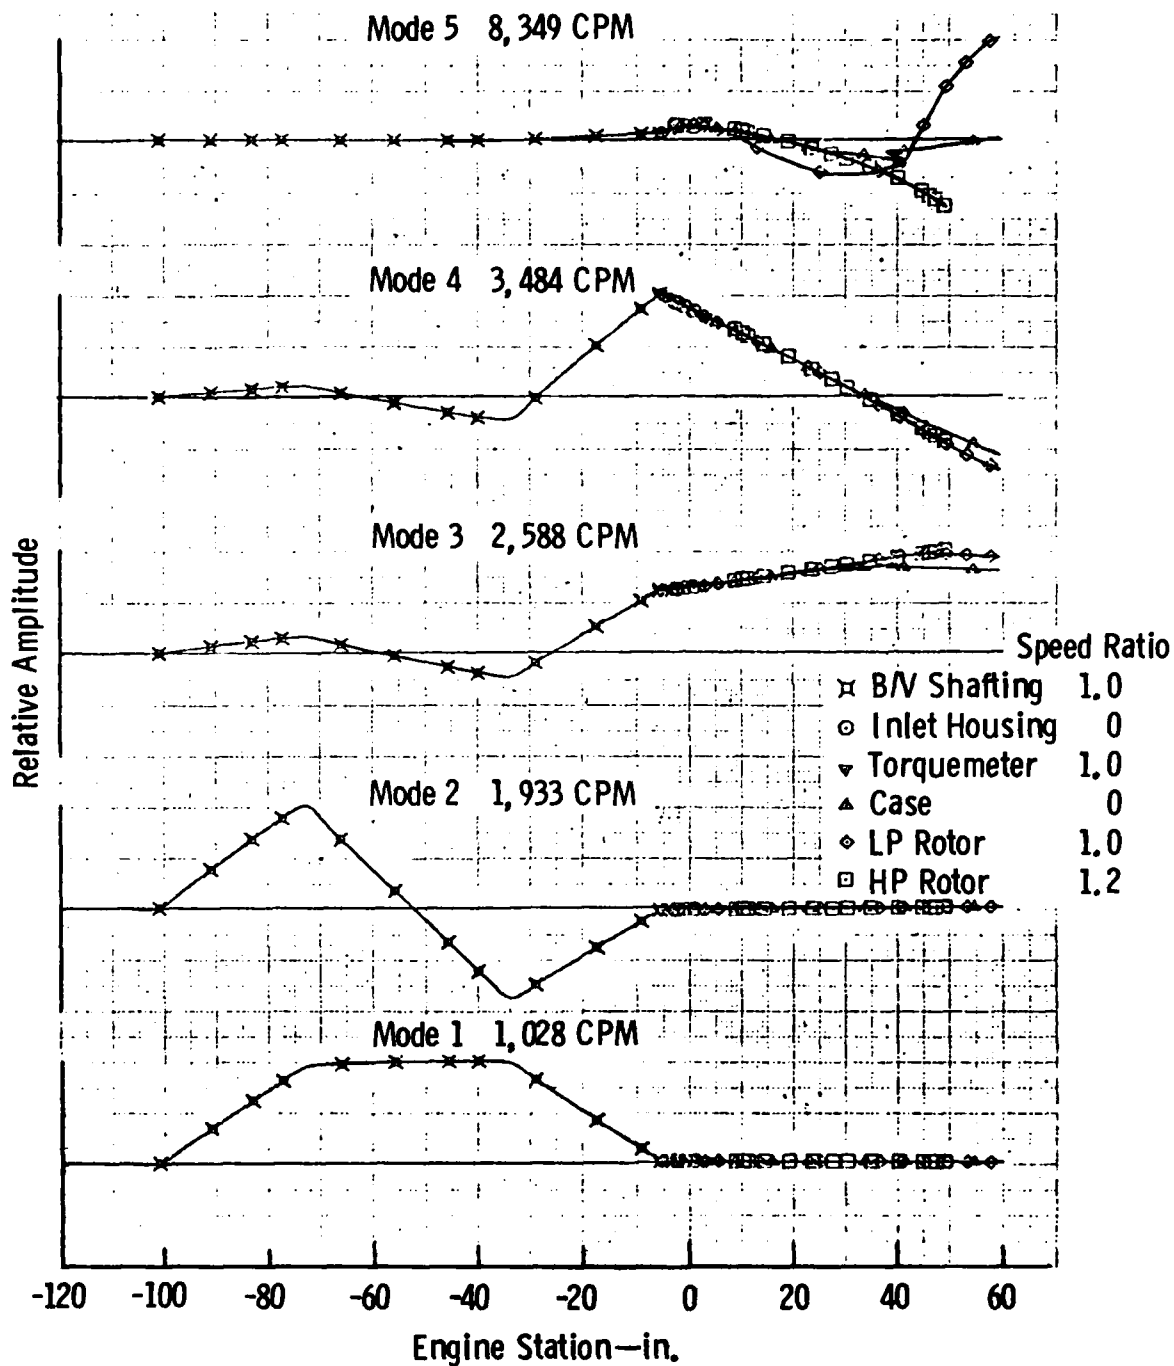
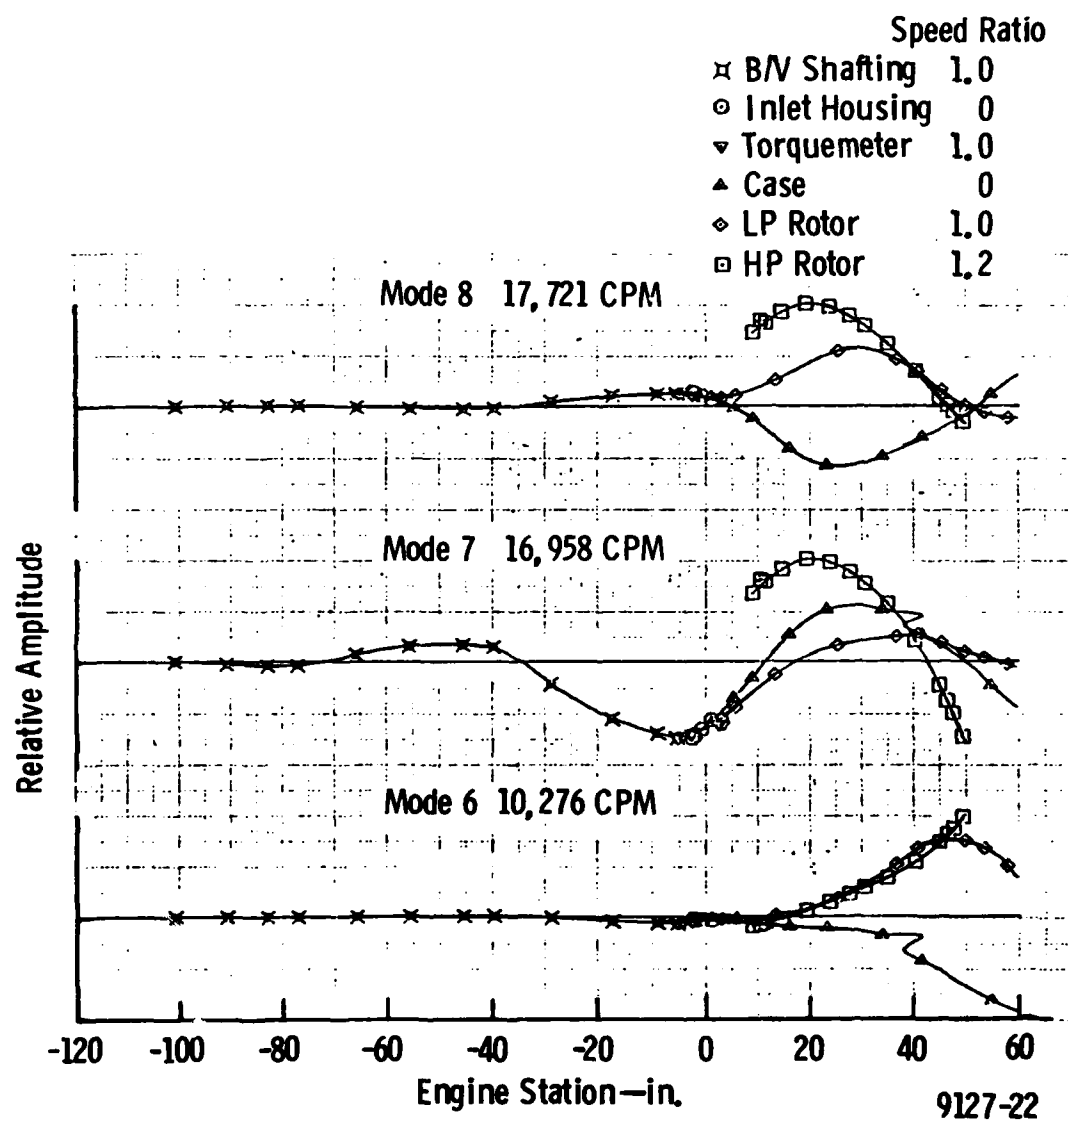
Figure 22. 501-M62B/Shafting System Dynamics (AL-18584)—With Isolator. (Sheet 1 of 2)

Since the frequency of the first mode above design speed is of such im-portance, the design/analysis was audited to identify potential weaknesses and to formulate contingency modifications. It was determined that once the shafting and torquemeter designs were fixed, the most influential parameter on determining the frequency of the critical mode was the spring rate of the rear turbine bearing support. The spring rate assumed in the analyses was 500,000 lb/in. A slightly reduced rate could place the critical mode in the operating range of the LP rotor. Therefore, a controlled mechanical flexibility (isolator) was designed for use as a con-tingency design. Figure 22 shows the effect of employing a spring rate of 100,000 lb/in. The effect has been to reduce the frequency of the 14,278 rpm mode to 8349 cpm without significantly altering the other modes; the mode would be encountered only during starting and shut-down transients. The first mode above the normal LP design speed occurs at 16,958 rpm,
