RESEARCH AND DEVELOPMENT TECHNICAL REPORT
DELET-TR-78-2

THERMAL CYCLE TESTING OF 7-SEGMENT LIGHT EMITTING DIODES (LED) DISPLAYS
(Test Evaluation)

M. Robert Miller
Electronics Technology & Devices Laboratory

January 1978

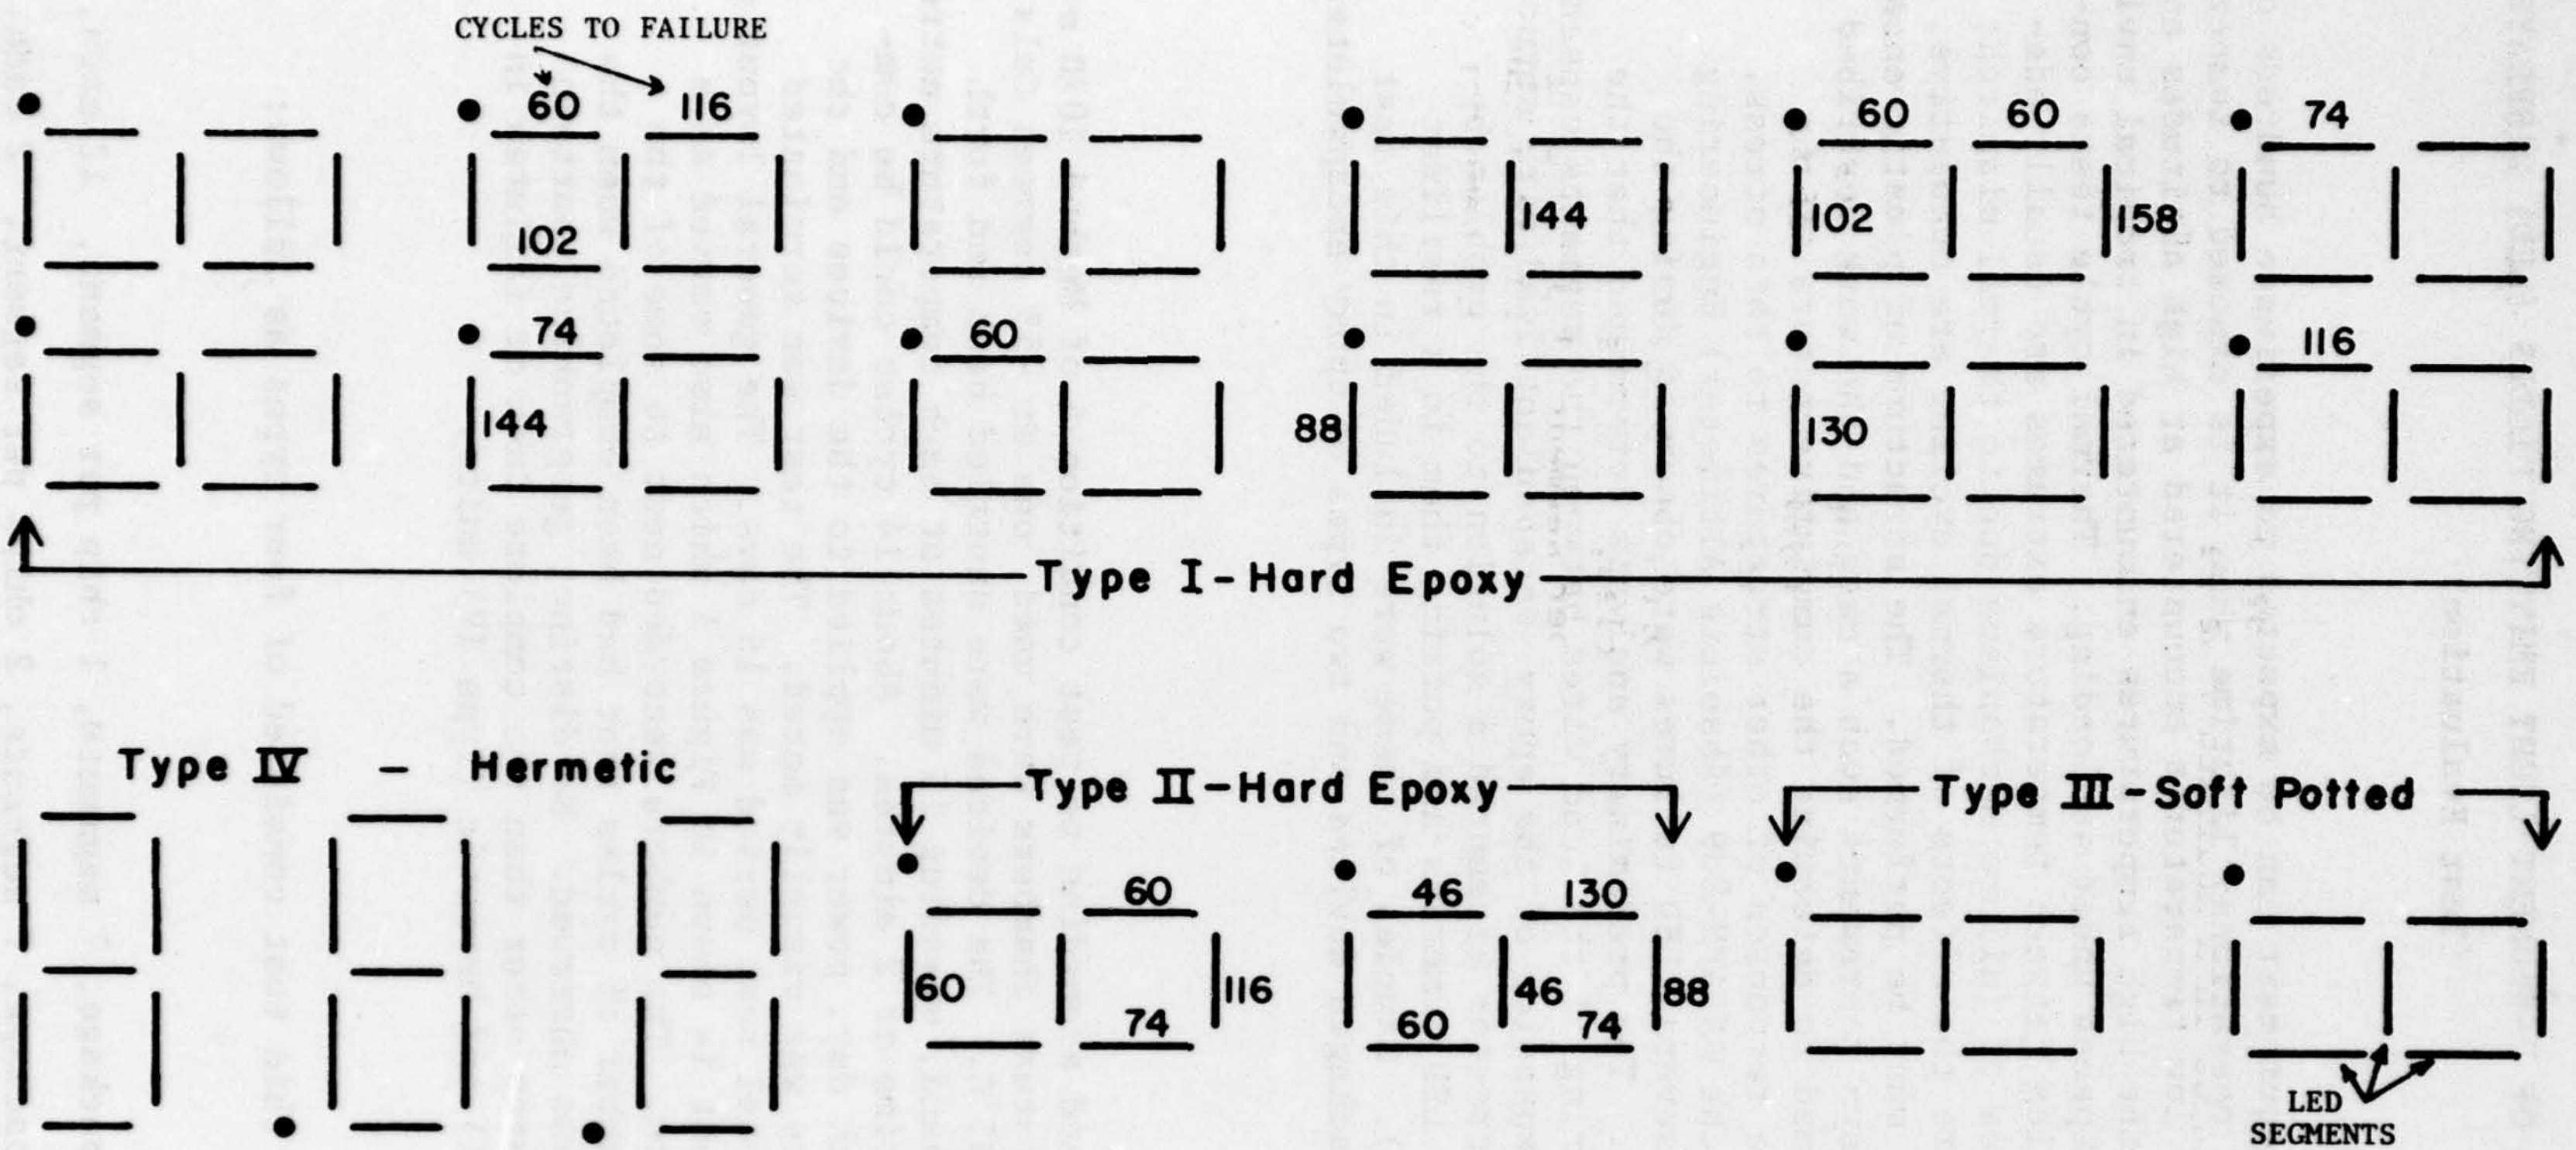
Figure I. LED Numeric Display Thermal Shock Test. Method 107D Test Condition A MIL-STD-202E.

Step
1— -55°C 15 min
2— 25°C 5 min (max)
3— 85°C 15 min
4— 25°C 5min(max)

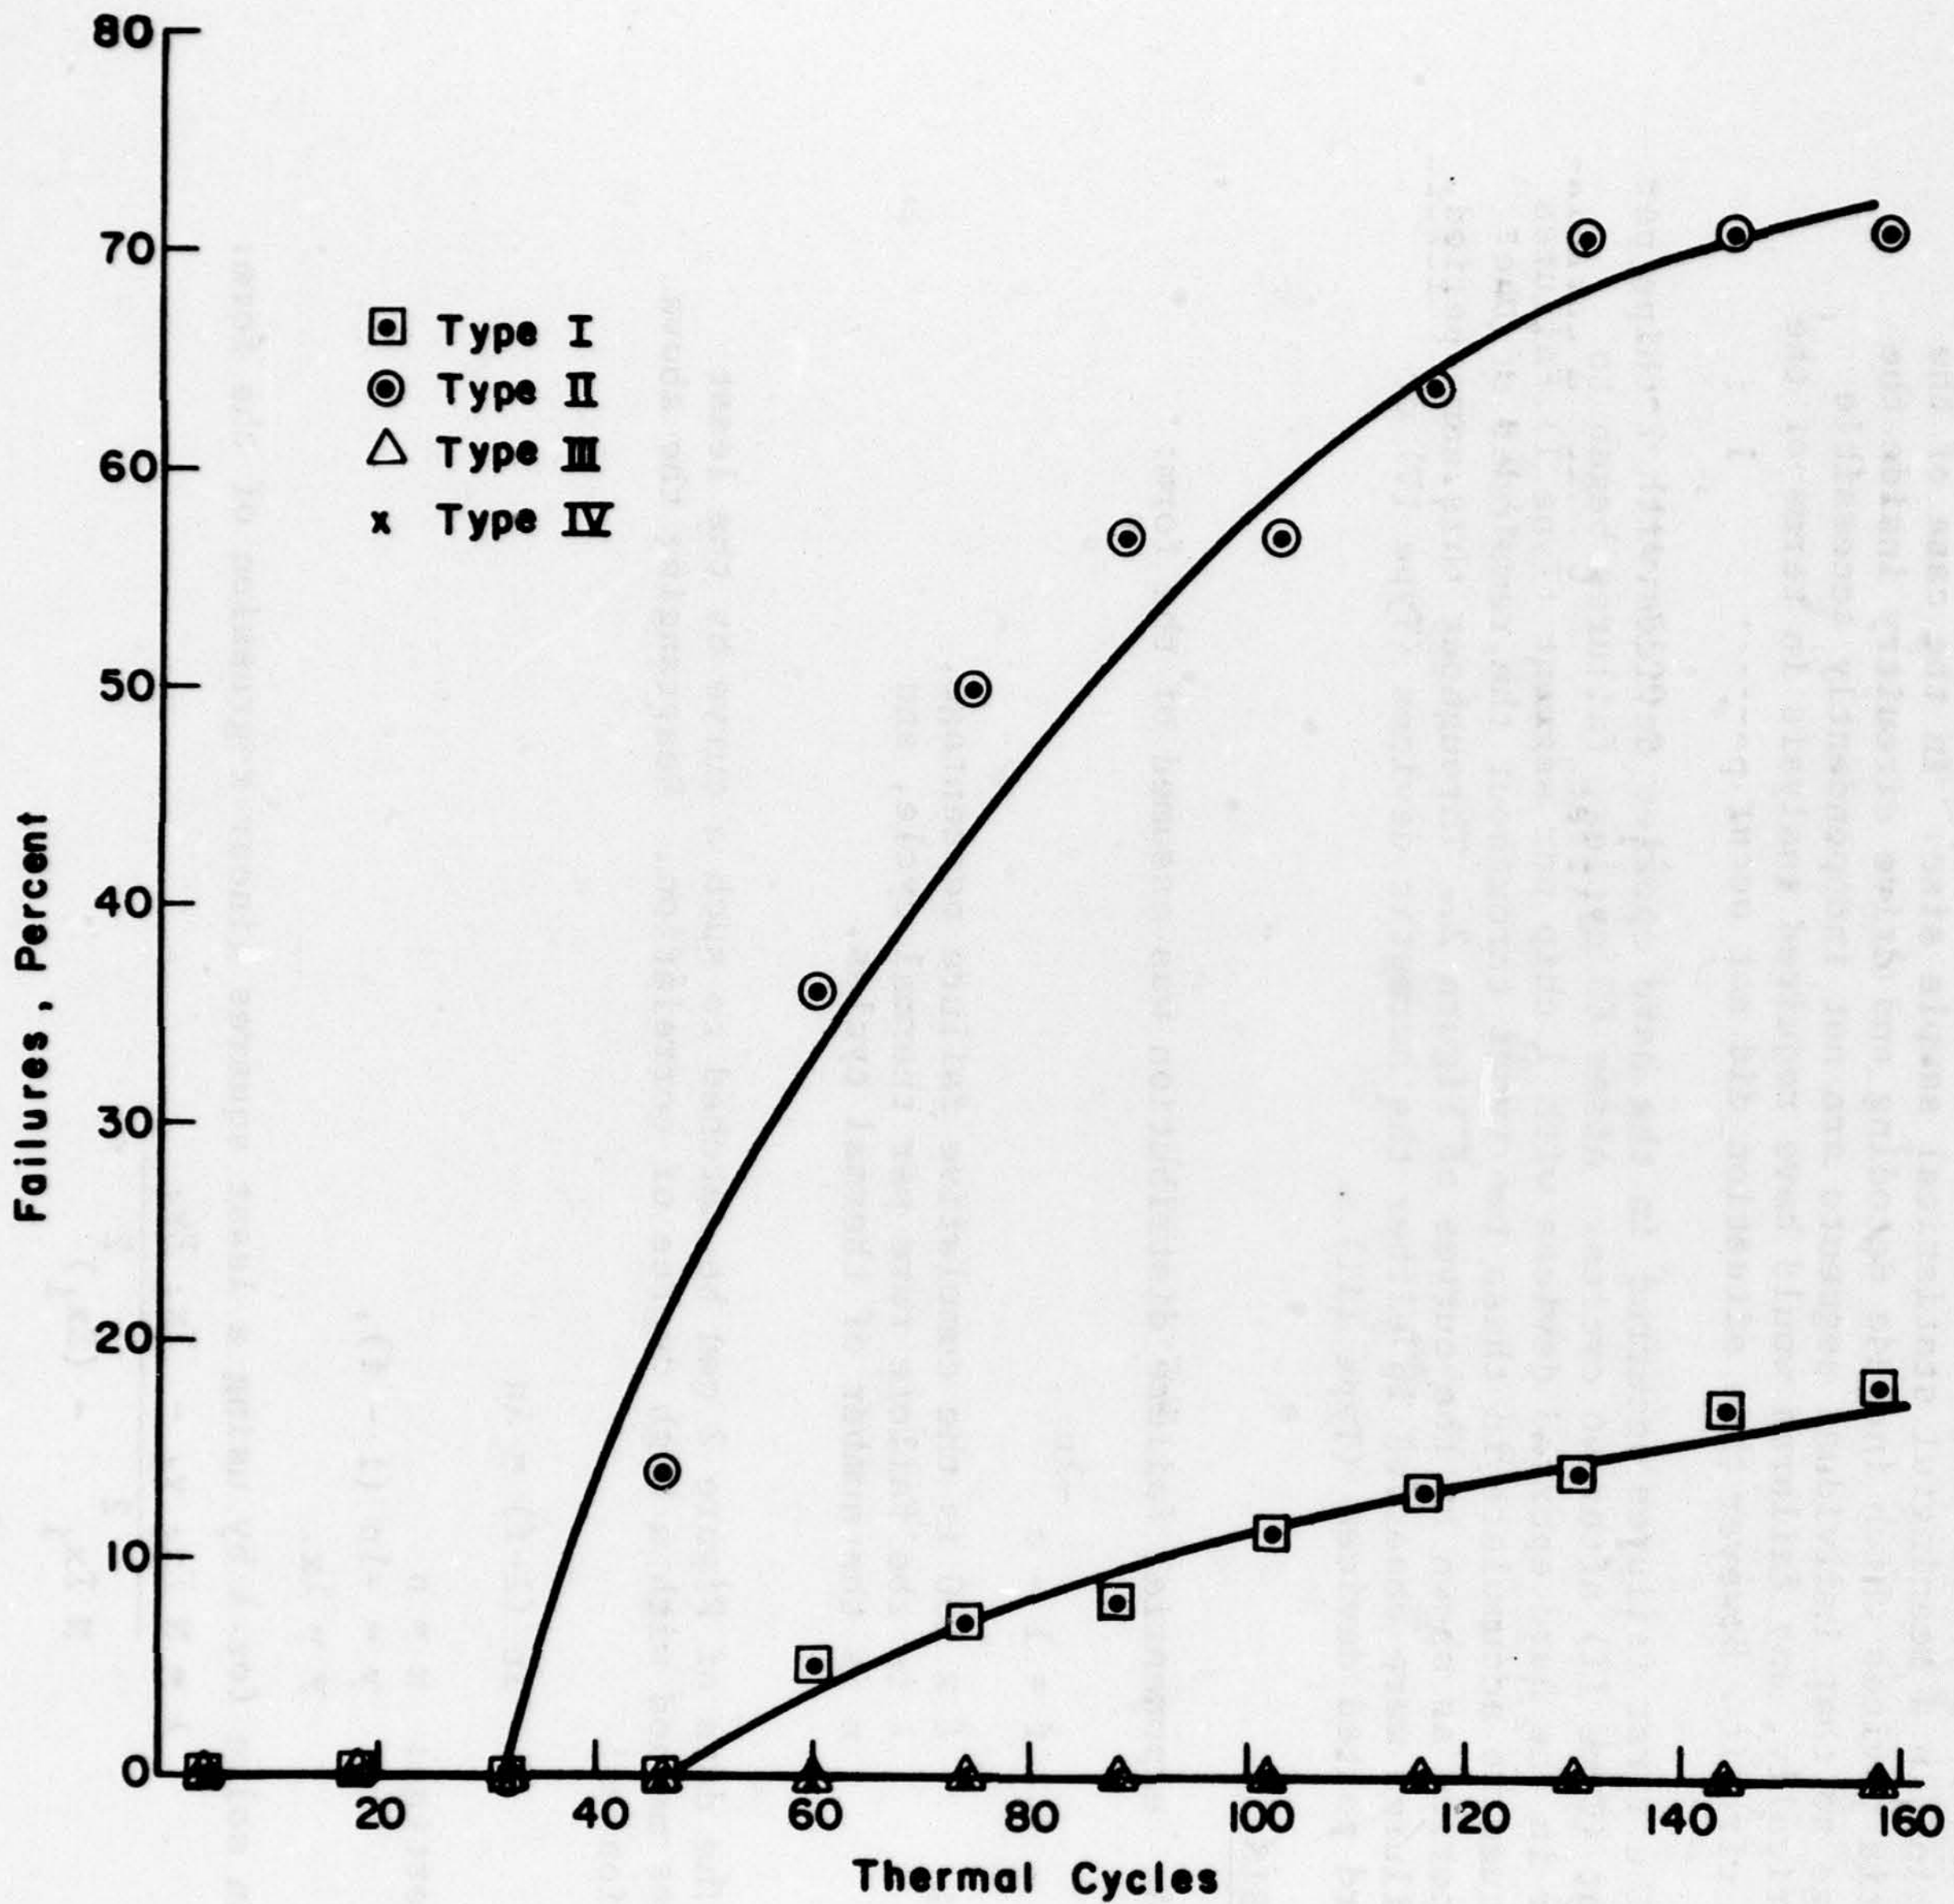
Figure 2. Graph of Cumulative Segment Failures.

The first failures occurred in the hard epoxied devices with 2 chips per segment (Type II) after 46 cycles. After 60 cycles, failures began to appear in the hard epoxied devices with 1 chip per segment (Type I). Failures continued to accumulate in these two types throughout the remainder of the test period as shown by the curves of Figure 2. Throughout this same period, no failures were observed in either the hermetic devices (Type IV) or Sylgard potted devices (Type III).

For the Type I device, the data yields $\lambda_I = 0.0017$ with a correlation coefficient $\gamma_I = 0.99$. For the Type II device, $\lambda_{II} = 0.01$ with a correlation coefficient $\gamma_{II} = 0.97$. These correlation coefficients are quite good considering the limited sample sizes that were used. It is therefore not unreasonable to conclude that these hard epoxy potted devices demonstrated constant failure rates of 0.17 percent per cycle and 1.0 percent per cycle respectively, and this can be compared to the hermetic and soft potted units in which no failures were induced by this test procedure.

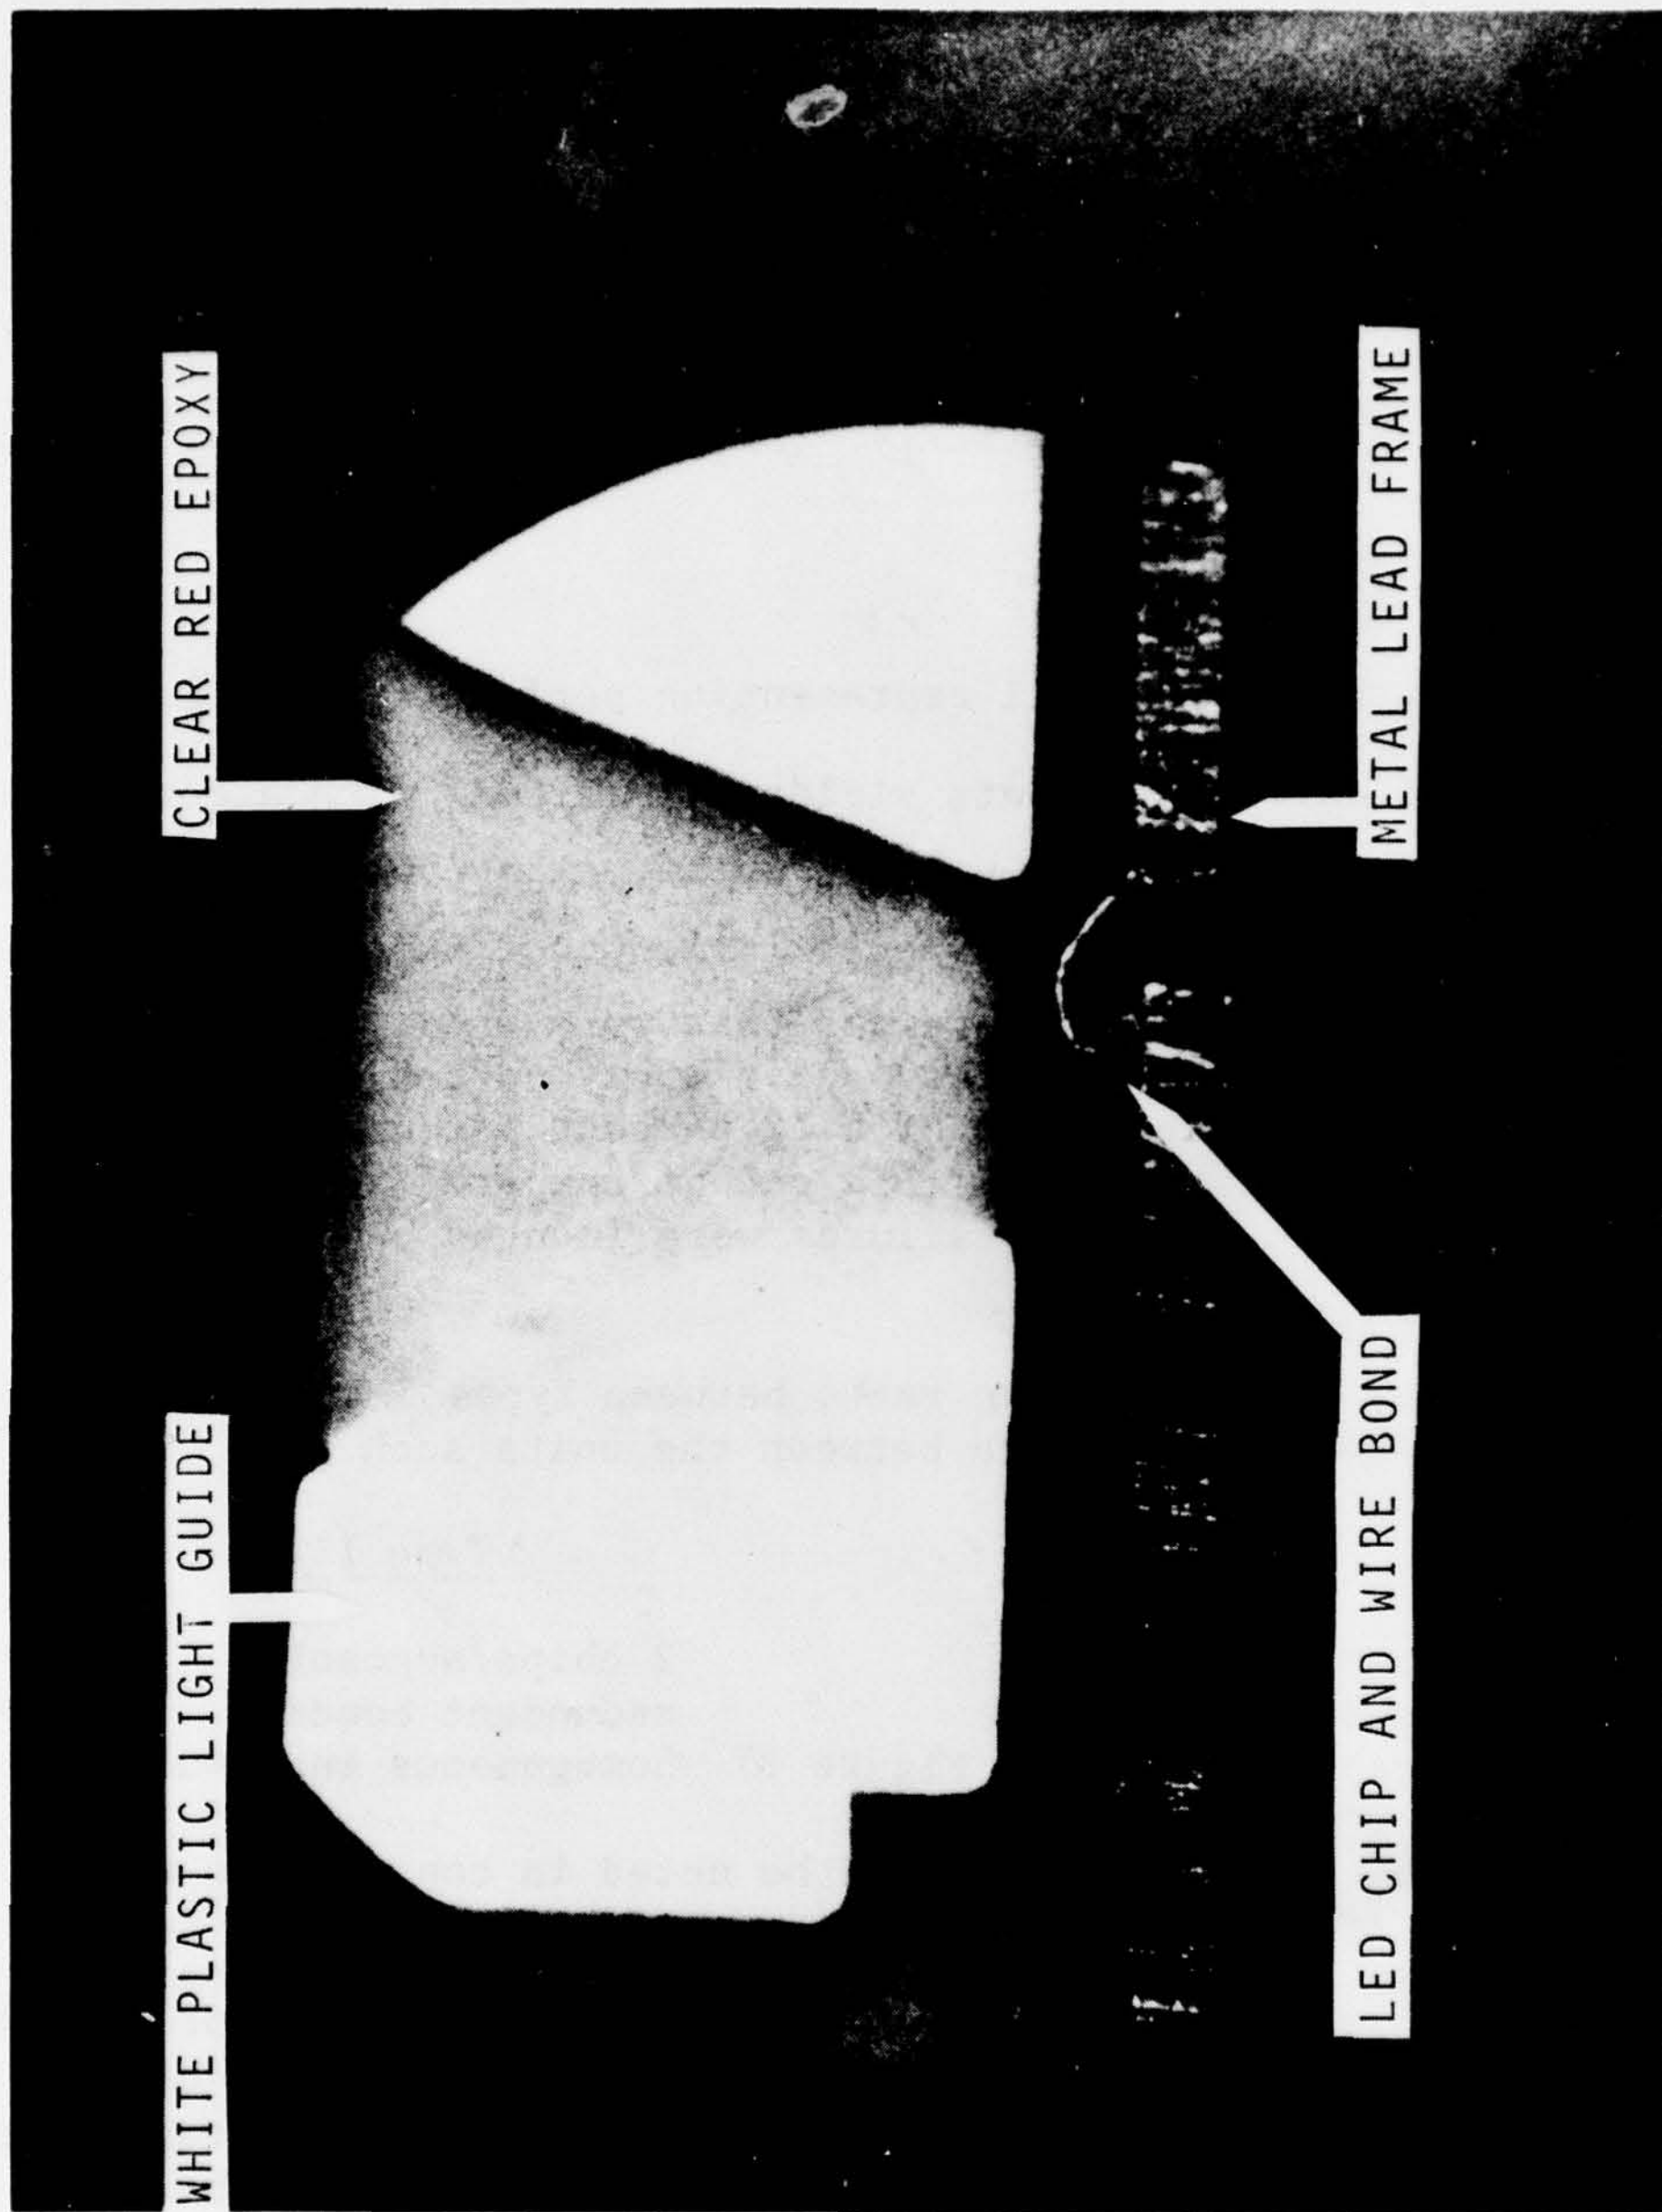
FIGURE 3. PHOTOGRAPH OF A SECTIONED TYPE I DEVICE

Type I	Type II
1 chip/segment	2 chips/segment
single wire bond/chip	redundant bonding
structured encapsulation (see Figure 3)	homogeneous encapsulant

Some features of the test results should be noted in conjunction with these structural differences. First, the use of redundancy, as in the redundant bonding of the Type II devices does not, by itself, guarantee high reliability. Also, the structured encapsulation of the Type I devices shown in Figure 3, which was designed primarily on the basis of optical considerations, is essentially the same as the homogeneously encapsulated devices with respect to the region around the lead wire where the breakage occurs.

Additional experimentation could also be considered to determine the effects of various potting compositions, but for immediate application where thermal cycling is an important consideration, these results indicate two approaches that appear acceptable. Hermetic devices are available off-the-shelf at a somewhat higher cost than the potted devices. Sylgard potting is not normally done by the device manufacturers but could be considered if the appropriate capabilities are available.

In the case of the AN/APN-209, the solution that was adopted for production of this equipment involving about 10,000 digits, was to purchase unpotted units from the device manufacturer, and to have the units potted in Sylgard by the contractor.
