**PROGRAM 624A  
QUARTERLY RELIABILITY AND  
QUALITY ASSURANCE REPORT  
VOLUME I: RELIABILITY**

JULY 1966

**MARTIN COMPANY  
A DIVISION OF MARTIN MARIETTA CORPORATION  
Denver, Colorado**

SSD-CR-66-168 (VOL I)

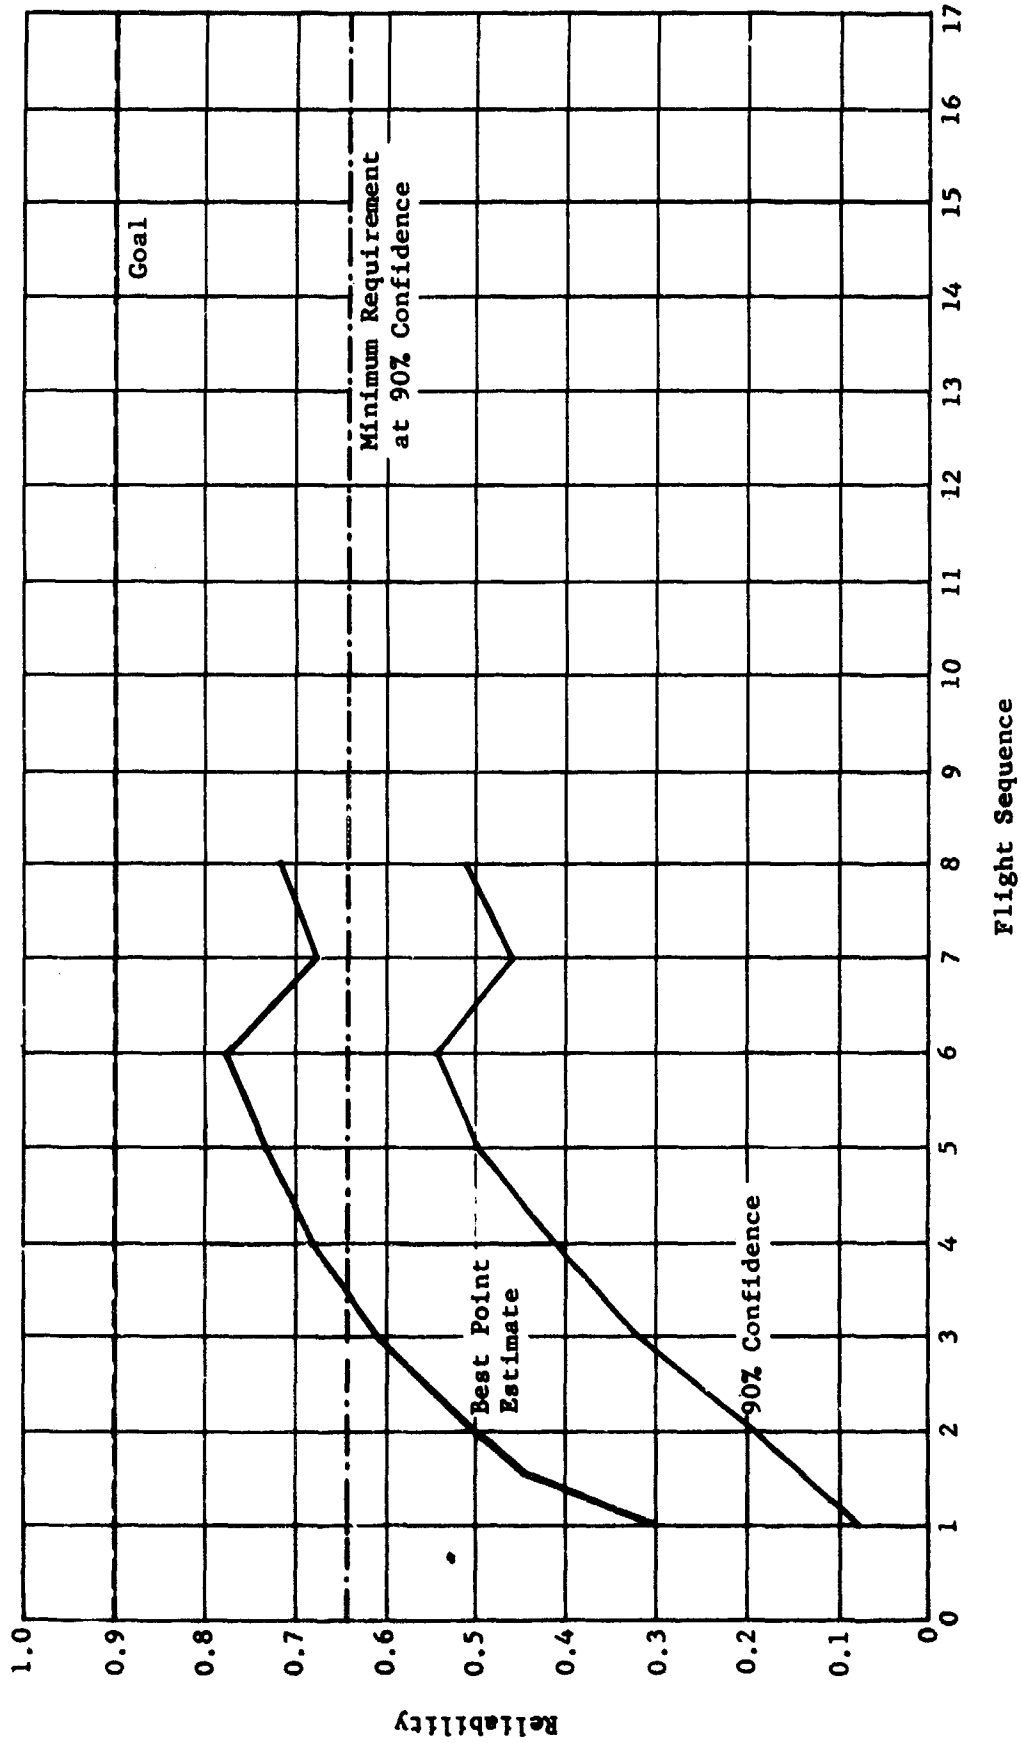
Fig. 3 Reliability Measurement (Mission Objective Criteria) for Martin Portion of Titan III during Flight

In addition to the performance measurements, the Flight Reliability Measurement (Mission Objective) for the Martin Portion of Titan III is included. This evaluation represents the probability of success for the Martin portion of Titan III in performing the flight functions required to place a payload into a desired orbit. This evaluation uses gross success and attempt data from Configurations A and C. This evaluation is presented in Fig. 3.

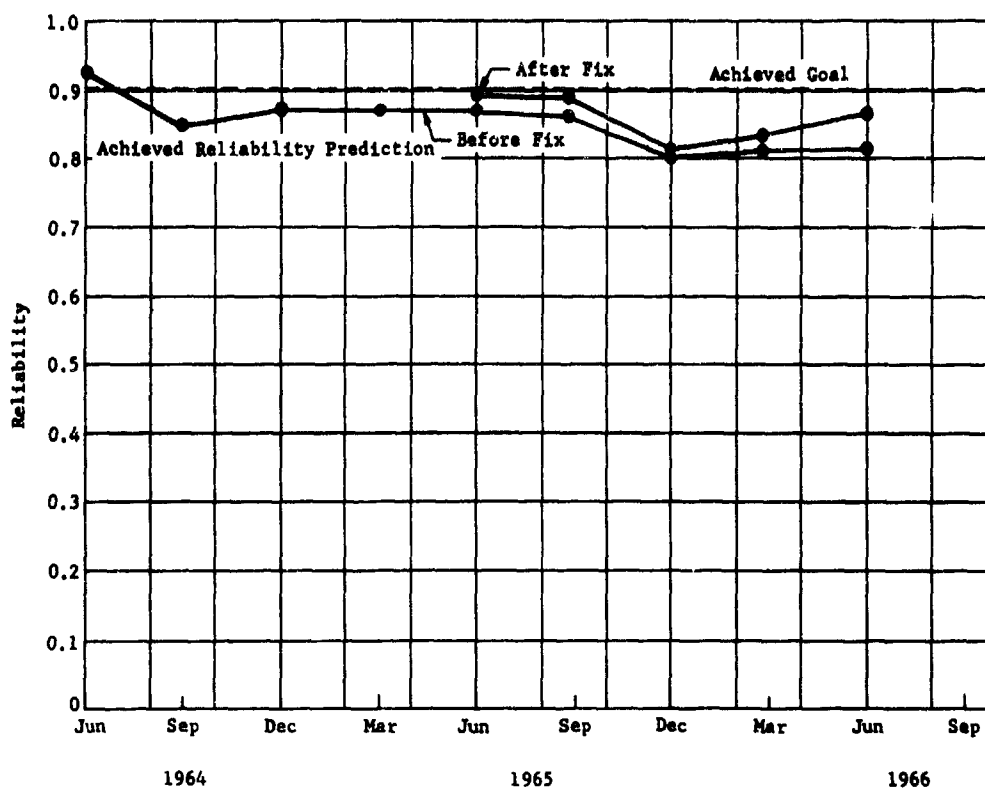
Fig. 11 Achieved Reliability Prediction for Martin Portion of Titan III (Configuration C) during Flight

- 1) Design Reliability Prediction for Martin Portion of Titan III (Configuration A) during Flight, Fig. 8;
- 2) Achieved Reliability Prediction for Martin Portion of Titan III (Configuration A) during Flight, Fig. 9;
- 3) Design Reliability Prediction for Martin Portion of Titan III (Configuration C) during Flight, Fig. 10;
- 4) Achieved Reliability Prediction for Martin Portion of Titan III (Configuration C) during Flight, Fig. 11.
