Publication 711-01-1-850

FINAL REPORT

RELIABILITY AND MAINTAINABILITY IMPROVEMENT PROGRAM FOR THE F-106 AVIONICS

3 November 1967

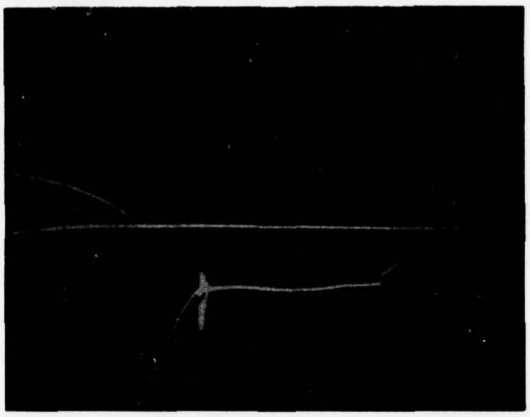
FIGURE 5-5

Another problem related to the clampax circuits is illustrated in Figure 5-5. During certain loading variations caused by system-mode switching, high-level oscillations occur on the +150 Vdc line.

COMPARISON OF THE +150 Vdc:
NO LOAD AND FULL LOAD

Figure 5-5 shows the +150 Vdc as observed in the electric-shop test stand. The slow oscillation shown was later corrected by replacing a gassy tube in the 991 unit. This condition was not observed when the equipment was operating under 50-percent or 100-percent loads. Figure 5-19 shows the slow recovery time of the +150 Vdc caused by the defective tube.

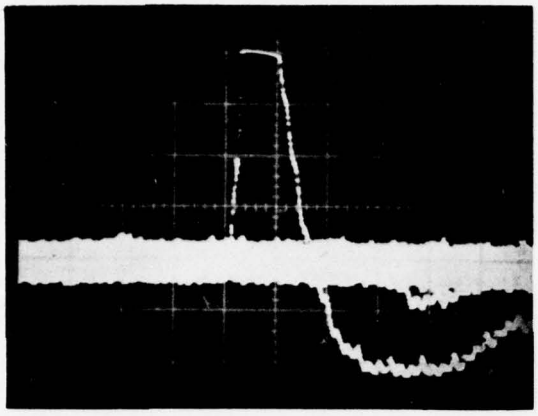
TRANSIENTS ON THE +28-Vdc LINE

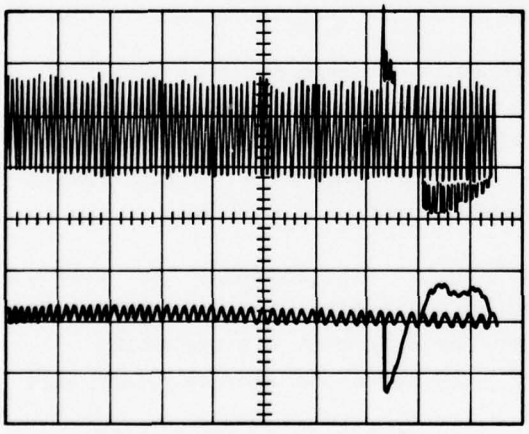
SWITCHING TRANSIENTS IN THE 28-Vdc DISTRIBUTION SYSTEM AND THE 115-V, 1600-Hz REFERENCE, MODULATED BY TRANSIENTS GENERATED IN THE 28-Vdc SYSTEM

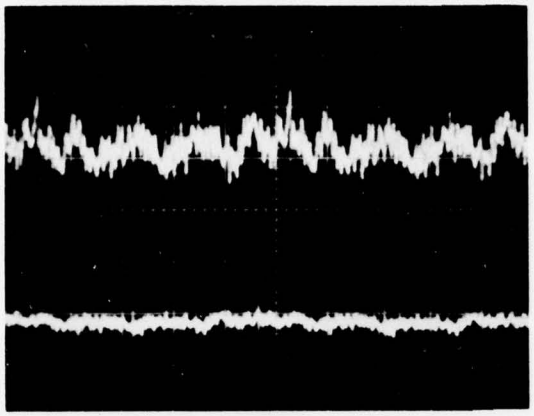
-140 Vdc
P/N 464062 Unit
Amplitude: 100 mV/cm

RIPPLE PRESENT IN THE 062 UNIT

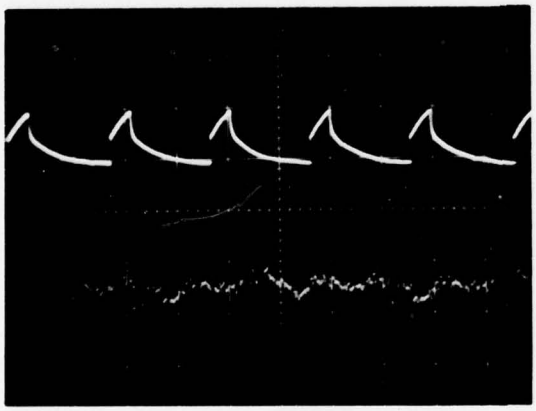
FIGURE 5-10

5.4.1.2 -140 Vdc [Maximum Allowable Ripple 200 Millivolts Peak to Peak (mV P-P)]. Measurements in the aircraft showed that the allowable maximum ripple was exceeded in the 062 unit (Figure 5-9), the 195 unit (Figure 5-10), the 289 unit (Figure 5-11) and the 389 unit (Figure 5-12).

VOLTAGE WAVEFORMS OF THE -140-Vdc DISTRIBUTION

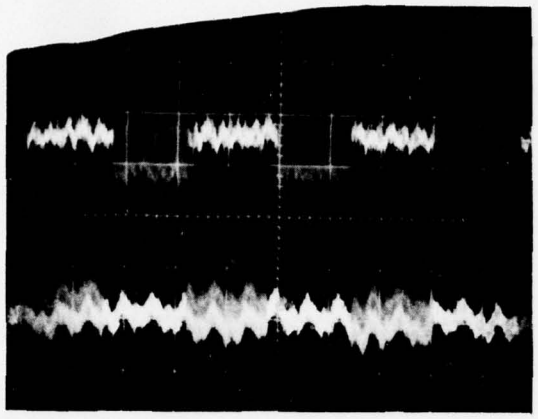
FIGURE 5

VOLTAGE WAVEFORMS IN THE 289 UNIT

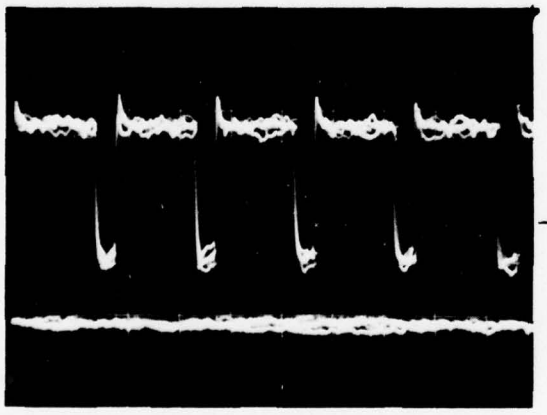
FIGURE 5-12

VOLTAGE WAVEFORMS OF THE -140-Vdc DISTRIBUTION

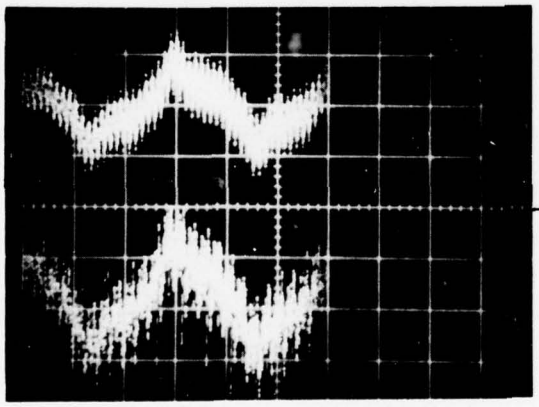
FIGURE 5-14

VOLTAGE WAVEFORMS FOR THE -140 Vdc AND THE -140-Vdc REFERENCE

The upper trace of Figure 5-14 shows the -140V reference as observed in the radar shop. This waveform does not resemble the waveforms observed in the aircraft. Note the presence of 60 Hz on the -140V reference in the radar shop.

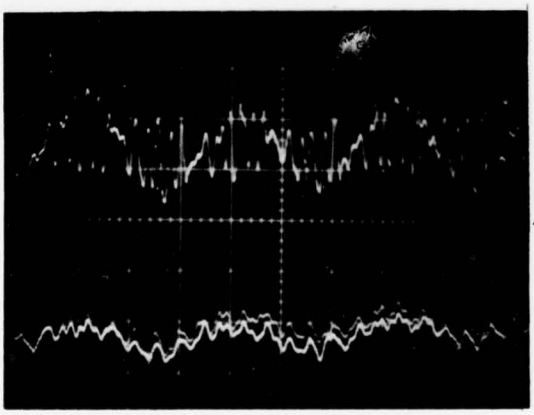
FIGURE 5-16

The +150 Vdc voltage in the radar shop was found to have a ripple level of 240 mV P-P (see Figure 5-16, lower trace). When this same voltage was observed on the electric shop test stand under both load and no-load conditions, the measured noise increased from 260 mV P-P under no-load (Figure 5-17, upper trace) to 500 mV P-P under 100% load (Figure 5-18, upper trace).

VOLTAGE WAVEFORMS OF THE -25-Vdc AND +150-Vdc DISTRIBUTION

When the -250 Vdc was observed in the radar shop, the ripple was found to be 460 mV P-P (see Figure 5-16, upper trace), but the waveform did not resemble that seen in the aircraft. In the shop, one noise component of about 300 mV P-P appears to be riding on a 1600-Hz signal.

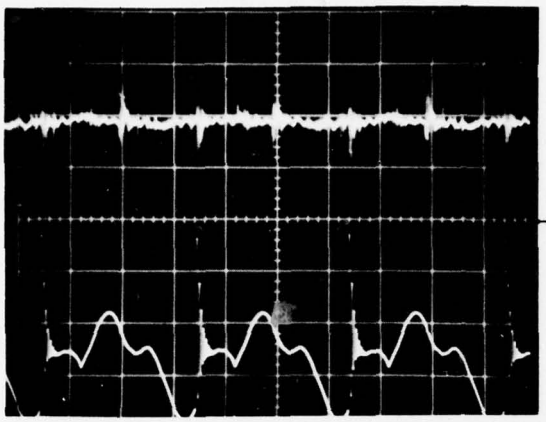
FIGURE 5-17

VOLTAGE WAVEFORMS OF THE +150-Vdc OUTPUT AND THE +150-V FIELD VOLTAGE

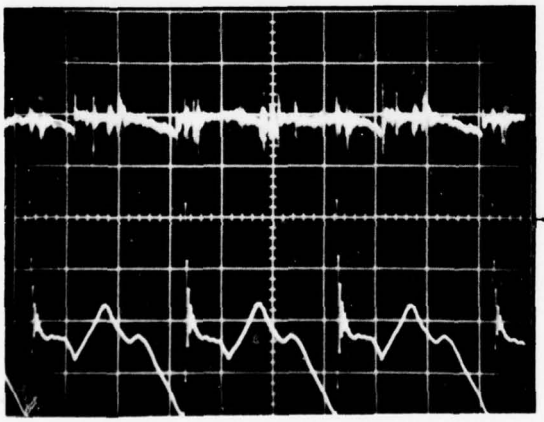
FIGURE 5-18

VOLTAGE WAVEFORMS OF THE +150-Vdc OUTPUT AND THE +150-V FIELD VOLTAGE

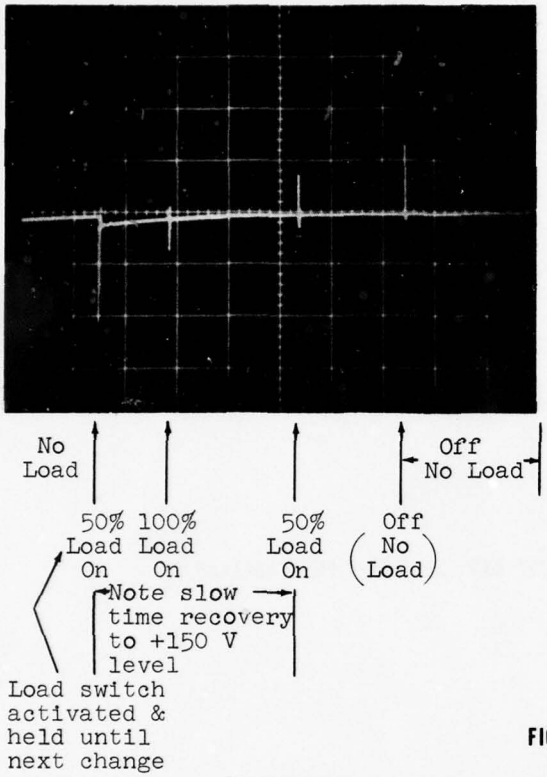
FIGURE 5-19

SWITCHING TRANSIENTS AND REGULATOR RECOVERY FOR THE +150-Vdc DISTRIBUTION

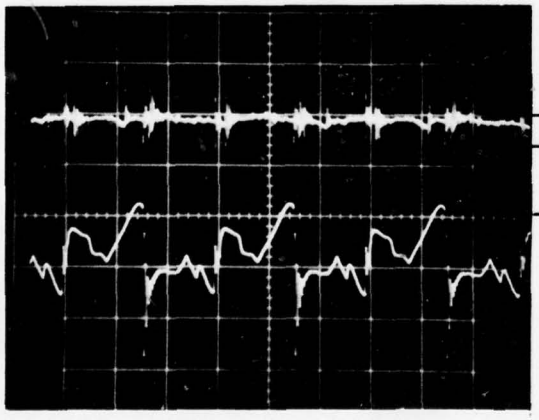
FIGURE 5-22

The +300 Vdc line was also monitored at the test points in the electric-shop test stand. The ripple present on the +300 Vdc supply under no load was 900 mV P-P (Figure 5-21, upper trace). When the load was increased to 100-percent, the ripple increased to 1.3 volts (Figure 5-22, upper trace). Although in both cases the specification was exceeded, since standard test procedures do not require the measurement of ripple voltage, this condition would go undetected and shop maintenance personnel would consider this to be a good unit.

RIPPLE VOLTAGE LEVELS OF THE +300-Vdc SYSTEM

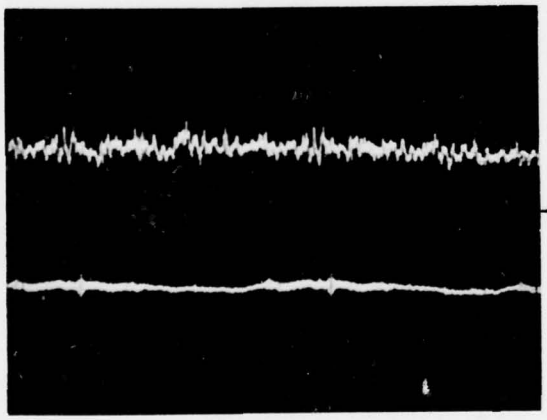
NOISE PRESENT IN THE +300-Vdc AND +100-Vdc REFERENCE

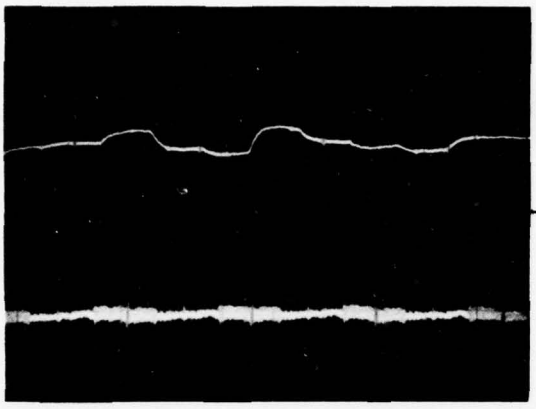
NOISE AND RIPPLE PRESENT IN THE -140-Vdc REFERENCE

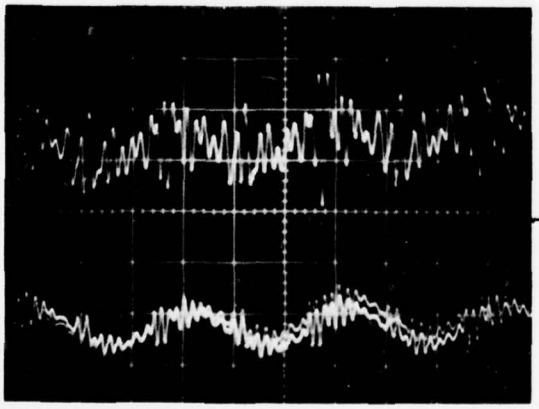
FIGURE 5-26

The noise level of the +100 reference voltage was recorded in the radar shop at 280 mV P-P as shown in Figure 5-26, lower trace. (The presence of 1600 Hz is also indicated.)

NOISE AND RIPPLE PRESENT IN THE -15-Vdc AND +100-Vdc REFERENCE DISTRIBUTION

The upper trace of Figure 5-26, taken in the radar-shop mock-up, shows the noise level to be 590 mV P-P, well over the 100 mV P-P specification.

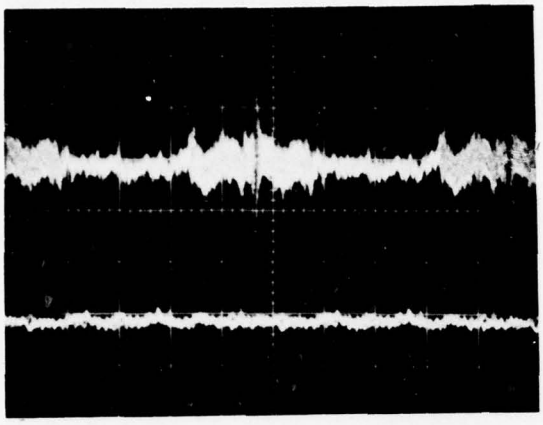
FIGURE 5-27

*Also note the lower trace (-250 Vdc) in Figure 5-27, which is the source for the -140V Reference. No evidence of noise peaks are seen here, indicating that the noise on the -140V Reference does not originate at the source (-250 Vdc).

NOISE PRESENT IN THE -14-Vdc REFERENCE AND THE -250-Vdc PRESENT AT THE 292 UNIT

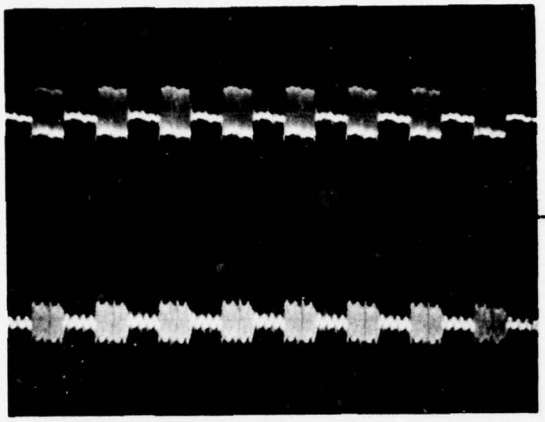
NOISE PRESENT IN THE -50-Vdc AND +50-Vdc DISTRIBUTION AT THE 096 UNIT (DEFECTIVE 326 UNIT IN USE)

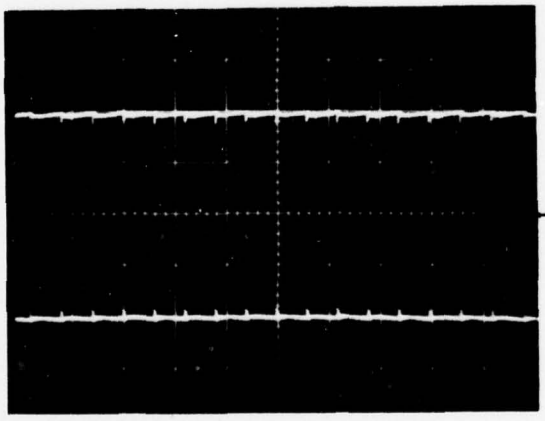
NOISE PRESENT IN THE -50-Vdc AND +50-Vdc DISTRIBUTION AT THE 096 UNIT (SERVICEABLE 326 UNIT IN USE)

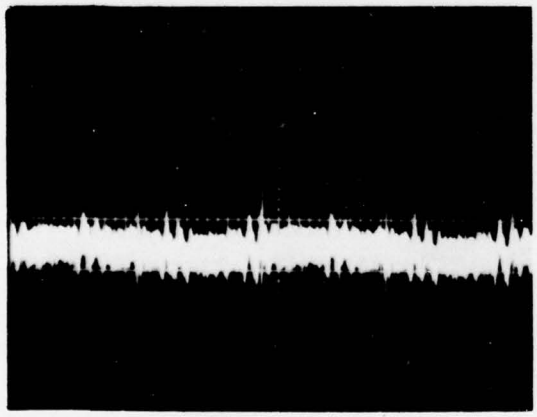
FIGURE 5-37

26-Vdc WAVEFORM SUPPLIED TO THE 289 UNIT

Figure 5-37 showed the voltage waveform for the 26-volt, 400-Hz input to the 289 unit. This voltage is developed from the aircraft 115-volt, 400 Hz, phase B through a step-down transformer in the 409 unit. This power is used in the 289 unit as the fixed field for the gimbal motors.

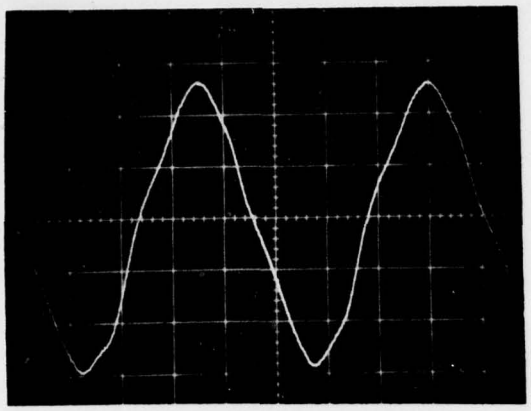
FIGURE 5-44

Phase C is shown in Figure 5-44 as the waveform appears on a magnetic tape run on the aircraft. Figure 5-45 is from a magnetic tape run in the shop mock-up. The upper trace of Figure 5-46 shows Phase C as it appears in the radar shop

WAVEFORM FOR 400 Hz, PHASE C IN AIRCRAFT

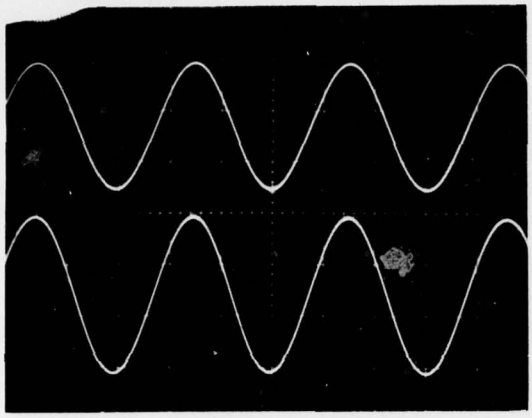
FIGURE 5-47

5.5.1.3 55/115-Vac Reference - The waveforms of the voltages as they appear in the aircraft are shown in Figure 5-47. Figure 5-48 shows the voltage waveforms as they appear in the radar shop. No changes in waveform were observed as a result of changing the loads by switching the radar.

A-C INPUTS TO THE 491 UNIT ON AIRCRAFT

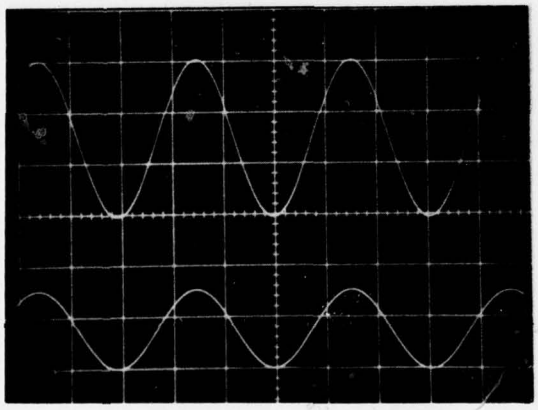
FIGURE 5-48

A-C INPUTS TO THE 491 UNIT IN SHOP

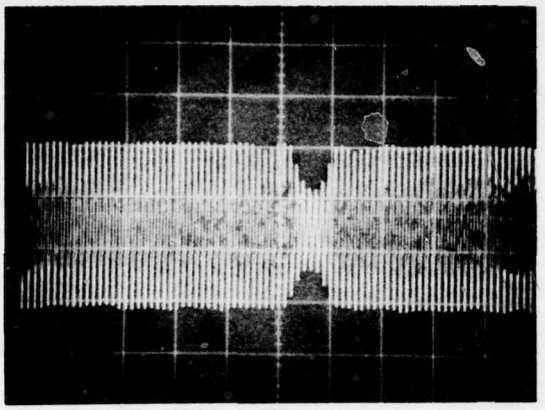
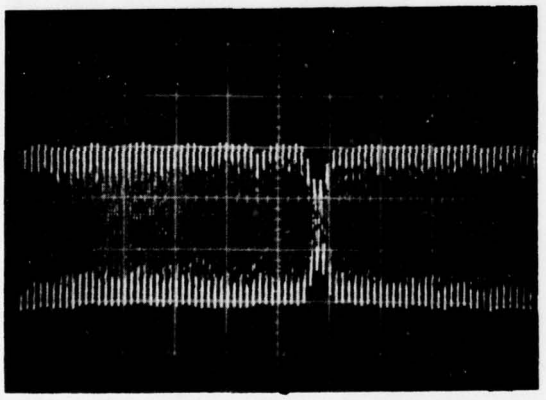
5.5.1.4 115 Vac, 1600 Hz Reference - Two photographs, Figures 5-49 and 5-50, were taken of a magnetic-tape recording in the computer stand, they show a point where the peak-to-peak amplitude dropped to 150 volts for several cycles. Figure 5-51, taken in the radar shop, also shows this ripple.

MODULATION OF 1600-Hz REFERENCE

A number of the units that failed to operate in the aircraft were made usable by replacement of the magnetic amplifiers (AR1 and AR2). This did not eliminate the problem of modulation but reduced it to an aircraft-acceptable level. However, reducing the modulation amplitude to an acceptable level is not considered to be the solution to the problem, although it has reduced the unit repeat-write-up rate and increased the number of available, useable 491 units at Dover AFB.

To eliminate the problem it will be necessary to perform a complete analysis of the associated circuitry to define the combination of components and conditions that are the cause of the problem.

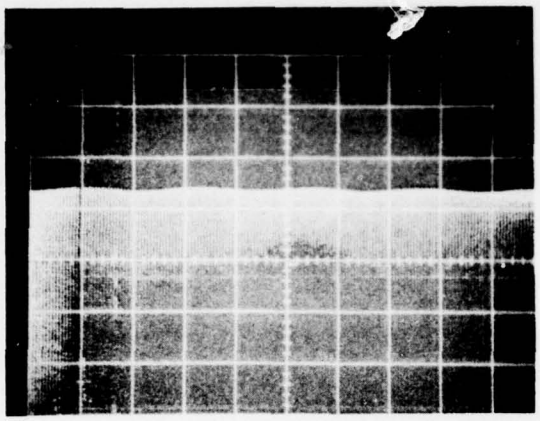
FIGURE 5-51

A-C RIPPLE ON 1600-Hz REFERENCE

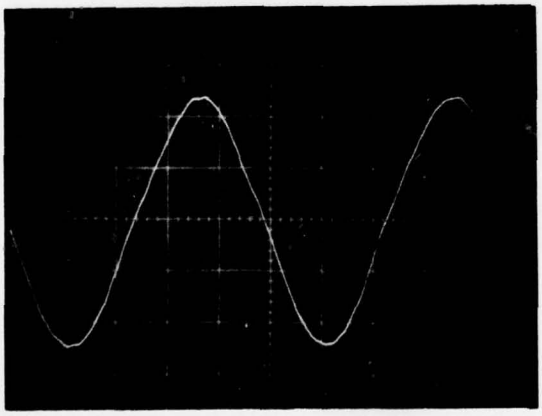
FIGURE 5-52

Figure 5-52 shows the waveform as it was recorded by magnetic tape in the aircraft. Figure 5-53 is a photograph of a magnetic tape recording of the shop mock-up waveform.

WAVEFORM FOR 1600-Hz REFERENCE IN AIRCRAFT

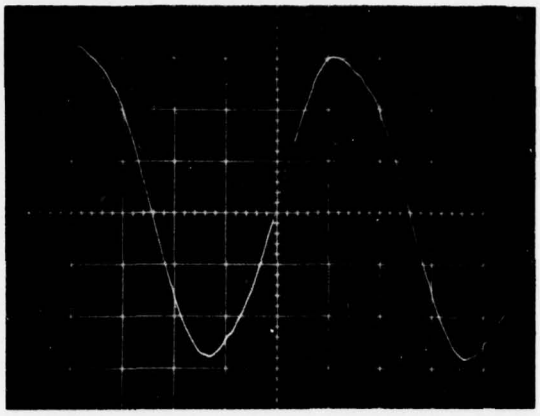
FIGURE 5-53

WAVEFORM FOR 1600-Hz REFERENCE IN SHOP

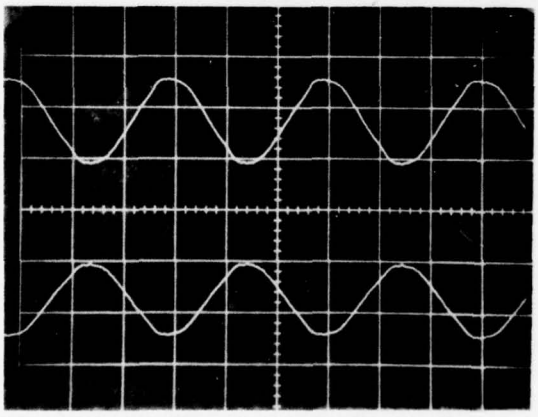
FIGURE 5-54

5.5.1.5 115 Vac, 1600 Hz Warm - The upper trace of Figure 5-54 shows the voltage waveforms (regulation provided by the AF/ECU-10M power unit) with the radar transmitter turned off. Note the waveform distortion that occurs in the upper trace of Figure 5-55 (same point where Figure 5-54 was taken) when one radar transmitter is turned on:

5.5.1.6 115 Vac, 1600 Hz Return - The lower trace of Figure 5-54 shows the waveform, radar transmitter off, in the shop mock-up. However, with the transmitter on, harmonic distortion occurs, as shown in Figure 5-55.

WARM AND RETURN LINES: RADAR OFF

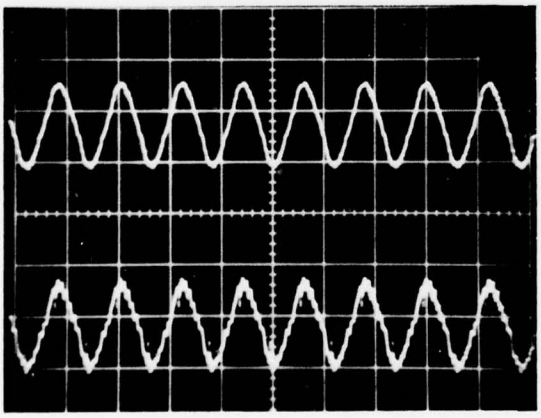
DISTORTION ON 1600-Hz LINE

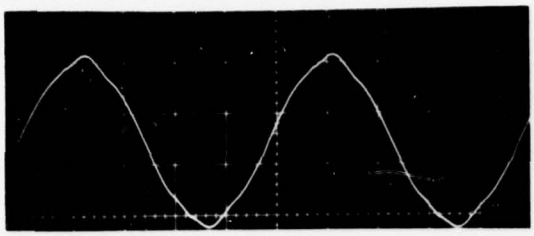
FIGURE 5-58

Figure 5-58 shows the phase B', 115-volt, 400-Hz power supplied from the 409 unit to the 289 unit at plug J28901, pin B. This photograph was reduced to a 35-millimeter slide and projected to approximately 20" by 25". Data points were

PHASE-B' WAVEFORM

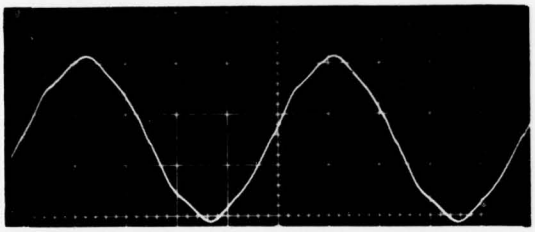
FIGURE 5-59

Figure 5-59 is the phase C', 115-volt, 400-Hz power supplied from the 409 unit to the 289 unit at plug J28901, pin C. As in the previous case, a 35mm slide was projected and data points obtained. Computer analysis resulted in the following equation:

PHASE-C' WAVEFORM

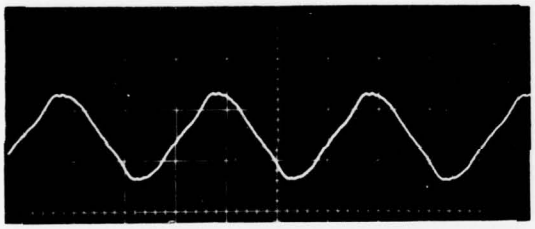
FIGURE 5-60

The 115-volt, 1600-Hz generator is arranged in the aircraft so that the center point is electrically at ground through the load. The 1600-Hz power is therefore carried by a twisted pair of shielded wires. One is designated the "signal" lead and the other the "return" lead (Figures 5-60 and 5-61). Although the total signal is 115 volts, the scope was referenced to aircraft ground and therefore shows 58 volts rms in each photo. The two waveforms closely resemble each other, and the five points of inflection near the maximum (and minimum) are of interest.

A 35mm slide of the waveform shown in Figure 5-60 was projected, and data points obtained for use in computer analysis. This wave is unsymmetrical about the horizontal axis and thus contains even-order harmonics. The fourier Series was developed through the twentieth harmonic, resulting in a close approximation of the original waveform. Table 5-8 lists of the coefficients of the Fourier Series for each harmonic and indicates the relative distortion.

SIGNAL WAVEFORM

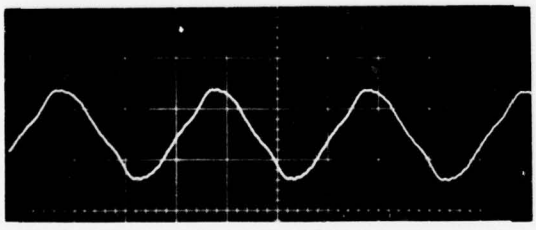
FIGURE 5-61

RETURN WAVEFORM

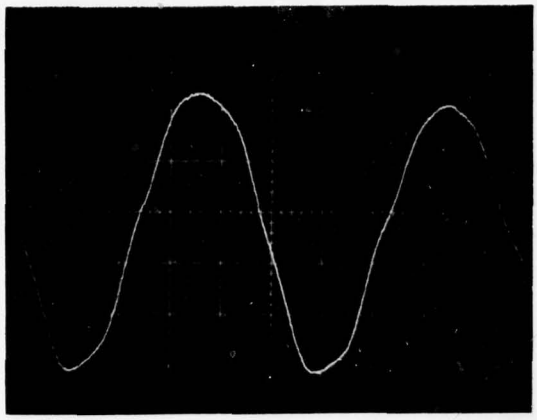
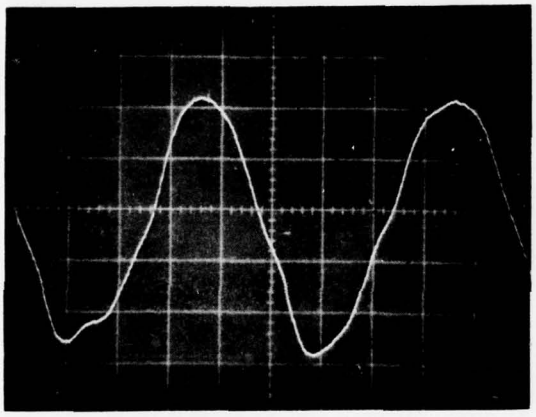
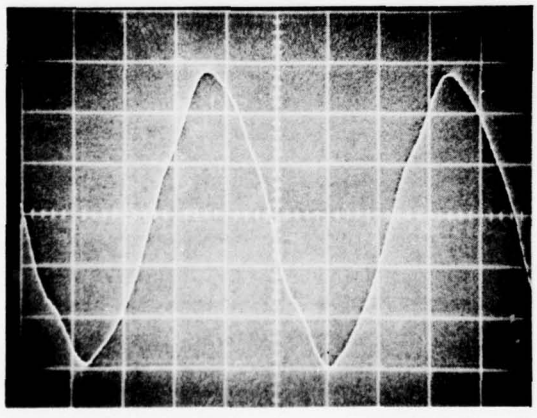
The 115-volt, 400-Hz power was recorded at the 489 unit. Figures 5-63, 5-64, and 5-65 show the phase A, B, and C waveforms as recorded. Visual inspection of these waveforms indicates that they are no worse than those analyzed earlier in this report. However, a peak-to-peak amplitude variation was present, and these amplitude variations prevent Fourier Analysis since the waveforms are nonperiodic. The worst amplitude variation recorded was approximately 10 percent, as shown in Figure 5-66 (Phase C).

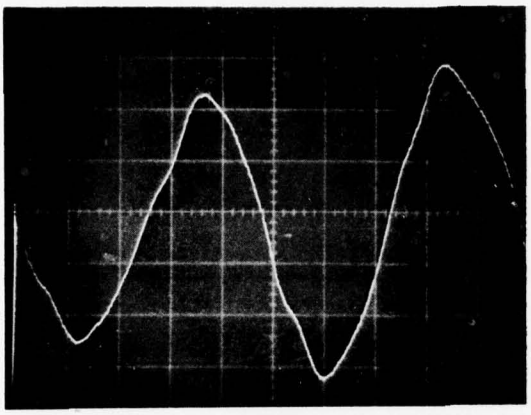
FIGURE 5-66

HARMONIC DISTORTION: AIRCRAFT PHASE C (WORST CASE OF AMPLITUDE VARIATION)

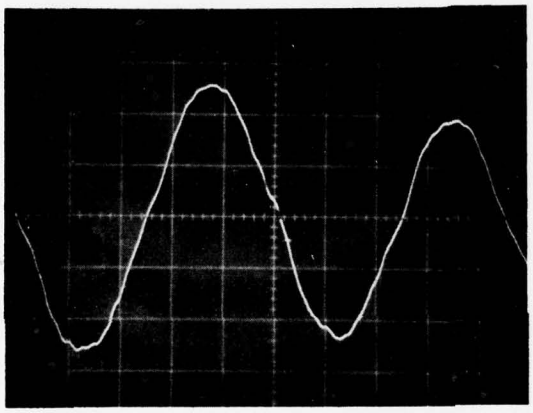
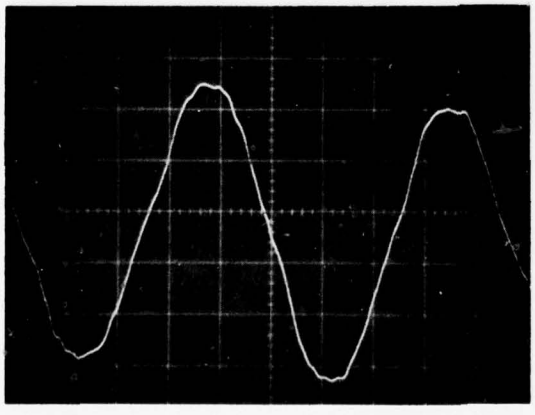
The 1600-Hz, 115-volt unregulated waveforms for the signal side and the return line are shown in Figures 5-67 and 5-68. The high levels of distortion

discussed earlier (Figures 5-60 and 5-61) did not occur during the in-flight recording; however, amplitude variations were present.

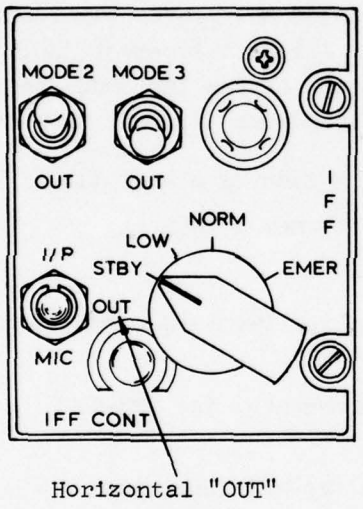
FIGURE 7-1

Figure 7-1 shows the front panel in its present configuration with the "OUT" decal for the toggle switch in a horizontal plane. Because of its proximity, the "OUT" position appears to be related to the IFF switch rather than the toggle switch.

PRESENT CONFIGURATION OF FRONT PANEL
