6 EUROPEAN MICROWAVE OUTAGES

(BLACKOUT OF GERMAN SCOPE COMM LINKS, OCT 75 THRU FEB 76)

1842 ELECTRONICS ENGINEERING GROUP (AFCS)

11 22 APR 76

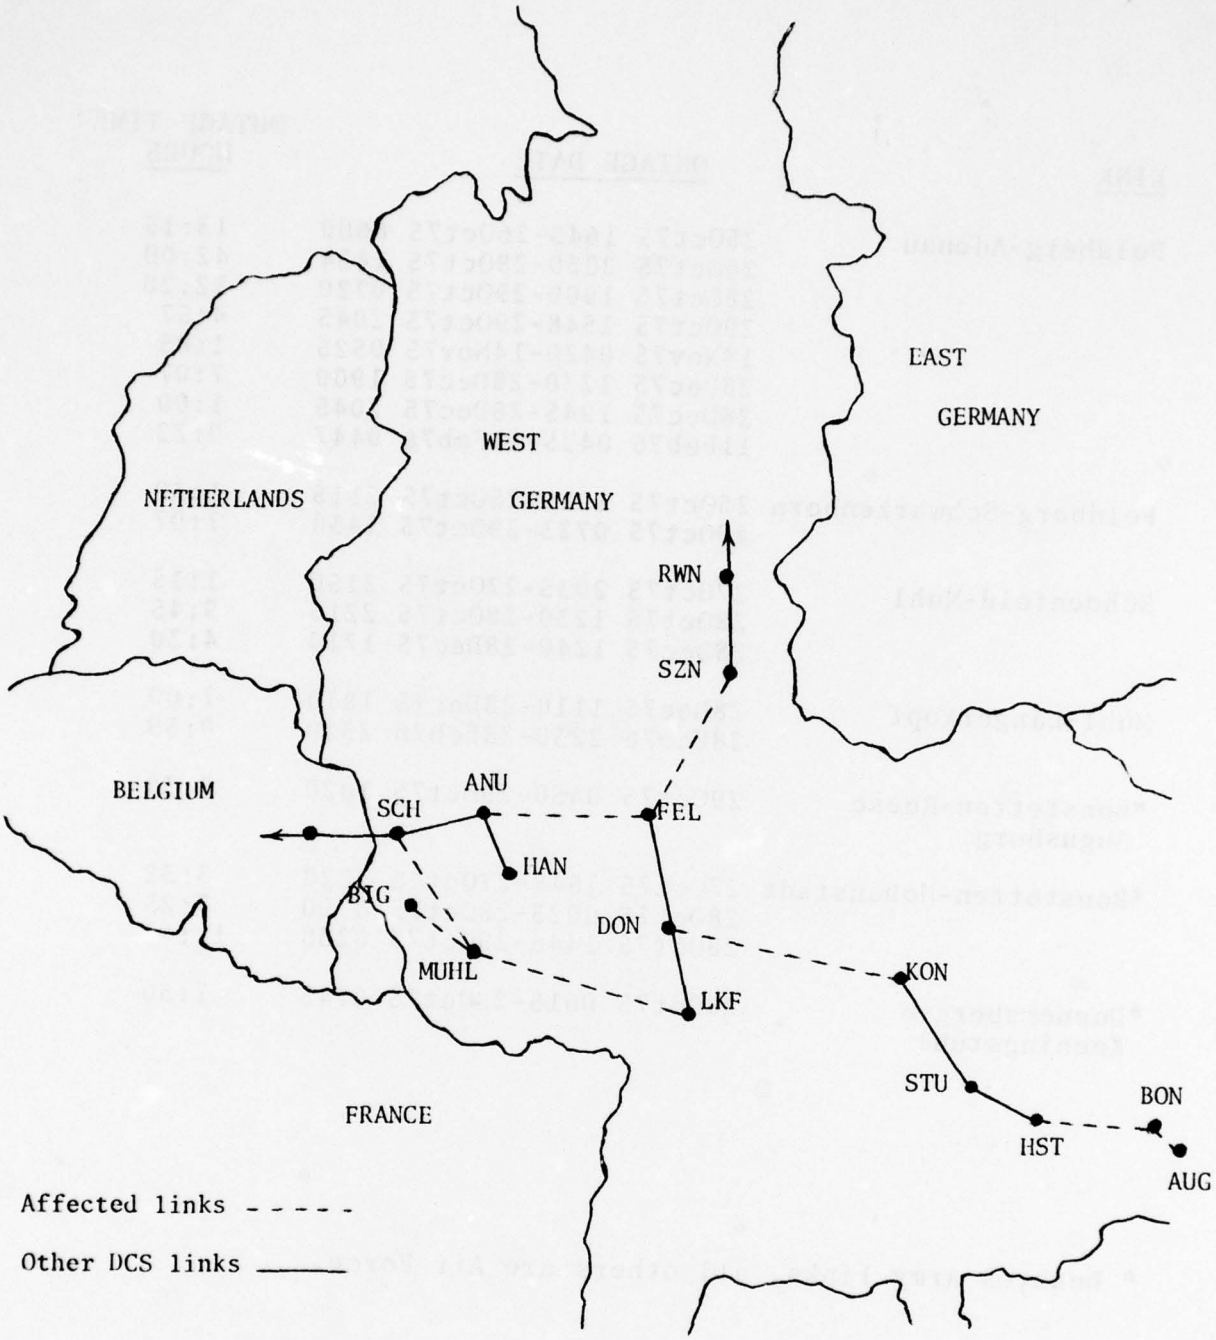
Figure 1. Map of Affected Area

The geographical extent of the problem is illustrated in Fig. 1. The distance from Schoenfeld to Reese-Augsburg is 400 km or more. Taking into account that available information is limited to DCS links, an affected region as large as 500 km in diameter is within the realm of reason. It should be noted that this region encompasses a wide variety of terrain types - from rugged, mountainous areas to rolling agricultural lowlands.

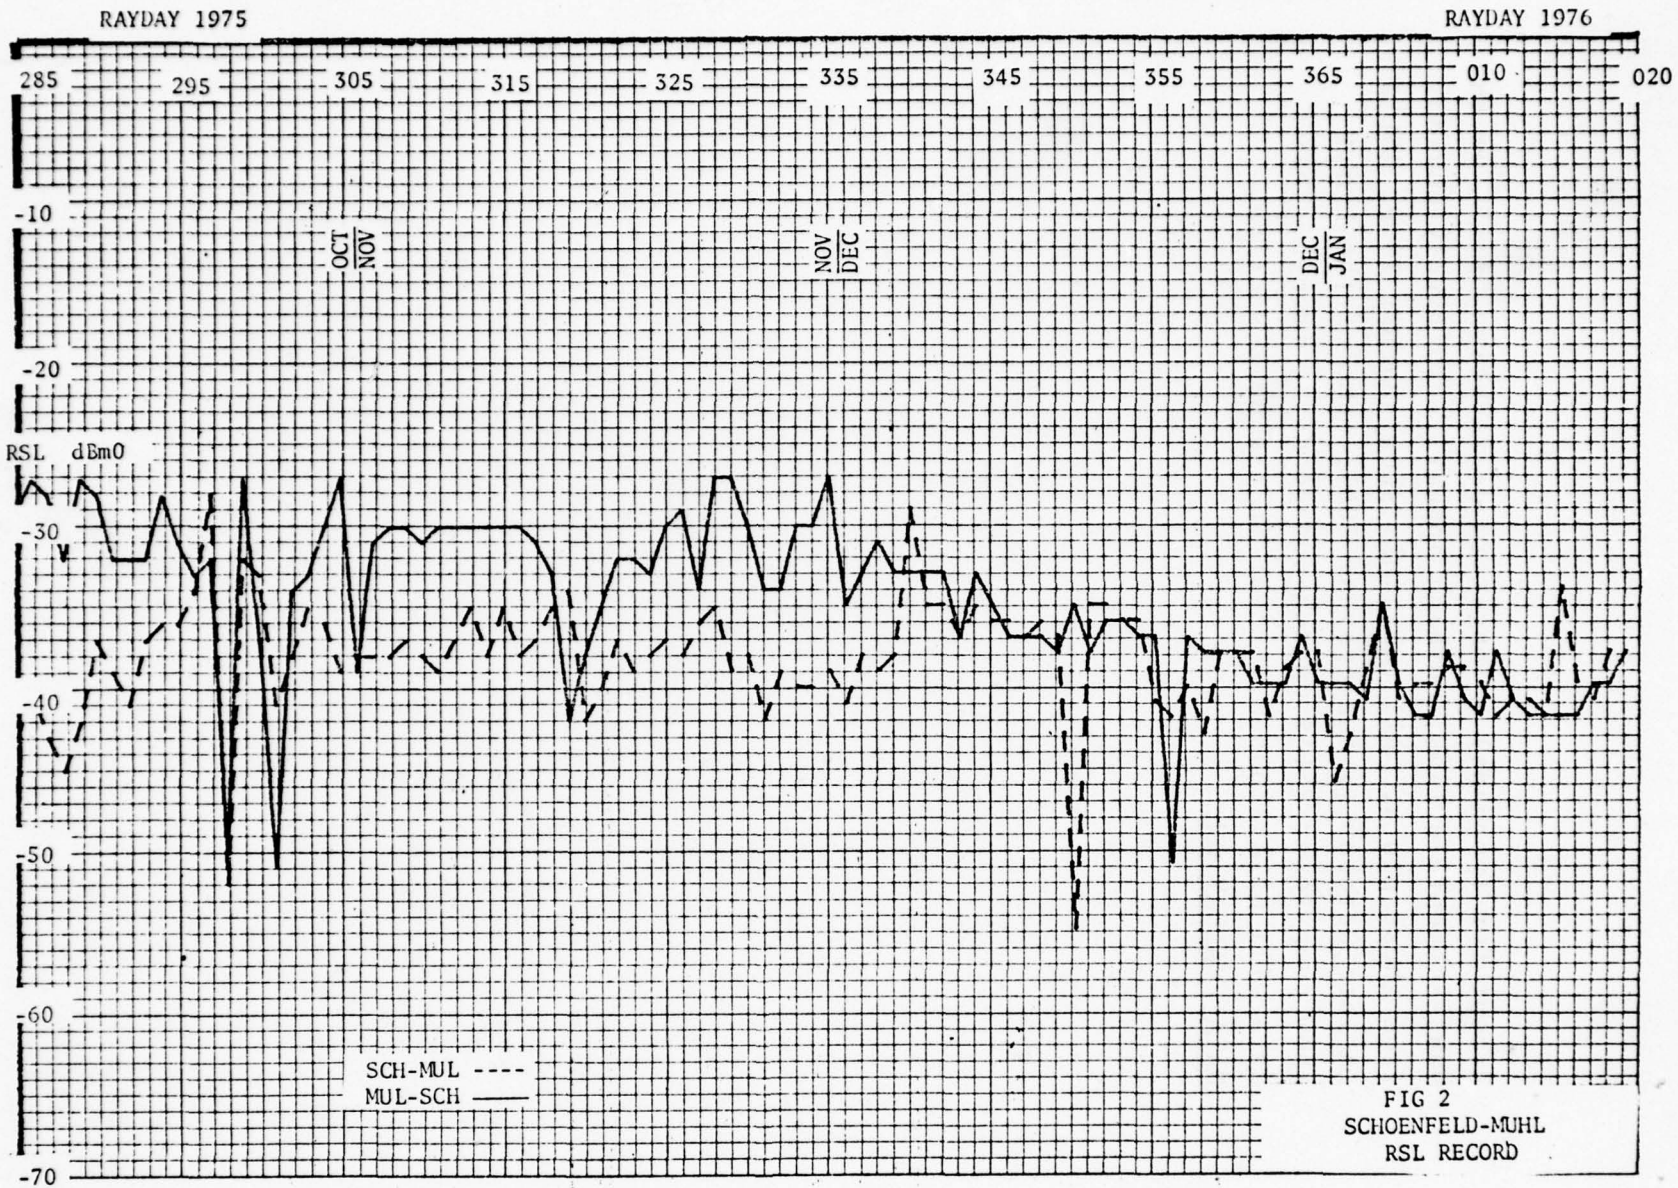
FIG 2
SCHOENFELD-MUHL
RSL RECORD

Except for (perhaps) a long-term degradation of RSL on the Muhl-Schoenfeld link, nothing appears intuitively obvious from these plots. All the links show sharply lower RSL's in late October (around rayday 300); some of the links show even lower RSL's on non-outage days, though. This data will be discussed further in the next section, DATA EVALUATION.

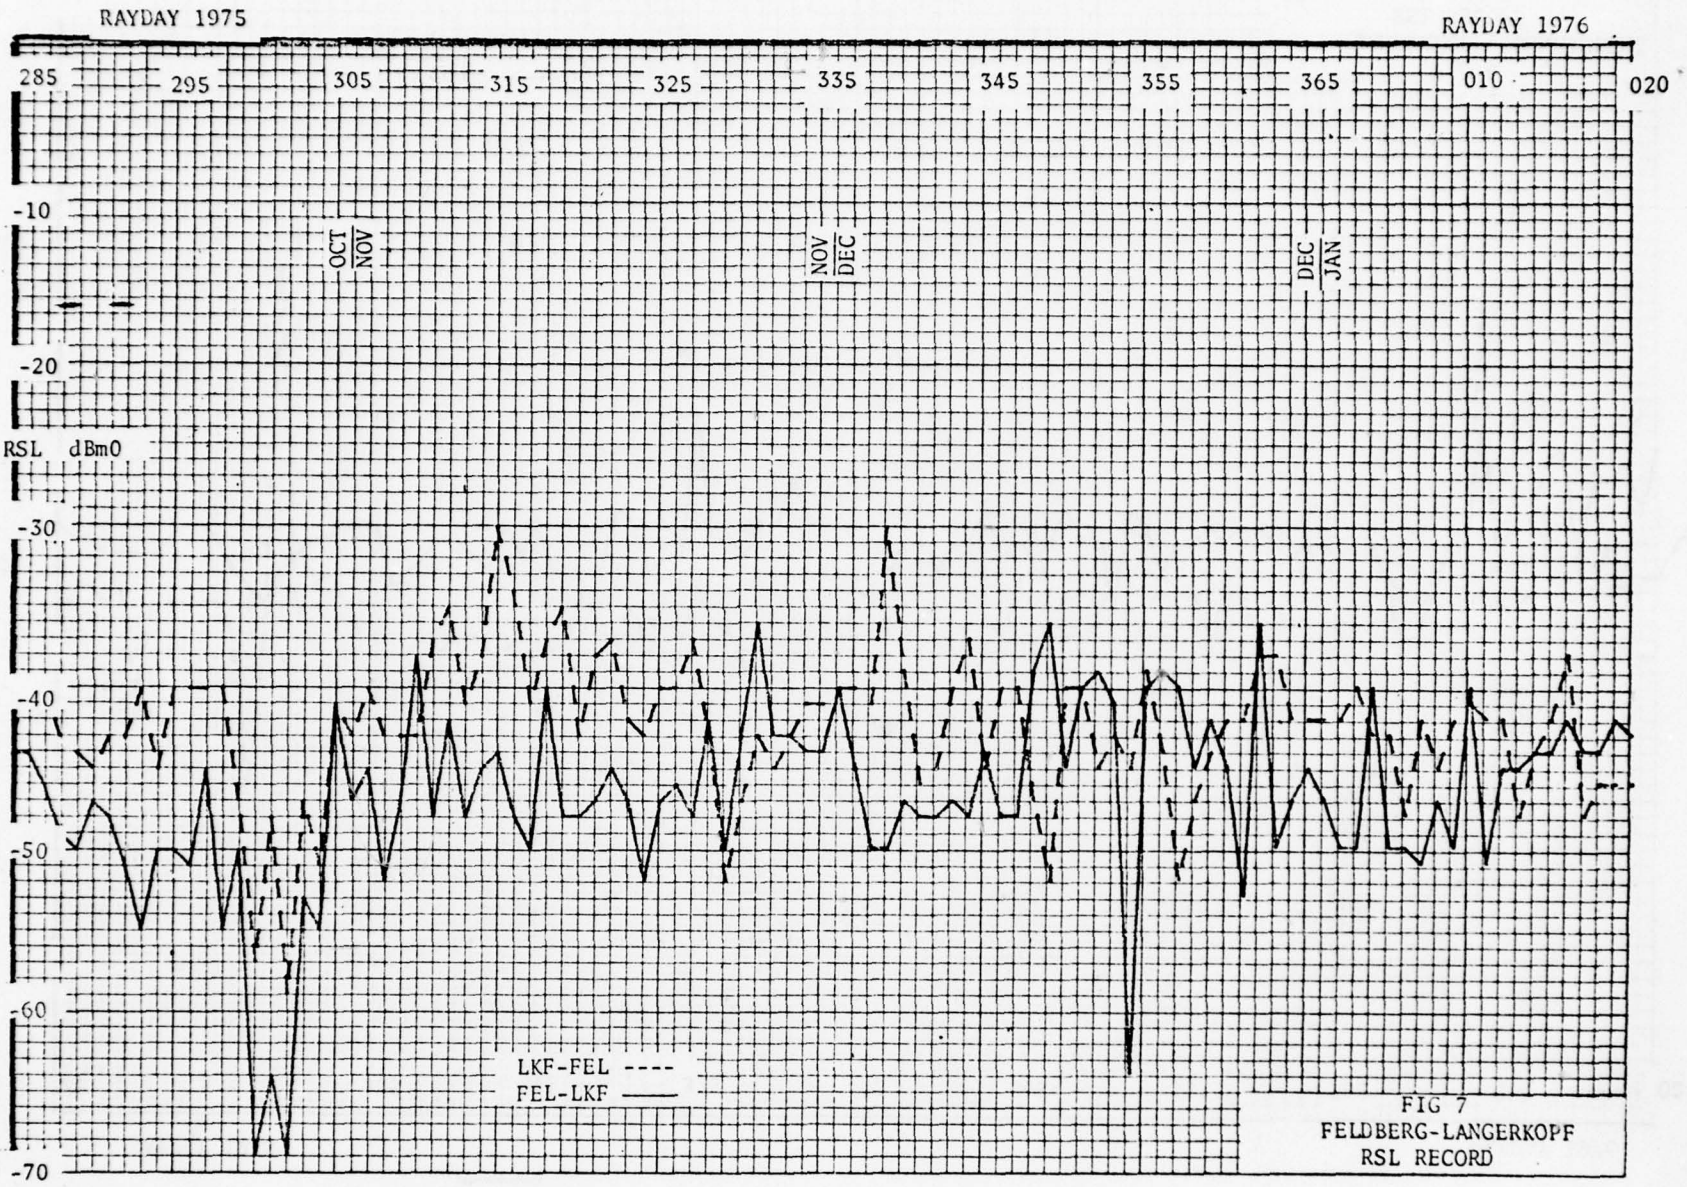
FIG 7
FELDBERG-LANGERKOPF
RSL RECORD

It should be noted that the Feldberg-Langerkopf link (4 GHz, 115 KM, no reported outages) is already operating with 5 to 10 dB less fade margin than the 8 GHz links in the same area which <u>did</u> have outages, due to a low RSL condition which has persisted since activation. A phenomena

On the other hand, RSL's on the Feldberg-Langerkopf link were found to have fairly good correlation with the Muhl-Langerkopf RSL's of the previous day - as one might expect since weather systems move regularly from west to east. A similar result holds for Feldberg-Langerkopf when compared against Muhl-Schoenfeld.
