CAVITATION AND HYDROABRASIVE RESISTANCE OF METALS IN HYDRAULIC TURBINES

CAVITATION AND HYDROABRASIVE RESIS-
TANCE OF METALS IN HYDRAULIC TURBINES
(Selected Articles)

Source: Kavitatsiya i Gidroshli-
fuyushchaya Stoykost' Metallov
v Gidravlisheskikh Turbinakh,
1965, pp. 95-104.

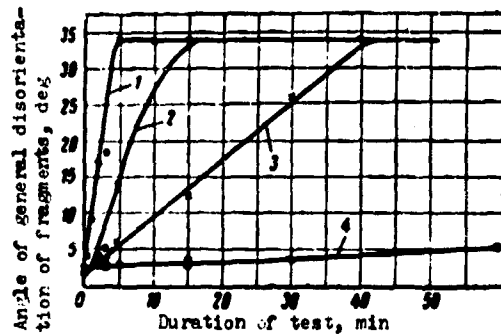
Fig. 1. Angle of general disorientation of fragments of α -phase of bronze Br A⁴ (1), Br A⁸ (2), Br A¹² (3) α - and β - phases of bronze Br A¹² (4) depending upon the duration of the cavitational test.

During the incubation period, microvolumes of the alloy with dimensions of 10^{-3} mm experienced plastic deformation, which leads to the development of surface relief which is accompanied by distortion of the crystal lattice of a second kind, splitting of blocks of the mosaic, and general disorientation of fragments (Fig. 1), the appearance of slip lines and microvoids, and growth in values of microhardness.

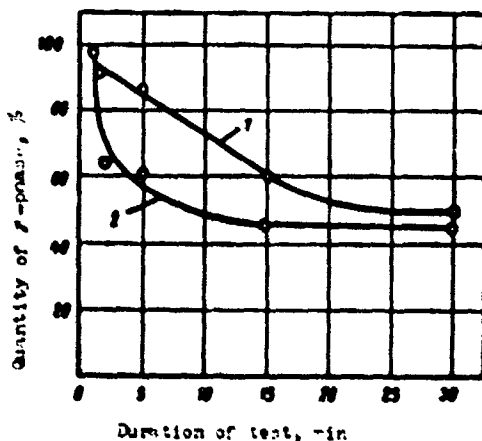
Fig. 2. Quantity of γ -phase in a cavitated layer of annealed (1) and hardened (2) steel 1Kh18N9T depending upon the duration of cavitation testing.

Along with these changes of the surface layer characteristic for all the investigated materials, in certain groups of alloys special phenomena are observed. Thus, in fine-grained materials (dimension of grain less than 3-5 μ) there is revealed a selective destruction of crystallites unfavorably oriented with respect to operational loads. In unbalanced alloys (hardened perlite steels and unstable austenitic steels) the mechanical and thermal effect of the cavitational zone causes phase transitions - tempering, transition of γ -phase to α -phase (Fig. 2).
