MLB/SERV (MOTOR LIFE BOATS/SURFACE  
EFFECT RESCUE VEHICLES) OPERATION  
STUDY

**MLB/SERV OPERATION STUDY**

**U.S. Coast Guard Station**

**MLB/SERV Unit 3960-01  
1 January 1973**

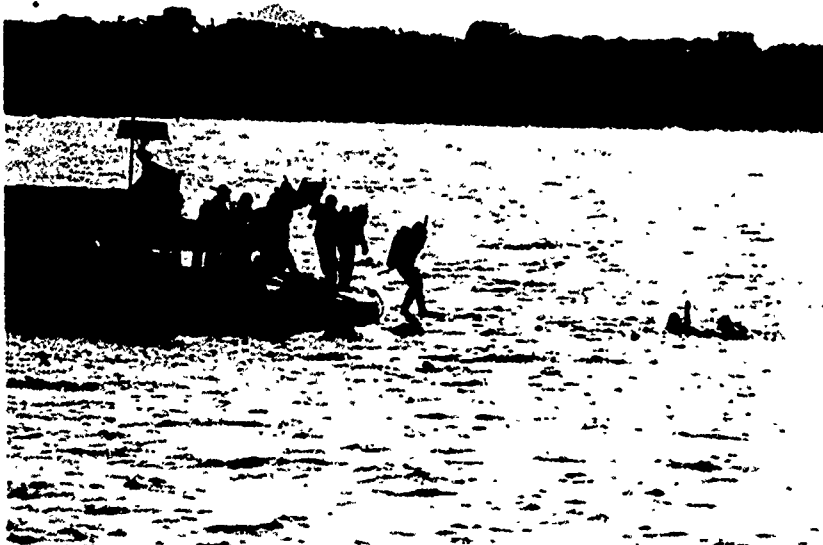
SERV on scene crash site.  
Rescue team preparing to  
deploy. Average speed  
enroute: 30 KTS

Rescue team departing  
SERV for simulated  
survivor rescue. Entire  
team in the water in  
30 Seconds.

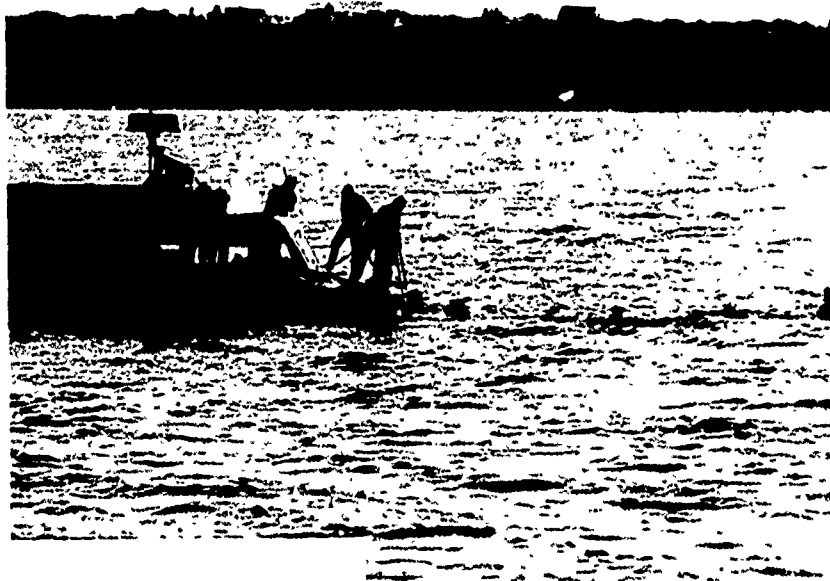
Rescue personnel being assisted aboard with two tenders using a bite of line

Bite of line placed between scuba tank and back harness. Tenders provide all required lift.

Recovery of all light rescue personnel was accomplished in 6.5 minutes
