EVALUATION AND MAINTENANCE OF EXPED-  
IENT-SURFACED AIRFIELD FACILITIES

May 1973

INSTRUCTION REPORT S-73-1

Conducted by **U. S. Army Engineer Waterways Experiment Station  
Soils and Pavements Laboratory  
Vicksburg, Mississippi**

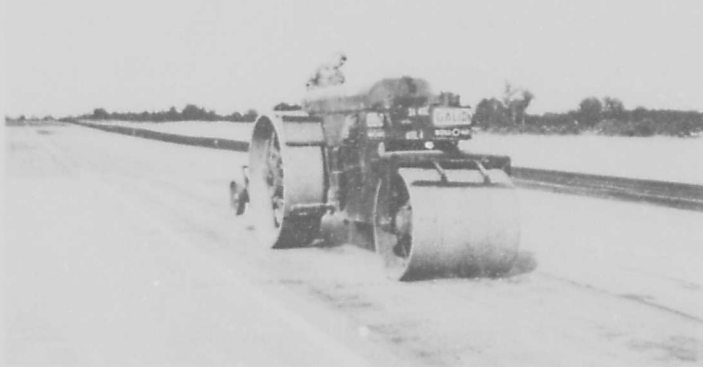
Fig. 2. Using steel-wheel roller to roll out ruts in soil subgrade beneath membrane surfacing

9. If the soil beneath the membrane surface becomes rutted by aircraft or truck traffic to the extent that the ruts constitute a further trafficking hazard then the area should be repaired. One means of repairing such an area consists of leaving the membrane surfacing in place and rolling the rutted area to smooth out the ruts and to compact the soil. Rolling can be accomplished with a steel-wheel roller (fig. 2), a rubber-tired roller, or a loaded M51 5-ton 6x6 dump truck.

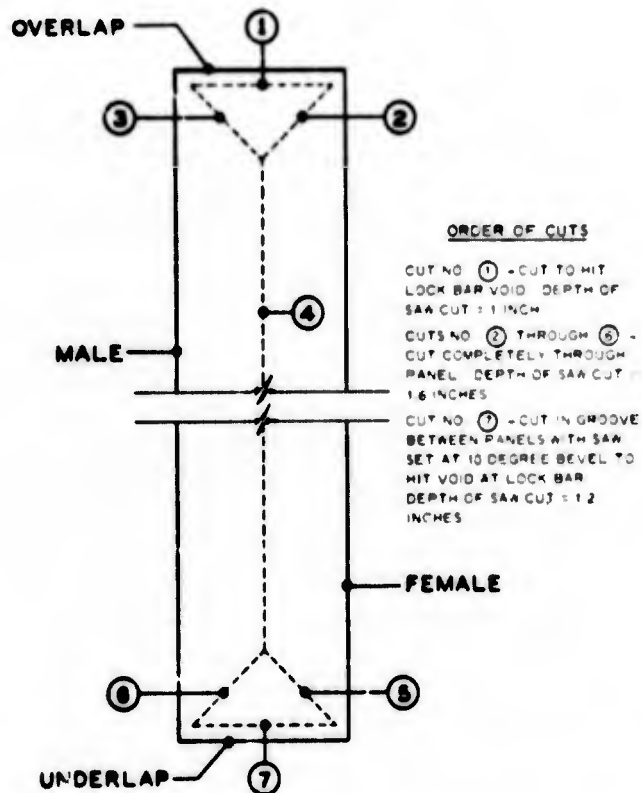
Fig. 8. Cutting method for removing AM2 or XM18 landing mats

- (b) Disconnect the ends of all panels that have been slid from the runway by removing the end connector bars.
  - (c) Discard the damaged panel. Connect a new panel in its place and lock at the end with the adjacent panel in the run. With a tooth of the motor patrol harrow, engage the panel end and slide the panel until only 2 to 4 in. of the new panel protrudes past the edge of the runway.
  - (d) Reinstall succeeding panels as in step (c) until all panels in the run are in their original position.
- (2) Cutting method.
- (a) Cut the damaged panel in seven places, as shown in fig. 8.
