INSTALLATION RESTORATION PROGRAM PHASE II - CONFIRMATION/QUANTIFICATION STAGE 1

VOLUME I

U.S. AIR FORCE PLANT NO. 42 Palmdale, California

FINAL REPORT

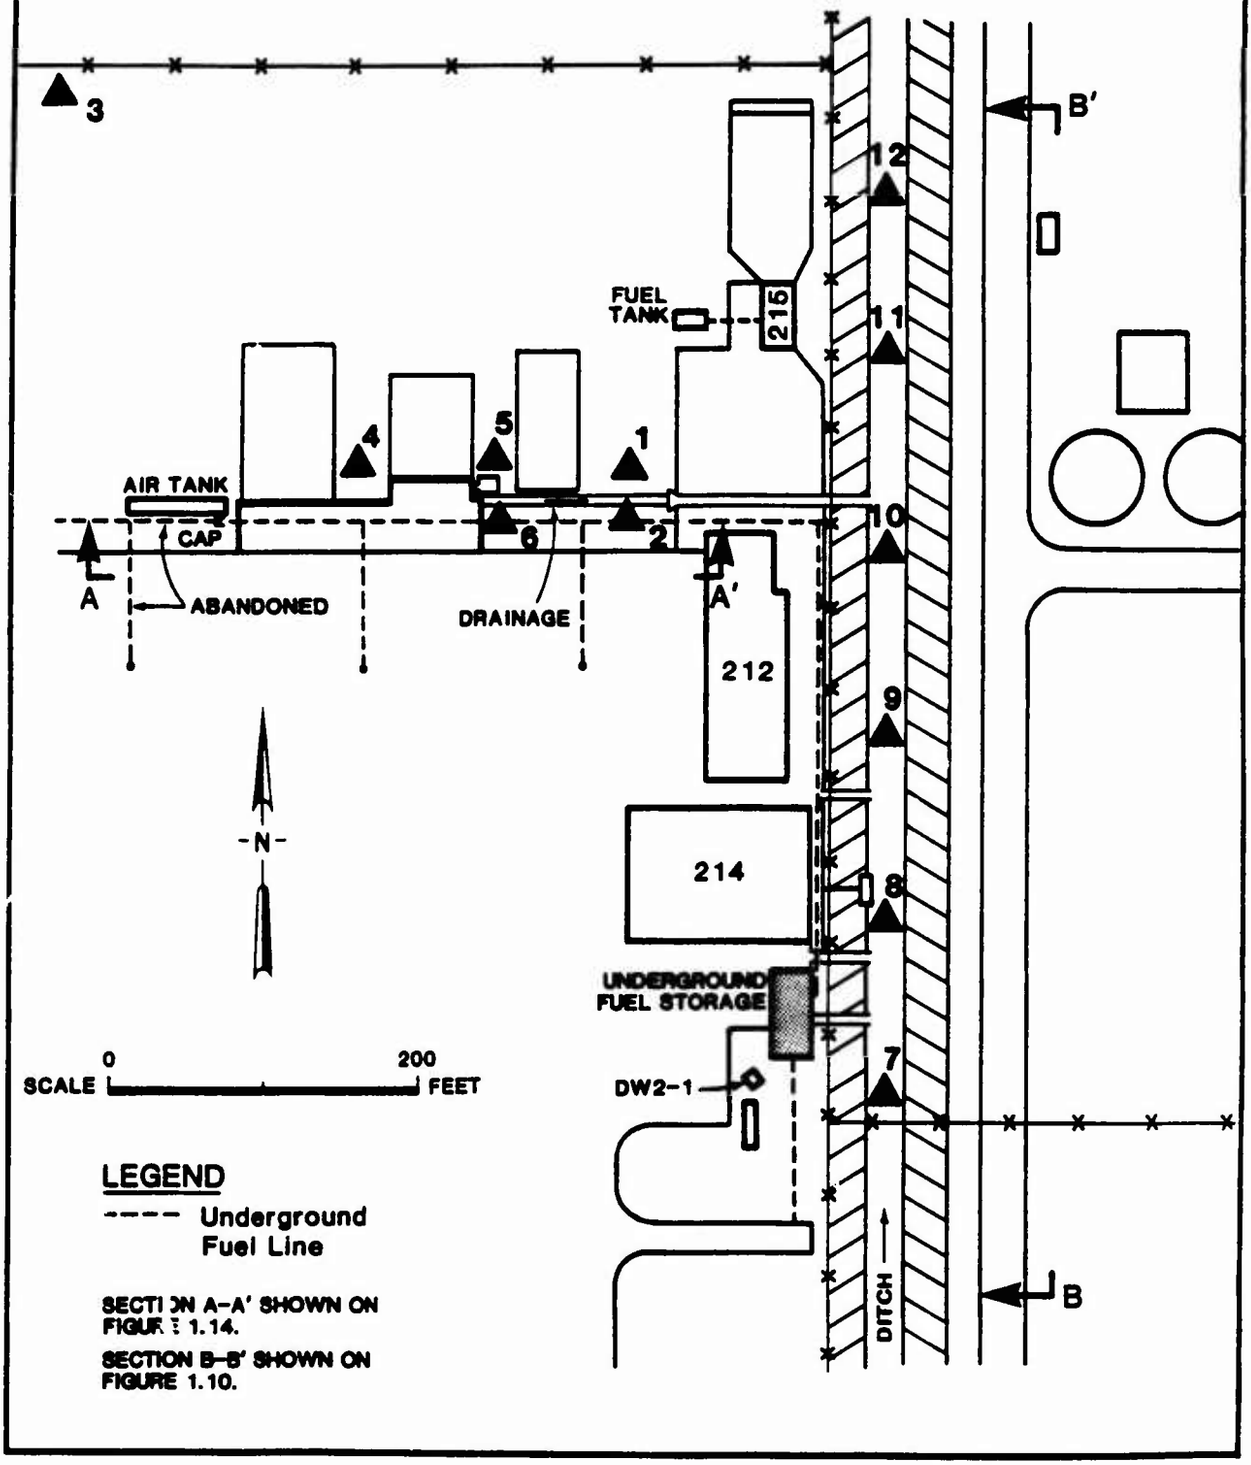
FIGURE 1.9

In July 1982, six soil borings were performed within the ditch at Site 1-FCD2, as shown in Figure 1.9. These borings (numbers 7 to 12) were completed at depths ranging from 40 to 50 feet below the bottom of the ditch. Laboratory analyses revealed the presence of fuels in soil samples from all six borings, at concentrations ranging from 200 to 16,000 mg/Kg, and fuel was found at the maximum sampling depth in all but one boring (number 11). A section drawing of the site is presented in Figure 1.10 which illustrates the extent of contaminantion found in the ditch. Results from the investigation are presented in Appendix F.

In July 1982, six soil borings were performed at this site, as shown in Figure 1.9. These borings (numbers 1 to 6) were all completed at a depth of 50 feet below land surface. No contaminants were detected in borings 3 and 4; but all the other borings contained fuel at concentrations ranging from 300 to 15,000 mg/Kg, and fuel was detected at the maximum sample depth (50 feet) in each of these. A section drawing of the site is presented in Figure 1.14 which illustrates the extent of contamination found at this site. Results from the investigation are presented in Appendix F.

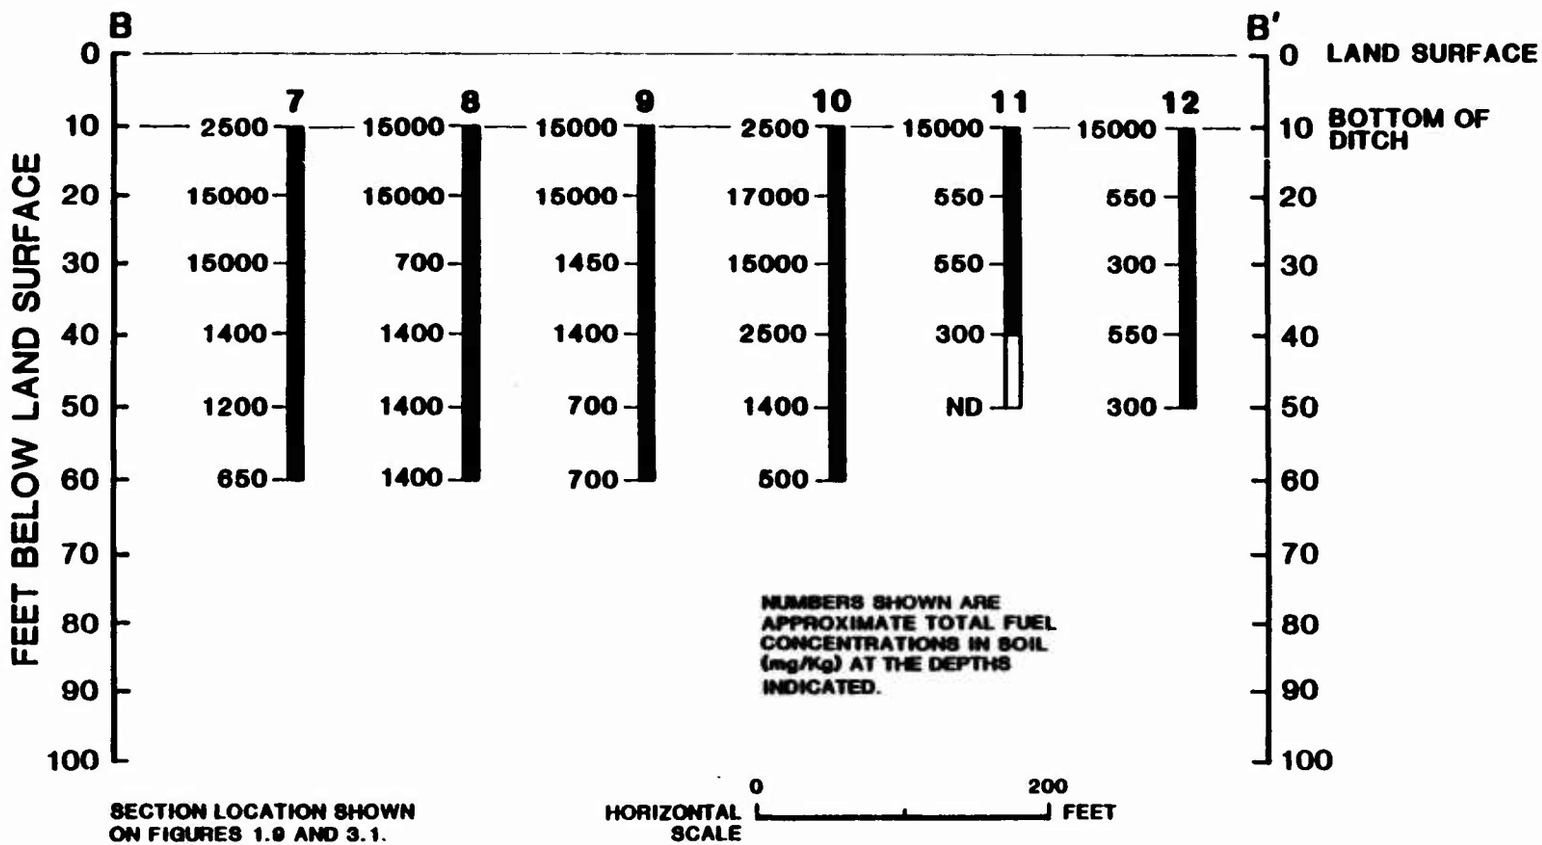
FIGURE 1.10

VERTICAL SECTION OF IRP SITE 1-FCD2 BASED ON RESULTS OF PREVIOUS INVESTIGATIONS

Cleanup and Abatement Order No. 83-1 was issued on January 11, 1983 by the California Regional Water Quality Control Board, Lahontan Region. A Draft Problem Exploration, Confirmation, and Quantification Presurvey Report was completed for this site.

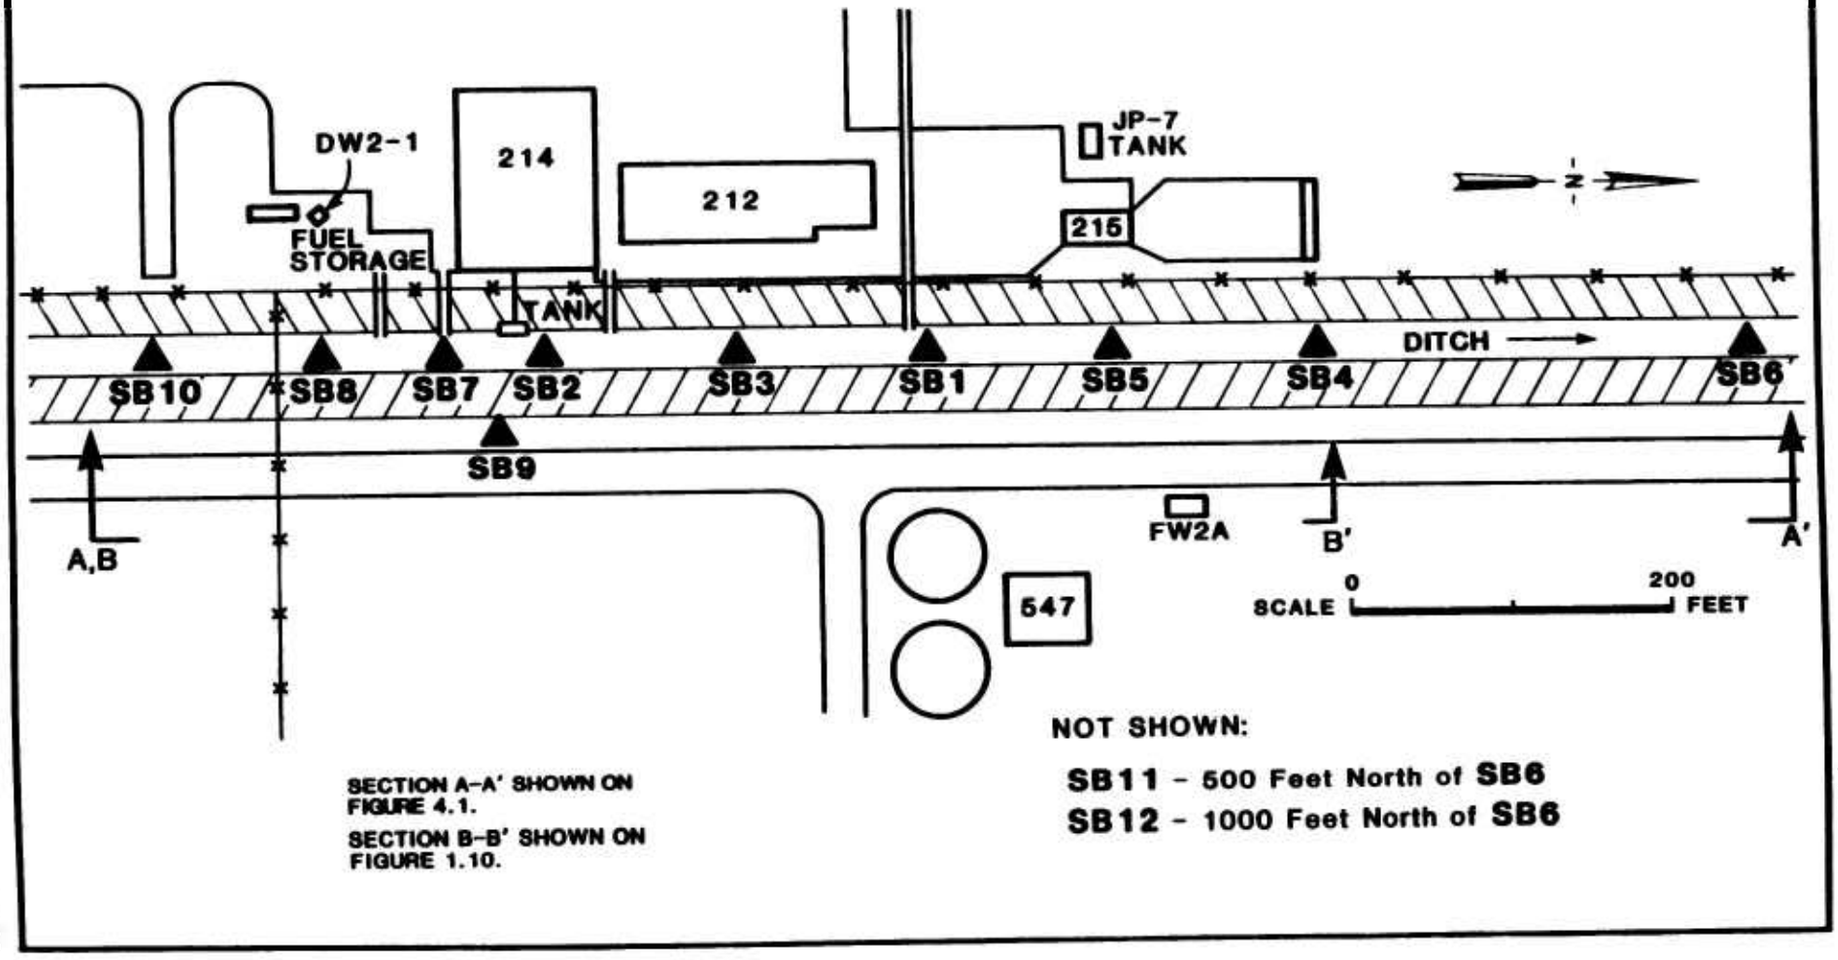
FIGURE 3.1

Soil samples were collected from twelve locations at this site (see Figure 3.1). Eight soil borings were made along the ditch centerline (SB1 to SB8) between the underground fuel storage area and the northern end of the Site 2 security perimeter. A ninth soil boring (SB9) was made about 40 feet east of the ditch centerline to determine whether contaminants had spread laterally from the ditch. Three near-surface soil samples (SB10, SB11 and SB12) were collected manually at other locations within the ditch (see Figure 3.1). A section drawing of the site is presented in Figure 4.1 which shows the extent of contamination, based on both field observations and chemical analytical results.

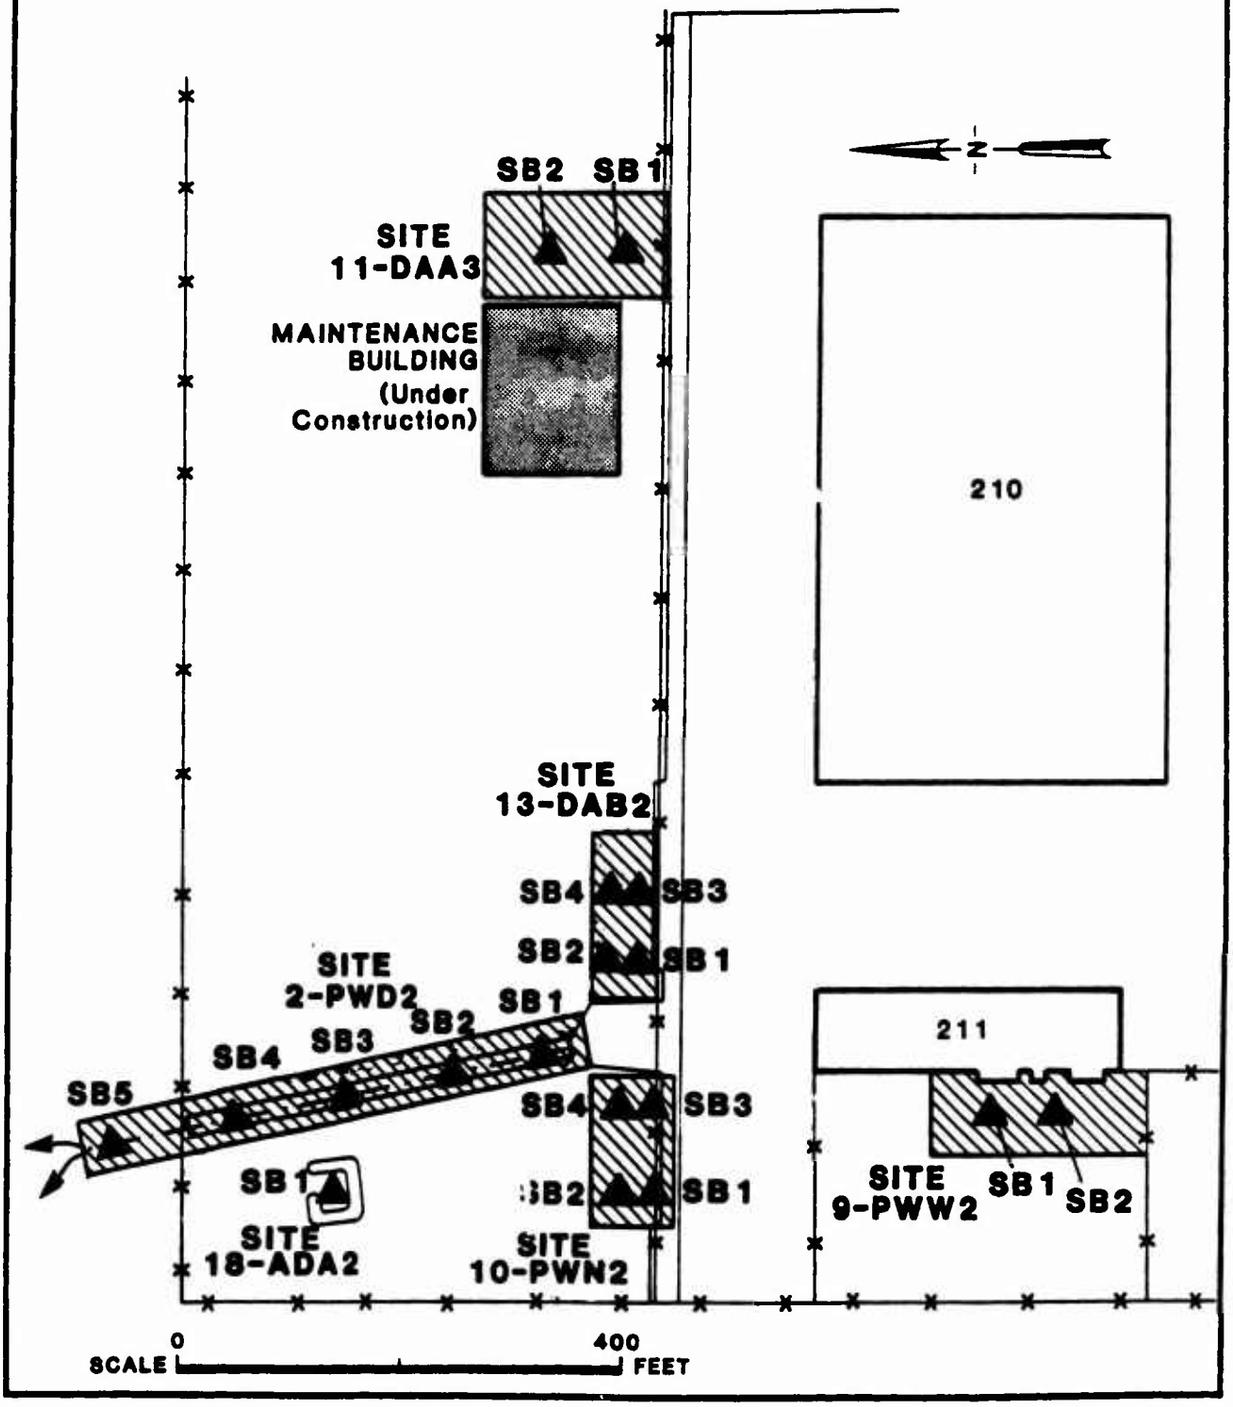
FIGURE 3.2

Five 50-foot deep soil borings were made at 100-foot intervals along the centerline of the former paint waste disposal ditch (see Figure 3.2). Table 4.3 presents observations made during drilling at this site. Soil discoloration was observed from the surface to a depth of 30 feet in SB4, and to somewhat shallower depths in SB1, SB2 and SB3. Soil from SB5 had a normal color over the entire boring depth. Odors were also detected at shallow depths in the first four borings, but not in SB5.

Table 4.4 presents analytical results for 19 soil samples collected at this site. A single halogenated volatile organic was detected in one sample, at its detection limit of 0.01 mg/Kg. Also, several aromatic volatile organics were found in the 2.5-foot sample from SB1. Since none of these compounds exceeded 10 mg/Kg, their identities were not confirmed. Likewise, two aromatic compounds which appeared at trace levels (0.009 mg/Kg) in the 50-foot sample from SB1 were not confirmed. Total oil & grease was found at 980 mg/Kg in the 2.5 foot sample from SB1, but all the other samples contained less than 40 mg/Kg. Total phenolics in all samples were either not detected or were present at trace levels (< 1.0 mg/Kg). The metals values presented in Table 4.4 were determined using the WET extraction procedure (CA Title 22:66700), so a reported value of 1.0 mg/L (1 ppm) is roughly equivalent to a soil concentration of 10 mg/Kg (10 ppm) of extractable metal.

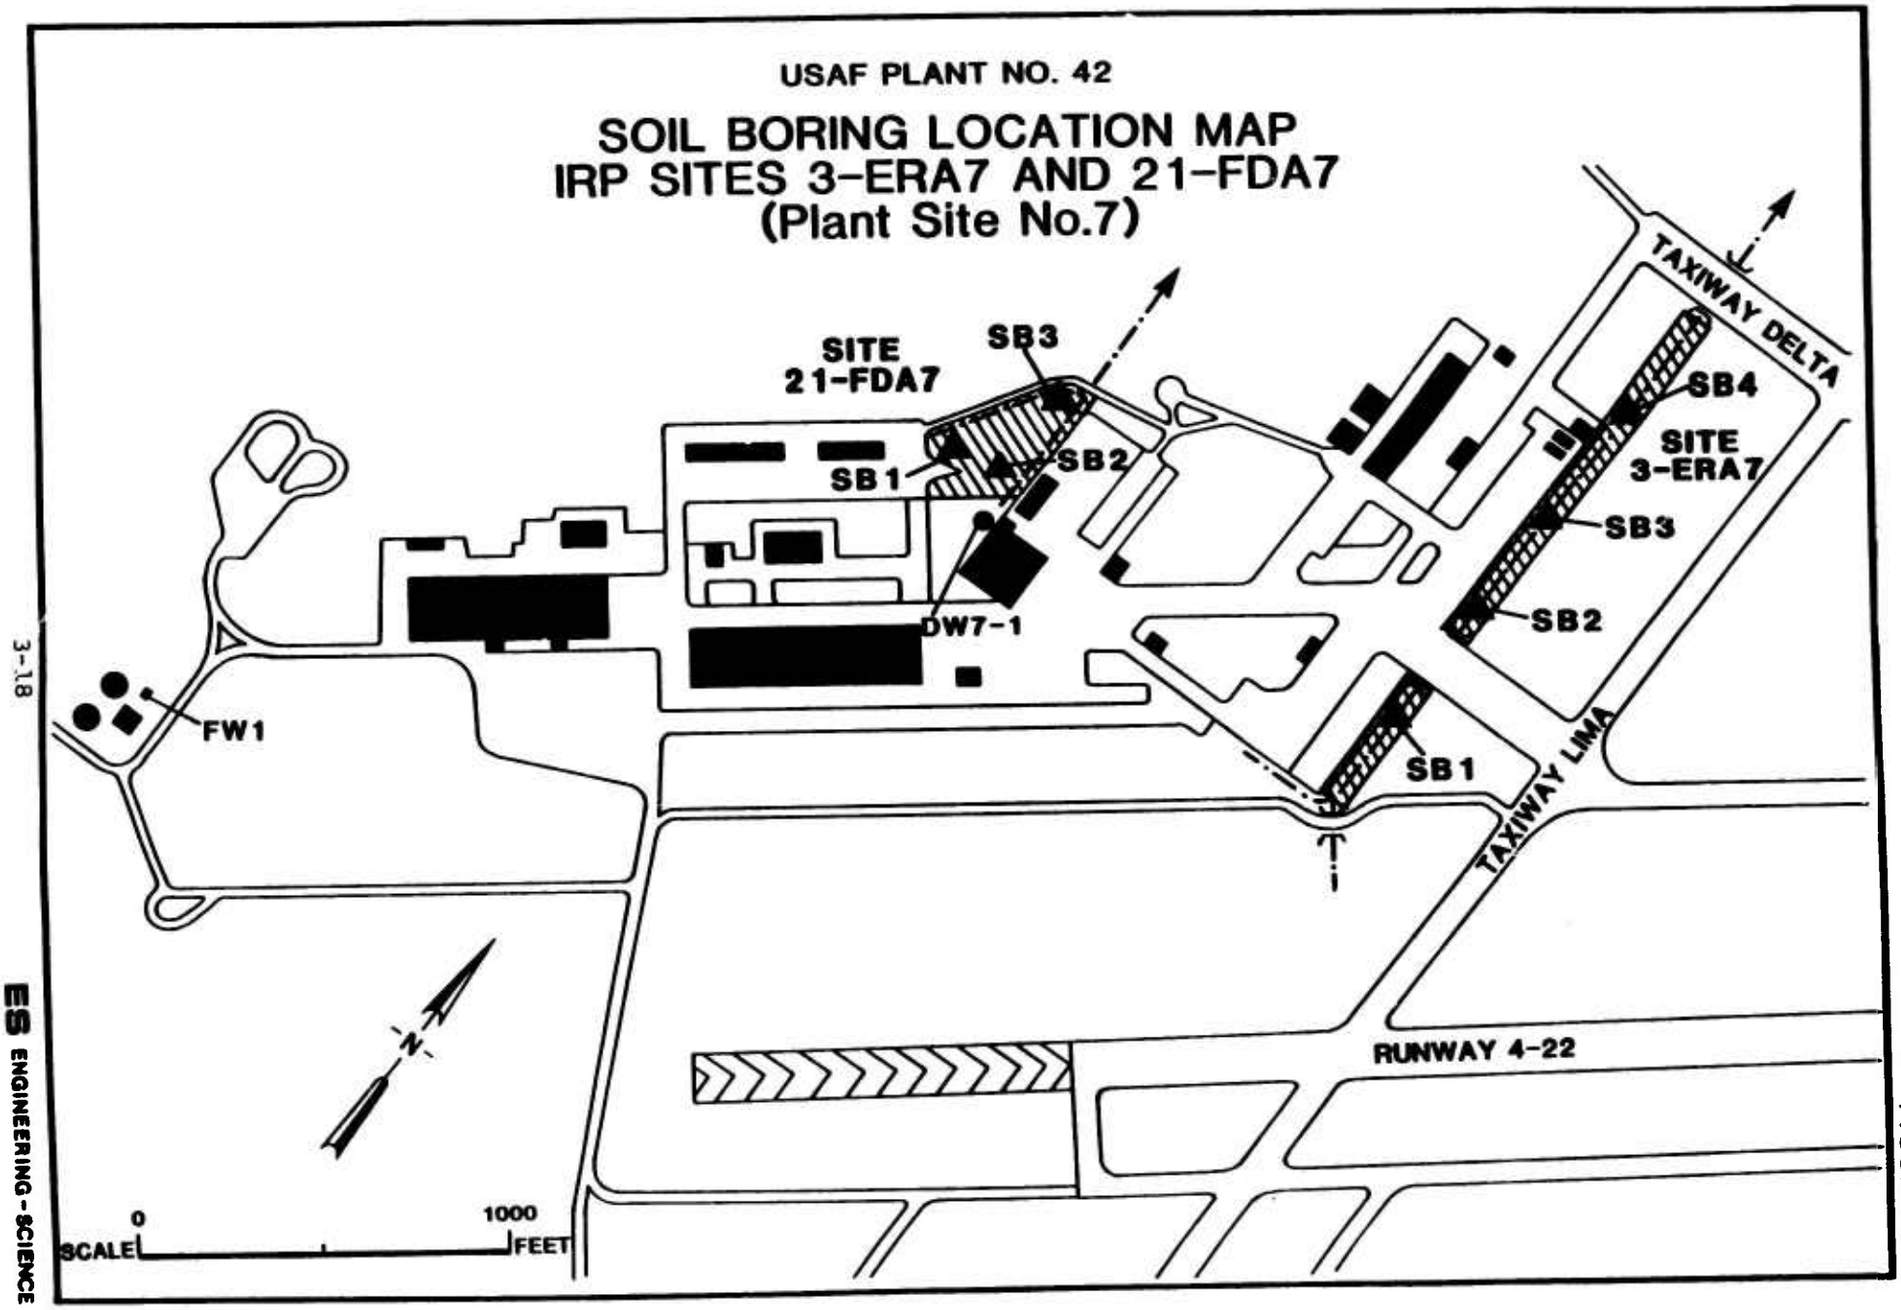
FIGURE 3.3

Four 20-foot soil borings were made along the centerline of the ditch (see Figure 3.3). No evidence of contamination was observed during drilling, as indicated in Table 4.5. Table 4.6 presents analytical results for eight soil samples from the site. Total oil & grease was detected only in the 5-foot sample from SB3, at a level of 45 mg/Kg. Trace levels (< 0.08 mg/Kg) of a few halogenated and aromatic volatile organic compounds were detected in some of the samples. Since none exeeded 10 mg/Kg, the identity of these was not confirmed.

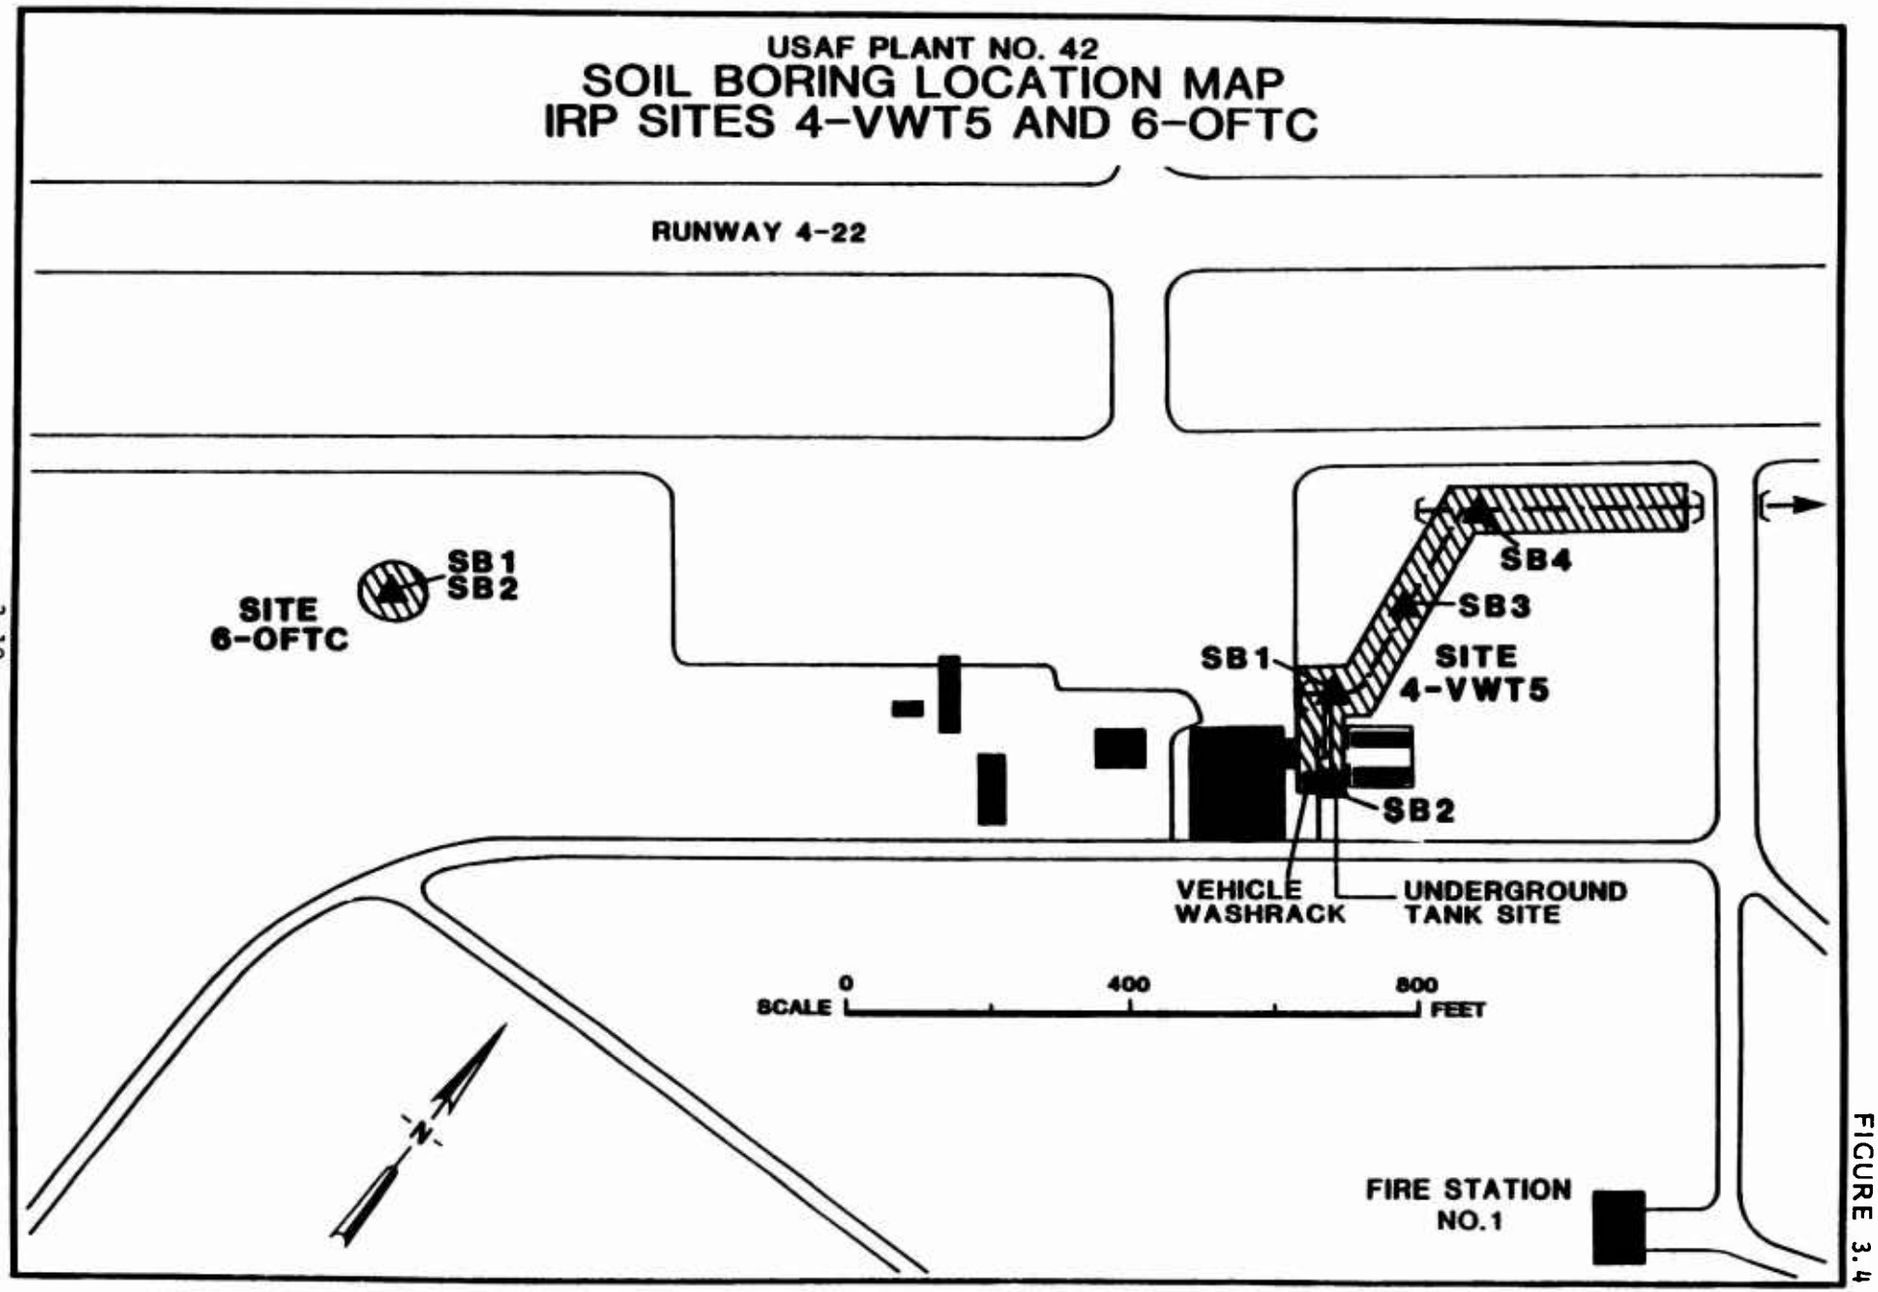
FIGURE 3.4

Four soil borings were made at this site (See Figure 3.4), three along the centerline of the drainage ditch leading from the vehicle washrack (SB1, SB3 and SB4) and one where the former underground waste-oil tank was located (SB2). No evidence of contamination was observed during drilling, as indicated in Table 4.7. Table 4.8 presents analytical results for eleven soil samples from this site. No halogenated or aromatic volatile organics were detected, and all but one sample had only trace levels (< 15 mg/Kg) of oil & grease or none was detected. The 5-foot sample from SB1 had an oil & grease concentration of 350 mg/Kg.

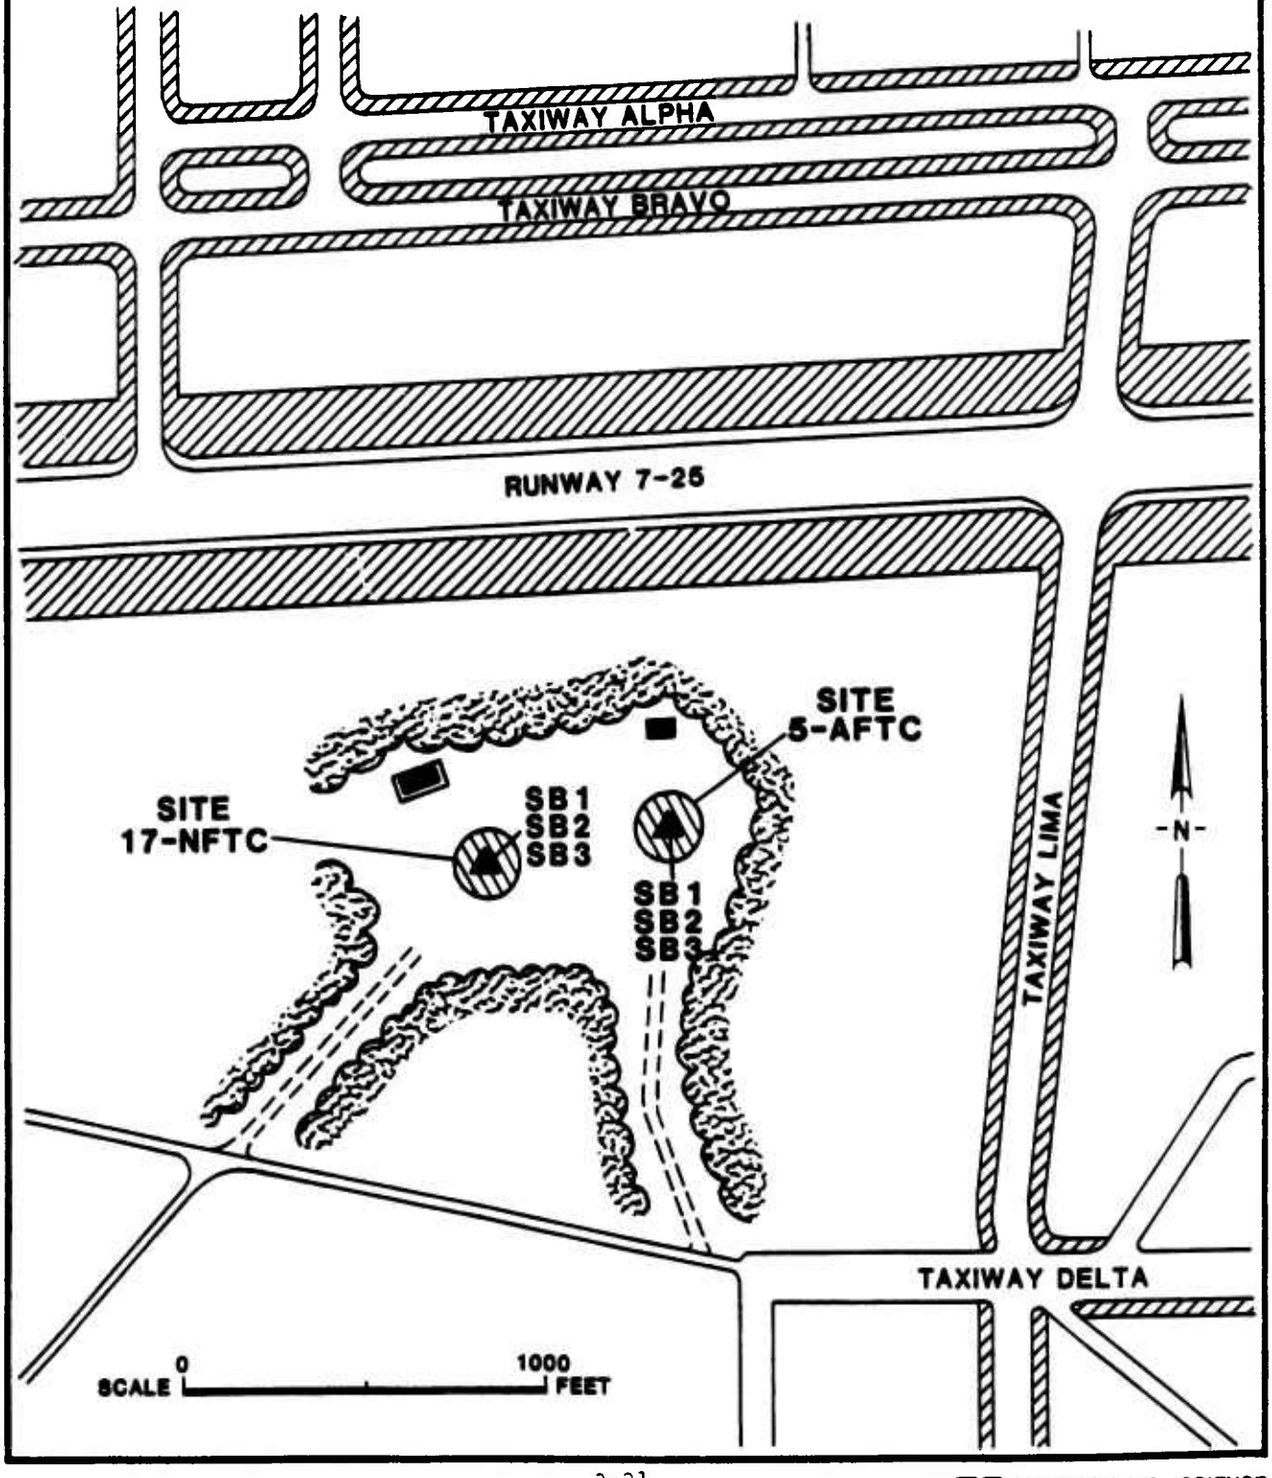
FIGURE 3.5

Two soil borings were made approximately in the center of the old burn area (see Figure 3.5). A near-surface sample was collected manually in the same immediate area. As indicated in Table 4.9, soil

Two borings were made approximately in the center of the burn area, just west of the mock airplane cockpit (see Figure 3.5). One near-surface sample was manually collected in the same immediate area. As indicated in Table 4.25, soil discoloration, fuel odor, and organic vapor readings were observed to depths of 10 to 15 feet. Fuel odor was apparent during digging of SB3, its soil color and organic vapor readings were normal. Only trace amounts (< 4 mg/Kg) of either total oil & grease or total petroleum hydrocarbons were detected in samples from this site (Table 4.25).

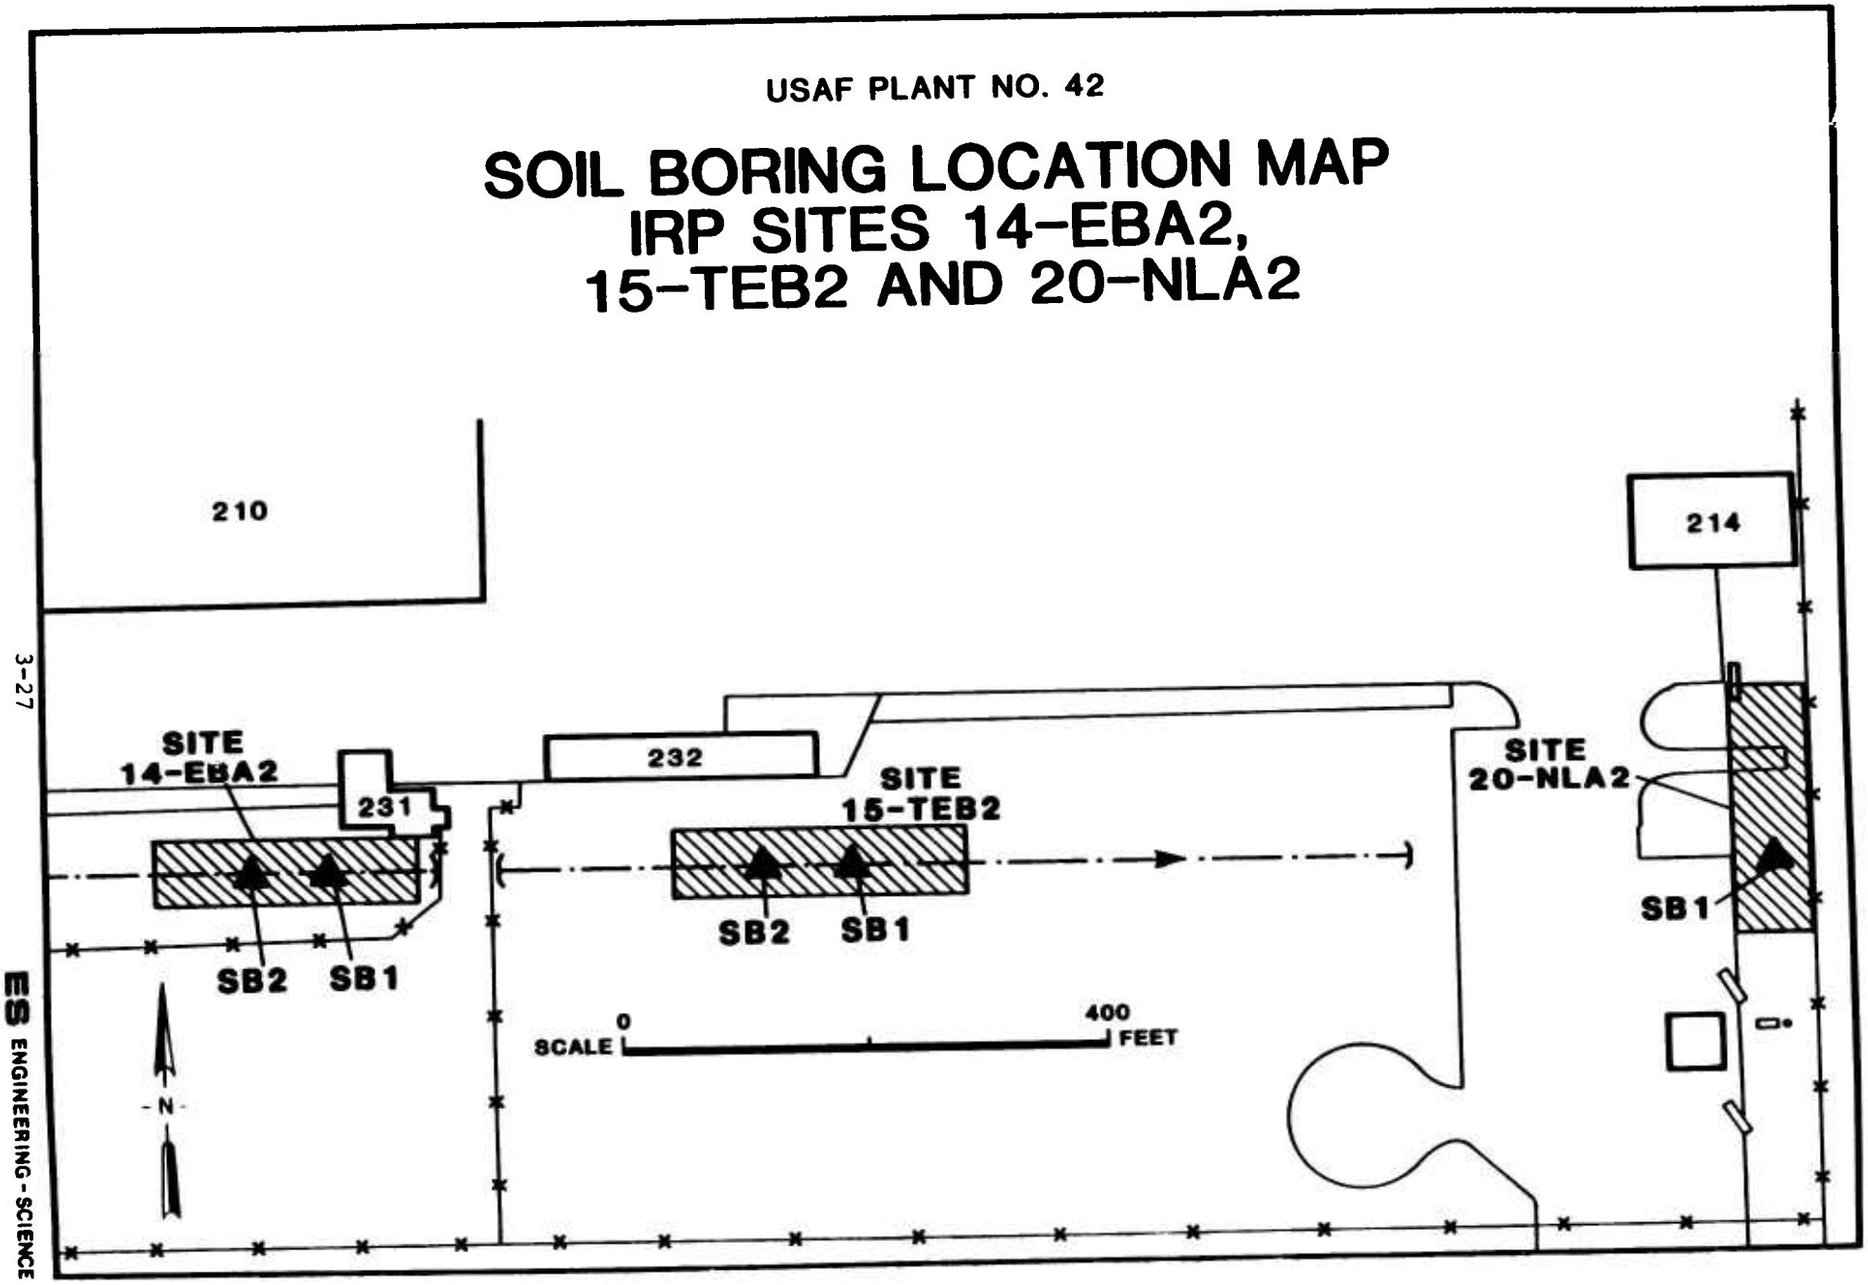
FIGURE 3.9

One 20-foot boring was made at this site (see Figure 3.9). As indicated in Table 4.28, a slight odor was detected to a depth of 7.5

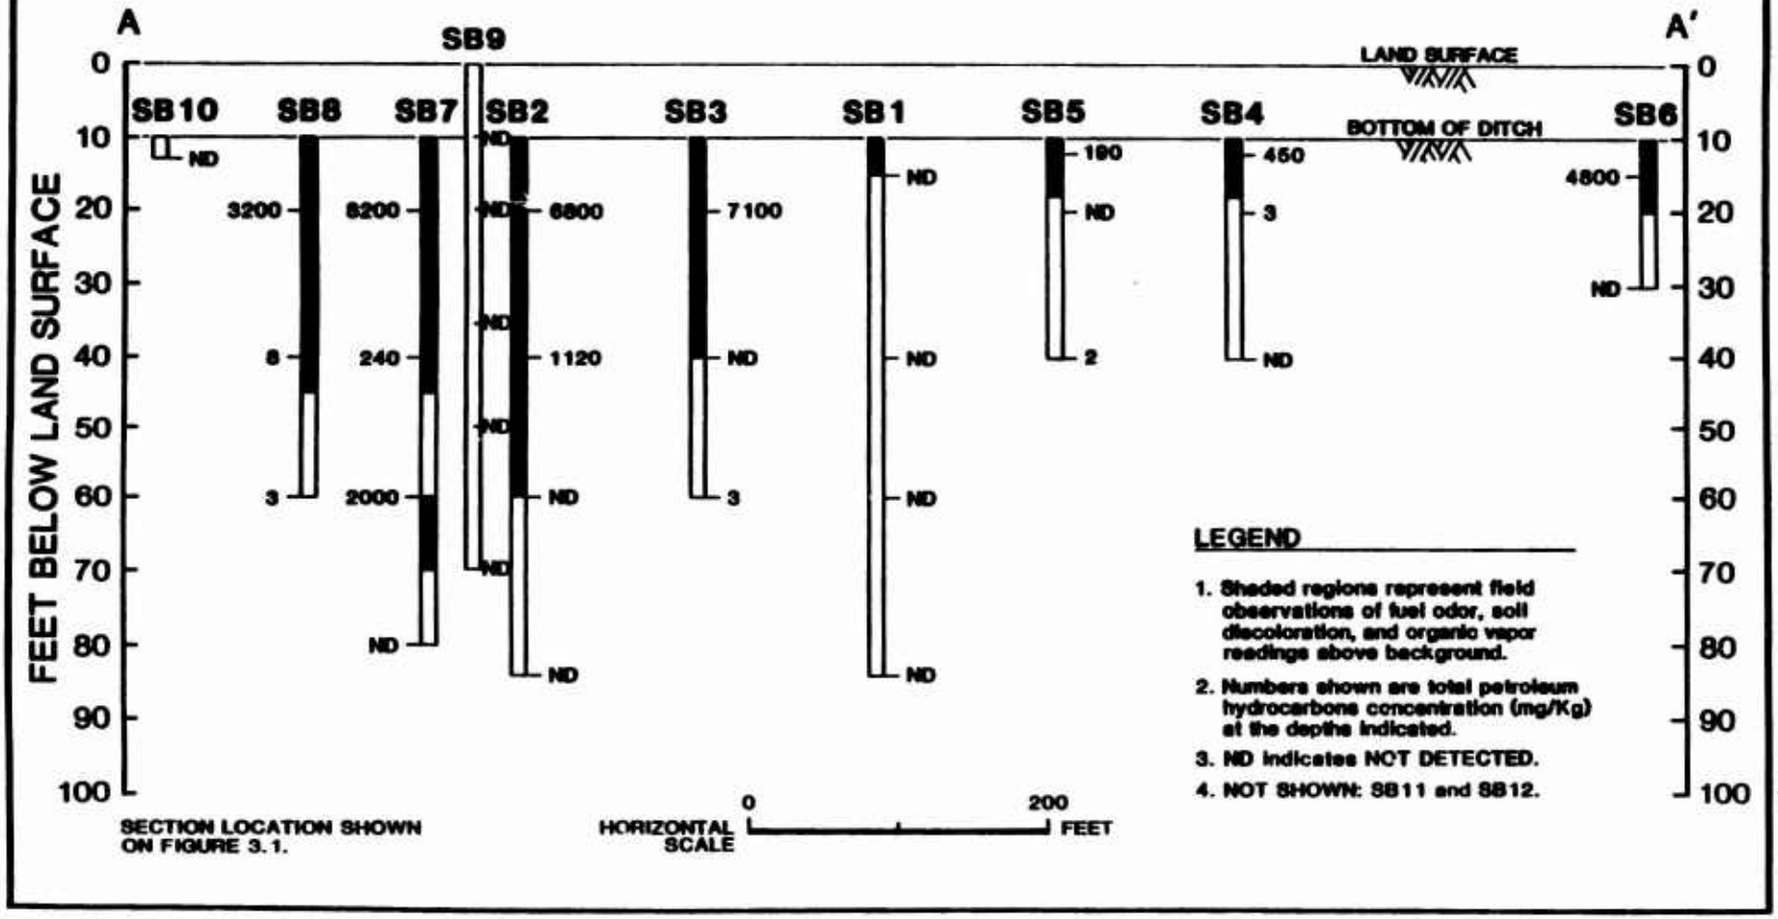
FIGURE 4.1

VERTICAL SECTION OF IRP SITE 1-FCD2 BASED ON RESULTS OF PHASE II, STAGE 1 INVESTIGATION

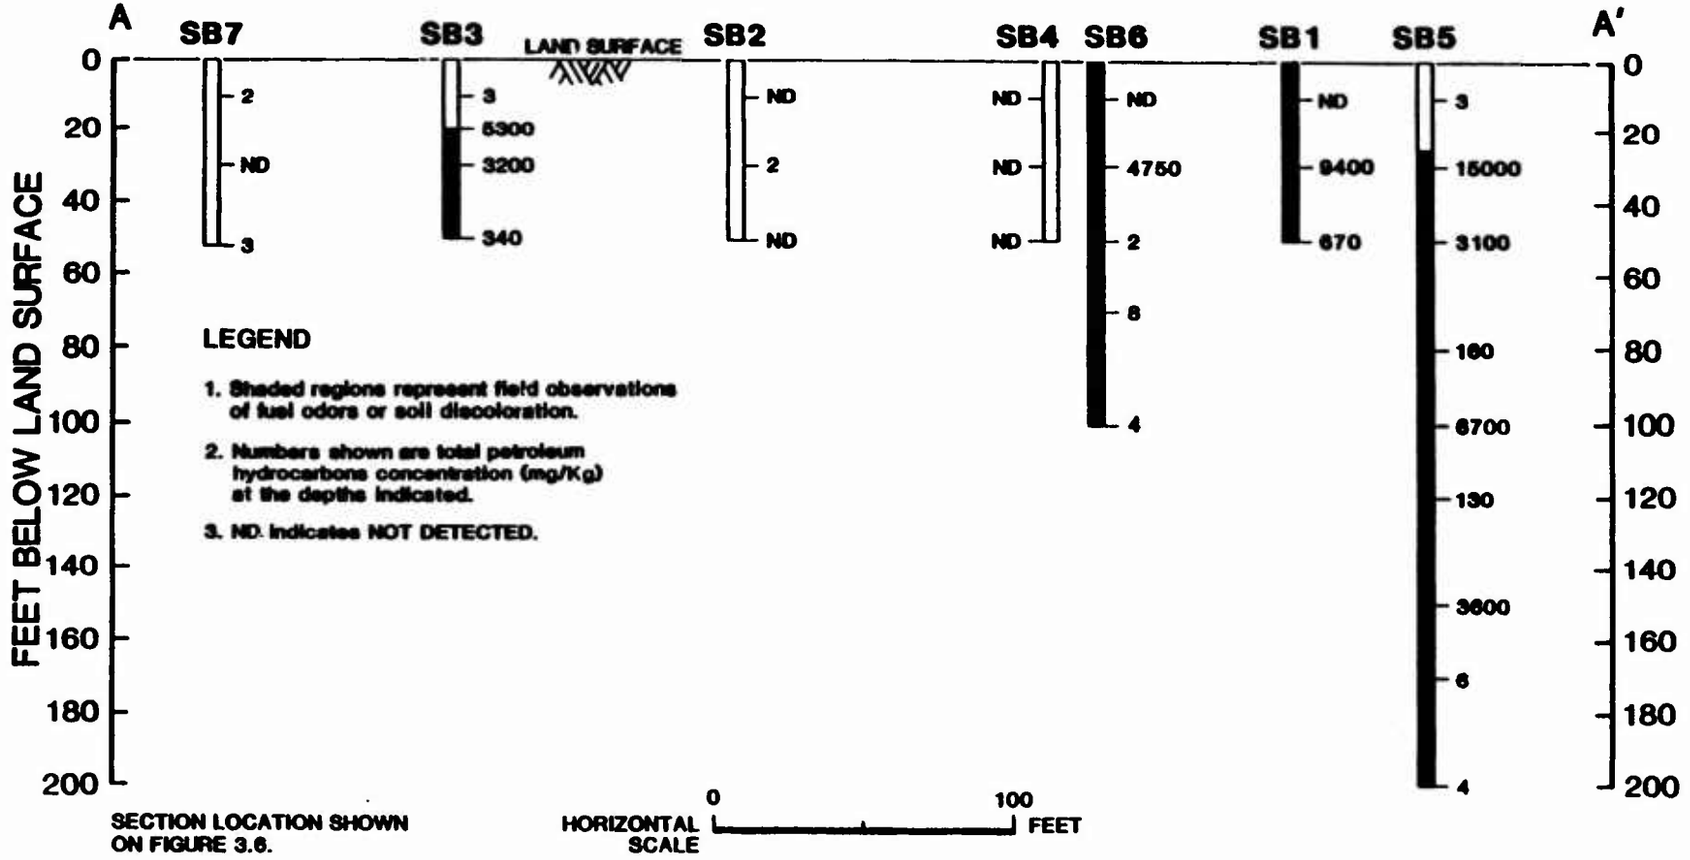
FIGURE 4.2

VERTICAL SECTION OF IRP SITE 7-ERA2 BASED ON RESULTS OF PHASE II, STAGE 1 INVESTIGATION
