USAAMRDL TECHNICAL REPORT 73-74

**EVALUATION OF VARIOUS SIZES AND CONFIGURATIONS
OF FUEL TANKS**

D. L. Byerley

December 1973

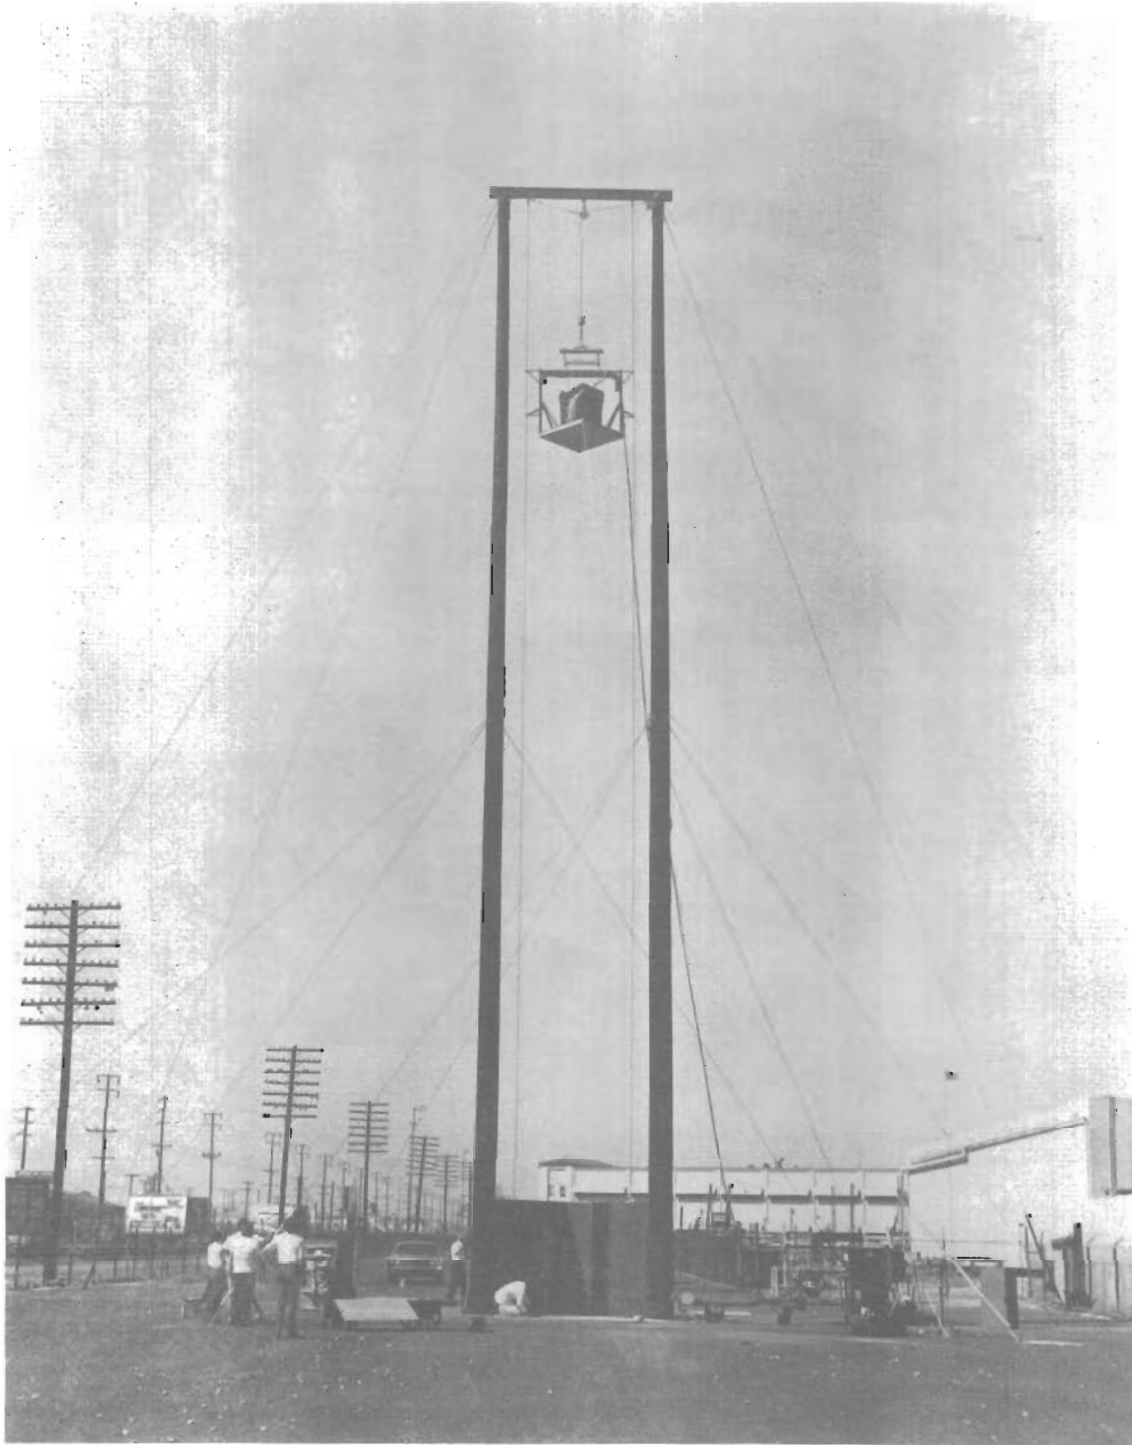
Figure 13. Tower With Test Tank Aloft.

Subsequent to this drop, the fill fixture was used only for strain gage location and to maintain the tank in a simulated "aircraft" configuration while being filled to capacity and evacuated. A number of drops were then performed on a guided platform of the type shown aloft in Figure 13. This platform design caused the rebounding tank to strike the crosspiece between the vertical uprights and threatened damage to the top transducer, cable entry point and cables. The platform release was then redesigned to the configuration shown in Figure 14, wherein the hinged crossarm remained aloft and offered no threat to the instrumentation. Two tanks, however, did fall on the projecting ends of the vertical uprights after rebound; but neither incident resulted in any serious damage to the tanks, and this system was used for the remainder of the drops. All drops were made from 65 feet.

1. The coaxial cables were extremely susceptible to damage. As can be seen in Figure 13, the cables extend from the instrumentation package to the drop platform and are attached to the tower at approximately the midpoint. This, the best of several ways tried, still resulted in a loop which was subject to sway in breezes and snagging on the falling platform.
