**EVALUATION AND IMPROVEMENT OF COATINGS  
FOR COLUMBIUM ALLOY GAS TURBINE ENGINE COMPONENTS**

**H. A. Hauser and J. F. Holloway, Jr.**

This report discusses the work performed by Pratt & Whitney Aircraft Division of United Aircraft Corporation, East Hartford, Connecticut on evaluation and improvement of coatings for columbium alloy gas turbine engine components during the period from 1 April 1965 to 30 April 1966. The work was performed in accordance with Contract No. AF33(615)-2117 under the direction of Mr. Norman M. Geyer (MAMP), Metals Branch, Metals and Ceramics Division of the Air Force Materials Laboratory. This contract was conducted under Project 7312, "Metal Surface Deterioration and Protection", Task 731201, "Metal Surface Protection", and was supported in part by the AFML Director's Fund. The report was submitted 31 May 1966 in compliance with Line Item 1c of DD Form 1423, dated 13 February 1965, attached to the original contract, and with Exhibit C, Part I, paragraph C of Contract Modification No. S2(66-1258), dated 1 April 1966. The contractor has assigned the number PWA-2809 to the report.

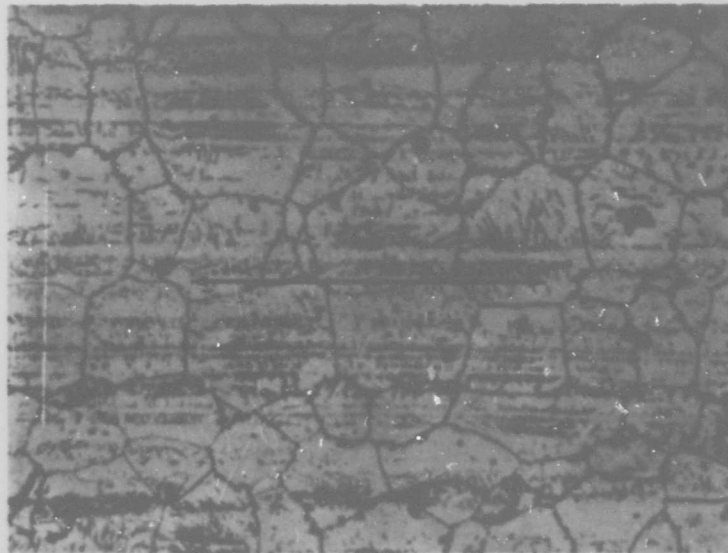
ALLOY: Cb-132M, EXTRUDED BAR  
PLANE: NORMAL TO EXTRUSION DIRECTION  
ETCH: 33% HYDROFLUORIC ACID, 33% NITRIC ACID, 33% WATER

ALLOY: Cb-132M, EXTRUDED BAR  
PLANE: PARALLEL TO EXTRUSION DIRECTION (ARROWS)  
ETCH: 33% HYDROFLUORIC ACID, 33% NITRIC ACID, 33% WATER

Figure 6. Microstructure of As-Received Cb-132M Alloy 5/8D Bar

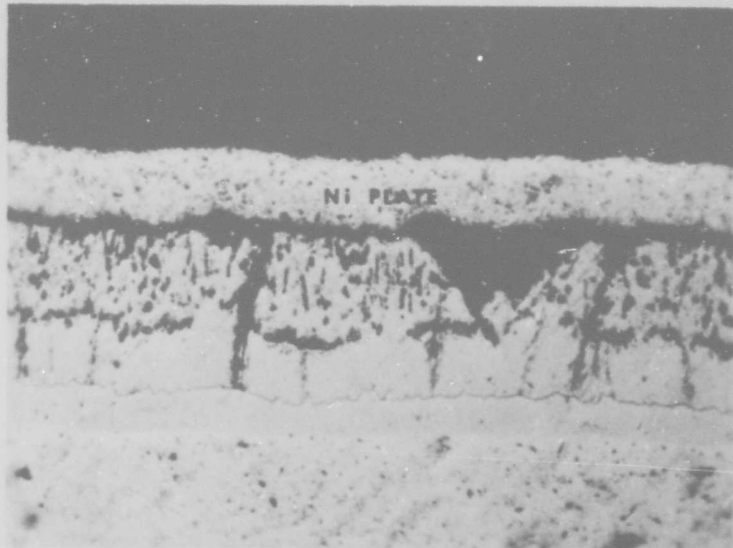
Figure 11. Typical Microstructure of the As-Applied TRW TiCr-Si (Slip) Pack Coating on Cb-132M Alloy

Two distinct coating layers were metallographically observed in addition to a 0.4-mil titanium-rich substrate diffusion layer (Figure 11). The outer coating layer appeared to have discontinuous silicon-rich regions in addition to the more continuous (Ti, Cr, Cb . . .)Si<sub>2</sub> phase. The second layer, also predominantly (Ti, Cr, Cb . . .)Si<sub>2</sub>, exhibited some penetration of the darker phase (silicon-rich) to the coating-substrate interface.

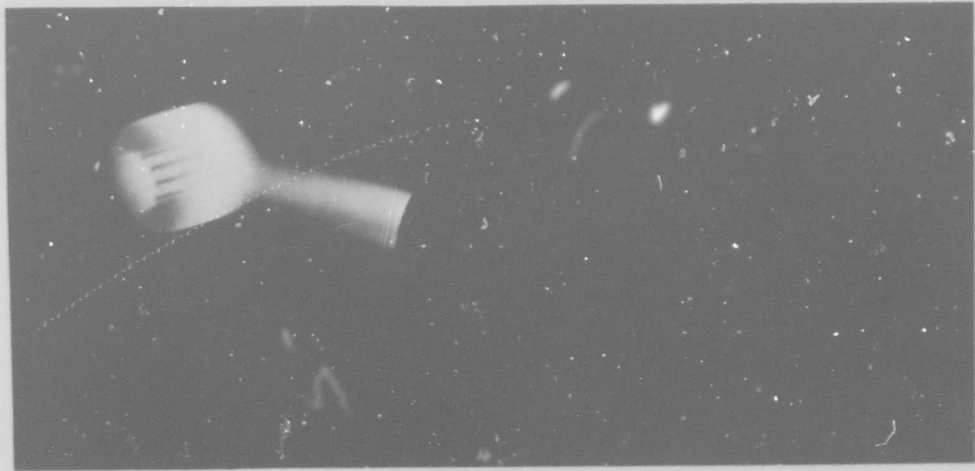
Figure 22. Burner Test Rig for Oxidation-Erosion Studies

The erosion test specimens were machined from 0.5-inch-diameter bar stock to the required "airfoil" shape (Figure 21). Testing was conducted in a combusted JP-5 fuel and air stream at 2200° and 2400°F using the test rig shown in Figure 22. Specimens were rotated at 1750 rpm in groups of eight for temperature uniformity. Temperature during testing was determined by an optical pyrometer and checked at 30-minute intervals. Coating-substrate systems not exhibiting failure after 100 hours at 2200°F were tested further at 2400°F. Specimens were visually inspected and/weighed after each 20 hours of testing. Four specimens were tested for each system evaluated.

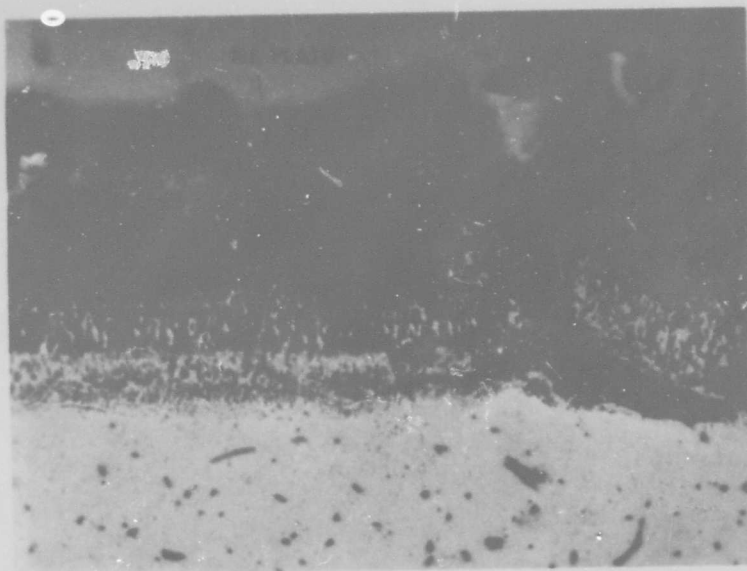
ETCH: 33% HYDROFLUORIC ACID, 33% NITRIC ACID, 33% WATER

MAG: 500X

Figure 34. Microstructure of Sylcor Ti-CrTi-Si (Triplex) Pack Coating on D-43 Columbium Alloy After 100 Hours of Oxidation-Erosion Testing at 2200°F

areas away from these point failures, the coating appeared completely intact and in satisfactory condition; i. e., failure of the airfoil surfaces was more confined for Sylcor/D-43 system than for the TRW/C-129Y and the TRW/Cb-132M systems. Microexamination (Figure 34) showed craze crack propagation extending through the coating. Oxidation progressed along the coating-diffusion-zone interface during continued testing.

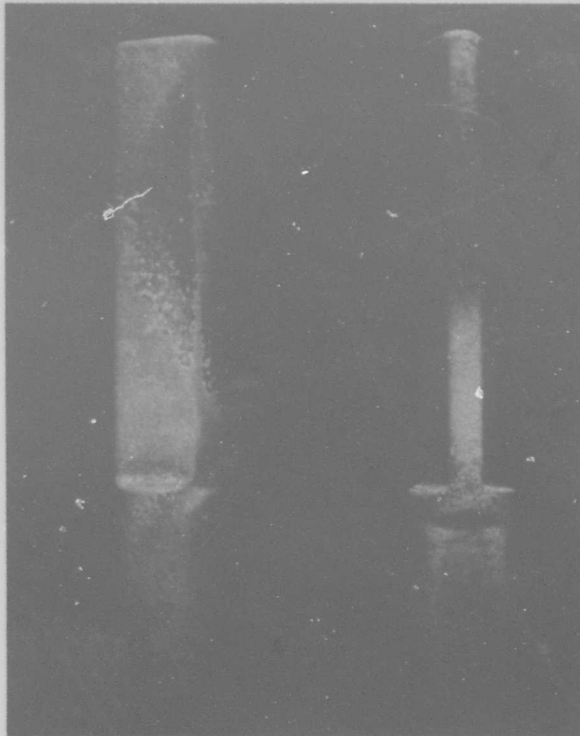
MAG: 1.2X

Figure 36. Typical Surface Appearance of the Sylcor SiCrTi Slurry Coating on D-43 Alloy After 100 Hours of Oxidation-Erosion Testing at 2200°F

Sylcor SiCrTi Slurry/D-43. Oxidation-erosion performance of the Sylcor SiCrTi slurry coating was markedly different from that of the other coatings. After 20 hours at 2200°F, the coating appeared to be eroding along the airfoil corners and edges (Figure 35). This behavior continued for approximately 60 test hours, resulting in increasing exposure of a dark underlayer. Although this behavior apparently resulted from coating erosion, the protective qualities of the coating did not appear to be detrimentally affected (Figure 36).

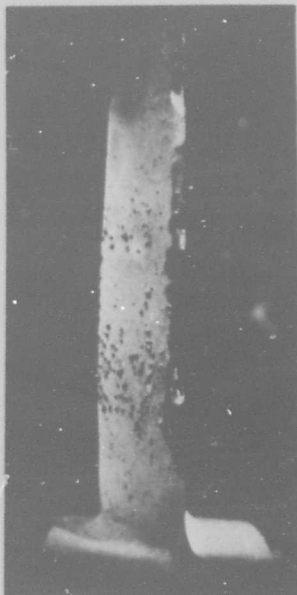
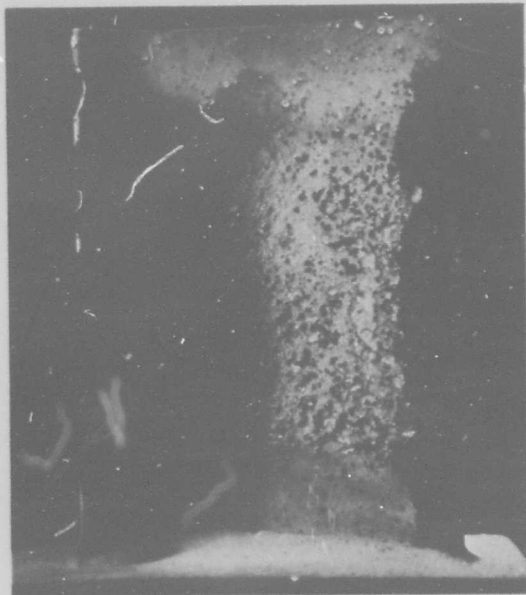
LEADING EDGE SURFACE

CONVEX AIRFOIL SURFACE  
(NOTE FLOW OF SiO<sub>2</sub>-RICH SURFACE PHASE)

TRAILING EDGE SURFACE

CONCAVE AIRFOIL SURFACE

MAG: 1X

Figure 40. TRW TiCr-Si (Vacuum) Pack Coated C-129Y Columbian Alloy Vane Specimen After 600 Thermal Cycles at 2200°F, 400 Cycles at 2400°F, and 400 Cycles at 2500°F

The additional 800 cycles at the elevated temperatures extended flow of a dark surface phase at the leading and trailing edges (Figure 40). The airfoil surface was analyzed by X-ray diffraction to determine whether any sulfur or sulfur-rich combustion products from the JP-5 fuel were reacting with the silicides in the coating to form the dark surface phase. No evidence of sulfur compounds was detected. The dark, glassy phase was

apparently an  $\text{SiO}_2$ -rich amorphous phase resulting from reaction with oxygen. Some erosion of the  $\text{SiO}_2$ -rich phase occurred on the specimen leading edge surface as illustrated in Figure 40.

Localized oxidation and spalling were observed on the internal airfoil surfaces and the external surfaces away from the leading and trailing edges. Substrate oxidation had occurred at three locations on the airfoil trailing edge (see Figure 40). No airfoil cracking was apparent, and, in most cases, oxidation at the base of coating craze cracks had not penetrated the  $(\text{Cb}, \text{Ti})\text{Cr}_2$  Laves phase. Increases in substrate microhardness just below the coating interface, however, suggest that embrittlement had occurred in these areas (Figure 41).

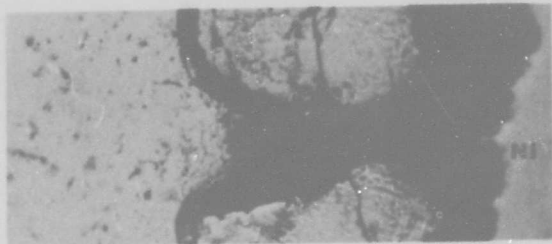
600 CYCLES AT 2200°F

600 CYCLES AT 2200°F  
+400 CYCLES AT 2400°F  
+400 CYCLES AT 2500°F

ETCH: 33% HYDROFLUORIC ACID, 33% NITRIC ACID, 33% WATER

MAG: 500X

Figure 42. Microstructure of the TRW TiCr-Si (Vacuum) Pack Coating on C-129Y Alloy Showing Extension of Craze Crack and Penetration of the  $(Cb, Ti)Cr_2$  Laves Phase as a Result of Continued Testing

In comparing the coating structure of the latter specimen with the one tested for only 600 cycles at  $2200^\circ\text{F}$ , two failure mechanisms were observed to be operative. First, repeated cycling (or longer times in the case of oxidation-erosion) at the higher temperatures led to increased craze crack oxidation extending laterally between the  $(\text{Cb}, \text{Ti})\text{Cr}_2$  Laves phase layer and the outer silicide layers of the coating (Figure 42). This continued oxidation caused greater separation of the coating layers and a widening of the craze cracks. Second, oxygen apparently penetrated the  $(\text{Cb}, \text{Ti})\text{Cr}_2$  Laves phase during this period, causing a volume increase in the contaminated substrate region. The Laves phase exhibited sufficient ductility at the elevated temperatures to plastically deform during the volume change. However, the phase eventually either mechanically ruptured or was depleted to the extent that attack of the columbium substrate occurred (see Figure 42).

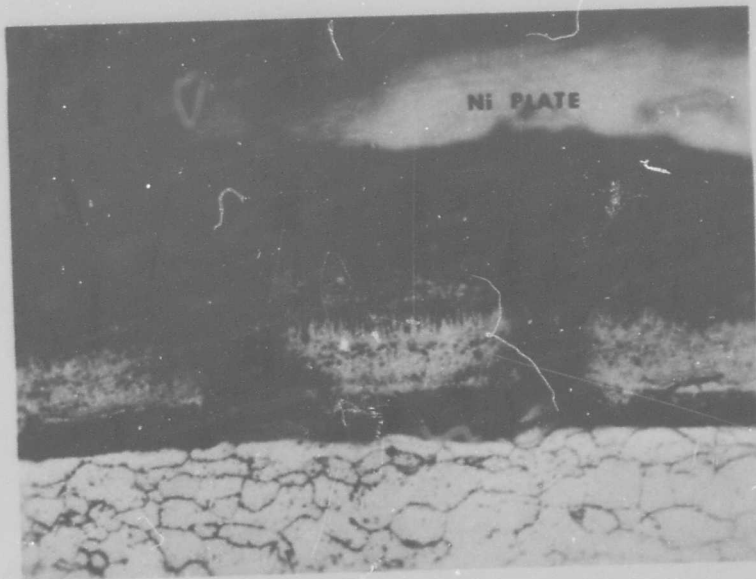
ETCH: 33% HYDROFLUORIC ACID, 33% NITRIC ACID, 33% WATER

MAG: 500X

Figure 44. Microstructure of the TRW TiCr-Si (Vacuum) Pack Coating on Cb-132M Alloy After 600 Thermal Cycles at 2200°F, 400 Cycles at 2400°F, and 400 Cycles at 2500°F

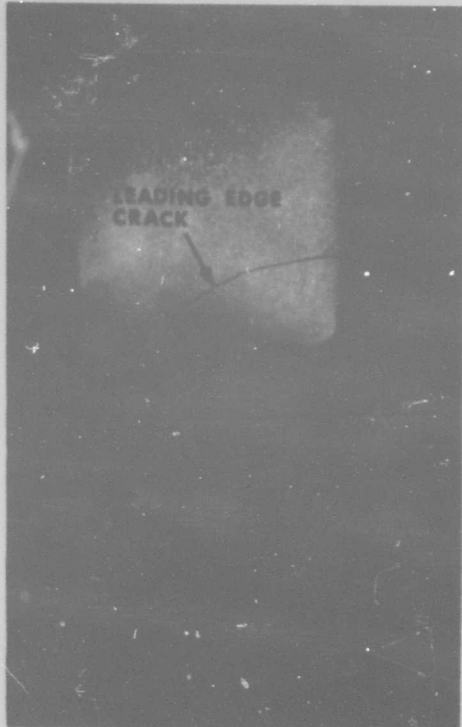
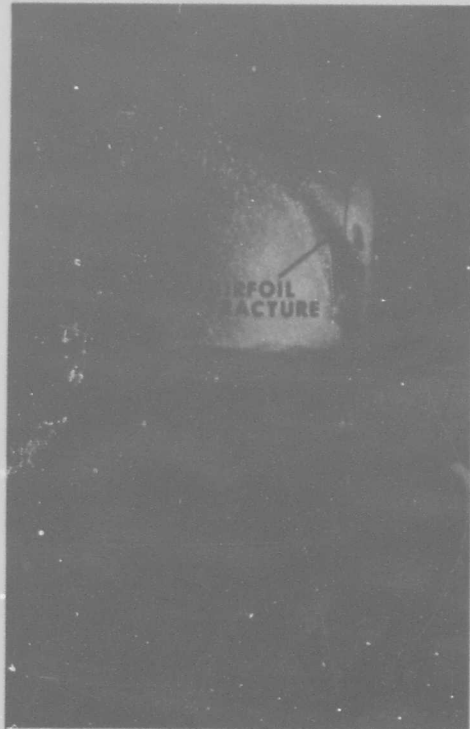
CONCAVE AIRFOIL SURFACE

CONVEX AIRFOIL SURFACE

MAG: 0.7X

Figure 48. Sylcor Ti-CrTi-Si (Triplex) Pack Coated D-43 Columbium Alloy Vane Specimen After 600 Thermal Cycles at 2200°F

Sylcor Ti-CrTi-Si (Triplex) Pack/D-43. Two specimens failed during 2200°F testing, one specimen after 400 cycles (Figure 47) and the other after 600 cycles (Figure 48). In both cases, failure was by airfoil cracking. The coating on the external airfoil surfaces after failure appeared to be in good condition with no areas of substrate oxidation. Metallographic examination revealed that the inadequate performance was due to the following factors.

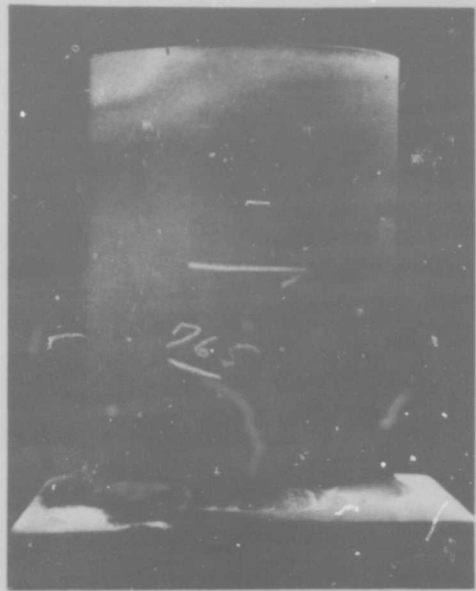
CONCAVE AIRFOIL SURFACE

CONVEX AIRFOIL SURFACE

MAG: 0.9X

Figure 51. Surface Appearance of the Sylcor SiCrTi Slurry Coating on D-43 Alloy After 600 Thermal Cycles at 2200°F

Sylcor SiCrTi Slurry/D-43. After 600 thermal fatigue cycles at 2200°F, both test specimens were in good condition. The general surface appearance of the coating was very good, although a reaction had occurred at the leading edge surface (Figure 51). Additional testing at 2400°F for 400 cycles resulted in continued reaction and liquid phase flow back along the airfoil surface (Figure 52).

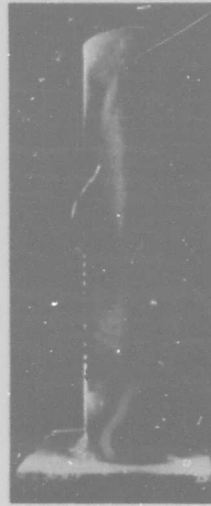
CONVEX AIRFOIL SURFACE

LEADING EDGE SURFACE

CONCAVE AIRFOIL SURFACE

MAG: 0.8X

Figure 52. Surface Appearance of the Sylcor SiCrTi Slurry Coating on D-43 Columbian Alloy After 600 Thermal Cycles at 2200°F and 400 Cycles at 2400°F

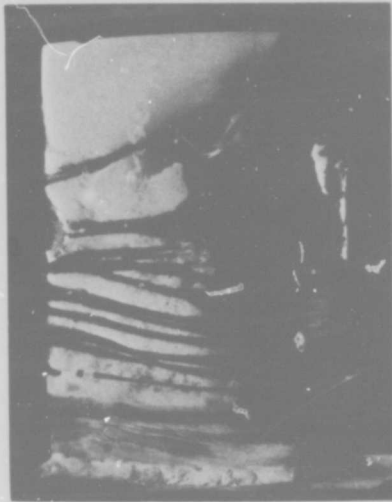
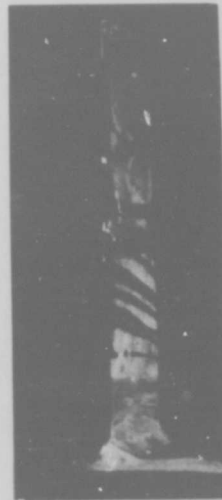
CONVEX AIRFOIL SURFACE

LEADING EDGE SURFACE

CONCAVE AIRFOIL SURFACE

TRAILING EDGE SURFACE

MAG: 0.8X

Figure 53. Surface Appearance of the Sylcor SiCrTi Slurry Coating on D-43 Columbium Alloy After 600 Thermal Cycles at 2200°F, 400 Cycles at 2400°F, and 500 Cycles at 2500°F (Specimen No. 1)

After an additional 500 cycles at 2500°F, the first specimen exhibited severe degradation at the leading edge, an area of substrate oxidation at the trailing edge, and substrate oxidation at the open end of the airfoil at the airfoil trailing edge weld joint (Figure 53). The previously described coating flow was witnessed during 2500°F testing. The flow was extensive and proceeded in a pulsating fashion.

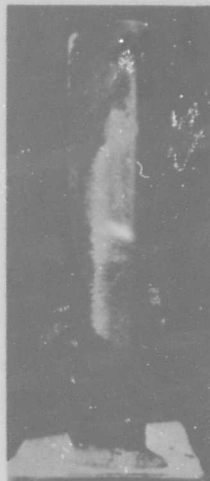
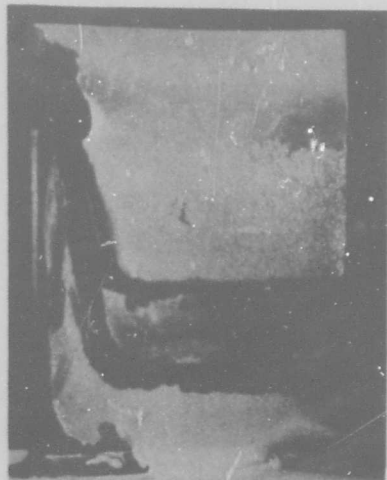
CONVEX AIRFOIL SURFACE

LEADING EDGE SURFACE

CONCAVE AIRFOIL SURFACE

Figure 54. Surface Appearance of the Sylcor SiCrTi Slurry Coating on D-43 Columbian Alloy After 600 Thermal Cycles at 2200°F, 400 Cycles at 2400°F, and 400 Cycles at 2500°F (Specimen No. 2)

An additional 400 thermal cycles at 2500°F on the second test specimen did not produce the severe degradation exhibited by the first specimen, but a small area of coating failure was observed on the leading edge surface (Figure 54). After testing, that portion of the leading edge from where the majority of the outer coating layers had flowed back along the airfoil was very smooth and appeared to be "fire polished". In addition to coating loss, metallographic examination of the leading edge revealed formation of discrete particles (probably oxide) in the outer layers of reacted coating. Penetration of oxide through the coating was evident (Figure 55), but no distinct oxidation of the substrate was noticeable. Metallographic

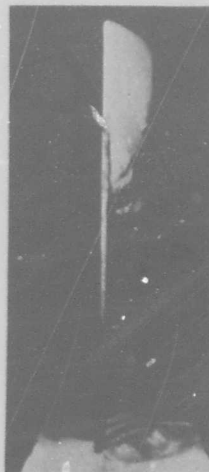
TRAILING EDGE SURFACE

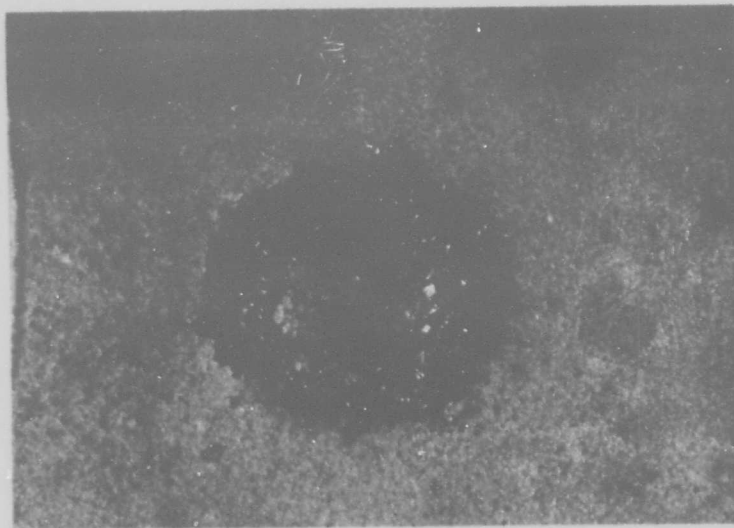
**Figure 63.** Surfaces of Sylcor Ti-CrTi-Si (Triplex) Pack Coated D-43  
Columbium Alloy After Impact at 500 Feet Per Second at  
2200°F (no oxidation exposure)

Due to the thickness of the blade airfoil test specimens (0.125 inches compared to 0.050 inches for the vane alloy test specimens), Zones IV and V did not appear on these specimens. The as-impacted surface appearance of representative specimens of each system are illustrated in Figures 58 through 65. A summary of the ballistic impact test results on all five coating-substrate systems is presented in Table IV, with the observed condition after oxidation exposure for various periods at 2200°F. In all cases, failures were first noted in the scabbed areas (either Zone II or Zone V). Oxidation was generally more prevalent on the impact sides of the specimens.

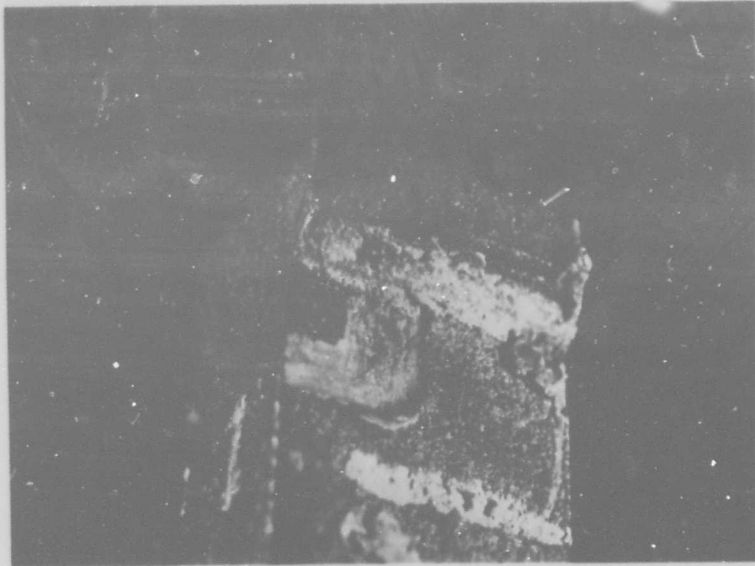
Figure 73. Typical Appearance of Sylcor Sn-Al (505-F) Coating on Cb-132M Columbian Alloy After Wear-Galling Testing for  $4.5 \times 10^5$  Cycles at 1300°F With a Tensile Load of 2000 psi

somewhat better than those obtained using the drum-type specimens. After  $4.5 \times 10^5$  cycles at  $1300^\circ\text{F}$ , both Sn-Al coated test specimens were brazed to the nickel-base turbine disk alloy in the contact areas. The coating was smeared and partially removed, but no areas of substrate oxidation were visible after testing (Figure 73). Subsequent exposure at  $1300^\circ\text{F}$  in still air revealed local oxidation on load-bearing surfaces after 4 hours. After 8 hours, general oxidation occurred along most of the wear-galling surfaces. The Ag-Al-Si coating suffered only minor braze bonding after  $4.5 \times 10^5$  cycles at  $1300^\circ\text{F}$ . However, significant flow of the coating out of the load-bearing areas was noted (Figure 74). No oxidation occurred after 24 hours of subsequent exposure at  $1300^\circ\text{F}$ .

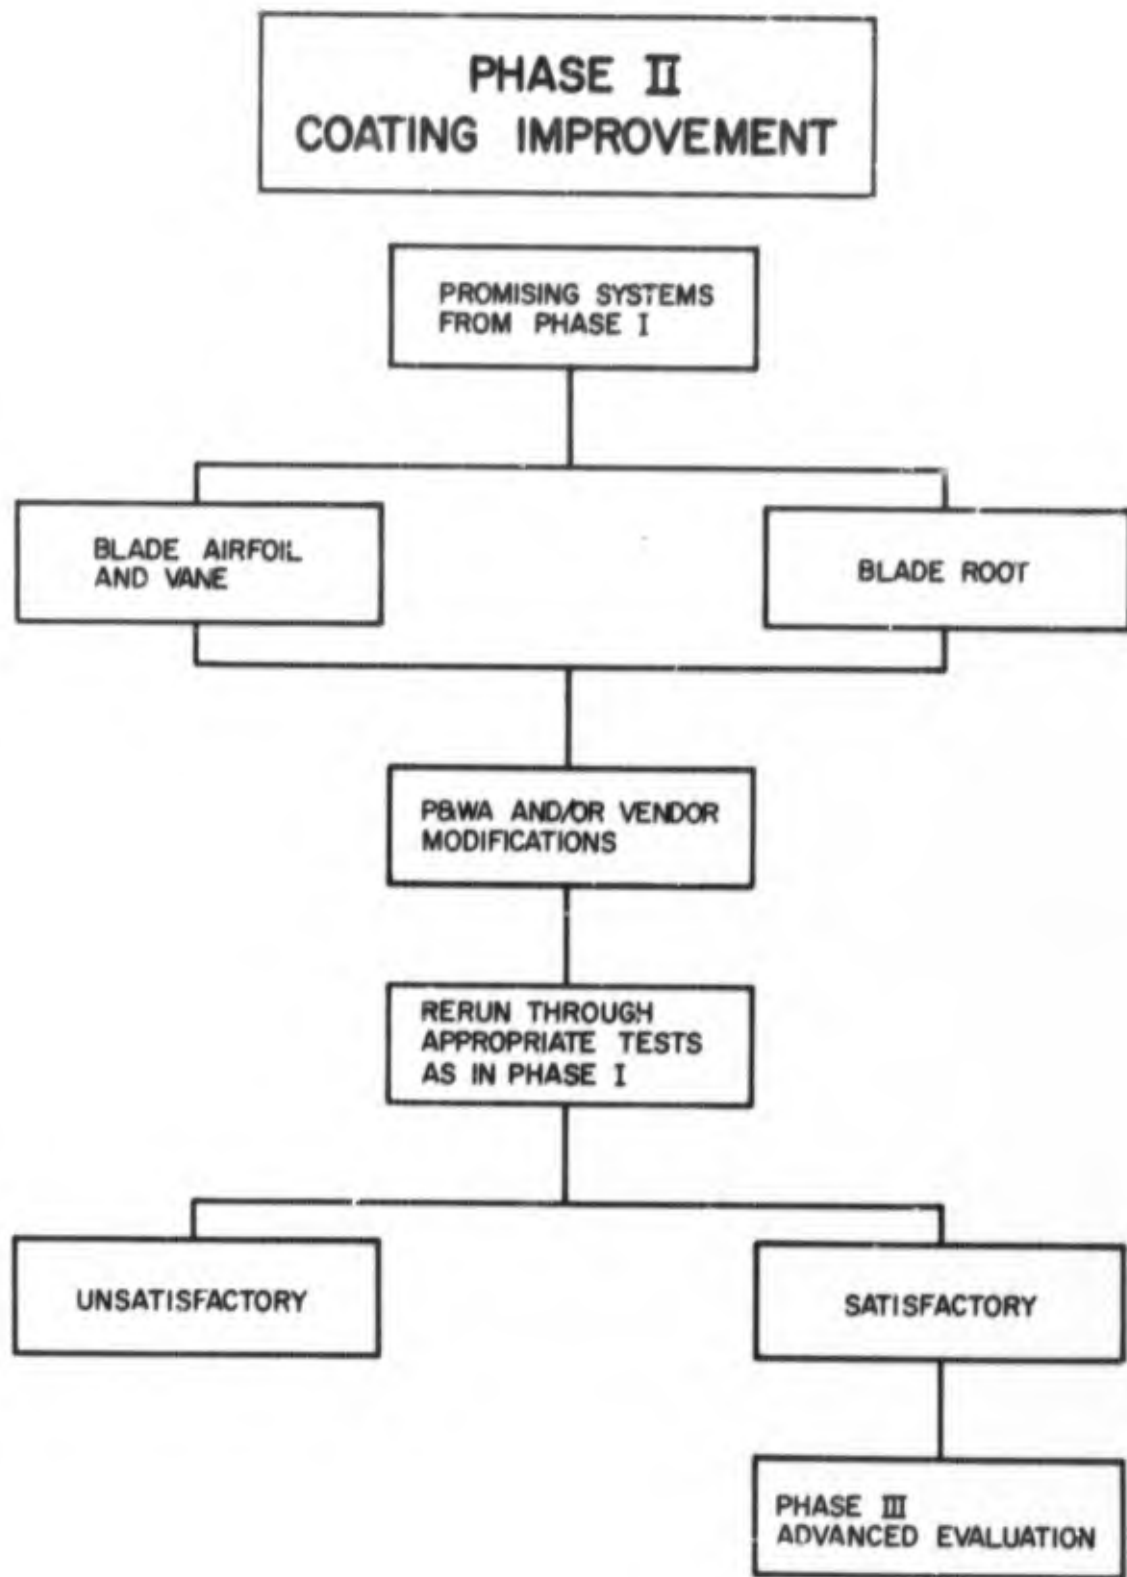
Figure 75. Flow Chart for Phase II of Program (Item 3)

The work required in Item 3 of the contract is Phase II of the coated columbium alloy evaluation program. In this phase the contractor must provide appropriate compositional and/or coating application processing modifications for any of the six original systems demonstrating substandard performance in Phase I (Item 2) tests. Appropriate Phase I tests for each of the modified systems must be conducted to verify optimization and justify promotion to Phase III (Items 4 and 5). A technical flow chart showing the progression of tests through Phase II of the program is presented in Figure 75.

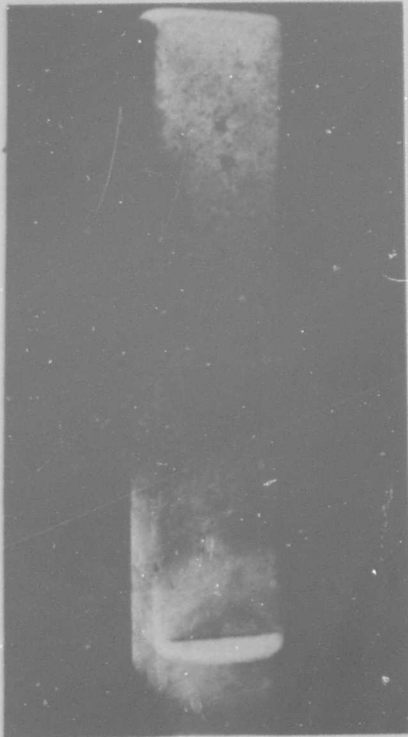
Figure 85. Typical Oxidation-Erosion Bars of Remodified TRW TiCr-Si (Vacuum) Pack Coated Cb-132M Alloy After 100 Hours at 2200°F Plus 60 Hours at 2400°F (arrows locate typical local oxidation failure)

Remodified TRW TiCr-Si (Vacuum) Pack/Cb-132M. Performance improvement of the remodified TRW coating consisted of an additional 20 test hours at 2400°F for all test specimens. Failure by localized oxidation of the airfoil trailing edge, leading edge, and/or flat airfoil surfaces (Figure 85) occurred after 100 hours at 2200°F plus 60 hours at 2400°F. Coating surface appearance after failure was generally good in areas away from the localized oxidation.

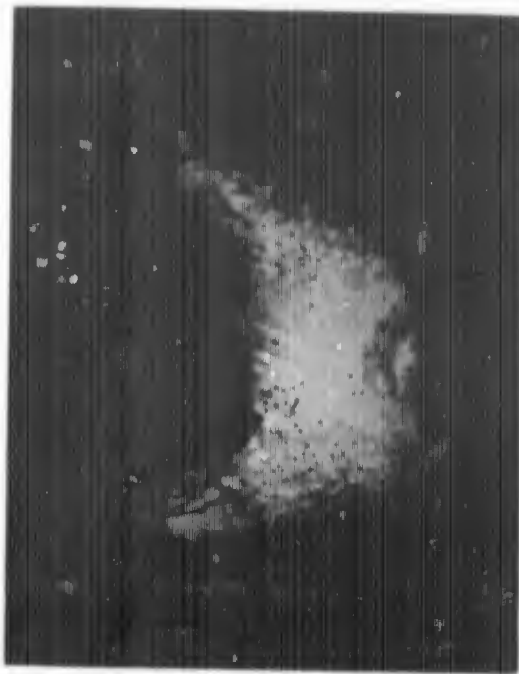
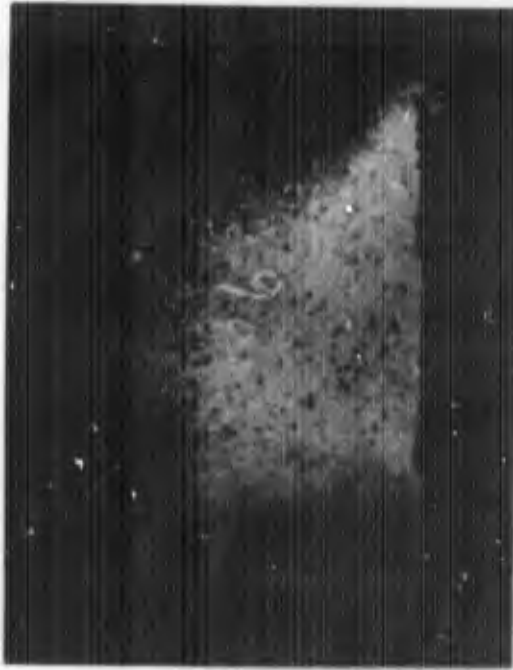
Figure 87. Modified TRW TiCr-Si (Vacuum) Pack Coated C-129Y Columbium Alloy Vane Specimen After 600 Thermal Cycles at 2200°F, 400 Cycles at 2400°F, and 400 Cycles at 2500°F (Specimen No. 1)

Although no airfoil failures (cracks) were observed at the conclusion of this test, some localized oxidation was noted on airfoil external surfaces (Figure 87). The general performance was superior to that of the unmodified coating in that no gross oxidation was apparent at the trailing edge and the localized oxidation and spalling on the external airfoil surfaces were less severe.

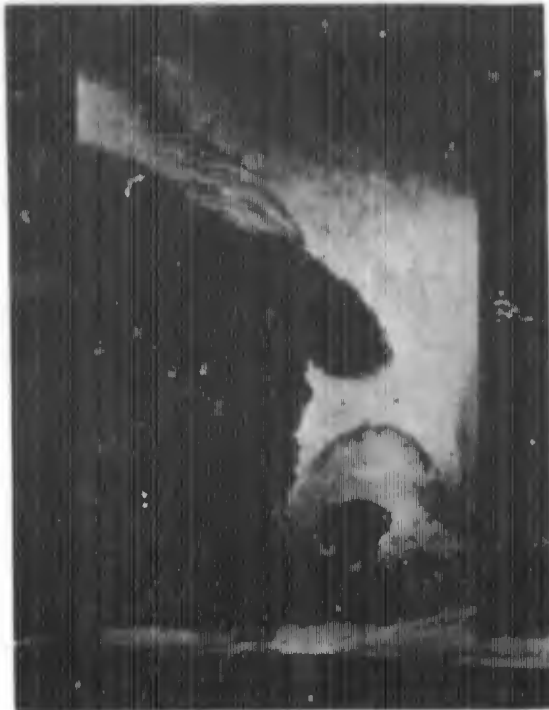
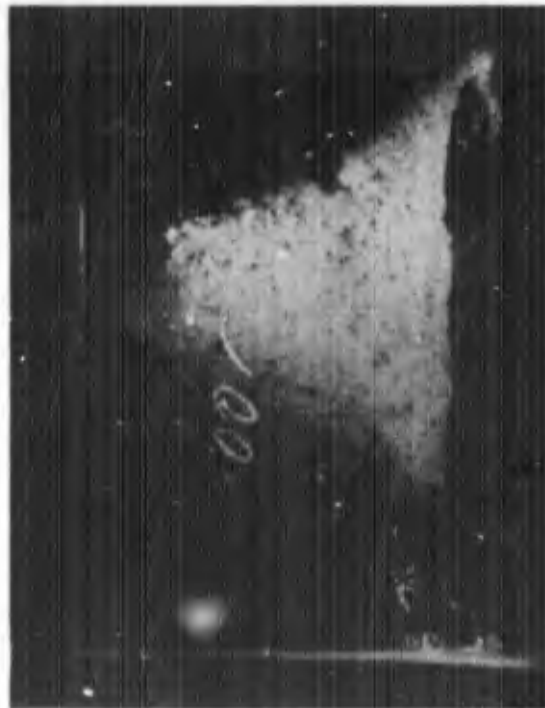
Figure 88. Modified TRW TiCr-Si (Vacuum) Pack Coated C-129Y Columbian Alloy Vane Specimen After 600 Thermal Cycles at 2200°F, 400 Cycles at 2400°F, and 400 Cycles at 2500°F (Specimen No. 2)

Hole in airfoil was due to handling damage during interim inspection.

The second thermal fatigue specimen was tested identically. During the last 100 cycles at 2500°F, a hole oxidized through the convex surface of the sheet metal airfoil and a portion of the specimen platform was oxidized (Figure 88). This unusual behavior was believed due to mechanical damage of the test part during the inspection period just prior to the last 100 cycles at 2500°F. In areas away from these failures, local oxidation was evident, but, excluding the mechanically damaged areas, the specimen was in good condition with performance comparable to that of the first test specimen. Localized oxide was metallographically observed to extend out of surface craze cracks (Figure 89).

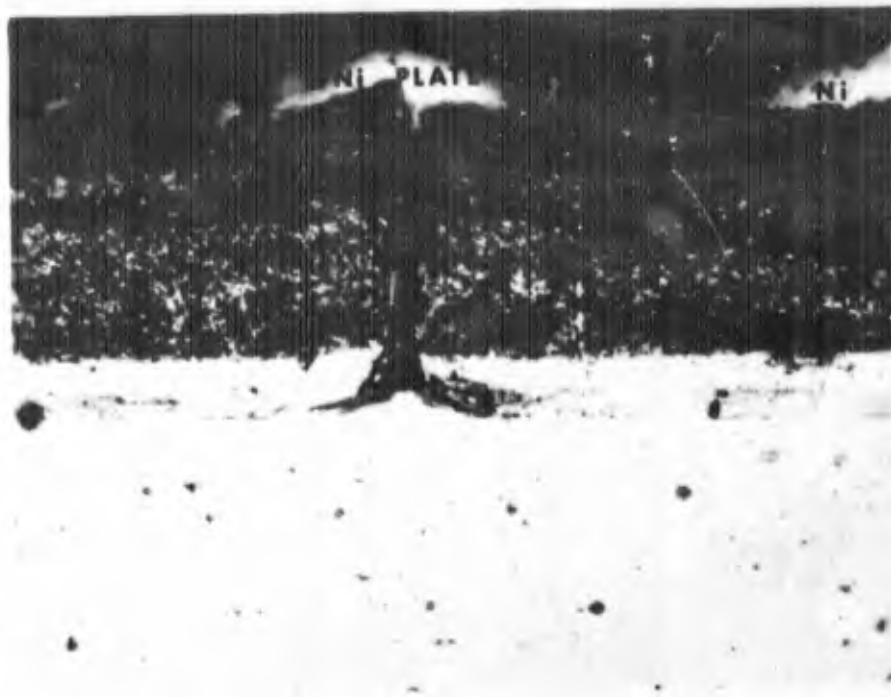
Figure 91. Microstructure of the Modified TRW TiCr-Si (Vacuum) Pack Coating on Cb-132M Alloy After 400 Thermal Fatigue Cycles at 2200°F

Modified TRW TiCr-Si (Vacuum) Pack/Cb-132M. No improvement in thermal fatigue performance was noted for the first modification of the TRW coating on Cb-132M alloy. After 400 thermal fatigue cycles at 2200°F, the specimens exhibited localized oxidation and spalling on the airfoil surfaces (Figure 90). Local oxidation resulted from the presence of surface craze cracks, which extended to the substrate in the absence of a continuous protective coating layer at the coating-substrate interface (Figure 91).

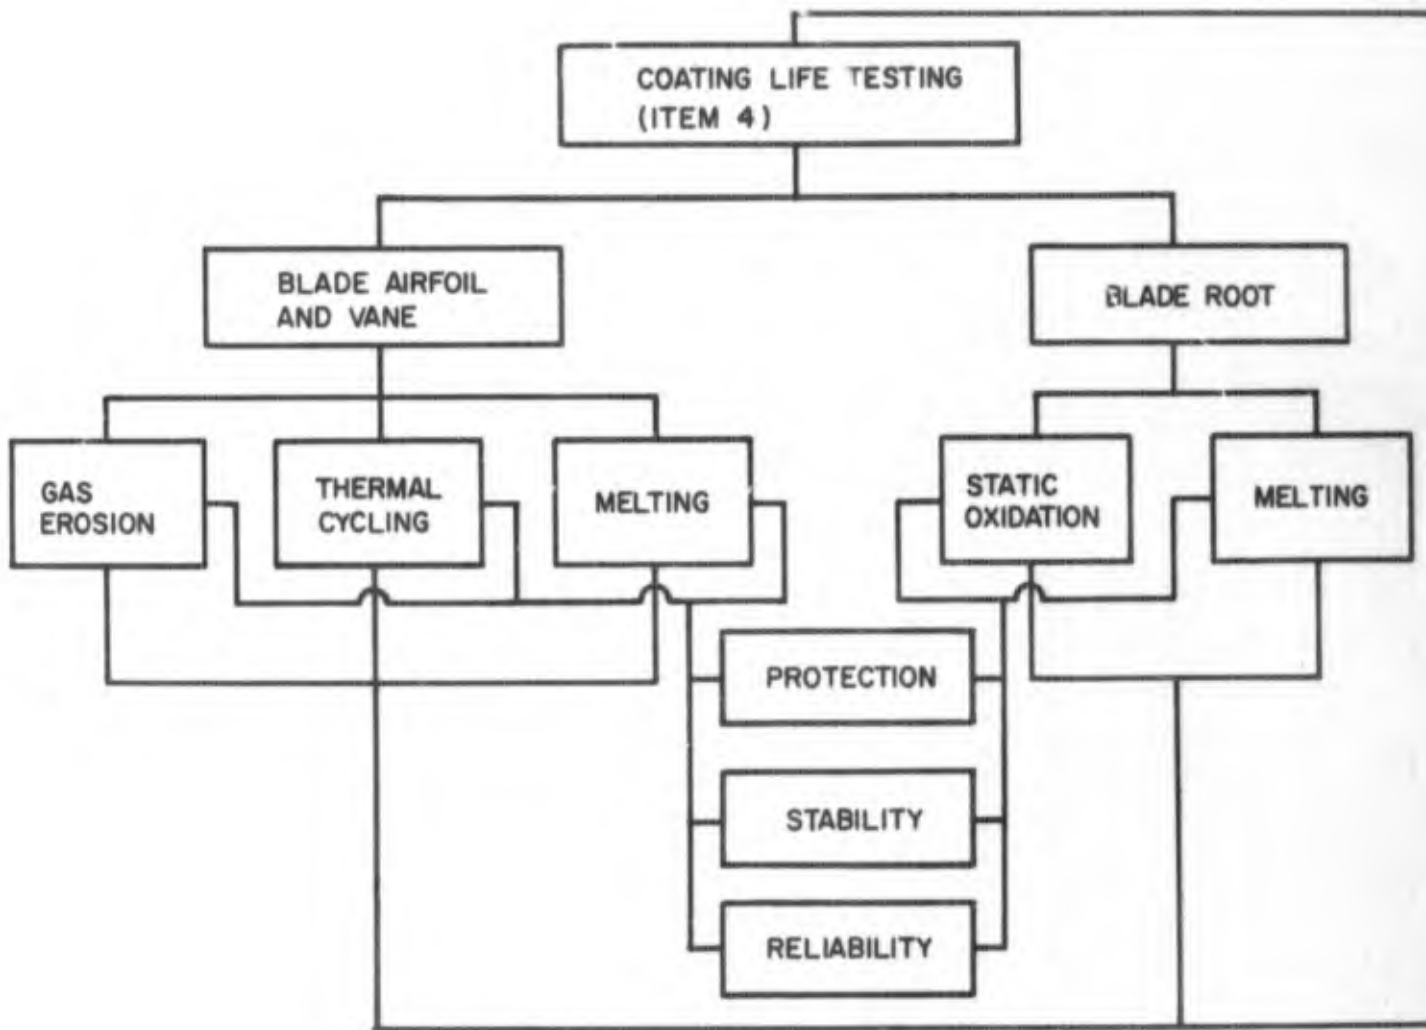
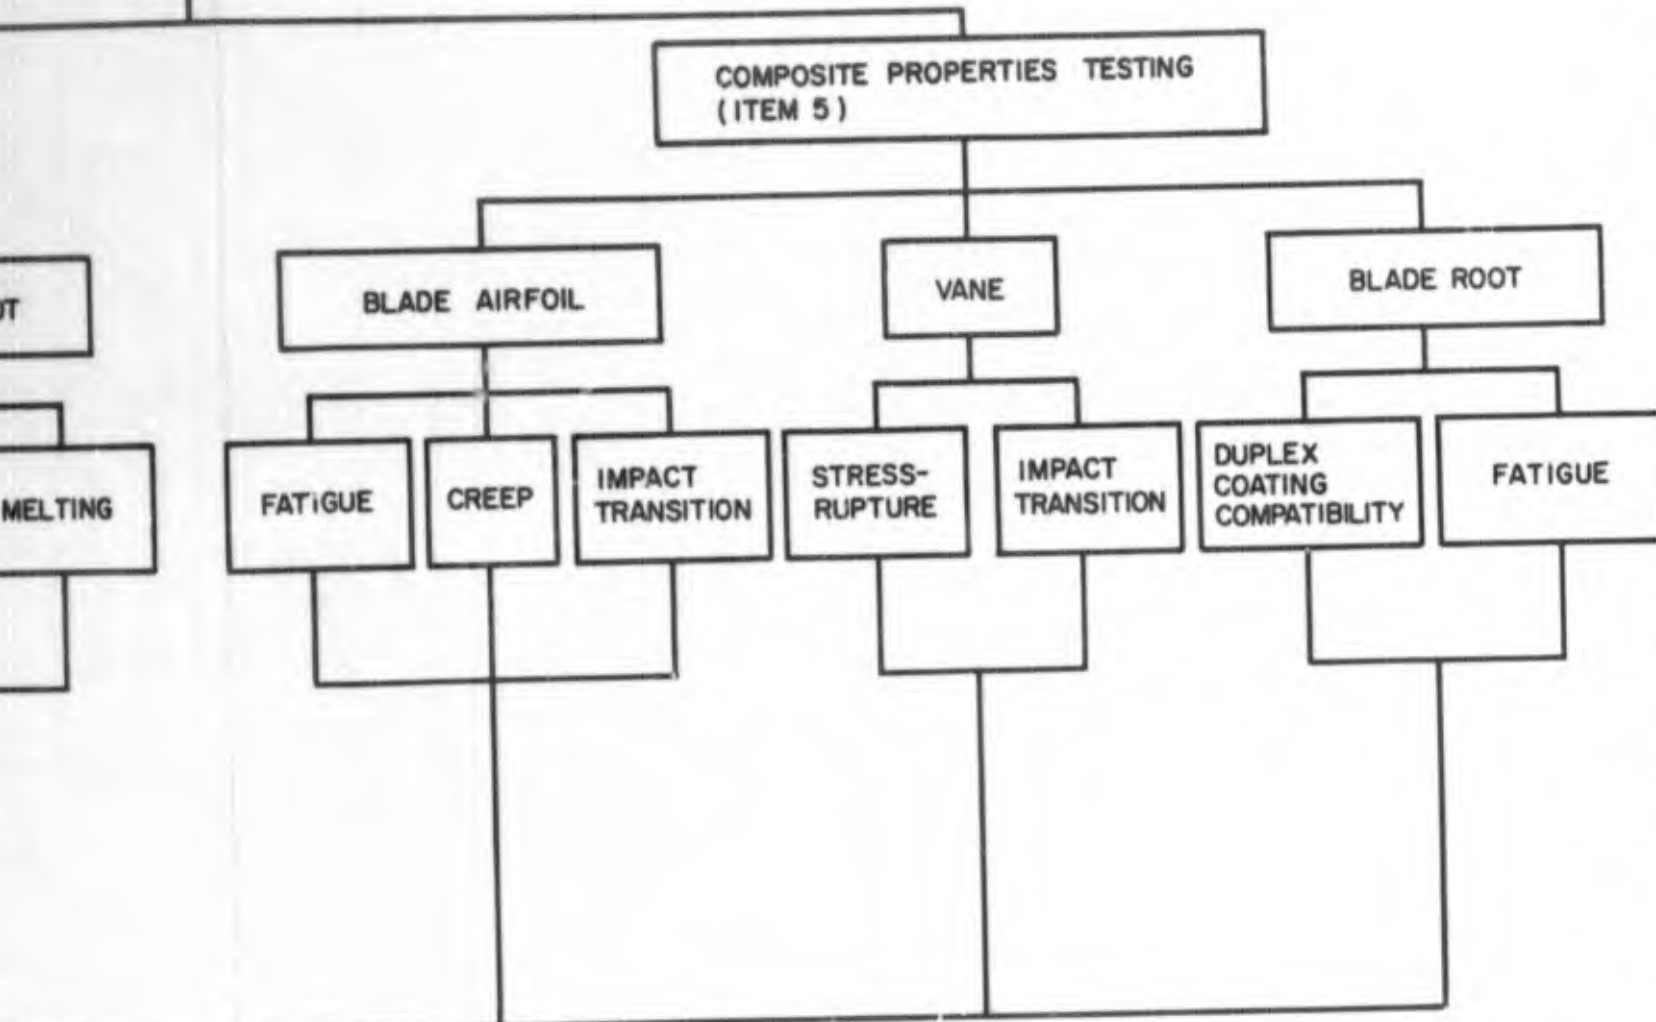
Figure 105. Flow Chart for Phase III of Program (Items 4 and 5)

A flow chart summarizing the tests and integration of both Items to form Phase III is presented in Figure 105. The primary purpose of Advanced Evaluation is to obtain quantitative data to assess the advisability of engine testing and aid in the design of components.

The Phase III evaluation of the TRW TiCr-Si/Cb-132M system for blade airfoil application has not been initiated because of the low ductility of the presently available Cb-132M alloy bar stock. Additional material is presently being ordered. The following tests are to be performed on receipt of the additional bar (see Figure 105):

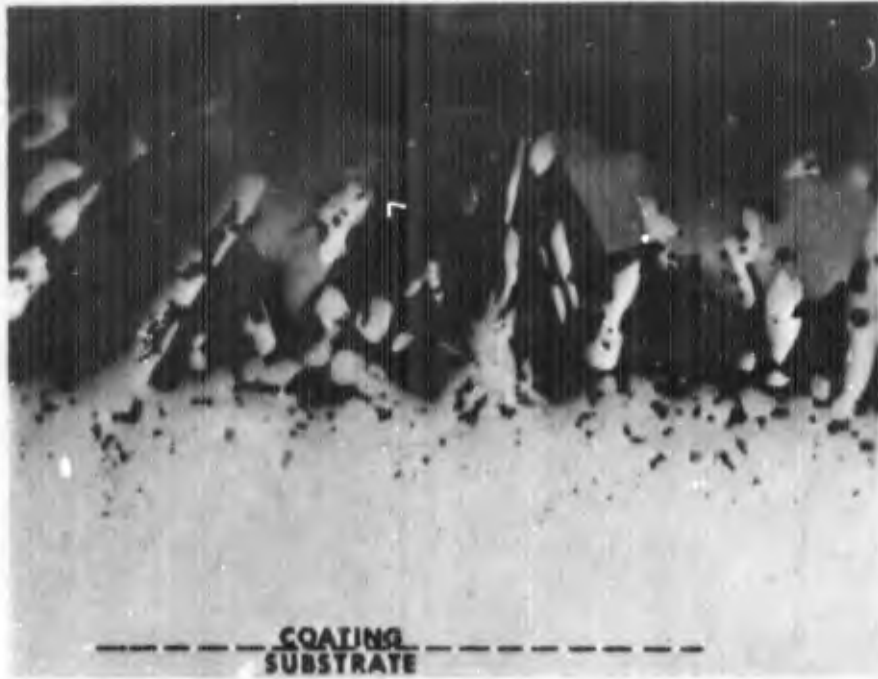
**Figure 108.** Microstructure of the As-Applied Phase III Sycor Ag-Al-Si (508-F) Coating on Cb-132M Columblum Alloy

As discussed previously under Phase II Coatings Application (see paragraph 3.2.5), the Ag-Al-Si (508-F) coating contains molybdenum in the outer coating layers. The slurry-applied coating was developed by a high-temperature vacuum diffusion cycle and varied in thickness from 3.9 to 5.5 mils (Figure 108). Although a fairly homogeneous 2.6-mil layer was observed adjacent to the substrate, the outer coating layer contained several phases. Microhardness values for these areas and the adjacent substrate are presented in Figure 109.

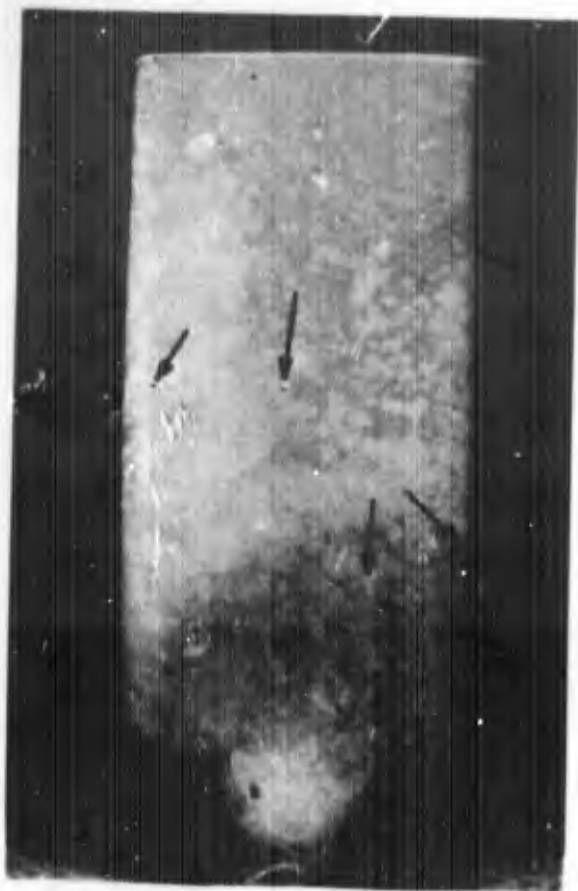
**Figure 115. TRW TiCr-Si (Vacuum) Pack Coated D-43 Columbium Alloy Thermal Fatigue Specimen After 1600 Cycles at 2000°F (arrows locate areas of localized oxidation)**

- 2000°F, 1200 and 1600 cycles (total time at 2000°F: 1255 and 1665 minutes): The general coating appearance was good, but oxidation had occurred in isolated areas, mostly on convex airfoil surfaces and the trailing edge tip (Figure 115).

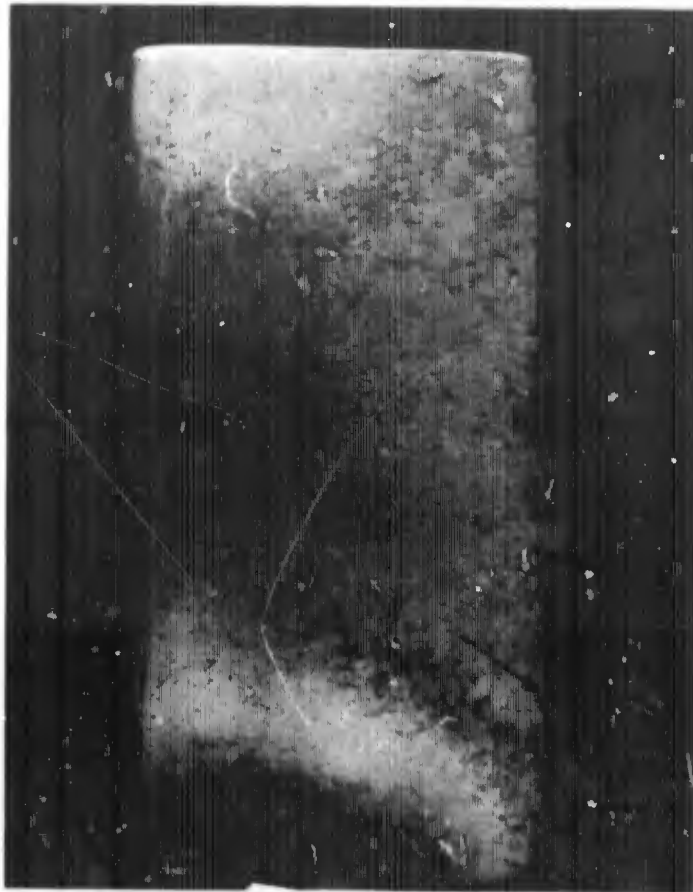
**Figure 116. TRW TiCr-Si (Vacuum) Pack Coated D-43 Columbium Alloy Thermal Fatigue Specimen After 800 Cycles at 2200°F (arrows locate areas of localized oxidation)**

- 2200°F, 800 cycles (total time at 2200°F: 845 minutes): Localized spalling and oxidation occurred on the concave airfoil surfaces near the leading and/or trailing edge(s) (Figure 116).

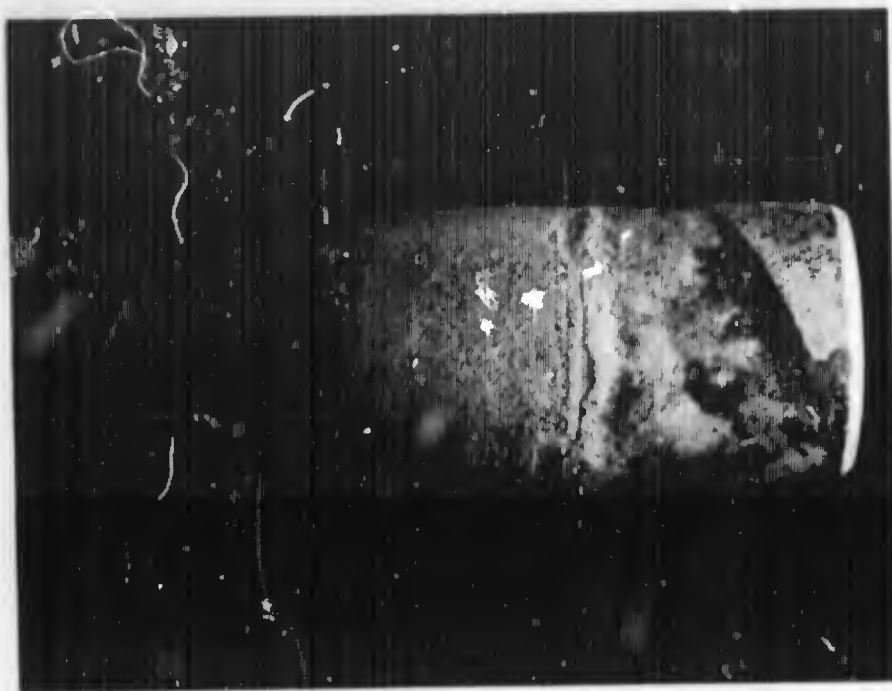
**Figure 130. Sylcor Ag-Al-Si and TRW TiCr-Si Coated Cb-132M Columbium Alloy Compatibility Test Specimen**

Compatibility testing of the Sylcor 508-F Ag-Al-Si and the TRW TiCr-Si (vacuum) pack coatings was conducted using four 0.5-inch-diameter by 3.25-inch-long specimens. On each specimen, the Ag-Al-Si coating overlapped the TiCr-Si coating for a 0.5-inch length along the bar at each of

two locations (Figure 130). One test specimen (two overlap areas) was evaluated under the four test conditions described previously for the oxidation and melting tests. The test conditions are repeated below:
