# OOAMA AIRMUNITIONS TEST REPORT

## DISPOSAL TESTS

## AIR-2A "GENIE" ROCKET MOTORS

**DISPOSAL TESTS**  
**FOR**  
**AIR-2A "GENIE" ROCKET MOTORS**

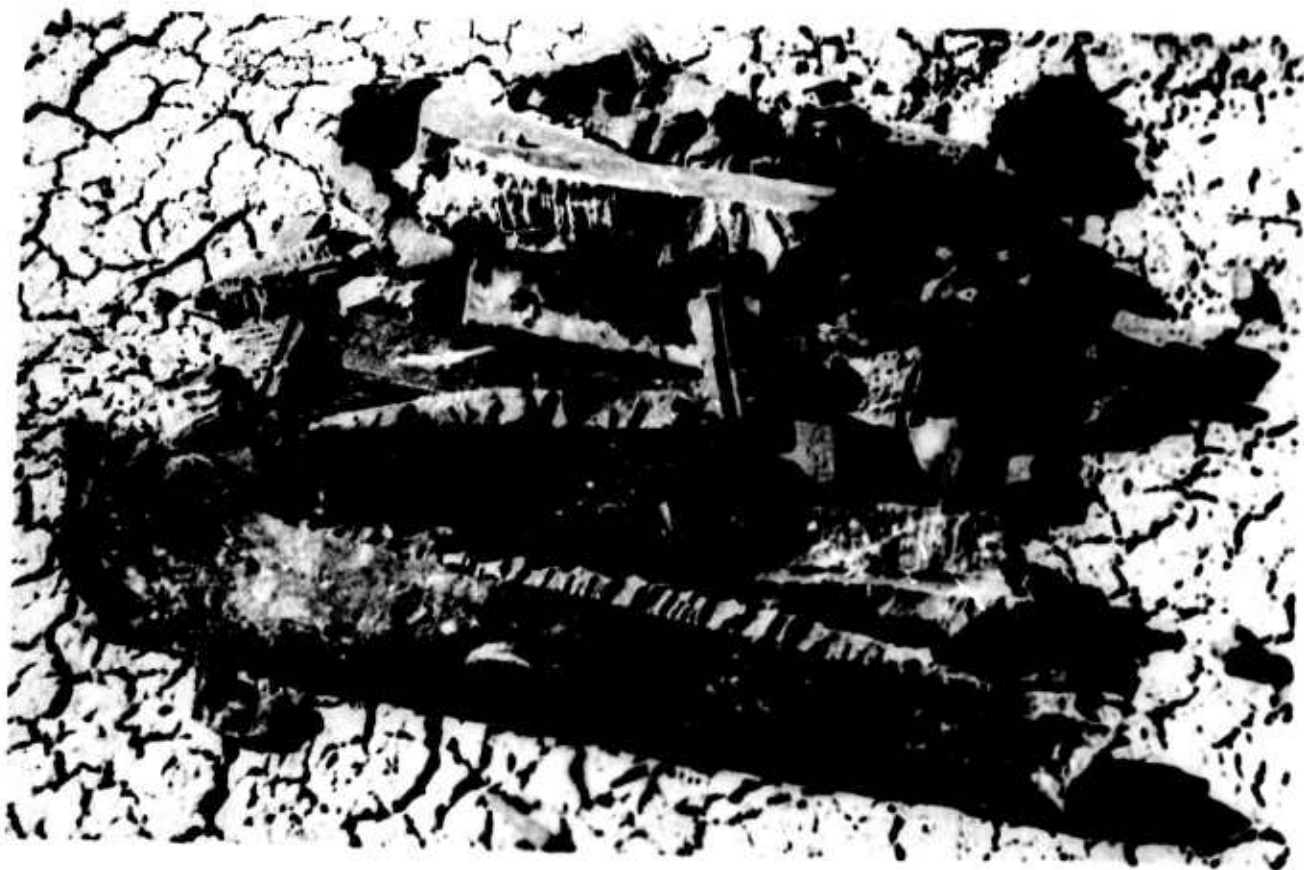
FIGURE 12: A PHOTOGRAPH OF THE UNBURNED PROPELLANT EJECTED DURING TEST 2.

The detonating cord assembly detonated with such force that approximately one-third of the rocket motor propellant grain was vertically ejected to a height of 40-90 feet. The propellant did not ignite and was scattered within 100 feet of the test area. There was no evidence of burning propellant being ejected from the hole in which the motor was placed. A post test examination of the rocket motor showed that the detonating cord assembly severed the motor longitudinally, at the forward dome and at the aft end. The remaining two-thirds of the propellant that was not ejected was ignited by the detonating cord assembly and burned at the test site. (See Figures 12 through 14)

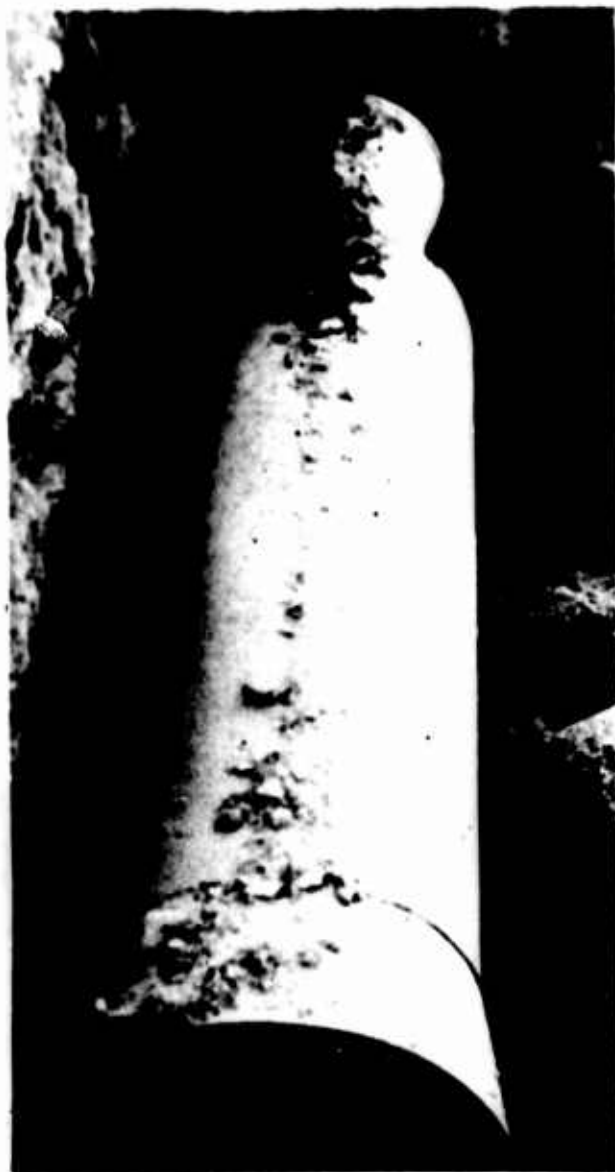
FIGURE 18: THE REMAINS OF THE ROCKET MOTOR  
AFTER INITIATION OF THE DETONATING  
CORD. (TEST 4)

The detonating cord assembly, when initiated, caused only superficial damage to the rocket motor. It did not sever the aft end of the motor case or split it longitudinally as intended. The propellant also was not initiated by the explosion of the detonating cord. The rocket motor was indented along the aft end of the case and longitudinally to a depth of three-sixteenths inch by the blast from the detonating cord assembly. (See Figures 17 and 18)
