United States Air Force
611th Air Support Group/
Civil Engineering Squadron

Remedial Investigation and Feasibility Study

Barter Island Radar Installation, Alaska

05 JANUARY 1996

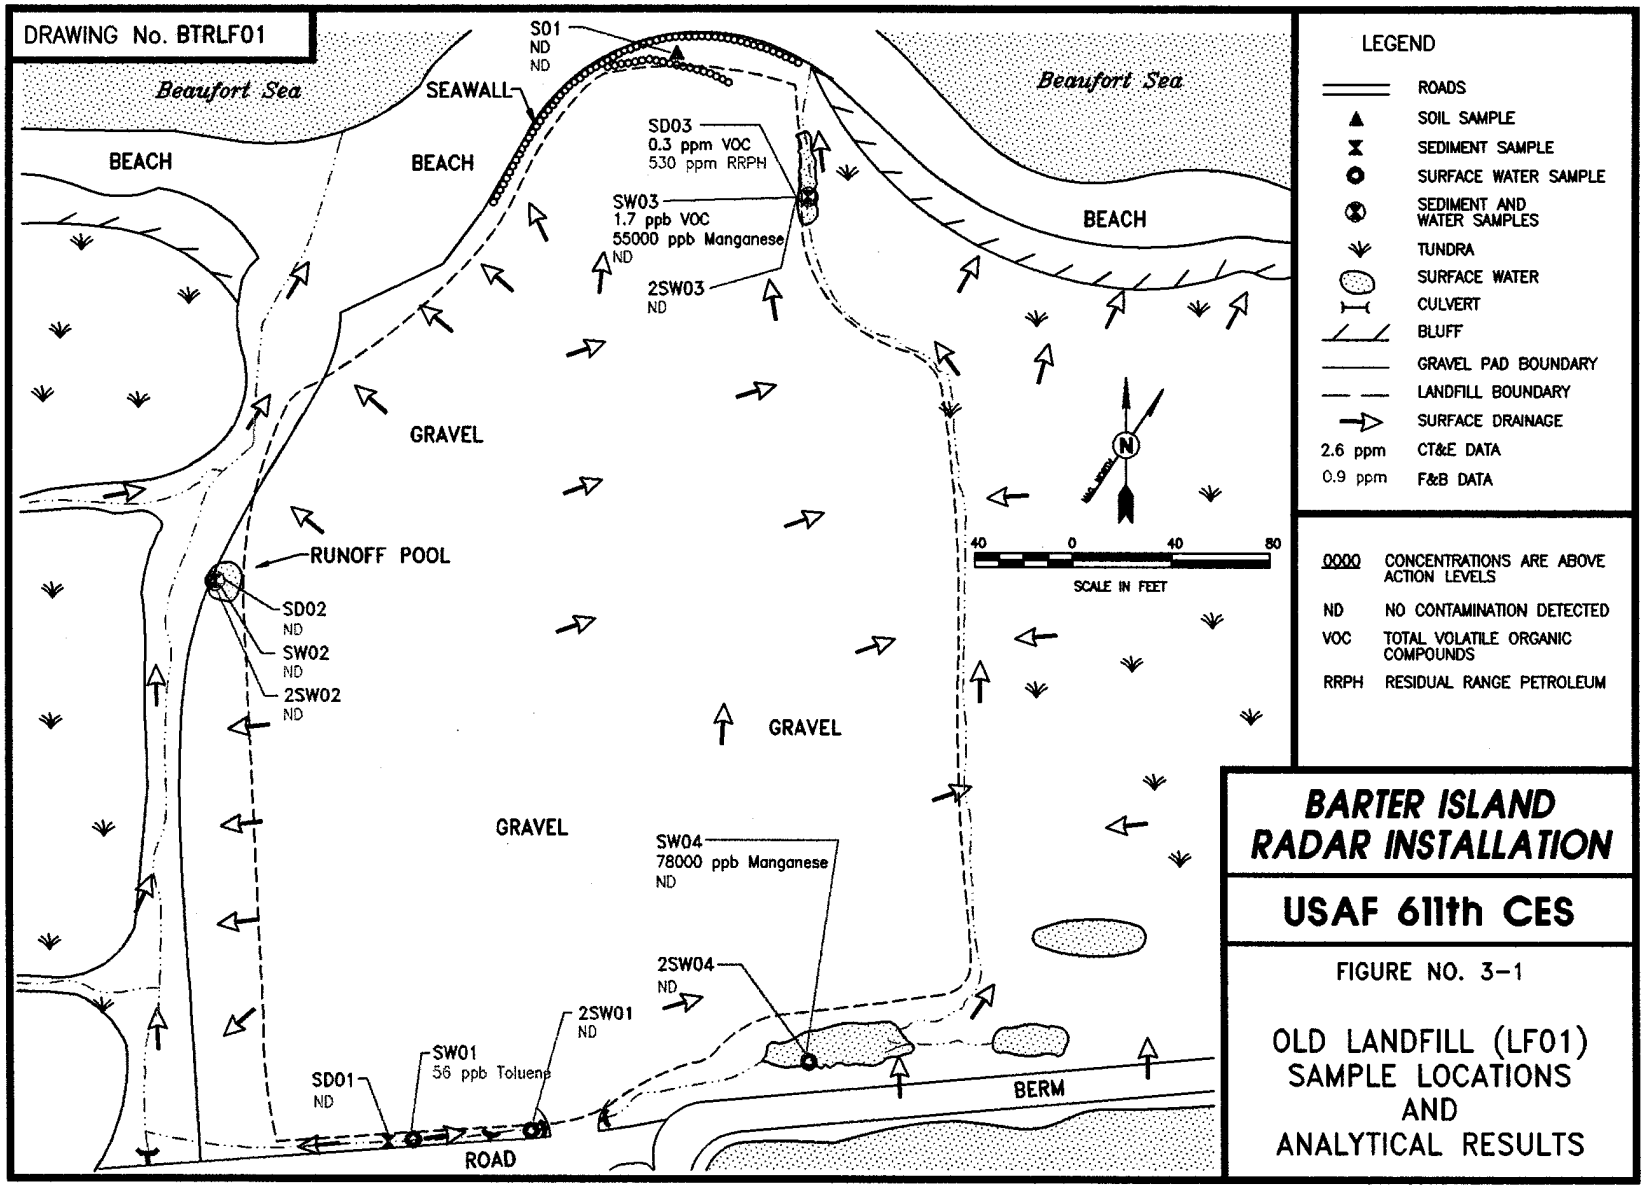
Based on the RI sampling and analyses, risk assessment, and current site uses, remedial actions are not warranted at the site. No chemicals detected at the site exceed ARARs, and no significant human health or ecological risks were identified at the site. Therefore, the Old Landfill (LF01) site is recommended for no further action.

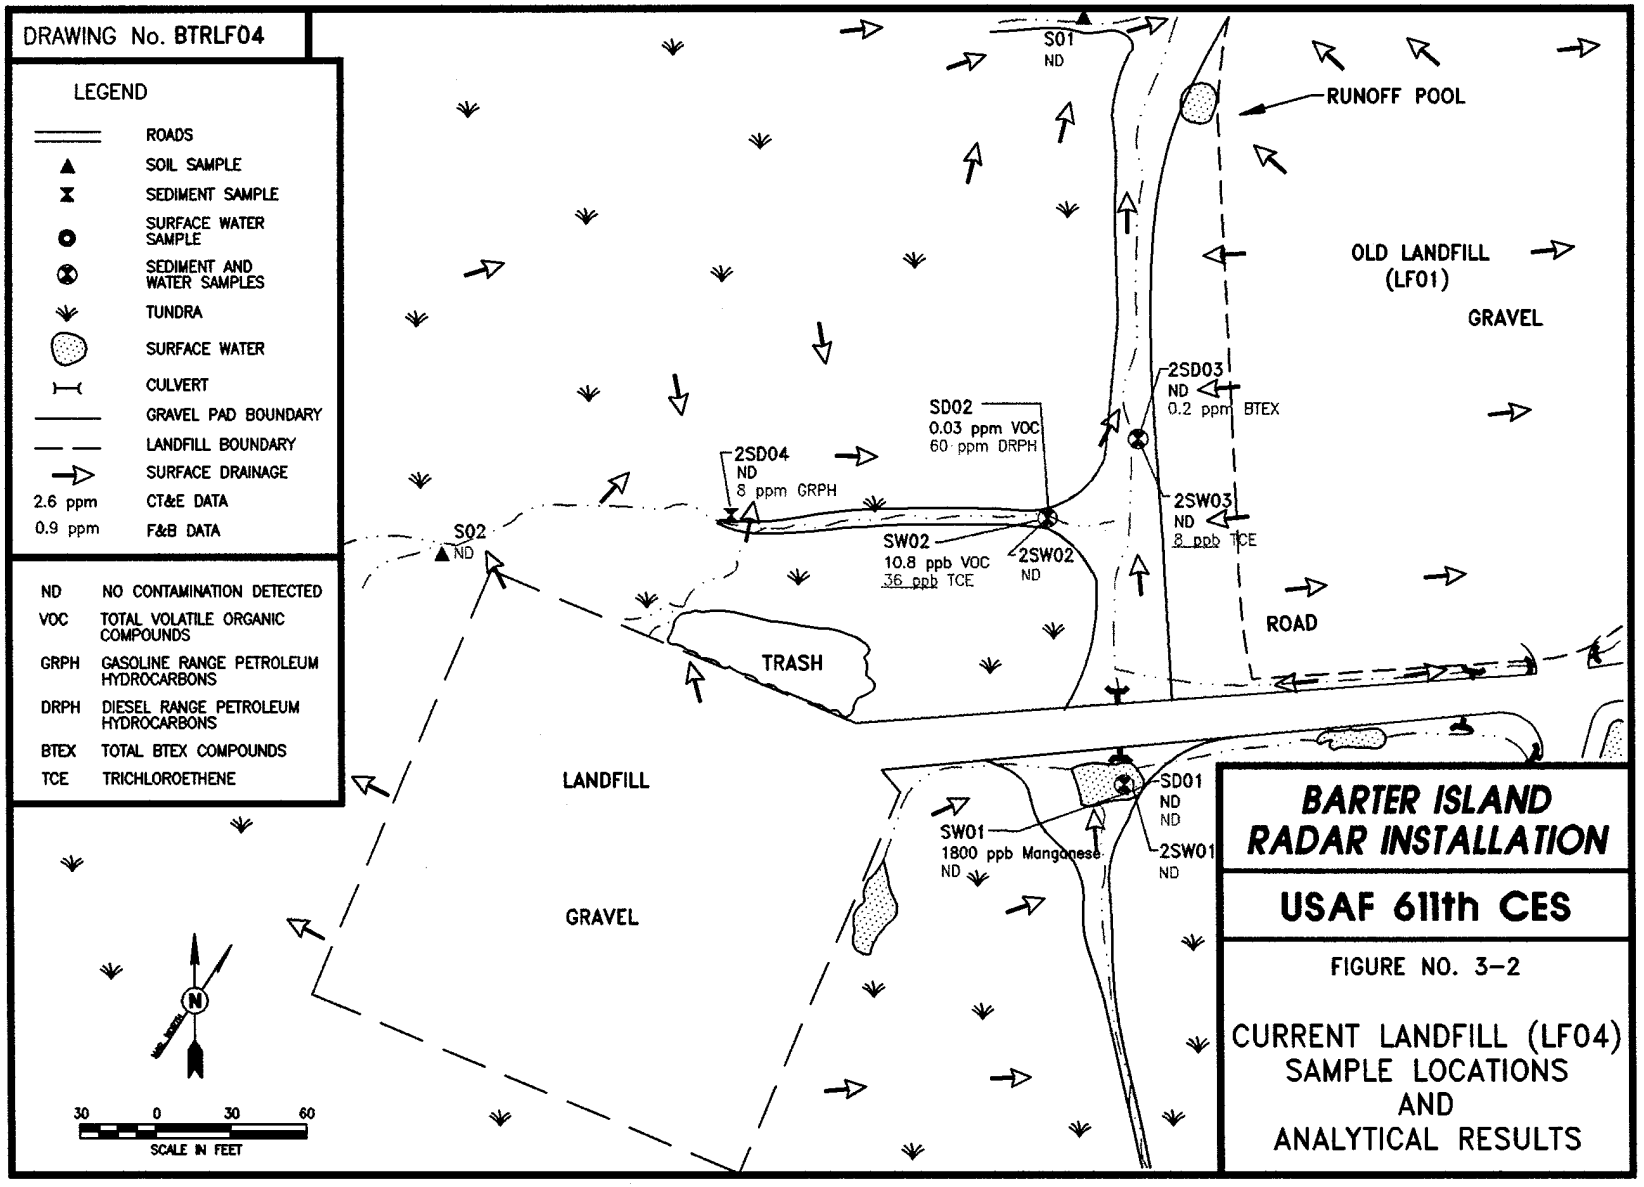
Migration of contaminants from the site appears minimal based on the surface water samples collected in drainage pathways leading from the site.

The risk assessment concluded that risks posed to human health and ecological receptors by site contaminants are minimal given current or future site uses. A potential noncancer hazard was identified in surface water from manganese. This potential human health hazard is based on a future scenario in which the site surface water would be used as a sole drinking water supply, and the noncancer hazard is likely to be overestimated. Even using the conservative future scenario, the potential human health risks at the site are not of a magnitude that normally requires remedial action. Based on the RI sampling and analyses, risk assessment, and current site uses, remedial actions are not warranted at the site. No significant human health or ecological risks were identified at the site. Therefore, the Current Landfill (LF04) site is recommended for no further action.

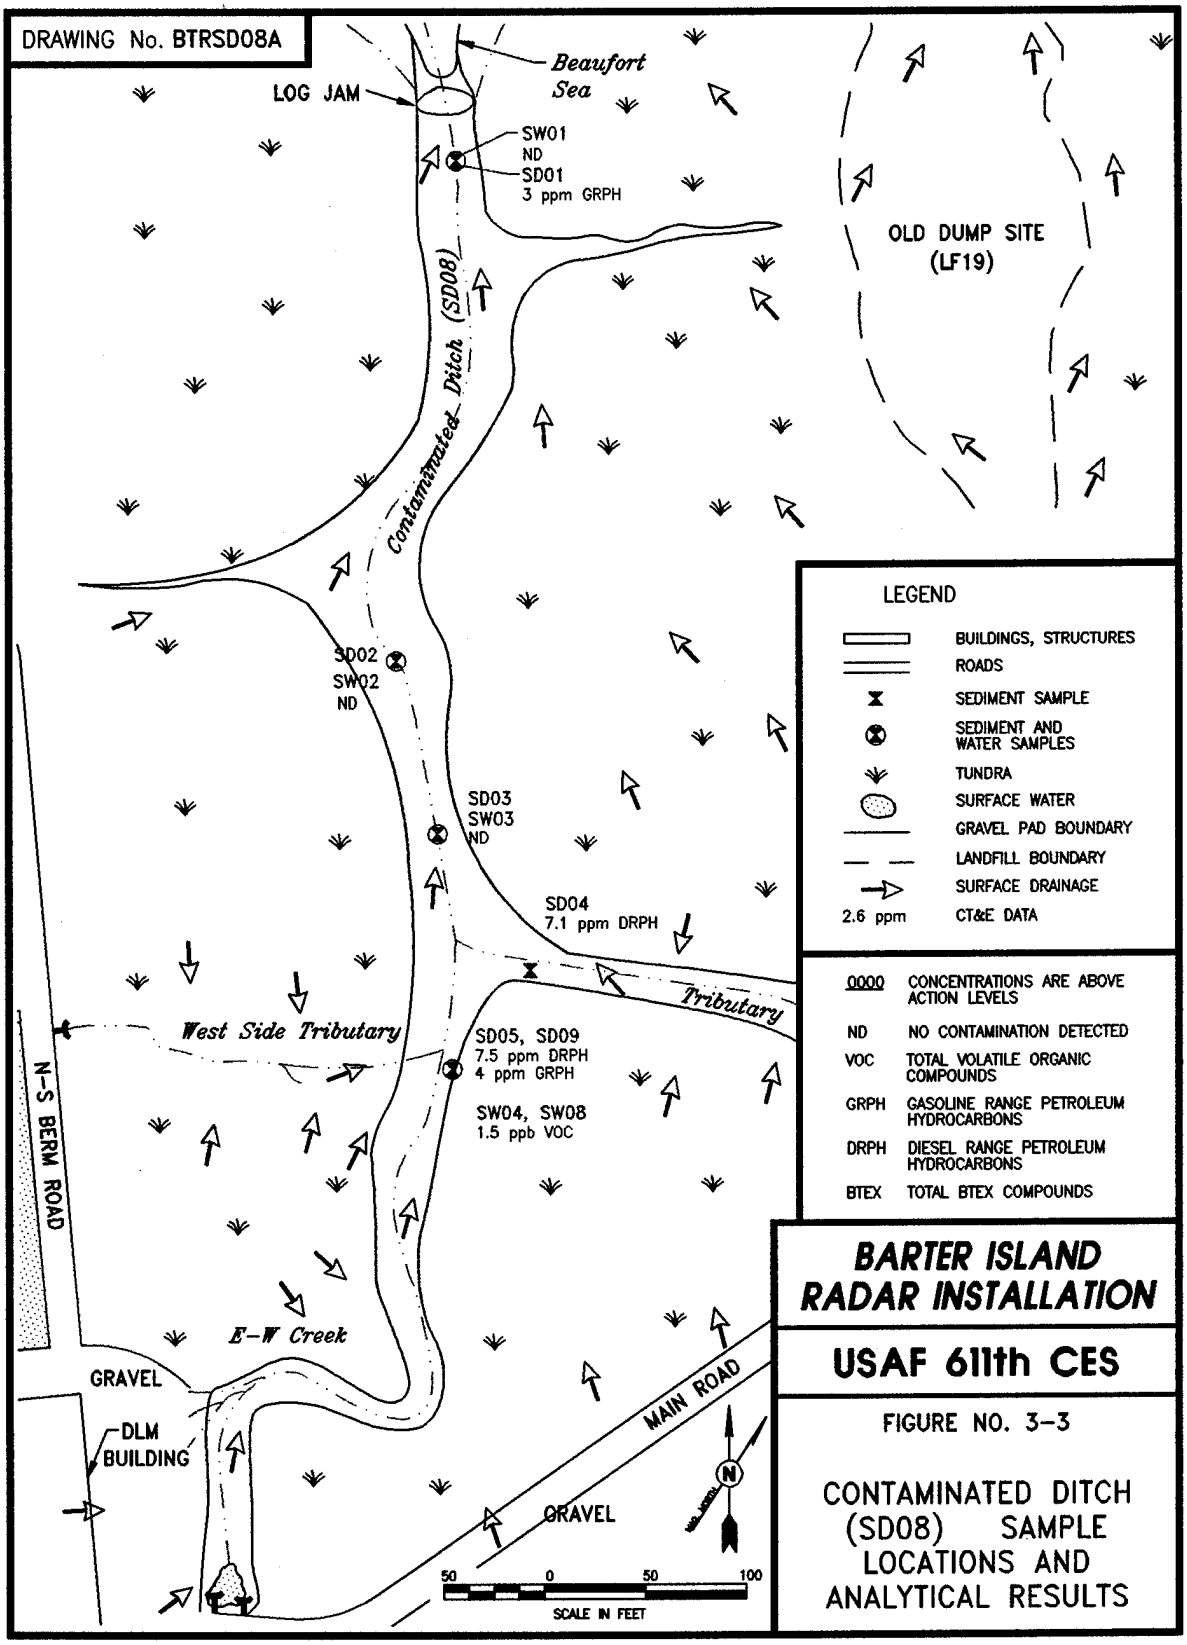
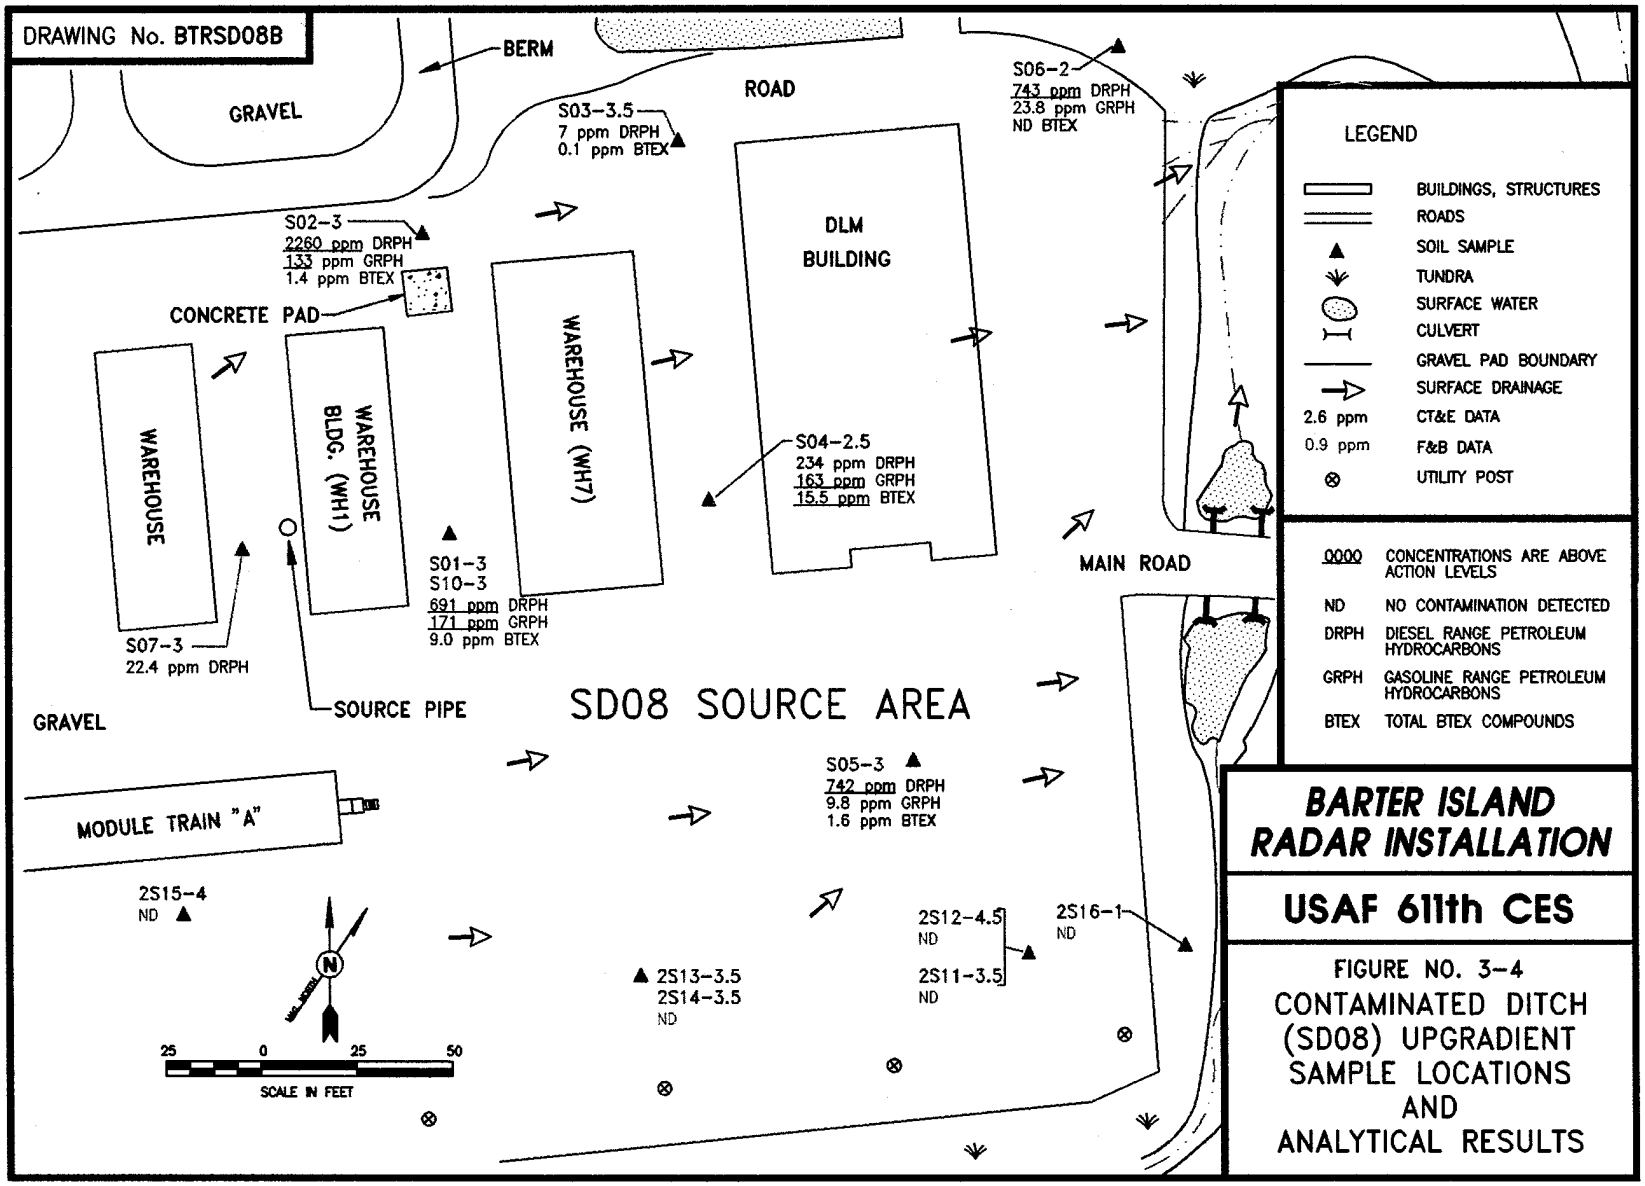
The risk assessment concluded that risks posed to human and ecological receptors by site contaminants are minimal given current or future site uses. A potential carcinogenic risk of 2×10^{-4} was identified in site soils based on the maximum concentrations of GRPH and beryllium detected at the site. This potential human health risk is based on a future residential scenario and soil ingestion rate. Even using the conservative future scenario, the potential human health risks at the site are not of a magnitude that normally requires remedial action.

Based on the RI sampling and analysis, risk assessment, and current site uses, remedial actions are not warranted at the site. Migration of contaminants appears minimal, and no significant human health or ecological risks were identified at the site. Therefore, the Contaminated Ditch (SD08) site is recommended for no further action.

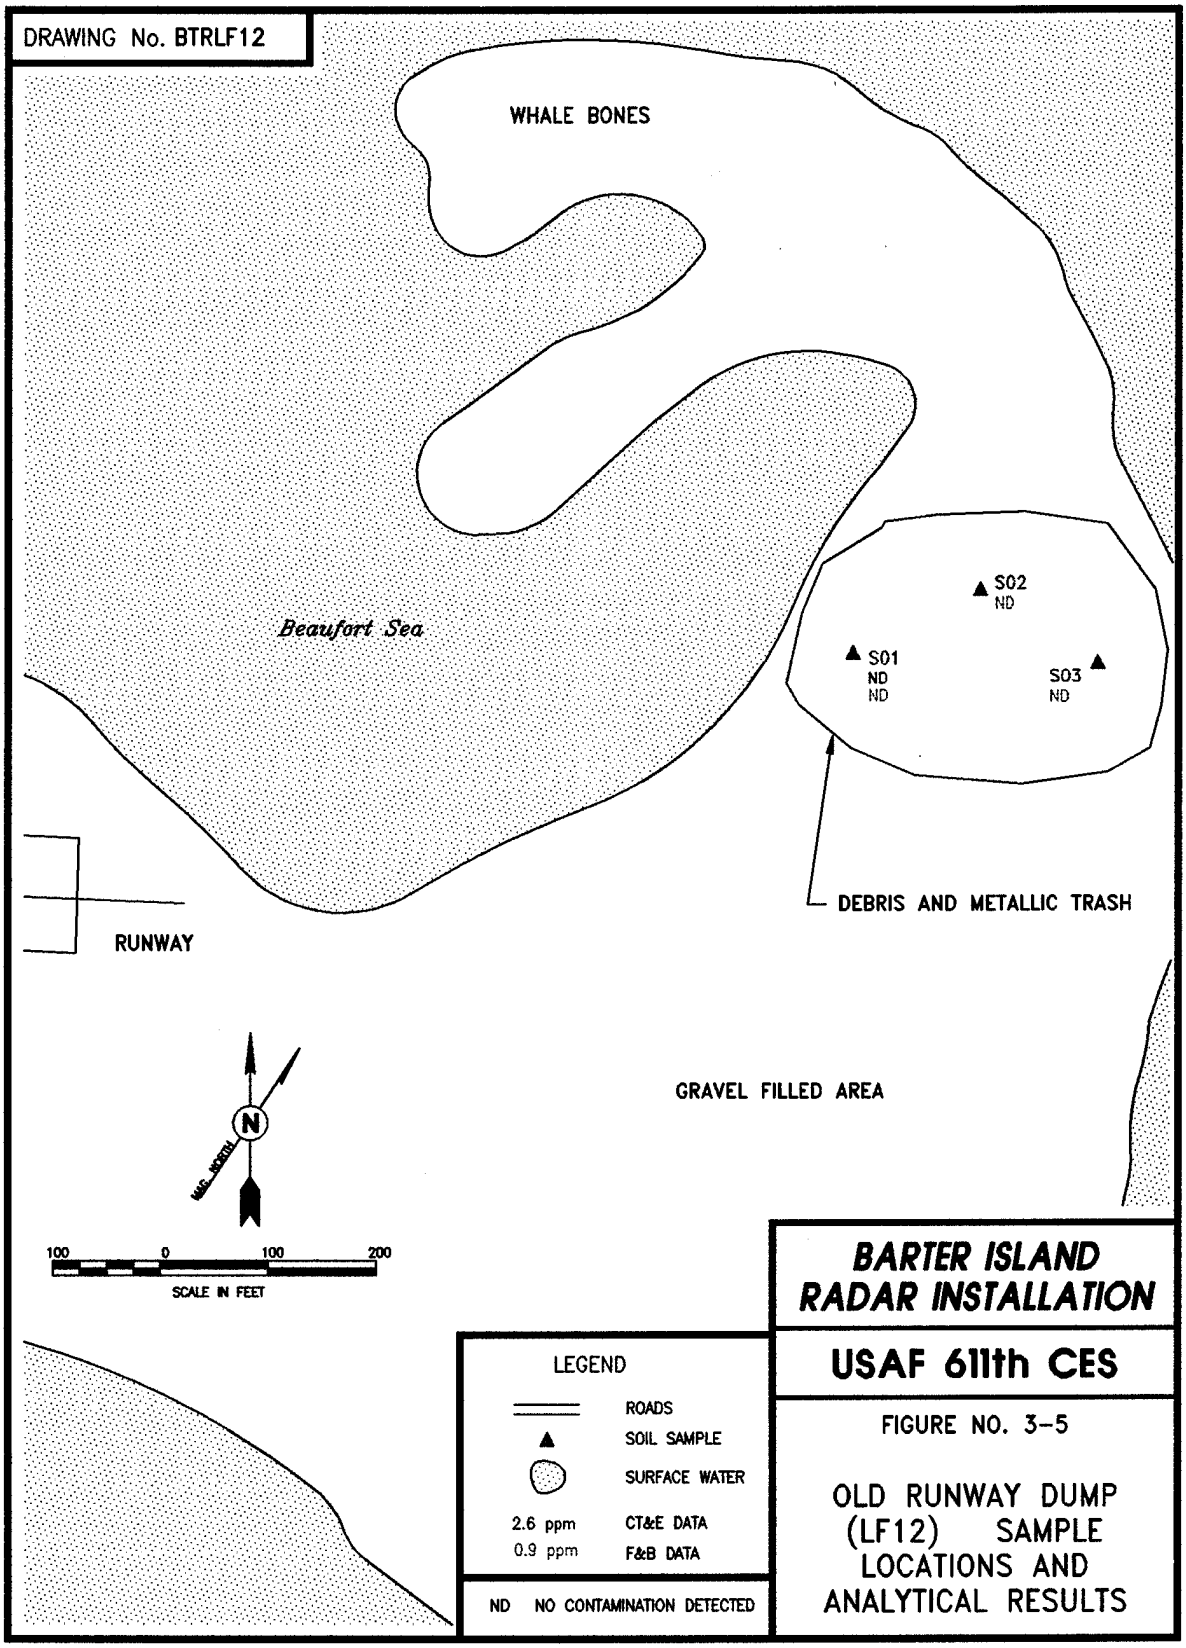
Sampling and analyses have determined that the Old Runway Dump (LF12) is not contaminated. No contaminant was detected in site samples. The site is subject to seasonal flooding by saltwater, so if contaminants were previously present they were probably diluted by seawater. Because no contaminant was detected at the site, there is no potential for contaminant migration or risk from the site to human health or ecological receptors. Based on the RI sampling and analyses, the Old Runway Dump (LF12) site is recommended for no further action.

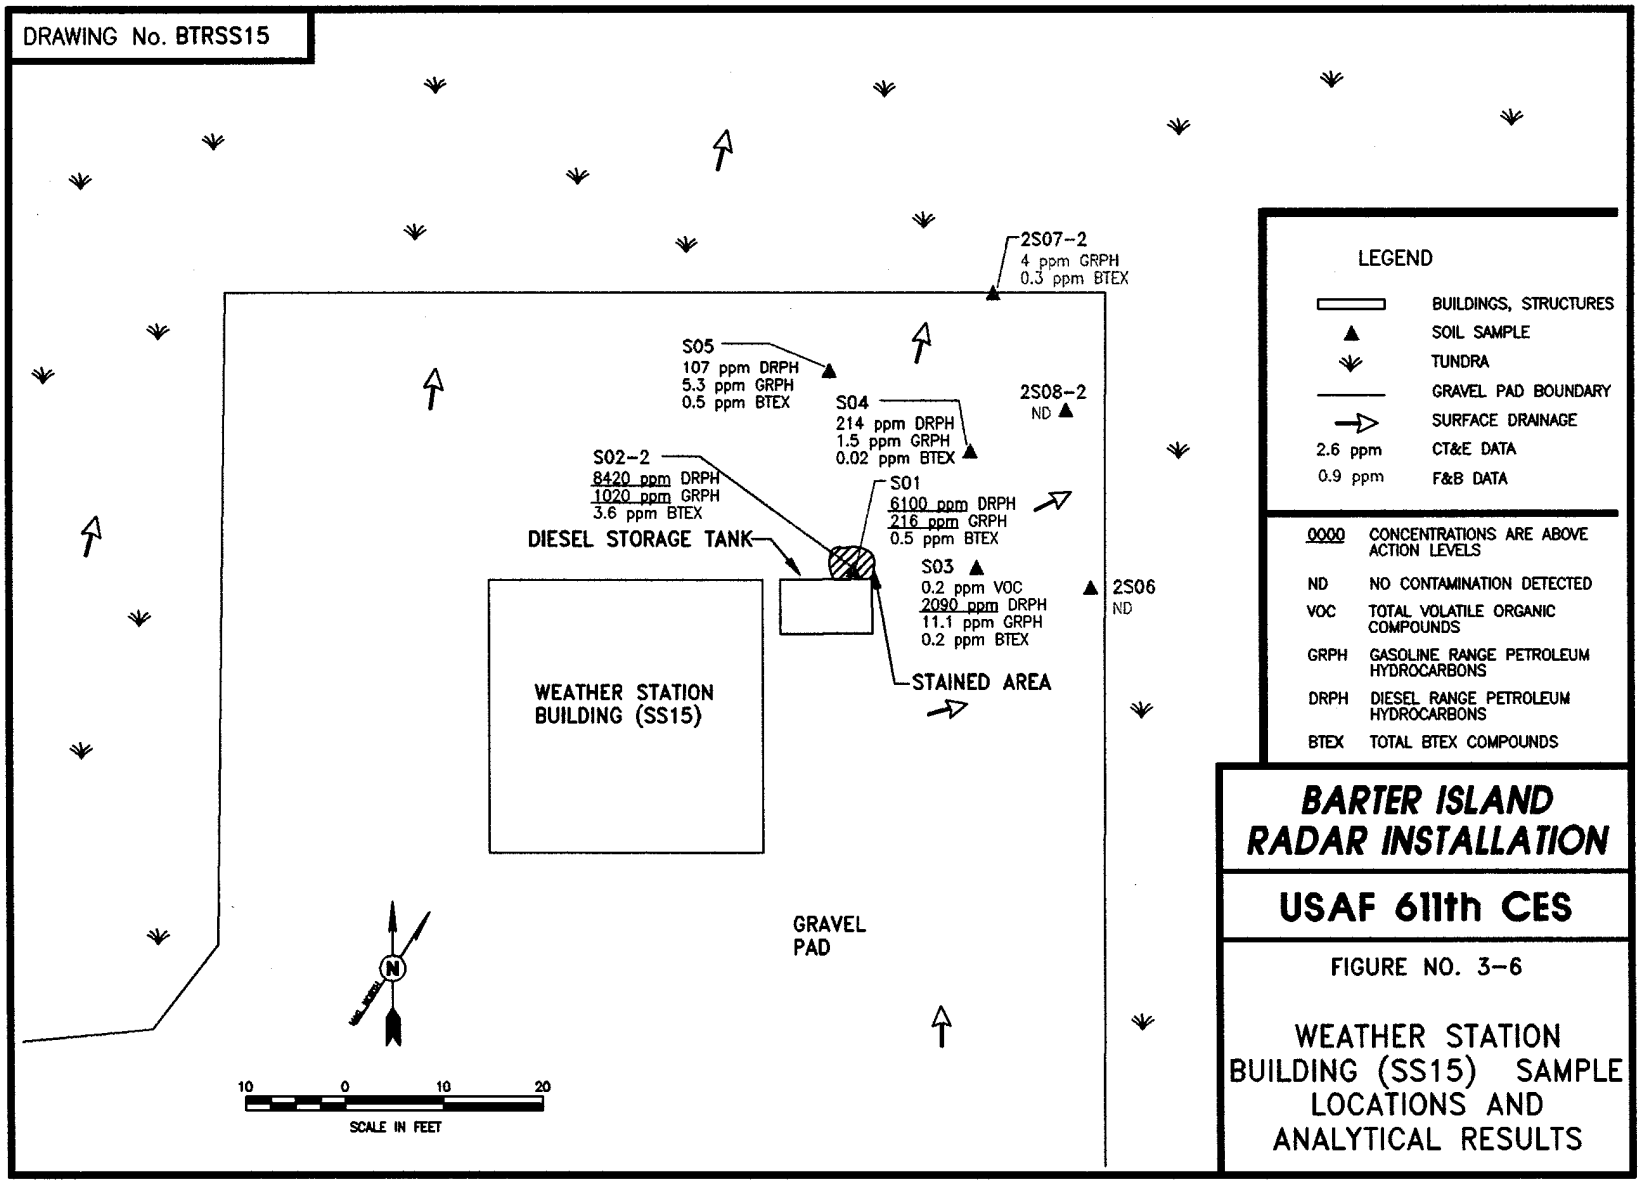
The risk assessment concluded that risks posed to human health and ecological receptors by site contaminants are minimal given current site uses. The potential human health risks at the site are not of a magnitude that normally requires remedial action. Based on RI sampling and analyses, risk assessment and current site uses, remedial actions are not warranted at the site. Chemicals detected at the site did not pose significant human health or ecological risks; therefore, the Weather Station Building (SS15) site is recommended for no further action.

DRAWING No. BTRSS15
2S07-2
4 ppm GRPH
0.3 ppm BTEX
S05
107 ppm DRPH
5.3 ppm GRPH
0.5 ppm BTEX
S04
214 ppm DRPH
1.5 ppm GRPH
0.02 ppm BTEX
2S08-2
ND
S02-2
8420 ppm DRPH
1020 ppm GRPH
3.6 ppm BTEX
S01
6100 ppm DRPH
216 ppm GRPH
0.5 ppm BTEX
DIESEL STORAGE TANK
S03
0.2 ppm VOC
2090 ppm DRPH
11.1 ppm GRPH
0.2 ppm BTEX
2S06
ND
STAINED AREA
WEATHER STATION BUILDING (SS15)
GRAVEL PAD
N
10 0 10 20
SCALE IN FEET
LEGEND
BUILDINGS, STRUCTURES
SOIL SAMPLE
TUNDRA
GRAVEL PAD BOUNDARY
SURFACE DRAINAGE
2.6 ppm CT&E DATA
0.9 ppm F&B DATA
0000 CONCENTRATIONS ARE ABOVE ACTION LEVELS
ND NO CONTAMINATION DETECTED
VOC TOTAL VOLATILE ORGANIC COMPOUNDS
GRPH GASOLINE RANGE PETROLEUM HYDROCARBONS
DRPH DIESEL RANGE PETROLEUM HYDROCARBONS
BTEX TOTAL BTEX COMPOUNDS
BARTER ISLAND RADAR INSTALLATION
USAF 611th CES
FIGURE NO. 3-6
WEATHER STATION BUILDING (SS15) SAMPLE LOCATIONS AND ANALYTICAL RESULTS

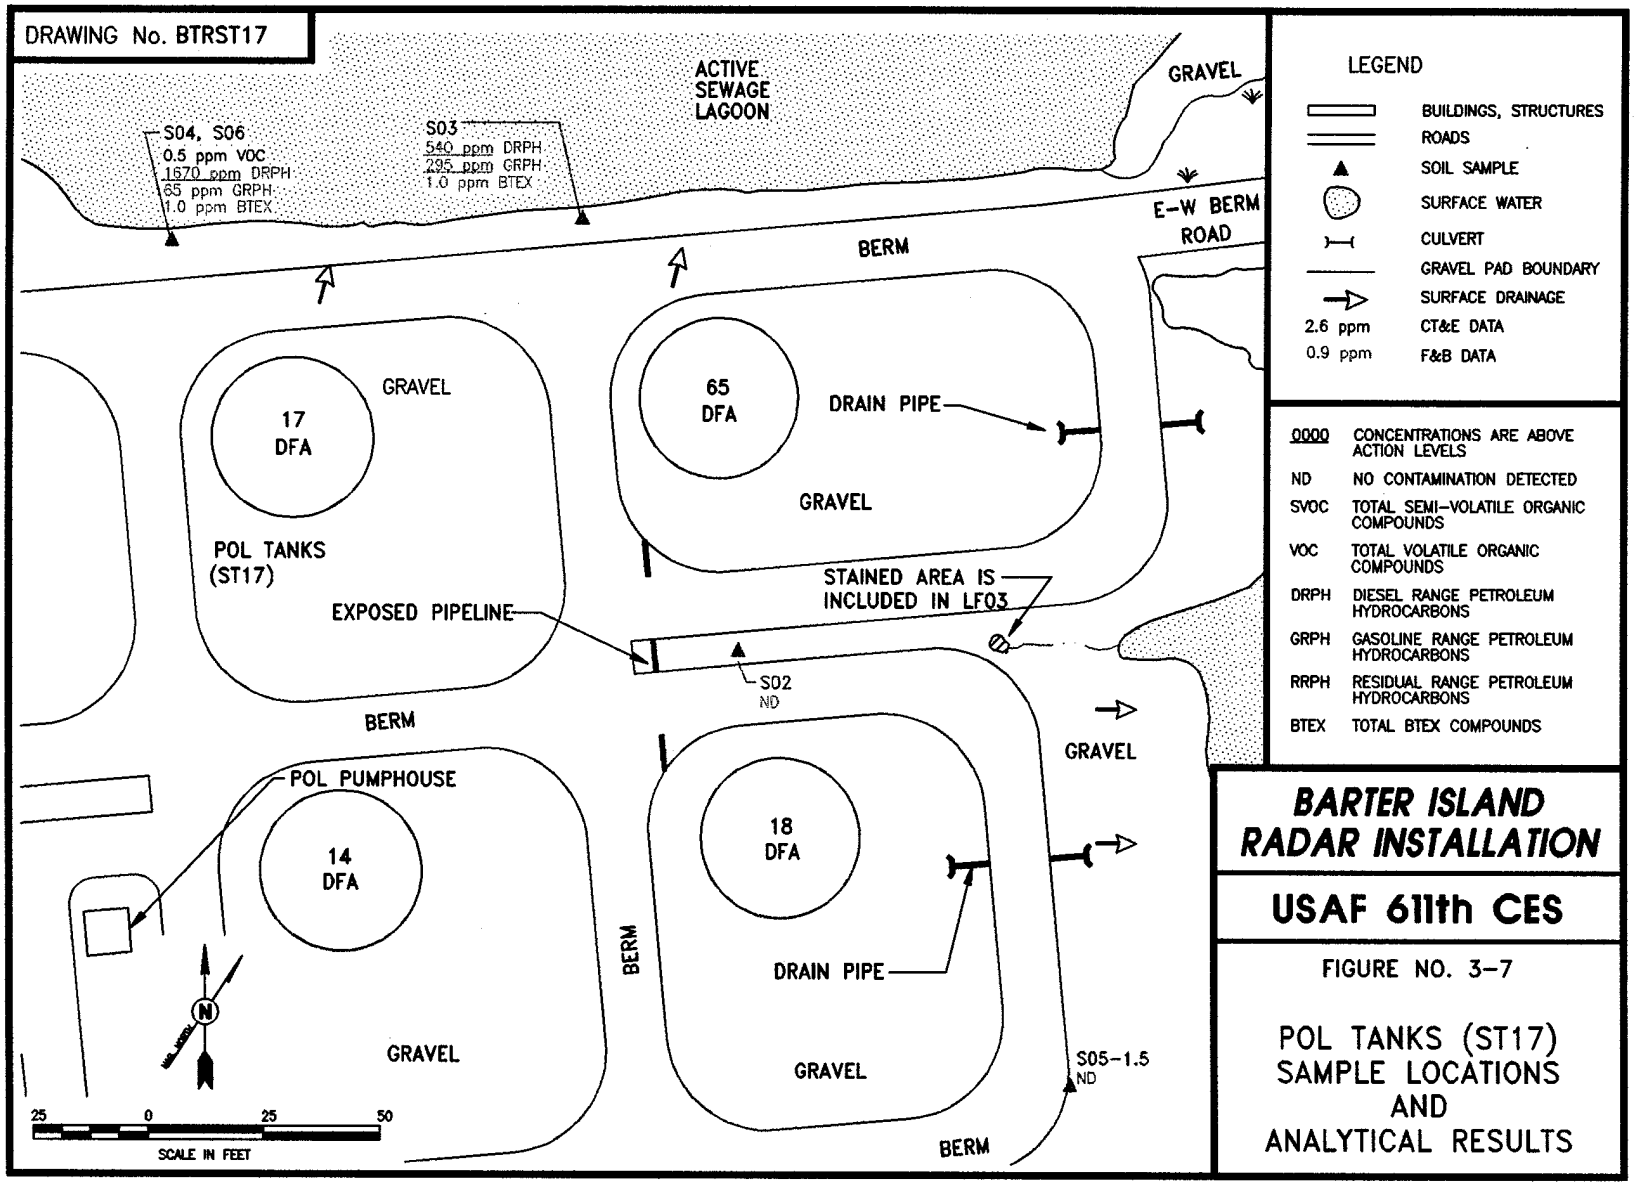
The risk assessment concluded that risks posed to human health and ecological receptors by site contaminants are minimal given current or future site uses. Based on the Ri sampling and analyses, risk assessment, and current site uses, remedial actions are not warranted at the site.

Both the POL Tanks and the sewage lagoon are active compliance sites, and ADEC has recommended that the POL Tank site be removed from the list of IRP sites at this installation. Any future spills or leaks from the site will be handled as compliance issues. Therefore, the POL Tanks (ST17) site is recommended for no further action.

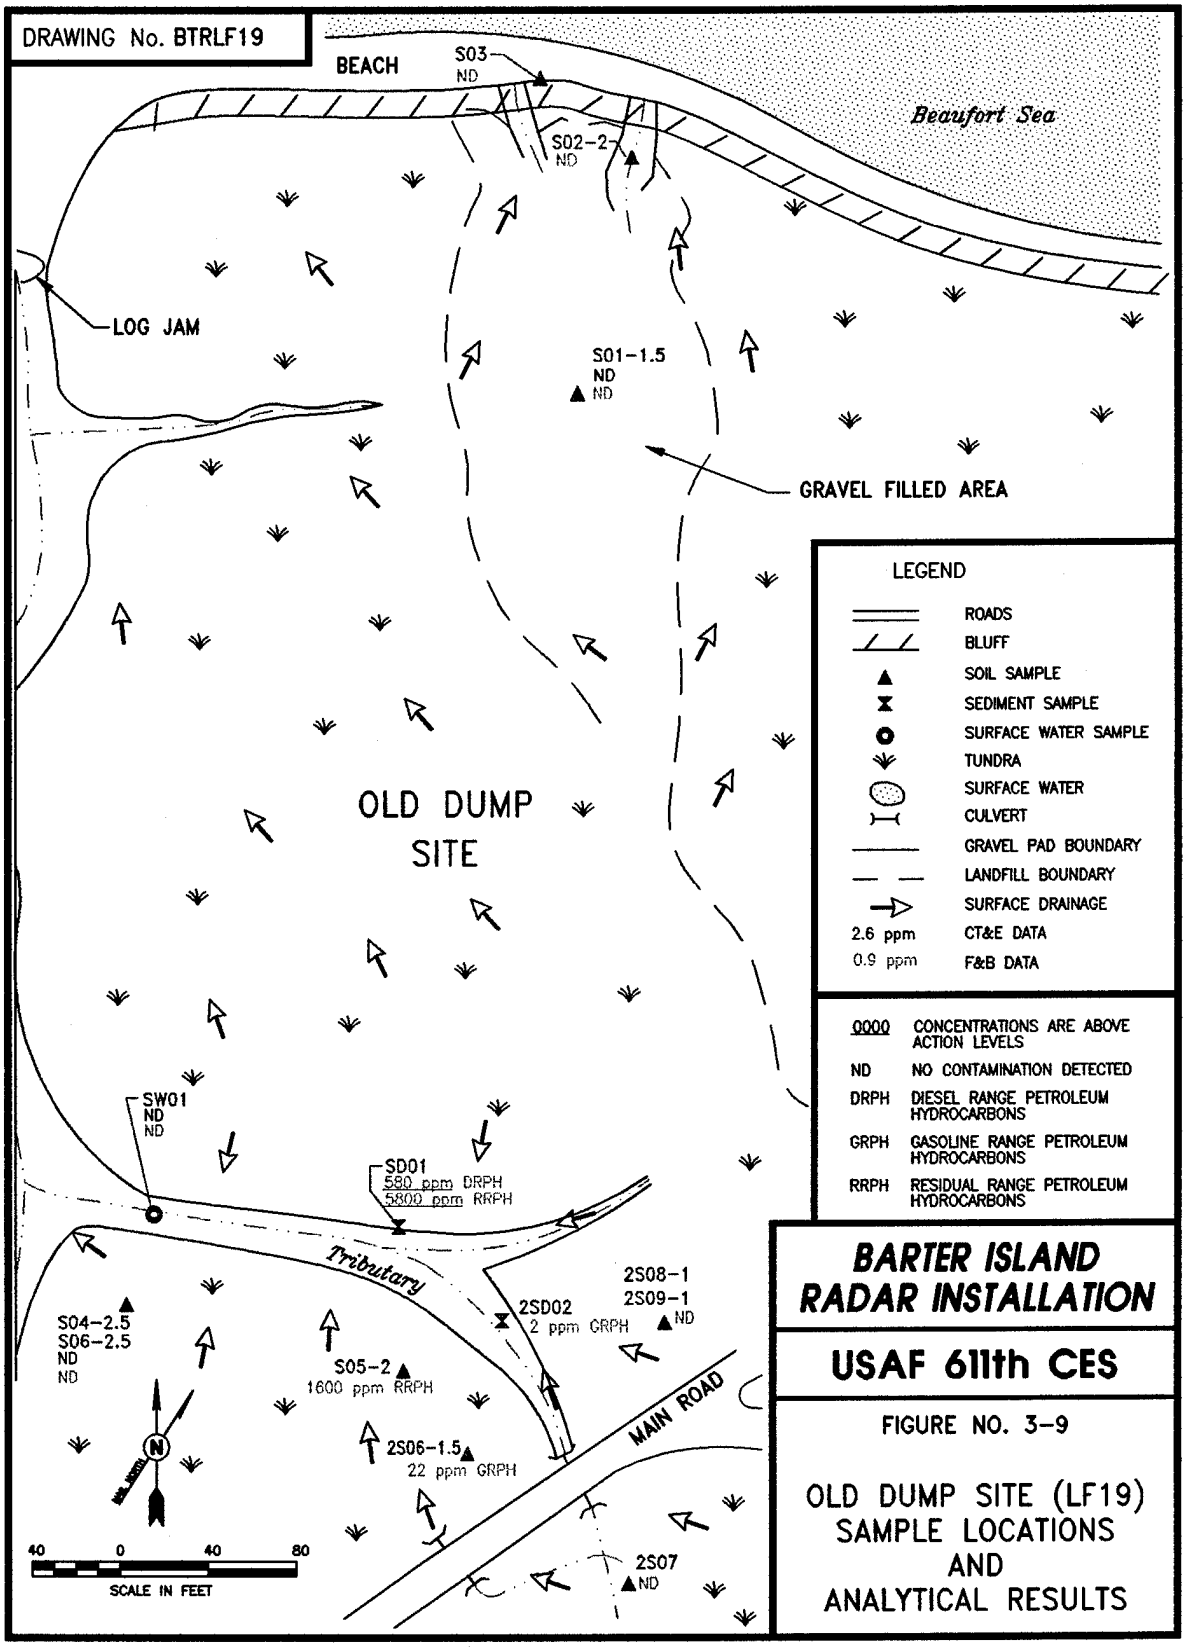
Sampling and analyses have determined that there is no significant contamination at the Old Dump Site (LF19). Petroleum hydrocarbons were detected in a few of the site samples; however, no source area or widespread areas of contamination were identified. No organic contaminants were detected in a surface water sample collected from a drainage pathway leading away from the site. The chemicals detected at the site are possibly associated with the past disposal practices at the site. The village of Kaktovik was located on this site from approximately 1952 to 1964.

DRAWING No. BTRLF19
BEACH
S03
ND
Beaufort Sea
S02-2
ND
LOG JAM
S01-1.5
ND
ND
GRAVEL FILLED AREA
OLD DUMP
SITE
SW01
ND
ND
SD01
580 ppm DRPH
5800 ppm RRPH
Tributary
2SD02
2 ppm GRPH
2S08-1
2S09-1
ND
S04-2.5
S06-2.5
ND
ND
S05-2
1600 ppm RRPH
2S06-1.5
22 ppm GRPH
MAIN ROAD
2S07
ND
N
40 0 40 80
SCALE IN FEET
LEGEND
ROADS
BLUFF
SOIL SAMPLE
SEDIMENT SAMPLE
SURFACE WATER SAMPLE
TUNDRA
SURFACE WATER
CULVERT
GRAVEL PAD BOUNDARY
LANDFILL BOUNDARY
SURFACE DRAINAGE
2.6 ppm CT&E DATA
0.9 ppm F&B DATA
0000 CONCENTRATIONS ARE ABOVE ACTION LEVELS
ND NO CONTAMINATION DETECTED
DRPH DIESEL RANGE PETROLEUM HYDROCARBONS
GRPH GASOLINE RANGE PETROLEUM HYDROCARBONS
RRPH RESIDUAL RANGE PETROLEUM HYDROCARBONS
BARTER ISLAND
RADAR INSTALLATION
USAF 611th CES
FIGURE NO. 3-9
OLD DUMP SITE (LF19)
SAMPLE LOCATIONS
AND
ANALYTICAL RESULTS

The risk assessment concluded that risks posed to human health and ecological receptors by site contaminants are minimal given current or future site uses. Based on the RI sampling and analyses, risk assessment, and current site uses, remedial actions are not warranted at the site. Therefore, the Old Dump Site (LF19) site is recommended for no further action.

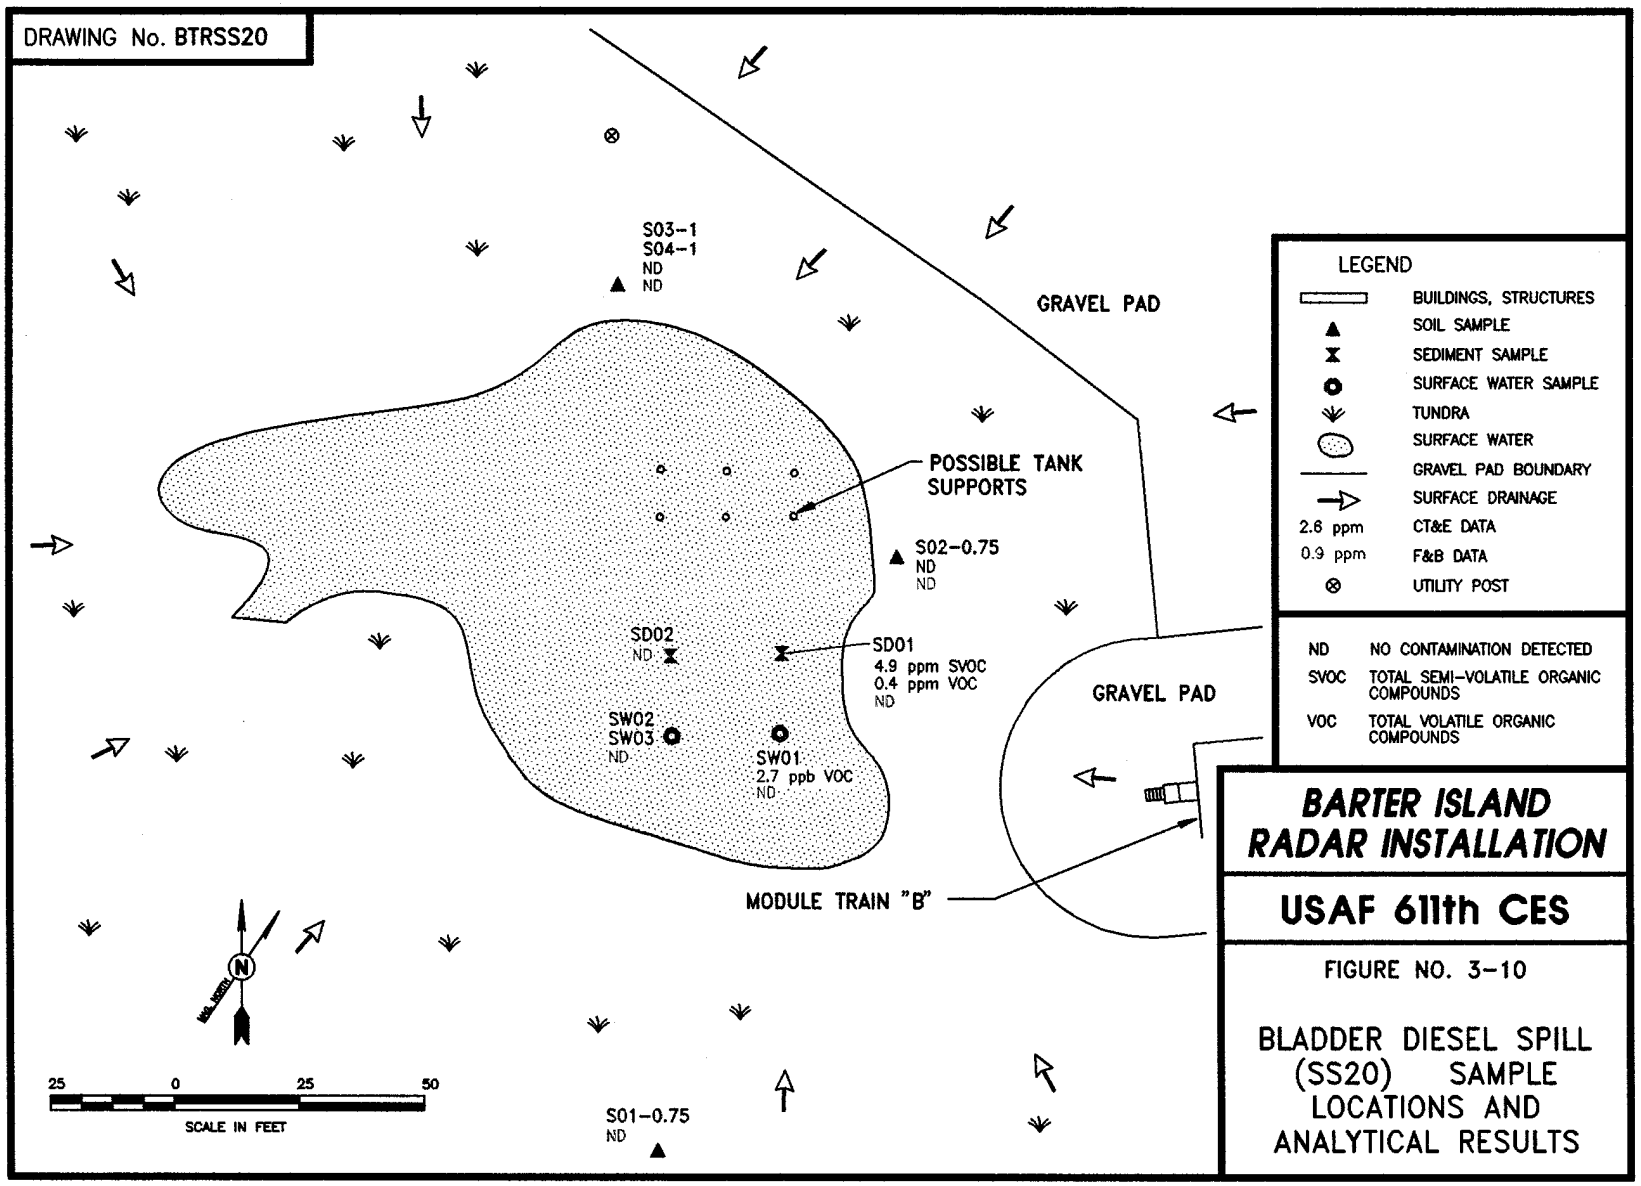
3.9.4.1 Chemicals of Concern. At the Bladder Diesel Spill (SS20), no COCs were identified for the soil/sediment or surface water matrices at the site. No organic constituents were detected in samples from the site, and no metal concentrations were above background levels, RBSL, or ARARs. Therefore, there are no apparent potential risks or hazards to human health from chemicals detected at the site.

DRAWING No. BTRSS20
S03-1
S04-1
ND
ND
GRAVEL PAD
POSSIBLE TANK SUPPORTS
S02-0.75
ND
ND
SD02
ND
SD01
4.9 ppm SVOC
0.4 ppm VOC
ND
SW02
SW03
ND
SW01
2.7 ppb VOC
ND
GRAVEL PAD
MODULE TRAIN "B"
S01-0.75
ND
25 0 25 50
SCALE IN FEET
LEGEND
BUILDINGS, STRUCTURES
SOIL SAMPLE
SEDIMENT SAMPLE
SURFACE WATER SAMPLE
TUNDRA
SURFACE WATER
GRAVEL PAD BOUNDARY
SURFACE DRAINAGE
2.6 ppm CT&E DATA
0.9 ppm F&B DATA
UTILITY POST
ND NO CONTAMINATION DETECTED
SVOC TOTAL SEMI-VOLATILE ORGANIC COMPOUNDS
VOC TOTAL VOLATILE ORGANIC COMPOUNDS
BARTER ISLAND RADAR INSTALLATION
USAF 611th CES
FIGURE NO. 3-10
BLADDER DIESEL SPILL (SS20) SAMPLE LOCATIONS AND ANALYTICAL RESULTS

Based on the RI sampling and analysis, risk assessment, and current site uses, remedial actions are not warranted at the site. Therefore, the Bladder Diesel Spill (SS20) site is recommended for no further action.

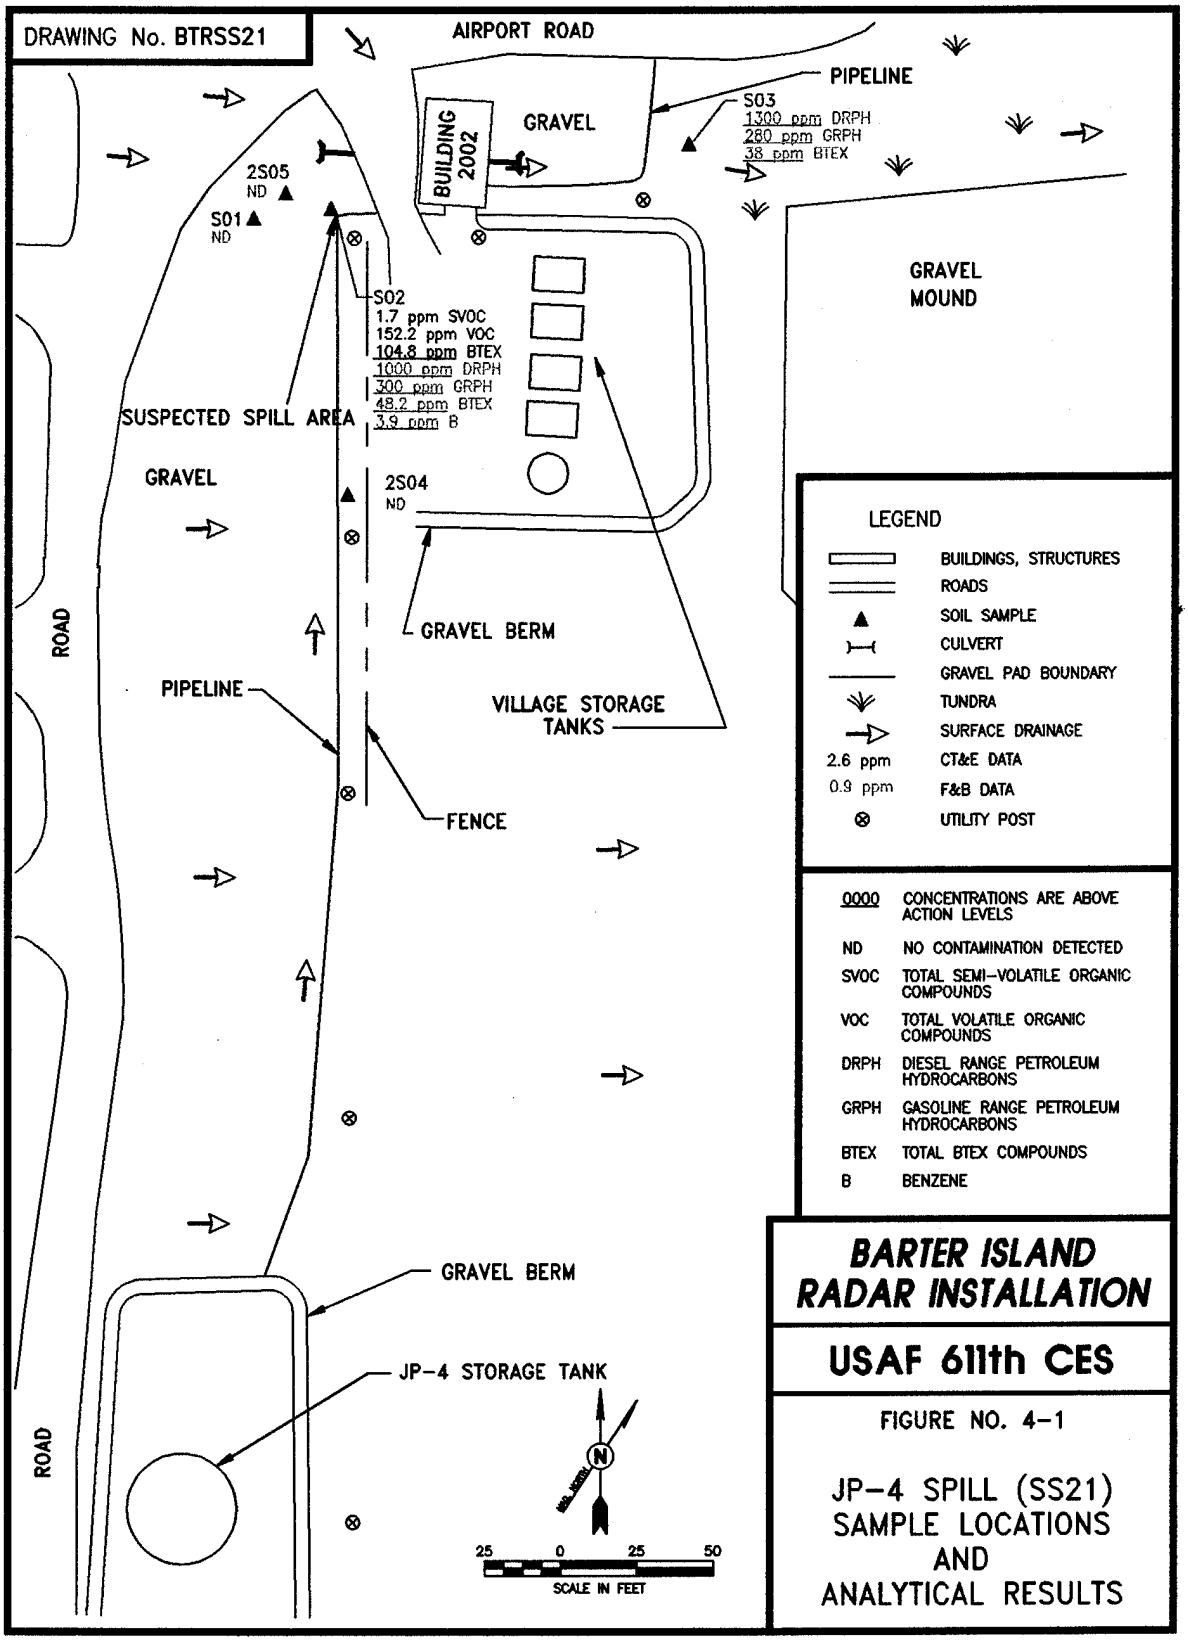
Levels of petroleum compounds detected at the site exceed ADEC guidance cleanup levels but the extent of contamination is not clearly defined. Therefore, the site is being recommended for additional sampling in order to more fully characterize the extent of petroleum hydrocarbon contamination.

DRAWING No. BTRSS21
AIRPORT ROAD
PIPELINE
S03
1300 ppm DRPH
280 ppm GRPH
38 ppm BTEX
BUILDING 2002
GRAVEL
2S05
ND
S01
ND
S02
1.7 ppm SVOC
152.2 ppm VOC
104.8 ppm BTEX
1000 ppm DRPH
300 ppm GRPH
