EVALUATION AND IMPROVEMENT OF COATINGS  
FOR COLUMBIUM ALLOY GAS TURBINE ENGINE COMPONENTS

PRATT & WHITNEY AIRCRAFT  
DIVISION OF UNITED AIRCRAFT CORPORATION

Technical Report AFML-TR-66-186, Part II

May 1968

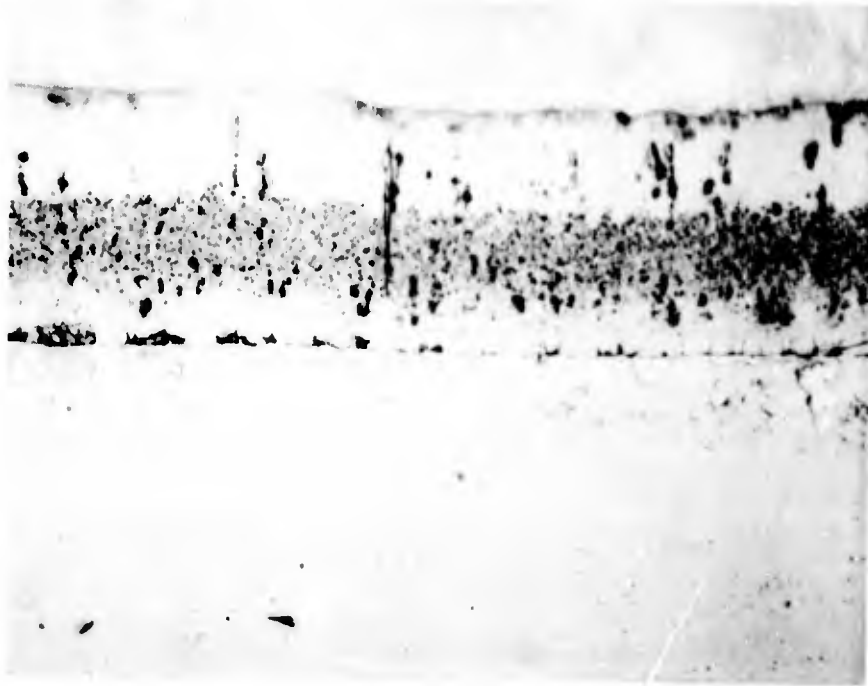
ETCH: 33% HYDROFLUORIC ACID, 33% NITRIC ACID, 33% WATER MAG: 500X

Figure 7. Microstructure of Remodified TRW TiCr-Si (Vacuum) Pack Coated Cb-132M Alloy

Metallographic examination of the 2.5-mil-thick coating revealed three distinct coating-substrate regions: an outer coating zone, an intermediate coating zone adjacent to the substrate, and a solid solution region within the alloy (Figure 7). Although the outer coating layer of 1.0 mil in thickness contained regions of second phase, these areas were relatively isolated and occurred in a direction perpendicular to the coating-substrate interface. The intermediate coating region of 1.5 mils thickness was predominantly two phase. However, within approximately 0.5 mil of the alloy interface, regions of second phase decreased significantly. The 1-mil-thick solid solution zone beneath the coating contained a second-phase precipitate, presumably a (Cb, Ti)Cr<sub>2</sub>-type Laves phase. Precipitation appeared to be at substrate grain boundaries (Figure 7).

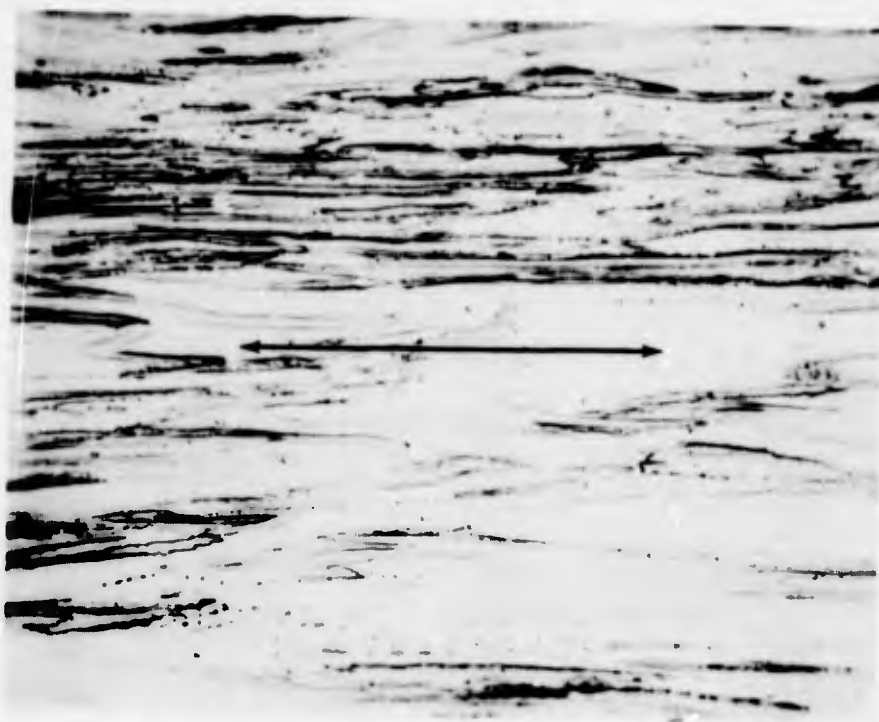
ALLOY: XB-88, SWAGED BAR  
 PLANE: NORMAL TO BAR AXIS  
 ETCH: 33% HYDROFLUORIC ACID, 33% NITRIC ACID, 33% WATER  
 MAG: 500X

ALLOY: XB-88, SWAGED BAR  
 PLANE: PARALLEL TO BAR AXIS (ARROW)  
 ETCH: 33% HYDROFLUORIC ACID, 33% NITRIC ACID, 33% WATER  
 MAG: 500X

Figure 25. Typical Microstructure of As-Received XB-88 Columbian Alloy Bar

As mentioned under Items 4 and 6, turbine blade alloys must have high fatigue strength, good creep resistance, and the ability to absorb impact forces without fracture. The Cb-132M blade alloy was supplied by Fansteel Metallurgical Corporation and extruded further at Nuclear Metals Division of the Whittaker Corporation. Composition, extrusion parameters, and microstructures are described in Items 4 and 6, paragraph 2.1, Substrate Materials. The XB-88 blade alloy was supplied by Westinghouse Astronuclear Laboratory in 0.50- and 0.75-inch-diameter bar form. The as-received material was in the as-swaged condition and exhibited a completely worked microstructure (Figure 25).

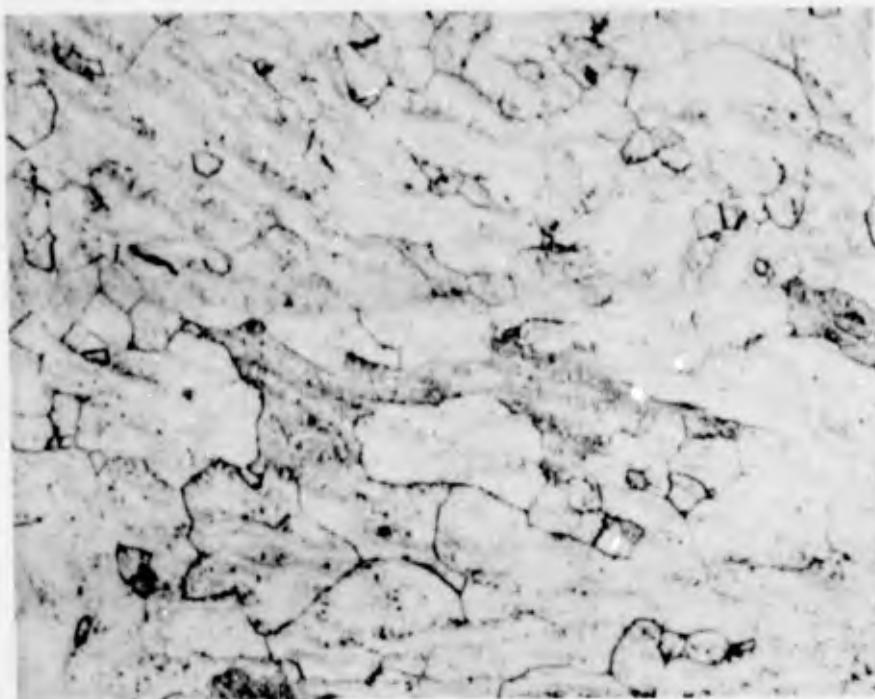
Figure 26. Typical Microstructure of XB-88 Columbian Alloy Bar After Heat Treatment for 1 Hour at 3000°F

To develop high-temperature strength properties while maintaining room temperature ductility, heat treatment was required for XB-88 creep, fatigue, and Charpy impact test specimens. Westinghouse personnel suggested a 1-hour heat treatment at  $3090^{\circ}\text{F}$ , but at the same time cautioned that slight variations from this "optimum" temperature might be necessary for different heats. An investigation was therefore performed by heat treating test specimens for 1-hour periods at  $3000^{\circ}$ ,  $3090^{\circ}$ , and  $3180^{\circ}\text{F}$  in vacuum. Appropriate micrographs of the heat treated structures were compared with micrographs supplied by Westinghouse. Comparative examination indicated that a 1-hour heat treatment at  $3000^{\circ}\text{F}$  corresponded to the "reference" condition for optimization of properties. The alloy structure was partially recrystallized (Figure 26). The XB-88 creep, fatigue, and Charpy impact specimens were therefore heat treated at  $3000^{\circ}\text{F}$  for 1 hour in vacuum.

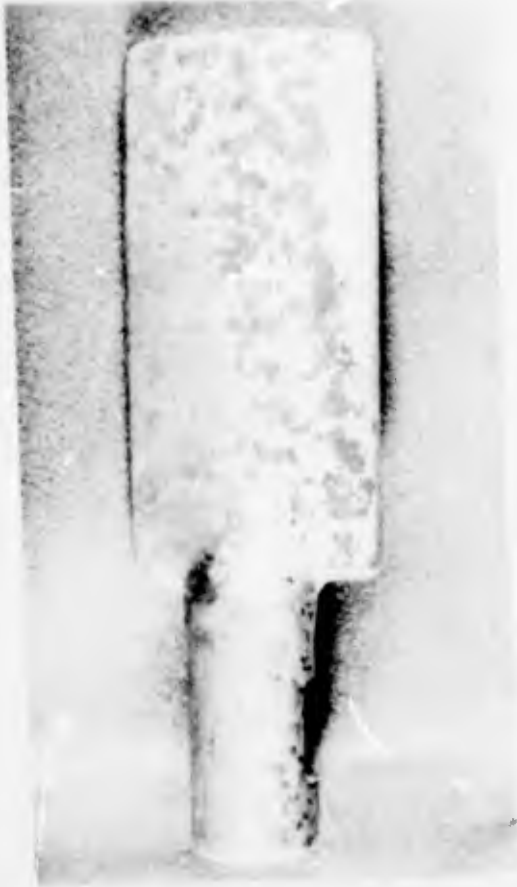
Figure 29. As-Coated TRW TiCr-Si/XB-88 Alloy Oxidation-Erosion Bar (Left) and Thermal Fatigue Paddle (Right)

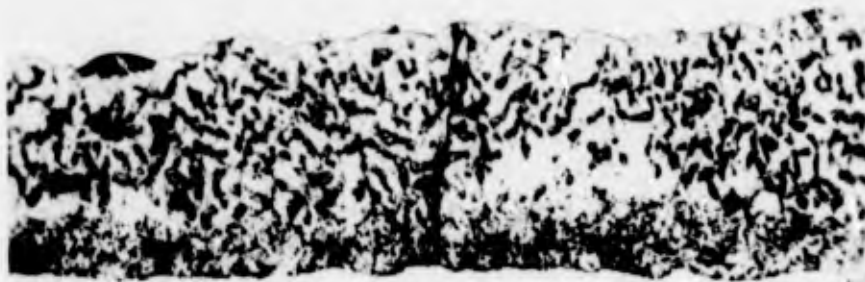
**ETCH: 20% HYDROFLUORIC ACID, 20% NITRIC ACID, 60% WATER      MAG: 500X**

**Figure 31.    Microstructure of the As-Applied Solar V-CrTi-Si Coating on  
Cb-132M Alloy**

A V-CrTi-Si coating of 2.3 to 2.6 mils was developed on the Cb-132M test specimens by Solar Division of International Harvester Company, with coating weights ranging from 25.6 to 31.4 milligrams per square centimeter. Coating coverage on specimen edges and corners was good. Metallographic examination of the composite revealed three microstructurally distinct coating regions (Figure 31). The outer coating layer of about 2.0 mils contained a discontinuous second phase of fairly uniform distribution. A second region of 0.4 mil at the coating-substrate interface also contained discontinuous phases; i.e., no discrete coating interfacial compound was observed. The third region consisted of a 0.5-mil solid solution zone beneath the coating.

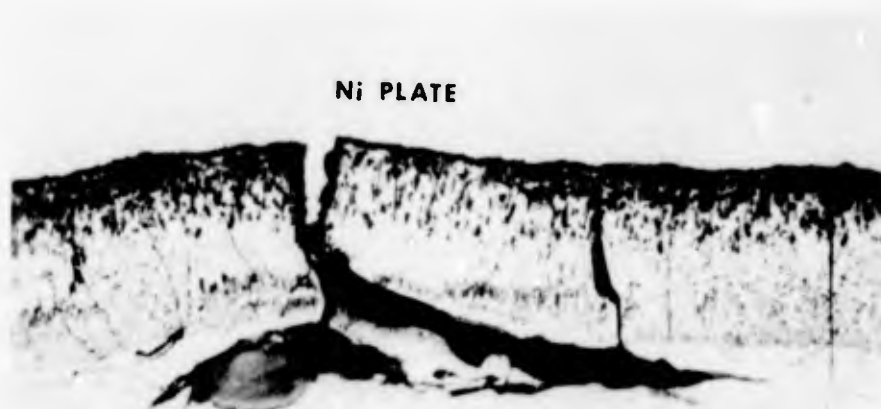
**ETCH: 20% HYDROFLUORIC ACID, 20% NITRIC ACID, 60% WATER      MAG: 250X**

**Figure 40.    Typical Oxidation Failure on TRW TiCr-Si Coated XB-88 Alloy  
Specimen Oxidation-Erosion Tested for 20 Hours at 2200°F**

TRW TiCr-Si (Vacuum) Pack/XB-88. Failure of four specimens, as judged by visible substrate oxide (Figure 39), was observed for the TRW TiCr-Si/XB-88 system after 20 hours at 2200° F. Metallographic examination revealed complete oxygen penetration of the coating in areas of surface craze cracking. Subsequent oxidation occurred along the coating-substrate interface (Figure 40).

were observed on airfoil surfaces (Figure 57). Composite microstructure after failure was similar to that observed for the system after failure in oxidation-erosion (see Figure 40); i.e., oxide penetration within coating craze cracks led to rupture of the coating and subsequent substrate oxidation.

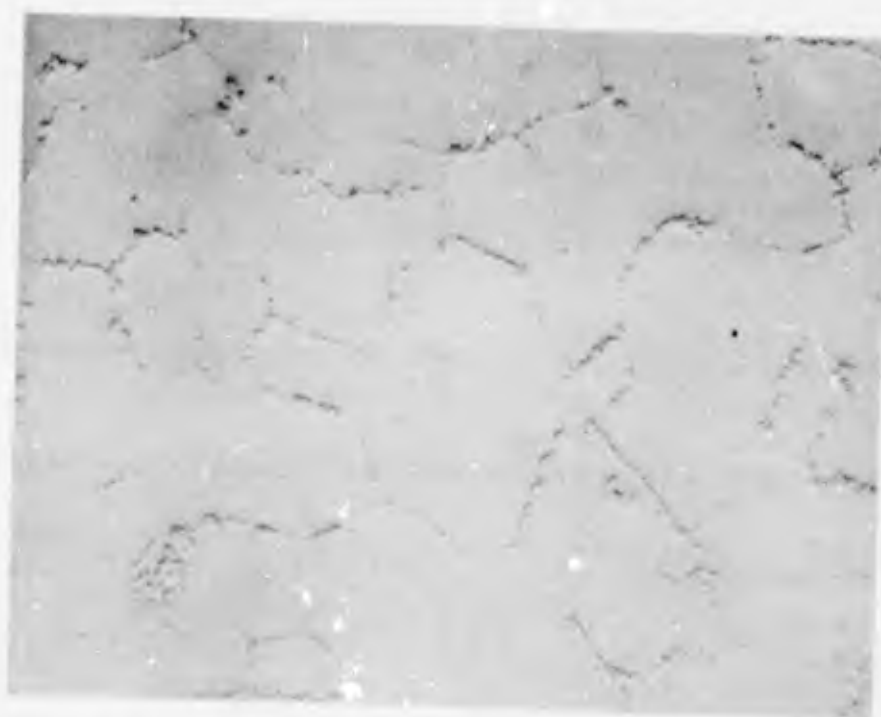
ETCH: 20% HYDROFLUORIC ACID, 20% NITRIC ACID, 60% WATER

Figure 44. Microstructure of Cb-132M Alloy Substrate Showing Grain Boundary Oxygen Enrichment Beneath a Typical Solar V-CrTi-Si Coating Failure in 2200°F Oxidation-Erosion

Metallographic examination of the specimens after test revealed general oxide penetration through coating cracks to the coating-substrate diffusion zone (Figure 42). The areas of local failure showed appreciable amounts of substrate oxide (Figure 43), and, in some cases, oxygen enrichment along grain boundaries extended for an appreciable distance (2 to 3 mils) beneath the oxide layer (Figure 44).

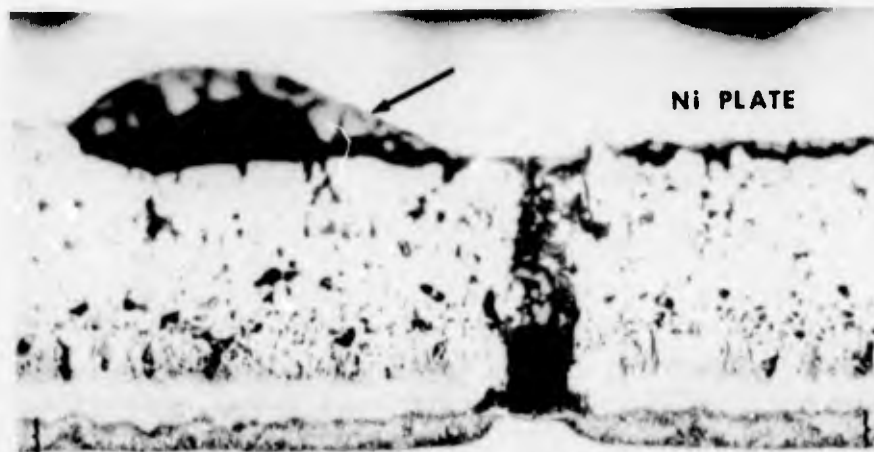
Figure 48. Microstructure of Solar MoTi-Si Coated Cb-132M Alloy After Oxidation-Erosion Testing for 100 Hours at 2200°F Plus 100 Hours at 2400°F Plus 40 Hours at 2500°F

Note devitrified glassy spot on coating surface (arrow) and the formation and penetration of second phase into the alloy substrate (brackets).

Metallographic examinations confirmed that surface beads were glassy formations. The glassy spots which were dark gray in color indicated glass devitrification on specimen cooling (Figure 48); the milky white spots, however, retained an amorphous structure (Figure 49). Coating structure beneath these glassy surface formations consisted of craze cracks extending to the coating-substrate interface. These cracks were filled with devitrified glass. During testing, an additional coating layer was formed at the coating-substrate interface. This layer also appeared glassy in nature. Additional layer formation was notably absent in substrate regions immediately beneath the glass-filled craze cracks (Figure 48). At failure, the glassy areas were bisque-colored in appearance, denoting substrate oxidation (Figure 50).

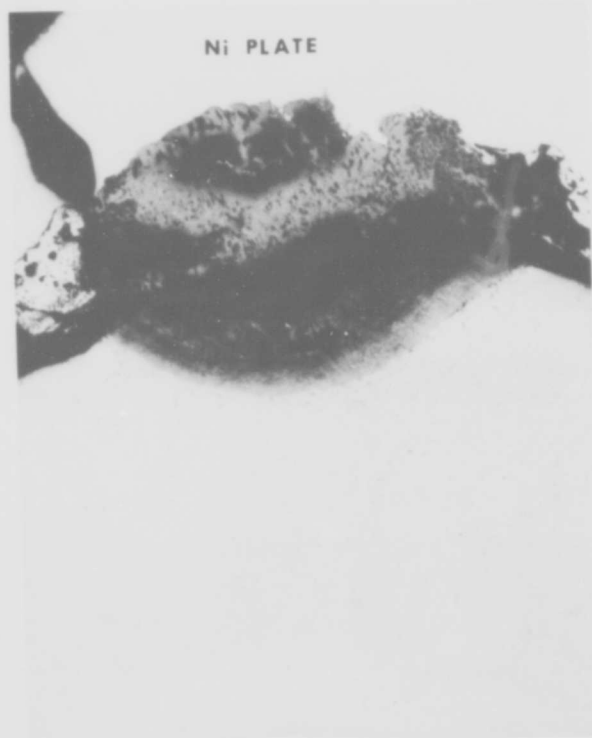
Figure 50. Microstructure of Solar MoTi-Si Coated Cb-132M Alloy Showing Substrate Oxidation Beneath Bisque-Colored Glassy Areas After Oxidation-Erosion Testing

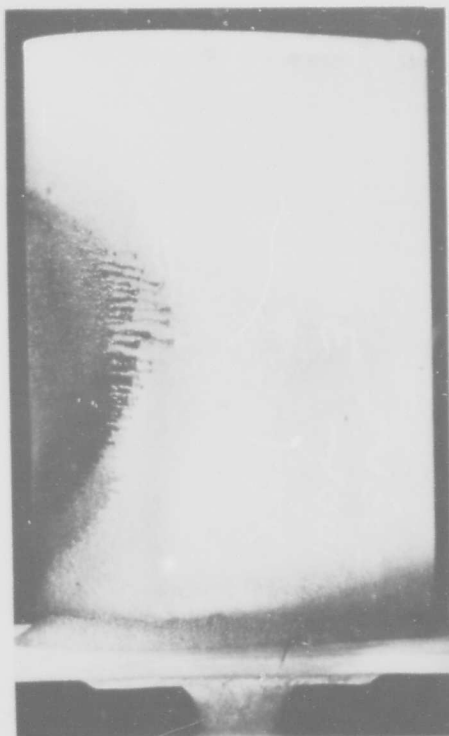
Figure 52. Sylvania SiCrTi Slurry Coated B-66 Alloy Vane Airfoils After 600 Thermal Fatigue Cycles to 2200°F Plus 400 Cycles to 2400°F

Sylvania SiCrTi Slurry/B-66. After thermal fatigue testing of the coated B-66 alloy vane airfoil specimens for 600 cycles to 2200°F (Figure 51) followed by 400 cycles to 2400°F (Figure 52), the Sylvania SiCrTi slurry coating was in good condition on both internal and external airfoil surfaces. However, oxidation had occurred on faying surfaces between the handle butt plate and airfoil platform (see Figure 34). During initial thermal fatigue testing to 2500° F, the embrittling effect of continued oxidation in this area led to weld cracking and subsequent handle-airfoil separation.

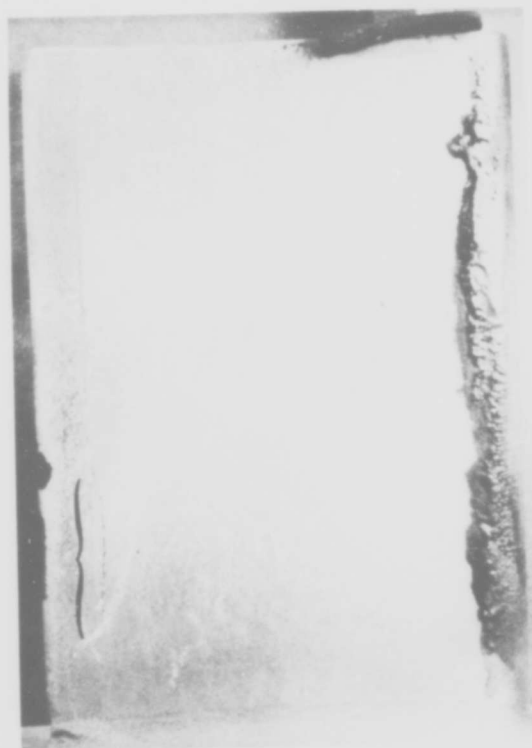
Figure 56. Sylvania SiCrTi Slurry Coated B-66 Alloy Vane Airfoil After 600 Thermal Fatigue Cycles to 2200°F Plus 400 Cycles to 2400°F Plus 700 Cycles to 2500°F; No Coating Failure

Brackets locate hairline cracks.

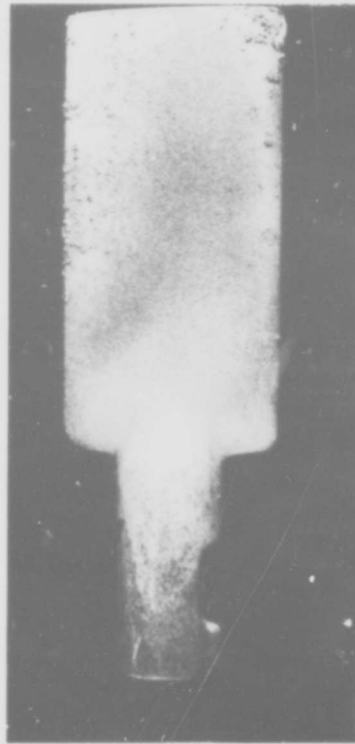
Figure 58. Solar V-CrTi-Si Coated Cb-132M Alloy Thermal Fatigue Specimens (Convex Surfaces) After 200 Cycles to 2200°F

Solar V-CrTi-Si/Cb-132M. Spalling and local oxidation of the Solar V-CrTi-Si coated Cb-132M thermal fatigue specimens was first observed after 200 cycles to 2200° F (Figure 58) and became more severe during the next 200 cycles (Figure 59). Metallography revealed substrate oxidation extending from coating craze cracks (Figure 60). In some cases, this oxidation led to complete rupture of the coating (Figure 61). Oxidation at the trailing edge of one specimen was severe (Figure 62).

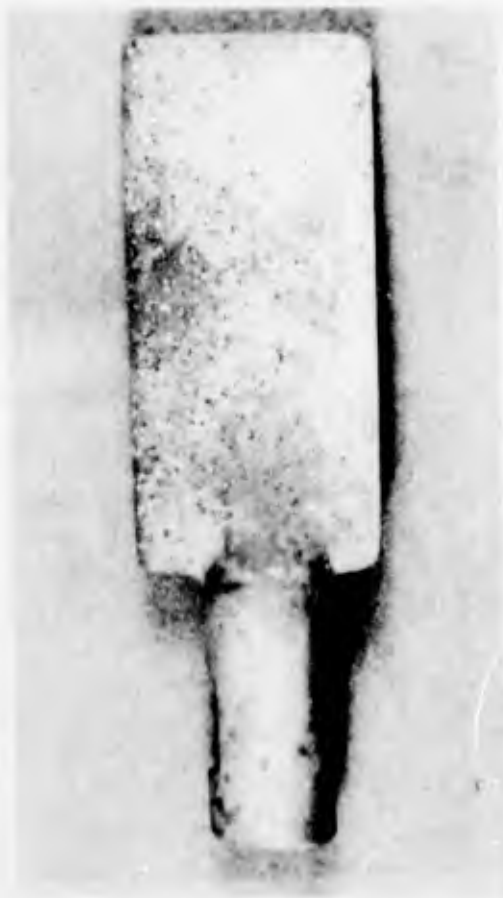
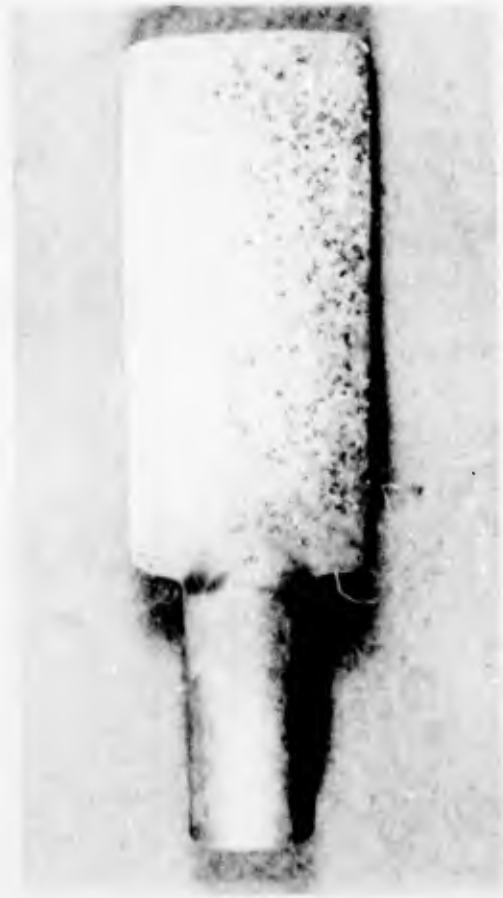
**Figure 57. TRW TiCr-Si Coated XB-88 Alloy Specimens After 200 Thermal Fatigue Cycles to 2200°F**

**Note numerous airfoil oxidation failures.**

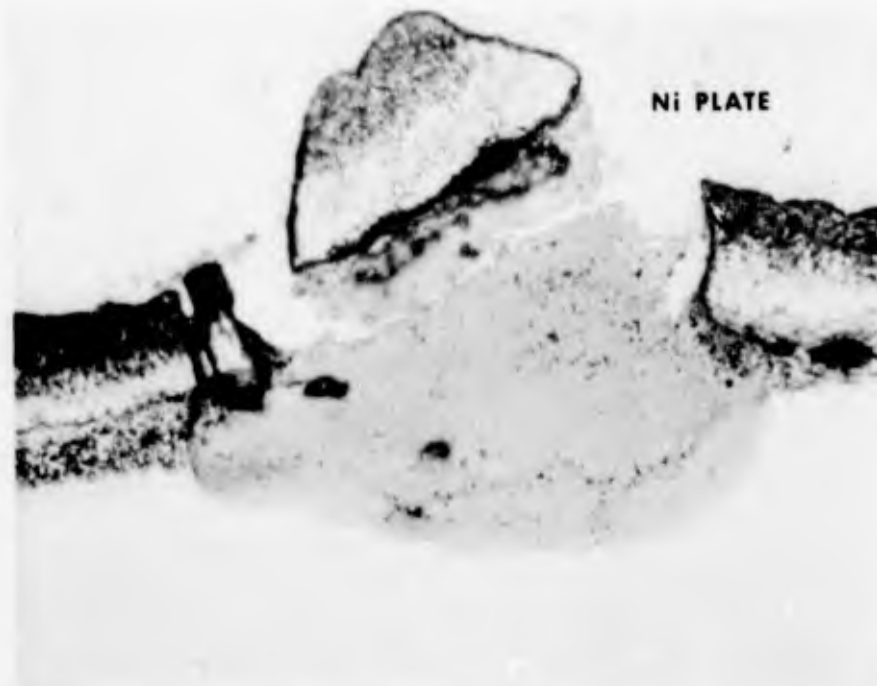
**Figure 61. Microstructure of Solar V-CrTi-Si Coated Cb-132M Alloy in Area of Local Oxidation Failure During 2200°F Thermal Fatigue Testing**

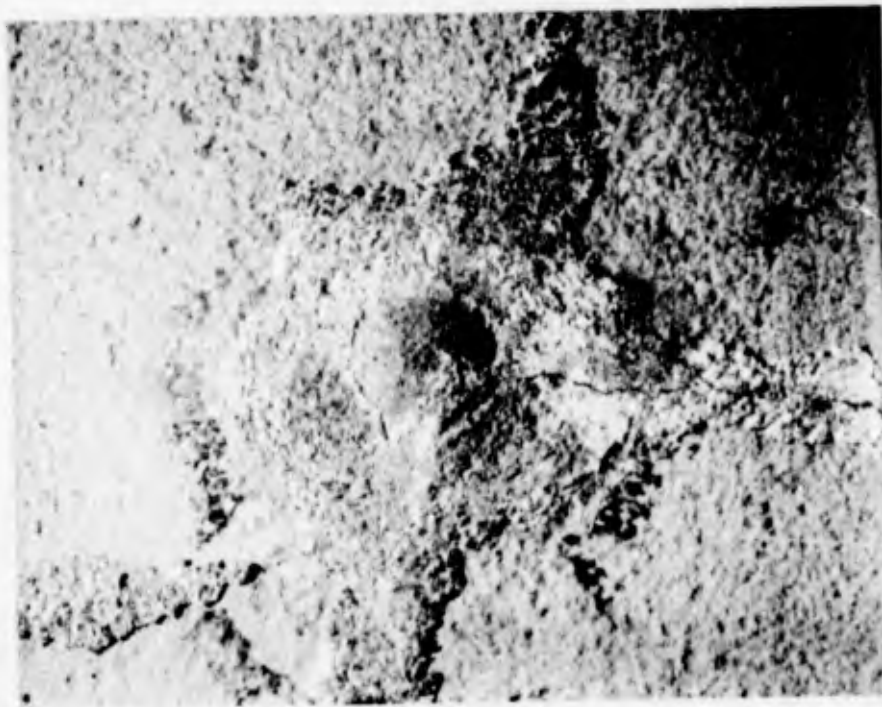
POINT OF IMPACT

SURFACE BEHIND IMPACT POINT

MAG: 10X

Figure 66. Surfaces of Sylvania SiCrTi Slurry Coated B-66 Alloy After Room Temperature Impact Testing at 500 Feet Per Second (No Oxidation Exposure)

Note coating-alloy composite cracking.

A summary of the ballistic impact test results on all four coating-substrate systems is presented in Table VIII, with the observed condition after oxidation exposure stated for various periods at 2200° F. In all cases, failures were first noted in the scabbed areas (either Zone II or Zone V). Oxidation was generally more prevalent on the impact sides of the specimens. The 500-ft/sec, 70° F impact condition was particularly severe for the Sylvania SiCrTi slurry/B-66 vane system. Both impacts resulted in fracture of the coating-alloy composite (Figure 66).

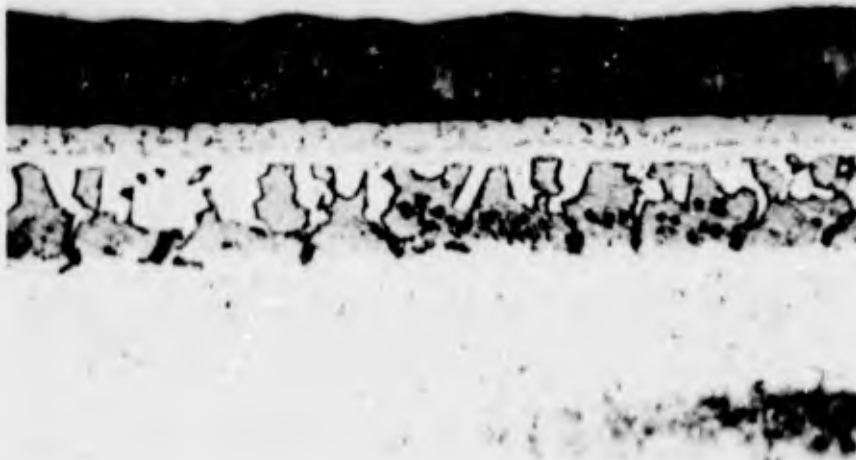
**ETCH: 33% HYDROFLUORIC ACID, 33% NITRIC ACID, 33% WATER**

**MAG: 500X**

**Figure 75. Microstructure of the TRW TiCr-Si (Vacuum) Pack Coating on Cb-132M Alloy**

Metallography revealed a coating structure consisting of two distinct layers (Figure 75). A 0.5-mil-thick layer of predominantly CrTi was observed adjacent to the substrate. This phase penetrated into the alloy substrate a distance of approximately 0.5 mil at intermittent locations. The outer coating region of 1.0 mil thickness contained numerous cracks extending from the surface through the coating to the layer adjacent to the substrate.

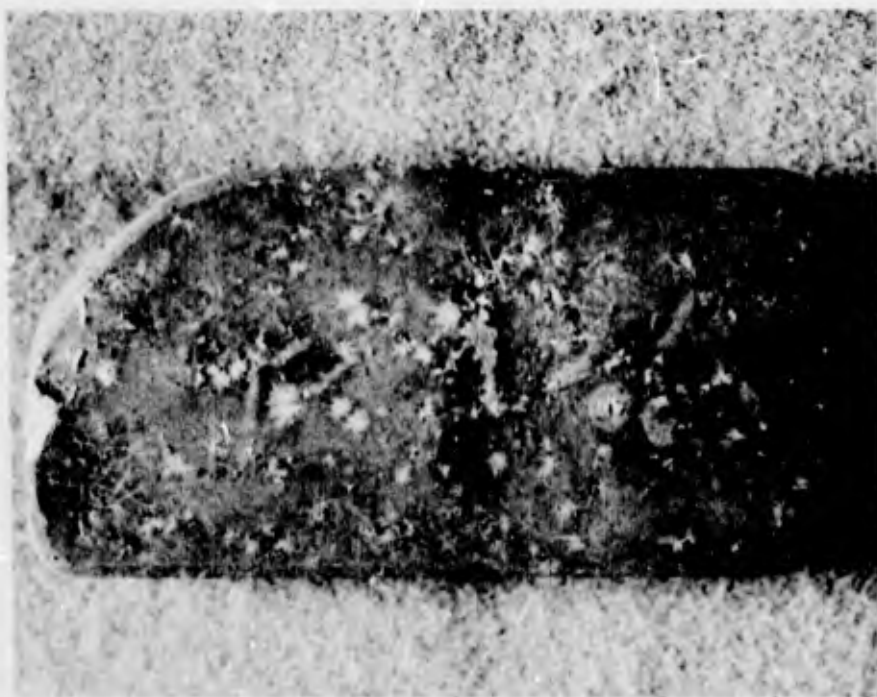
MAG: 4X

**Figure 81.** TRW TiCr-Al (Vacuum) Pack Coated Cb-132M Alloy Specimen Showing Edge Failure After 54 Hours Oxidation Exposure at 1600°F

The 1600°F failures for the TRW TiCr-Al coating were confined to corners and edges. In other areas, however, the specimen surfaces were rough and appeared nonhomogeneous (Figure 81). No failures occurred after 400 hours at 1300°F.

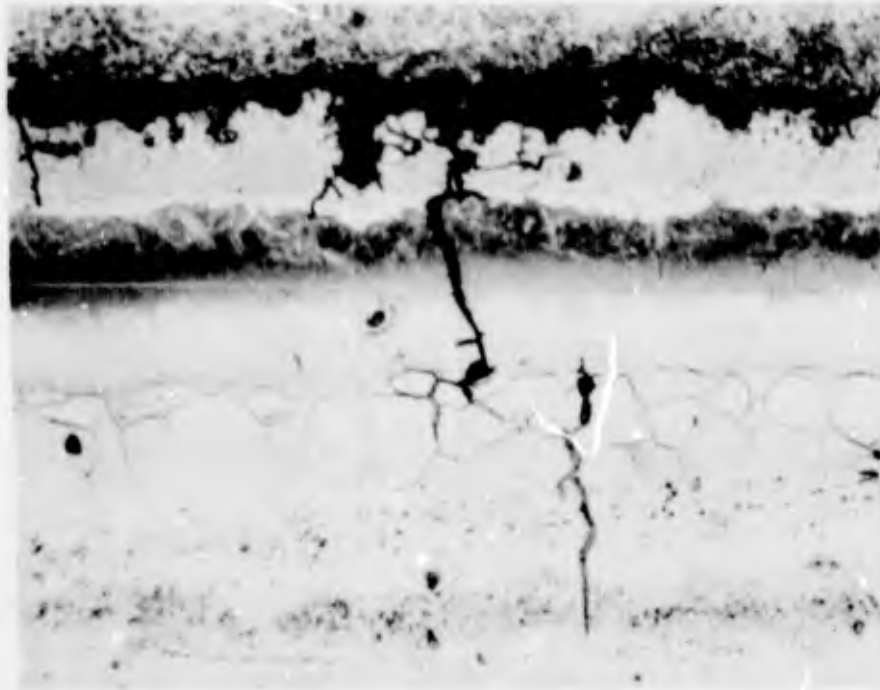
**ETCH: 20% HYDROFLUORIC ACID, 20% NITRIC ACID, 60% WATER      MAG: 500X**

**Figure 89.    Microstructure of TRW TiAl (Vacuum) Pack Coated Cb-132M Alloy After Tensile Failure at 70°F**

No other areas contained coating cracks extending into the substrate.

- One of the TRW TiAl coated tensile specimens failed in the elastic region. A second specimen tested at 70°F, however, developed plastic strain. Metallographic examination of the gage section showed some coating cracks (Figure 89), but more extensive cracking at the center of the specimen diameter suggests that the coating may not be responsible for the tensile failure.

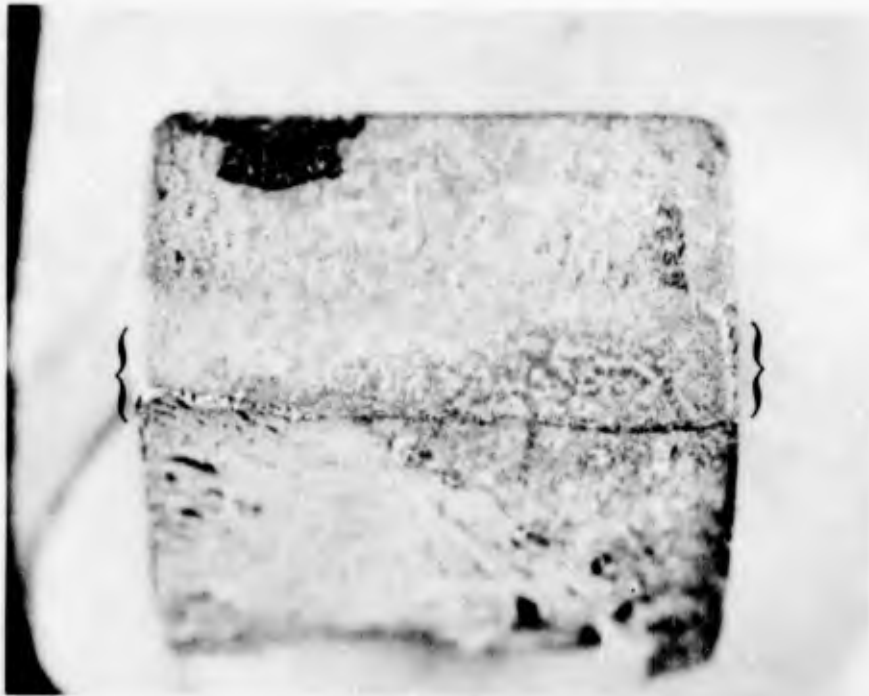
MAG: 10X

Figure 94. Sylvania SiCrFe Slurry Coated Cb-132M Alloy Wear-Galling Specimen Showing Wear Surface (Brackets) After 97,000 Cycles at 1300°F and a Tensile Stress of 30,000 Psi

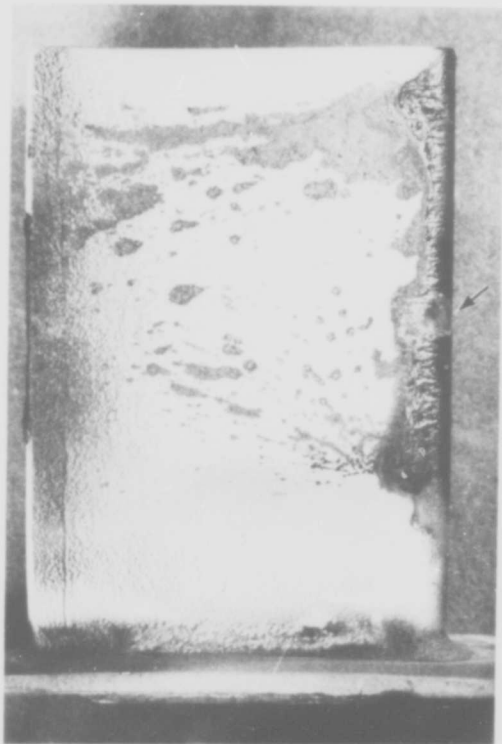
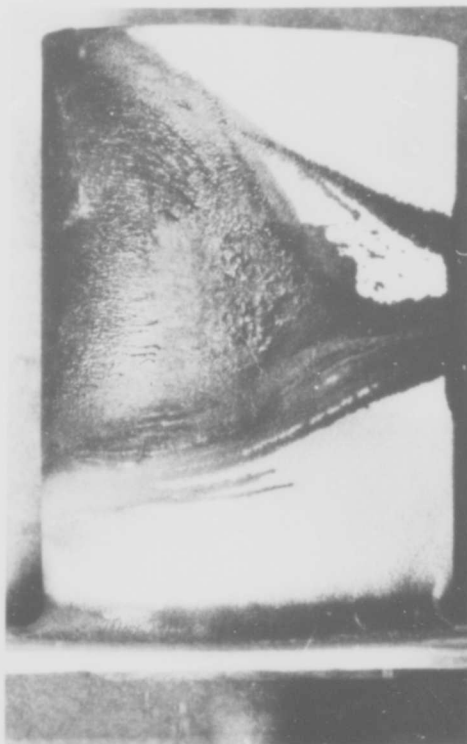
CONCAVE AIRFOIL SURFACE

CONVEX AIRFOIL SURFACE

Figure 106. Modified Sylvania SiCrTi Slurry Coated B-66 Alloy Vane Airfoil After Thermal Fatigue Testing for 600 Cycles to 2200°F Plus 400 Cycles to 2400°F Plus 300 Cycles to 2500°F

Arrow locates area of coating failure on leading edge.

To determine the rapidity of specimen deterioration after localized failure on the leading edge, one of the two test airfoils (Figure 106) was subjected to additional thermal fatigue cycles to 2200°F. After 300 additional cycles, oxidation produced only a pinhole through the leading edge (50-mil-thick sheet prior to coating) within the initial failure region (Figure 107). An additional 100 cycles to 2200°F led to continued penetration and enlargement of the oxidized region (Figure 108).

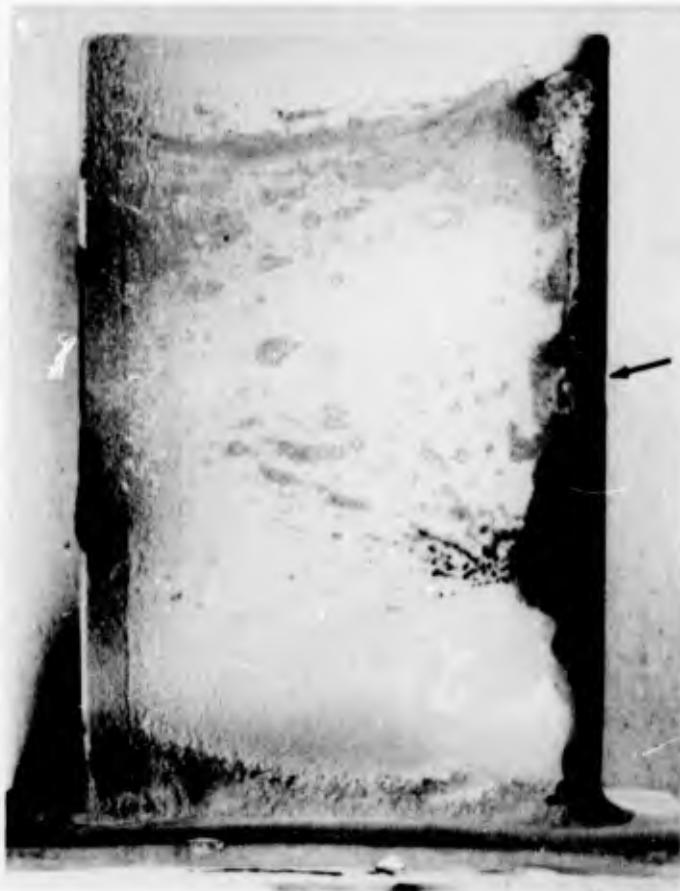
Figure 108. Concave Surface of Modified Sylvania SiCrTi Slurry Coated B-66 Alloy Vane Airfoil (Same Airfoil Shown in Figures 106 and 107) After 100 Additional Thermal Fatigue Cycles to 2200°F (Total Cycles in Order: 600 to 2200°F, 400 to 2400°F, 300 to 2500°F, and 400 to 2200°F)

Note oxidation through leading edge wall (arrow) 400 cycles after detection of initial coating failure.

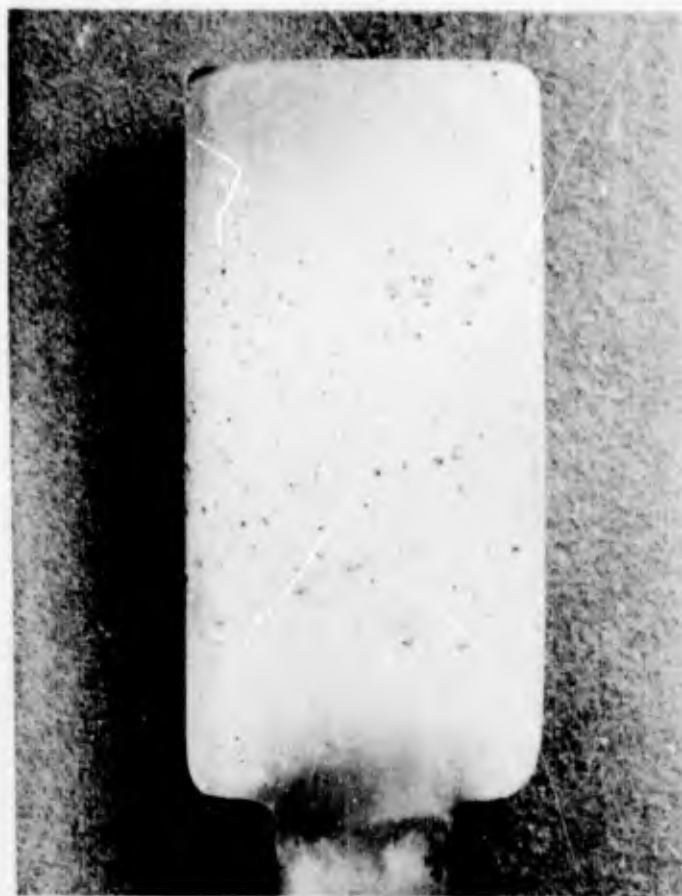
**Figure 109.** Convex Airfoil Surface of Modified TRW TiCr-Si (Vacuum) Pack Coated XB-88 Alloy Specimen Showing Spot Oxidation Failures After Thermal Fatigue Testing for 600 Cycles to 2200°F

Modified TRW TiCr-Si (Vacuum) Pack/XB-88. Thermal fatigue testing resulted in failure of the modified TRW TiCr-Si/XB-88 system after 400 and 600 cycles to 2200°F (two specimens). Localized (spot) oxidation occurred along random airfoil locations (Figure 109) with coating characteristics after failure similar to those observed after oxidation-erosion testing.

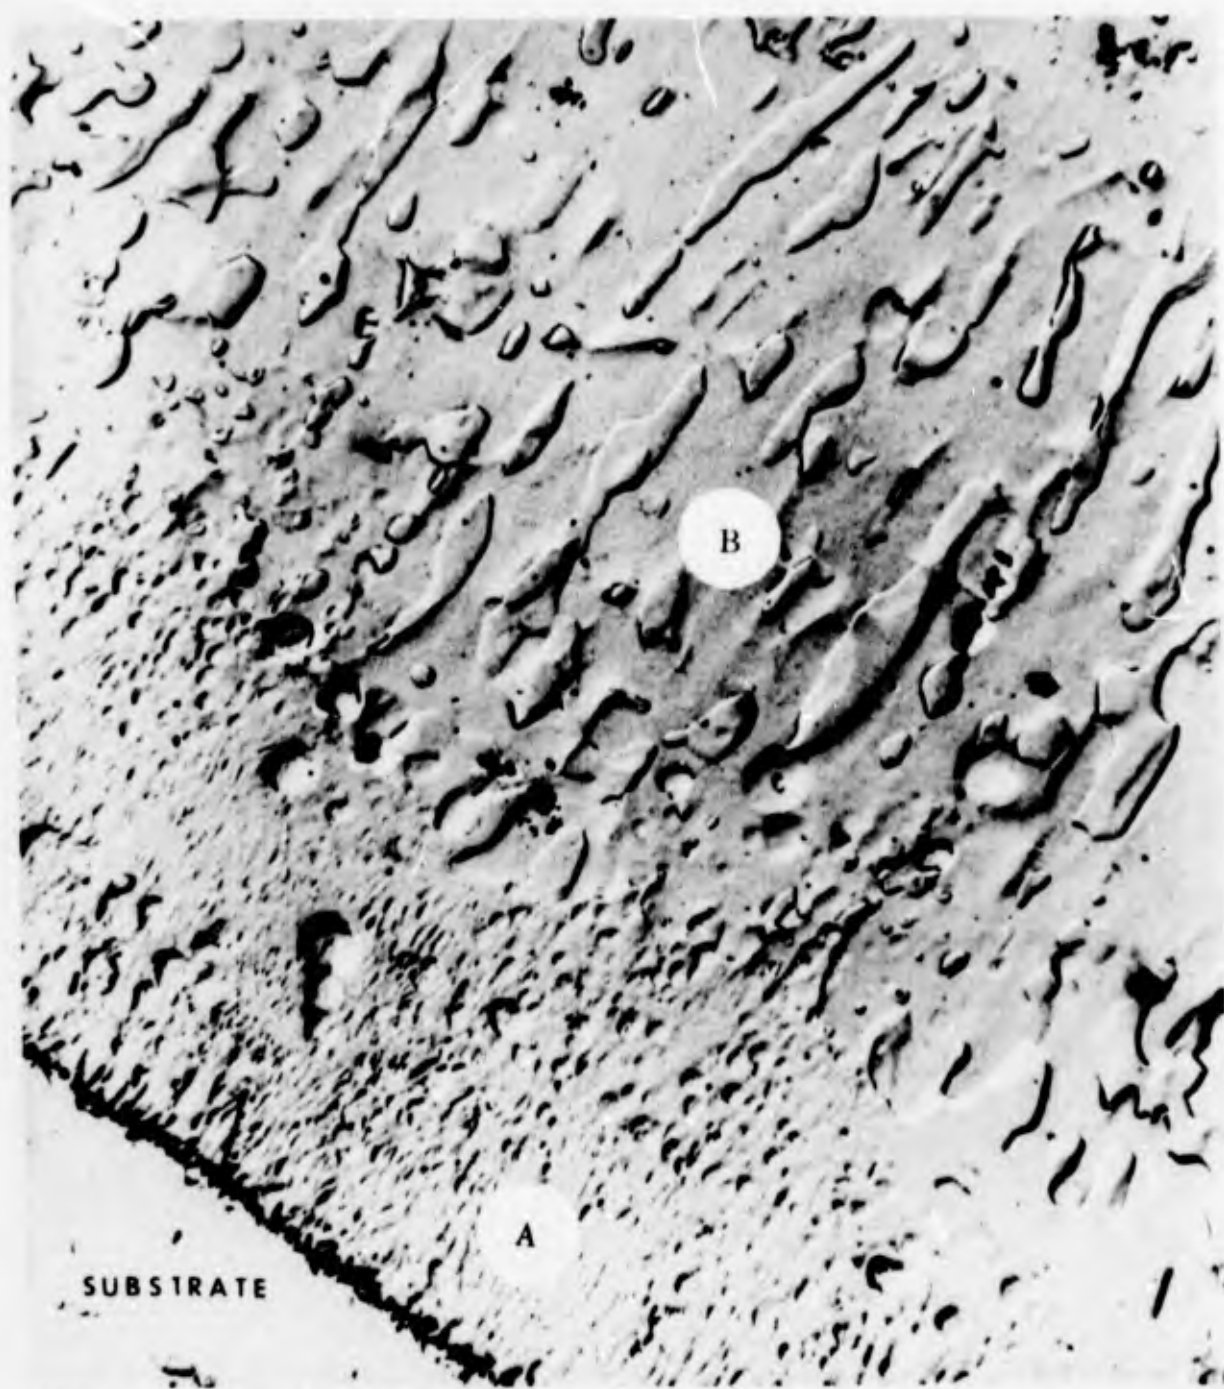
REPLICA: CHROMIUM-CARBON

Figure 121. Electron Micrograph of As-Applied Phase VII Sylvania SiCrTi Slurry Coating on XB-88 Alloy Showing Columnar Growth Within the Diffusion Zone (A) and Intermediate Coating Layer (B)

Three regions were observed metallographically in the 5.0-mil-thick coating (Figure 120). A 0.25-mil-thick continuous layer exhibiting columnar-type phase growth (Figure 121) was present at the coating-substrate interface. Above this diffusion zone, a 1.0-mil-thick continuous intermediate region, also exhibiting columnar-type phase growth, was denuded of second-phase material. The outer coating region of 3.5 to 3.75 mils in thickness contained second-phase particles in an equiaxed, continuous matrix. Concentration of the particles increased from the coating surface through the outer region to the intermediate coating layer.

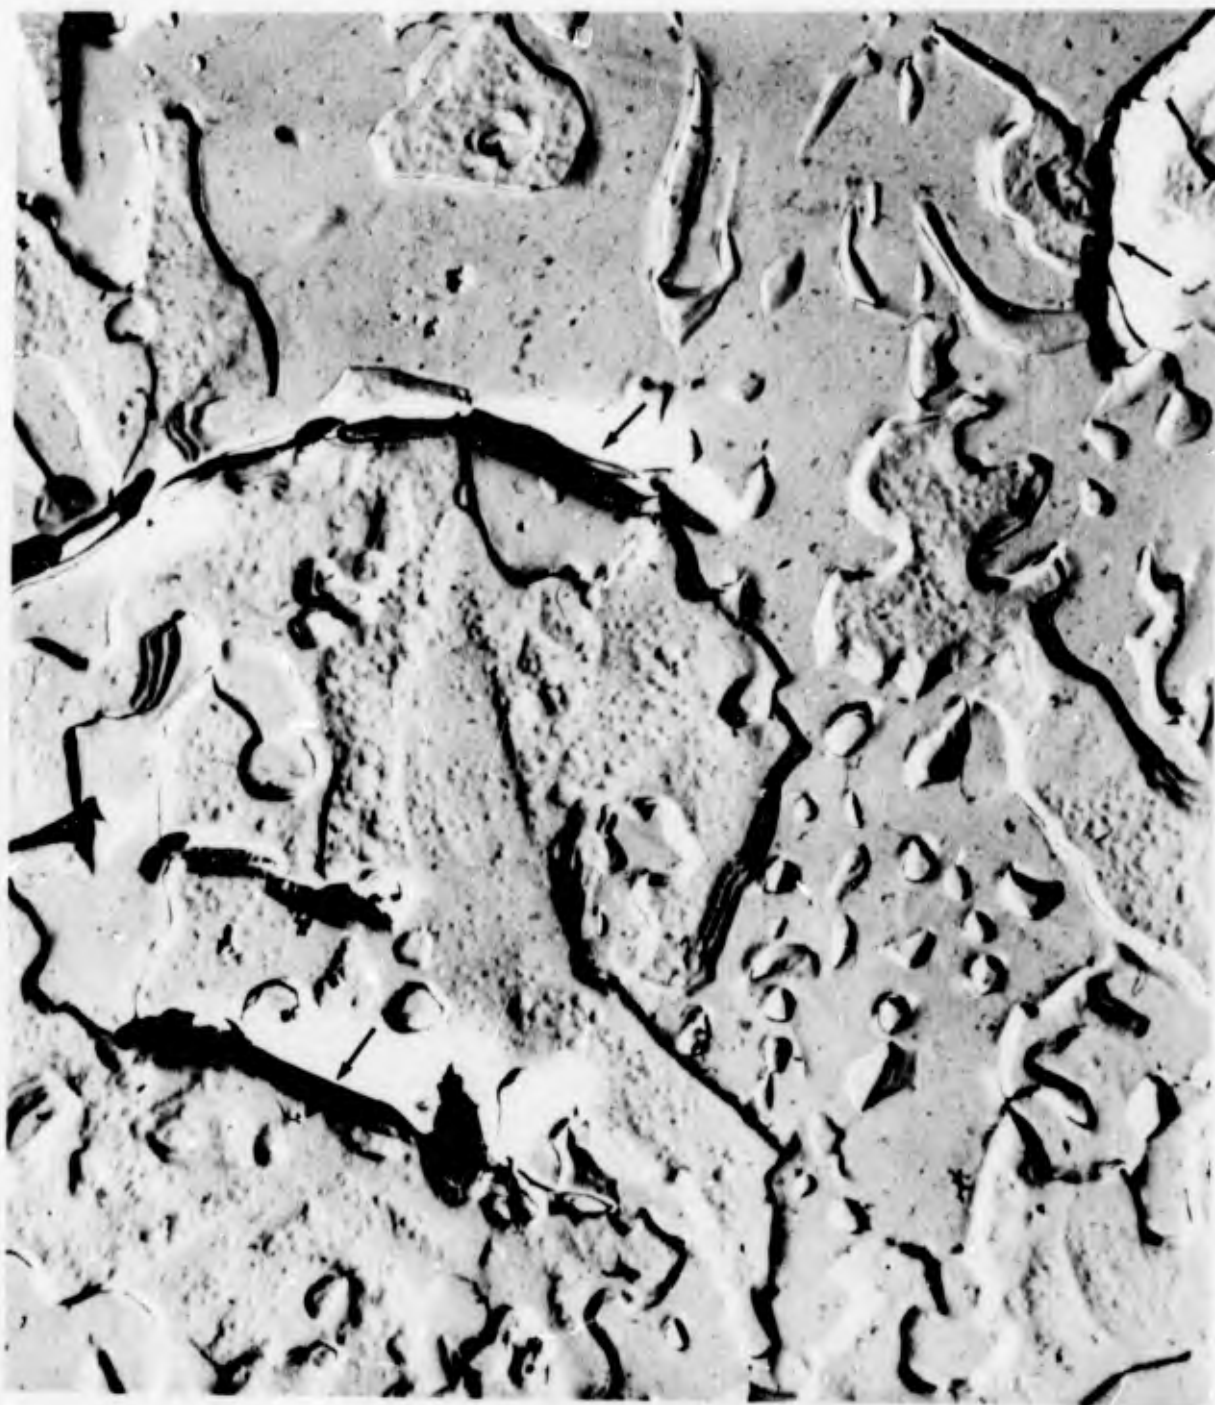
Figure 123. Electron Micrograph of As-Applied Phase VII Sylvania SiCrTi Slurry Coating on XB-88 Alloy Showing Lateral Microcracks (Arrows) and the Absence of Diffusion Surrounding Precipitated Particles in the Outer Coating Region

- Radial cracks: These separations were quite extensive and in some cases extended from the surface to the coating-substrate interface (Figure 122).
- Lateral cracks: Separations propagating parallel to the coating-substrate interface were of short length and appeared to be confined to the outer coating region (Figure 123).

A third dissimilarity was the absence of distinct diffusion envelopes encompassing the second-phase particles in the outer coating region (Figure 123). These envelopes, believed to be transition regions between silicide compounds, were observed in the SiCrTi coating on B-66 alloy (see Figure 118).

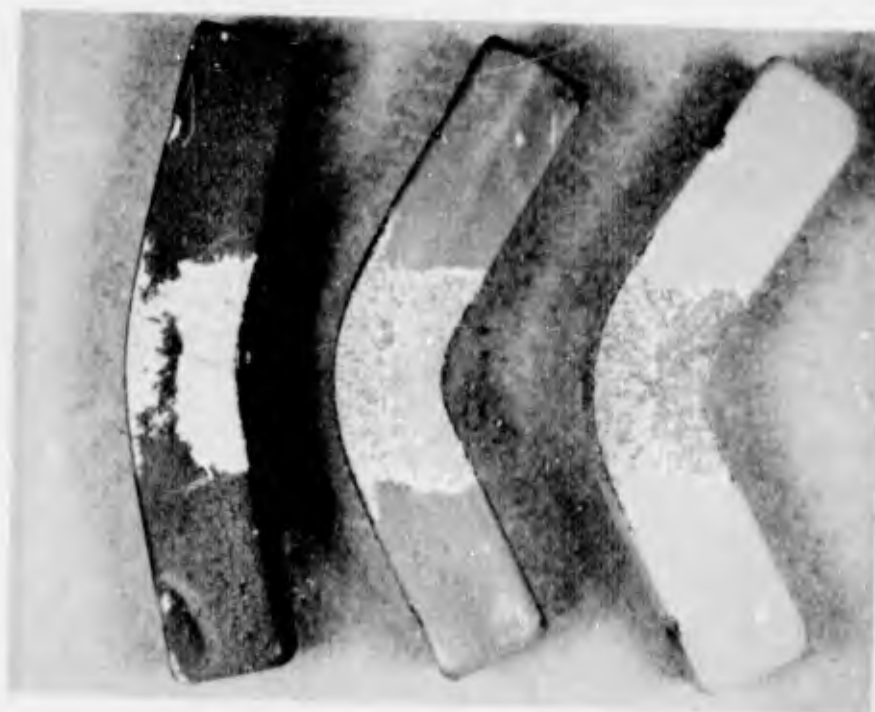
Figure 143. Appearance of Phase VII Sylvania SiCrTi Slurry Coated XB-88 Alloy After Charpy Impact Testing at 1400°F, 60 Ft-Lb (Left); 1700°F, 120 Ft-Lb (Center); and 2000°F, 120 Ft-Lb (Right)

Smooth Charpy impact testing of Sylvania SiCrTi coated XB-88 columbium alloy was performed in air at 70°, 1400°, 1700°, and 2000°F. Two uncoated specimens were also impacted at 70°F. Impact test results (Table XVII) indicate a ductile-brittle transition between 70°F and 1400°F. Very good toughness was indicated at 1400°, 1700°, and 2000°F; no failures were noted (Figure 143).

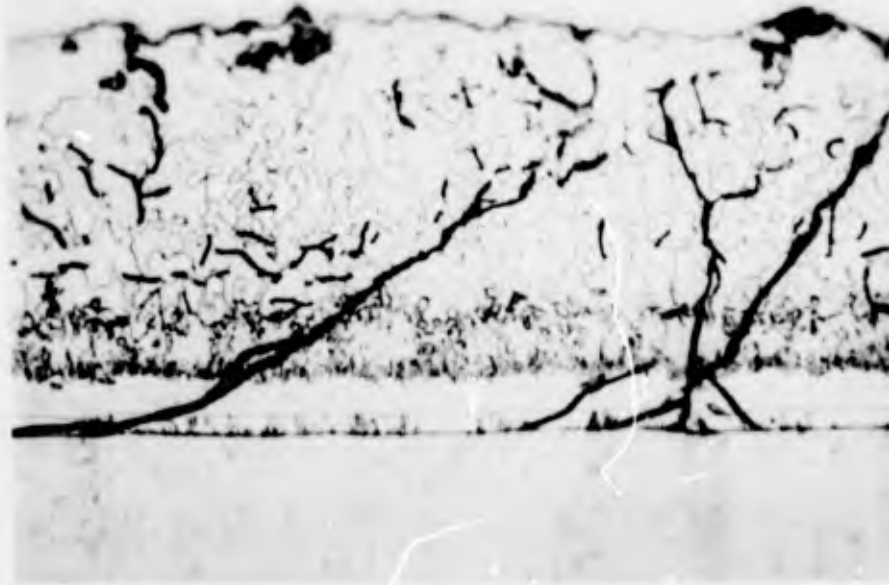
**Figure 144. Typical Microstructure of As-Applied Sylvania SiCrFe Slurry Coating on XB-88 Alloy**

The Sylvania SiCrFe coating was applied to XB-88 alloy using a Si-20Cr-20Fe-mixture vehicle slurry and heat treating for 1 hour at 2550°F. Excellent coverage of specimen corners and edges was obtained. Five distinct regions were noted during metallographic examination of the 4.2-mil-thick coating (Figure 144). Above a continuous 0.2-mil-thick region at the coating-substrate interface, a continuous dark-colored 0.2-mil-thick region extended into a 0.3-mil third coating layer of dendritic appearance. Above this third layer, a 1.3-mil fourth layer appeared continuous and homogeneous. The two-phased outer coating region was 2.2 mils thick.

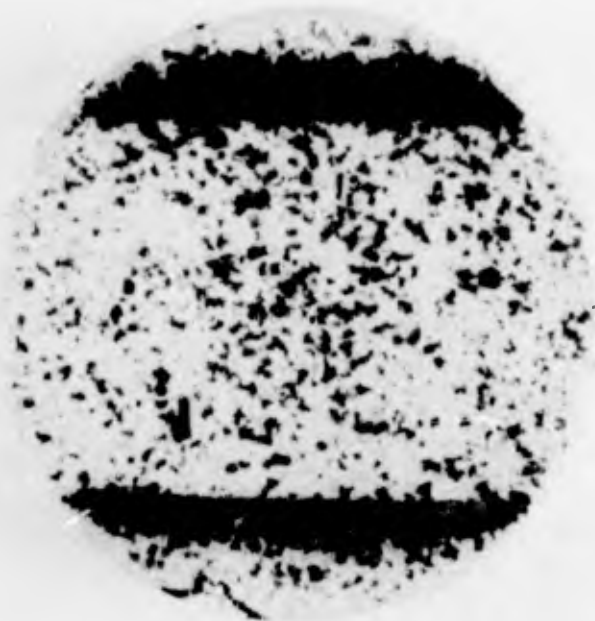
Figure 150. Sylvania SiCrFe Slurry Coated XB-88 Alloy Specimen Showing Edge Failure After 24-Hour Postcyclic Exposure at 1600°F

Although there was an edge failure after 24 hours of test at 1600°F on one of the SiCrFe coated specimens (Figure 150), this system performed well, with the remaining nine specimens all surviving the test period. The TiAl coated specimens did not perform satisfactorily, with failure occurring at 24, 48, and 96 hours and only one of the ten specimens surviving the test period. Figures 151 and 152 illustrate failures of the TiAl coating at 1400° and 1600°F exposure, respectively.

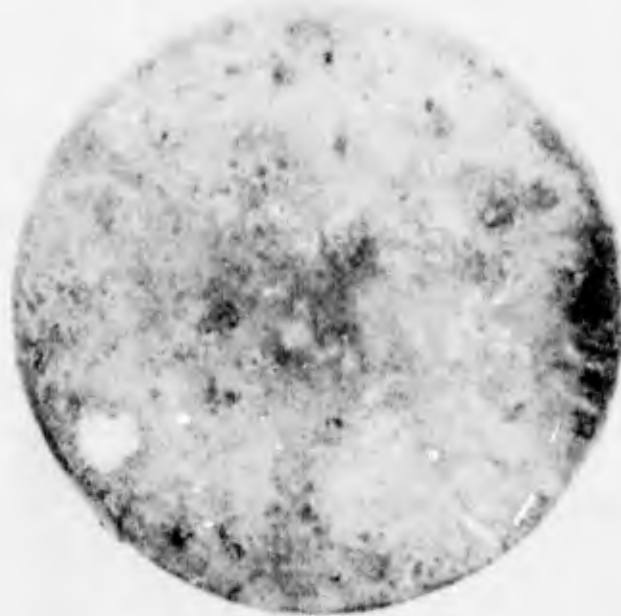
Figure 151. TRW TiAl (Vacuum) Pack Coated XB-88 Alloy Specimens Showing Edge and Surface Failures After Postcyclic Exposure at 1400°F

The specimen at top failed after 168 hours exposure; the specimen at bottom failed after 96 hours exposure.

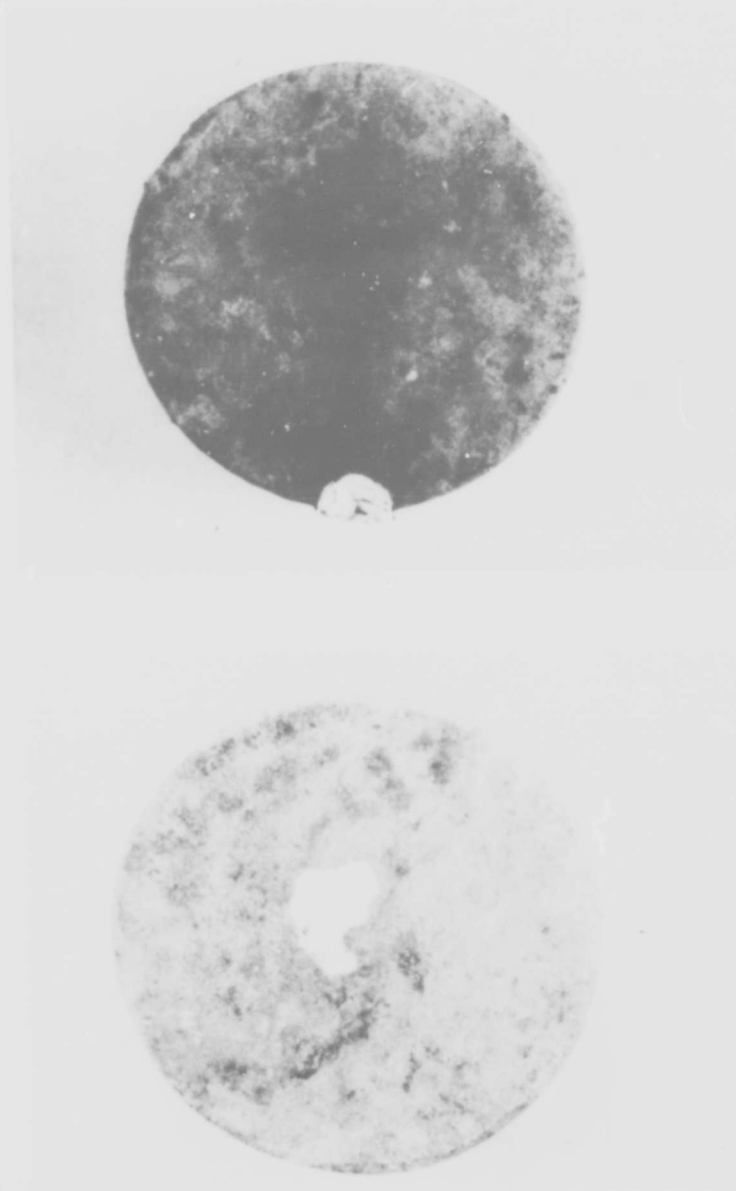
Figure 152. TRW TiAl (Vacuum) Pack Coated XB-88 Alloy Specimens Showing Typical Edge and Surface Failures After Postcyclic Exposure at 1600°F

The specimen at top failed after 168 hours exposure; the specimen at bottom failed after 48 hours exposure.
