United States Air Force
611th Air Support Group/
Civil Engineering Squadron

Remedial Investigation and Feasibility Study

Barter Island Radar Installation, Alaska

05 JANUARY 1996

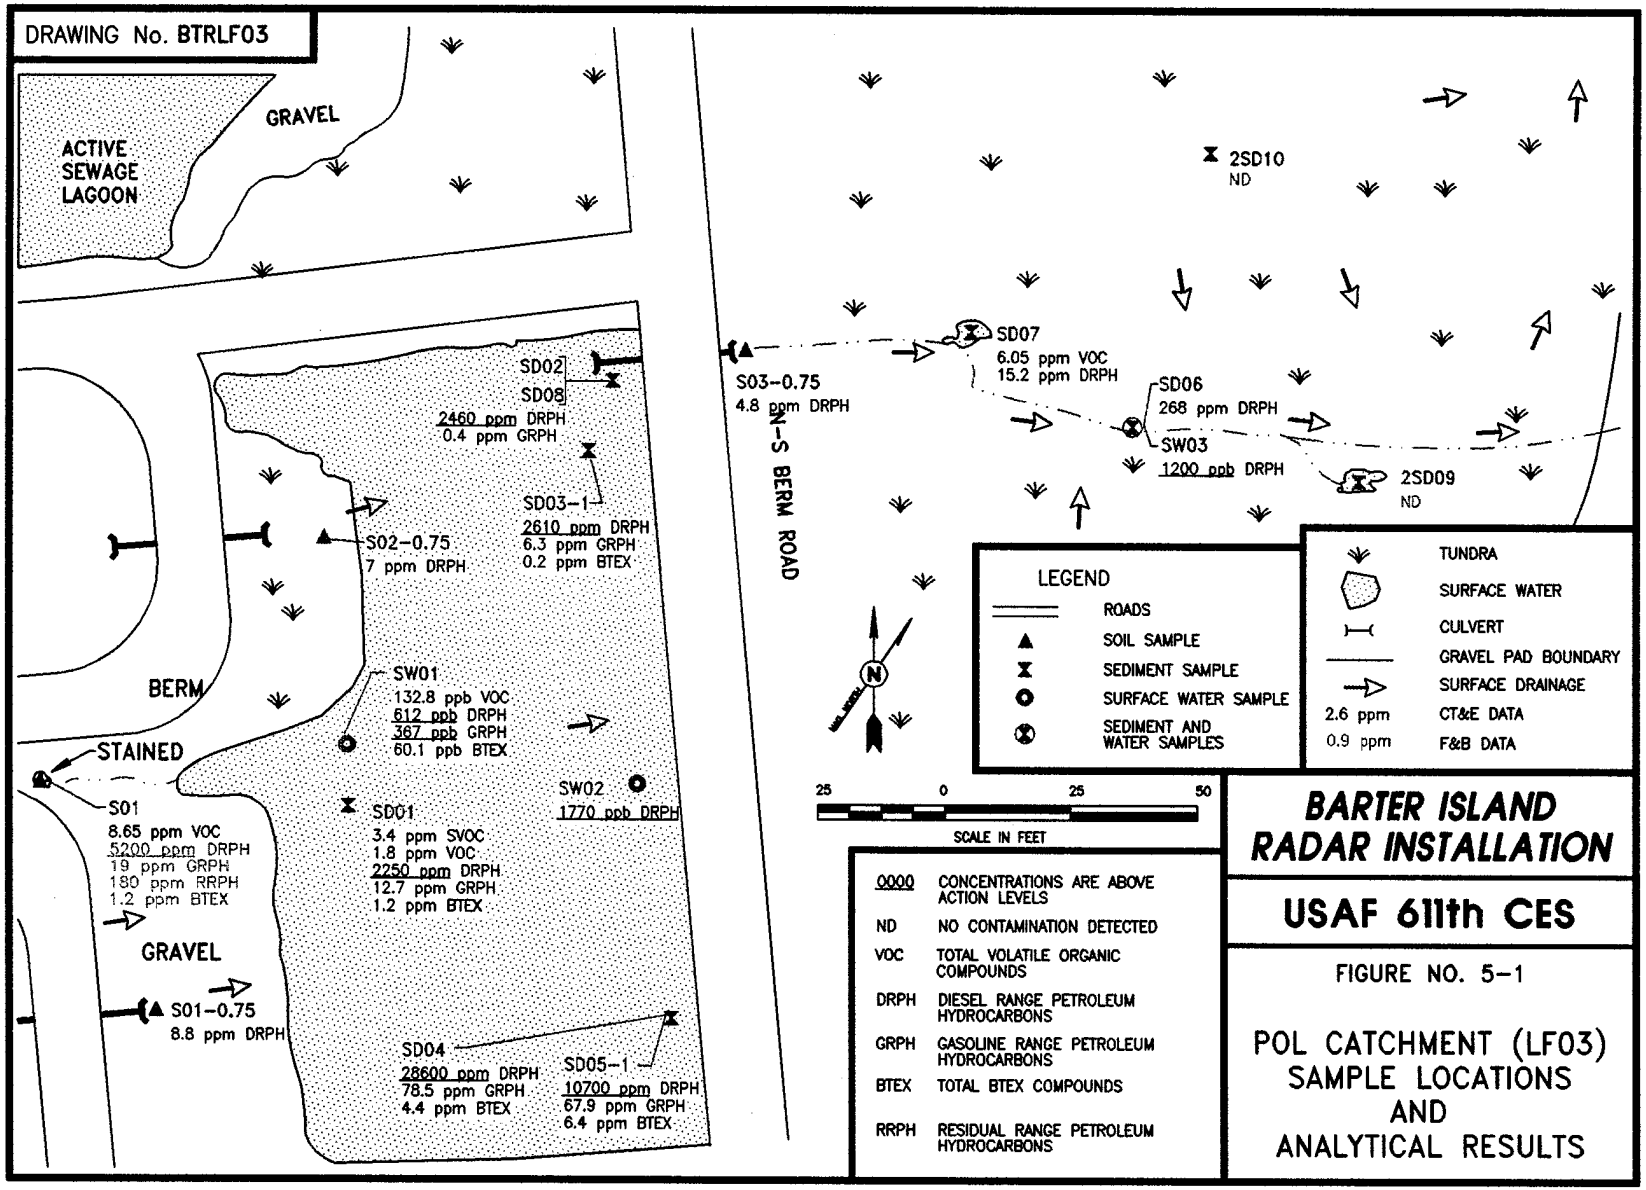
Levels of petroleum compounds (primarily diesel) detected at the site significantly exceed ADEC guidance cleanup levels, and migration of contaminants has occurred. Therefore, the site is recommended for remedial action. The contaminated area at the site consists of 5 cubic yards of gravel and 2,500 cubic yards of tundra. Passive bioremediation is the recommended alternative for remediation of both the gravel and tundra areas of the site.

DRAWING No. BTRLF03
ACTIVE SEWAGE LAGOON
GRAVEL
BERM
STAINED
GRAVEL
N-S BERM ROAD
S01
8.65 ppm VOC
5200 ppm DRPH
19 ppm GRPH
180 ppm RRPH
1.2 ppm BTEX
S01-0.75
8.8 ppm DRPH
S02-0.75
7 ppm DRPH
SD02
SD08
2460 ppm DRPH

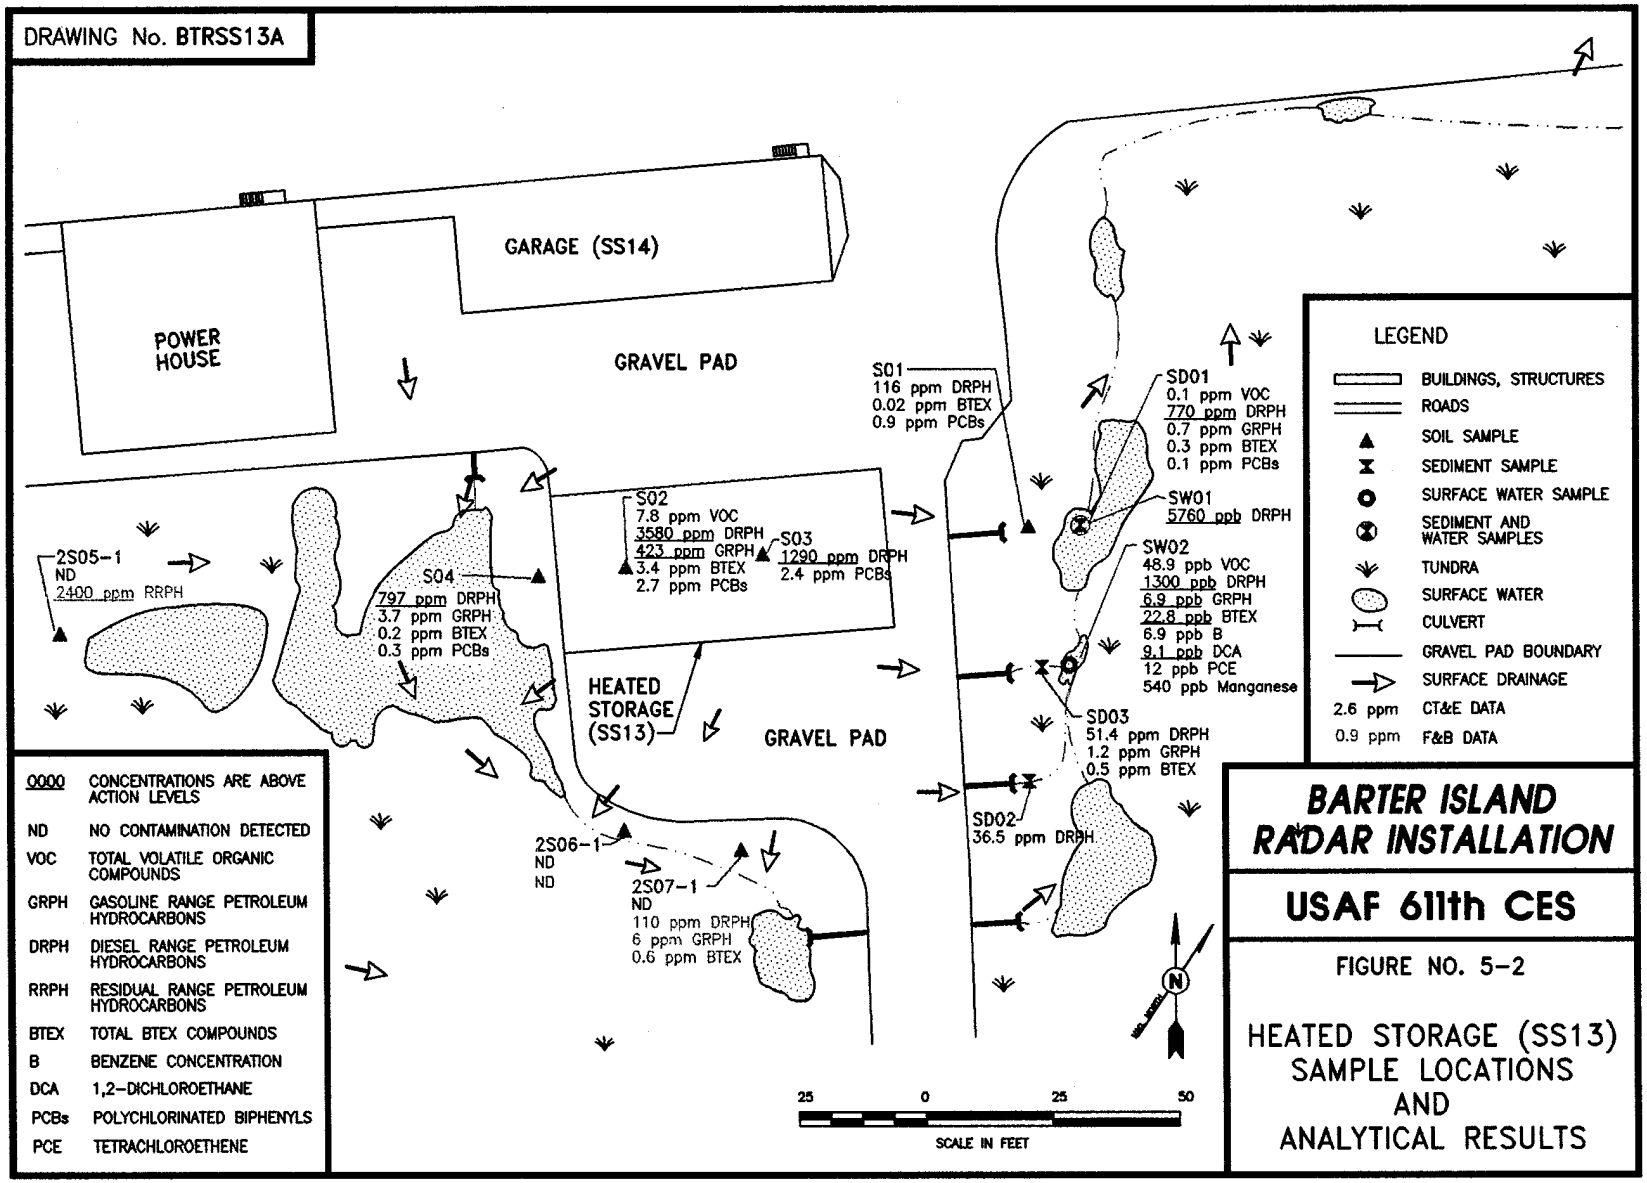
Levels of petroleum compounds (primarily diesel and gasoline) detected in soil/sediment at the site significantly exceed ADEC guidance cleanup levels. In addition, contaminants have migrated downgradient of the site and have impacted soil/sediment and surface water. Therefore, the site is being recommended for remedial action. The contaminated areas at the site include 110 cubic yards of soil beneath the building, 50 cubic yards of gravel, and 232 cubic yards of tundra. The remedial action alternative recommended for beneath the building is in situ biosurfactants, for gravel areas, and for tundra, passive bioremediation is the recommended alternative. A complete description and evaluation of the remedial alternatives recommended for this site are presented in the Feasibility Study, Section 6.0.

DRAWING No. BTRSS13A
GARAGE (SS14)
POWER HOUSE
GRAVEL PAD
S01
116 ppm DRPH
0.02 ppm BTEX
0.9 ppm PCBs
SD01
0.1 ppm VOC
770 ppm DRPH
0.7 ppm GRPH
0.3 ppm BTEX
0.1 ppm PCBs
SW01
5760 ppb DRPH
SW02

48.9 ppb VOC
1300 ppb DRPH
6.9 ppb GRPH
22.8 ppb BTEX
6.9 ppb B
9.1 ppb DCA
12 ppb PCE
540 ppb Manganese
SD03
51.4 ppm DRPH
1.2 ppm GRPH
0.5 ppm BTEX
SD02
36.5 ppm DRPH
S02

2.6 ppm CT&E DATA
0.9 ppm F&B DATA
0000 CONCENTRATIONS ARE ABOVE ACTION LEVELS
ND NO CONTAMINATION DETECTED
VOC TOTAL VOLATILE ORGANIC COMPOUNDS
GRPH GASOLINE RANGE PETROLEUM HYDROCARBONS
DRPH DIESEL RANGE PETROLEUM HYDROCARBONS
RRPH RESIDUAL RANGE PETROLEUM HYDROCARBONS
BTEX TOTAL BTEX COMPOUNDS
B BENZENE CONCENTRATION
DCA 1,2-DICHLOROETHANE
PCBs POLYCHLORINATED BIPHENYLS
PCE TETRACHLOROETHENE
25 0 25 50
SCALE IN FEET
N
BARTER ISLAND RADAR INSTALLATION
USAF 611th CES
FIGURE NO. 5-2
HEATED STORAGE (SS13) SAMPLE LOCATIONS AND ANALYTICAL RESULTS

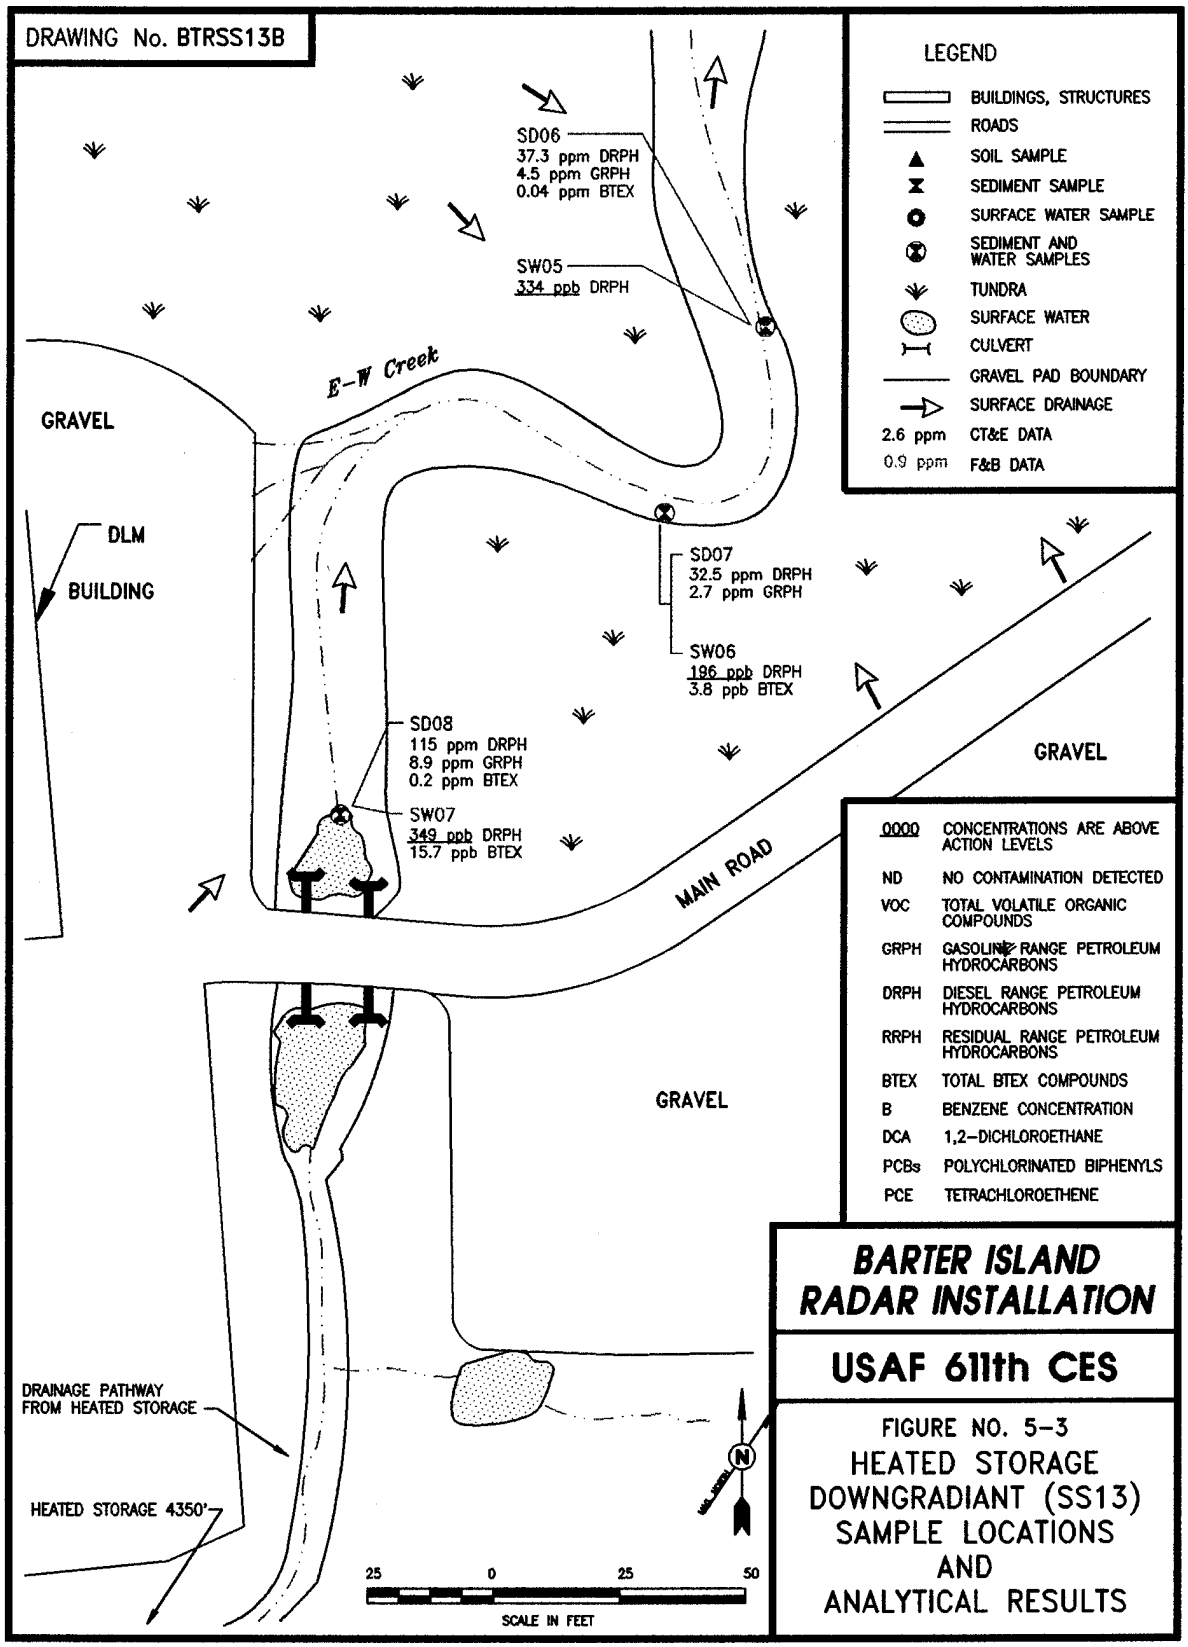
DRAWING No. BTRSS13B
SD06
37.3 ppm DRPH
4.5 ppm GRPH
0.04 ppm BTEX
SW05
334 ppb DRPH
E-W Creek
GRAVEL
DLM
BUILDING
SD07
32.5 ppm DRPH
2.7 ppm GRPH
SW06
196 ppb DRPH

3.8 ppb BTEX
SD08
115 ppm DRPH
8.9 ppm GRPH
0.2 ppm BTEX
SW07
349 ppb DRPH
15.7 ppb BTEX
MAIN ROAD
GRAVEL
GRAVEL
DRAINAGE PATHWAY
FROM HEATED STORAGE
HEATED STORAGE 4350'
25 0 25 50
SCALE IN FEET
LEGEND
BUILDINGS, STRUCTURES
ROADS
SOIL SAMPLE
SEDIMENT SAMPLE
SURFACE WATER SAMPLE
SEDIMENT AND WATER SAMPLES
TUNDRA
SURFACE WATER
CULVERT
GRAVEL PAD BOUNDARY
SURFACE DRAINAGE

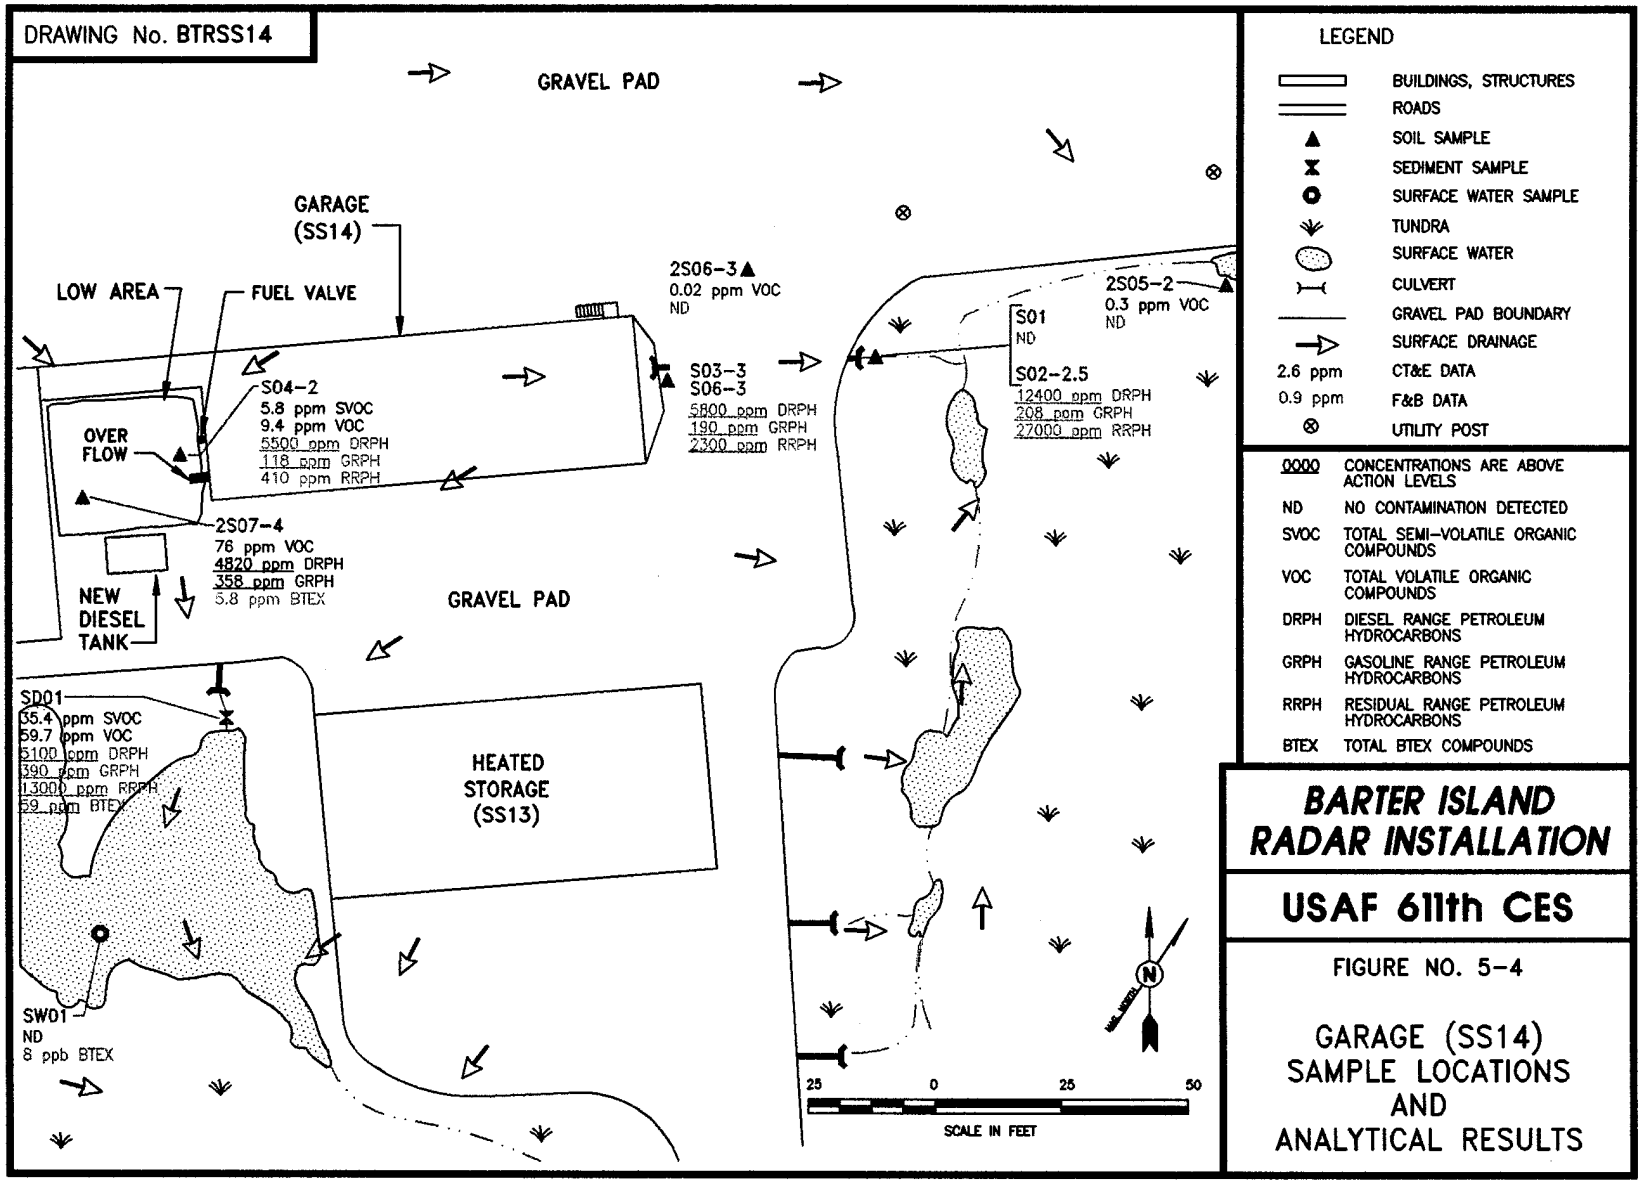
Levels of petroleum compounds (primarily diesel and gasoline) detected in soil/sediment at the site exceed ADEC guidance cleanup levels. In addition, site contaminants have migrated downgradient of the site, have impacted gravel areas, and are likely to have contributed to the contaminated tundra areas associated with the Heated Storage (SS13) site. Therefore, the site is being recommended for remedial action. The contaminated areas at the site include 110 cubic yards of soil beneath the building and 150 cubic yards of adjoining gravel. The remedial action alternative recommended for soil beneath the building is in situ biosurfactants. For gravel areas, the recommended remedial alternative is passive bioremediation. A complete description and evaluation of the remedial alternatives considered for this site are presented in the Feasibility Study, Section 6.0.

DRAWING No. BTRSS14
GRAVEL PAD
GARAGE (SS14)
LOW AREA
FUEL VALVE
OVER FLOW
S04-2
5.8 ppm SVOC
9.4 ppm VOC
5500 ppm DRPH
118 ppm GRPH
410 ppm RRPH
2S06-3
0.02 ppm VOC
ND
S03-3
S06-3
5800 ppm DRPH
190 ppm GRPH
2300 ppm RRPH
2S05-2

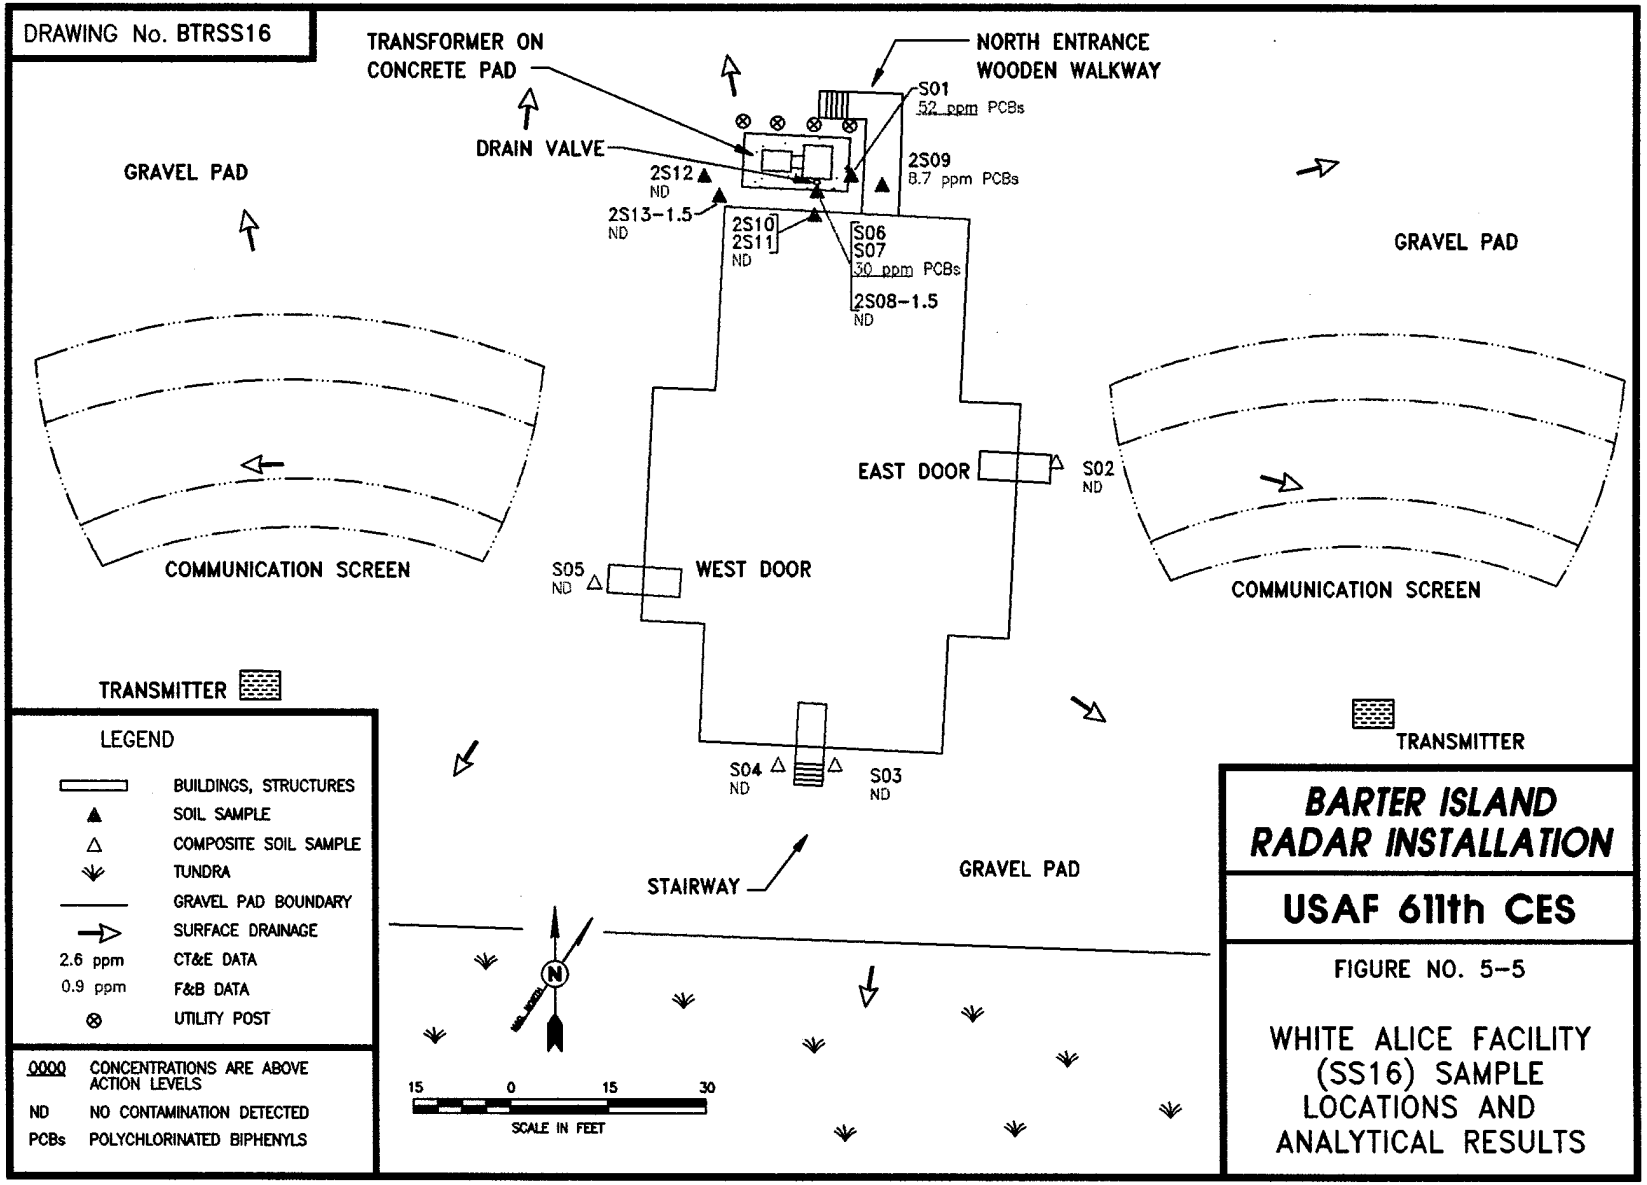
Levels of PCBs detected in gravel at the site exceed regulatory cleanup levels and can potentially bioaccumulate in the environment. Therefore, the site is being recommended for remedial action. The contaminated area at the site consists of approximately two cubic yards of gravel. The remedial action alternative recommended for the site is excavation and offsite incineration. A complete description and evaluation of the remedial alternatives considered for this site are presented in the Feasibility Study, Section 6.0.

DRAWING No. BTRSS16
TRANSFORMER ON CONCRETE PAD
NORTH ENTRANCE WOODEN WALKWAY
DRAIN VALVE
S01
52 ppm PCBs
2S09
8.7 ppm PCBs
2S12
ND
2S13-1.5
ND
2S10
2S11
ND
S06
S07
30 ppm PCBs
2S08-1.5
ND
GRAVEL PAD
GRAVEL PAD
EAST DOOR
S02
ND
COMMUNICATION SCREEN
S05
ND
WEST DOOR
COMMUNICATION SCREEN
TRANSMITTER
TRANSMITTER
S04
ND
S03
ND
STAIRWAY
GRAVEL PAD
LEGEND
BUILDINGS, STRUCTURES
SOIL SAMPLE
COMPOSITE SOIL SAMPLE
TUNDRA
GRAVEL PAD BOUNDARY
SURFACE DRAINAGE
2.6 ppm CT&E DATA
0.9 ppm F&B DATA
UTILITY POST
0000 CONCENTRATIONS ARE ABOVE ACTION LEVELS
ND NO CONTAMINATION DETECTED
PCBs POLYCHLORINATED BIPHENYLS
15 0 15 30
SCALE IN FEET
BARTER ISLAND RADAR INSTALLATION
USAF 611th CES
FIGURE NO. 5-5
WHITE ALICE FACILITY (SS16) SAMPLE LOCATIONS AND ANALYTICAL RESULTS

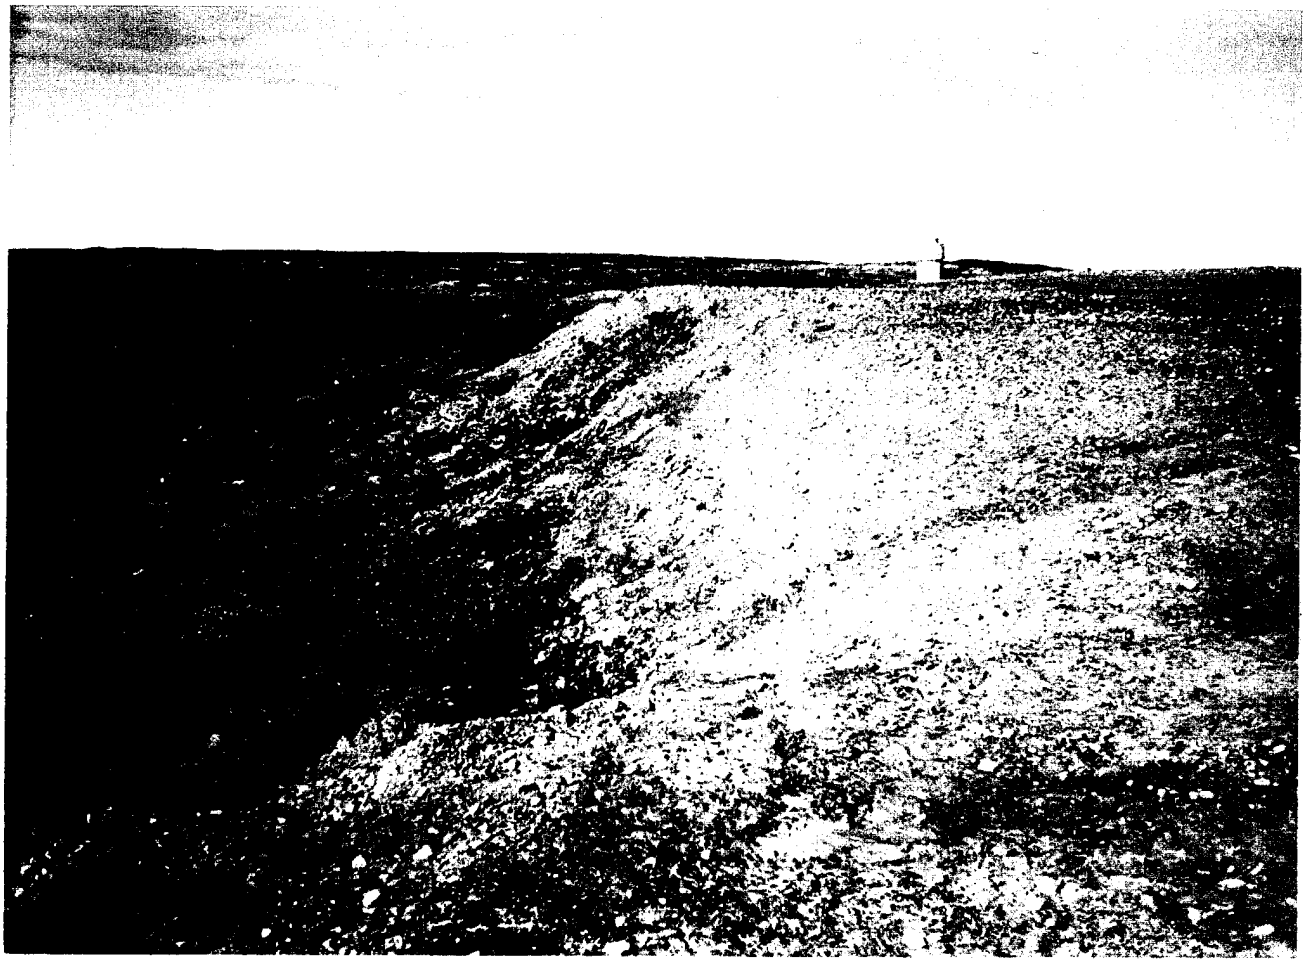
View to the north of the west side of the Old Landfill (LF01) site. This area was regraded and recompacted in 1993. An incised stream runs along the western boundary of the site.

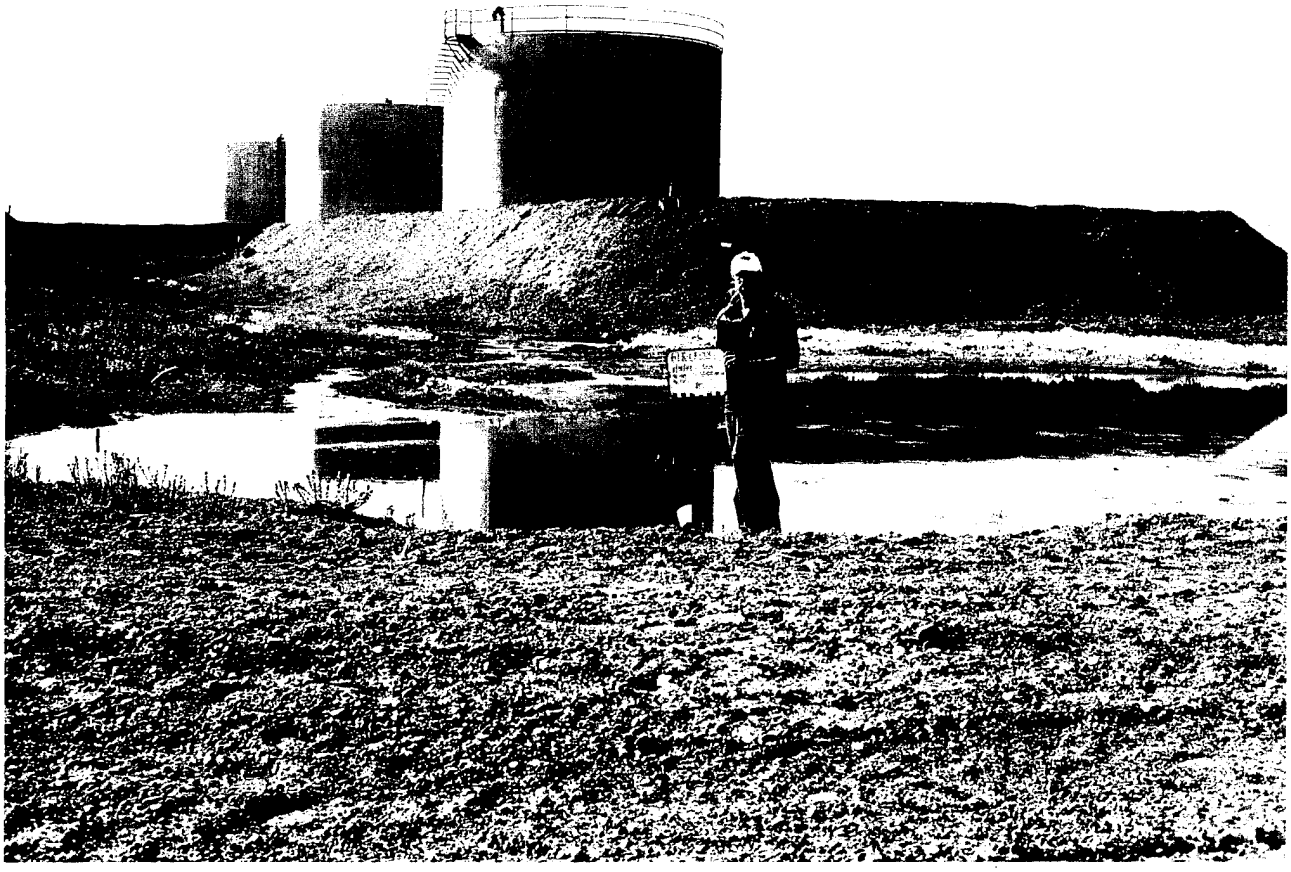
The POL Catchment (LF03) site is a tundra area surrounded by a berm. This is a view to the west from the east berm looking towards the POL Tanks (ST17) site. Note: vegetation (Alaska cottongrass) in catchment basin area not covered with water.

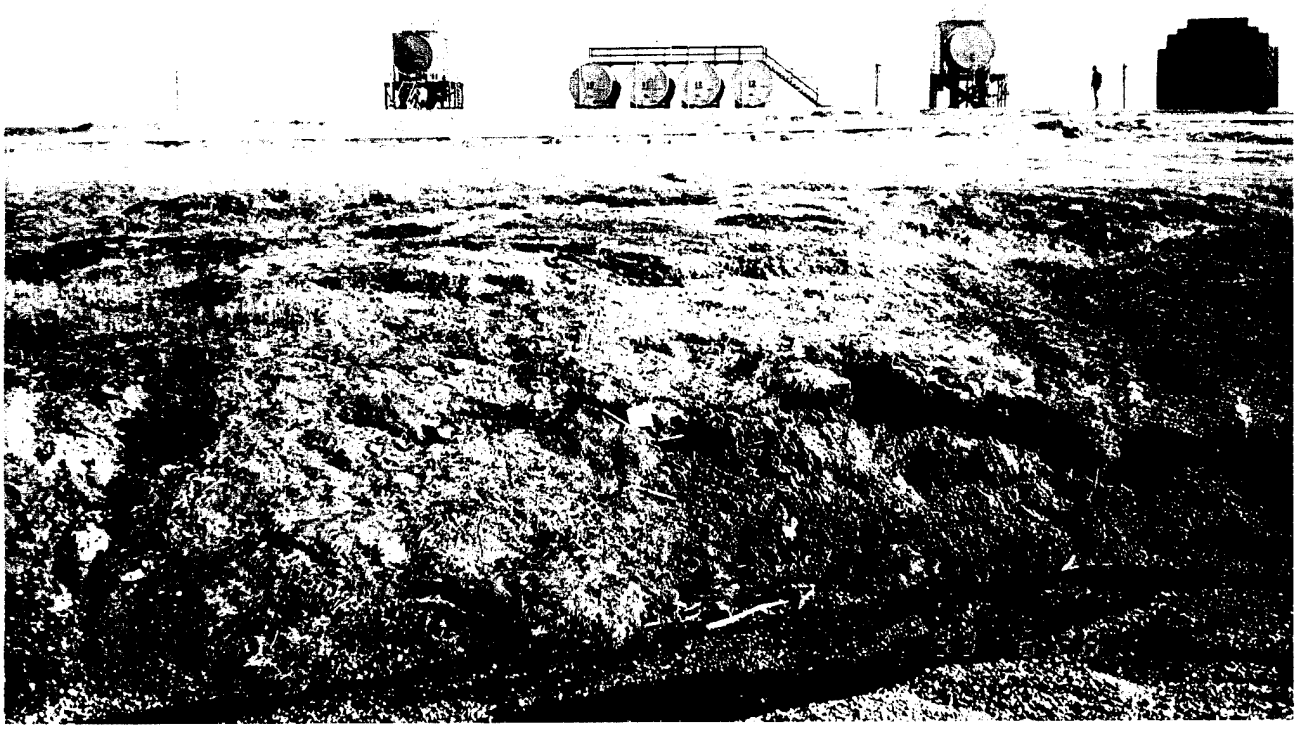
A view to the south of the Contaminated Ditch (SD08) site. The Fuel Tanks (ST18) site is shown in the background.

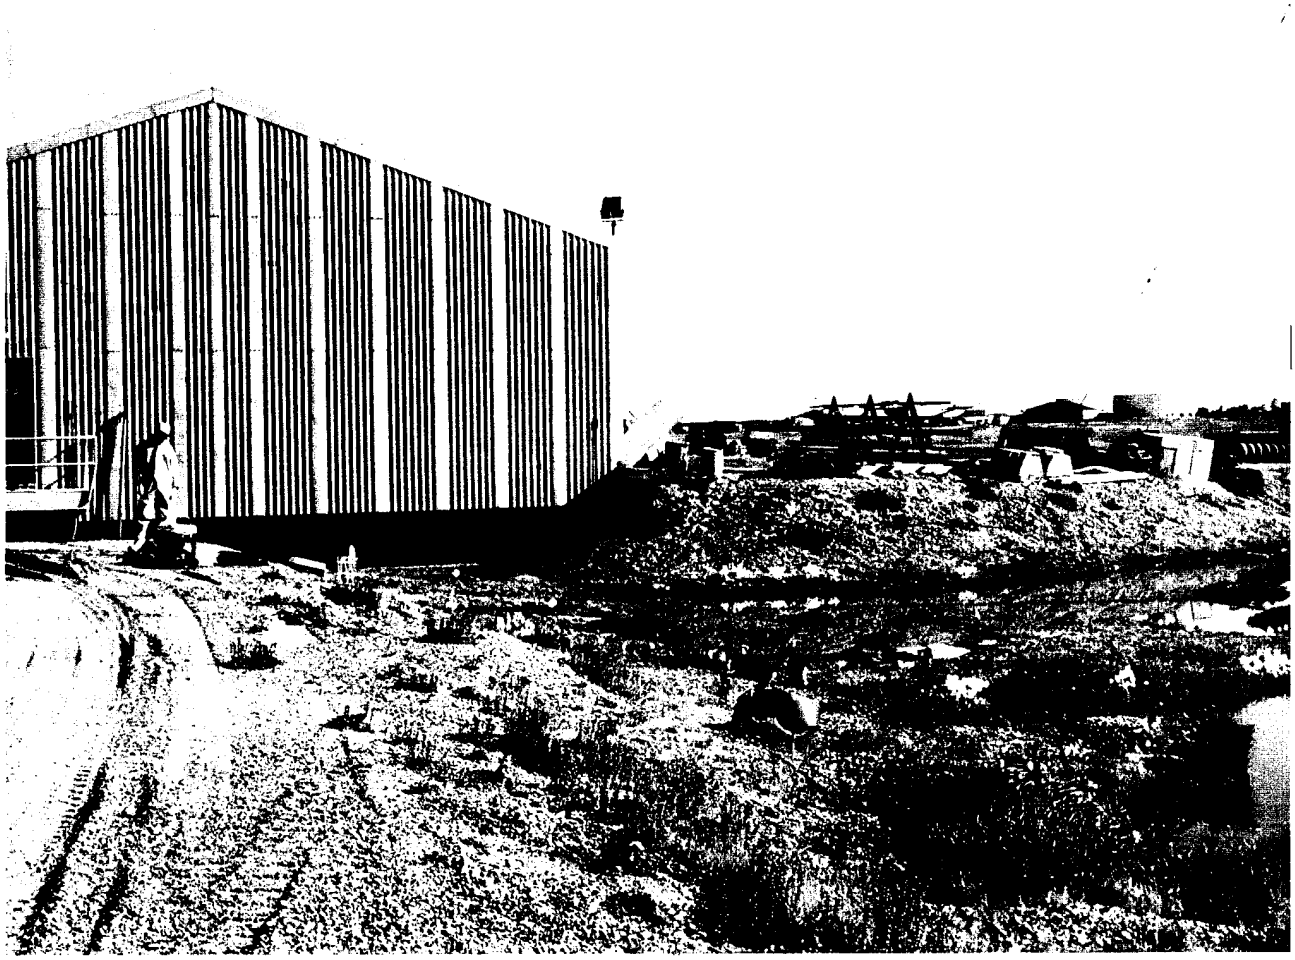
A view to the south of the Weather Station Building (SS15) site. The 1,200-gallon diesel fuel tank adjacent to the building appears to be the source of contamination at this site.

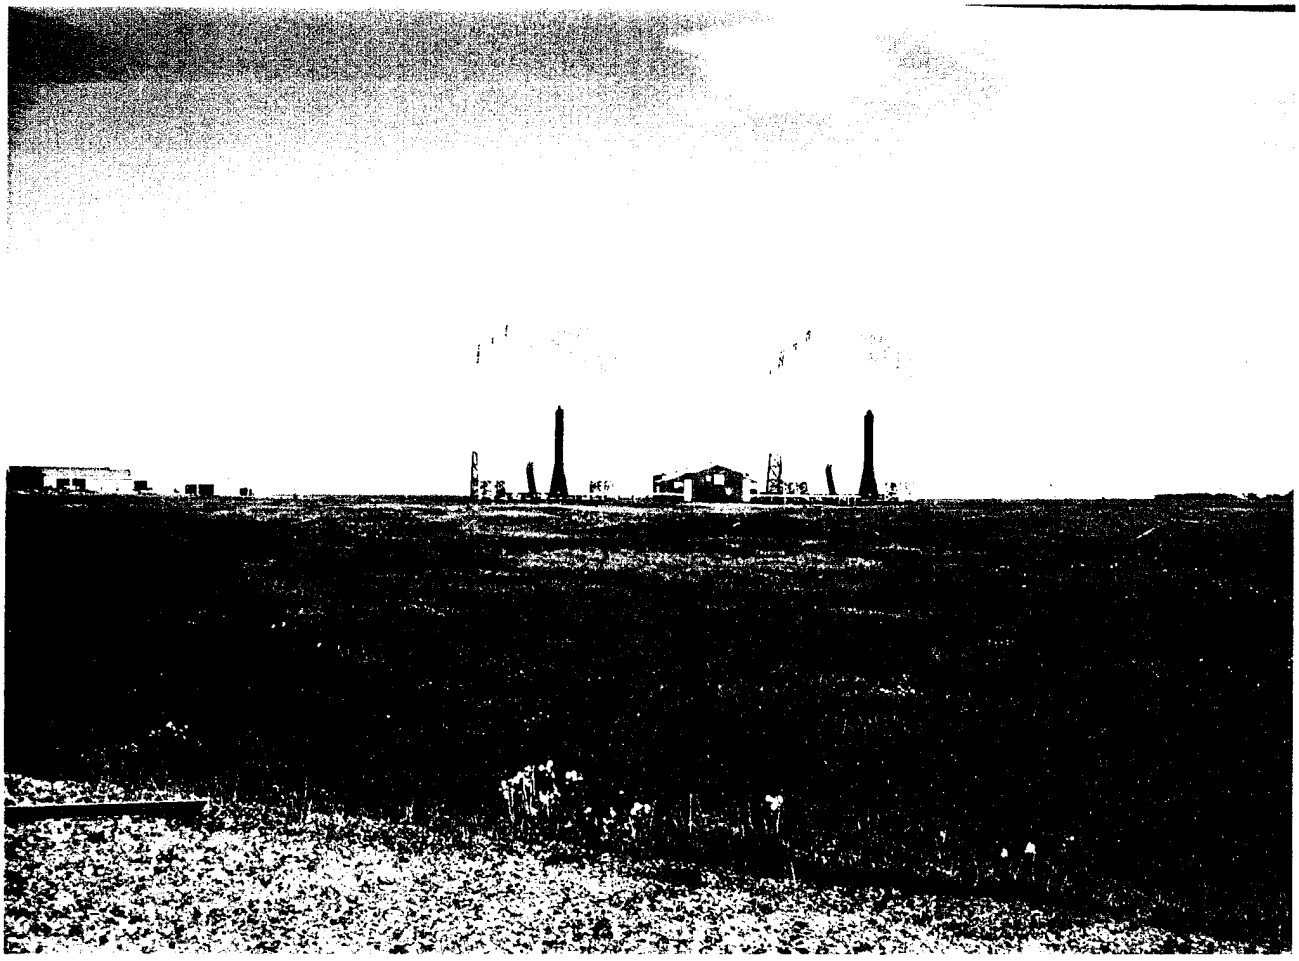
View to the north of the White Alice Facility (SS16) site.

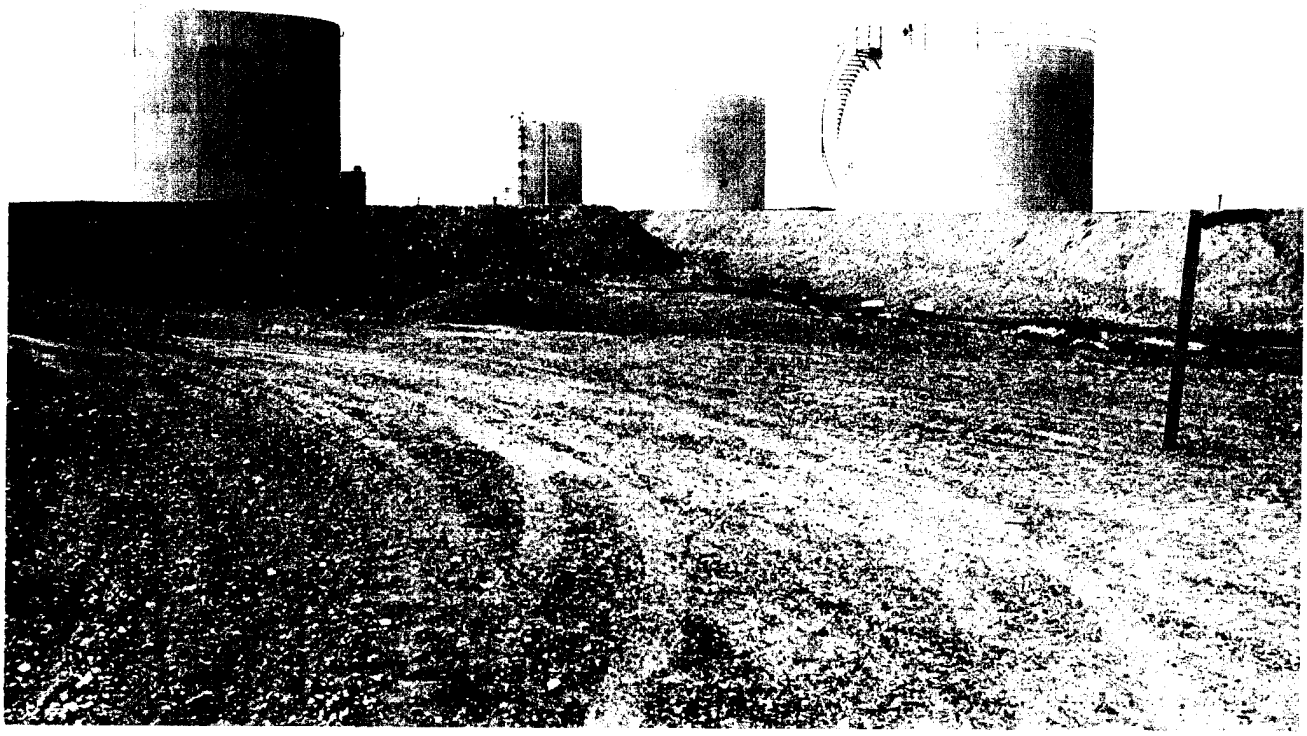
The POL Tanks (ST17) site. This is a view towards the northwest from the gravel pad from the southeast of the POL Tanks.

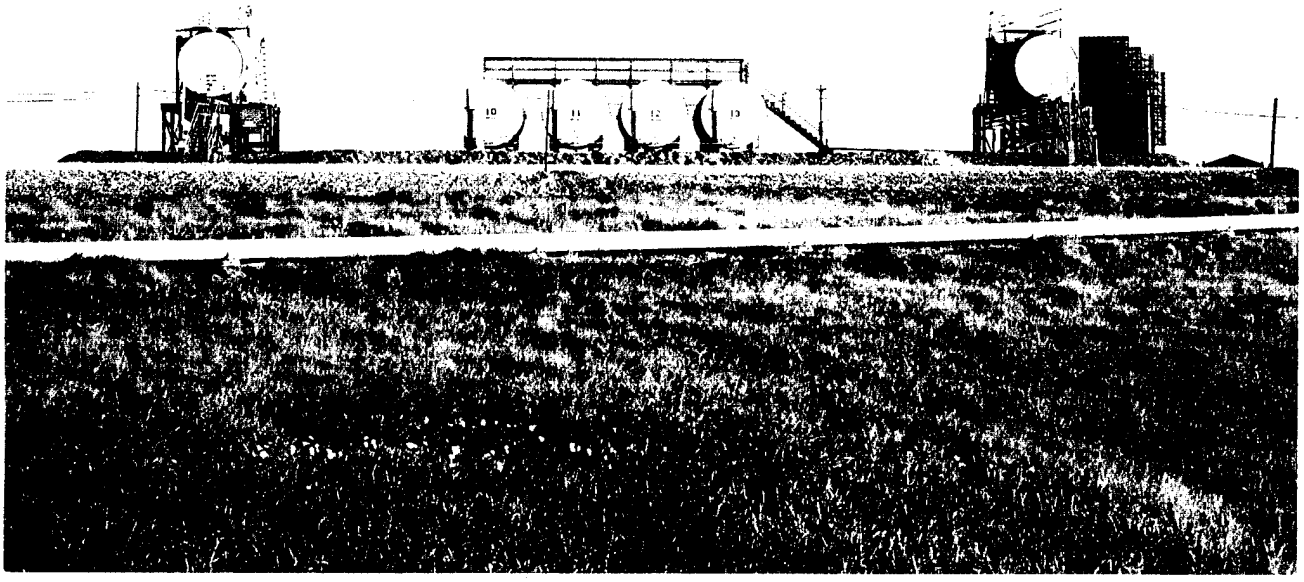
The Fuel Tanks (ST18) are used to store gasoline and diesel. The tanks are surrounded by a berm. This is a view to the south showing the north side of the six storage tanks within the site.
