EVALUATION AND IMPROVEMENT OF COATINGS  
FOR COLUMBIUM ALLOY GAS TURBINE ENGINE COMPONENTS

PRATT & WHITNEY AIRCRAFT  
DIVISION OF UNITED AIRCRAFT CORPORATION

Technical Report AFML-TR-66-186, Part II

May 1968

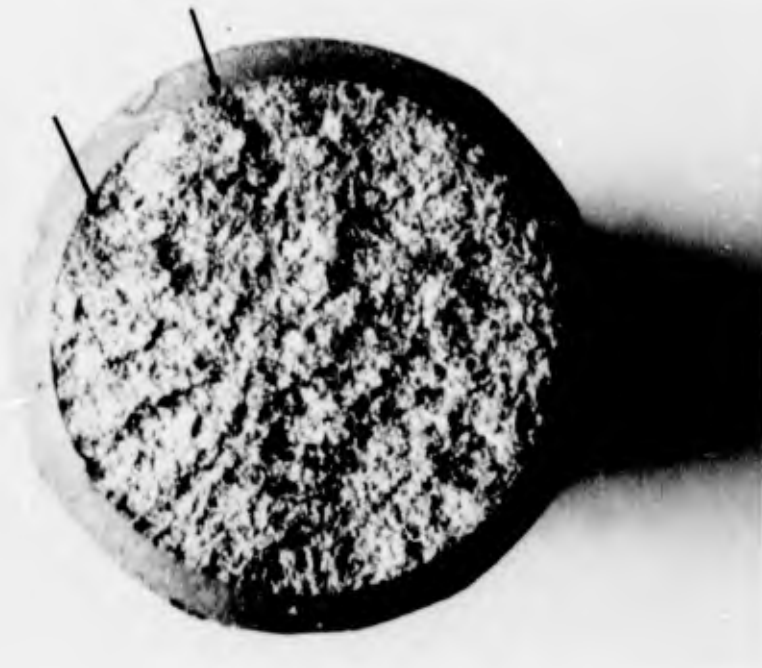
Figure 155. TRW TiAl (Vacuum) Pack Coated XB-88 Alloy Notched ( $K_t = 3.2$ ) Fatigue Specimen Showing Room Temperature Fracture Surface After Testing at 30,000 Psi in Air at 1250°F

At 1250°F the TRW TiAl coated notched XB-88 alloy specimen exhibited a fatigue limit of less than 30,000 psi, while the smooth specimens had a fatigue limit greater than 55,000 psi, which is approximately equal to the yield strength of the uncoated alloy. The fracture surfaces of the notched specimens after test and room temperature fracture showed small oxidized areas of fatigue progression (Figure 155).

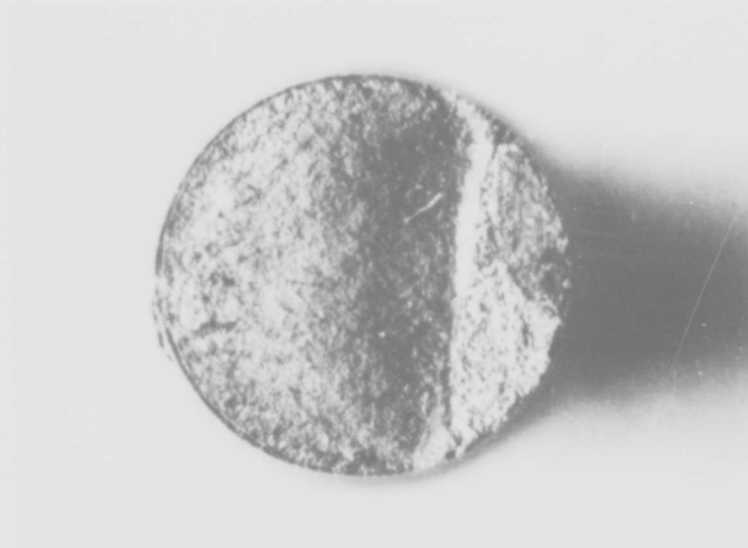
Figure 157. TRW TiAl (Vacuum) Pack Coated XB-88 Alloy Smooth Fatigue Specimen Showing Room Temperature Fracture Surface After Testing at 52,500 Psi Stress in Air at 1600°F

Failure occurred after  $6.1 \times 10^5$  cycles. Dark areas are the areas of fatigue.

of the uncoated XB-88 alloy. Fracture surfaces of the specimens indicated fatigue progression (Figures 156 and 157).
