PROTECTION OF AIRCRAFT FLUID SYSTEMS

LTV Aerospace Corporation

TECHNICAL REPORT AFML-TR-68-125

May 1968

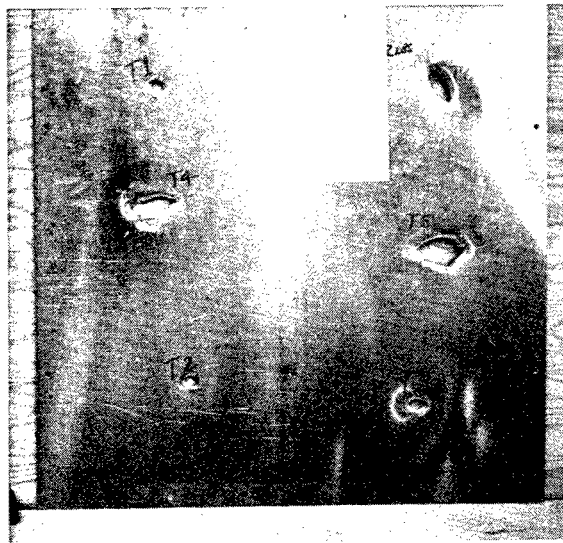
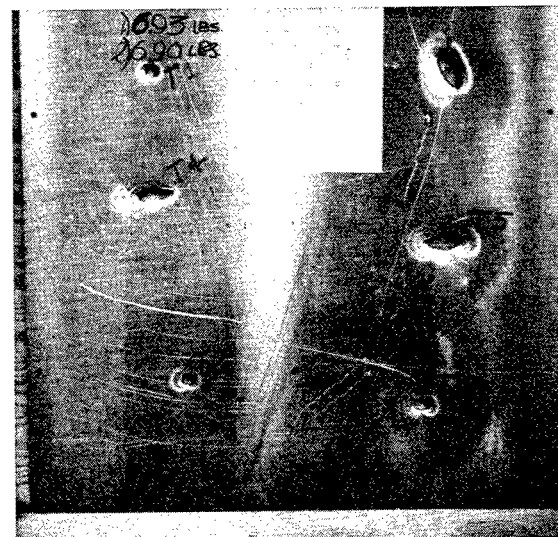
Figure F-1 CALIBER .50 SHOTS, 6061-T6 ALUMINUM

Figures F-1 through F-8 of Appendix F show photographs of all skins tested and Tables G-I through G-VIII of Appendix G show the measured detail size and comments on type of damage incurred by the panels. Round numbers T1 through T59, shown in the photographs, correspond to the round numbers listed in the tables of Appendix G. The effect of any one particular round can be traced through all three panels by the round number shown in the photograph and the correlating tabulated measurements and comments. For added convenience, the tables are cross-referenced to the photographic figure of the gunfired panel. Most of the photographs are views of the entrance and exit sides of the test panel. Some edge shots are included to show petal height and petal roll.

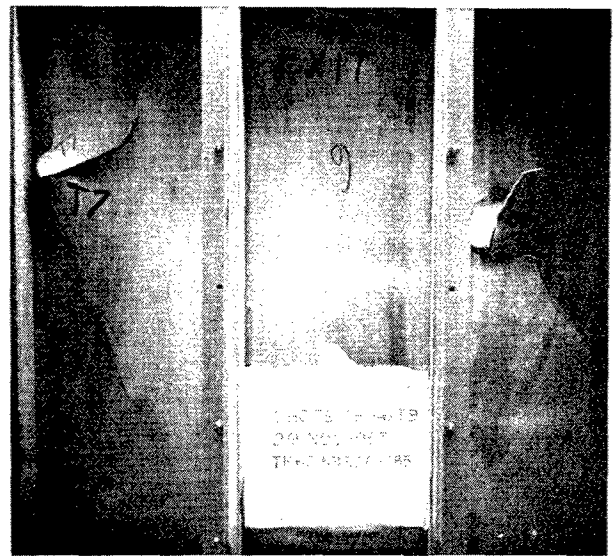
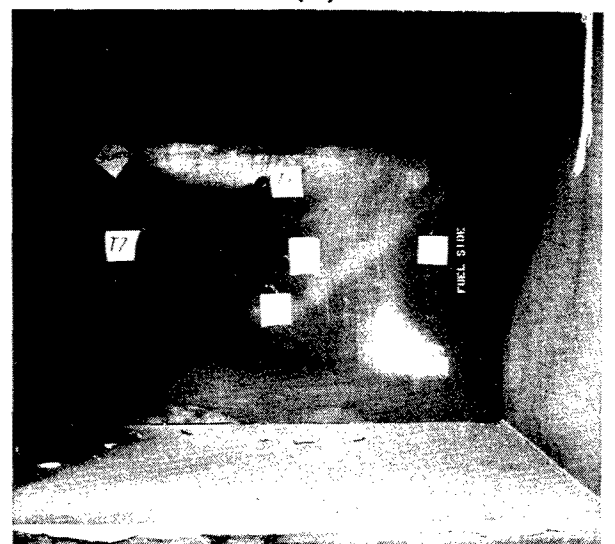
Figure H-1 Photographs, Blocks B8, B8.1

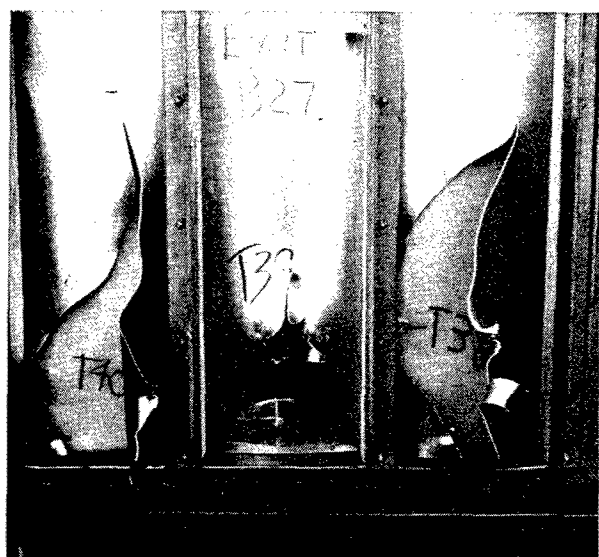
Figure H-3 Photographs, Block B27
