HEADQUARTERS
20TH ENGINEER BATTALION (COMBAT)
APO San Francisco 96318

14 May 1967

SUBJECT: Operational Report - Lessons Learned (RCS CSFOR-65), for Quarterly Period Ending 30 April 1967

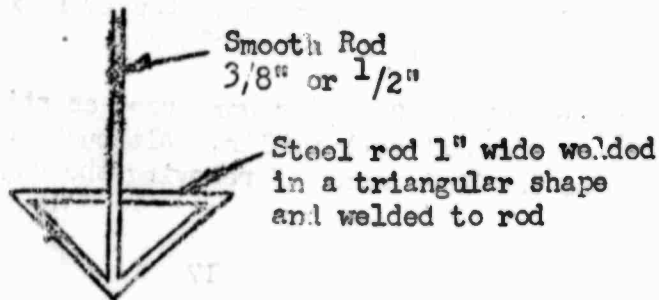
Discussion: Mixing the nonskid compound is a time consuming task and utilizes many personnel.

Observation: A paint mixer was fabricated to use with the heavy duty electric drills in the pioneer electrical tool sets. This method was quicker and required fewer people. The design is as follows:
