SERVICE TEST OF

RECOVERY VEHICLE, FULL-TRACKED:

LIGHT ARMORED (M113A1), XM806E1

FINAL REPORT

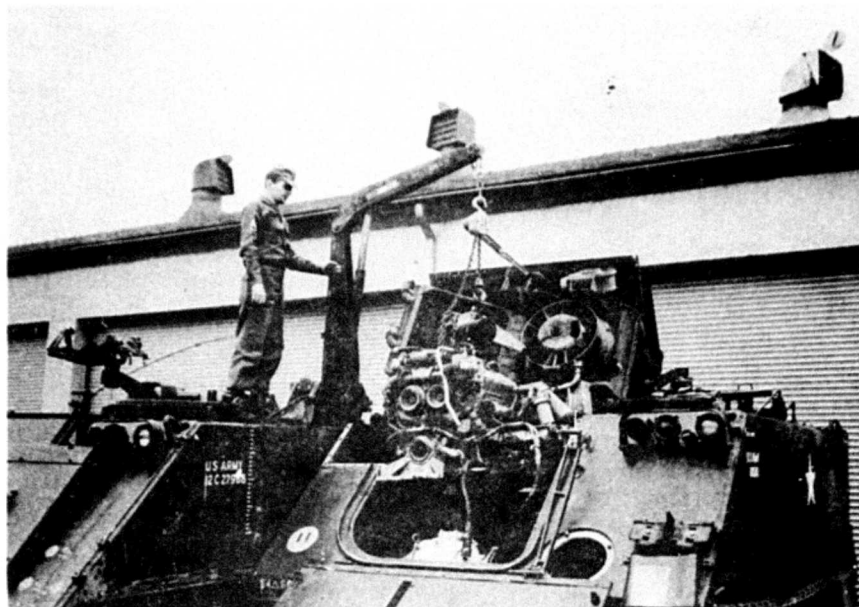
US ARMY ARMOR AND ENGINEER BOARD USATECOM PROJ NO 1-7-2625-34
FORT KNOX, KY PHOTO NO 69-125A

RECOVERY VEHICLE, FULL-TRACKED:
LIGHT ARMORED (M113A1), XM806E1

REMOVAL OF POWER PACKAGE FROM
STANDARD M113A1 ARMORED PERSONNEL CARRIER

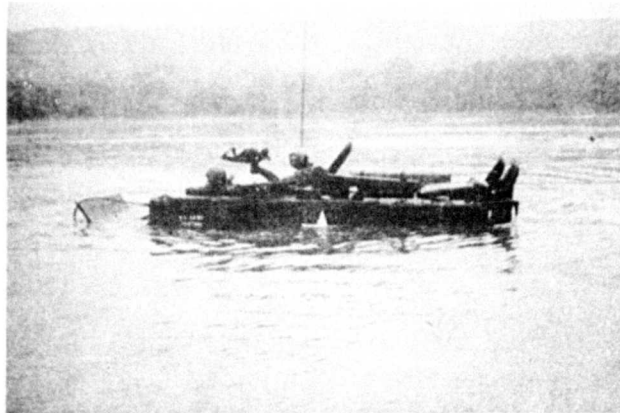
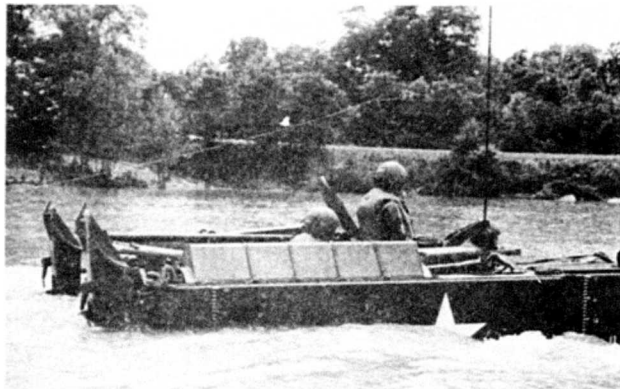
US ARMY ARMOR AND ENGINEER BOARD USATECOM PROJ NO 1-7-2625-34
FORT KNOX, KY PHOTO NO 69-476A AND 68-451C

RECOVERY VEHICLE, FULL-TRACKED:
LIGHT ARMORED (M113A1), XM806E1
