USAAVLABS TECHNICAL REPORT 69-92

HOT CORROSION RESISTANCE OF MATERIALS FOR SMALL GAS TURBINE RECUPERATORS

THE GARRETT CORPORATION

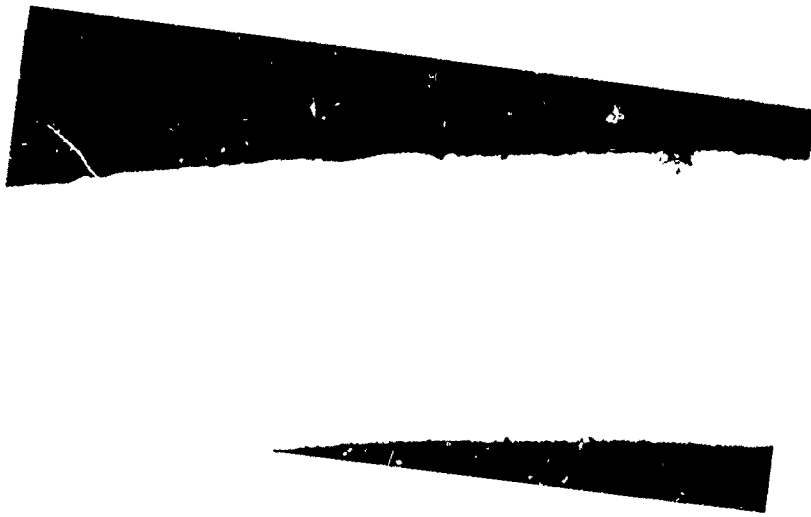
Figure 7. Inconel 625 Tube Wall Section
(Second Lot).

A second batch of material was received, and inspection of the tubes showed that these also had surface defects. Microstructural examination revealed what appeared to be foreign particles impressed into the surface (Figure 7). It appeared that alloying occurred between the particles and the Inconel 625 during annealing. The supplier was requested to analyze this tubing, and his report confirmed that the surface imperfections were widespread. Identification of the contaminant was hampered by the difficult etching characteristics of the thin-wall tubing. However, a review of the manufacturing history indicated that the contamination occurred in finishing processes. It was also concluded from the unusual nature of the defect that it was an isolated occurrence and that there should be no inherent difficulty in manufacturing thin-wall tubing from Inconel 625. The entire second consignment was rejected and returned to the vendor.

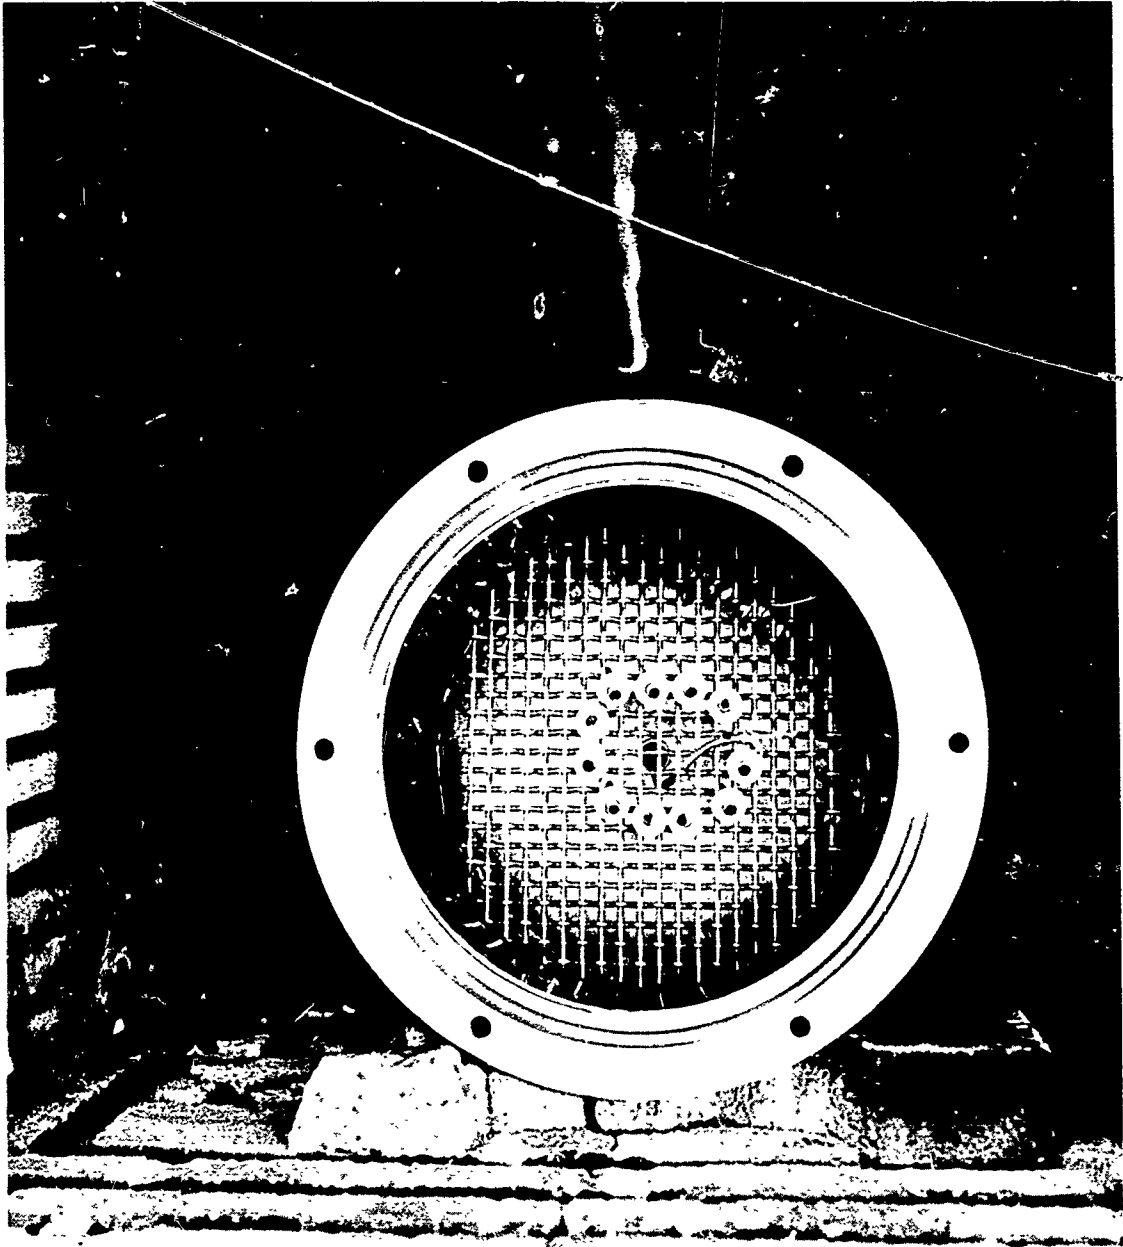
Figure 10. Test Specimens Mounted in Static Hot Corrosion Test Retort.

The retort depicted in Figure 9 was built to hold the brazed tube-header specimens such that the hot corrosion gases would impinge upon and engulf all pieces equally. The specimens were mounted on a wire screen with their longitudinal axes parallel to the direction of flow. (See Figure 10.) Temperature inside the retort was monitored by a chromel-alumel thermocouple attached to the wire screen. A schematic layout of the test apparatus is shown in Figure 11, and a general view of the test rig is shown in Figure 12.

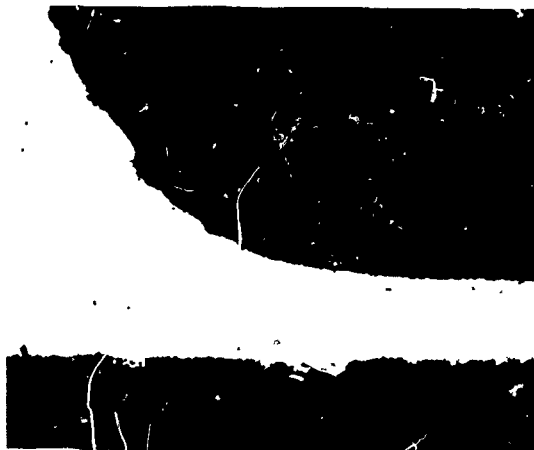
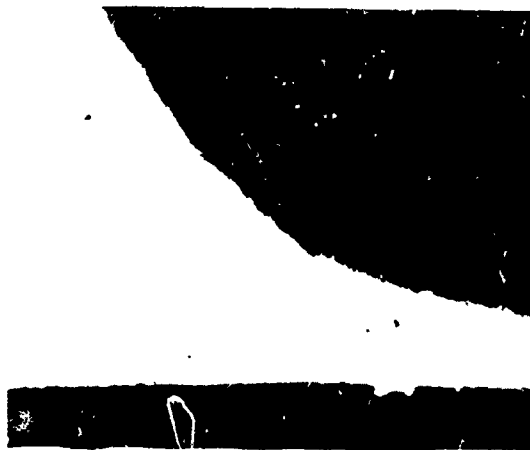
- a. PALNIRO 4 BRAZING ALLOY, VACUUM BRAZED AT 2170°F WITH HOLD TIME OF 10 MIN. NO CORROSION OF PALNIRO 4. UNETCHED

- b. J-8100 BRAZING ALLOY, VACUUM BRAZED AT 2150°F WITH HOLD TIME OF 10 MIN. NO CORROSION OF J-8100. UNETCHED

- c. PALNIRO 1 BRAZING ALLOY, VACUUM BRAZED AT 2070°F WITH HOLD TIME OF 10 MIN. NO CORROSION OF PALNIRO 1. UNETCHED

- d. MICROBRAZ 135 BRAZING ALLOY, VACUUM BRAZED AT 2000°F WITH HOLD TIME OF 10 MIN. SOME CORROSION OF MICROBRAZ 135 NOTED. UNETCHED

Figure 13. Hastelloy X Tube-Header Joints After 100 hr at 1500°F, Static Hot Corrosion Test.

The 1-in.-long tube-header samples were sectioned longitudinally, and their microstructures were examined for the effects of the static hot corrosion test. Photomicrographs of the brazed joints in the unetched condition are shown in Figures 13 through 17. These figures show the resistance of the various tube material/filler metal combinations to the corrosive atmospheres at 1500°F for 100 hr.

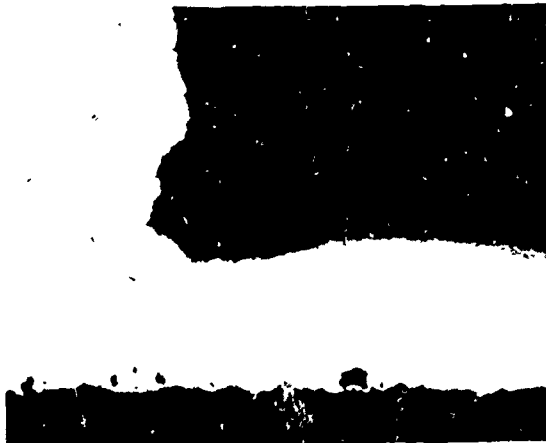
- a. J-8100 BRAZING ALLOY. VACUUM BRAZED AT 2150°F WITH HOLD TIME OF 10 MIN. NO CORROSION OF J-8100 NOTED. UNETCHED

- b. ENGELHARD 135 BRAZING ALLOY. BRAZED AT 2100°F IN HYDROGEN ATMOSPHERE WITH 10 MIN HOLD TIME. EXTENSIVE CORROSION OF ENGELHARD 135 OCCURRED. UNETCHED

- c. MICROBRAZ 135 BRAZING ALLOY. VACUUM BRAZED AT 2000°F WITH HOLD TIME OF 10 MIN. SOME CORROSION OF MICROBRAZ 135 NOTED. UNETCHED

- d. MICROBRAZ 65 BRAZING ALLOY. BRAZED AT 1950°F IN HYDROGEN WITH HOLD TIME OF 10 MIN. HEAVY CORROSION OF MICROBRAZ 65. UNETCHED

Figure 14. Inconel 625 Tube-Header Joints After 100 hr at 1500°F, Static Hot Corrosion Test.

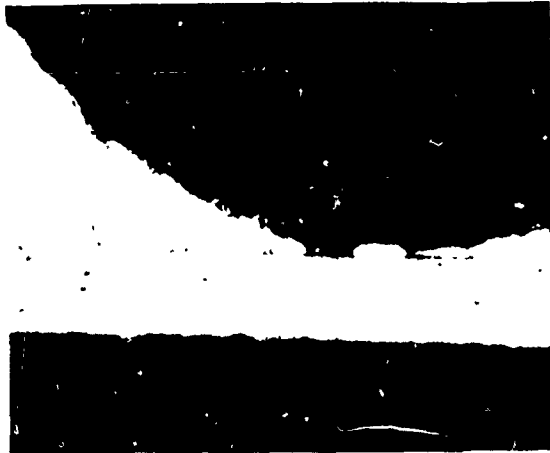
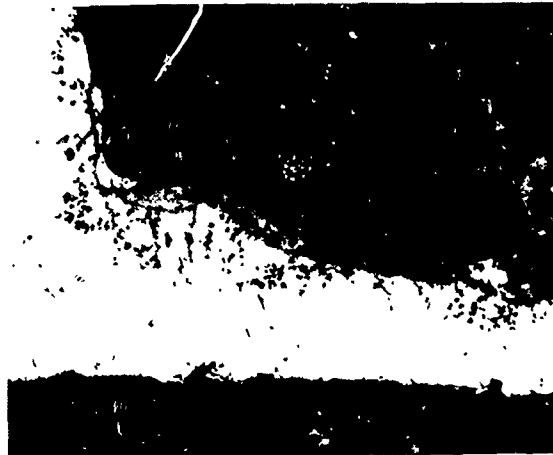
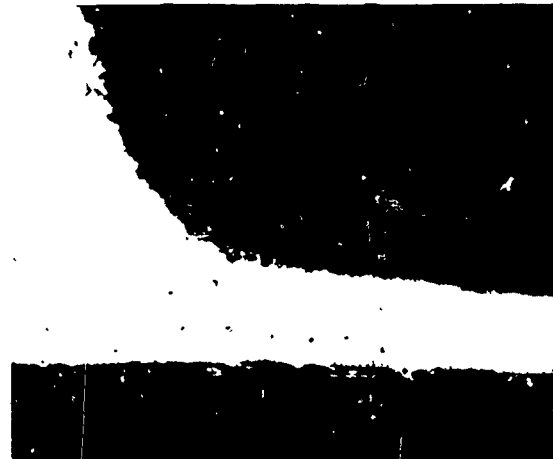
- a. MICROBRAZ 135 BRAZING ALLOY. VACUUM BRAZED AT 2000°F WITH 10 MIN HOLD TIME. SOME CORROSION OF MICROBRAZ 135 NOTED. UNETCHED

- b. MICROBRAZ 65 BRAZING ALLOY. BRAZED AT 1950°F IN HYDROGEN WITH 10 MIN HOLD TIME. EXTENSIVE CORROSION OF MICROBRAZ 65. UNETCHED

- c. PALNIRO 7 BRAZING ALLOY. VACUUM BRAZED AT 1950°F WITH 10 MIN HOLD TIME. NO CORROSION OF PALNIRO 7 NOTED. UNETCHED

- d. COAST METALS 50B BRAZING ALLOY. VACUUM BRAZED AT 2050°F WITH 10 MIN HOLD TIME. SOME CORROSION OF 50B NOTED. UNETCHED

Figure 15. Incoloy 800 Tube-Header Joints After 100 hr at 1500°F, Static Hot Corrosion Test.

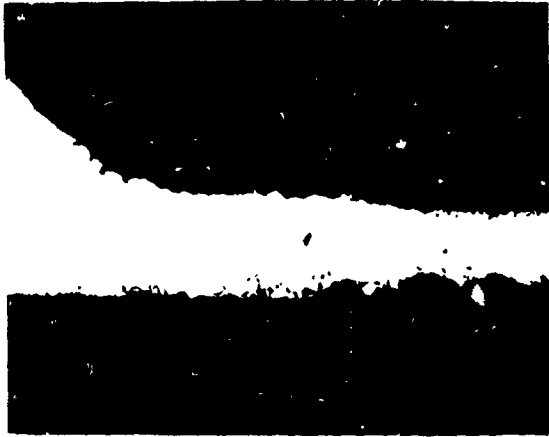
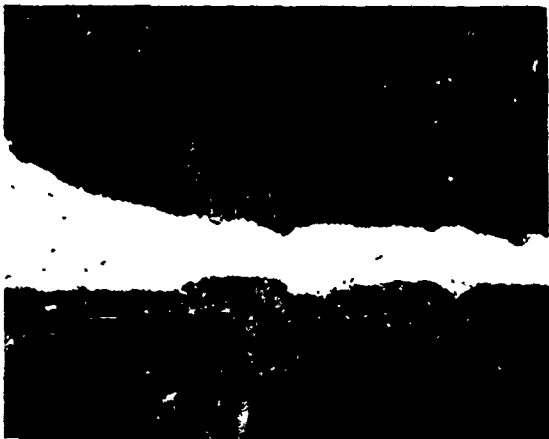
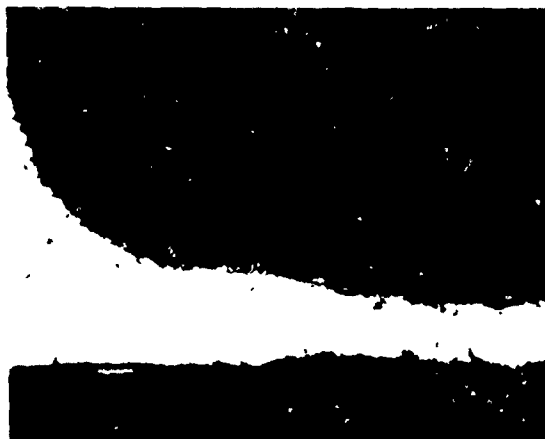
- a. MICROBRAZ 135 BRAZING ALLOY, VACUUM BRAZED AT 2000°F WITH 10 MIN HOLD TIME. SOME CORROSION OF MICROBRAZ 135 NOTED. UNETCHED

- b. MICROBRAZ 65 BRAZING ALLOY, BRAZED AT 1950°F IN HYDROGEN WITH 10 MIN HOLD TIME. CORROSION OF MICROBRAZ 65 NOTED. UNETCHED

- c. PALMIRO 7 BRAZING ALLOY, VACUUM BRAZED AT 1950°F WITH 10 MIN HOLD TIME. NO CORROSION OF PALMIRO 7 NOTED. UNETCHED

- d. COAST METALS 50B BRAZING ALLOY, VACUUM BRAZED AT 2050°F WITH 10 MIN HOLD TIME. SOME CORROSION OF 50B NOTED. UNETCHED

With the exception of type 347 stainless steel, none of the tube-header joints showed more than superficial corrosion. The stainless steel, however, was more heavily oxidized, as can be seen in Figure 17. Palniro 4, J-8100, Palniro 1, Palniro 7, and Nicrobraz 200 filler metals were not attacked by the sulfurous atmosphere. Nicrobraz 135 and Coast Metals 50B suffered moderate attack, and Nicrobraz 65 and Englehard 135 were both severely corroded.

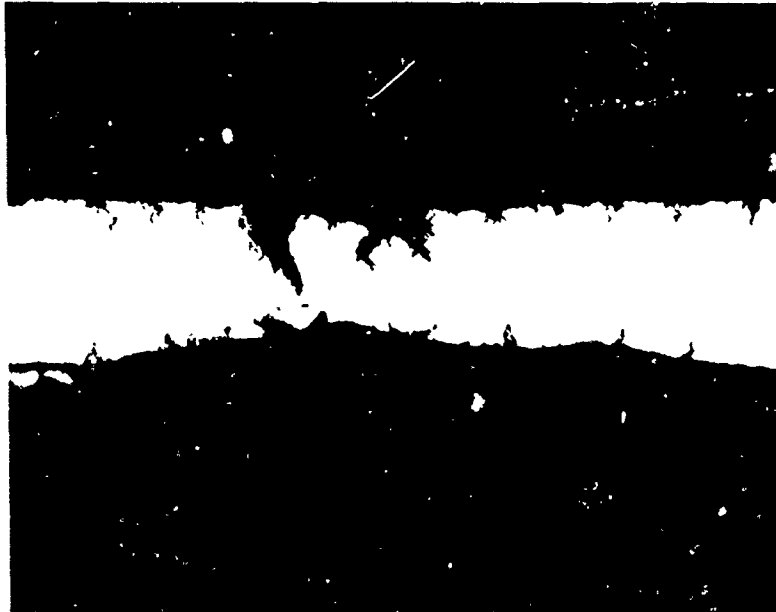
MAG = X230

Figure 23. Hastelloy X After a 204-hr Exposure at 1300°F and 20.8 ksi.

Grain boundary attack was clearly evident after Hastelloy X was submitted to high stress levels for both the 1500^o and 1300^oF conditions. No appreciable oxide layer was detected on any sample examined, but in some cases the grain boundaries were so severely attacked that the tube wall was almost penetrated. This type of corrosion is illustrated in Figure 23, which shows Hastelloy X after 204 hr at 1300^oF and 0.8 ksi. Concentration of the attack in the grain boundaries is not surprising with such high stresses involved. Loss of cohesive strength at the grain boundaries is the normal mode of stress-rupture failure; consequently, the effects of hot corrosion may have been slight. Microprobe analysis identified the corrosion product as a chromium oxide phase, free of nickel or iron oxides, which adhered to a metal layer depleted in chromium content. No sulfides were associated with the oxide.

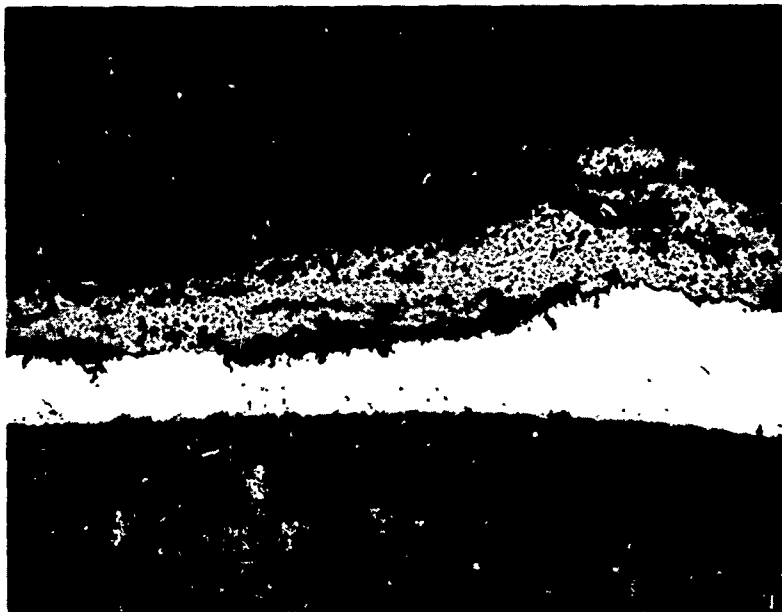
Figure 26. Type 347 Stainless Steel After 77.4 hr at 1500°F and 3.0 ksi.

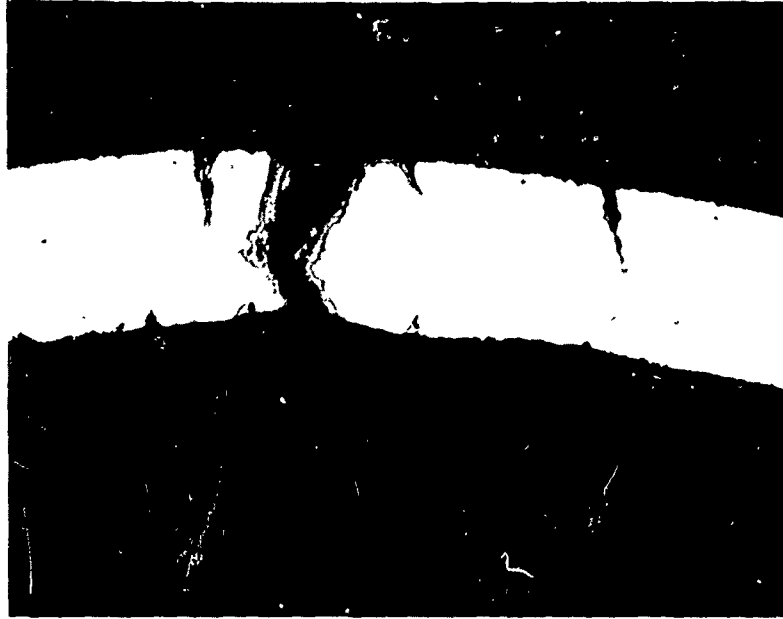
Figure 27. Inconel 625 After 146 hr at 1500°F and 12.1 ksi.

Little or no oxide layer was found on Inconel 625 tubes. Failure along the oxidized grain boundaries resulted from high pressure levels at 1300° and 1500°F. Microprobe analysis showed that the surface oxide film was approximately 5 μ thick and consisted essentially of chromium oxide. Extending below the oxide layer was a zone of metal depleted of molybdenum, nickel, and chromium. X-ray scanning displays illustrated that no sulfides were associated with the corroded areas. The brazing alloys (J-8100 and Microbraz 135) were slightly oxidized, but failure never occurred at the simulated tube-header joint. Figure 27 shows the most severe case of oxidation observed for Inconel 625 tubing.

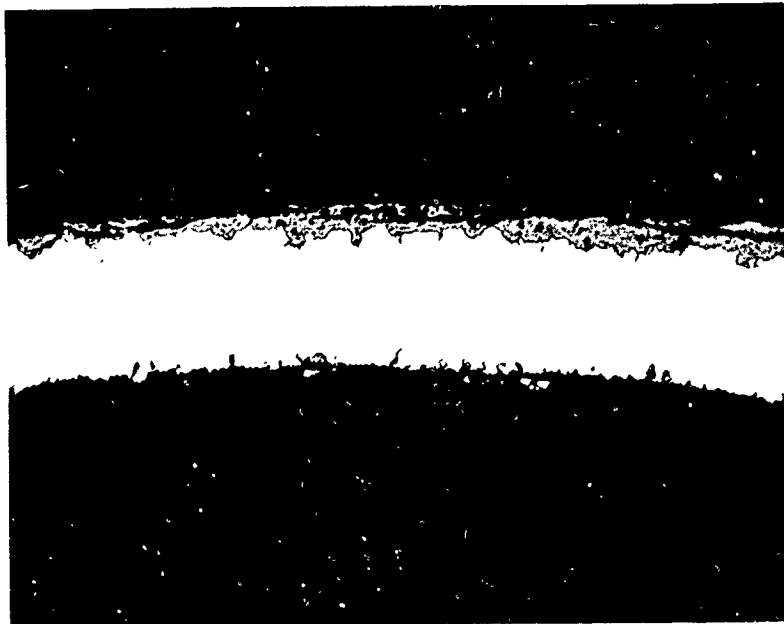
Figure 51. Incoloy 800 Exposed for 464 hr at 1500^oF to 0.1-ppm Maximum Sea Salts in Recuperator Test Rig (Module 6-2).

An oxide layer approximately 0.6 mil thick was observed on the portion of the tube heated to 1500°F, and some intergranular penetration had occurred on the outside, and to a lesser extent on the inside, tube surfaces (see Figure 51). Microprobe analysis confirmed the oxide thickness.

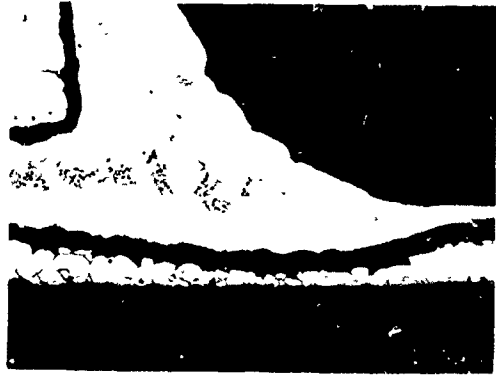
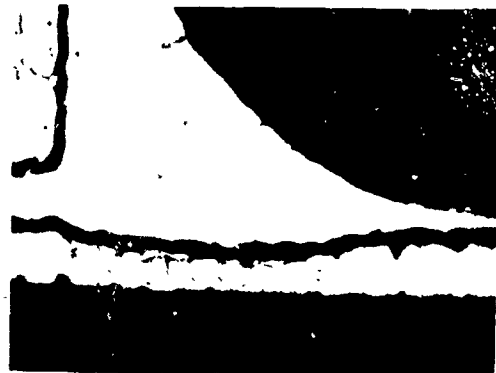
a. 2200°F BRAZING TEMPERATURE.

c. 2175°F BRAZING TEMPERATURE.

e. 2150°F BRAZING TEMPERATURE.

Figure 57. Photomicrographs of Hastelloy X Tube-Header Joints Brazed With Palniro 4 Brazing Alloy, in Vacuum, With a 10-Min Hold Time at Temperature. Etched with Kalling's Reagent.

Tube-header joints were brazed with each of the five selected materials and the four selected braze alloys. After brazing, the 1-in.-long samples were sectioned longitudinally and prepared for metallographical evaluation. The results of this examination are presented in the main body of the report. Figures 57 through 76, presented in this appendix, illustrate the microstructures of the various tube material brazing alloy combinations after brazing at the three predetermined brazing temperatures for 10 min each.

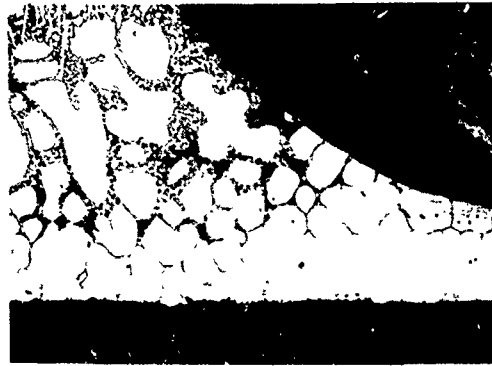
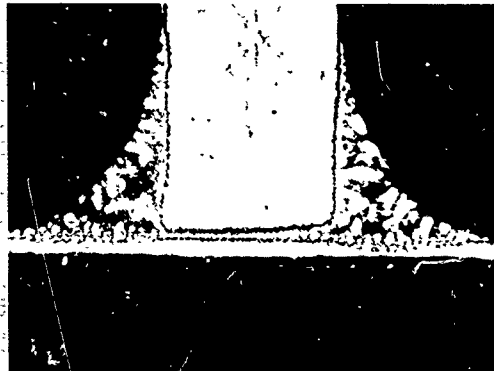
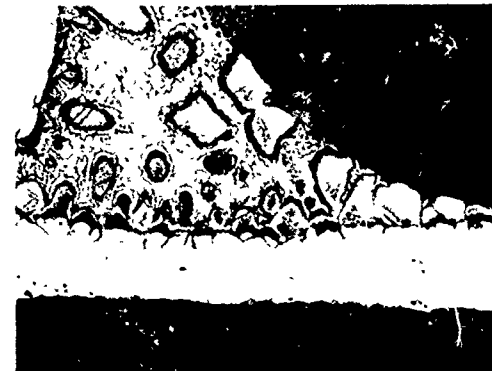
a. 2175°F BRAZING TEMPERATURE.

c. 2150°F BRAZING TEMPERATURE.

e. 2125°F BRAZING TEMPERATURE.

Figure 58. Photomicrographs of Hastelloy X Tube-Header Joints Brazed With J-8100 Brazing Alloy, in Vacuum, With a 10-Min Hold Time at Temperature. Etched With Kalling's Reagent.

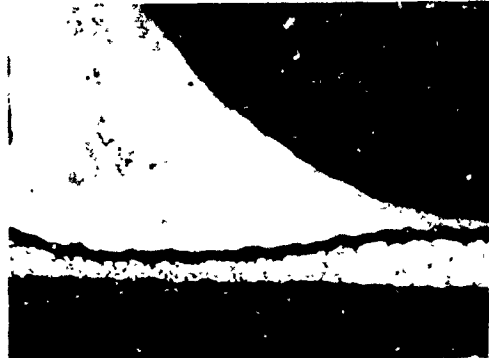
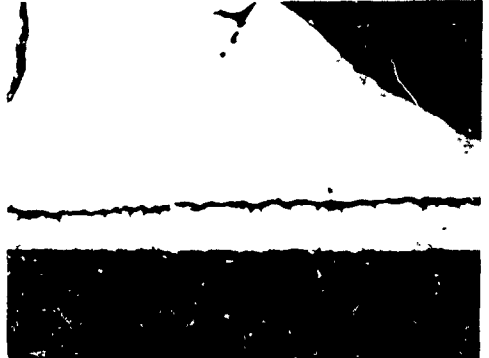
a. 2100°F BRAZING TEMPERATURE.

c. 2075°F BRAZING TEMPERATURE.

e. 2050°F BRAZING TEMPERATURE.

Figure 59. Photomicrographs of Hastelloy X Tube-Header Joints Brazed With Palniro I Brazing Alloy, in Vacuum, With a 10-Min Hold Time at Temperature. Etched with Kalling's Reagent.

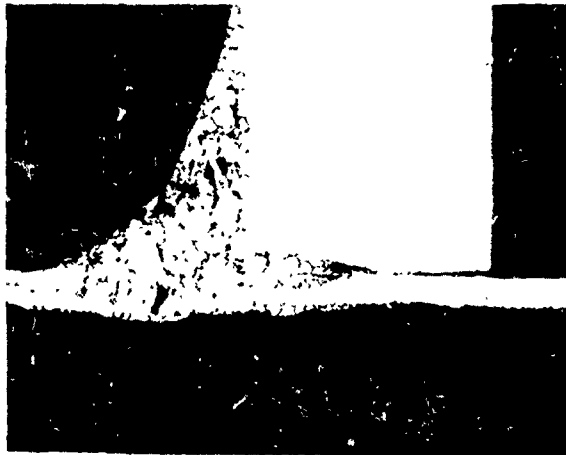
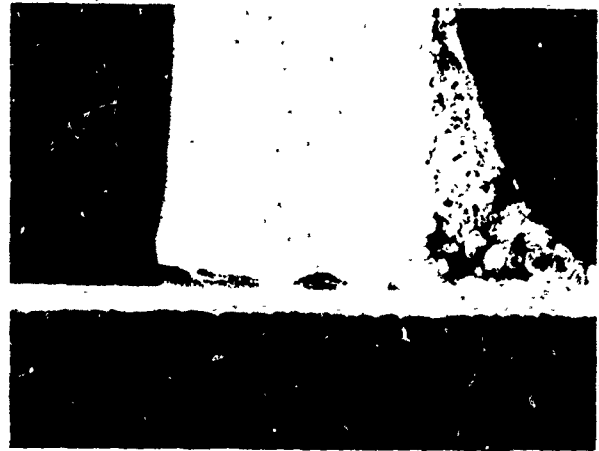
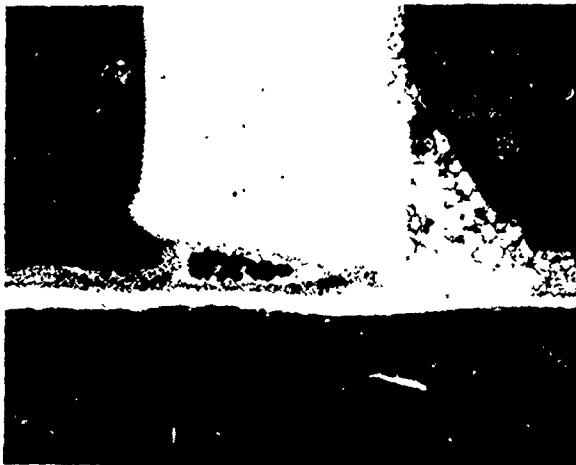
a. 2175°F BRAZING TEMPERATURE.

b. 2150°F BRAZING TEMPERATURE.

c. 2125°F BRAZING TEMPERATURE.

Figure 61. Photomicrographs of Inconel 625 Tube-Header Joints Brazed With J-8100 Brazing Alloy, in Vacuum, With a 10-Min Hold Time at Temperature. Etched With Kalling's Reagent.

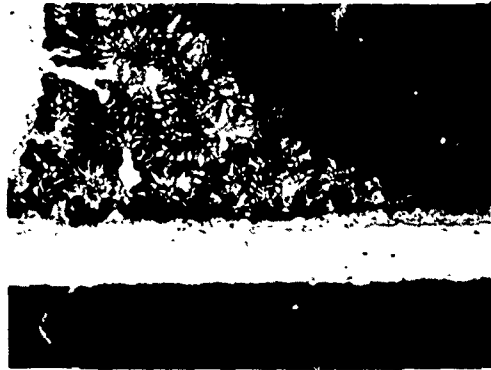
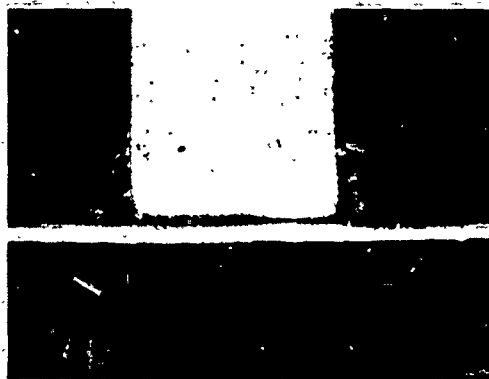
a. 2125°F BRAZING TEMPERATURE.

c. 2100°F BRAZING TEMPERATURE.

e. 2075°F BRAZING TEMPERATURE.

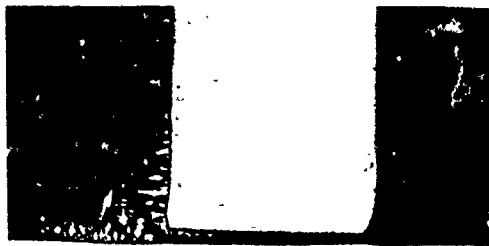
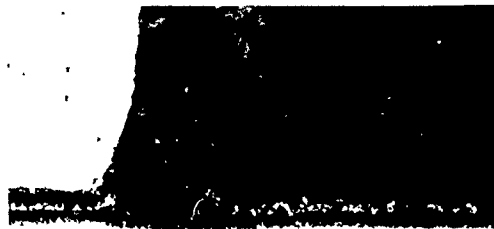
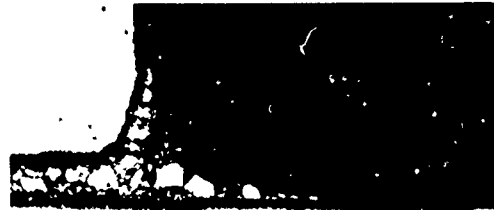
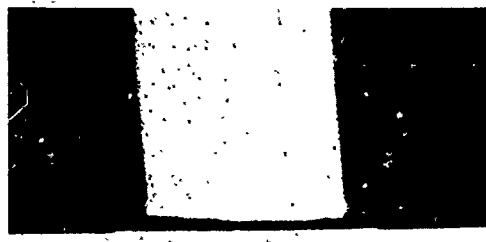
Figure 63. Photomicrographs of Inconel 625 Tube-Header Joints Brazed With Microbraz 135 Brazing Alloy, in Vacuum, with a 10-Min Hold Time at Temperature. Etched with Kalling's Reagent.

MAG = X50

a. 1975°F BRAZING TEMPERATURE.

MAG = X150

b. 1975°F BRAZING TEMPERATURE.

c. 1950°F BRAZING TEMPERATURE.

d. 1950°F BRAZING TEMPERATURE.

e. 1925°F BRAZING TEMPERATURE.

f. 1925°F BRAZING TEMPERATURE.

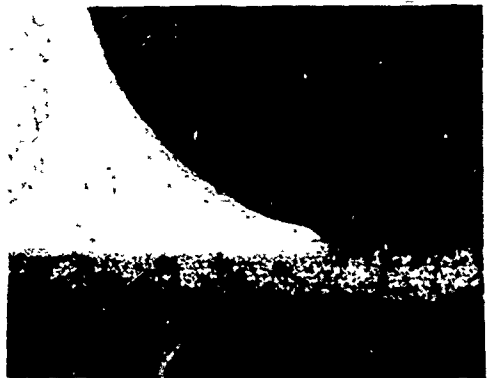
Figure 64. Photomicrographs of Inconel 625 Tube-Header Joints Brazed With Microbraz 65 Brazing Alloy, in Hydrogen, With a 10-Min Hold Time at Temperature. Etched With Kalling's Reagent.

MAG = X50

a. 2025°F BRAZING TEMPERATURE.

MAG = X150

b. 2025°F BRAZING TEMPERATURE.

c. 2000°F BRAZING TEMPERATURE.

d. 2000°F BRAZING TEMPERATURE.

e. 1975°F BRAZING TEMPERATURE.

f. 1975°F BRAZING TEMPERATURE.

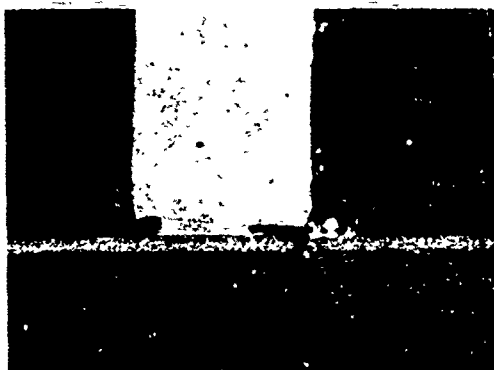
Figure 65. Photomicrographs of Incoloy 800 Tube-Header Joints Brazed With Microbraz 135 Brazing Alloy, in Vacuum, With a 10-Min Hold Time at Temperature. Etched With Kalling's Reagent.

MAG = X50

a. 1975°F BRAZING TEMPERATURE

MAG = X150

b. 1975°F BRAZING TEMPERATURE

c. 1950°F BRAZING TEMPERATURE

d. 1950°F BRAZING TEMPERATURE

e. 1925°F BRAZING TEMPERATURE

f. 1925°F BRAZING TEMPERATURE

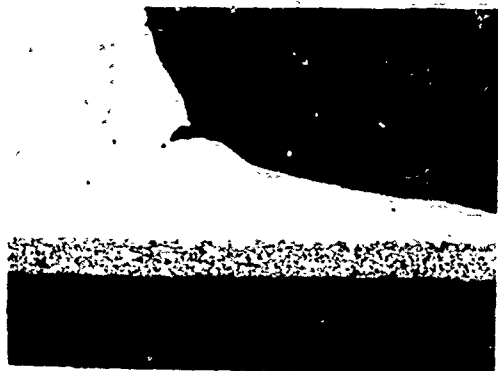
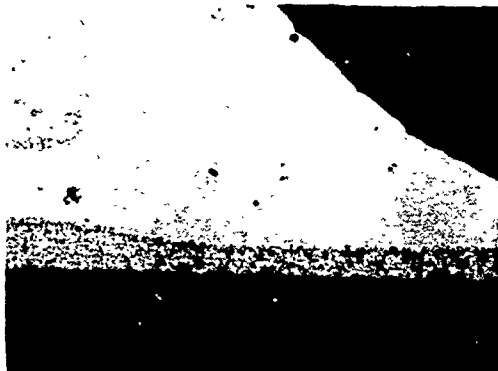
Figure 66. Photomicrographs of Incoloy 800 Tube-Header Joints Brazed With Microbraz 65 Brazing Alloy, in Hydrogen, With a 10-Min Hold Time at Temperature. Etched With Kalling's Reagent.

MAG = X50

a. 1975°F BRAZING TEMPERATURE

MAG = X150

b. 1975°F BRAZING TEMPERATURE

c. 1950°F BRAZING TEMPERATURE

d. 1950°F BRAZING TEMPERATURE

e. 1925°F BRAZING TEMPERATURE

f. 1925°F BRAZING TEMPERATURE

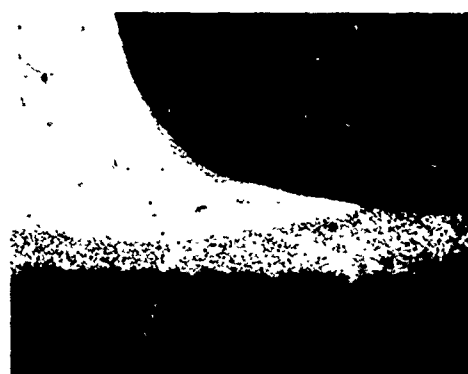
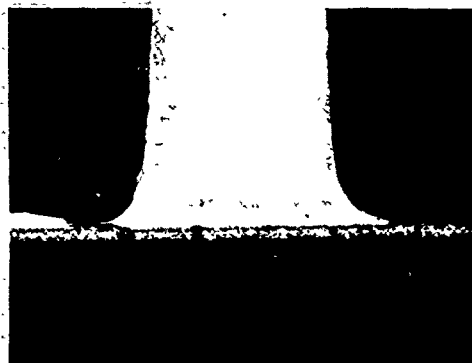
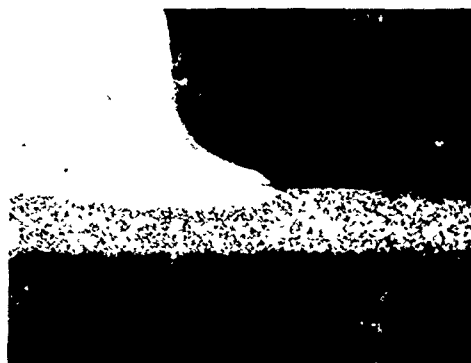
Figure 67. Photomicrographs of Incoloy 800 Tube-Header Joints Brazed With Palniro 7 Brazing Alloy, in Vacuum, With a 10-Min Hold Time at Temperature. Etched with Kalling's Reagent.

MAG = X50

a. 2075°F BRAZING TEMPERATURE.

MAG = X150

b. 2075°F BRAZING TEMPERATURE.

c. 2050°F BRAZING TEMPERATURE.

d. 2050°F BRAZING TEMPERATURE.

e. 2025°F BRAZING TEMPERATURE.

f. 2025°F BRAZING TEMPERATURE.

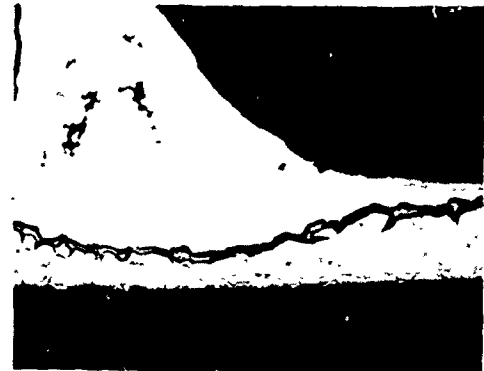
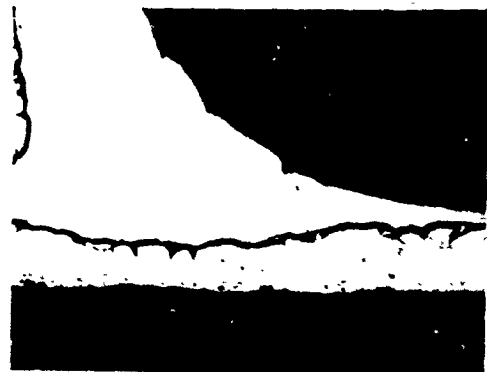
Figure 68. Photomicrographs of Incoloy 800 Tube-Header Joints Brazed With Coast Metals 50B Brazing Alloy, in Vacuum, With a 10-Min Hold Time at Temperature. Etched With Kalling's Reagent.

MAG = X50

a. 2200°F BRAZING TEMPERATURE.

MAG = X150

b. 2200°F BRAZING TEMPERATURE.

c. 2175°F BRAZING TEMPERATURE.

d. 2175°F BRAZING TEMPERATURE.

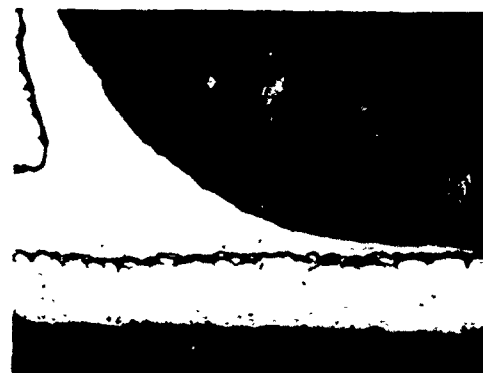
e. 2150°F BRAZING TEMPERATURE.

f. 2150°F BRAZING TEMPERATURE.

Figure 69. Photomicrographs of Multimet N-155 Tube-Header Joints Brazed With Palniro 4 Brazing Alloy, in Vacuum, With a 10-Min Hold Time at Temperature. Etched With Kalling's Reagent.

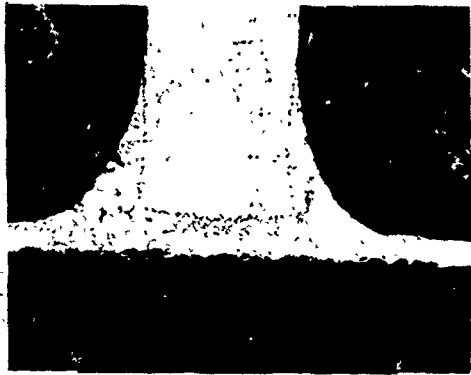
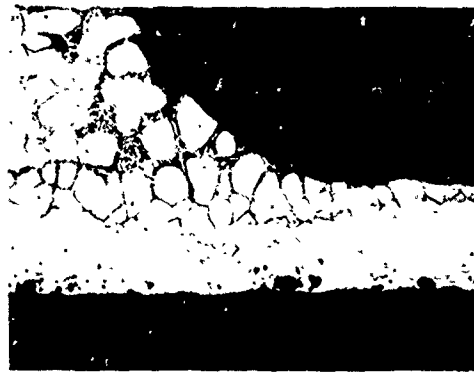
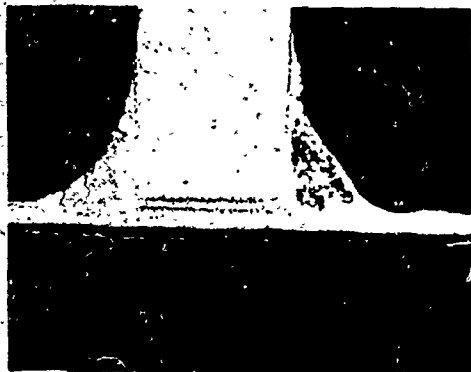
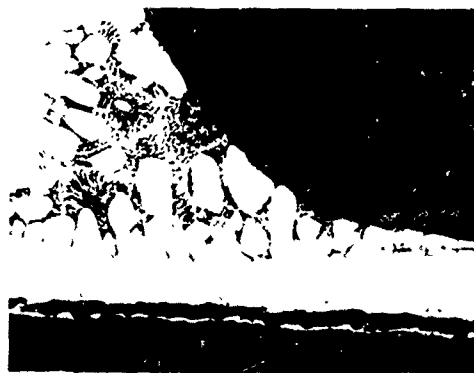
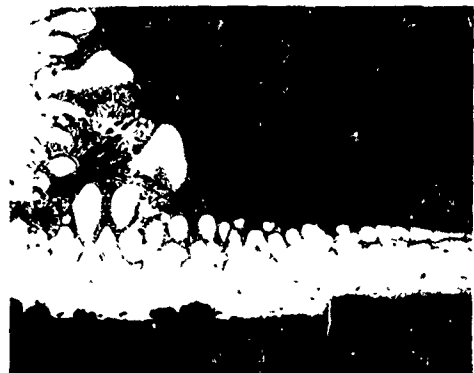
a. 2175°F BRAZING TEMPERATURE.

b. 2175°F BRAZING TEMPERATURE.

c. 2150°F BRAZING TEMPERATURE.

d. 2150°F BRAZING TEMPERATURE.

e. 2125°F BRAZING TEMPERATURE.

f. 2125°F BRAZING TEMPERATURE.

Figure 70. Photomicrographs of Multimet N-155 Tube-Header Joints Brazed With J-8100 Brazing Alloy, in Vacuum, With a 10-Min Hold Time at Temperature. Etched With Kalling's Reagent.

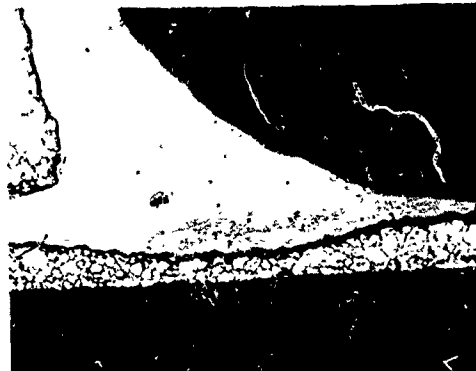
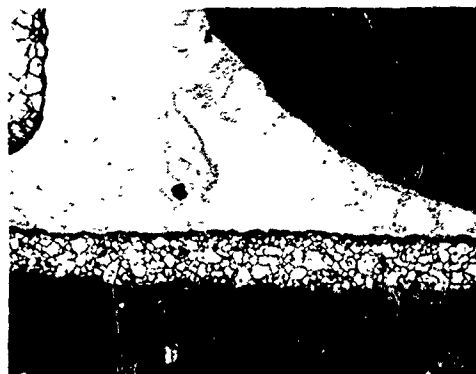
a. 2100°F BRAZING TEMPERATURE.

b. 2100°F BRAZING TEMPERATURE.

c. 2075°F BRAZING TEMPERATURE.

d. 2075°F BRAZING TEMPERATURE.

e. 2025°F BRAZING TEMPERATURE.

f. 2025°F BRAZING TEMPERATURE.

Figure 71. Photomicrographs of Multimet N-155 Tube-Header Joints Brazed With Palniro I Brazing Alloy, in Vacuum, With a 10-Min Hold Time at Temperature. Etched With Kalling's Reagent.

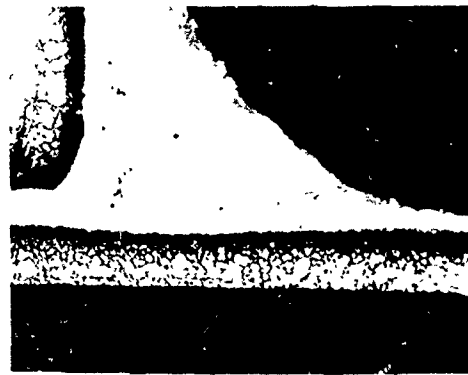
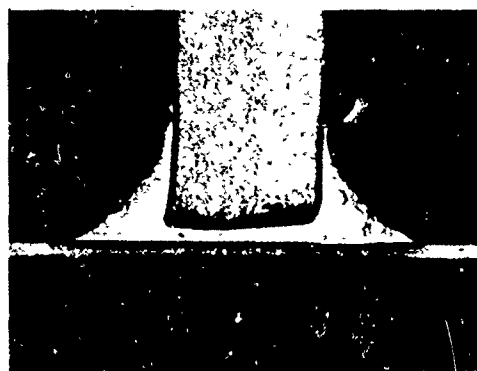
a. 1975°F BRAZING TEMPERATURE.

b. 1975°F BRAZING TEMPERATURE.

c. 1950°F BRAZING TEMPERATURE.

d. 1950°F BRAZING TEMPERATURE.

e. 1925°F BRAZING TEMPERATURE.

f. 1925°F BRAZING TEMPERATURE.

Figure 72. Photomicrographs of Multimet N-155 Tube-Header Joints Brazed With Microbraz 200 Brazing Alloy, in Vacuum, With a 10-Min Hold Time at Temperature. Etched With Kalling's Reagent.

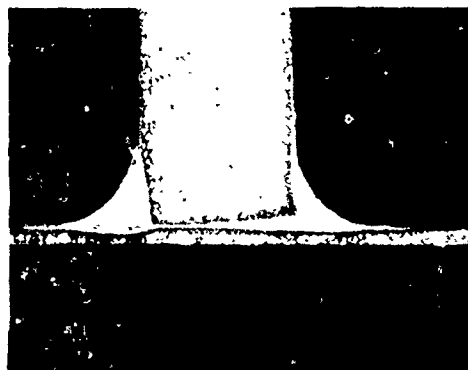
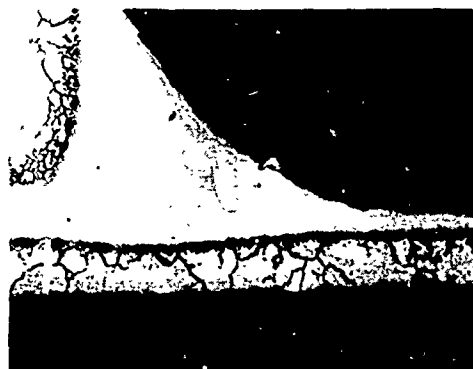
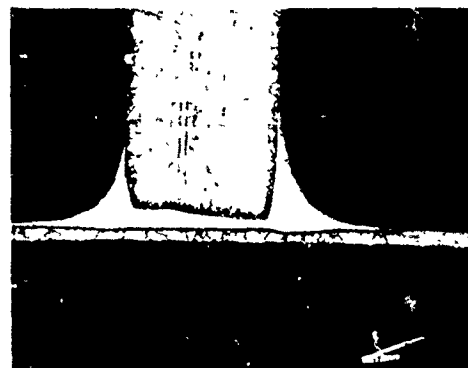
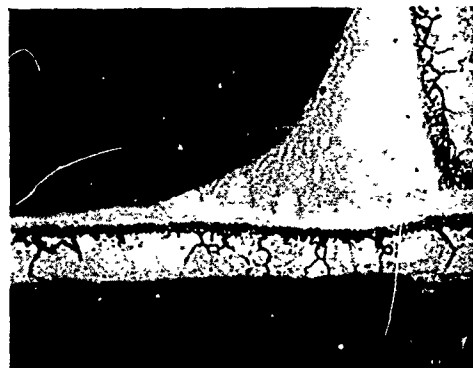
a. 2025°F BRAZING TEMPERATURE.

b. 2025°F BRAZING TEMPERATURE.

c. 2000°F BRAZING TEMPERATURE.

d. 2000°F BRAZING TEMPERATURE.

e. 1975°F BRAZING TEMPERATURE.

f. 1975°F BRAZING TEMPERATURE.

Figure 73. Photomicrographs of Type 347 Stainless Steel Tube-Header Joints Brazed With Microbraz 135 Brazing Alloy, in Vacuum, With a 10-Min Hold Time at Temperature. Etched With Kalling's Reagent.

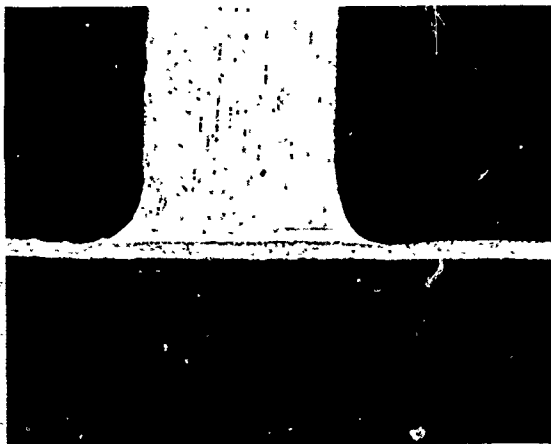
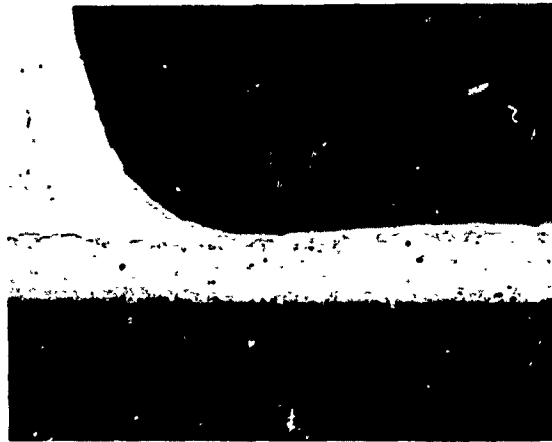
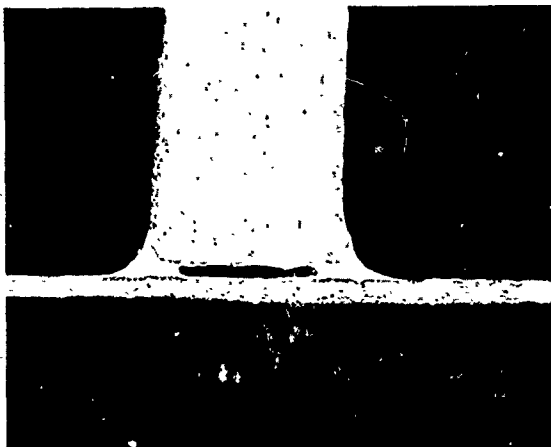
a. 1975°F BRAZING TEMPERATURE.

b. 1975°F BRAZING TEMPERATURE.

c. 1950°F BRAZING TEMPERATURE.

d. 1950°F BRAZING TEMPERATURE.

Figure 74. Photomicrographs of Type 347 Stainless Steel Tube-Header Joints Brazed With Microbraz 65 Brazing Alloy, in Hydrogen, with a 10-Min Hold Time at Temperature. Etched With Kalling's Reagent.

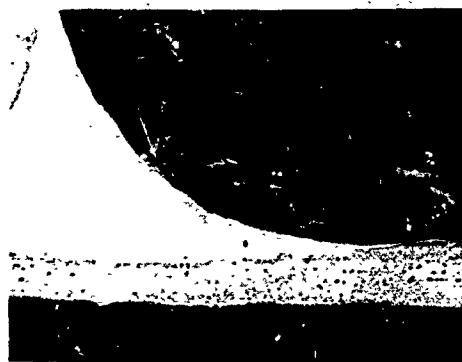
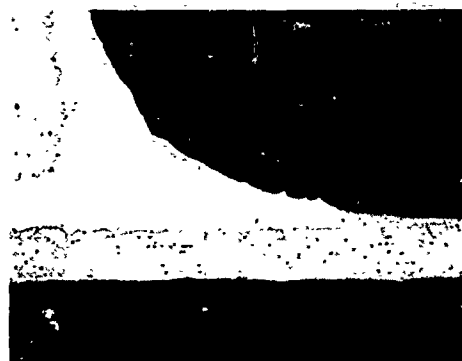
a. 1975°F BRAZING TEMPERATURE.

b. 1975°F BRAZING TEMPERATURE.

c. 1950°F BRAZING TEMPERATURE.

d. 1950°F BRAZING TEMPERATURE.

e. 1925°F BRAZING TEMPERATURE.

f. 1925°F BRAZING TEMPERATURE.

Figure 75. Photomicrographs of Type 347 Stainless Steel Tube-Header Joints Brazed With Palniro 7 Brazing Alloy, in Vacuum, With a 10-Min Hold Time at Temperature. Etched With Kalling's Reagent.

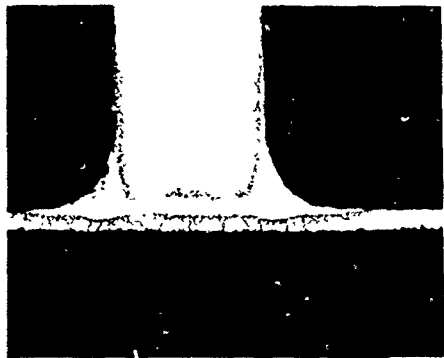
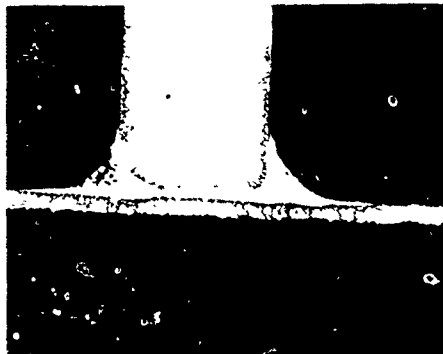
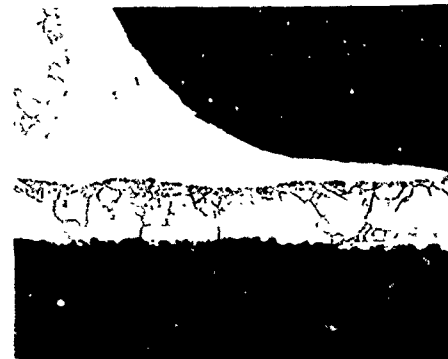
a. 2075°F BRAZING TEMPERATURE.

b. 2075°F BRAZING TEMPERATURE

c. 2050°F BRAZING TEMPERATURE.

d. 2050°F BRAZING TEMPERATURE.

Figure 76. Photomicrographs of Type 347 Stainless Steel Tube-Header Joints Brazed With Coast Metals 50B Brazing Alloy, in Vacuum, With a 10-Min Hold Time at Temperature. Etched with Kalling's Reagent.

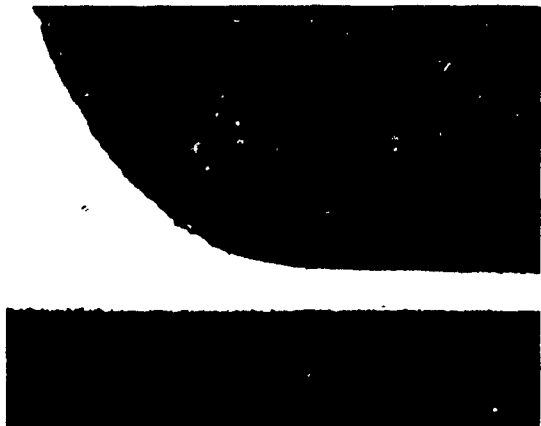
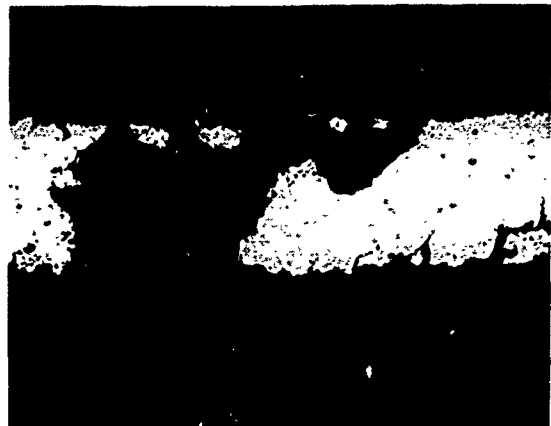
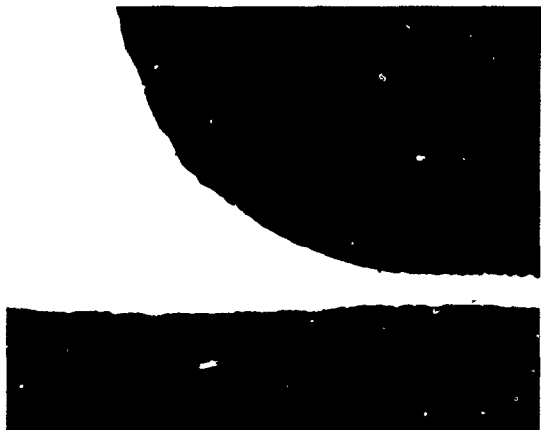
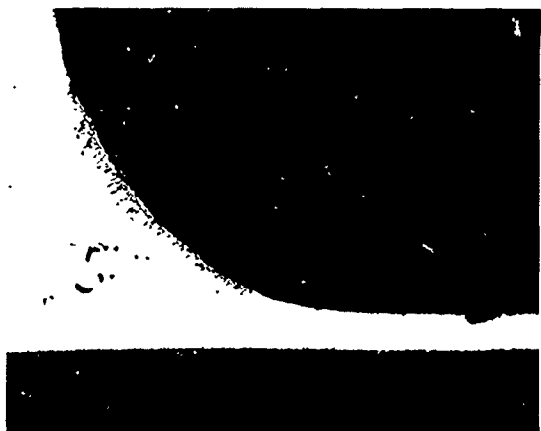
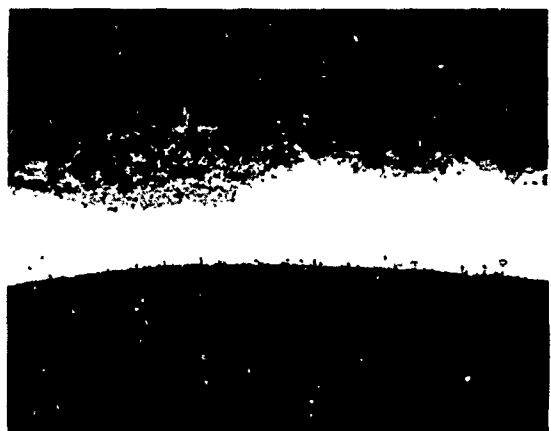
Figure 87. Photomicrographs of Multimet N-155 Tubes Brazed with Palniro I Brazing Alloy.

1500°F AND 20 KSI, FAILED AFTER 14.4 HOURS

1500°F AND 15.2 KSI, FAILED AFTER 25.7 HOURS

1500°F AND 10 KSI, FAILED AFTER 83.6 HOURS

Temperature (°F)	Stress (ksi)	Life (hr)	Visual Examination*				Metallographical Examination		Photomicrograph Figure No.
			Failure		Corrosion	Brazing Alloy Fillet	Point of Failure		
			Type	Location					
1500	20	14.4	P	-1	S	No corros. in	Grain boundary oxidation, completely penetrated	87	
1500	15.2	25.7	P	J	M	No corrosion	Internal oxidation, slight porosity	87	
1500	10	83.6	P	-1/4	M	Intergranular oxide layer	Wart. Metal 1 mil thick	87	
1500	4.5	1196.3	P	-3	M	No corrosion	Oxide layer 1/2 mil thick, internal oxidation	88	
1300	30	110.3	P	-1	S	No corrosion	Intergranular oxidation	88	
1300	26.7	87.9	P	J	S	No corrosion	Internal oxide layer	88	
1300	22.5	712.2	P	-1-1/2	M	Heavy oxide layer	Internal attack, oxide layer	89	
1300	22.5	106.7	P	J	M	Slight oxidation	Internal oxide layer at tube/braze interface	89	
1100	40	760.4	P	-1/2	M	No corrosion	Oxidized fissure	89	
1100	40	532.7	P	-4	S	No corrosion	Intergranular oxidation	-

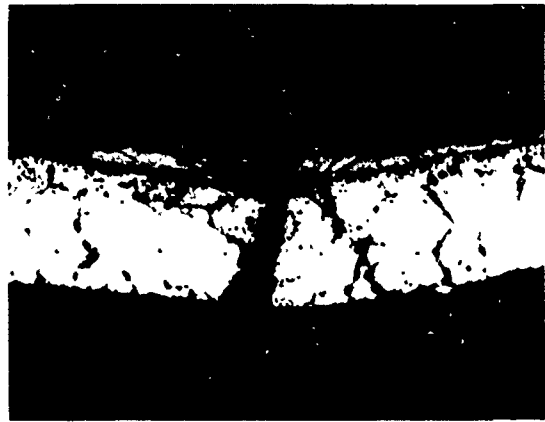
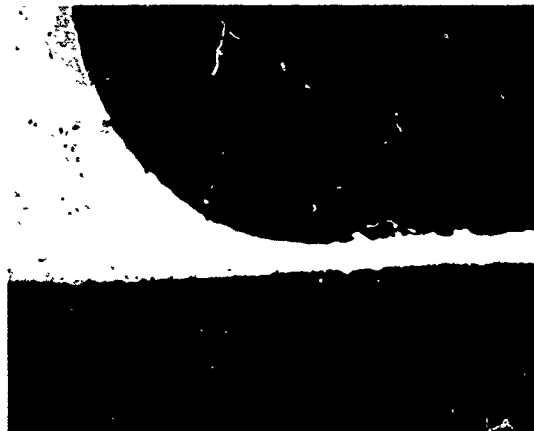
Figure 88. Photomicrographs of Multimet N-155 Tubes Brazed With Palniro I Brazing Alloy.

1500°F AND 4.5 KSI, FAILED AFTER 119.6 HOURS

1300°F AND 30 KSI, FAILED AFTER 110.3 HOURS

1300°F AND 26.7 KSI, FAILED AFTER 87.9 HOURS

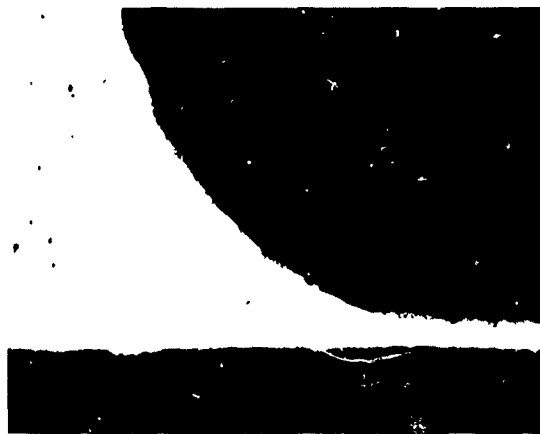
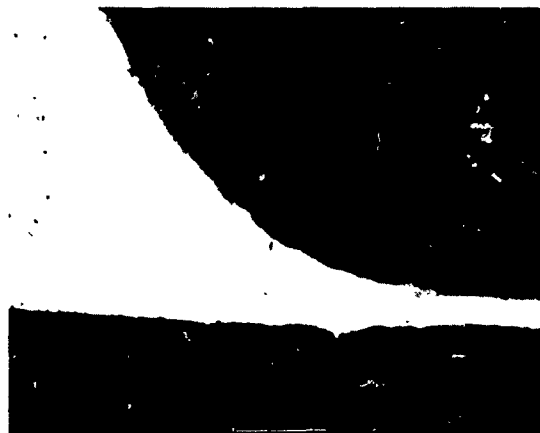
1300°F AND 22.5 KSI, FAILED AFTER 712.2 HOURS

1300°F AND 22.5 KSI, FAILED AFTER 106.7 HOURS

1100°F AND 40 KSI, FAILED AFTER 760.4 HOURS

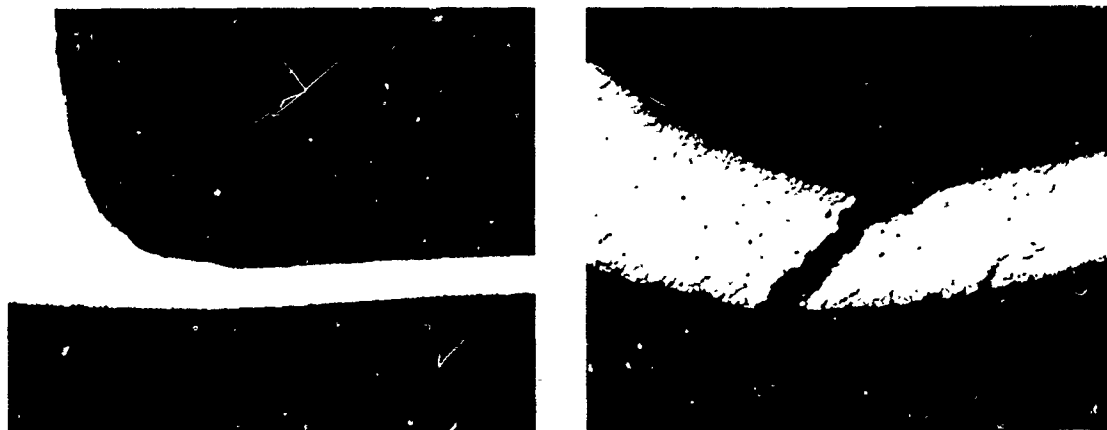
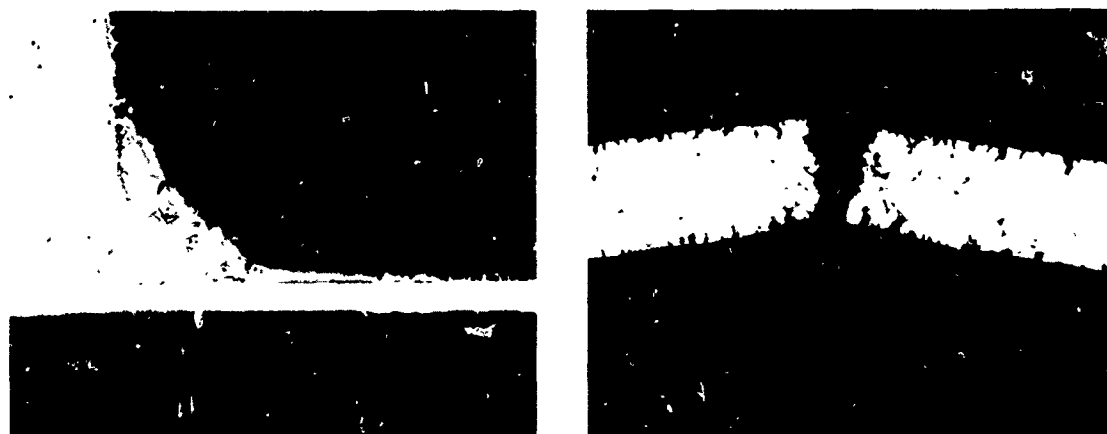
Figure 90. Photomicrographs of Multimet N-155 Tubes Brazed With Microbraz 200 Brazing Alloy.

1500°F AND 20 KSI, FAILED AFTER 24.5 HOURS

1500°F AND 15.2 KSI, FAILED AFTER 7.8 HOURS

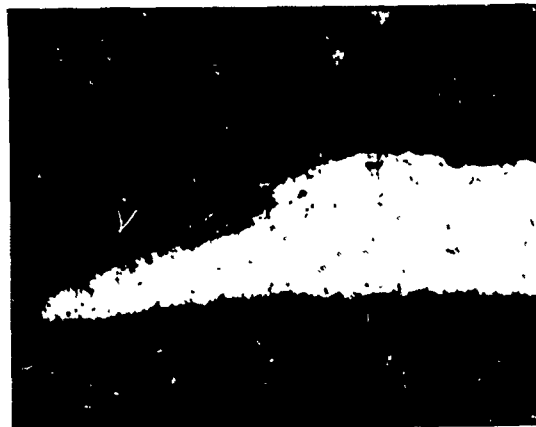
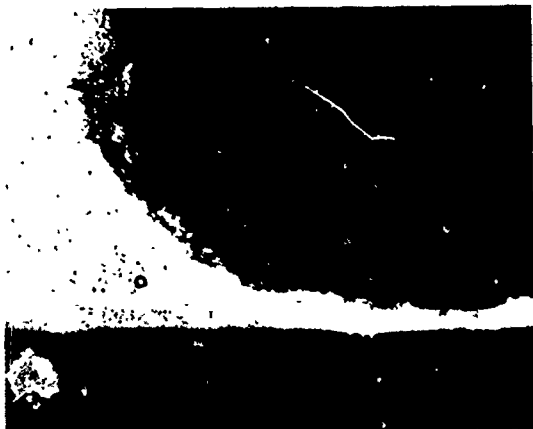
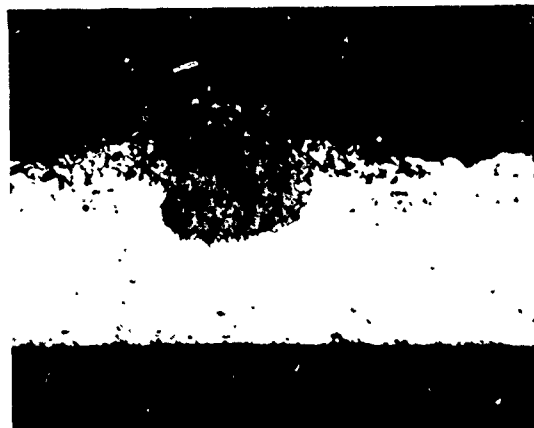
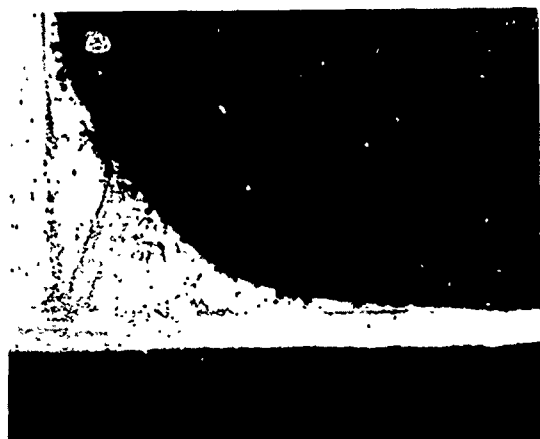
Figure 91. Photomicrographs of Multimet N-155 Tubes Brazed With Microbraz 200 Brazing Alloy.

1500°F AND 4.5 KSI, FAILED AFTER 908.4 HOURS

1500°F AND 4.5 KSI, FAILED AFTER 967.5 HOURS

1300°F AND 26.7 KSI, FAILED AFTER 127.3 HOURS
