USAAVLABS TECHNICAL REPORT 69-92

HOT CORROSION RESISTANCE OF MATERIALS FOR SMALL GAS TURBINE RECUPERATORS

THE GARRETT CORPORATION

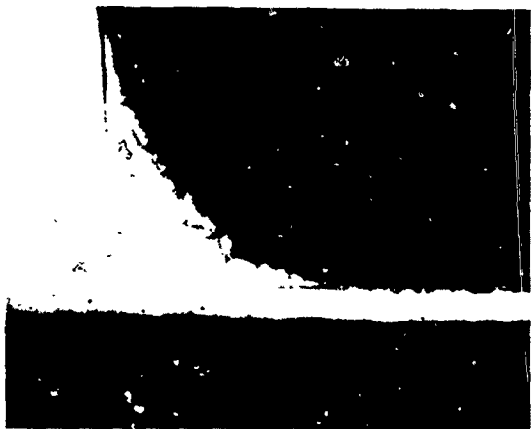
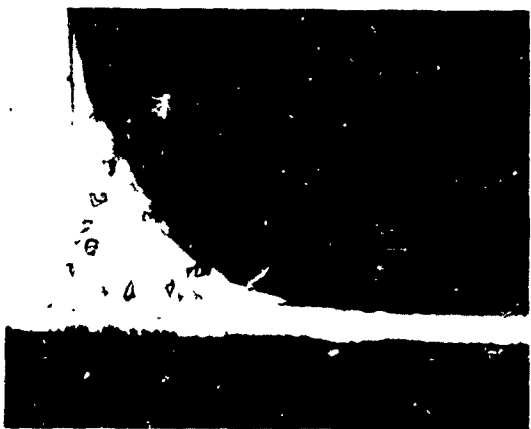
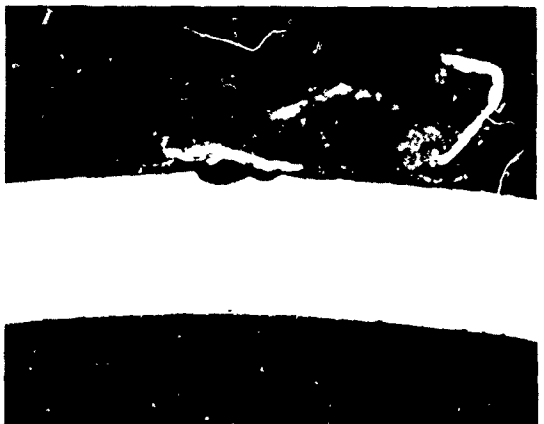
Figure 92.

1300°F AND 26.7 KSI, FAILED AFTER 85.0 HOURS

1300°F AND 25 KSI, FAILED AFTER 398.6 HOURS

1300°F AND 22.5 KSI, FAILED AFTER 221.4 HOURS

Photomicrographs of Multimet N-155 Tubes
Brazed With Microbraz 200 Brazing Alloy.

Temperature (°F)	Stress (ksi)	Life (hr)	Visual Examination*				Metallographical Examination		Photomicrograph Figure No.
			Failure		Corrosion	Braze Alloy Fillet	Point of Failure		
			Type	Location					
1500	20	24.5	P	-1	S	No corrosion	In. granular penetration, oxidized fissure	90	
1500	15.2	17.8	P	-1	S	No corrosion	Internal oxidation, porous	90	
1500	10	81	P	-1/2	M	Some surface oxidation	Intense local attack, wart	90	
1500	4.5	908.4	R	-5	M	Little surface corrosion	Internal oxidation, oxidized fissure	91	
1500	4.5	967.5	P	J	M	Heavy oxide layer	Intense local attack, wart	91	
1300	26.7	127.3	P	-10	S	No corrosion	Slight oxidation, crack	91	
1300	26.7	85.0	P	-1/2	S	No corrosion	Slight oxidation, crack	92	
1300	25	398.6	P	-5	S	No corrosion	Slight oxidation, intergranular and internal	92	
1300	22.5	221.4	P	-9	S	No corrosion	No evidence of failure	92	
1300	22.5	852	P	-2	H	No corrosion	Intergranular oxidation, metal thickness = 0.001 in.	93

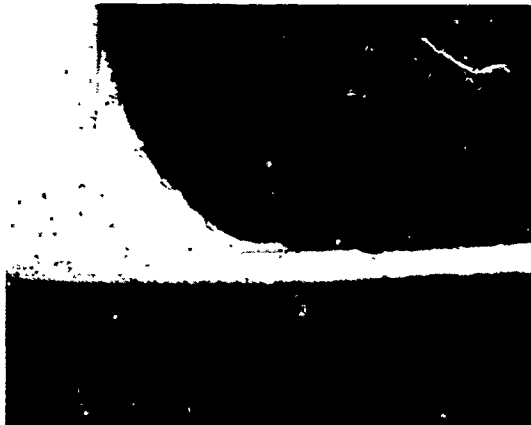
1300°F AND 22.5 KSI, FAILED AFTER 852.0 HOURS

1100°F AND 40 KSI, FAILED AFTER 1023.6 HOURS

1100°F AND 40 KSI, FAILED AFTER 485.2 HOURS

1100	40	1023.6	P	-4	M	No corrosion	Internal oxidation	93	
1100	40	485.6	R	J	S	No corrosion	Intergranular penetration at tube/ braze interface	93

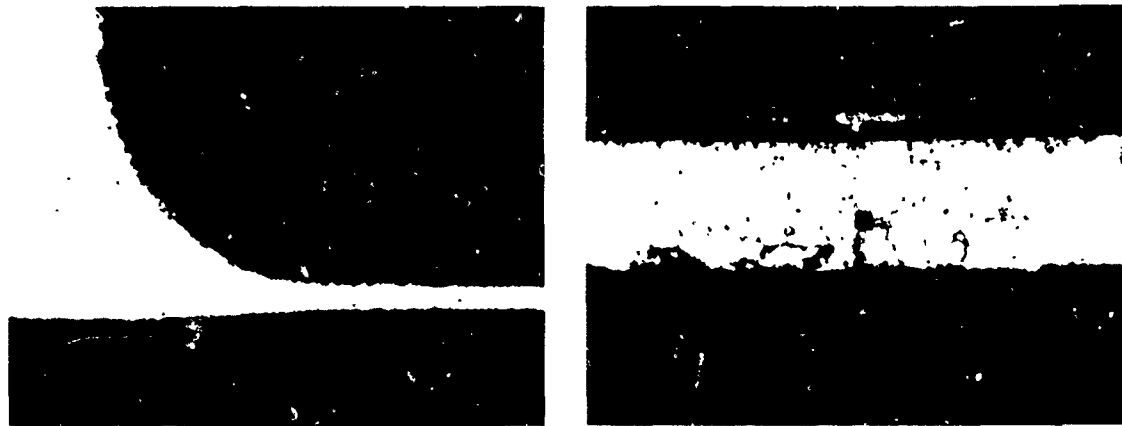
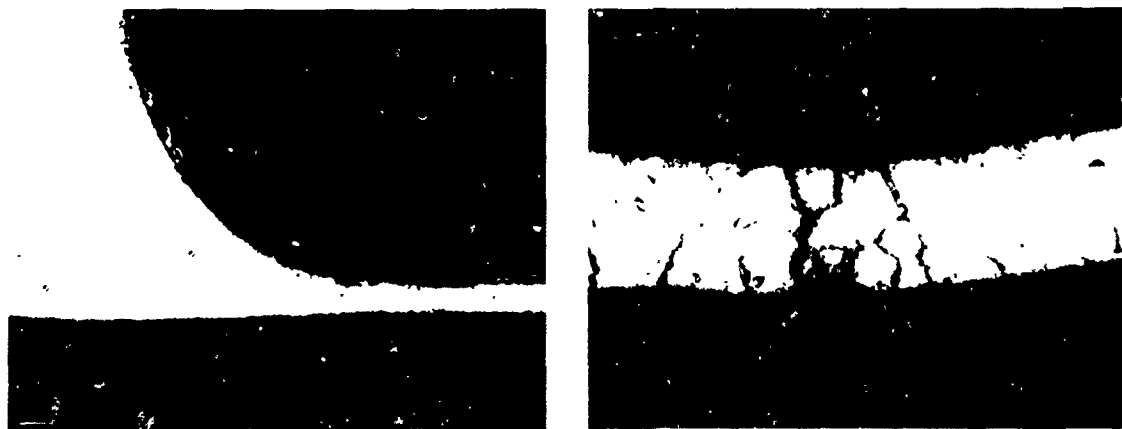
Figure 94. Photomicrographs of Hastelloy X Tubes Brazed With Palniro I Brazing Alloy.

1500°F AND 13.9 KSI, FAILED AFTER 13.8 HOURS

1500°F AND 9.0 KSI, FAILED AFTER 114.4 HOURS

1500°F AND 9.0 KSI, FAILED AFTER 135.9 HOURS

Temperature (°F)	Stress (ksi)	Life (hr)	Visual Examination*		Metallographical Examination		Photomicrograph Figure No.	
			Failure Type	Location	Corrosion	Point of Failure		
								Braze Alloy Fillet
1500	13.9	13.8	P	-2 in.	S	Very light intergranular corrosion	Extensive grain boundary oxidation	94
1500	7.0	114.4	P	J	S	Slight intergranular corrosion	Grain boundary oxidation, some internal oxidation	94
1500	9.0	135.9	P	+1/4	S	Slight intergranular corrosion	Extensive grain boundary oxidation	94
1500	6.5	35.4	P	J	S	Moderate internal oxidation layer	Internal oxidation at interface	95
1500	6.5	277	R	-1/2	S	Slight intergranular corrosion	Internal oxidation, porous	95
1500	6.5	341.3	R	J	H	Heavy internal oxidation layer	Internal oxidation, porous	95
1500	4.5	325.8	P	J	H	Slight intergranular corrosion	Internal oxidation, porous	95
1300	20.8	175.2	R	J	S	Some internal oxidation	Internal oxidation at interface	96

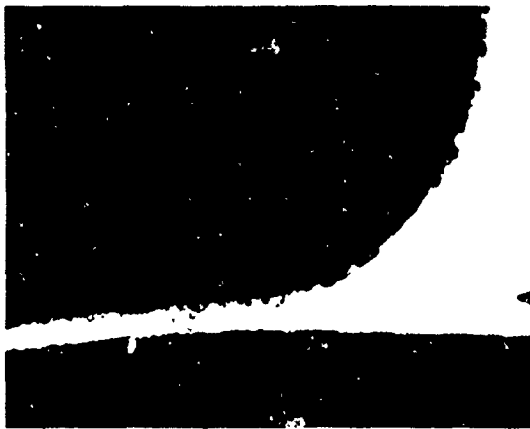
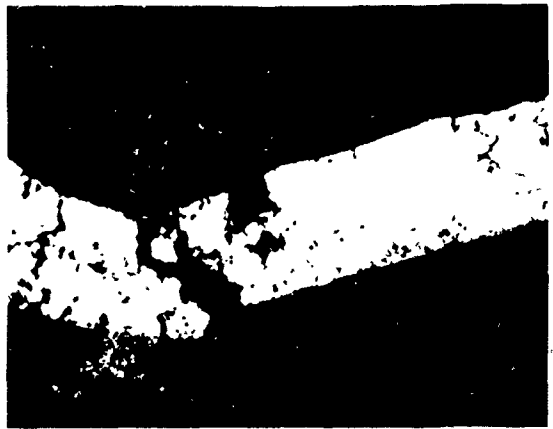
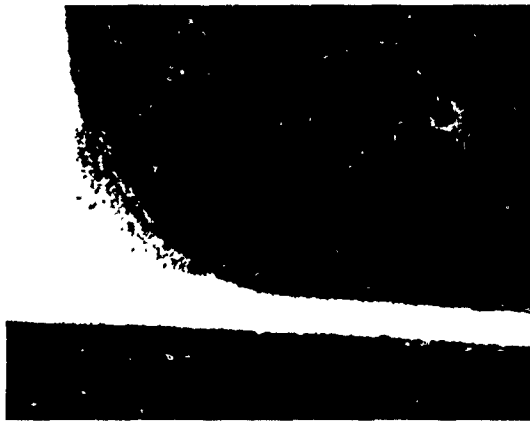
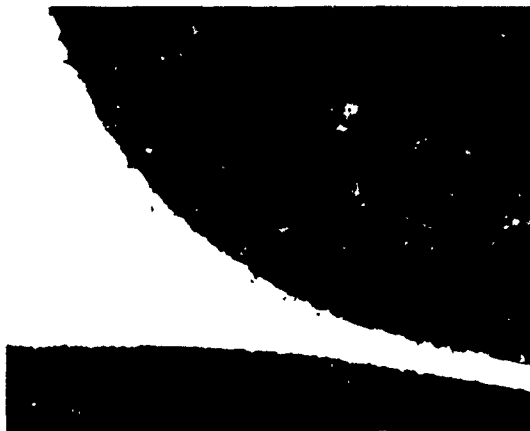
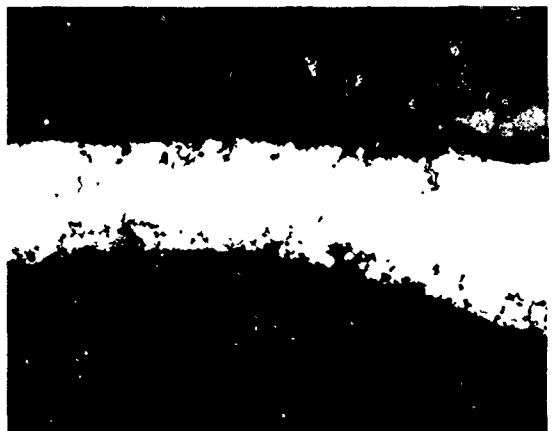
Figure 95. Photomicrographs of Hastelloy X Tubes Brazed With Palniro I Brazing Alloy.

1500°F AND 6.5 KSI, FAILED AFTER 277.0 HOURS

1500°F AND 6.5 KSI, FAILED AFTER 341.3 HOURS

1500°F AND 4.5 KSI, FAILED AFTER 325.8 HOURS

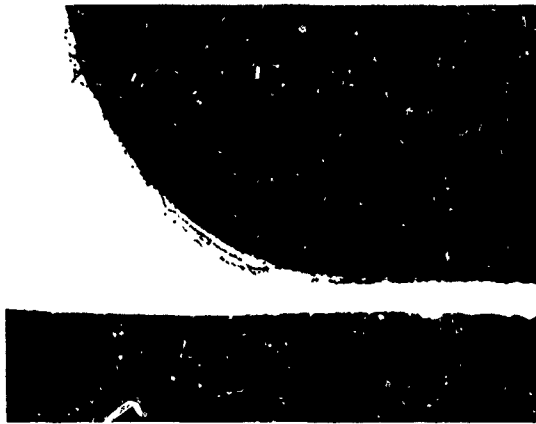
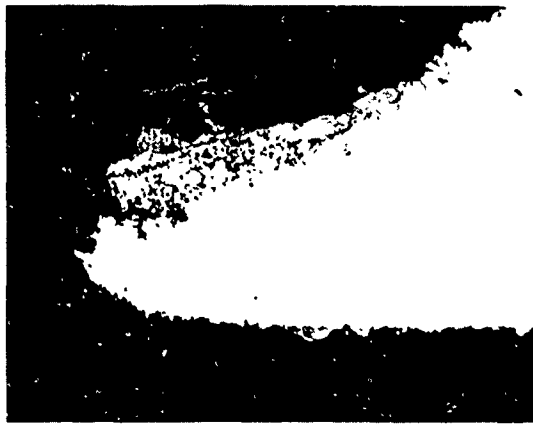
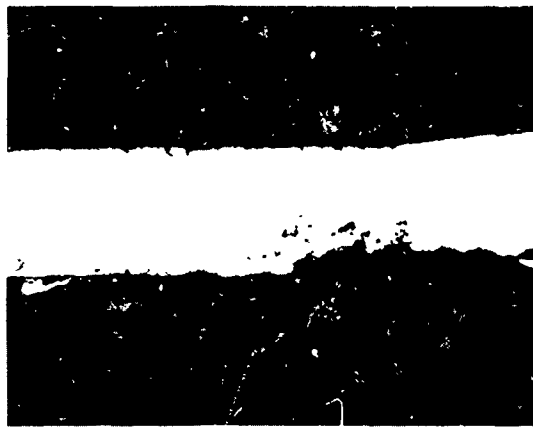
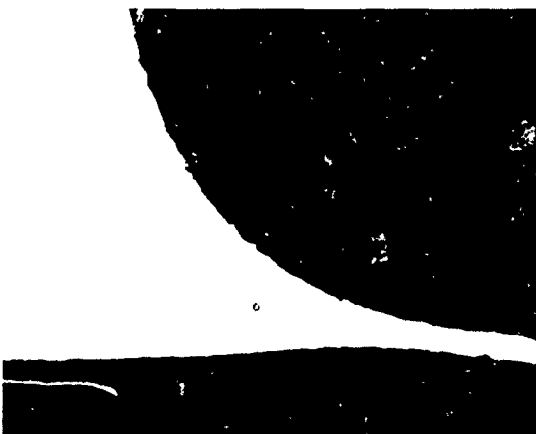
Figure 96. Photomicrographs of Hastelloy X Tubes Brazed With Palniro I Brazing Alloy.

1300°F AND 20.8 KSI, FAILED AFTER 175.2 HOURS

1300°F AND 19.1 KSI, FAILED AFTER 137.2 HOURS

1300°F AND 19.1 KSI, FAILED AFTER 385.6 HOURS

1300	19.1	187.2	P	J	H	Very slight internal corrosion	Internal oxidation, porous	96
1300	19.1	385.6	P	-2 in.	H	Very slight internal corrosion	Grain boundary oxidized	96
1300	16.0	424.7	P	+1/4	H	No corrosion	Very little oxidation	97
1300	16.0	951.4	P	+6	H	No corrosion	Extensive grain boundary oxidation	97
1100	34.7	1121	P	+2	S	No corrosion	Slight intergranular oxidation	97

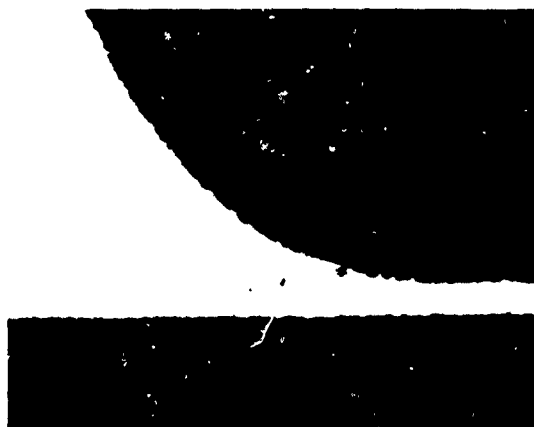
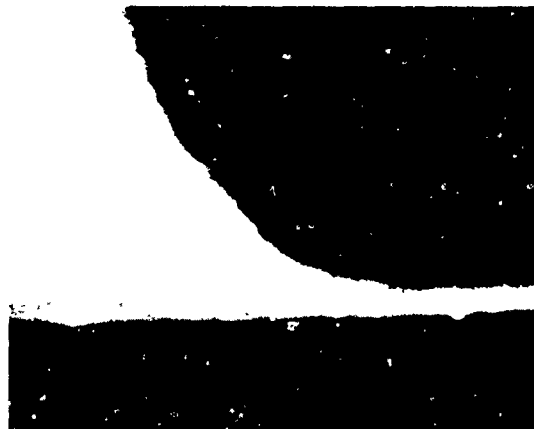
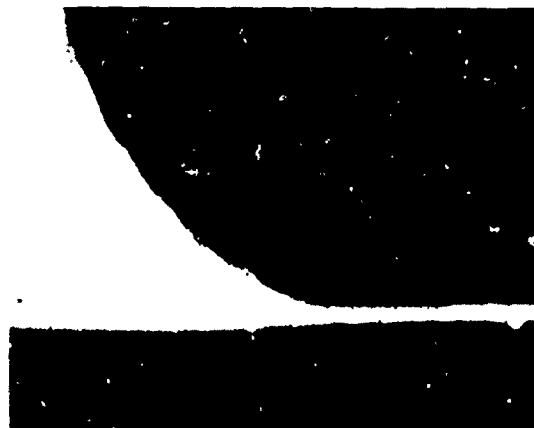
1300°F AND 16 KSI, FAILED AFTER 424.7 HOURS

1300°F AND 16 KSI, FAILED AFTER 951.4 HOURS

1100°F AND 34.7 KSI, FAILED AFTER 1121.0 HOURS

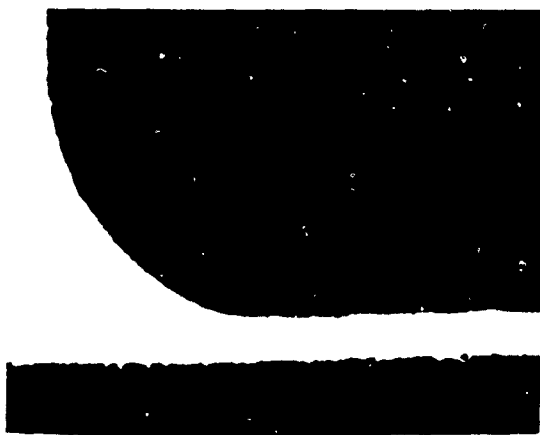
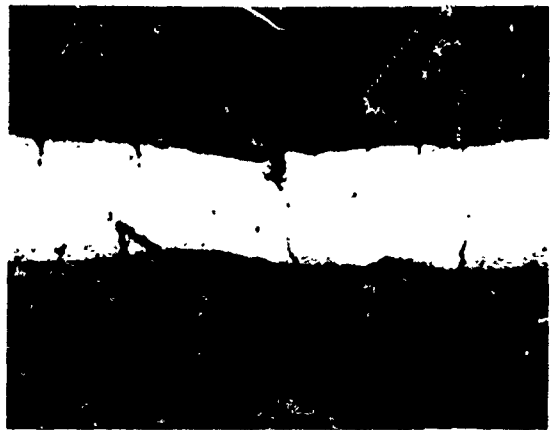
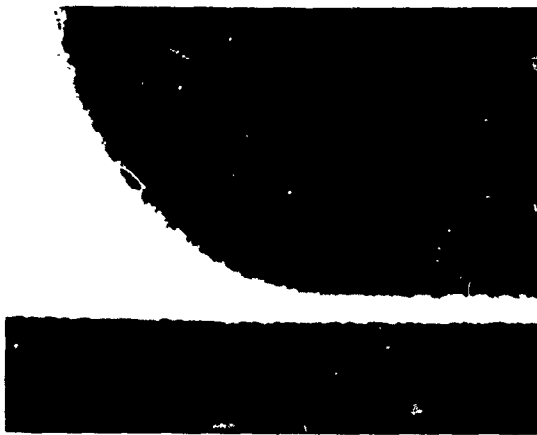
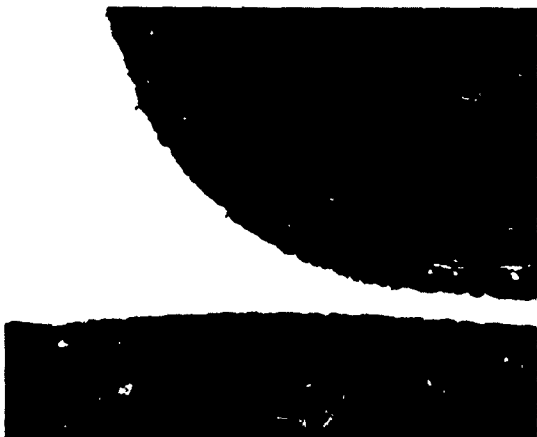
Figure 98. Photomicrographs of Hastelloy X Tubes Brazed With J-8100 Brazing Alloy.

1500°F AND 13.9 KSI, FAILED AFTER 28.1 HOURS

1500°F AND 9 KSI, FAILED AFTER 171.4 HOURS

1500°F AND 6.5 KSI, FAILED AFTER 156.6 HOURS

Temperature (°F)	Stress (ksi)	Life (hr)	Visual Examination*			Metallographical Examination		Photomicrograph Figure No.
			Failure		Corrosion	Brace Alloy Fillet	Point of Failure	
			Type	Location				
1500	13.9	28.1	P	-1	S	No corrosion	Intergranular penetration 1/3 way through	98
1500	9.0	171.4	P	-1	M	No corrosion	Intergranular penetration all way through	98
1500	6.5	156.6	P	J	S	No corrosion	Intergranular oxidation, some porosity	98
1500	6.5	141.8	P	-1	M	Slight oxidation	Intergranular penetration all way through	99
1500	4.5	418.9	P	J	M	Slight intergranular oxidation	Some intergranular oxidation	99
1300	25	122.2	P	-1-1/2	S	No corrosion	Intergranular oxidation	99
1300	20.0	204.4	P	-1	S	No corrosion	Intergranular penetration 3/4 way through	100
1300	20.0	344.4	P	-2	M	No corrosion	Intergranular penetration 1/2 way through	100
1300	20.0	991.0	P	-1	M	Slight intergranular attack	Intergranular penetration all way through	100

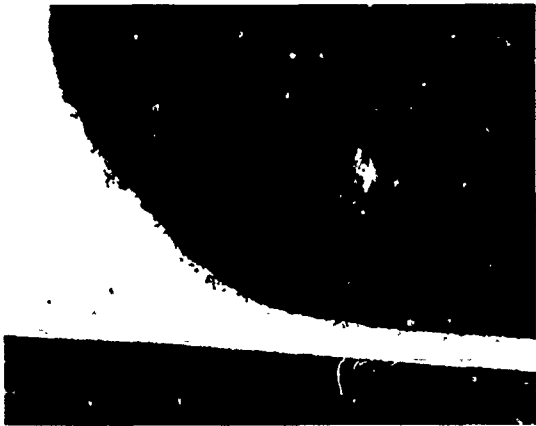
1500°F AND 6.5 KSI, FAILED AFTER 141.8 HOURS

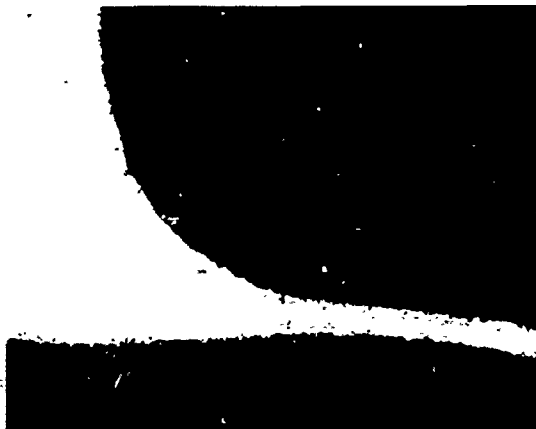
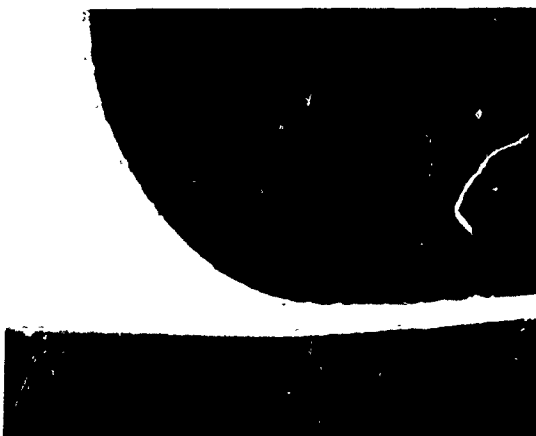
Figure 99. Photomicrographs of Hastelloy X Tubes Brazed With J-8100 Brazing Alloy.

1500°F AND 4.5 KSI, FAILED AFTER 418.9 HOURS

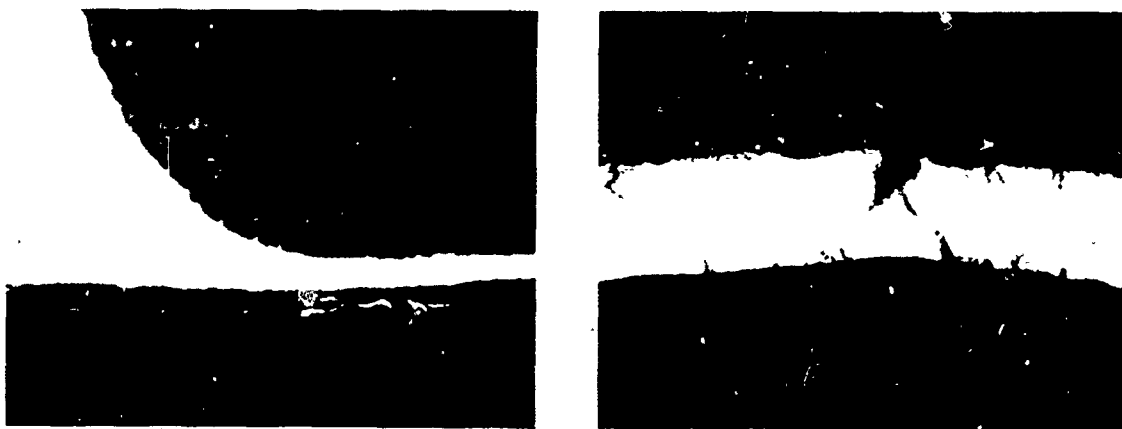
Figure 100. Photomicrographs of Hastelloy X Tubes Brazed With J-8100 Brazing Alloy.

1300°F AND 25 KSI, FAILED AFTER 122.2 HOURS

1300°F AND 20.8 KSI, FAILED AFTER 204.4 HOURS

1300°F AND 20 KSI, FAILED AFTER 344.4 HOURS

1300°F AND 20 KSI, FAILED AFTER 991.0 HOURS

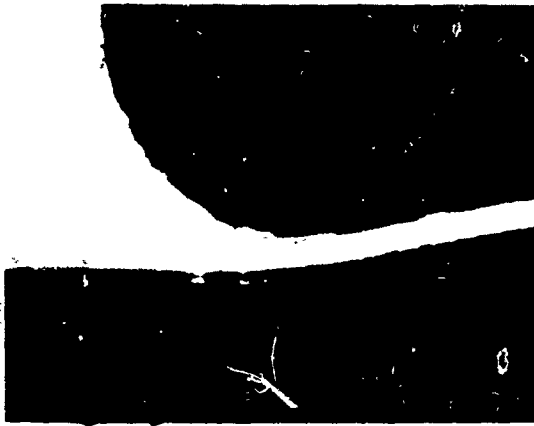
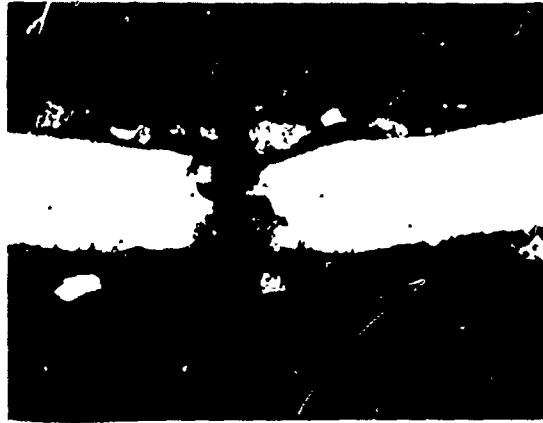
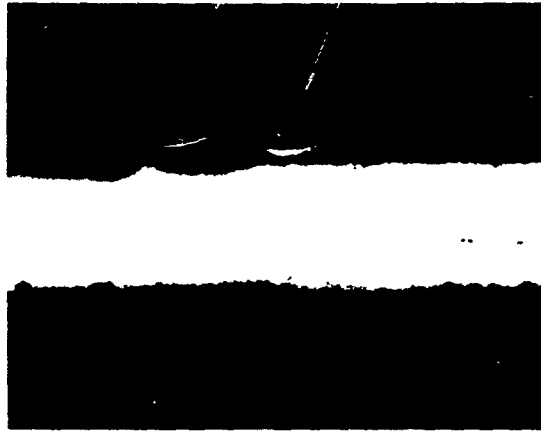
1100°F AND 34.7 KSI. FAILED AFTER 364.2 HOURS

1100°F AND 34.7 KSI. AFTER 1507.5 HOURS WITHOUT FAILURE

1100	34.7	364.2	P	-1	S	No corrosion	Intergranular attack, little oxidation	101
1100	34.7	1507.5	No failure	No failure	S	No corrosion	Slight surface layer of corrosion products	101

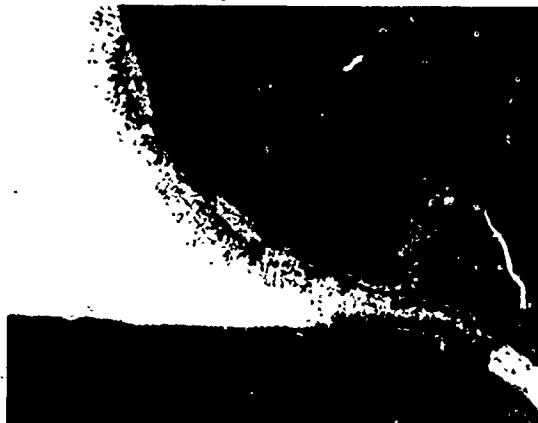
Figure 102. Photomicrographs of Incoloy 800 Tubes Brazed With Palniro 7 Brazing Alloy.

1500°F AND 8.3 KSI, FAILED AFTER 16.4 HOURS

1500°F AND 2.8 KSI, FAILED AFTER 361.4 HOURS

1500°F AND 1.21 KSI, FAILED AFTER 644.3 HOURS

TABLE XXX. INCOLOY 800 BRAZED WITH PALNIRO 7, FAILURE AND CORROSION EXAMINATION										
Temperature (°F)	Stress (ksi)	Life (hr)	Visual Examination*			Metallographical Examination				Photomicrograph Figure No.
			Failure		Corrosion	Braze Alloy Fillet	Point of Failure			
			Type	Location						
1500	8.3	16.4	P	J	S	Slight intergranular corrosion	Oxidized through, porous		102	
1500	2.8	361	P	+1/4	H	Heavy corrosion	Oxidized through at fillet/tube interface		102	
1500	1.2	644.3	R	J	H	Extensive oxidation	Oxidized through, porous		102	
1500	1.2	1501.7	No failure		H	Slight intergranular corrosion	Oxidized through, porous		103	
1300	15.3	35.4	P	+1-1/4	S	Slight intergranular corrosion	No general penetration, oxidized fissure		103	
1300	9.5	201.7	P	J	H	Slight intergranular corrosion	Corrosion layer 1-1/2 mil intergranular penetration		103	
1300	6.1	1103	P	J	H	Heavy corrosion	Extensive internal oxidation		104

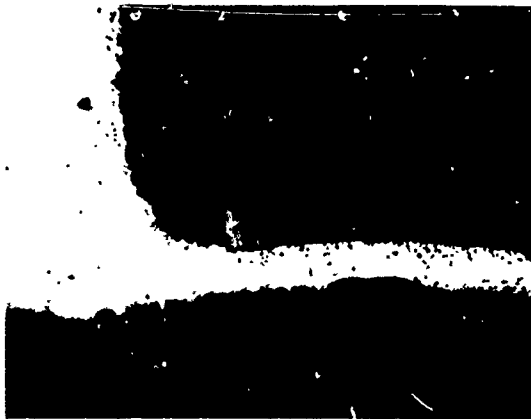
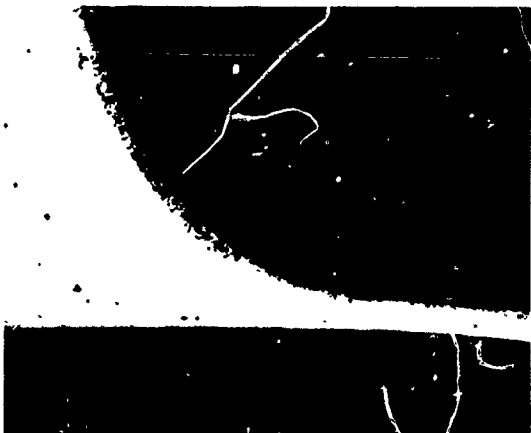
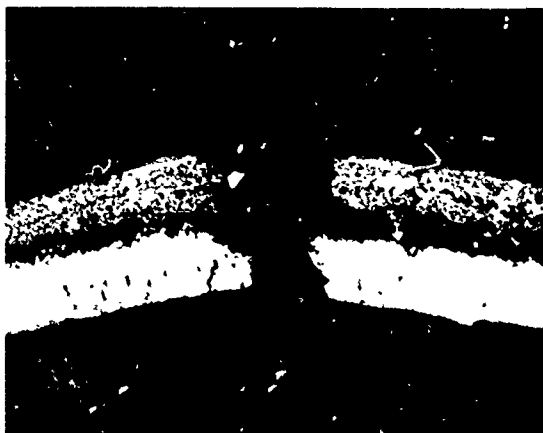
Figure 103. Photomicrographs of Incoloy 800 Tubes Brazed With Palniro 7 Brazing Alloy.

1500°F AND 1.2 KSI, AFTER 1501.7 HOURS WITHOUT FAILURE

1300°F AND 15.3 KSI, FAILED AFTER 35.4 HOURS

1300°F AND 9.5 KSI, FAILED AFTER 201.7 HOURS

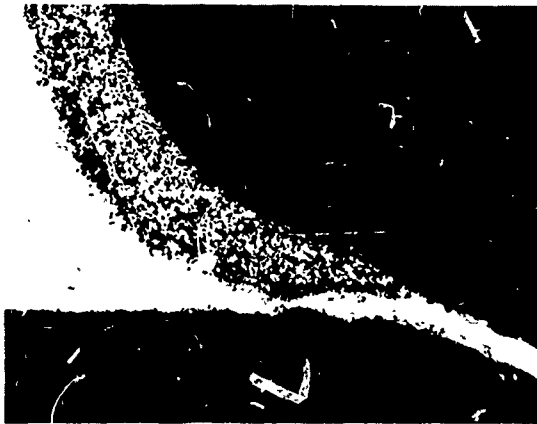
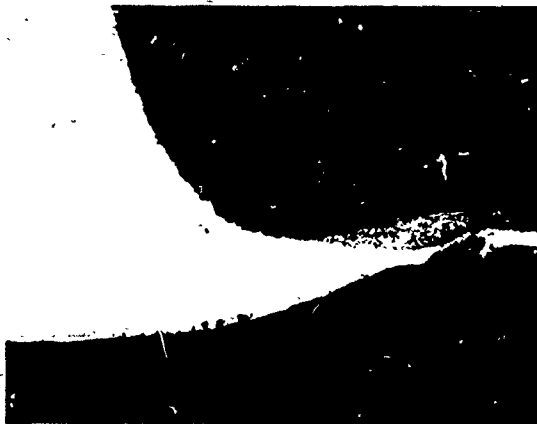
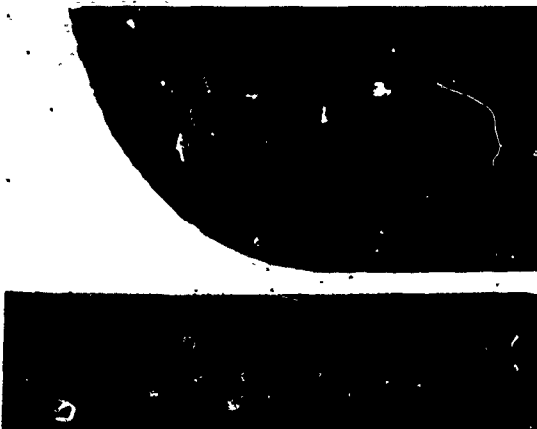
Figure 104. Photomicrographs of Incoloy 800 Tubes Brazed With Palnirc 7 Brazing Alloy.

1300°F AND 6.1 KSI, FAILED AFTER 1105.0 HOURS

1300°F AND 6.1 KSI, FAILED AFTER 490.6

1100°F AND 30 KSI, FAILED AFTER 68.2 HOURS

1300	6.1	490.6	P	J	H	Slight intergranular corrosion	Extensive internal oxidation		104	
1100	30	68.2	R	-1	S	No evidence of oxidation	No evidence of oxidation		104	
1100	27.8	314.5	R	-1/2	S	No corrosion	Some internal pitting		105	
1100	27.8	147.9	R	-1/2	S	No corrosion	No evidence of oxidation		105	
1100	7.2**	950.0	No failure		S	No corrosion	No evidence of oxidation		105

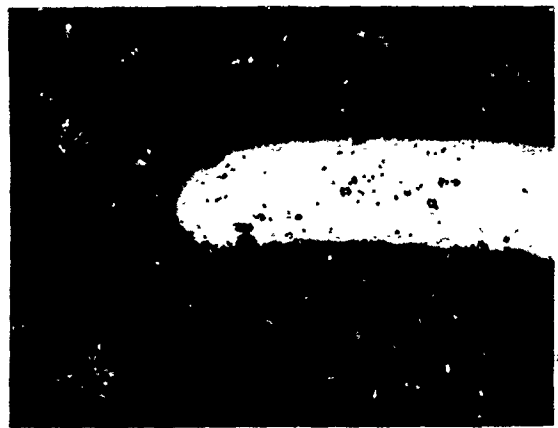
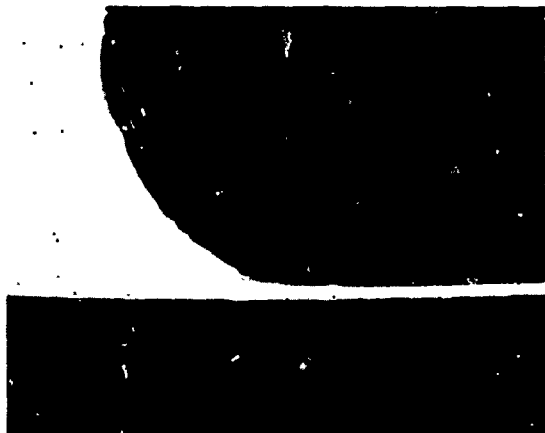
1100°F AND 27.8 KSI, FAILED AFTER 314.5 HOURS

1100°F AND 27.8 KSI, FAILED AFTER 147.9 HOURS

1100°F AND 7.2 KSI, AFTER 950.0 HOURS WITHOUT FAILURE

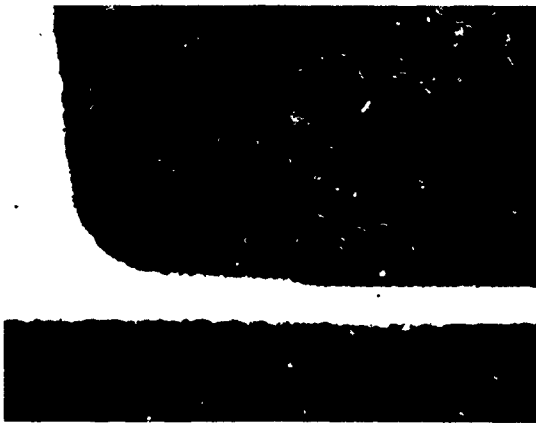
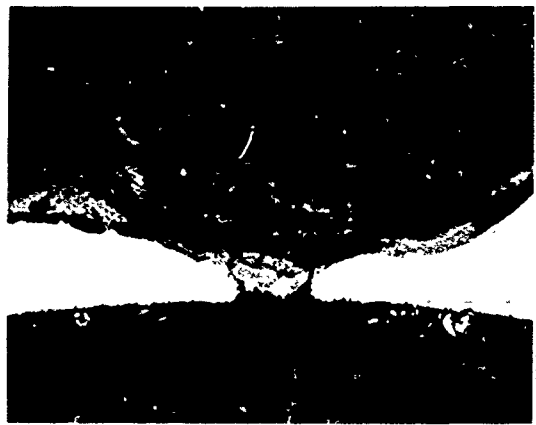
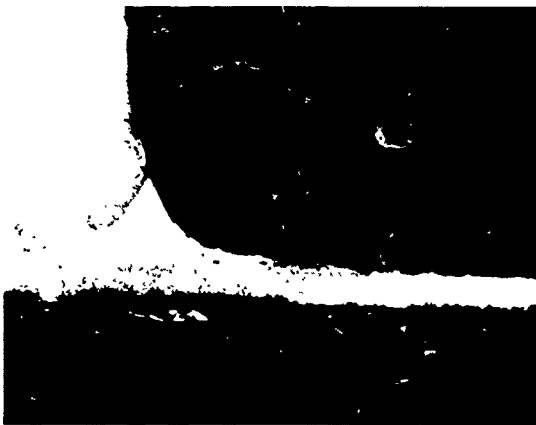
1500°F AND 8.3 KSI, FAILED AFTER 29.8 HOURS

1500°F AND 2.8 KSI, FAILED AFTER 21.4 HOURS

Temperature. (°F)	Stress (ksi)	Life (hr)	Visual Examination*		Metallographical Examination		Photomicrograph Figure No.
			Failure		Brace Alloy Fillet	Point of Failure	
			Type	Location			
1500	8.3	29.8	P	+1	No corrosion	Oxidized through, porous	106
1500	2.8	21.4	P	+1	No corrosion	Intense localized oxidation	106
1500	2.8	222.6	P	-3	No corrosion	Intense localized oxidation	106
1500	2.8	502	P	+1/2	Slight intergranular penetration	Internal oxidation, porous	107
1500	2.8	812	P	±1	Slight corrosion	Internal oxidation, porous	107
1500	1.73	346.5	P	J	Slight corrosion	Slight internal oxidation	107
1500	1.73	1177.4	No failure		Pitted	Slight internal oxidation	108
1300	15.3	33.6	P	-1/2	Slight corrosion	No general penetration, oxidized fissure	108
1300	9.5	217.5	R	-1-1/2	No corrosion	Slight internal oxidation, porous	108
1300	6.1	1081.5	R	J	Slight corrosion	Internal oxidation, porous	109
1300	6.1	740.1	P	J	Slight corrosion	Internal oxidation, porous	109

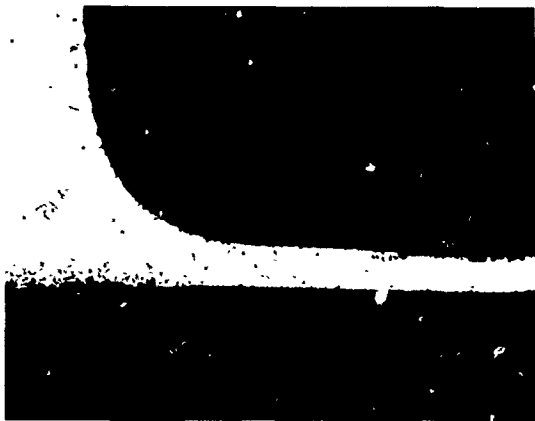
MAG = X75

MAG = X250

1500°F AND 2.8 KSI, FAILED AFTER 502.0 HOURS

Figure 107. Photomicrographs of Incoloy 800 Tubes Brazed With Coast Metals 50B Brazing Alloy.

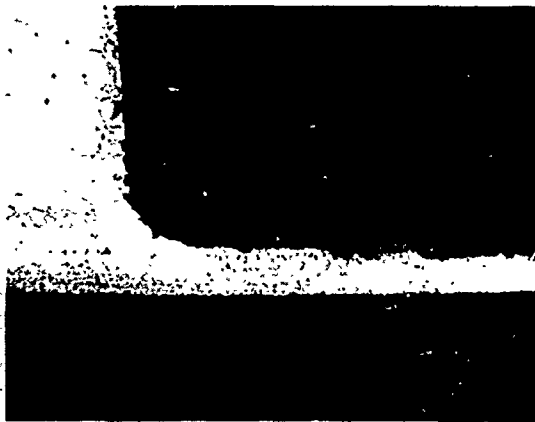
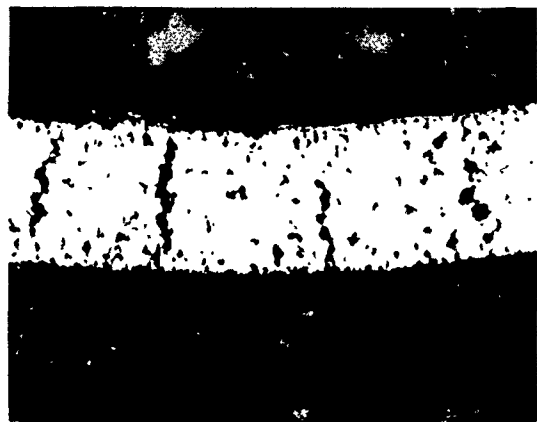
MAG = X75

MAG = X250

1500°F AND 2.8 KSI, FAILED AFTER 812.0 HOURS

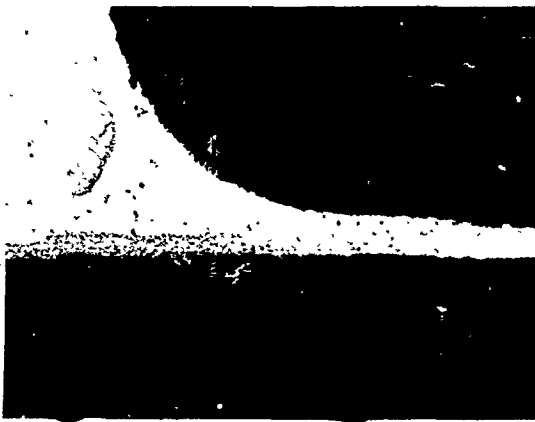
MAG = X75

MAG = X250

1500°F AND 1.73 KSI, FAILED AFTER 346.5 HOURS

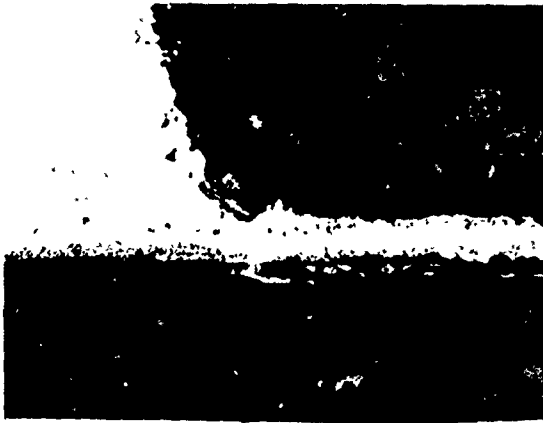
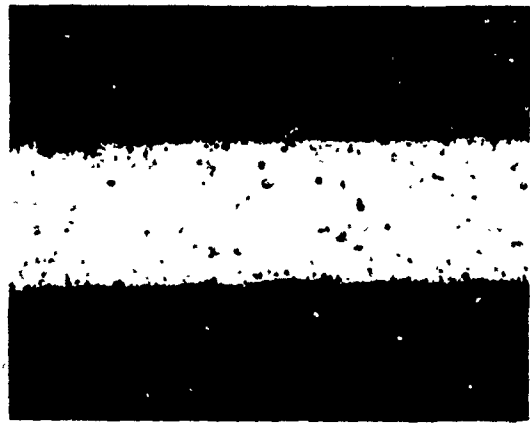
MAG = X75

MAG = X250

1500°F AND 1.73 KSI, AFTER 1172.4 HOURS WITHOUT FAILURE

Figure 108. Photomicrographs of Incoloy 800 Tubes Brazed With Coast Metals 50B Brazing Alloy.

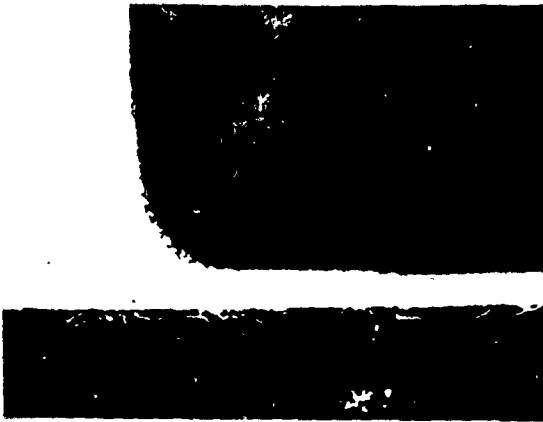
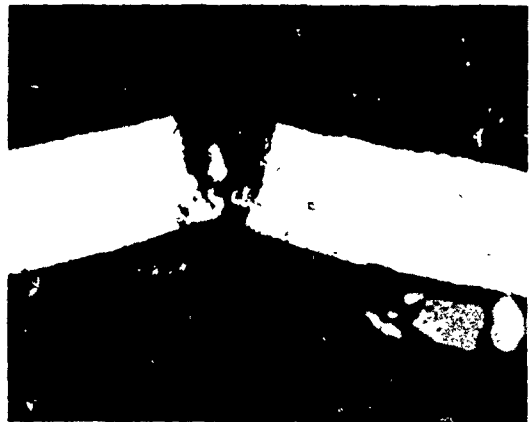
MAG = X75

MAG = X250

1300°F AND 15.3 KSI, FAILED AFTER 33.6 HOURS

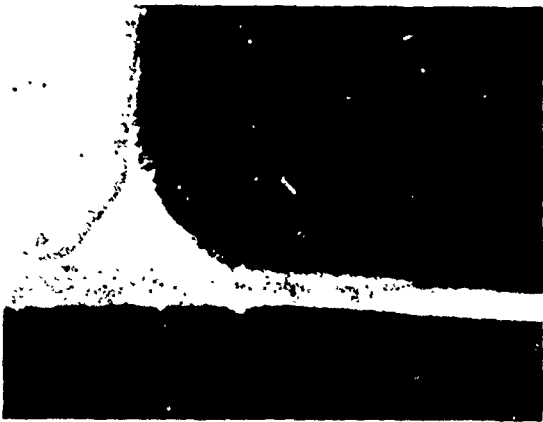
MAG = X75

MAG = X250

1300°F AND 9.5 KSI, FAILED AFTER 217.5 HOURS

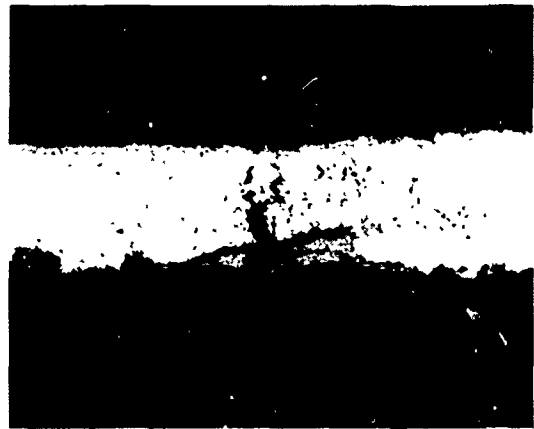
MAG = X75

MAG = X250

1300°F AND 6.1 KSI, FAILED AFTER 740.1 HOURS

Figure 109. Photomicrographs of Incoloy 800 Tubes Brazed With Coast Metals 50B Brazing Alloy.

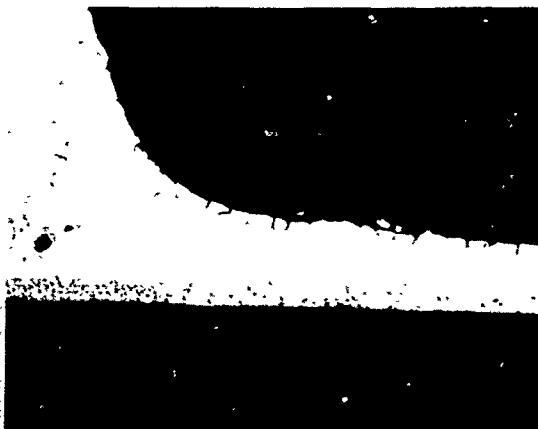
MAG = X75

MAG = X250

1100°F AND 30 KSI, FAILED AFTER 11.6 HOURS

1100	30	11.6	P	-3	No corrosion	Slight internal oxidation, porous	109
1100	30	43.4	P	-1	No corrosion	Slight internal oxidation, porous	110
				-2			
1100	27.8	420.2	P	1-1/2	No corrosion	Slight internal oxidation, porous	110
1100	7.2**	1100	No failure		No corrosion	No evidence of oxidation	110

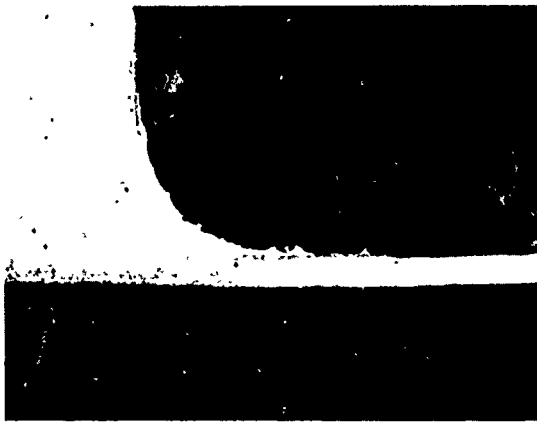
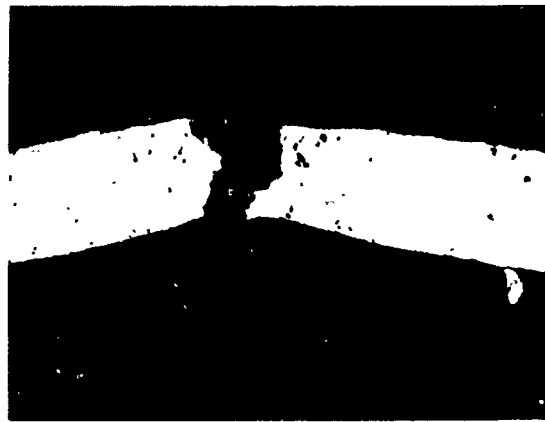
MAG = X75

MAG = X250

1100°F AND 30 KSI, FAILED AFTER 43.4 HOURS

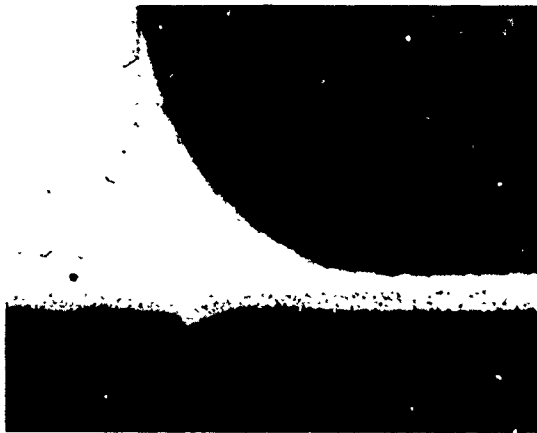
MAG = X75

MAG = X250

1100°F AND 27.8 KSI, FAILED AFTER 420.2 HOURS

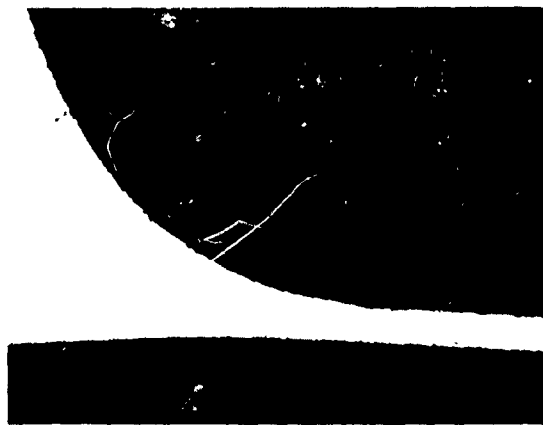
MAG = X75

MAG = X250

1500°F AND 9.2 KSI, FAILED AFTER 31.4 HOURS

Figure 111. Photomicrographs of Type 347 Stainless Steel Tubes Brazed With Palniro 7 Brazing Alloy.

Temperature (°F)	Stress (ksi)	Life (hr)	Visual Examination*			Metallographical Examination		Photomicrograph Figure No.
			Failure Type	Location	Corrosion	Brazed Alloy Fillet	Point of Failure	
1500	9.2	31.4	P	-1	H	No intergranular corrosion	Heavy oxide layer 1-1/2 mils thick, some intergranular oxidation	111
1500	9.2	47.1	P	-1	H	No corrosion	Slight oxide layer, oxidized fissure	111
1500	5.0	129.4	P	J	H	Heavy internal oxidation	Heavy oxide layer 2 mils thick	111
1500	3.0	6.8	R	-1	H	Slight intergranular oxidation	Oxide layer, almost no metal remaining	112
1500	3.0	154.4	P	J	H	Heavy internal oxidation	Heavy oxide layer 8 mils thick, oxidized all way through tube wall	112
1300	13.9	104.1	P	+1/2	M	Moderate intergranular oxide layer	Deep intergranular penetration	112
1300	10.0	608.7	P	J	H	Heavy intergranular oxide layer	Heavy oxide layer 2 mils thick	113
1300	8.0	486.4	P	-1/4	H	Heavy oxide layer, particularly at interface	Heavy oxide layer, metal 1.0 mil thick	113

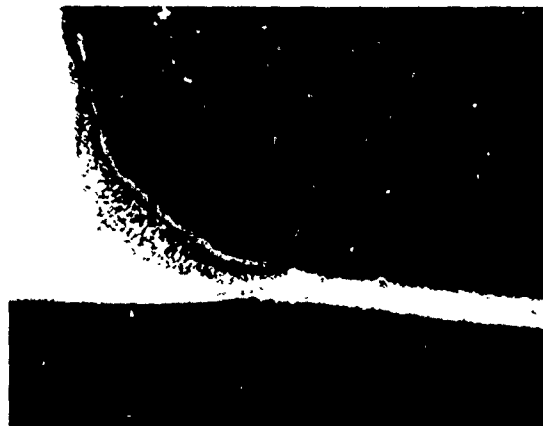
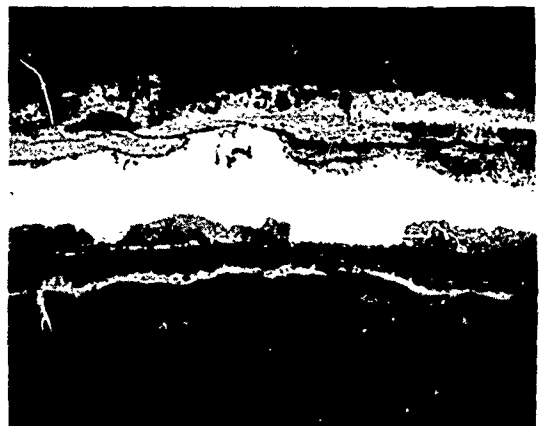
MAG = X75

MAG = X250

1500°F AND 5.0 KSI, FAILED AFTER 129.4 HOURS

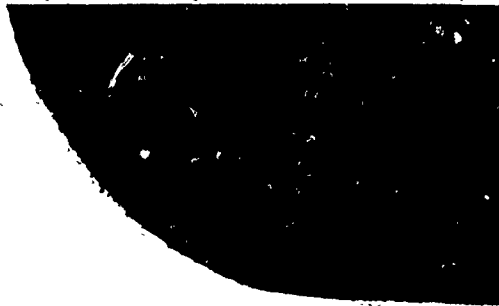
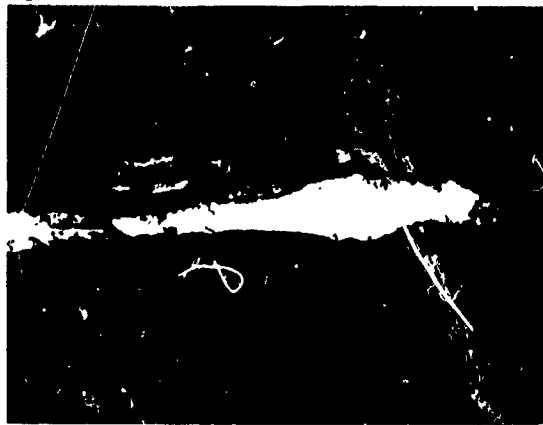
MAG = X75

MAG = X250

1500°F AND 3.0 KSI, FAILED AFTER 6.8 HOURS

Figure 112. Photomicrographs of Type 347 Stainless Steel Tubes Brazed With Palniro 7 Brazing Alloy.

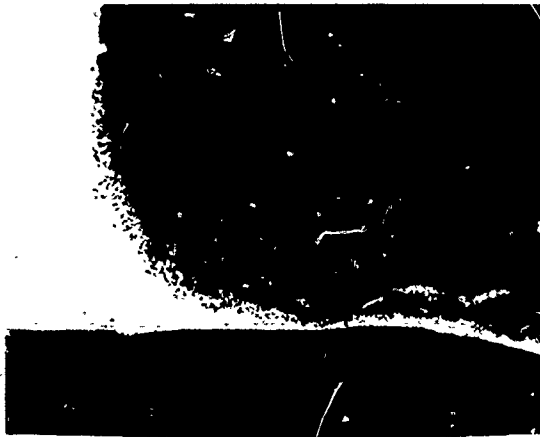
MAG = X75

MAG = X250

1500°F AND 3.0 KSI, FAILED AFTER 154.4 HOURS

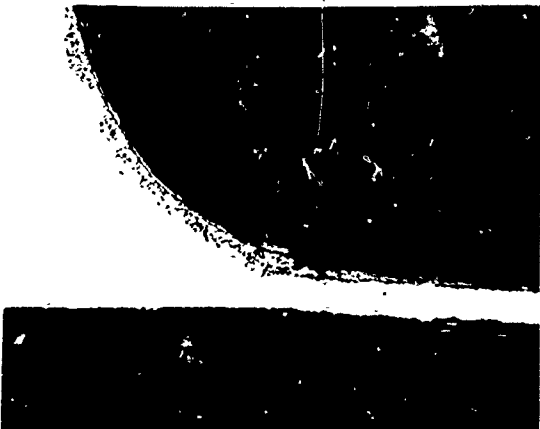
MAG = X75

MAG = X250

1300°F AND 13.9 KSI, FAILED AFTER 104.1 HOURS

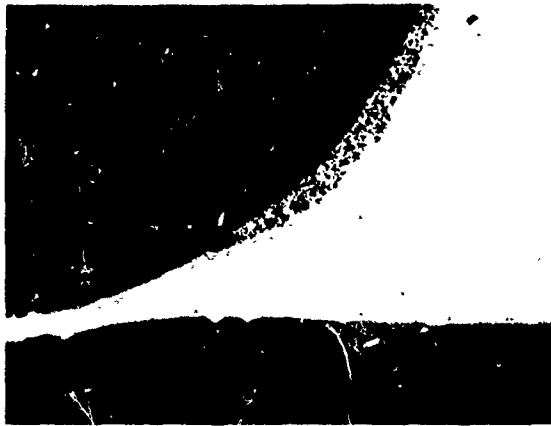
MAG = X75

MAG = X250

1300°F AND 10 KSI, FAILED AFTER 608.7 HOURS

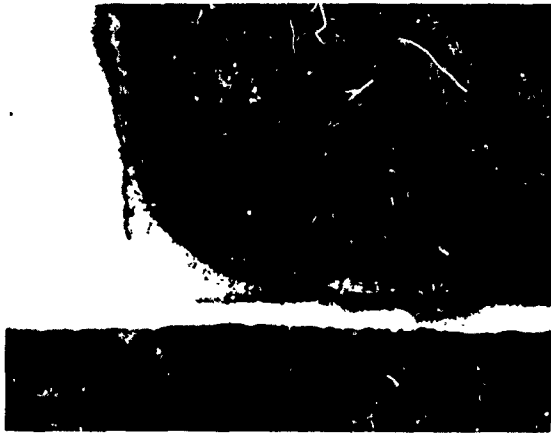
MAG = X75

1300°F AND 8.0 KSI, FAILED AFTER 486.4 HOURS

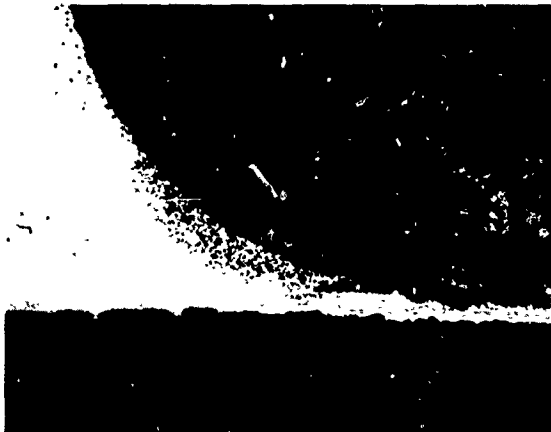
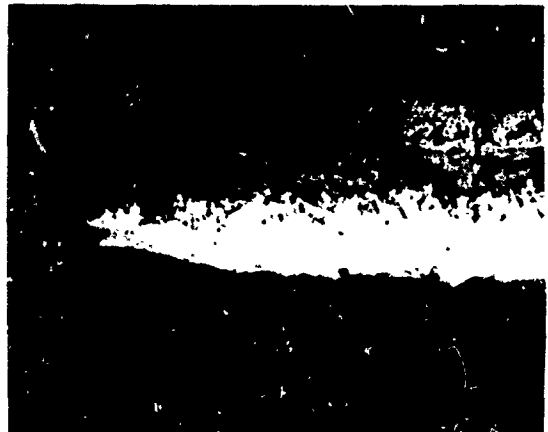
Figure 113. Photomicrographs of Type 304 Stainless Steel Tubes Brazed With Palniro 7 Brazing Alloy.

MAG = X250

MAG = X75

1300°F AND 8.0 KSI, FAILED AFTER 465.4 HOURS

1300	8.0	465.4	R	+1	H	Heavy oxide layer, particularly at interface	Heavy oxide layer, metal 0.5 mil thick	113
1100	35	57.2	R	±1	S	No corrosion	Metal thinning, slight corrosion	114
1100	30	250.1	P	-2	S	No corrosion	Slight oxide layer	114
1100	26.9	1238.7	P	+1/4	M	Some intergranular corrosion	Oxide layer 1.0 mil thick	114
1100	26.9	461	P	J	M	No corrosion	Heavy oxide layer, complete penetration	-

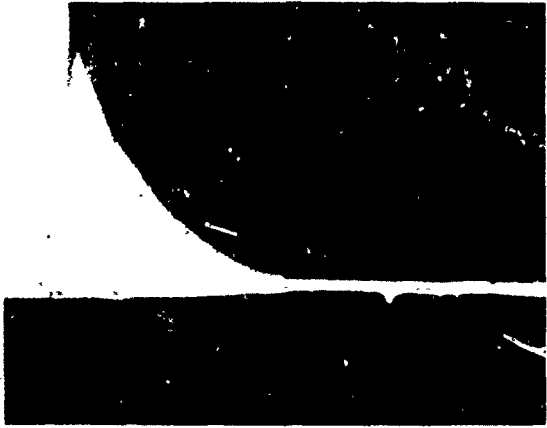
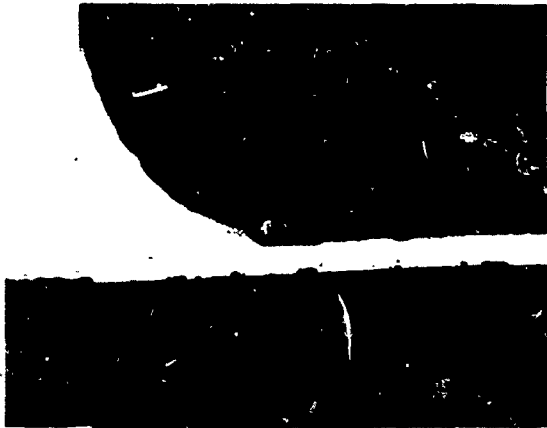
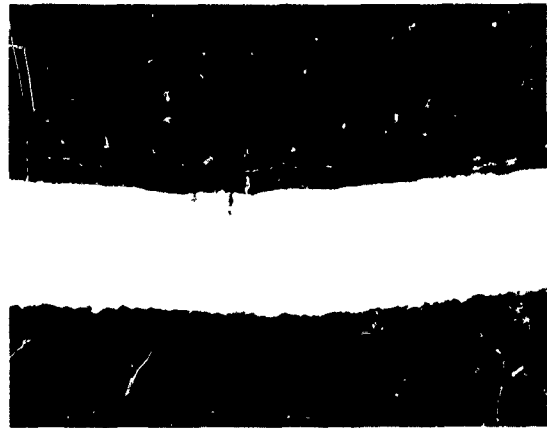
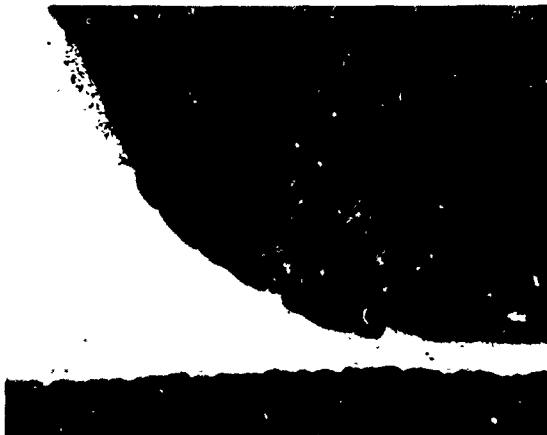
Figure 114. Photomicrographs of Type 347 Stainless Steel Tubes Brazed With Palniro 7 Brazing Alloy.

MAG = X75

MAG = X250

1100°F AND 35 KSI, FAILED AFTER 57.2 HOURS

1100°F AND 30 KSI, FAILED AFTER 250.1 HOURS

1100°F AND 26.9 KSI, FAILED AFTER 1238.7 HOURS

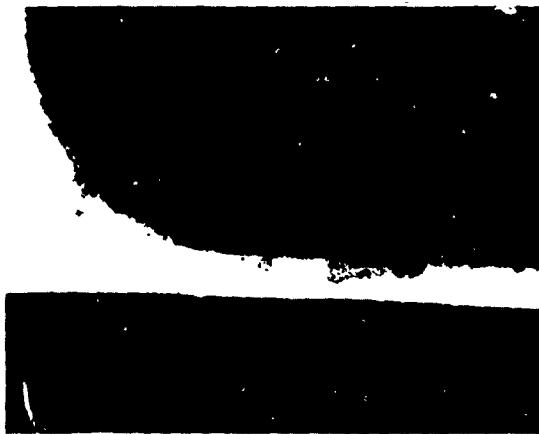
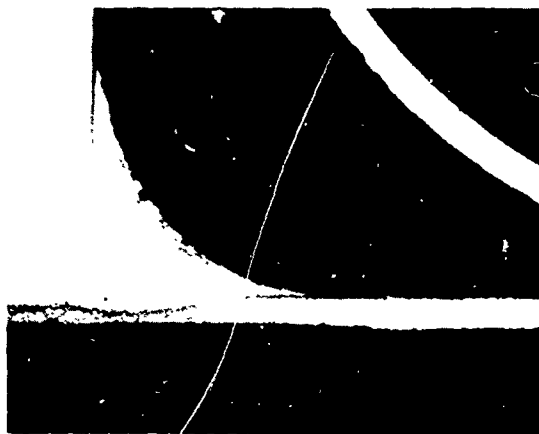
Figure 116. Photomicrographs of Type 347 Stainless Steel Tubes Brazed With Microbraz 135 Brazing Alloy.

MAG = X75

MAG = X250

1500°F AND 3.0 KSI, FAILED AFTER 17.4 HOURS

1360°F AND 13.9 KSI, FAILED AFTER 82.7 HOURS

1300°F AND 13.9 KSI, FAILED AFTER 107.7 HOURS

Temperature (°F)	Stress (ksti)	Life (hr)	Visual Examination*			Metallographical Examination		Photomicrograph Figure No.
			Failure Type	Location	Corrosion	Braze Alloy Fillet	Point of Failure	
1500	9.2	35.0	P	-1/2	M	Some surface porosity	Heavy oxide layer 1-1/2 mils thick, intergranular oxidation	115
1500	9.2	125.1	P	-1	H	No corrosion	Thin layer, little attack	115
1500	5.0	170.2	P	+1	H	No corrosion	Heavy oxide layer 1-1/2 mils thick, complete intergranular penetration	115
1500	3.0	77.4	P	-3	H	Moderate intergranular corrosion	Heavy oxide layer, 2-1/2 mils thick, some intergranular attack	116
1300	15.9	82.7	R	-3	M	Some surface porosity	Shallow oxide layer, deep intergranular oxidation	116
1300	13.9	107.7	P	-3/4	M	Slight oxide layer	Moderate oxide layer, intergranular penetration	116
1300	10.0	461.2	P	-1	H	No corrosion	Heavy oxide layer 1-1/2 mils thick, some intergranular oxidation	117
1300	8.0	676.7	P	-2	H	Slight intergranular oxidation	Heavy oxide layer	117

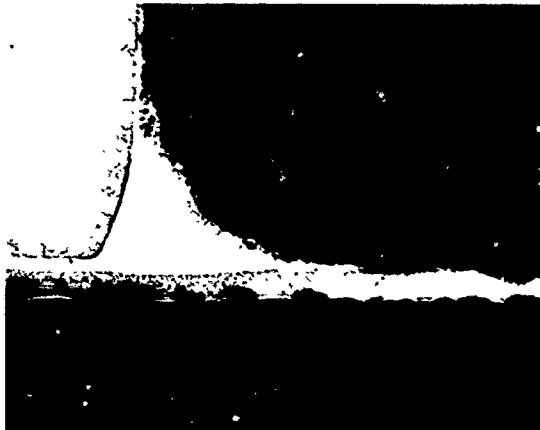
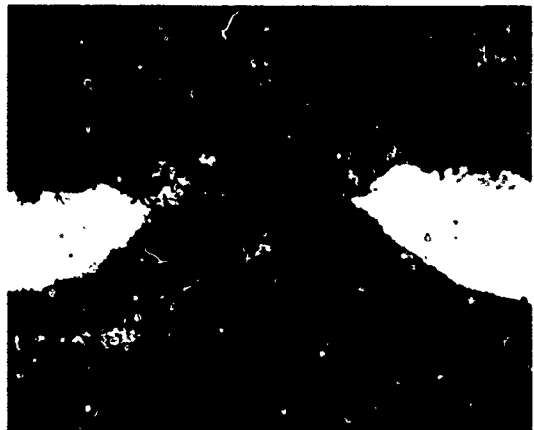
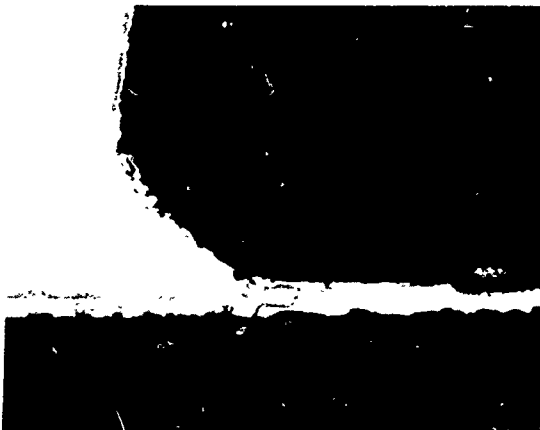
Figure 117. Photomicrographs of Type 347 Stainless Steel Tubes Brazed With Microbraz 135 Brazing Alloy.

MAG - X75

MAG - X250

1300°F AND 10.0 KSI, FAILED AFTER 441.2 HOURS

1300°F AND 8.0 KSI, FAILED AFTER 676.7 HOURS

1300°F AND 8.0 KSI, FAILED AFTER 578.5 HOURS

1300	8.0	578.5	P	+2	H	Some intergranular oxidation	Heavy oxide layer 1-1/2 mils thick	117
1100	35.0	228.1	P	J	S	No corrosion	Oxide layer 1 mil thick, oxidized fissure	118
1100	30.0	248.8	P	+1	S	No corrosion	Thin oxide layer	118
1100	26.9	1023.1	P	+1/2	M	No corrosion	Thin oxide layer	118

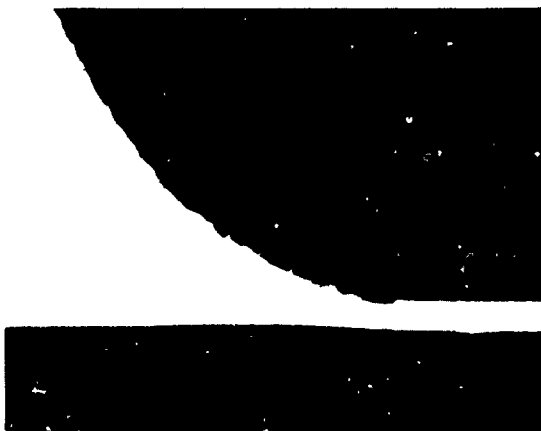
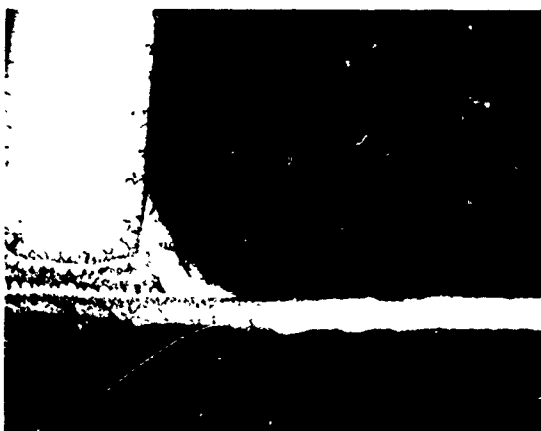
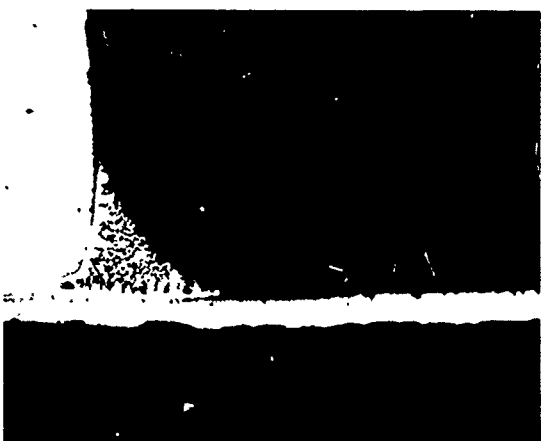
Figure 118. Photomicrographs of Type 347 Stainless Steel Tubes Brazed With Microbraz 135 Brazing Alloy.

MAG = X75

MAG = X250

1100°F AND 35 KSI, FAILED AFTER 228.1 HOURS

1100°F AND 30 KSI, FAILED AFTER 248.8 HOURS

1100°F AND 26.9 KSI, FAILED AFTER 1023.0 HOURS
