USAAVLABS TECHNICAL REPORT 69-92

HOT CORROSION RESISTANCE OF MATERIALS FOR SMALL GAS TURBINE RECUPERATORS

THE GARRETT CORPORATION

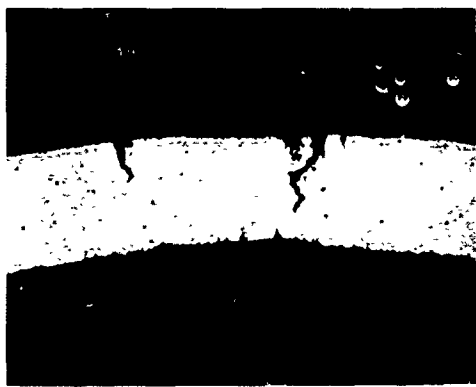
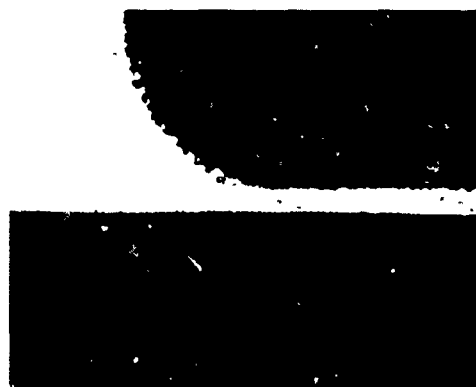
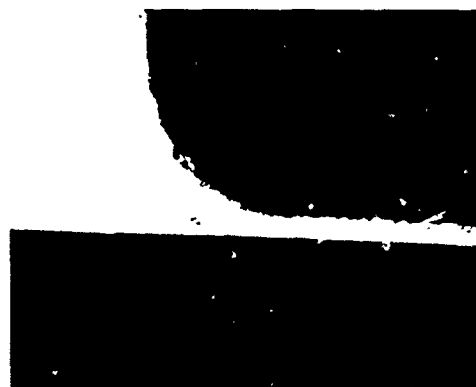
Figure 119. Photomicrographs of Inconel 625 Tubes Brazed With Microbraz 135 Brazing Alloy.

MAG = X75

MAG = X250

1500°F AND 12.1 KSI, FAILED AFTER 89.5 HOURS

1500°F AND 8.7 KSI, FAILED AFTER 230.0 HOURS

1500°F AND 6.6 KSI, FAILED AFTER 570.0 HOURS

Temperature (°F)	Stress (ksi)	Life (hr)	Visual Examination*			Metallographical Examination			Photomicrograph Figure No.
			Failure		Corrosion	Braz Alloy Fillet	Point of Failure		
			Type	Location					
1500	12.1	89.5	P	-1/2	H	No corrosion, no alloy penetration	Oxidation along boundaries at failure site	119	
1500	8.7	230.4	P	-1	H	Slight corrosion, no alloy penetration	Oxidation along boundaries at failure site, oxide film 0.5 mil thick	119	
1500	6.6	570.4	P	-1	H	Slight corrosion, no alloy penetration	Oxidation along grain boundaries at failure site	119	
1300	33.0	169.2	P	-2	S	No corrosion, no alloy penetration	Oxidized grain boundaries along stress-rupture fissure	120	
1300	26.0	675	P	+1/2	S	Slight corrosion, no alloy penetration, small fillet	Oxidized grain boundaries and fissure face	120	
1300	19.1	160.5	**		H	Slight corrosion, no alloy penetration	No grain boundary oxidation, slight oxide layer 0.1 mil thick	120

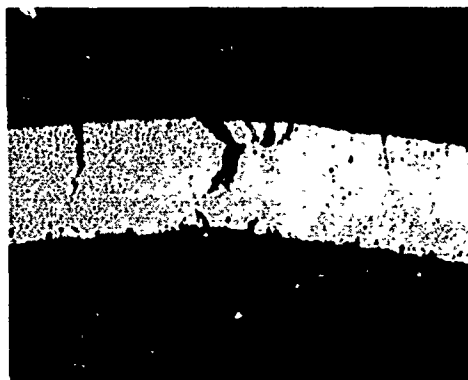
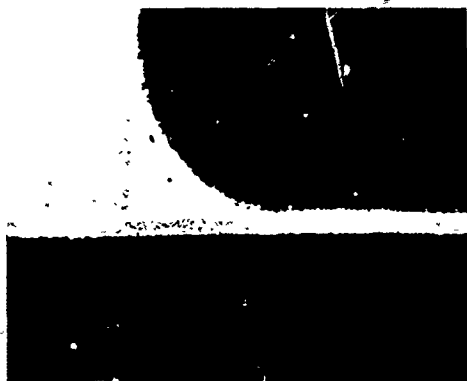
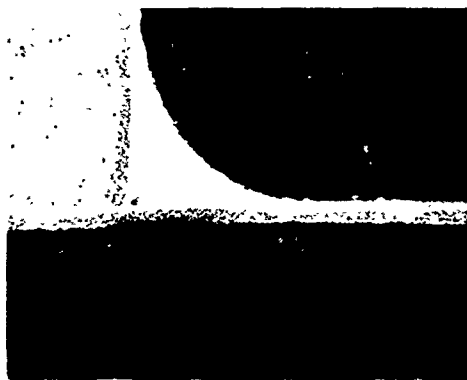
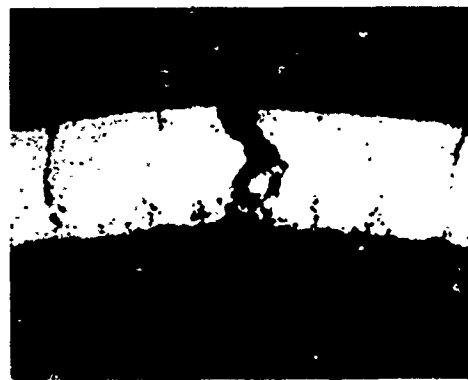
Figure 120. Photomicrographs of Inconel 625 Tubes Brazed With Microbraz 135 Brazing Alloy.

1300°F AND 33 KSI, FAILED AFTER 169.0 HOURS

1300°F AND 26 KSI, FAILED AFTER 675.0 HOURS

1300°F AND 19.1 KSI, NO FAILURE AFTER 1605.0 HOURS

1200	50.4	56.6	P	+1/2	S	No corrosion, no alloy penetration, small fillet	No oxidation observed	121	
1200	46.4	394.6	**	-	S	No corrosion, slight alloy penetration, small fillet	Discontinuous oxide layer 0.2 mil thick	121	
1200	40	655.6	P	-1	S	No corrosion, no alloy penetration, small fillet	No oxidation observed	121	
1200	34.7	1610	**		S	No corrosion, slight alloy penetration, small fillet	Discontinuous oxide layer 0.2 mil thick	121

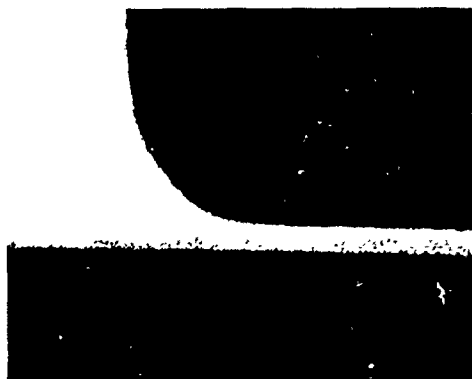
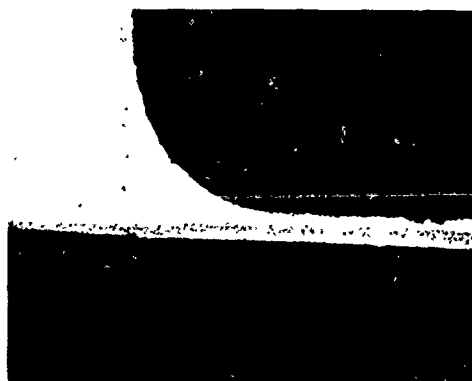
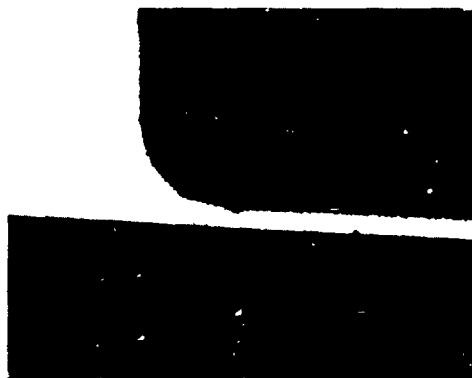
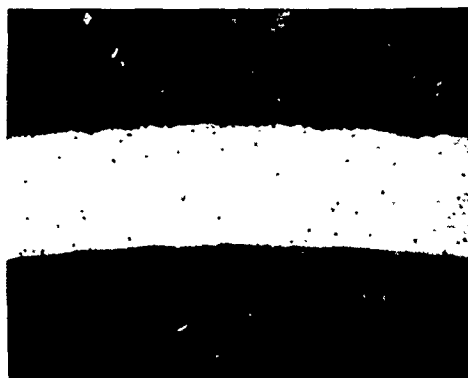
1200°F AND 50.4 KSI, FAILED AFTER 56.0 HOURS

1200°F AND 46.4 KSI, FAILED AFTER 394.0 HOURS

1200°F AND 34.7 KSI, FAILED AFTER 1610.0 HOURS

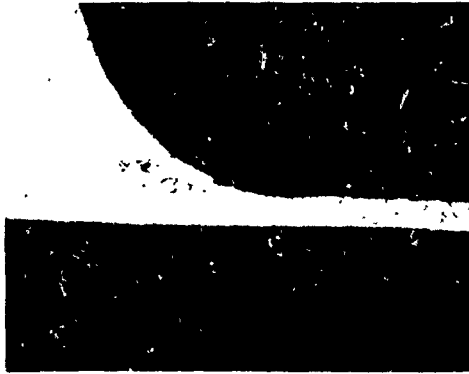
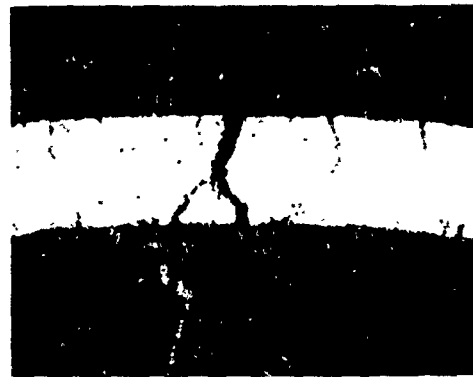
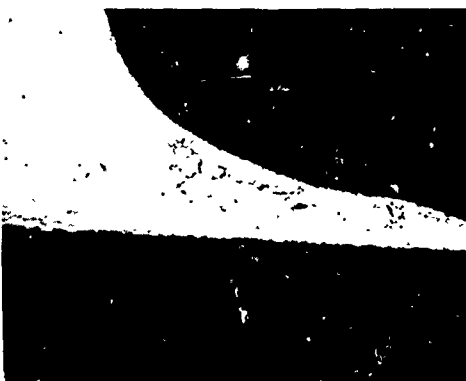
Figure 122. Photomicrographs of Inconel 625 Tubes Brazed With J-8100 Brazing Alloy.

1500°F AND 12.1 KSI, FAILED AFTER 146.0 HOURS

1500°F AND 8.7 KSI, FAILED AFTER 209.0 HOURS

1500°F AND 6.6 KSI, FAILED AFTER 570.0 HOURS

Temperature (°F)	Stress (ksi)	Life (hr)	Visual Examination*			Metallographical Examination			Photomicrograph Figure No.
			Failure Type	Location	Corrosion	Brace Alloy Fillet	Point of Failure		
1500	12.1	146.3	P	-1	H	No oxidation, complete penetration	Grain boundaries oxidized at failure site, no oxide on surface layers	122	
1500	8.7	208.9	P	-1-1/2	H	No oxidation, complete penetration	Very thin surface oxide layer, grain boundary oxidation at failure site	122	
1500	6.6	570.4	P	-	H	Slight intergranular oxidation, complete penetration	Very thin surface oxide layer, grain boundary oxidation at failure site	122	
1300	35.0	158.1	P	-1/2	S	No oxidation, complete penetration of tube wall by brazing alloy	No oxidation observed	123	
1300	26.0	843.4	P	-2	H	Some oxidation observed, complete penetration	Some oxidation along stress-rupture fissure	123	
1300	19.1	1604	**		H	Slight oxidation of brazing alloy, complete penetration	Oxide film 0.2 mil thick observed, very slight intergranular penetration	123

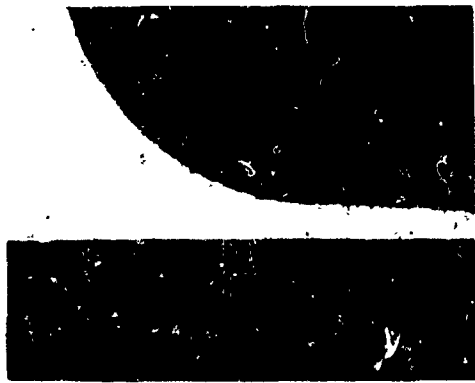
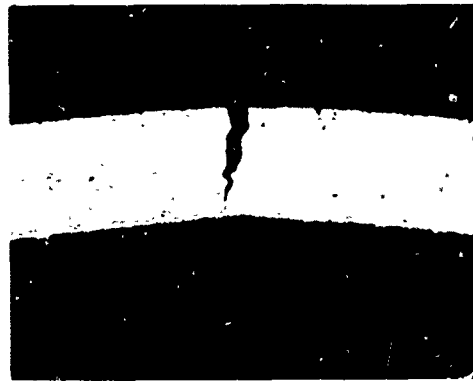
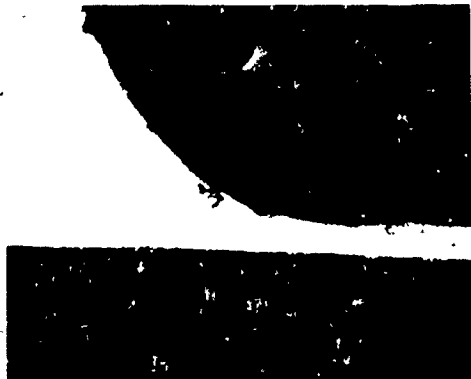
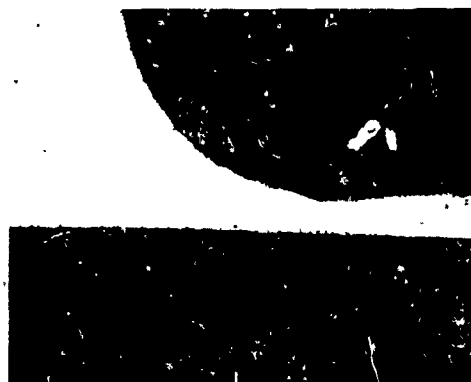
Figure 123. Photomicrographs of Inconel 625 Tubes Brazed With J-8100 Brazing Alloy.

1300°F AND 33.0 KSI, FAILED AFTER 158.0 HOURS

1300°F AND 26.0 KSI, FAILED AFTER 843.0 HOURS

1300°F AND 19.1 KSI, FAILED AFTER 1604.0 HOURS

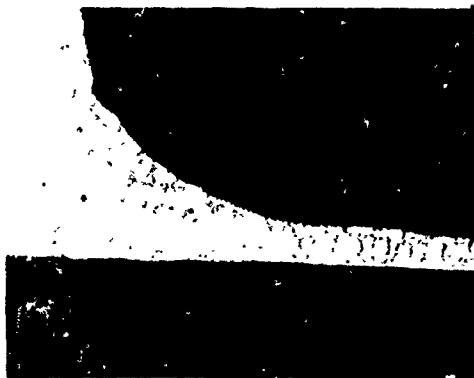
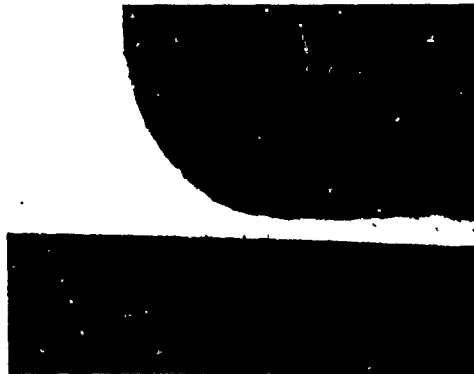
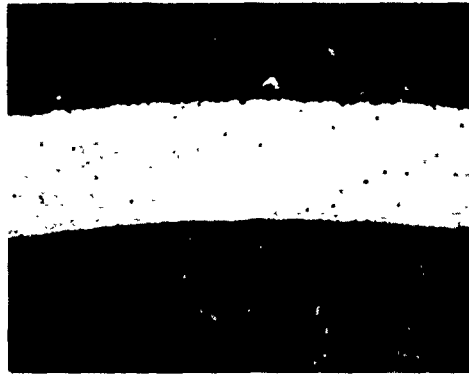
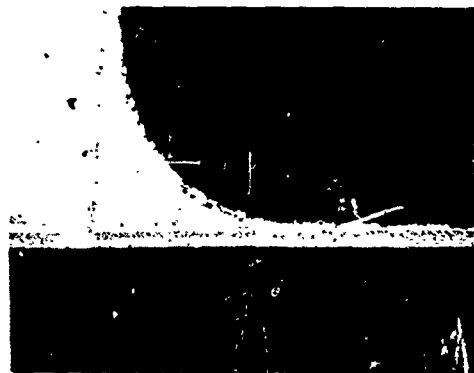
1200°F AND 50 KSI, FAILED AFTER 43.0 HOURS

1200°F AND 41.0 KSI, FAILED AFTER 955.0 HOURS

1200°F AND 35.0 KSI, FAILED AFTER 1610.0 HOURS

1200	50.4	43.0	P	-1/2	S	No corrosion, complete penetration of tube by brazing alloy, good filletting	No oxidation observed	124	
1200	46.4	394.6	**	-	S	No corrosion, complete penetration of tube by brazing alloy, good filletting	No oxidation observed	124	
1200	41.0	955.1	**	-	S	No corrosion, 50 percent penetration of tube by brazing alloy, good filletting	No oxidation observed	124	
1200	35.7	1610	**	-	S	Slight oxidation of brazing alloy, good filletting	Very slight oxidation detected (0.1-mil-thick oxide film)	124
