SUPERSONIC RAIN AND SAND EROSION RESEARCH:  
CHARACTERIZATION AND DEVELOPMENT OF  
EROSION RESISTANT MATERIALS

TEXTRON'S BELL AEROSPACE COMPANY

TECHNICAL REPORT AFML-TR-72-85

MAY 1972

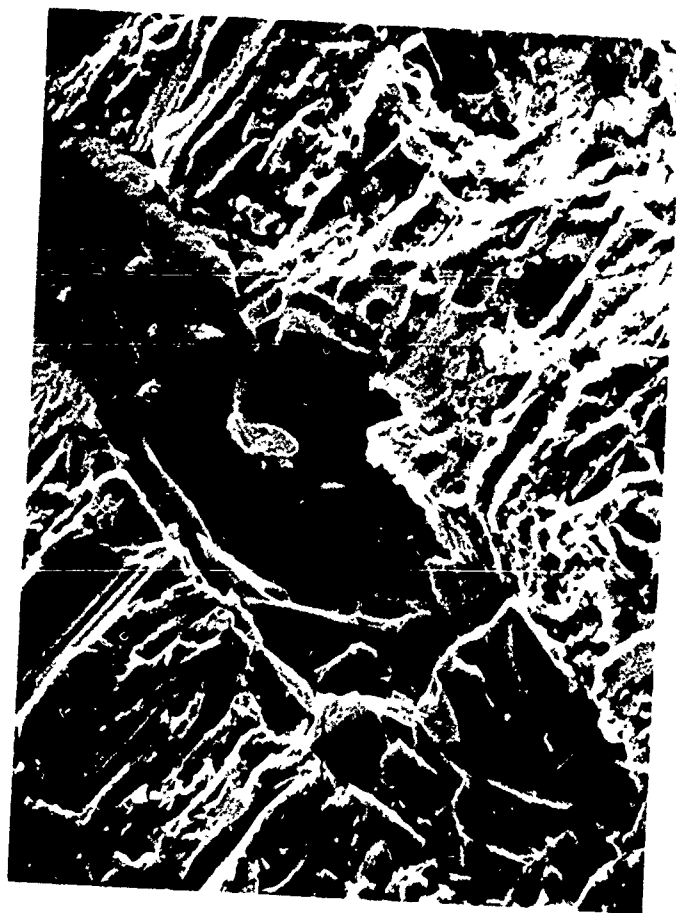
Figure 75. Scanning Electron Micrograph at 400X Showing Void in Surface of Boron-aluminum Composite
