*Airfield Damage Repair Modernization Program*

## **Validation of FRP Matting Requirements**

Final report

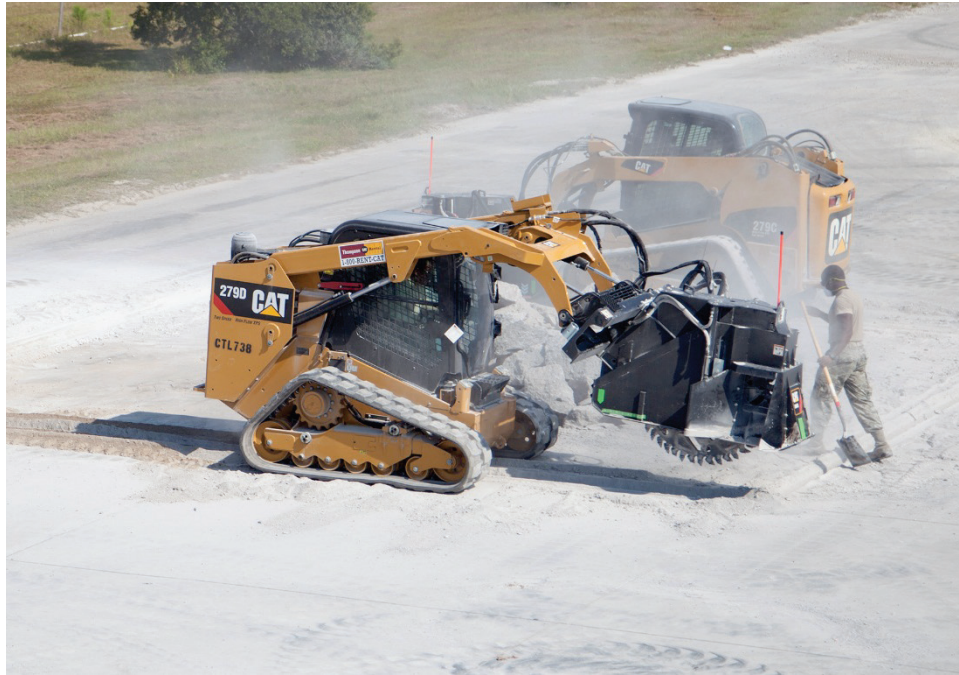
Caterpillar 279D rubber-tracked compact terrain loaders (CTLs), also known as skid steers, were used during the demonstration. The CTLs had high-flow hydraulic systems capable of operating the ADR attachments. A Caterpillar SW45 wheel-saw attachment (Figure 3) and a 78-in. bucket attachment (Figure 4) were the primary tools used in the crater repair process. Wheel saws were used to rapidly cut the pavement surrounding the crater for a square-shaped repair. The bucket attachment was used for debris removal during the excavation process.

Figure 3. CTL with wheel-saw attachment.

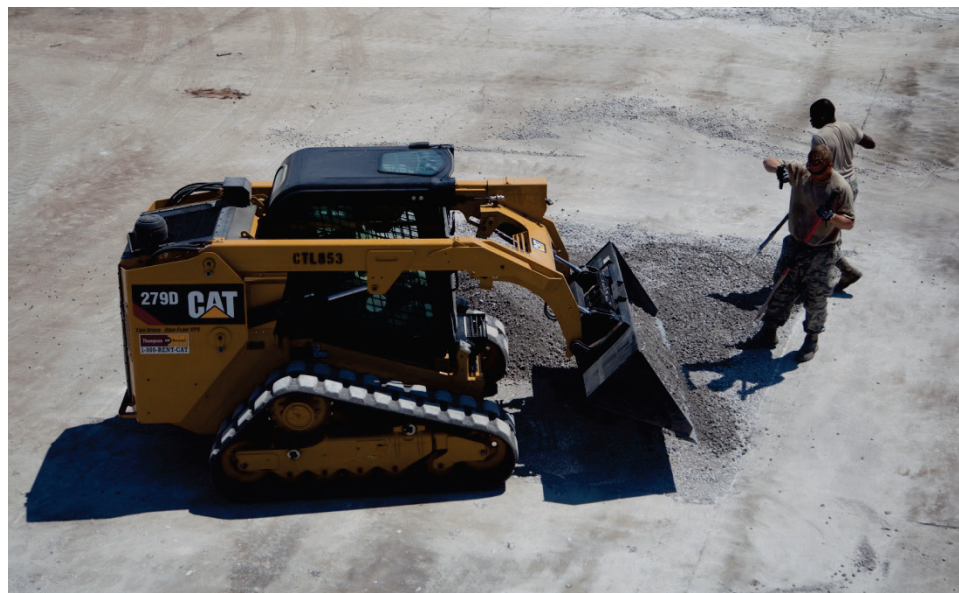
Figure 4. CTL with bucket attachment.

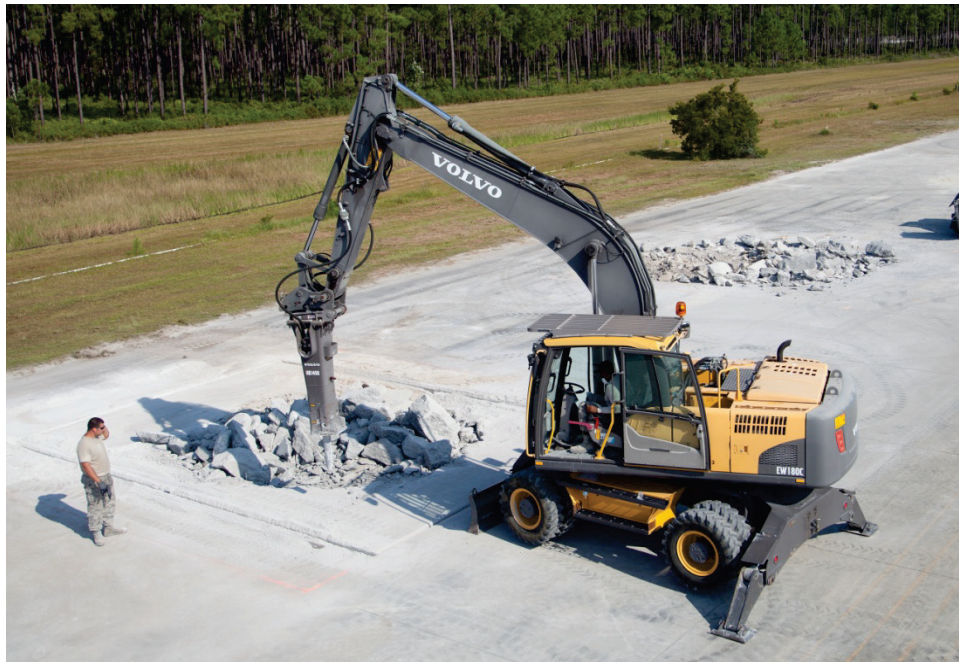
Two Volvo EW180D wheeled excavators were used as part of the crater repair process. One was equipped with a HB1400 chisel-tipped hammer attachment (Figure 5) and was used to break PCC from within the repair area. The other was equipped with a 36-in.-wide toothed bucket (Figure 6) and was used for removing broken PCC and underlying material.

Figure 5. Wheeled excavator with breaker attachment.

Breaking the upheaved pavement was accomplished using the Volvo Wheeled Excavator with the breaker attachment (Figure 23). The goal of the breaking process was to fracture the upheaved pavement surface into manageable pieces that could be removed using the excavator with a bucket attachment or the CTL with a bucket attachment. Table 6 provides the timing data from the breaking procedure for each crater.

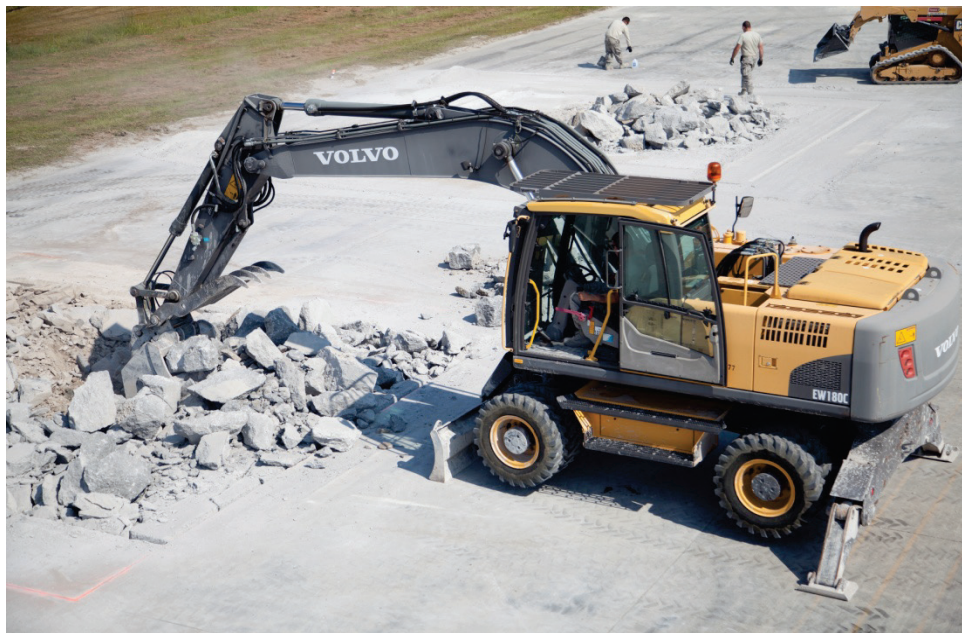
Figure 6. Wheeled excavator with bucket attachment.

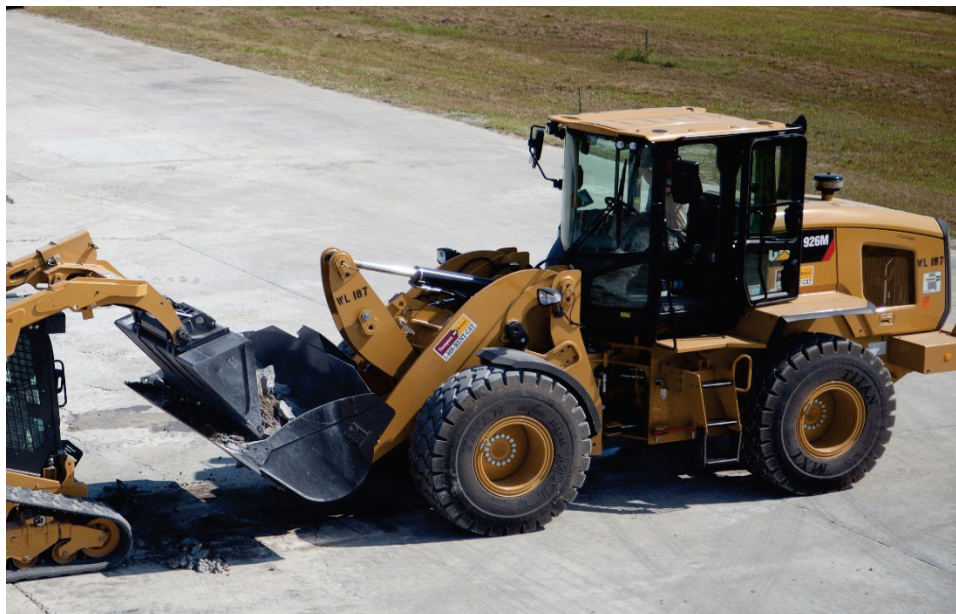
A Caterpillar 926M front-end loader was used to load and transport crushed stone for the crater backfill (Figure 7). For the larger craters, stone was loaded into dump trucks that backed near the crater and dumped the crushed stone directly into the crater. For small craters, the front-end loaders were used to transport the stone for placement in the crater.

Figure 7. Front-end loader.

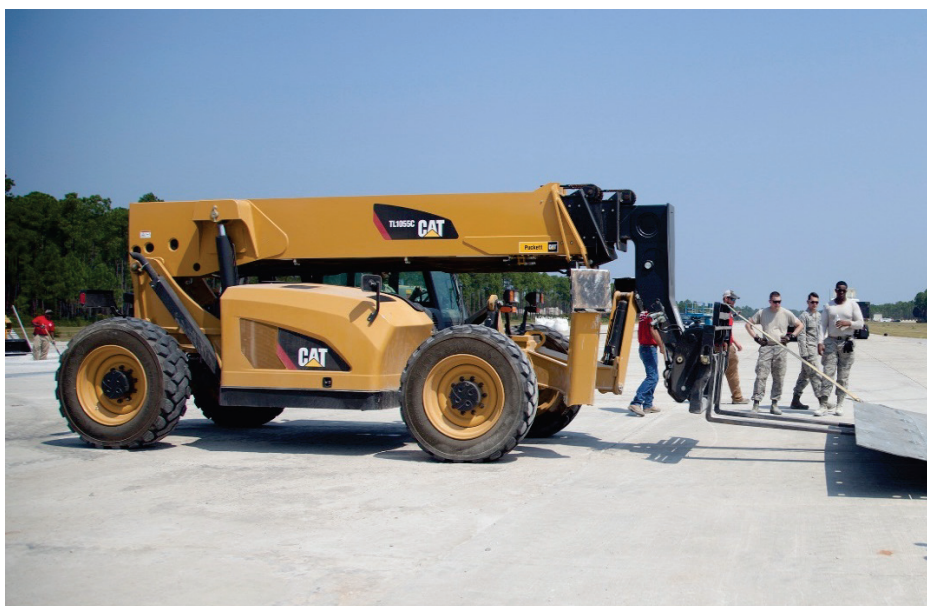
A Caterpillar TL1055C extendable-boom fork lift was used to transport the matting systems (Figure 8). Additionally, a Caterpillar 10E913 forklift was borrowed from Silver Flag to assist with handling FFM matting. This forklift was used in training of the legacy system by Silver Flag. The two forklifts were used side by side for loading and unloading FFM. For FRP matting, the TL1055C was used to load/unload mats and to support the matting assembly as pieces were being unloaded during assembly.

Figure 8. Extendable-boom fork lift.

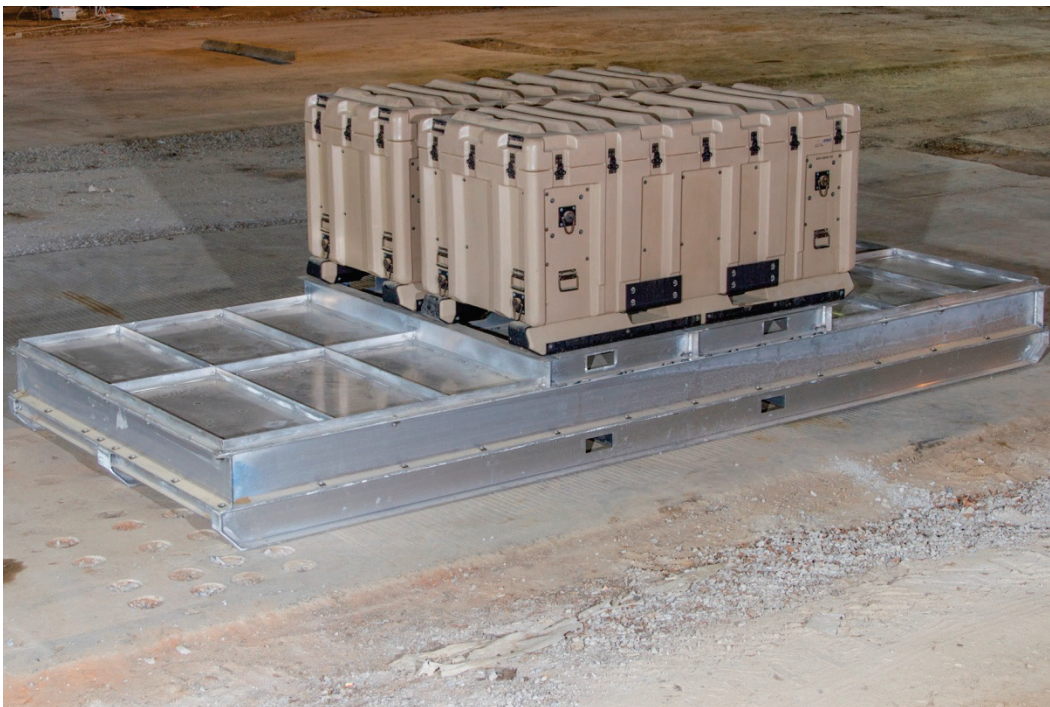
The complete FRP air-droppable mat kit, shown in Figure 9, was designed to be a scalable system that can support multiple crater dimensions and shapes. The kit was comprised of three main components, i.e., the prototype FRP mat container with FRP mat panels (contents in Table 2), a container with consumable materials (contents in Table 3), and a container with installation tools (contents in Table 4). The kit was designed so a single installation tool set could support multiple mat and consumable packages. The consumables and installation tools are packaged in two Hardigg 16848-100 Air Drop Boxes. The FRP panels were packaged in a prototype FRP mat container designed to function as a palletized skid that can be attached to a 20-ft, Type V airdrop platform. The two Hardigg 16848-100 Air Drop Boxes together with the prototype FRP mat container form a single air droppable kit. Each kit is capable of providing a FOD cover for 13 5-ft-diameter craters, five 10-ft-diameter craters, three 15-ft-diameter craters, or one large crater up to 28-ft diameter.

Figure 9. Complete FRP air-droppable mat kit.

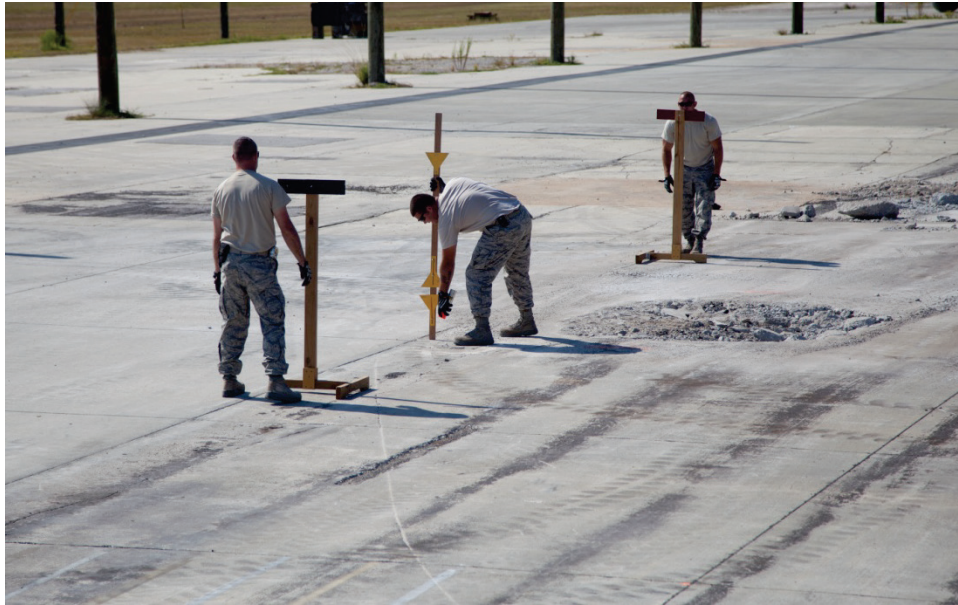
For the exercise, the equipment operators deployed to the crater site in the required equipment. The team cleared peripheral debris, identified the required repair area, and marked square lines for cutting (Figure 11). Two CTLs with the SW45 wheel-saw attachments then began to simultaneously cut parallel lines in opposite directions (Figure 12). After completing the first cuts, the CTLs were repositioned, and the adjacent parallel lines were cut with the saws operating in opposite directions.

Figure 11. Marking crater repair area.

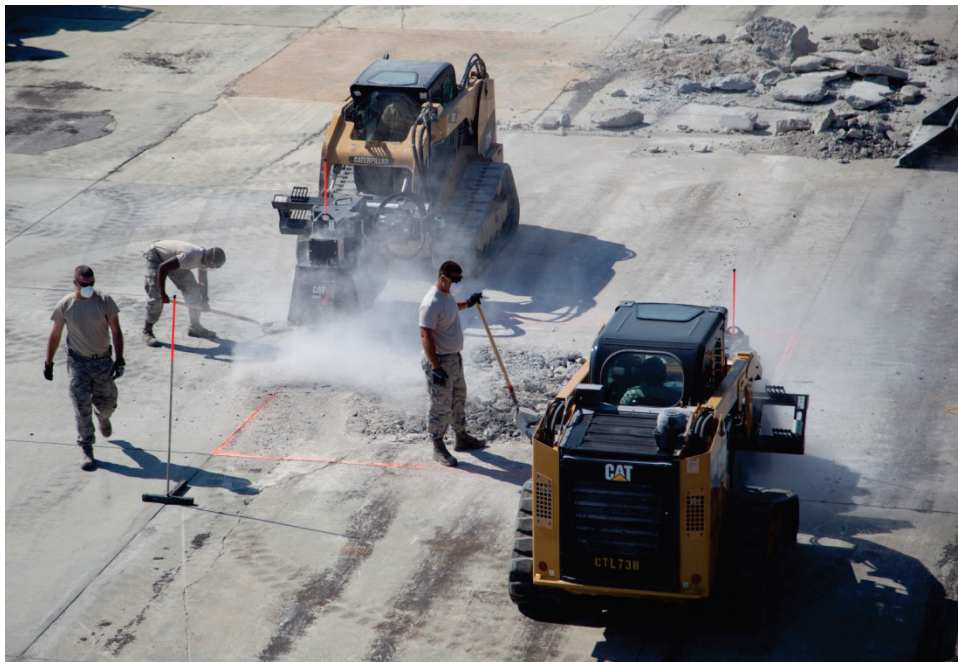
Figure 12. Sawing crater repair area.

After the surface debris was removed and the upheaval marked, two CTLs with the SW 45 wheel-saw attachments saw cut opposite sides of the crater repair while operating in opposite directions (Figure 12). The time required to cut the perimeter of the repair area was influenced by the type of pavement surface and its thickness. Because the experiment area is frequently used for testing, the pavement surface material and thickness varied by location. The typical pavement thickness was 10 in., and the surface was typically ordinary Portland cement concrete. Saw-cutting rates were calculated by dividing the total length of the saw cut by the time required to complete the cut. Table 5 provides cutting rates for each repair.

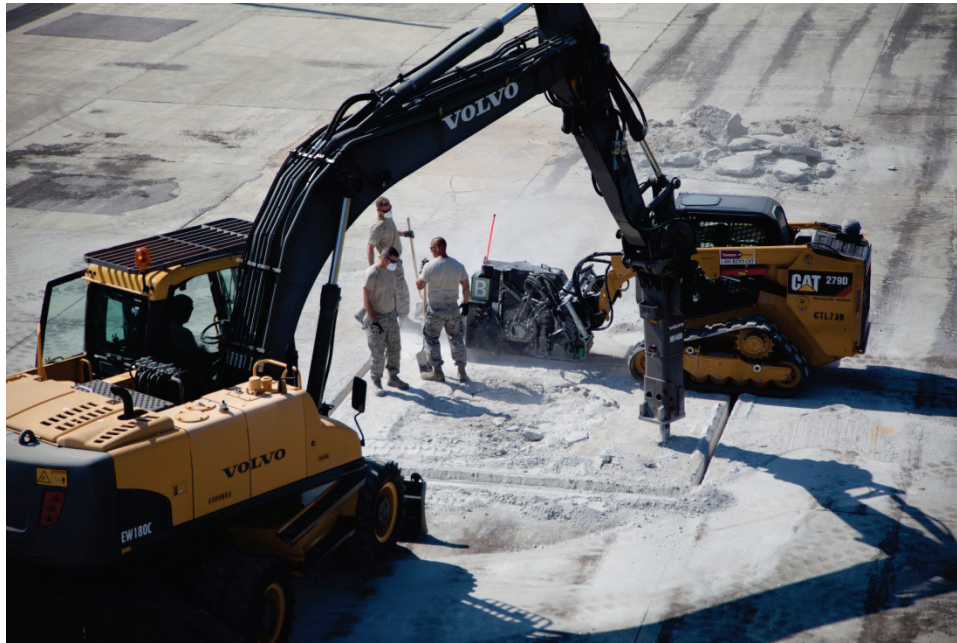
Once cutting was complete, the Volvo excavator with the breaker attachment was used to break the PCC surface into bucket-sized pieces by repositioning the breaking head on the pavement surface (Figure 13). Once complete, the Volvo excavator with the bucket attachment was used to scoop the chunks of concrete and place them adjacent to the crater (Figure 14). The operator continued to excavate the crater until the depth was uniform and at least 18 in. below the pavement surface.

Figure 13. Breaking crater repair area.

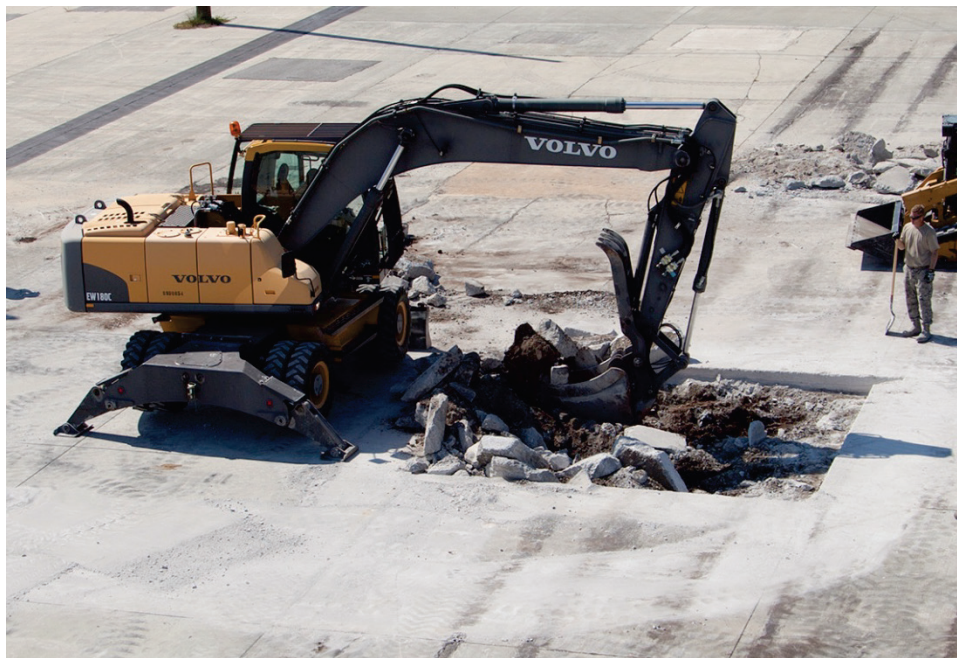
Figure 14. Removing debris using bucket attachment.

The Volvo Wheeled Excavator with the bucket attachment was used to excavate the debris from the crater (Figure 14). The goal of the excavation process was to remove the pavement surface and subgrade soil to a depth of 18 in. below the pavement surface. Table 7 provides the timing data from the excavation procedure for each crater.

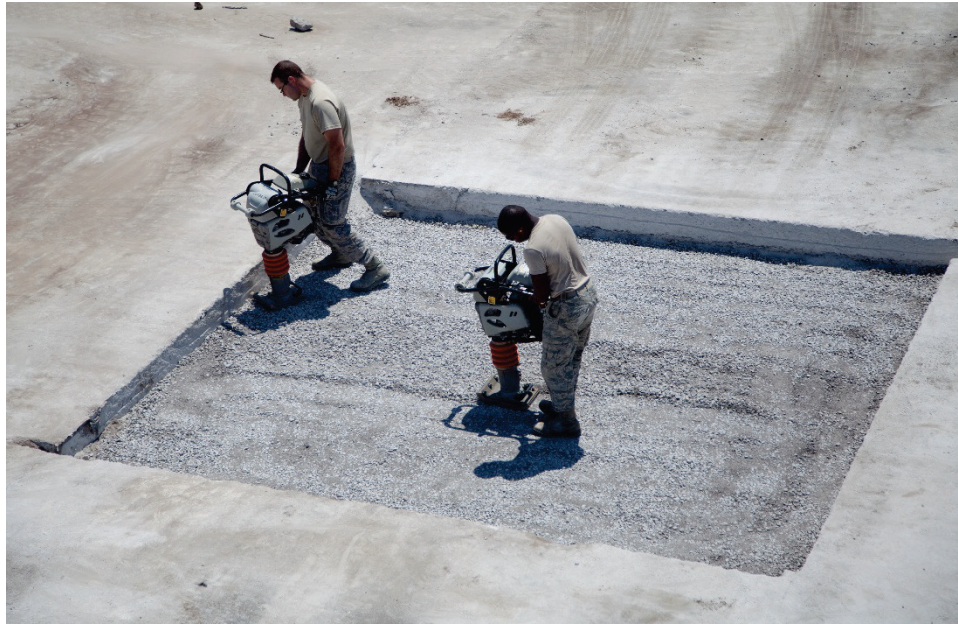
Once the final depth was achieved, the subgrade material in the bottom of the crater was compacted using two MultiQuip MTX-60 jumping jack compactors. Next, limestone base course material was placed in 6-in. lifts and compacted using the MultiQuip MTX-60s (Figure 15). Three lifts were compacted to achieve the total 18-in. repair thickness. The CTL with bucket attachment was used to ensure the surface was at final grade.

Figure 15. Compacting limestone with MultiQuip MTX-60.

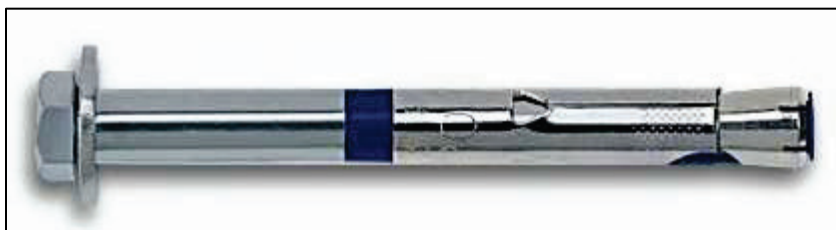
The Powers Fastener anchor bolt (part number 06957) is a  $\frac{3}{4}$ - x  $8\frac{1}{4}$ -in. COTS product that has been used extensively for anchoring to PCC surfaces. The anchor consists of a threaded bolt housed in a sleeve with a specially designed expanding attachment secured to the base of the anchor. This attachment expands as torque is applied to the anchor bolt after placement into the anchor hole to effectively secure the Power Bolt in place. Figure 20 is a photograph of the Powers Bolt 6957.

Figure 20. Powers Bolt 06957 (Powers Fasteners, Inc.).

1. Using a hammer drill with a  $\frac{3}{4}$ -in.-diameter drill bit, drill to a depth of at least 9 in.
2. Using compressed air, clear all debris from the anchor hole.
3. Remove the washer from Powers Bolt 6957, replace with an anchor bushing, and reattach sleeve/expanding attachment to the bolt.
4. Force the bolt into the anchor hole carefully to avoid deployment of the expanding attachment at the base of the bolt. Use of a hammer may be necessary.
5. Using an impact wrench apply torque to the anchor bolt head to deploy the expanding attachment and secure the anchor.

The type B-3 polymer glue anchor system utilizes the same Powers Bolt 6957 anchor described in Section 2.8.1 (Figure 20). However, the anchor is installed using a different installation technique more suited to asphalt pavements. Following the drilling of the anchor hole into the asphalt pavement, a high-strength, two-part epoxy polymer glue is introduced into the anchor hole. Following introduction of the polymer glue, the anchor bolt (having already been threaded through the anchor bushing) is placed into the anchor hole. Once the polymer glue material has sufficiently hardened, the anchor bolt may be tightened.

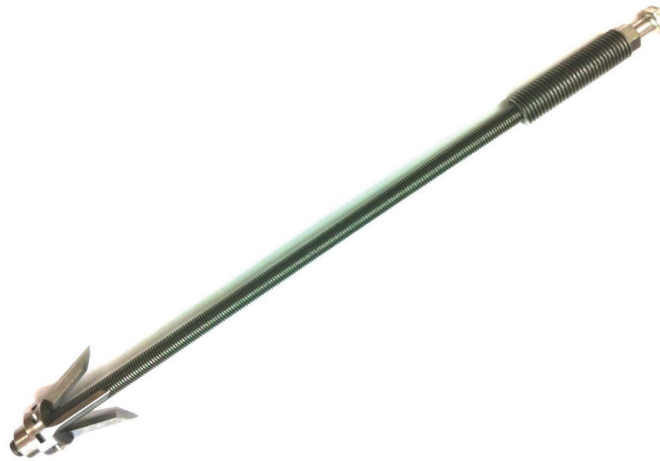
Development of the Tri-Talon anchor system and previous design iterations are discussed in Gartrell 2007 and Gartrell 2008. The original design included components made from proprietary threaded rods that were relatively expensive and could only be procured from a single source. In an effort to increase competition in manufacturing and reduce anchor costs, the Tri-Talon anchor system was re-designed using a commercial-off-the-shelf (COTS) B7 threaded rod. However, since the original system had been certified under live-flight aircraft conditions (Priddy et al. 2011), the performance of the new design needed to be verified to be equivalent to that of the old design. A series of tests were conducted to validate the strength of the new design and to determine the vertical pull-out resistance of the Tri-Talon anchor system in asphalt pavements of various material compositions, structures, strengths, and thicknesses (Rushing et al. [in preparation]). An image of the Tri-Talon anchor is shown in Figure 21.

Each anchor consists of (from bottom to top) a retaining ring, the Tri-Talon, the threaded anchor rod, the special anchor coupling (connecting the rod and anchor bolt), and the anchor bolt. Detailed drawings of the Tri-Talon anchor system are in Rushing et al. (in preparation.) The primary advantage of the Tri-Talon anchor system is its use of the entire pavement structure to resist vertical pull-out. Figure 22 shows an overall schematic of an installed Tri-Talon anchor.

Figure 21. Tri-Talon Anchor.

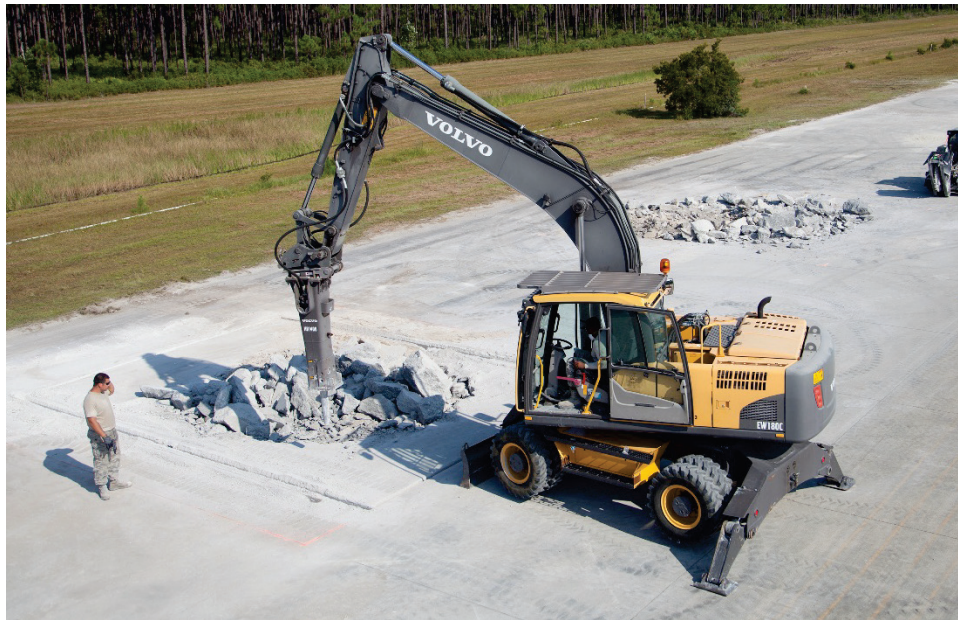
Figure 23. Large crater repair area.

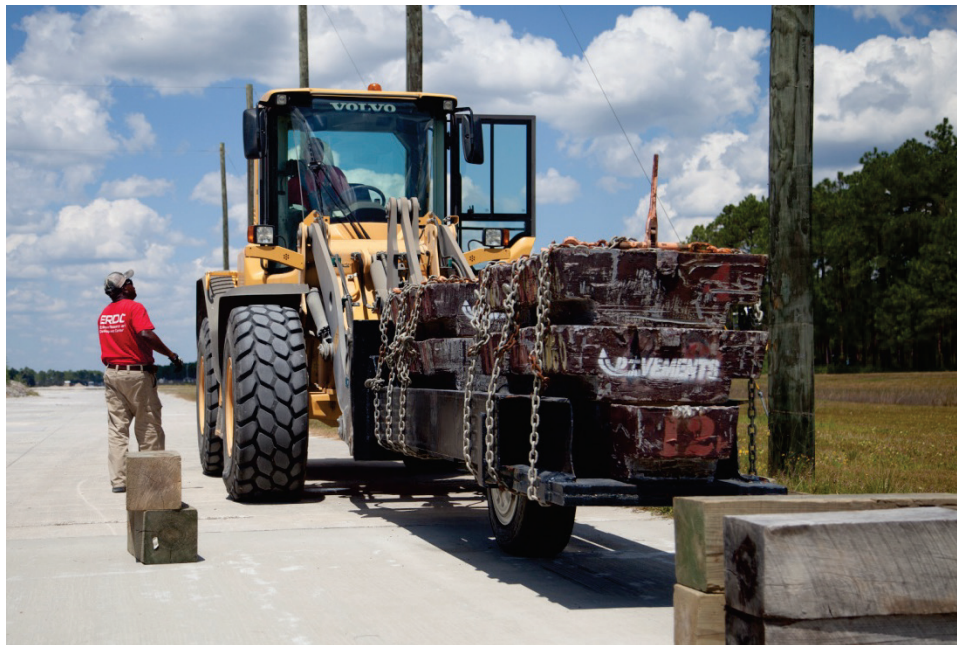
A specially designed single-wheel load cart was used to simulate F-15E aircraft traffic. The load cart was equipped with a 36-in. by 11-in. tire inflated to 325 lbf/in.<sup>2</sup> and loaded such that the test wheel was supporting 35,235 lb. A photograph of the load cart is shown in Figure 24.

Figure 24. F-15E load cart.

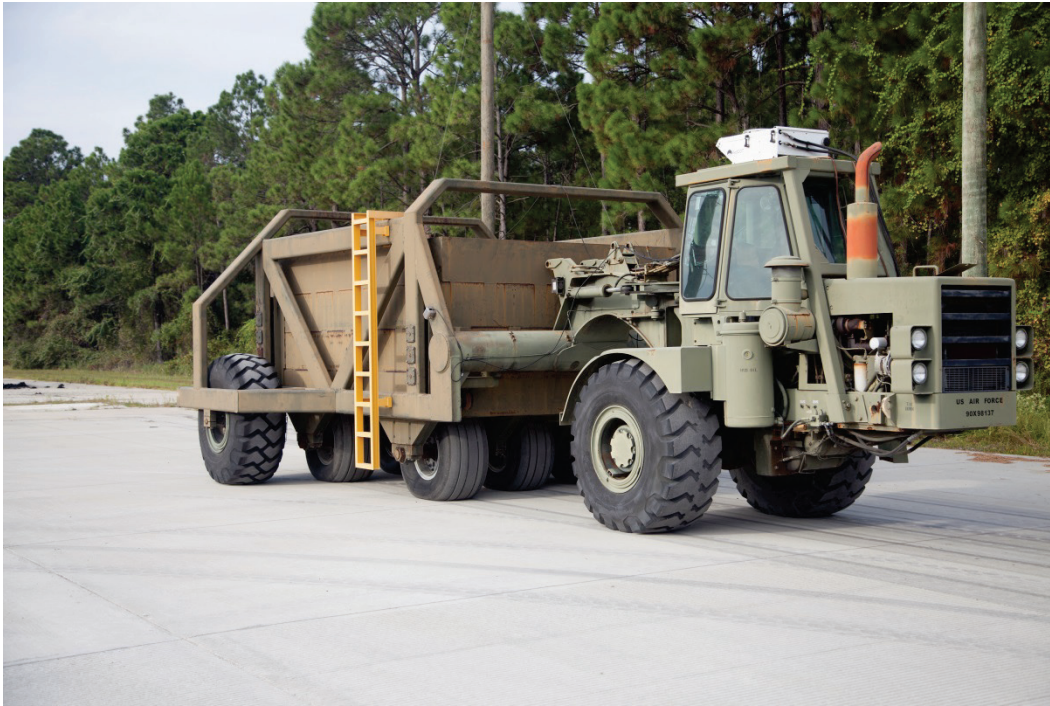
The multiple-wheel C-17 load cart was designed to exactly match one-half of the full main gear of a C-17 aircraft. The multiple-wheel C-17 load cart was equipped with six 50 in. x 21 in. tires inflated to 142 lbf/in.<sup>2</sup>. The cart was loaded with lead weights so that the test gear was supporting approximately 269,000 lb. A photograph of the load cart is shown in Figure 25.

Figure 25. C-17 load cart.
