# NAVAL POSTGRADUATE SCHOOL

**IMPACT ANALYSIS OF LOW VELOCITY TO COMPOSITE BOX  
CONTAINING WATER**

Taylor J. South, Kyoung Jae Yun and Young W. Kwon

July 2016

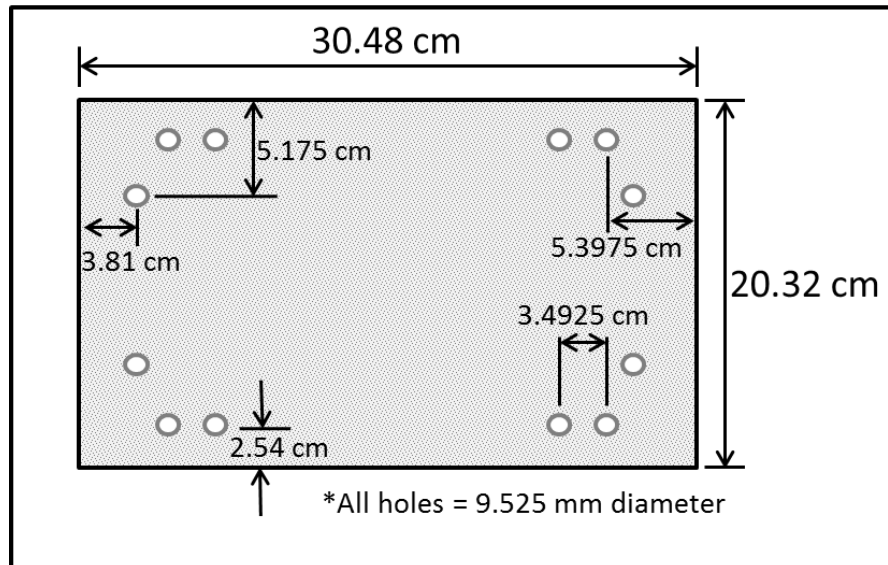
A mounting plate was fabricated from 6061 aluminum plate that was 30.48 cm x 20.32 cm, and 0.635 cm thick. Holes were drilled through the plate as shown in Figure 15, and the plate mounted to the test stand collar using 3/8-16 U-bolts. A 6061 aluminum tube that was 30.48 cm long, with outer diameter of 2.54 cm and wall thickness of 0.635 cm, was secured in two pillow block mounted roller bearings. The roller bearings were bolted to the base plate providing the axis of rotation for the pendulum as shown in Figure 16.

Figure 15. Mounting plate design

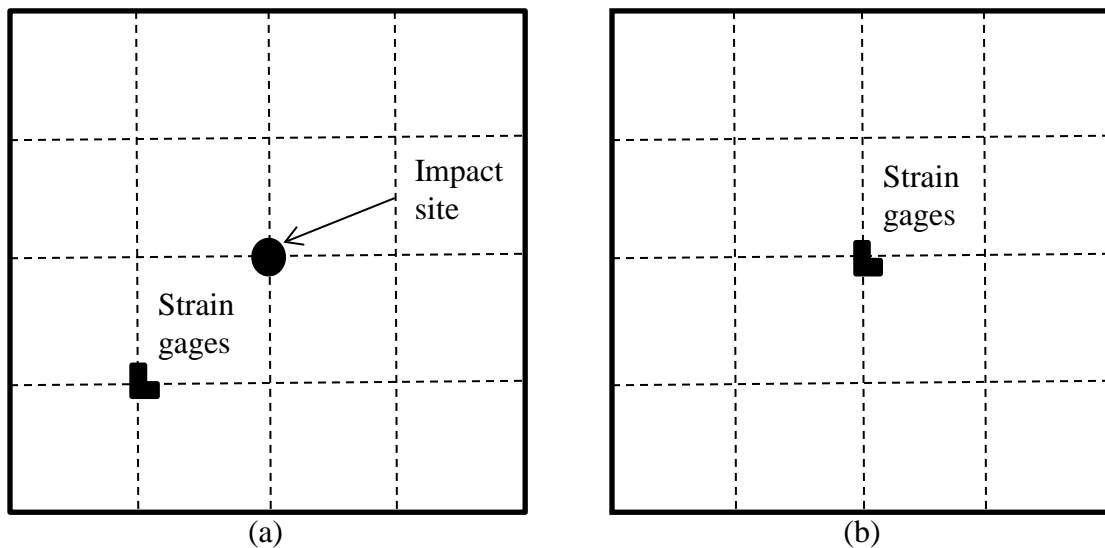
Figure 29. gage locations. (a) front surface, (b) side and back surfaces

In order to measure strains on each side, strain gages were attached to each composite surface. Figure 29 shows the strain gage locations. All strain gages were attached at the center of each surface except for the front surface because the impact hammer struck the center location. As a result, the strain gages were fixed at the bottom left quarter point location of the front surface. Each strain gage had two measurements in the horizontal and vertical directions.

The following strains are for the horizontal components unless otherwise mentioned. The strain gage location at the front surface is shown in Figure 29. As the impactor hit the center of the front surface of the box with the low fill, the front plate started to concave locally from the center. Until the concave spread further throughout the front surface, the strain gage showed tensile strain. As the concave spread out widely while the impactor was in contact with the front surface, the strain gage showed the negative strain for the contact duration. On the other hand, the strain gage for the mid and high fill cases showed the opposite behavior. It varied from compression to tension. The initial contact duration was shorter for the mid to high fills. As stated above, the mid to high fill cases had higher frequencies of motion than the low fill cases as shown in Figure 34. The maximum magnitude of the front surface strain was in compression for all the cases except for the 100% fill case which had the maximum tensile strain. The maximum strain was larger with more water fill in general. However, the 75% fill case had a slightly greater peak strain than the 100% fill case. The former occurred in compression while the latter happened in tension. The 50% full case had the maximum strain much later than other cases while the 100% full case had the earliest peak strain. The 90% and 95% full cases were plotted in Figure 35 in order not to crowd Figure 34 too much. Their behaviors were close to that of the 100% full case.

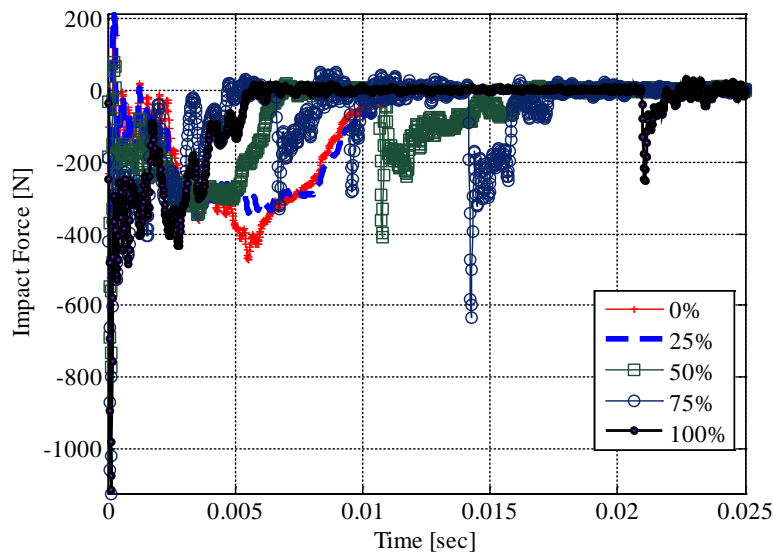
Figure 32. Plot of impact force vs. time: (a) zoom-in view (b) zoom-out view

All the following results are for the  $45^\circ$  impact without baffles unless otherwise mentioned. Under the same initial impact condition like the same impact mass and impact velocity, the water level influenced the impact force applied to the front surface as shown in Figure 32.

When the water level was 25% or less called the low fill, the influence of the water was negligible on the peak impact force. On the other hand, as the water level became 75% or higher called the high fill, there was a large effect of the water on the peak impact force. However, the maximum impact force was almost constant. When the water level was at the impact location, i.e. 50% full water called the mid fill, water affected the maximum impact force whose magnitude was between the low and high fills as shown in Figure 33.

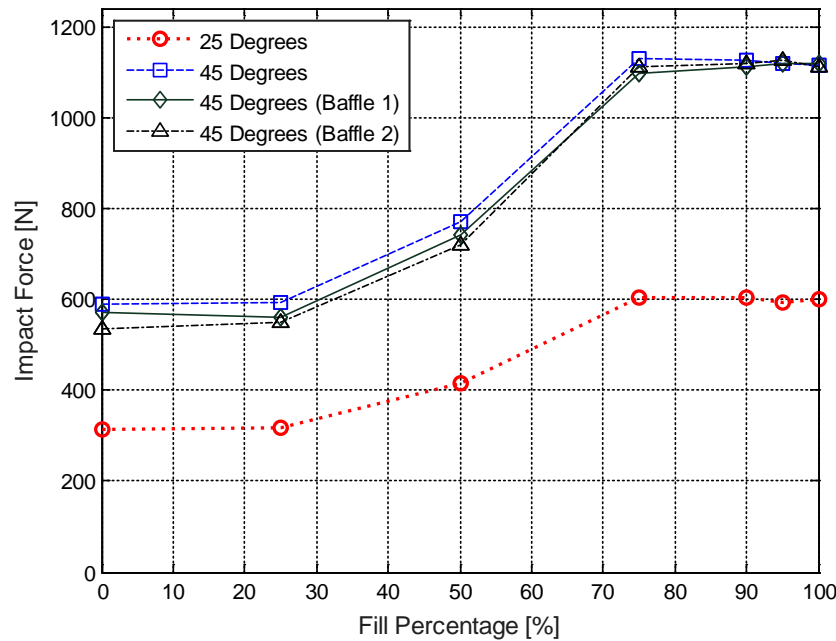
Figure 33. Plot of maximum impact force for different water fill levels

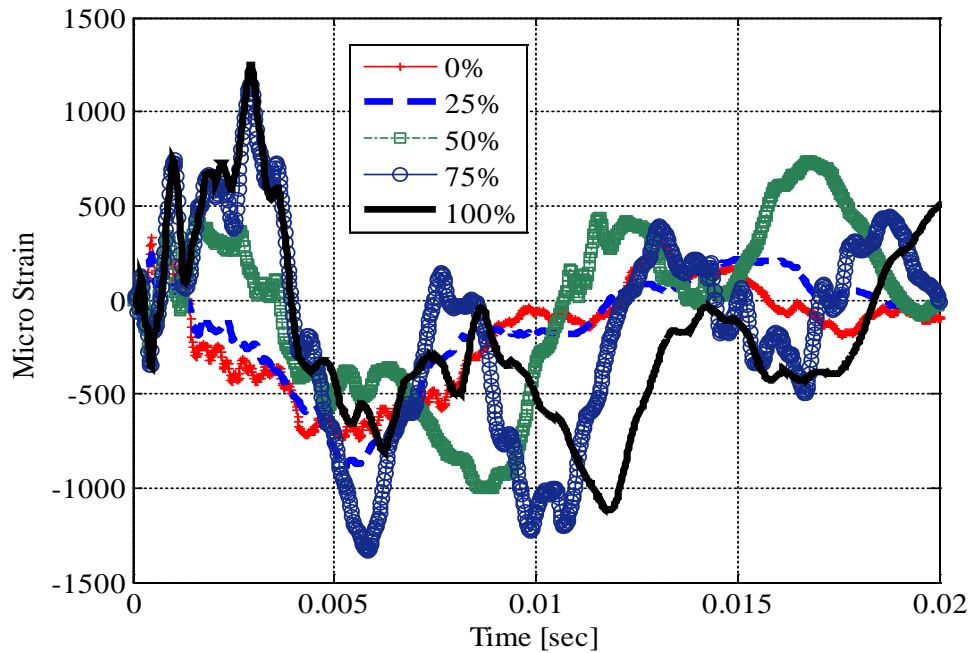
Figure 34. Plot of horizontal strain time history at the front surface

However, the 95% full case had the largest tensile strain while the 90% full case had the smallest tensile strain among the three cases as seen in Figure 34. On the other hand, the 90% full case had the greatest compressive strain while the 100% full case showed the smallest compressive strain. The peak compressive strain was greater than the peak tensile strain in terms of magnitude for the 90% case. The maximum magnitude of strain at the front surface gage was plotted as a function of the water level in Figure 36. The maximum strain increased with more water for the low and mid fill cases. However, it was different for high fill cases, and the 100% full case had the smallest strain out of the high fill cases.

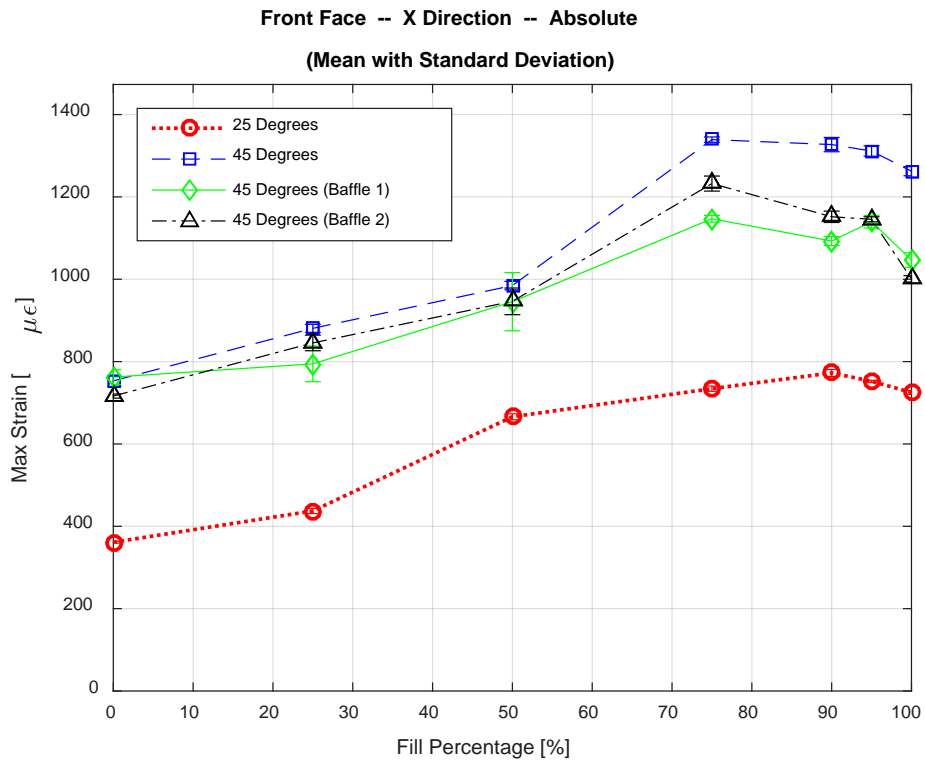
Figure 36. Plot of the maximum strain at the front surface vs. water fill level

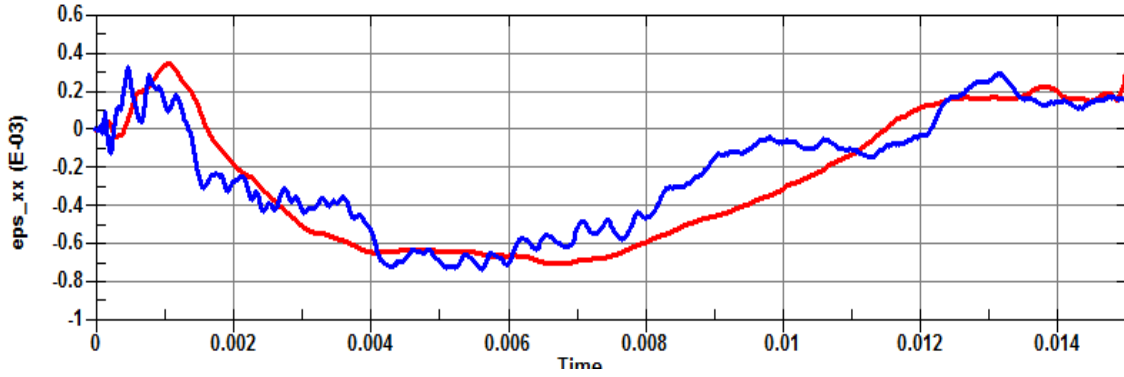
Figure 41. Comparison of strains at the front surface between the numerical and experimental results for empty box

The next study was the numerical result. The numerical results were compared to the experiment data so as to validate the model. Figures 41 and 43 compare the strains in the 0% filled water (empty) composite box. And Figures 44 and 46 compare the strains in the 50% filled water composite box. Finally, Figures 47 and 49 compare the strains in the 100% water-full composite box. The comparison was made at the front surface, side surface, and back surface of the empty box, 50% water filled box and the 100% water-full box, respectively.

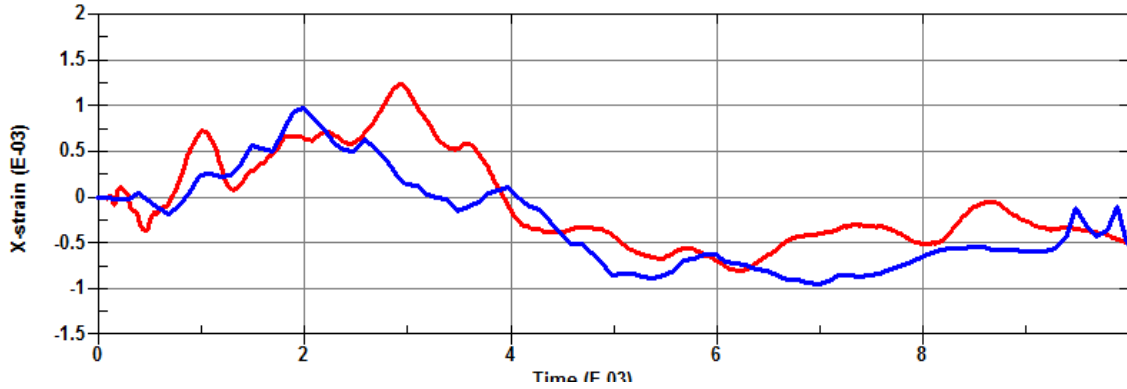
Figure 44. Comparison of strains at the front surface between the numerical and experimental results for box with 100% full water

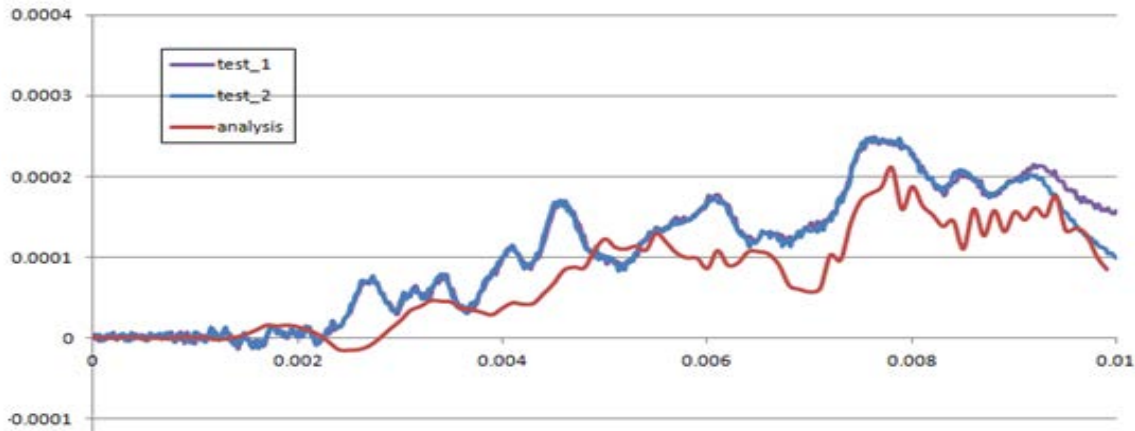
Figure 49. Comparison of strains at the back surface between the numerical and experimental results for box with 100% full water

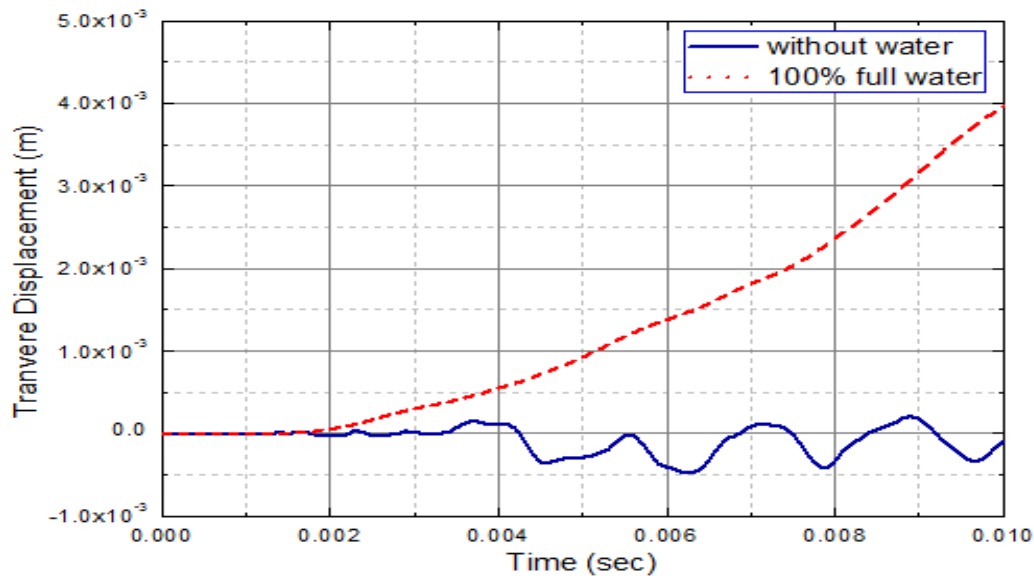
Figure 50. Comparison of transverse displacement at the back surface of the box without water and with 100% full water

The numerical results agreed well with the experimental data. Then, the transverse displacement at the center of the back surface was compared between the empty and 100% water-full boxes as seen in Figure 50. The internal water reduced the oscillatory motion of the back side significantly. The comparison showed that the 100% full water yielded much greater displacement with one order magnitude.

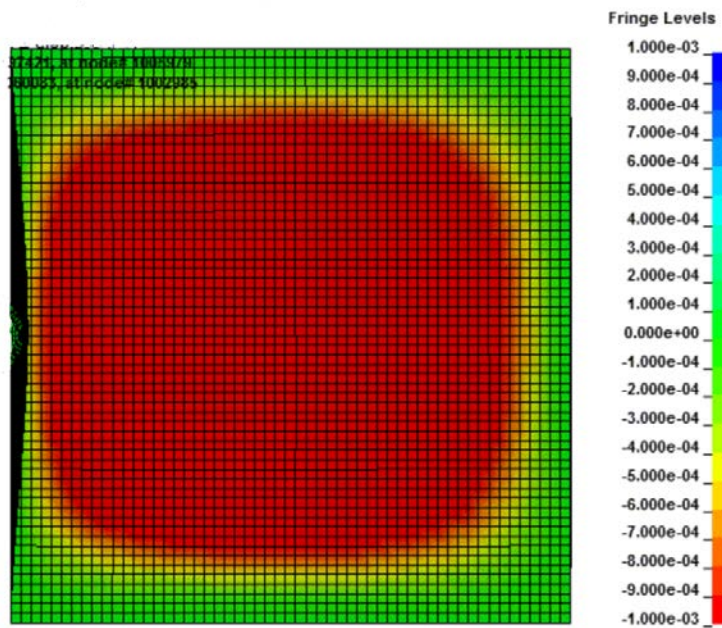
Figure 53. Comparison of contour plots of the side surface deformation (a) without water and (b) with 100% water

Figures 51 through 53 compare deformation contours at the front, side, and back surfaces with 100% full water and without water. The deformations of the front surface were similar between the two cases at least qualitatively as shown in Figure 51 even though they were different quantitatively in terms of magnitude and frequency. Both cases vibrated in the first mode shape because the impactor hit the center of the plate. However, the side and back surfaces showed very different contour patterns. The more uniform deformation was caused by the water. Finally, the back surface has drastically different contours with and without water. The back surface without water vibrated more or less randomly while the water resulted in more regular shape of vibrations as sketched in Figure 52. The side surface without water showed asymmetric contours with larger deformation toward the impact side while the side surface with water exhibited more or less symmetric contours as shown in Figure 53.

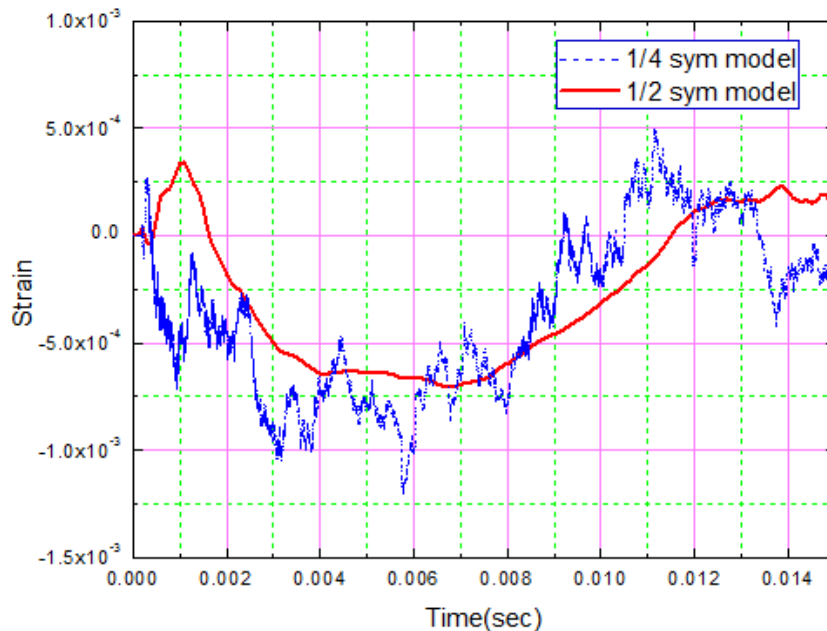
Figure 54. Comparison of strains at the front surface of the empty box with two different boundary conditions

Another numerical study was conducted assuming the top and bottom sides constrained simultaneously. Therefore, a quarter symmetric model could be used for this study. The same impact loading was applied as before. Figure 54 compares the strains at the front surface of the empty box with two different boundary conditions; one with the bottom side constrained and the other with both top and bottom sides constrained. Constraining both top and bottom sides resulted in larger values as well as greater oscillatory variations of the strains. In other words, the movable top reduced the strain and its oscillatory motion.

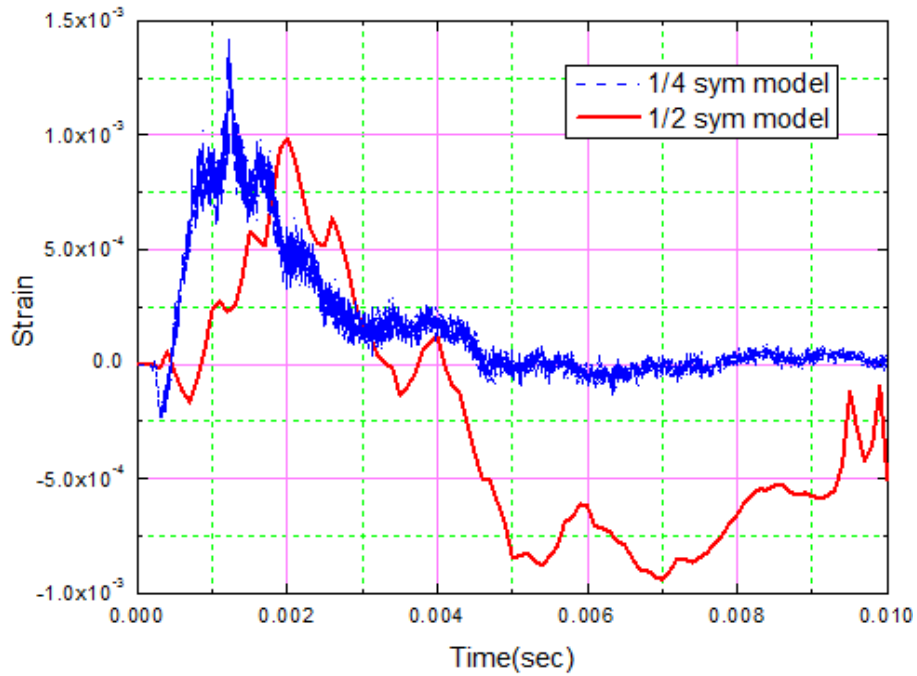
Figure 55. Comparison of strains at the front surface of the empty box with two different boundary conditions

On the other hand, the water inside the box with both sides constrained reached the strain-free state much faster with a very high frequency motion when compared to the other constrained case as seen in Figure 55. The most significant effect resulting from the extra top constraint occurred at the back side with the water. The strain at the back side was significantly minimized with the extra constraint as shown in Figure 56. Constraining both top and bottom sides would minimize potential failure of the back side of the box.
