Naval Surface Warfare Center Carderock Division

NSWCCD-61-TR-2015/11

An Analysis of U.S. Navy Arctic and Ice Operations With Regard to Ship Hull Coating Systems

David M. Stamper and Elizabeth G. Haslbeck

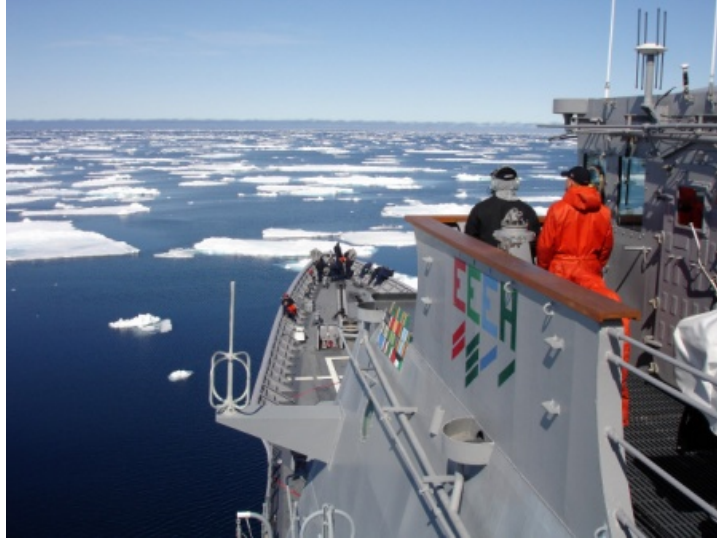
Figure 4. USS Normandy (CG 60) navigates an open pack ice (Appendix A) north of Iceland (June, 2007). U.S. Navy photo by LTJG Ryan Birkelbach. Notice the six or seven lookouts at the bow, and the two people on lookout watch in the foreground.

Although there have been more recent examples of Arctic operations, only one instance of operations in the Arctic by a surface ship could be identified where the vessel clearly encountered sea ice - USS Normandy (CG 60) in June 2007 (Figure 4). The hull inspection carried out after these operations indicated no coating damage and likely reflects on the attention paid by vessel operators to avoid ice impact. In contrast with USS Normandy, documentation indicates SA Agulhas, an ice-strengthened South African research and supply vessel, passed directly through sea ice that scoured away ~30% of the self-polishing AF coating (Interspeed 340) [Lee and Chown, 2009]. Scoured areas were rapidly colonized by organisms, including *Ciona intestinalis* (Figure 5), an invasive biofouling organism also found in the Northern Hemisphere [Patanasatienkul *et al.*, 2014]. The type and condition of the AC coating was not reported for this vessel. Similar AF coating loss could be expected for Navy surface ships if they did not avoid exposure to sea ice.

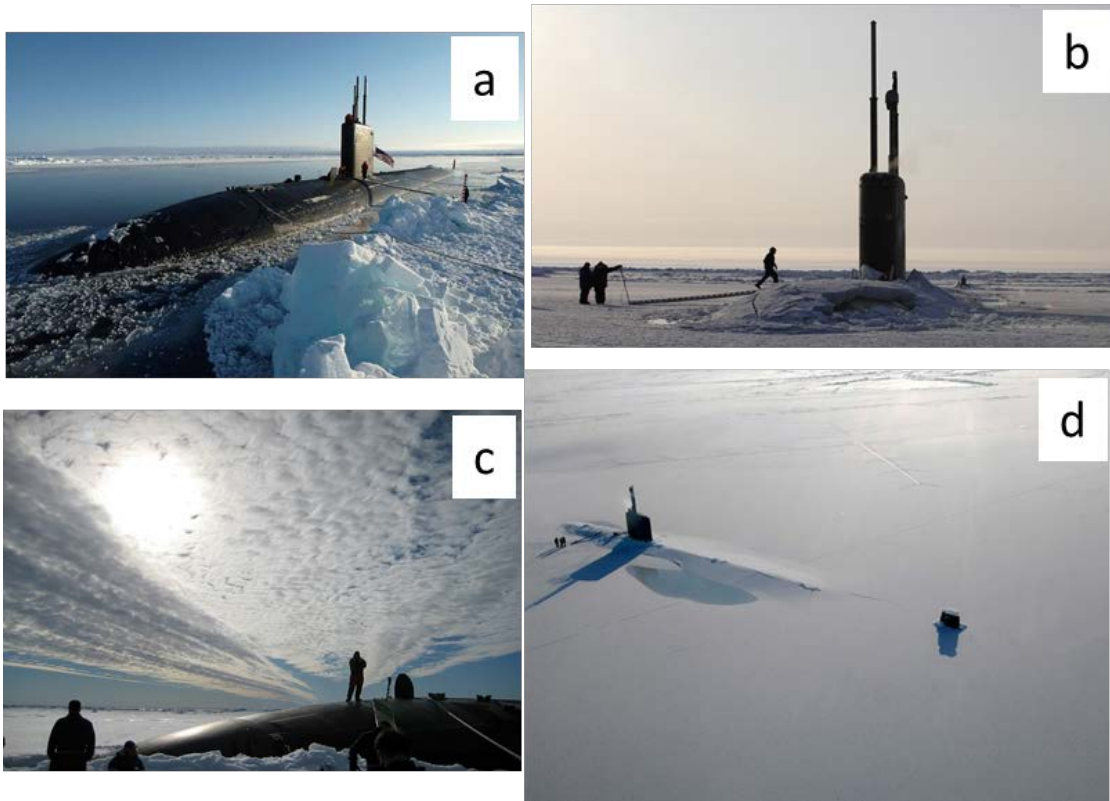
Figure 6. Representative images of submarine Arctic operations. A) USS Hampton (SSN 767) surfaced at the North Pole, taking part in ICEX 04 (April, 2004). U.S. Navy photo by Chief Journalist Kevin Elliott. B) USS Alexandria (SSN 757) surfaced through two feet of ice during ICEX-07 (March, 2007). U.S. Navy photo by Chief Mass Communication Specialist Shawn P. Eklund. C) USS Providence (SSN 719) breaks through the ice at the North Pole in the Arctic Ocean (July, 2008). U.S. Navy photo by Yeoman 1st Class J. Thompson. D) USS Annapolis (SSN 760) rests in the Arctic Ocean after surfacing through three feet of ice during ICEX 09 (March, 2009). U.S. Navy photo by Petty Officer 1st Class Tiffini M. Jones.

Although the surface Navy avoids direct sea ice exposure, many submarine exercises in the Arctic are designed to encounter ice (Figure 6). In fact, the majority of the Navy Arctic operations we identified have involved submarines. During these operations submarines tend to surface slowly with zero forward motion [Hopper, 2014]. Since 2003 at least 18 U.S. Navy submarines were found to have encountered ice (Table 2; publicly-released reports only). Some vessels encountered ice more than once (noted with the use of “underline”). Coating damage was reported on a subset of these (noted with the use of “**bold**”), but the damage frequently could not
