NRL Report No. P-1426

The Suitability of Rubatex and Chlorinated
Rubber as a Flotation Material.

NAVAL RESEARCH LABORATORY
ANACOSTIA STATION
WASHINGTON, D.C.

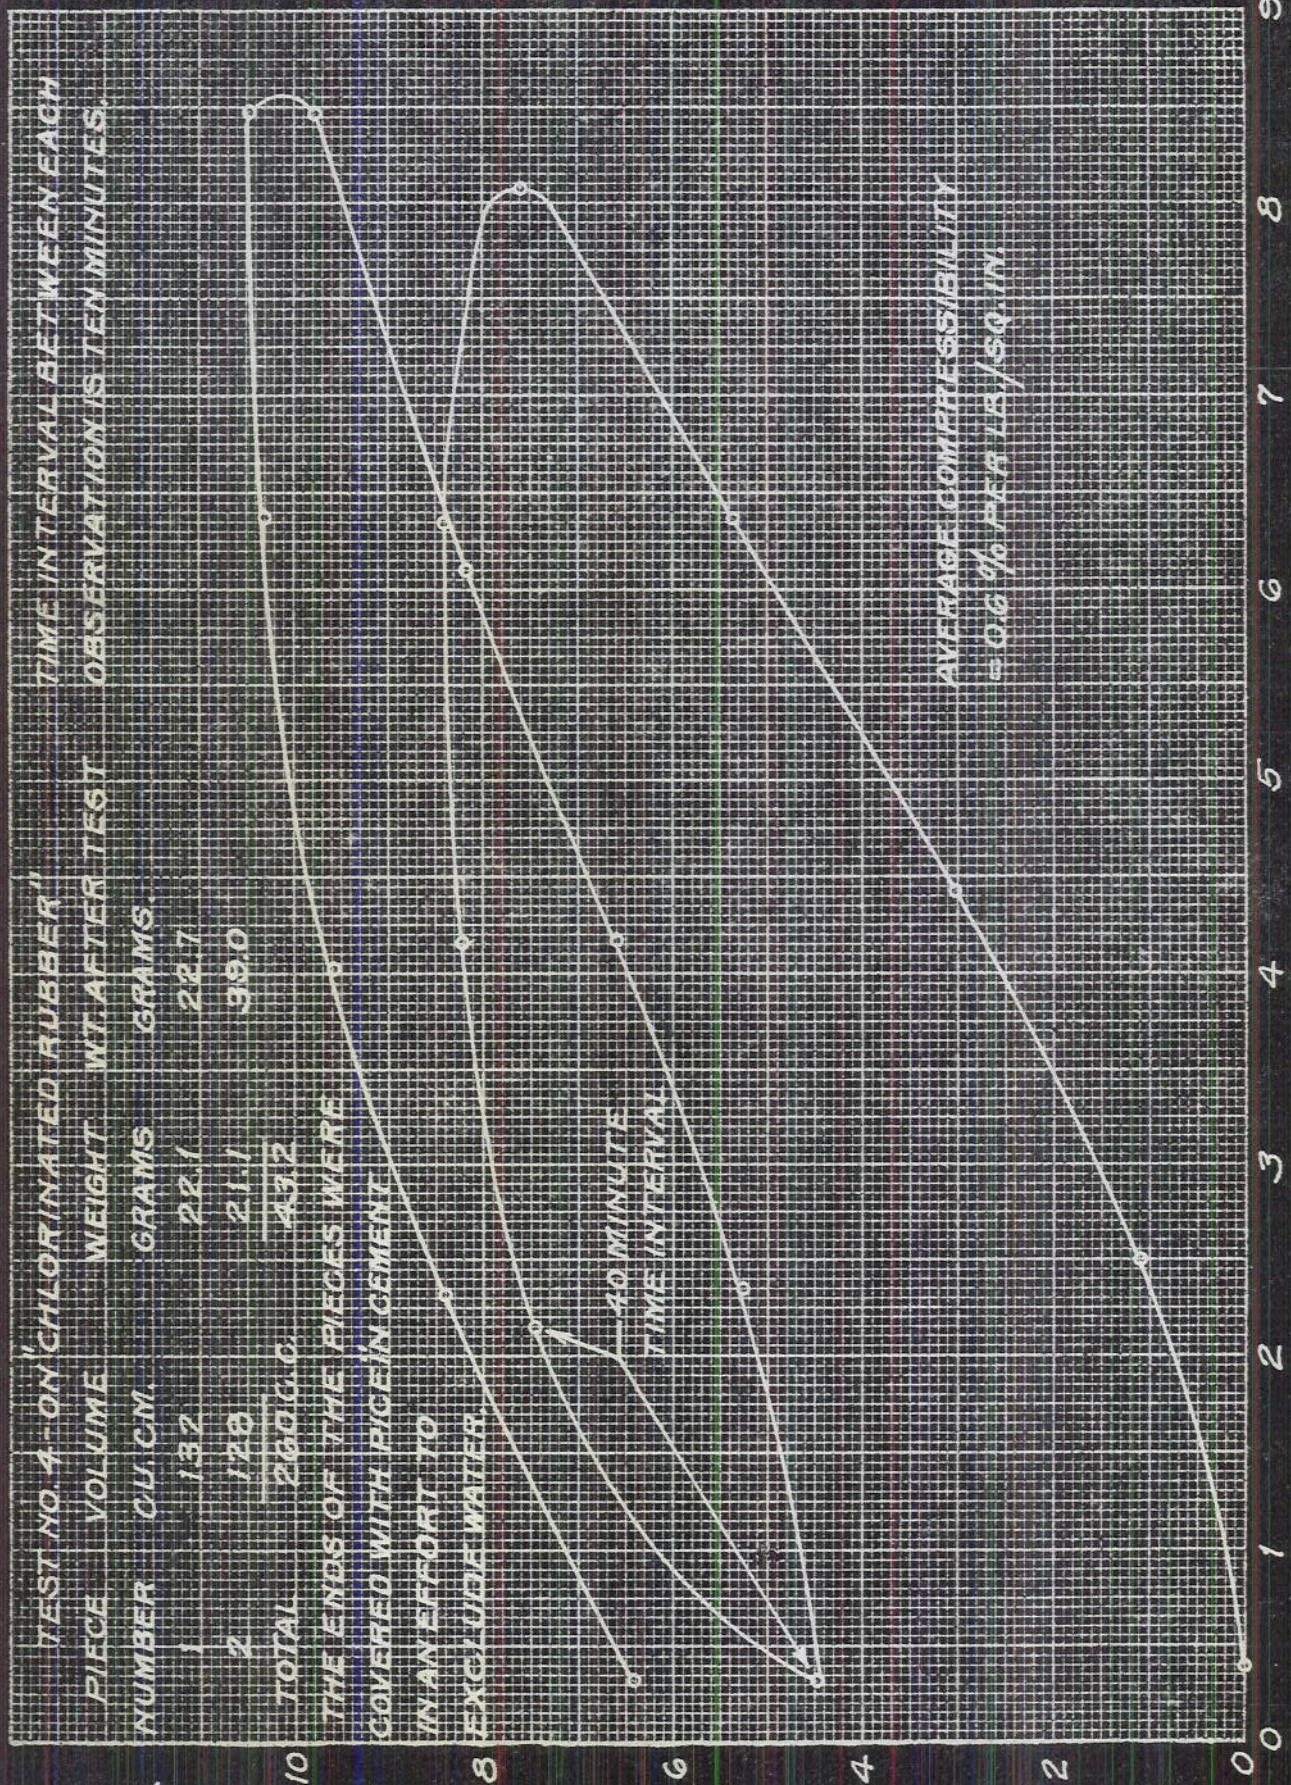
TEST NO. 4 - ON "CHLORINATED RUBBER"
 TIME INTERVAL BETWEEN EACH
 OBSERVATION IS TEN MINUTES.

PER CENT DECREASE IN VOLUME AT 0.99 LBS./SQ. IN.

POUNDS PER SQUARE INCH.

Curve sheet, Test No. 3, Rubatex.Plate 1
Curve sheet, Test No.4, Chlorinated Rubber.Plate 2
