**US Army Corps  
of Engineers®**  
Engineer Research and  
Development Center

*Navigation System Research Program*

# **Experimental Fatigue Evaluation of Underwater Steel Panels Retrofitted with Fiber Reinforced Polymers**

Final Report

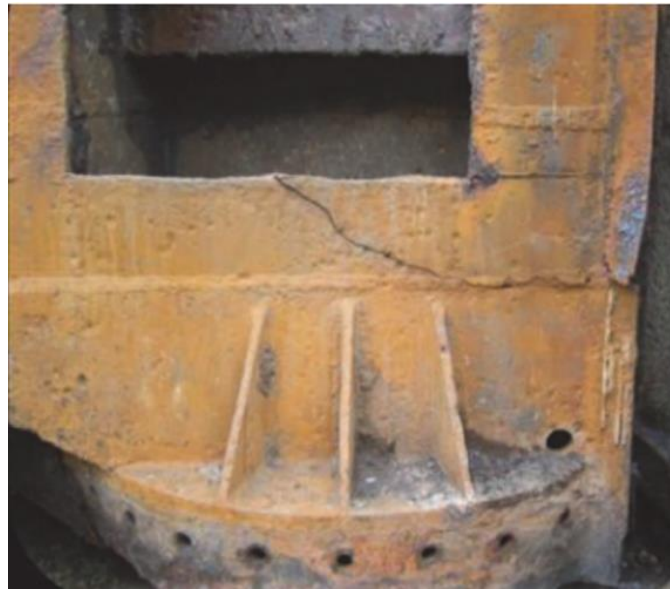
Figure 1. Crack near the pintle socket of a miter gate (Mahmoud and Riveros 2013).

Significant and extensive cracking has been repeatedly noted in SHS, especially in locations that are continuously submerged and not easily detectable without dewatering (USACE 2010). Cracks are commonly noted at welded joints, where residual stresses can cause tensile fatigue loading even if the location experiences compressive loading. Figure 1 and Figure 2 show examples of cracked miter gate components that are submerged during operation. Previous repair methods have imitated those used in the bridge industry, such as gouging and rewelding and adding welded cover plates (Mahmoud and Riveros 2013). After repairing and resuming service, these methods do not consistently offer long-term solutions, as cracks tend to reinitiate after relatively few cycles due to newly introduced residual stresses.

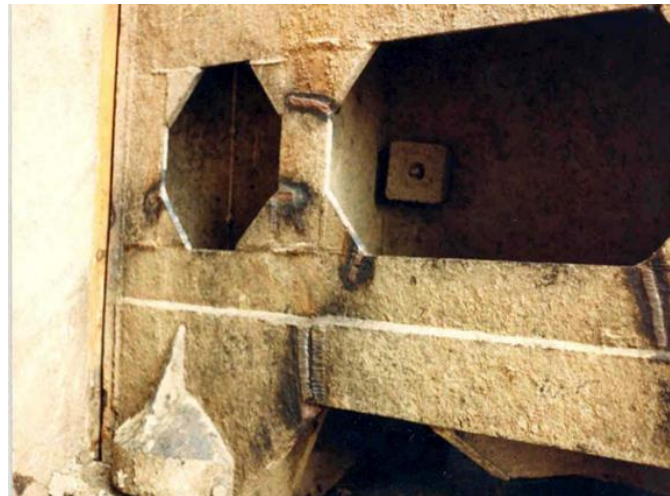
Figure 2. Cracks repaired by rewelding in miter gate girder and diaphragm flanges that experience compression loads during gate operation (USACE 2010).

Fatigue cracks in welded joints in the miter gates at the Markland Locks and Dam on the Ohio River, for example, were first observed and repaired by gouging and rewelding in 1984 after 24 years in service. Four years after the first repairs, cracks at the previously repaired locations and new locations were noted. Triangular welded gusset plates were added to reduce stresses at the locations as shown in Figure 2. Six years later, cracking around the gusset plates was noticed, and the gusset plates were replaced with a window frame–type repair as shown in Figure 3, successfully mitigating additional cracking (USACE 2010). While existing repair methods can provide solutions to continue safe operation, frequent

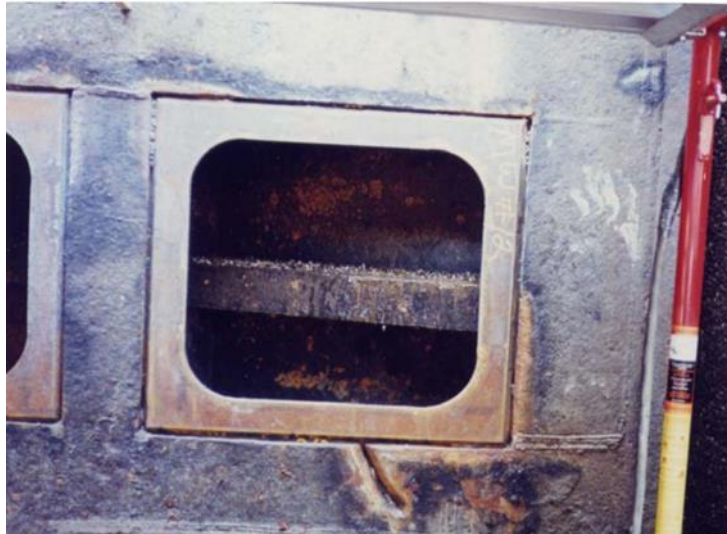
Figure 3. Welded window frame-type repair implemented for gates at the Markland Locks and Dam.

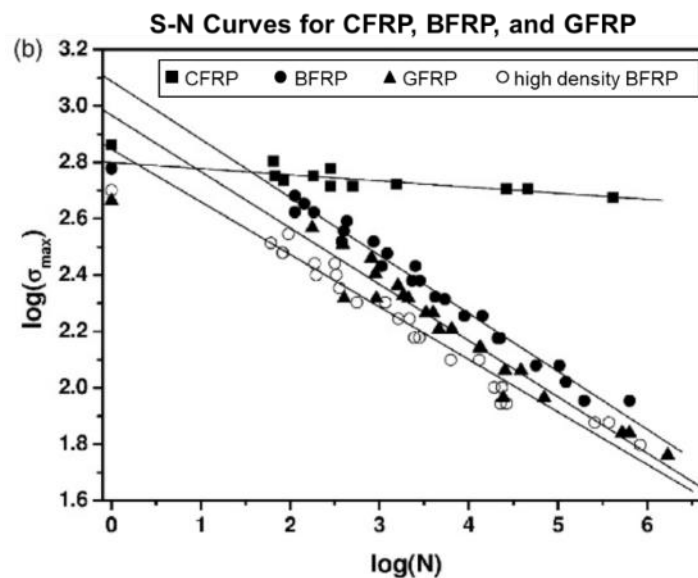
Figure 9. S-N curves for glass, basalt, and carbon FRP developed by Dorigato and Pegoretti (2012).

Due to previous use in other industries, fatigue life of BFRP has been studied. BFRP does not perform as well in fatigue as CFRP. Dorigato and Pegoretti (2012) developed S-N (alternating stress versus number of cycles to failure) curves for carbon, basalt, and glass fiber laminates in tensile fatigue, as shown in Figure 9. The slope of the S-N curve for BFRP is dramatically steeper than that for CFRP, indicating a reduced fatigue life in comparison to CFRP. Fatigue limits for CFRP and BFRP determined by Z. Wu et al. (2010) indicated that BFRP has infinite life under constant amplitude fatigue when the stress is less than 55% of its tensile strength, whereas the same is true for CFRP when the stress is less than 84% of its tensile strength. Due to the lower fatigue resistance of BFRP, more fatigue life consideration of the composite may be needed when BFRP is used as an alternative to CFRP in fatigue repairs.

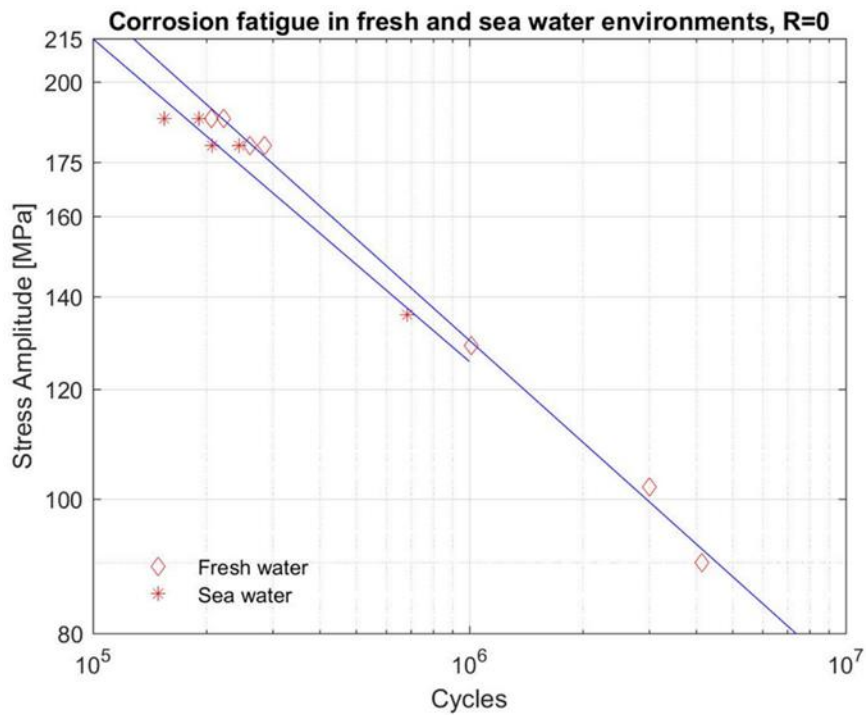
Figure 11. Comparison of S-N curves for steel in fresh water and salt water (Morgantini et al. 2018).

Similarly, varying the stress range can indirectly introduce a time variable that affects fatigue life underwater. If maintaining all other variables, reducing the stress range lowers the crack growth rate and therefore increases the time required for a crack to grow to a given length. If underwater, the increased time needed for crack growth allows the environmental factors a longer time to react, resulting in more pronounced degradation. This can result in a larger difference between fatigue life in air and water with lower stress ranges compared to higher stress ranges. Plots of stress range versus number of cycles for air, fresh water, and saltwater environments were developed and compared by Morgantini et al. (2018). Round rod specimens were axially fatigue tested with varying stress ranges and stress ratios in the three environments. Comparing the resulting S-N curves for fresh water and air, as shown in Figure 10, indicates that the environmental factors are much more present with low stress ranges. At higher stress ranges, at which the tests took fewer than  $10^6$  cycles, the results in water showed little difference from those in air. However, at the lowest stress ranges tested, which approached  $10^7$  cycles, the fatigue life was reduced by a factor of 2.1 when in water. The authors attribute this to the larger amount of time in water when the stress range is low. Also, the fatigue limit for the underwater environment was not reached in the stress ranges that were tested, which implies that the life reduction could be even greater with lower stress range. Comparing the resulting S-N curves in fresh water and salt water as shown in Figure 11 shows that salt water reduces fatigue life more than does fresh water, but the difference is very small compared to that between fresh water and air.

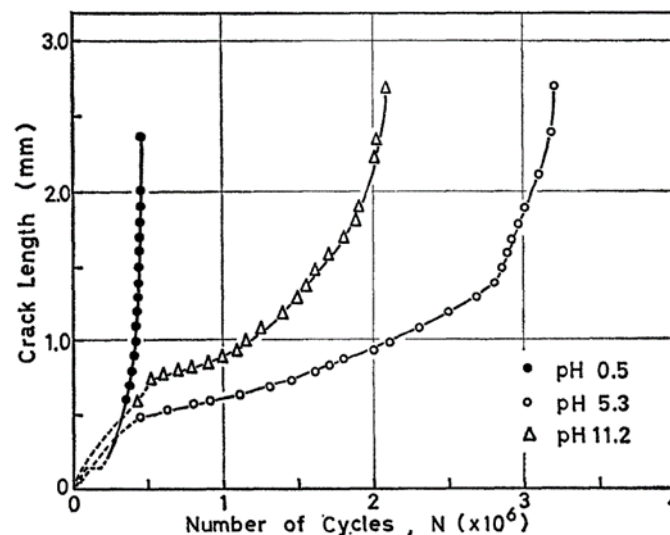
Figure 12. Fatigue crack propagation of steel in solutions of varying pH (Misawa and Kobayashi 1976).

it is logical that the pH of the environment may affect fatigue life. Differences in fatigue life between steel in solutions of various acidities were explored by Misawa and Kobayashi (1976). Round rod specimens with 15 mm diameter and 2.5 mm machined notches were tested in a rotating-bending fatigue machine. A corrosion cell around the specimens contained water with pH of 0.5, 5.3, or 11.2. Crack length and number of cycles were recorded throughout each of the tests. The solution closest to neutral, with a pH of 5.3, resulted in the highest fatigue life. Both the acidic and basic solutions reduced the life; however, it was reduced significantly more with the acidic solution, as depicted in Figure 12. This suggests a complex relationship between the pH of water and fatigue life of steel.

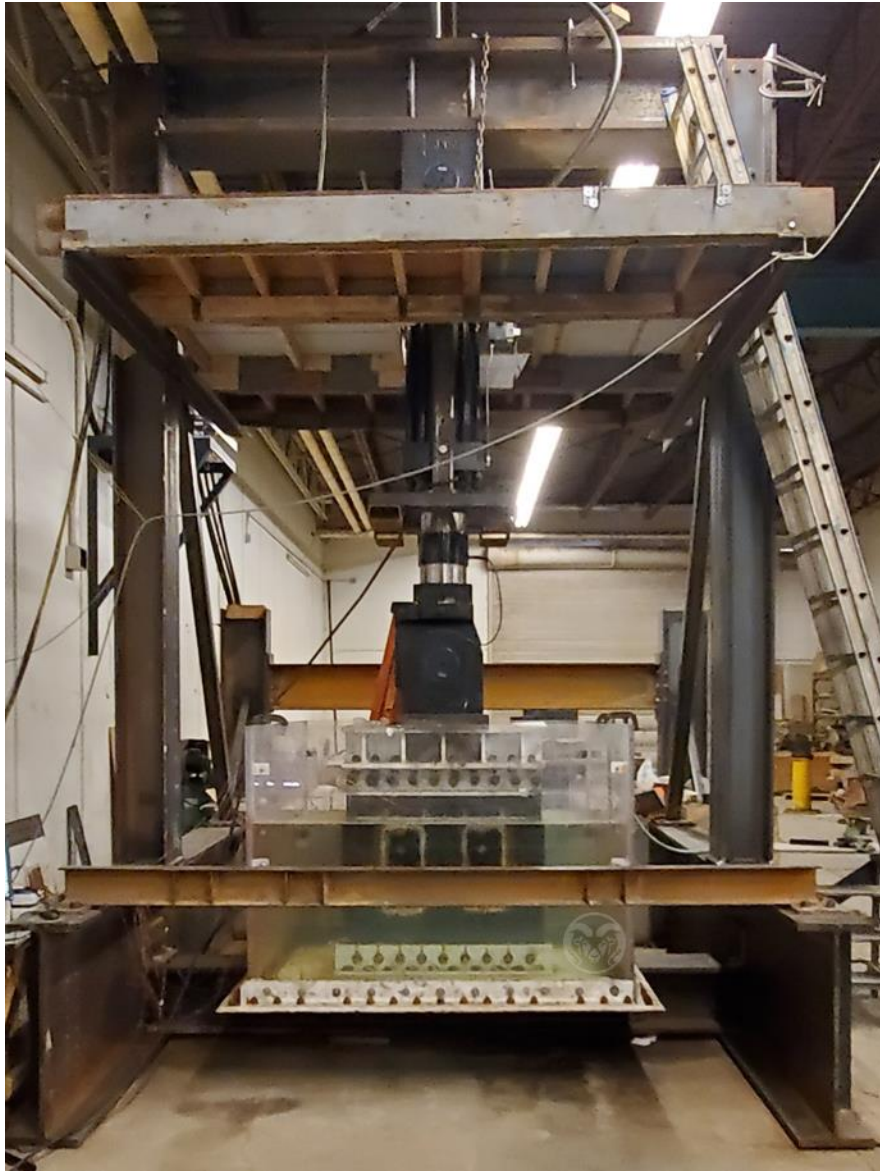
Figure 16. Photo of test frame.

A tank surrounding the specimens was built for use when an underwater test environment was needed. The steel tank floor rested on the lower test frame beam. Acrylic sheets were used as tank walls so that the specimens could be observed from outside the tank. Pumps were installed so that the tank could be easily filled and drained when needed. A schematic of the test frame and water tank as viewed looking south is provided in Figure 15. A photo of the test system viewed looking south is shown in Figure 16.

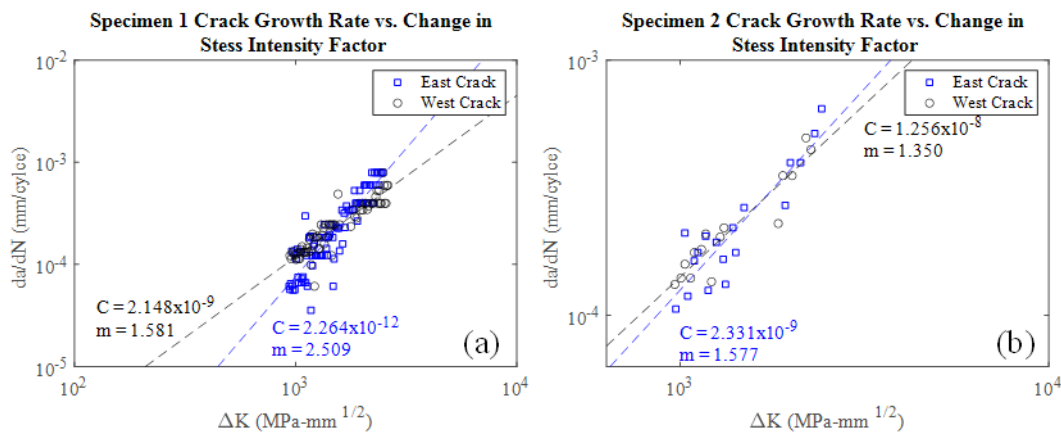
Figure 20. Plot of crack growth rate and stress intensity factor range for determination of Paris' law parameters for (a) specimen S1 and (b) specimen S2.

To further reflect on the crack growth rate for the unrepaired specimens (in air and underwater,) the parameters for Paris' law were calculated from the test data. Paris' law can be applied as a simple analytical method for understanding the growth rate of the test specimens' crack. Using the crack growth data acquired from specimens S1 and S2, Paris' law parameters  $C$  and  $m$  were estimated by calculating crack growth rate ( $da/dN$ ) and stress intensity factor range ( $\Delta K$ ).  $C$  and  $m$  are the y-intercept and slope, respectively, of  $da/dN$  versus  $\Delta K$  plotted on a log-log scale, as shown in Figure 20. Separate parameters were calculated for the east and west cracks. The difference between the estimated parameters for the east and the west cracks is minimal, which could be due to uneven stress distribution in the specimen due to minute misalignment in the test setup. Calculated parameters are for crack length and stress intensity factor in units of mm and MPa-mm<sup>1/2</sup>, respectively. The first several crack length measurements were excluded from the calculation because they may have been affected by the presence of the tack welds. Additionally, measurements taken after unstable growth was noted were excluded, as Paris' law no longer applies. A comparison between specimens S1, shown in Figure 20*a*, and specimen S2, displayed in Figure 20*b*, reveals that in

each specimen there was a difference between the crack growth rates for the east and west sides. The slope values for the east and west cracks, per meter, reduced from 2.51 and 1.58 for specimen S1 to 1.58 and 1.35 for specimen S2, which reflects the impact of the surrounding environment on the accelerating crack growth rates.

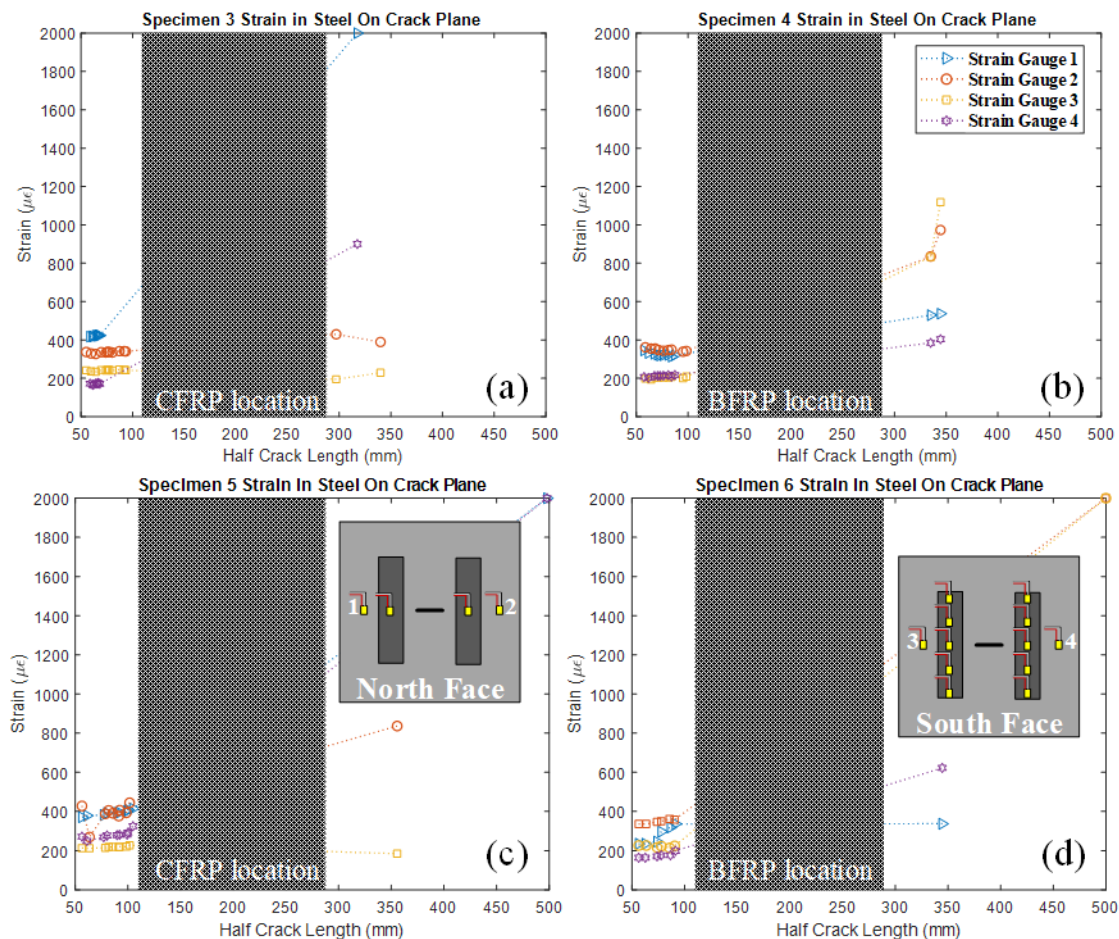
Figure 21. Strain data from strain gauges located in the steel at the crack plane vs. half-crack length for specimens strengthened with two patches including (a) specimen S3, (b) specimen S4, (c) specimen S5, and (d) specimen S6.

Strain gauges applied on the steel were located along the crack plane, and readings corresponding to measured crack lengths are shown in Figure 21 for specimens S3, S4, S5, and S6 that were retrofitted with two patches. For specimen 3, the strain in gauges 1 and 4 located on the east side of the specimen increased as the crack approached the gauges. The crack did not reach the gauges, however, due to a fracture of the west side. This means that the maximum strain that would have occurred when the crack tip reached the gauges was not recorded. Strain gauges 2 and 3 located on the west side showed a slight increase as the crack approached, but no rapid increase in strain was noted. As the west crack grew, it curved slightly upward such that its path was above the strain gauges rather than directly through them, so elevated strain values were not observed. For specimen S4, a rapid increase in the readings from strain gauges 2 and 3 along the west was recorded after the crack length was beyond the BFRP. However, the elevated values were not as high as those recorded for other specimens because the crack grew slightly above the strain gauges.

The east crack approached strain gauges 1 and 4 just as the fracture of the west half of the specimen took place, and increased values were recorded at that instance. For specimen S5, once the crack was beyond the CFRP, the readings from strain gauges 1, 2, and 4 were significantly increased. At the same time, the readings from strain gauge 3 were also increased but with less magnitude, which matched the observation that the crack grew past slightly above strain gauge 4 located in the east half before the west half of the specimen fractured. Unlike the previously retrofitted specimens, the fracture in specimen S6 occurred in the east half. Strain data for strain gauges 2 and 3 located in the east half showed a sudden increase in strain magnitude while increases recorded for strain gauges 1 and 4 were mild. The crack in the west half was about to approach strain gauges 1 and 4 in the same instance when the fracture of the west half took place.

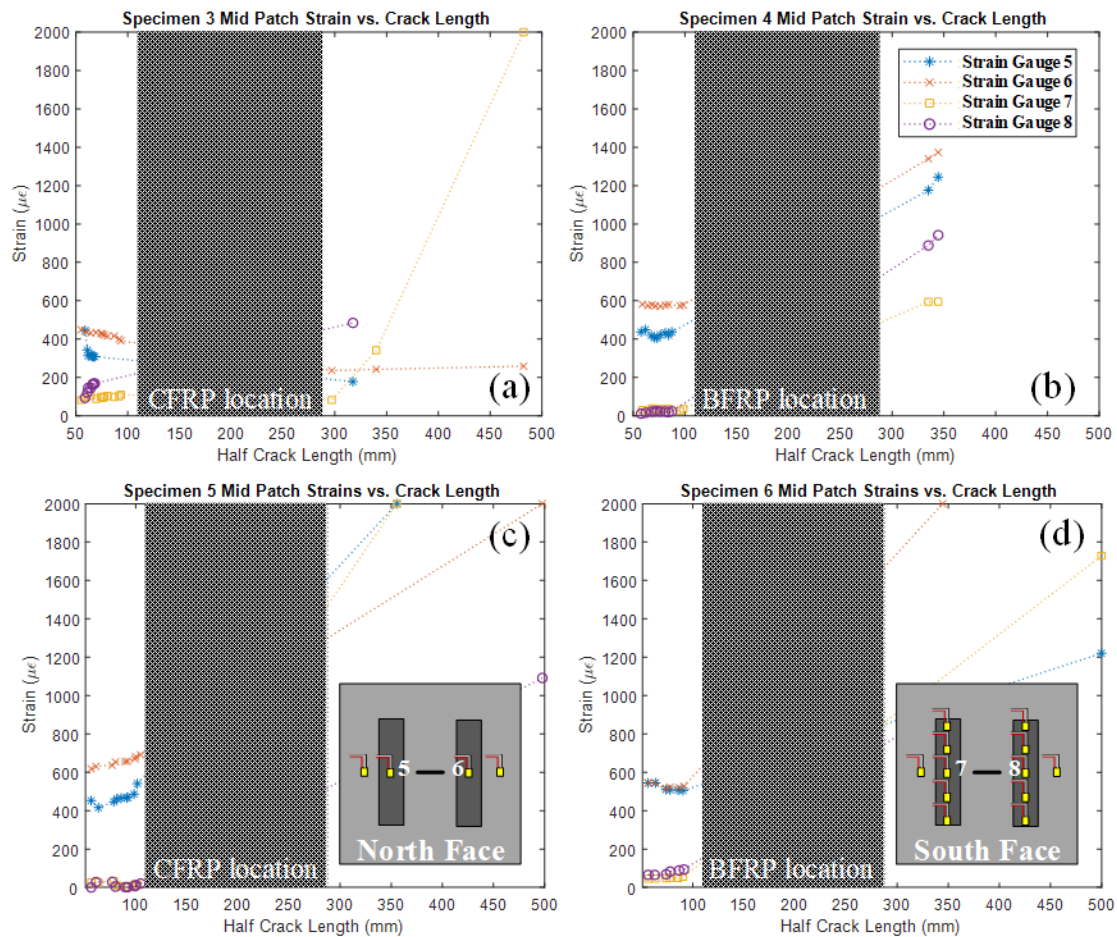
Figure 22. Strain data from strain gauges located in the patches at the crack plane vs. half crack length for specimens strengthened with two patches including (a) specimen S3, (b) specimen S4, (c) specimen S5, and (d) specimen S6.

Strain gauges on the FRP were installed along the crack plane on both faces and along the height of the patches on the south face. A comparison between the strain data collected from these strain gauges is shown in Figure 22. Similar to Figure 21, this figure displays the results of the specimens repaired with two patches. The strain magnitudes were non-uniformly distributed over the patches. For all the specimens, strain magnitudes recorded in the strain gauges located in the south face were less than the ones located in the north face. For specimen S3, Figure 22*a* shows that recorded values from strain gauges 5 and 6 slightly dropped during the test, which is an indication that debonding occurred in the patches located on the north face. All the strain gauges on the south face showed an increase in the strain magnitudes throughout the test, indicating that they remained well bonded. The south patches were bridging the crack and providing a crack closure effect until they ruptured. Unlike specimen S3, the magnitudes of all the strains were increasing with the half-crack length indicating that no debonding took place in specimens S4, S5, and S6 as shown in Figures 22*b*, 22*c*, and 22*d*, respectively.

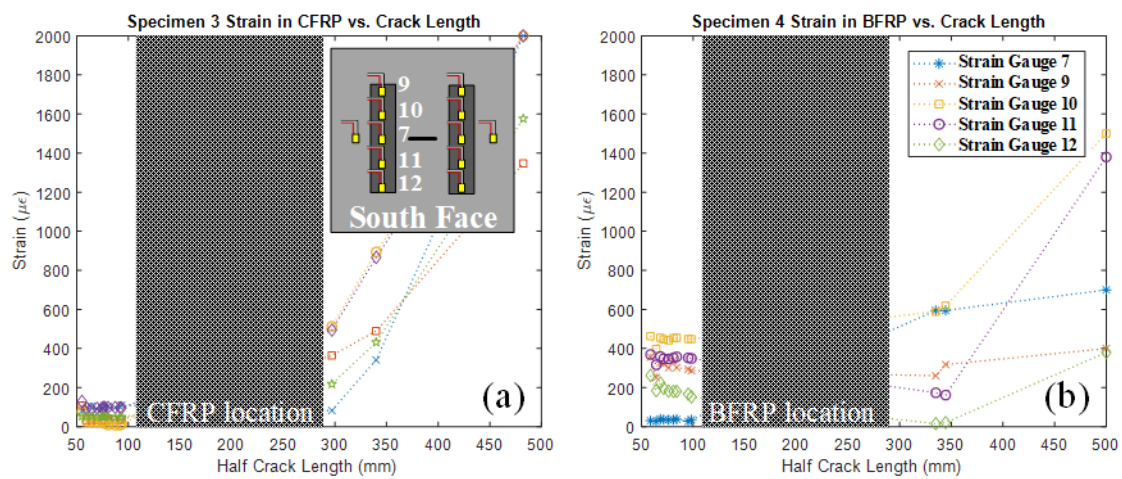
Figure 23. Plot of the strain data collected from strain gauges located along the height of the repair patches in the south face and at the west half of the specimens (a) S3 and (b) S4.

Strain gauges were also placed along the height of the patches on the south face to assist with detecting debonding from the steel. The strain results from the west half of the specimen are used as an example of the CFRP behavior and the strain distribution along the patches. Figures 23a and 23b show the strain data collected from specimens S3 and S4, respectively. For both specimens, all the strain gauges on the south face recorded increasing strains throughout the test, indicating that they remained well bonded. Therefore, the south patches were effectively bridging the crack and providing a crack closure effect until they ruptured. However, for specimen S3, only one of the strain gauges that was located on the north side of the specimen, shown in Figure 22a, showed decreasing values throughout the test. This matches the visual observation on that face.

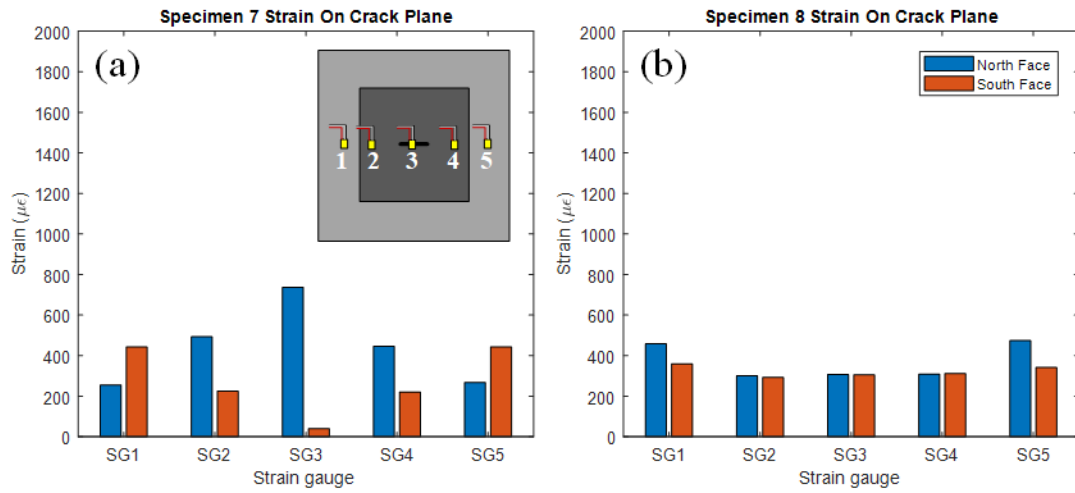
Figure 24. Plot of the strain data collected from strain gauges located along the crack length of the specimens (a) S7 and (b) S8.

To understand the strain distribution on the crack plane for the specimens S7 and S8 which were repaired with full patches, five strain gauges are installed on each face of each specimen. The strain data for these two specimens were stable, and no changes in the strain were recorded over the test. A comparison between the values of the strain data collected from these strain gauges is displayed in Figures 24a and 24b for specimens S7 and S8, respectively.

The results show that the strain distributions on the north and south faces are slightly different, which was attributed to slight misalignment in the test frame. Variation in the strain distribution between the north and south faces for the specimen retrofitted with the BFRP was less compared with the specimen retrofitted with CFRP, which is an indication of the effectiveness of the BFRP in redistributing the strain and stresses over the tested specimen's components. Also, the average strains on the BFRP patches were less than on the CFRP patches. The average strains in the steel repaired with BFRP were more than the ones repaired with CFRP. The average strains recorded on the west and east sides of both were symmetric, where the average strains recorded at strain gauges 1 and 2 were similar in magnitude to the strains in strain gauges 4 and 5, respectively. This similarity in the recorded strains reflects the symmetry in the test configuration between the east and west sides. These two tests were stopped when the number of cycles reached the pre-defined threshold of 3 million cycles and the crack in these two specimens showed no initiation.
