# **Aquatic Ecosystem Restoration in the Texas Western Gulf Coast Plain / Lower Rio Grande Alluvial Floodplain Ecoregion**

Resaca Boulevard Resaca Section 206—Vegetation Community Adaptive Management

Final report

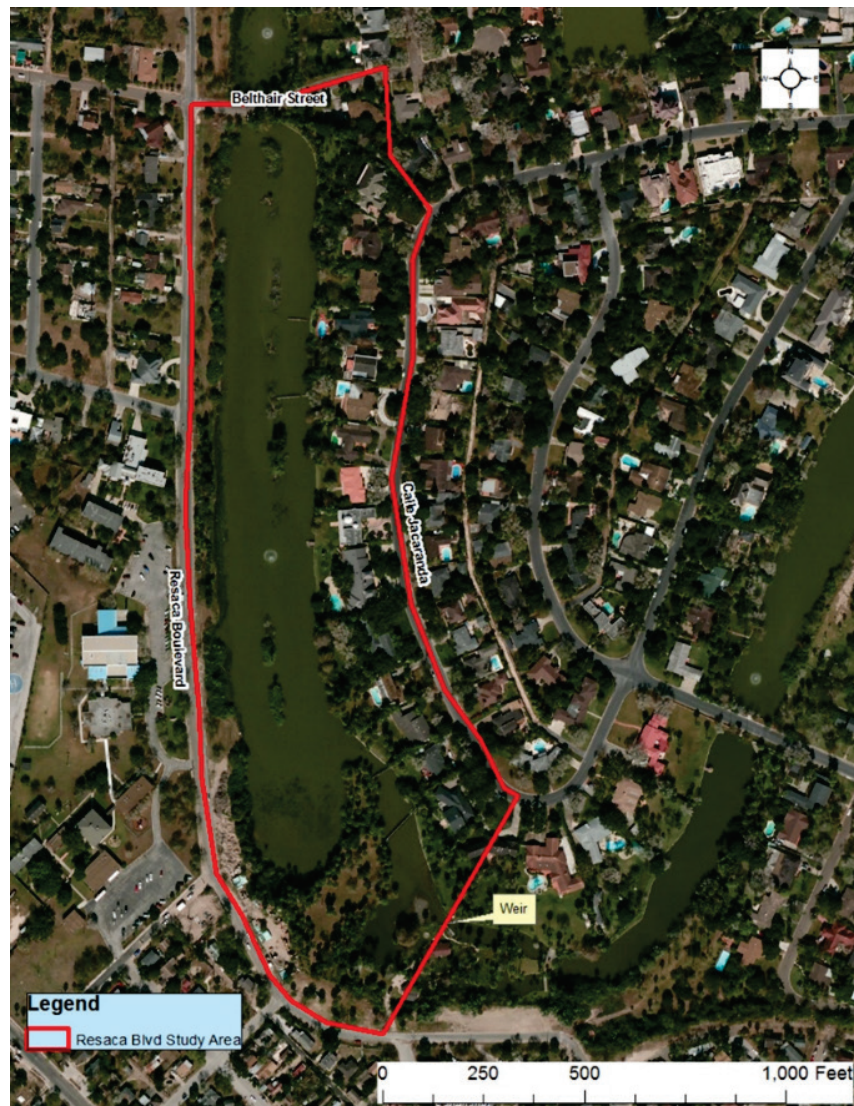
Figure 2. Resaca Boulevard Resaca study area includes the resaca and adjacent lands.

The project location was in the City of Brownsville in Cameron County, Texas (SWG 2016). The study area included the RBR and surrounding lands between Belthair Street and a downstream weir located at the southern end of the resaca. The total project area encompassed approximately 2.16 ha (5.35 acres), which was composed of 0.75 acres of aquatic and emergent wetland habitat and 4.6 acres of riparian habitat (Figure 2). The RBR was part of the Town Resaca system that flows west to east across the southern section of Brownsville. The area had subtropical climate with warm maritime influence from the Gulf of Mexico. The RBR study area had a relatively flat topography associated with a large river delta at elevations of 25 ft above mean sea level.

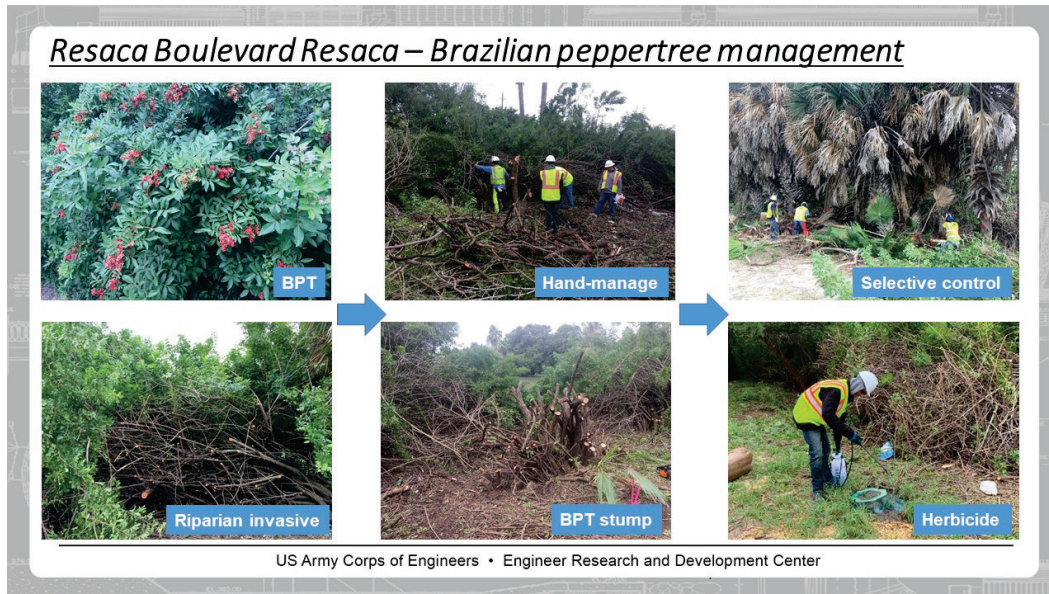
Figure 3. Brazilian peppertree removal process at RBR project site.

maturation of seeds. In addition to Brazilian peppertrees, several other tree species were treated or removed where necessary and possible (Figure 3). Scattered Chinaberry and Chinese tallow trees were cut and stump-treated in the same manner as Brazilian peppertree. Additionally, a large stand of Australian pines was removed from near the center of the site.

The initial deadline was established to avoid the spread of seeds across the study area and elsewhere, and thereby minimizing the need to treat additional areas where the seeds may sprout. However, due to significant delays, the implementation of Brazilian peppertree treatment was not initiated until late-summer 2018. With treatment being conducted after fruiting was completed, USACE SWG and ERDC identified mitigation measures that would minimize the spread of seeds outside the existing distribution of Brazilian peppertree. Initial mitigation measures involved placing tarps abutting the existing edges of the Brazilian peppertree footprint. Vehicles and trailers used to haul off debris were positioned adjacent to these tarps ensuring any fallen seed material during such transfer would not fall on bare ground. Seeds situated on the tarp or those that may have inadvertently fallen off were collected and properly disposed of. Following invasive species treatment, the entire site was continually monitored for Brazilian peppertree and other nuisance tree species seedlings and treated as needed.

By incorporating these measures into the construction plan, the risk associated with the removal and treatment of Brazilian peppertree during the fruiting season was minimized to an acceptable risk level. The SAMES construction crew, herbicide treatment crew, and USACE Biologists (RPEC and ERDC) then conducted several site visits to remove the peppertrees and followed the mitigation measures to reduce the spread of fruits and seeds. Non-fruiting branches were dragged to the disposal piles. On-site district biologists, often with ERDC assistance, continually monitored progress of Brazilian peppertree and other nuisance tree removal at the onset of the project. Documentation and recommendations were made as removal progressed, including estimates of efficacy of treatments, occurrences of missed trees, provision of protecting desirable tree species (e.g., flagging), and identification and locations (by flagging) of seedlings and saplings that occurred postremoval.

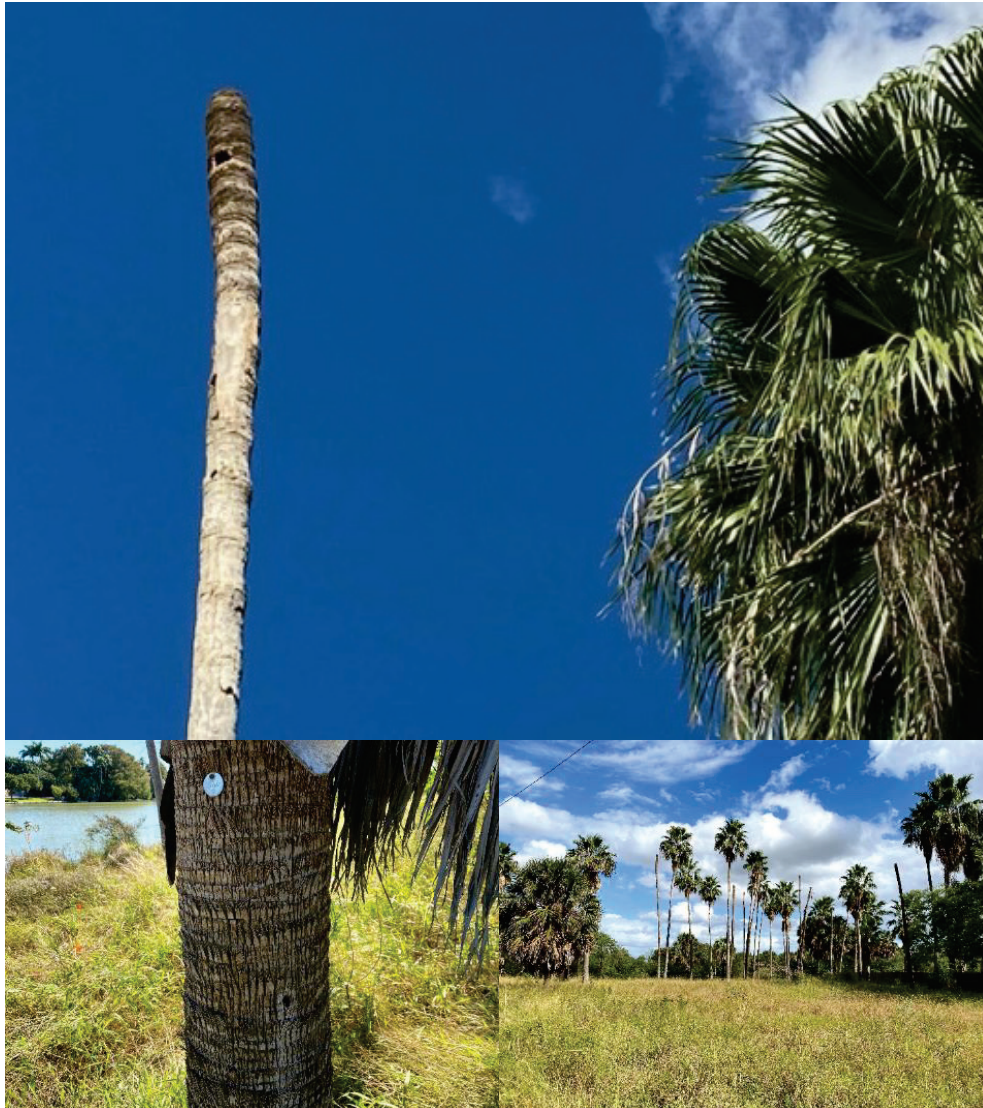
**Figure 4. Nonnative palm snags at RBR for the purposes of red-crowned parrot and woodpecker habitat.**

Working maps were continuously created to show the next treatment dates for each area and document the fate of invasive trees in the project area. This identified the six-week windows (to confirm invasive plant mortality from herbicide before grubbing) for the separate segments of Brazilian peppertree and other nuisance tree treatment areas. The last treatment and the earliest grubbing dates were marked for each segment. They also identified the fate of targeted trees and the species of trees that remain, non-native palms that were treated and killed, those that will be treated in 5 yr, and those that will be treated in 10 yr. Non-native palm trees were thinned, and a subset of the palms were treated with glyphosate to create standing snags to serve as nesting habitat for golden-fronted woodpeckers and red-crowned parrots (Figure 4).

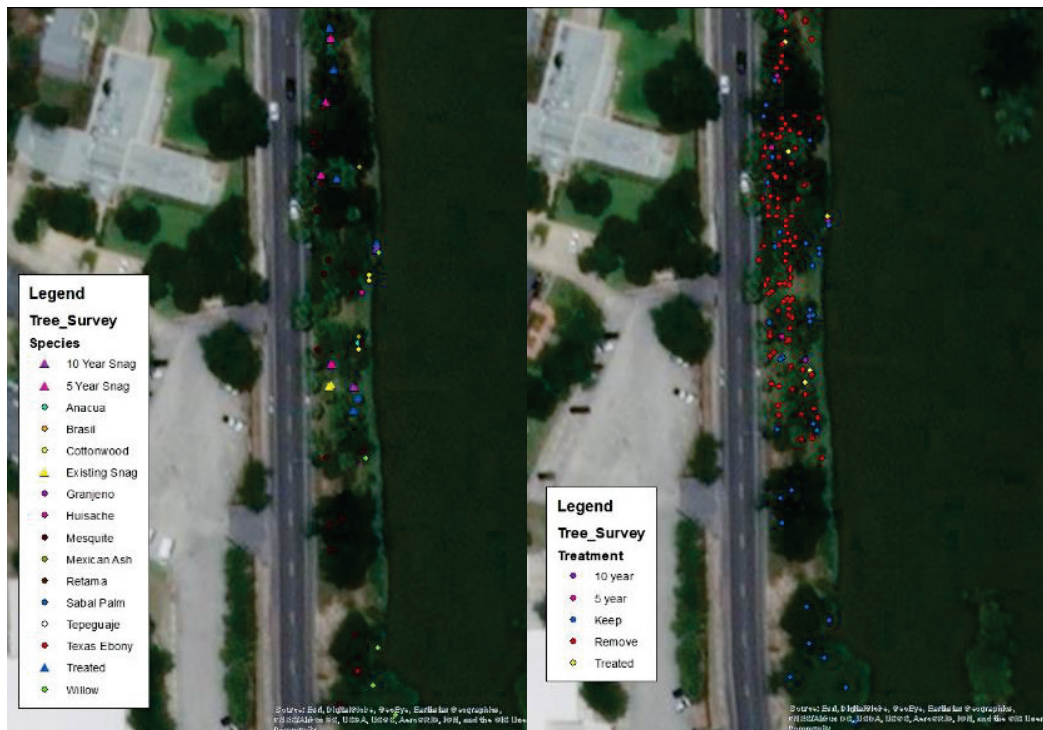
Figure 7. Paired maps that identify fate of trees to keep, remove, and treat (*left*) and the species of trees that remain (*right*).

ERDC-EL-LAERF assisted with onsite biological monitoring of invasive species removal, native plant avoidance, improvements in installations, and other contractor activities throughout construction to ensure project success. Figure 7 illustrates an example of native plants to stay during invasive species removal phase (USACE RPEC).

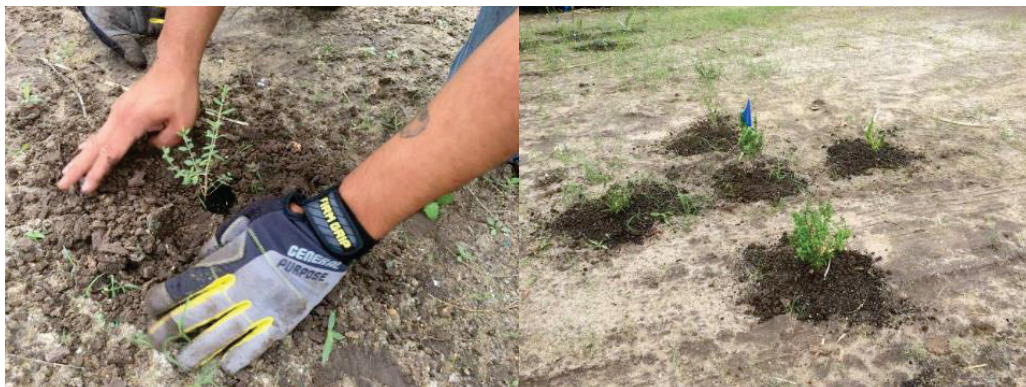
**Figure 9. Woody and herbaceous vegetation planting in riparian areas at RBR in April 2019.**

The first planting effort consisted of woody and herbaceous containerized plants (riparian or shoreline and upland) to promote the RBR ecosystem restoration goals of native plant establishment. Plantings occurred in two general areas, south and north sites from a species selected list (Table 4). Plants were placed in clusters leaving 7–10 ft between to enable mowing over herbaceous cover when necessary. Holes were dug using small gas-powered augers and plantings were backfilled with on-site sediment. Most of the plants were planted on the landside of the existing silt fence, while 26 Montezuma cypress and 9 ash trees were planted 4 ft away from the silt fence towards the water (lower elevation, saturated soils). On the south site, a total of 330 plants were planted including five Rio Grande palmettos and ten Montezuma cypress. On the north site, 231 plants were transplanted, including three clusters of sabal palms (approximately 25 each) along with 16 Montezuma cypress plants. The north end also included a one 10 ft x 30 ft flag marked woody seeding location containing native plants (Rio Grande palmetto, sweet acacia, ebony, blackbrush acacia, cedar elm, crucillo, tenaza, hog plum, and anacua). Starting monthly on 15 April 2019, ERDC-EL-LAERF assessed plant and vegetation site conditions (see Results). Figure 9 illustrates planting method results of first plantings efforts, April 2019.

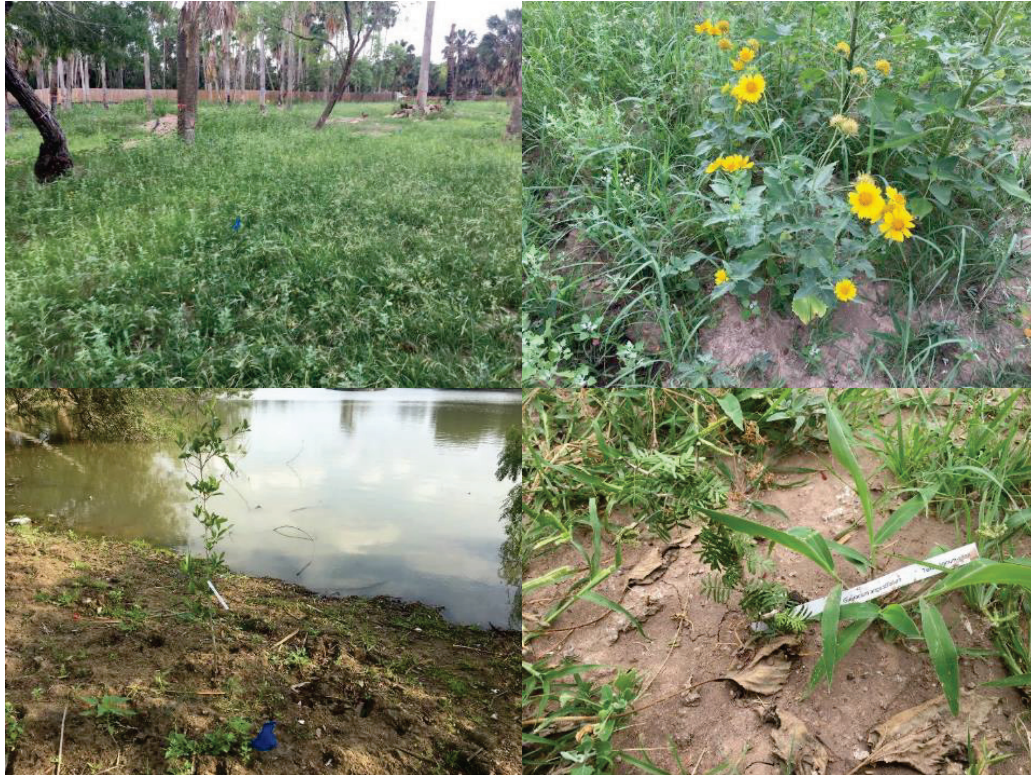
The first site assessment occurred 01 May 2019, following the January 2019 seeding and April 2019 woody planting. Six of the seeded native species were observed along with some desirable volunteer vegetation (e.g., cowpen daisy) (Figure 13) and some less than desirable vegetation (goosefoots and annual sunflowers). Minimal herbivory (estimated at 1% or less) was observed on woody transplants throughout the site (Figure 13). Appendix E provides detailed photograph examples of woody plantings. Due to this and the short duration since planting, survival was near 100%. Mowing was prohibited in several areas at that time because some native vegetation was flowering and needed to go to seed before mowing. Annual sunflowers were also culled by hand to allow for better establishment of desirable species. In addition to grasses and forbs, Chinese tallow seedlings were observed and designated for treatment during this assessment.

Figure 13. First site assessment (1 May 2019); *top left* – successful seeding; *top right* – cowpen daisy; *bottom left*–woody species planted, Mexican Ash; *bottom right* – Texas lignum-vitae.

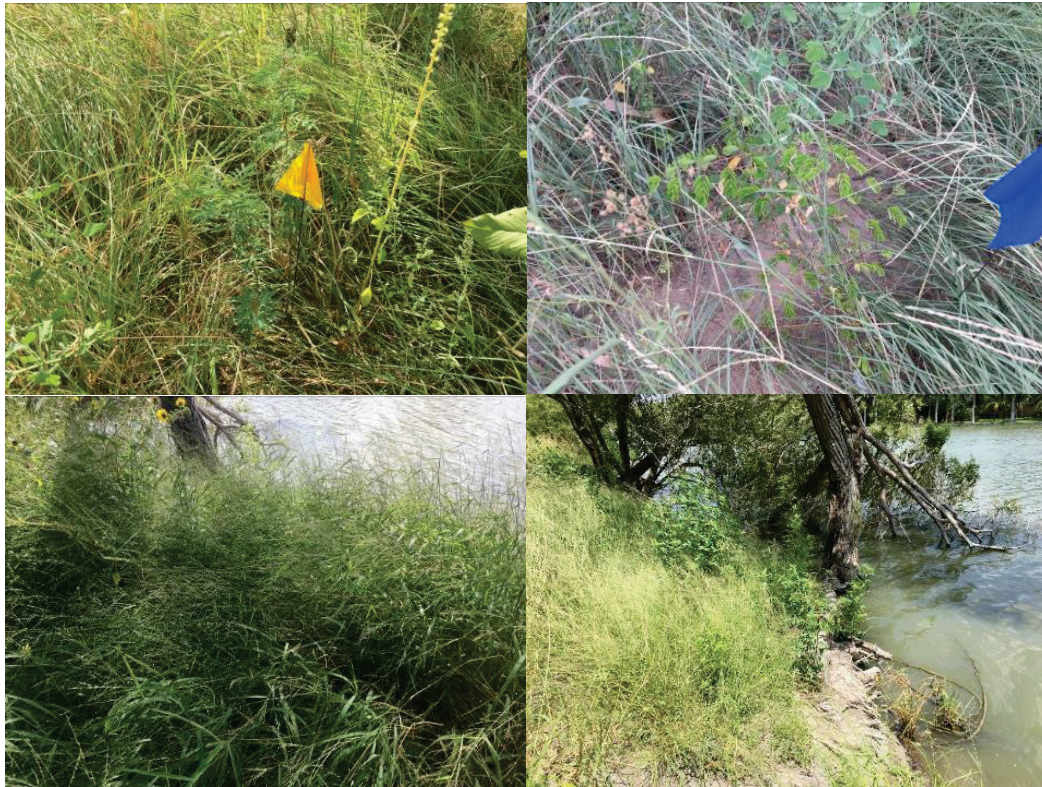
The next assessment occurred on 17 July 2019, in which woody vegetation transplant survival remained around 90% with minimal herbivory observed (Figure 17). As in the earlier assessment, smaller transplants continued to be more successful than larger transplants (lowest mortality observed in smaller, younger, and 1-year-old transplants). Other observations included measurable above-ground growth in certain species, such as Montezuma cypress, acacias, ebony, hackberries, and Mexican Poinciana. The post-seeded truck irrigation path exhibited poor establishment from seed in a few areas. Guineagrass had moderately expanded in no-mow areas to an estimated 15% coverage and occasional Brazilian peppertree and Chinese tallow seedlings occurred in small numbers and were scheduled for later treatment (Figure 17).

Figure 17. July 2019: *top left* – acacia transplant; *top right* – Mexican holdback transplant; *bottom left* – invasive guineagrass; and *bottom right* – invasive Brazilian peppertree regrowth.

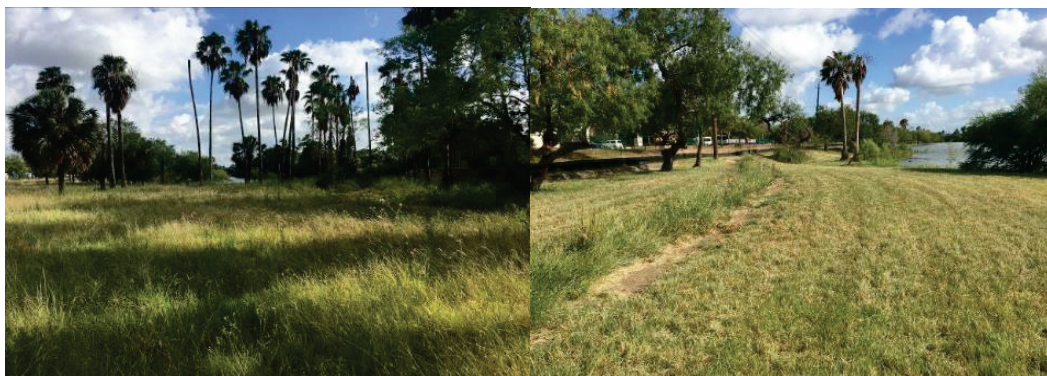
The first mow versus non-mow areas was assessed and appeared to be successful by the contractor (Figure 18). Thirteen species from the seeding efforts were observed (Table 8) and ground coverage was >80%. Some remaining annual sunflowers had gone to seed and occurred at their highest density in the north planting area. Annual plant senescence was expected to reduce the “eye-sore” issue raised by some residents. After going to seed, any contractor efforts to remove standing vegetation would be for general aesthetics and would not contribute to control in subsequent growing seasons. Targeted mowing prior to seeding to continue management that promotes other native perennial species was a better use of resources to meet project goals, and to reduce sunflower populations over time.

Figure 18. *Left* – mow, and *right* – no-mow zones, 17 July 2019.

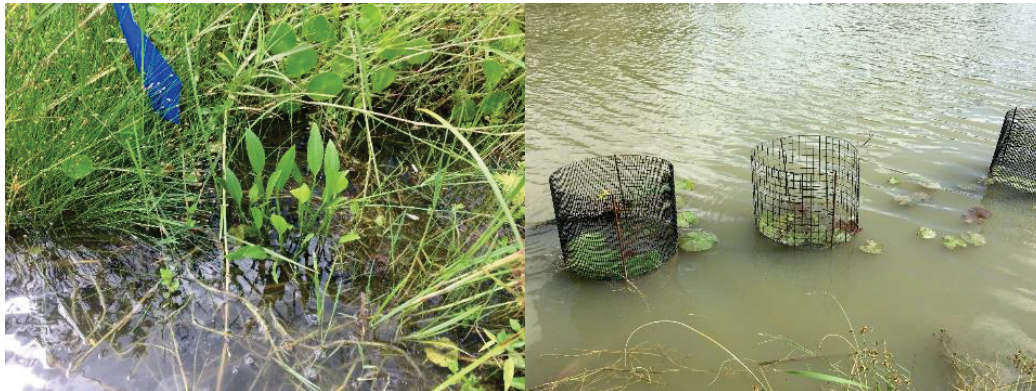
Figure 19. Emergent and aquatic vegetation condition–October 2019, *left* - delta arrowhead; *right* - American white waterlily.

Aquatic plantings, in addition to general site conditions and other vegetation community developments, were assessed monthly from October 2019–February 2020. Throughout, minimal, if any, herbivory was observed on SAV founder colony sites. This was surprising due to the potential existing herbivores, including nutria, backing turtles, and armored catfish, but fortunate as sites would successfully serve as propagule sources for wetland-wide spread. This was first observed as early as 29 October 2019 (Figure 19). Emergent vegetation was also observed to be successfully established; bulrushes, spikerushes, delta arrowhead, and water hyssop being the most successful species. Appendix D provides aquatic vegetation photographs throughout the project.

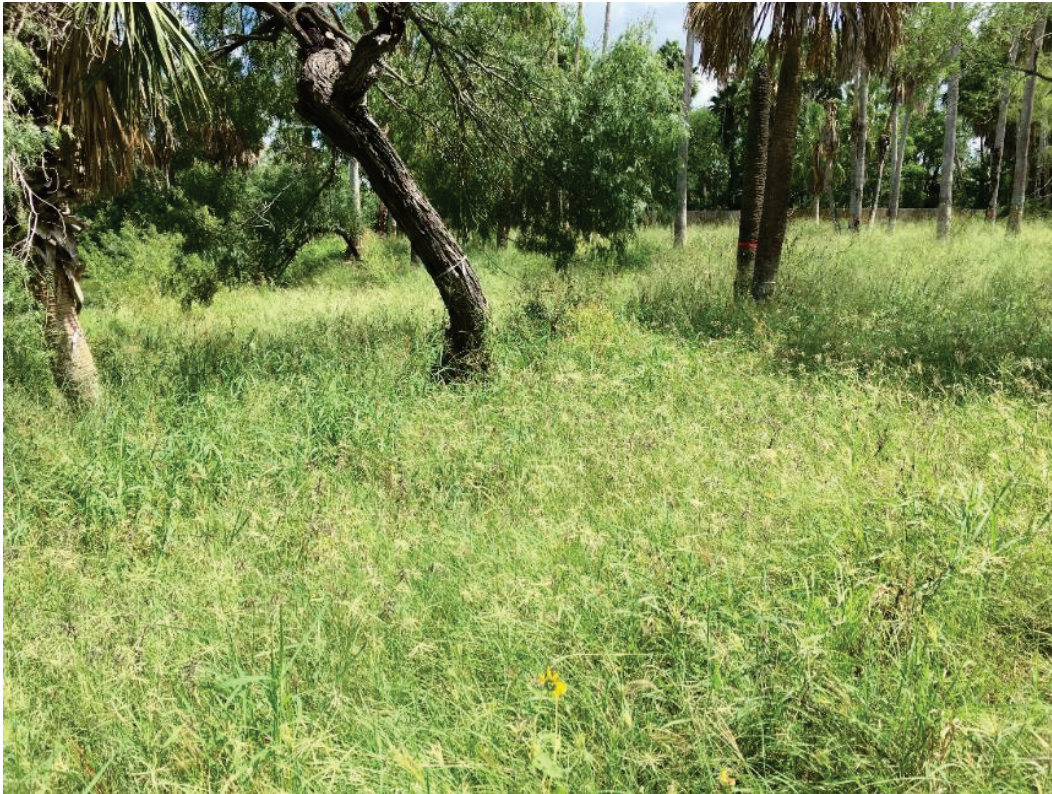
Figure 20. Native seeding condition as of 1 October 2019.

In October 2019, seeded areas were again thriving (Figure 20), but scattered woody invasives remained an issue. Thus, a priority on subsequent site visits was the coordination of retreatments of invasive species seedlings with the contractor. Continued removal of invasive species provides space for establishing native plant communities, which in turn reduces the ability of invasive species to recover. Another assessment occurred on the 13 November 2019 with onsite observations of various invasive species (Brazilian peppertree, Chinese tallow, Chinaberry tree, and river tamarind). They were identified and flagged for contractor removal/retreatment (Figure 21). Approximately 50 invasive Chinese tallow seedlings marked for removal were sparsely located throughout site, but denser in the north section. Other observations during this time included occurrences of native woody plant recruitment in no-mow areas, including willows and retama. Aquatic plant establishment was successfully progressing with minimal herbivory observed. Unauthorized

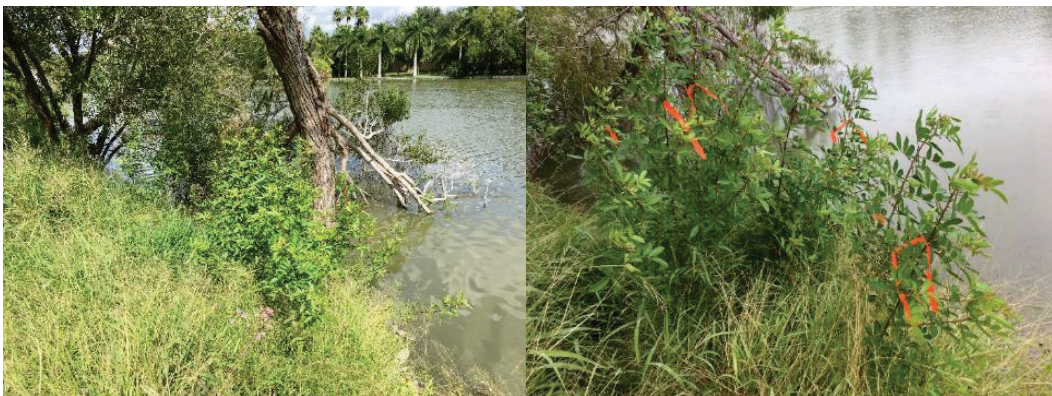
Figure 21. Invasive species resprouting; marked for removal.

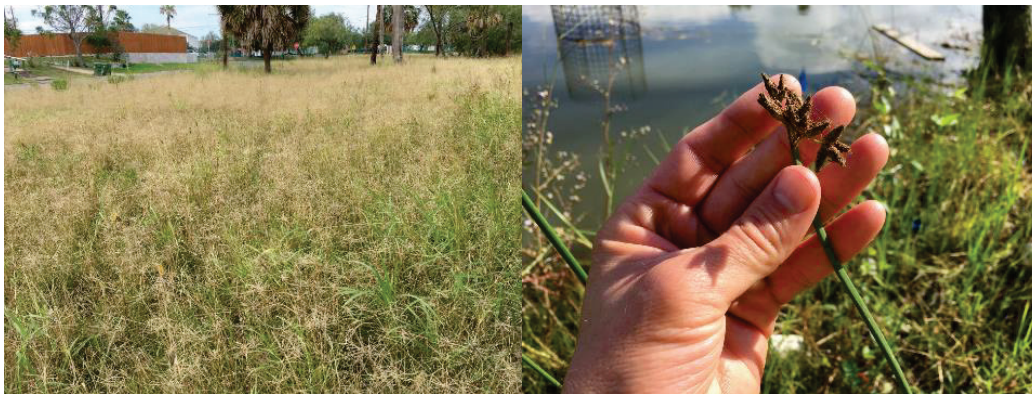
Figure 22. Plant observations during 4 December 2019 site visit: *left* – seeding development and *right* – softstem bulrush showing seeding.

The next assessment was completed on 04 December 2019. It was determined the central area needed to be reseeded by a contractor and planted with additional containerized plants by ERDC-EL-LAERF team by January 2020 due to the previous irrigation path, which had resulted in a few bare areas. The north no-mow seeded area supported wildflowers and the south no-mow area exhibited native grass seed cover (Figure 22).

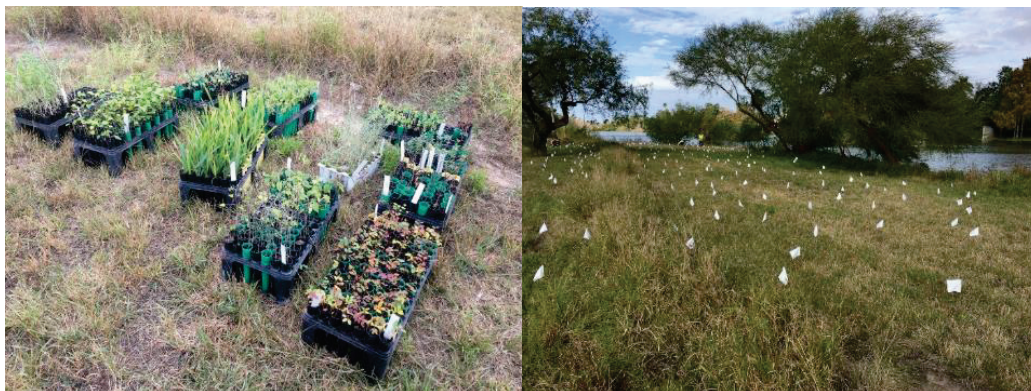
Figure 23. Plantings, 10 January 2020: *left* – transplants and *right* – flagged area.

A follow-up woody planting occurred on 10 January 2020 and involved a site-wide planting that included installation of 12 plant species totaling 800 plants (Table 9). Containerized plantings were flagged (Figure 23), while bare areas in the north site that had been reseeded by the contractor were included in the planting area. The contractor completed spot-treatment of Brazilian peppertree and Chinese tallow and removed treated biomass by this time. ERDC-EL-LAERF requested mowing cease following this effort to avoid damage to planted trees and shrubs. In coordination with COB and BPUB, ERDC-EL-LAERF continued monitoring vegetation community development and provided recommendations for any management needs through 2020.

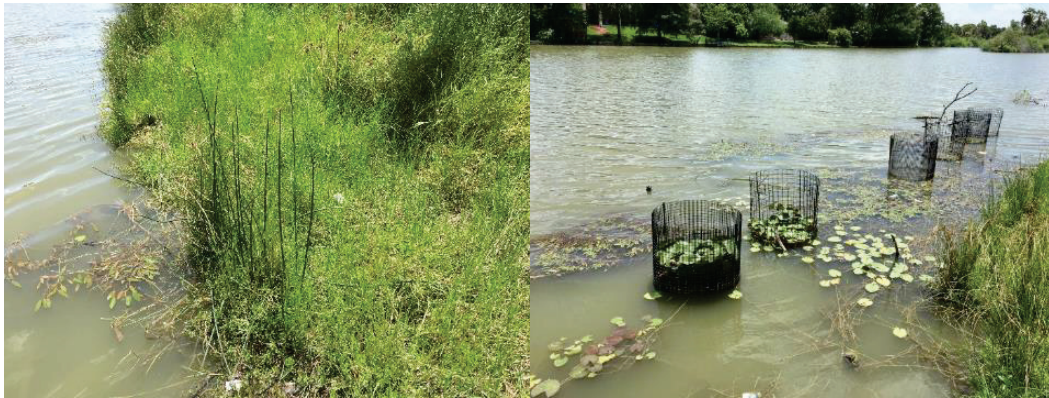
**Figure 24. August 2020: aquatic and emergent vegetation spread.**

The next assessment occurred in February 2020. Submersed and floating-leaved species protected by exclosures exhibited high survival and showed signs of spread outside of protected areas. Colonies of planted emergent and desirable volunteer species had expanded, dominated by bulrushes and sedges. Containerized plantings (2019) in other areas were also exhibiting good survival and growth, including Texas ebony, Mexican poinciana, and Mexican olive plants. Due to travel restrictions by the 2020 pandemic, the site was not assessed again until August 2020. As illustrated in Figure 24 and Appendix D, most of the planted vegetation, especially aquatics, were spreading and thriving. However, additional

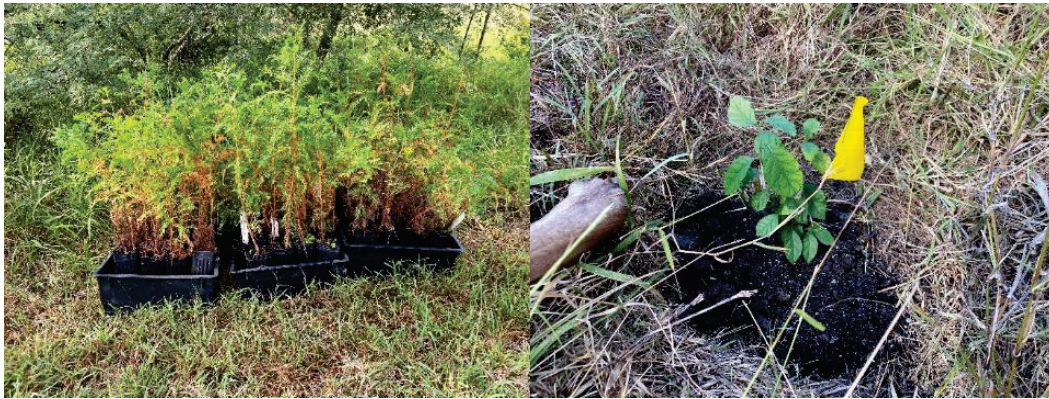
Figure 25. Transplant examples from November 2020 adaptive management supplemental planting: *left* – Montezuma cypress and *right* – anacua.

The final ERDC-EL-LAERF planting occurred in November 2020 and involved a site-wide supplemental / adaptive management planting that included installation of 17 plant species totaling 700 plants. Species planted included anacua, Texas lignum-vitae, catclaw acacia, sabal palm, Mexican holdback, milkweeds, whitebrush, lotebush, Mexican olive, blackbrush acacia, spiny hackberry, Texas ebony, Brazilian bluewood, Texas persimmon, Montezuma cypress, and guajillo (Figure 25). During this time, site conditions were also assessed. SAV founder colony sites were functioning as planned and the most successful woody vegetation remained was anacua, Mexican holdback, Montezuma cypress, Mexican olive, Mexican ash, acacias, sabal palms, hackberries, cedar elms, Texas persimmons, and whitebrush (Appendices D and E).

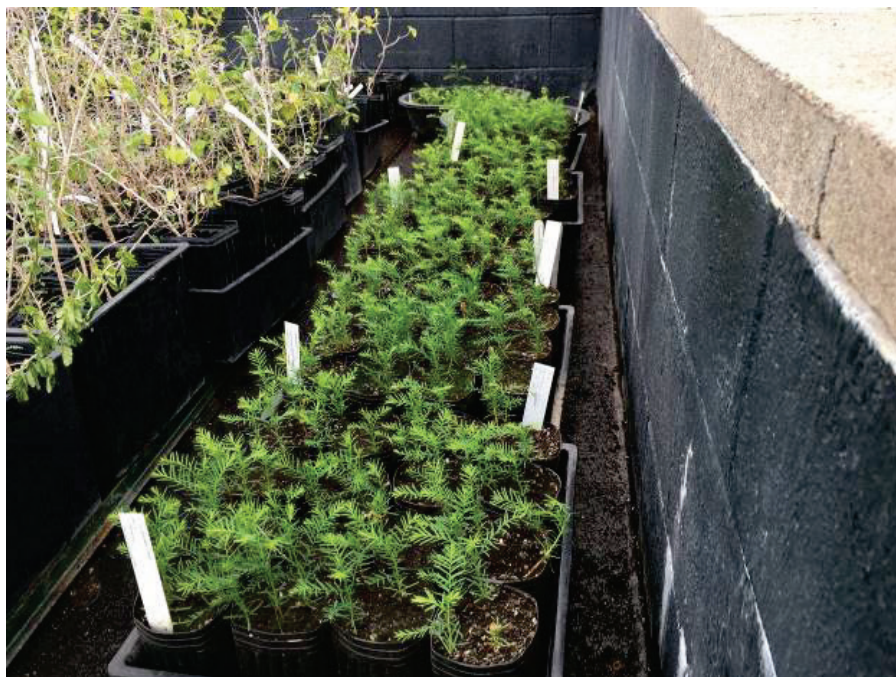
Figure A-1. Propagation of Montezuma cypress (*Taxodium mucronatum*) at the Lewisville Aquatic Ecosystem Research Facility (LAERF) for resaca restoration plantings.

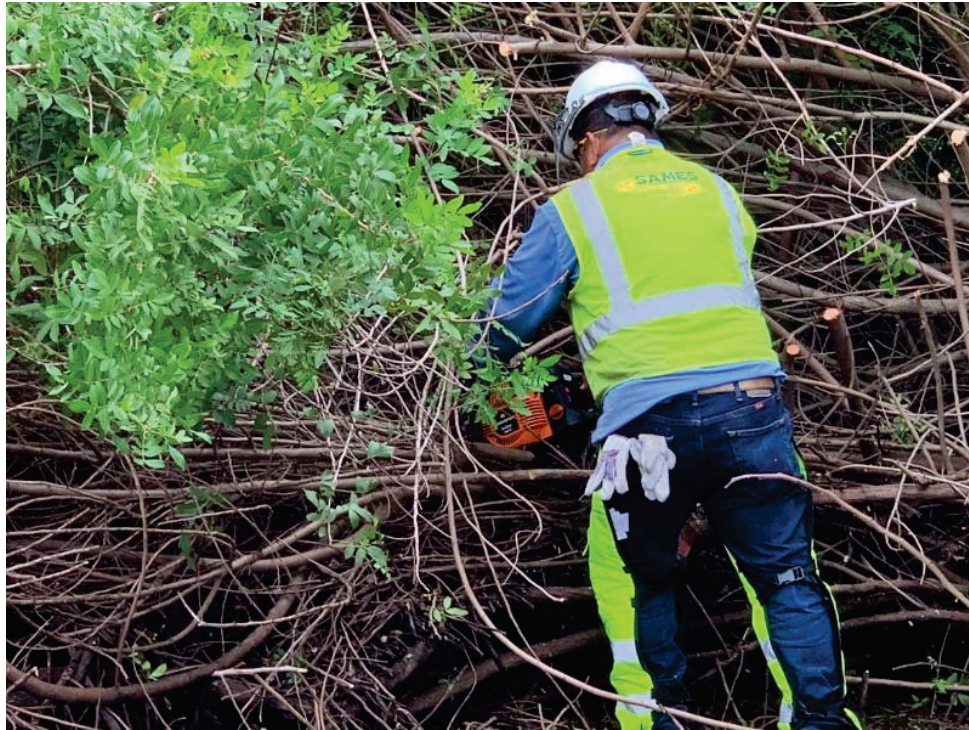
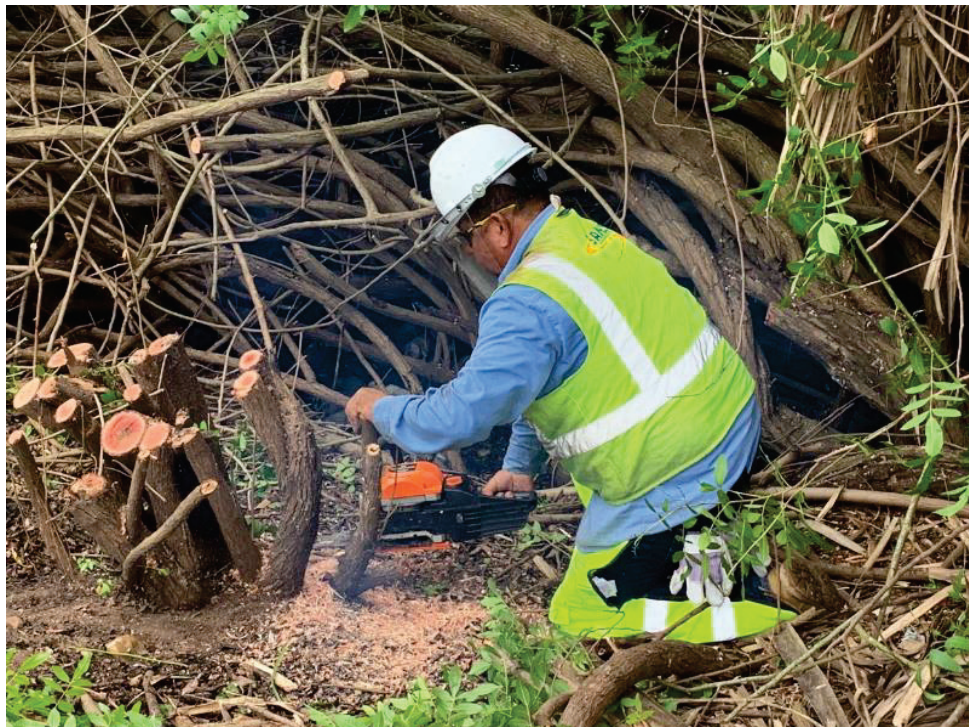
Figure B-1. Manual cutting of Brazilian peppertree (BPT) stumps before herbicide (triclopyr) application.

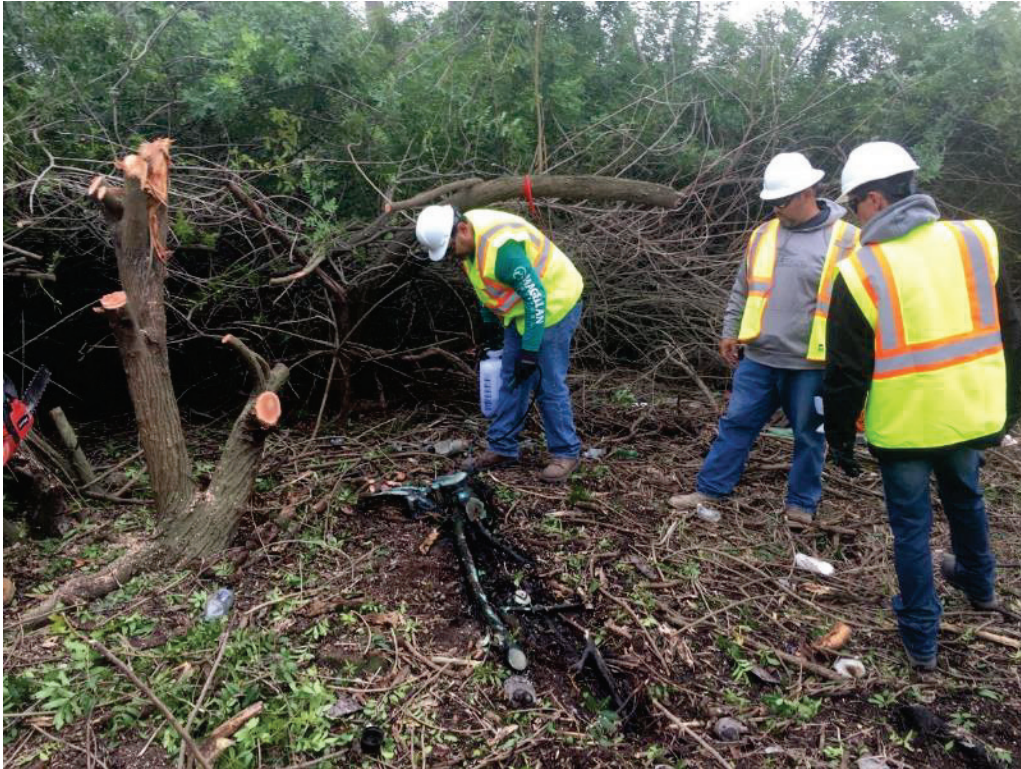
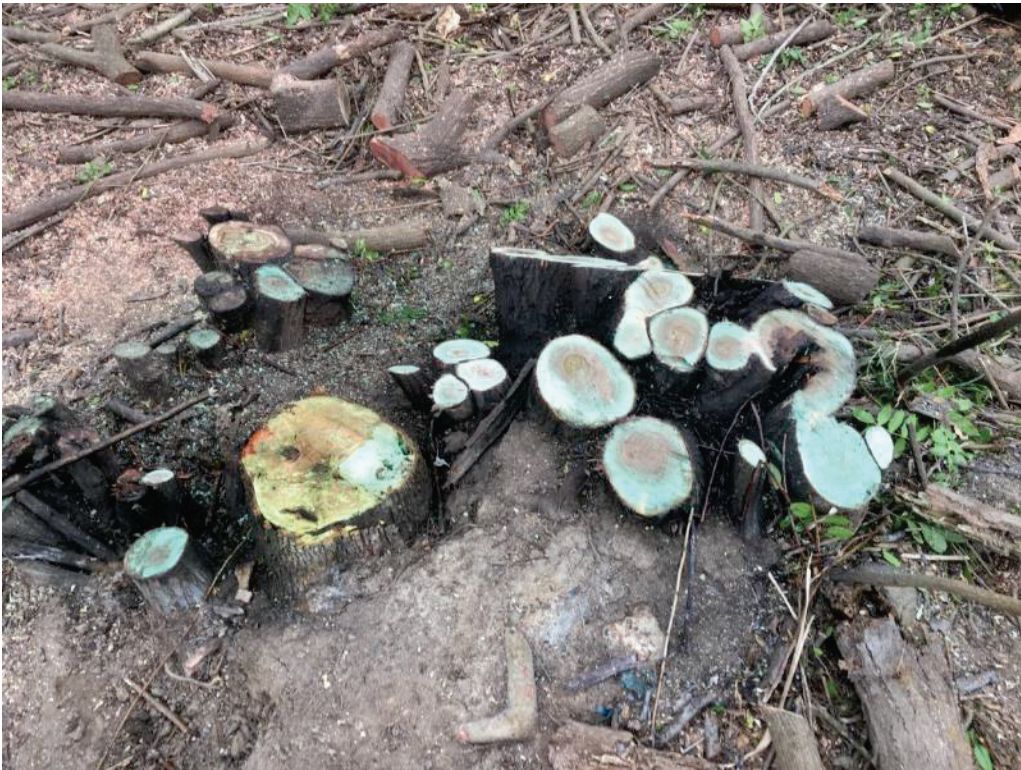
Figure B-2. Brazilian peppertree (BPT) stump-cut herbicide (triclopyr) application.

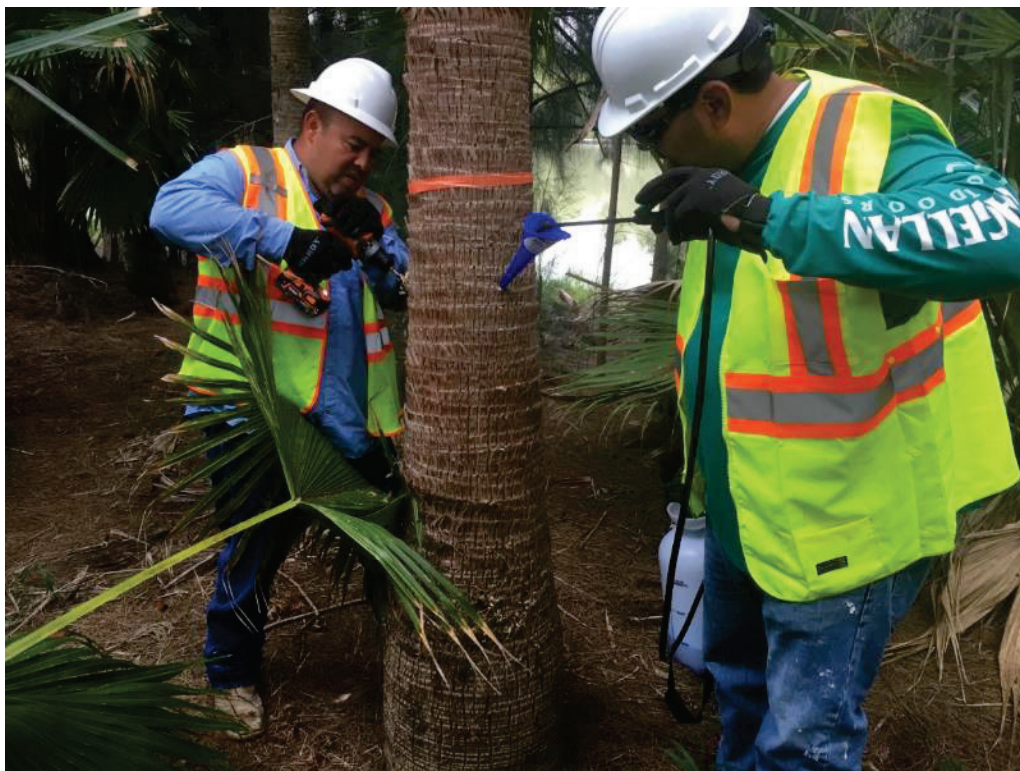
Figure B-3. Creating snag habitat from nonnative palms by herbicide injection

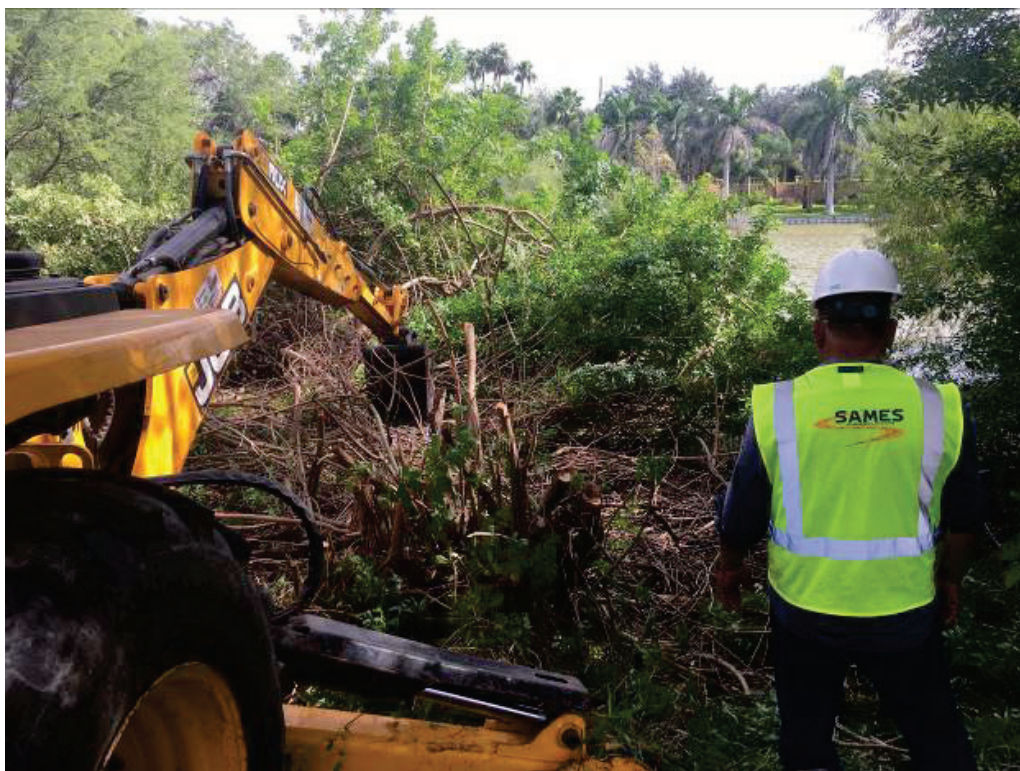
Figure B-4. Physical biomass removal of cut invasive species.

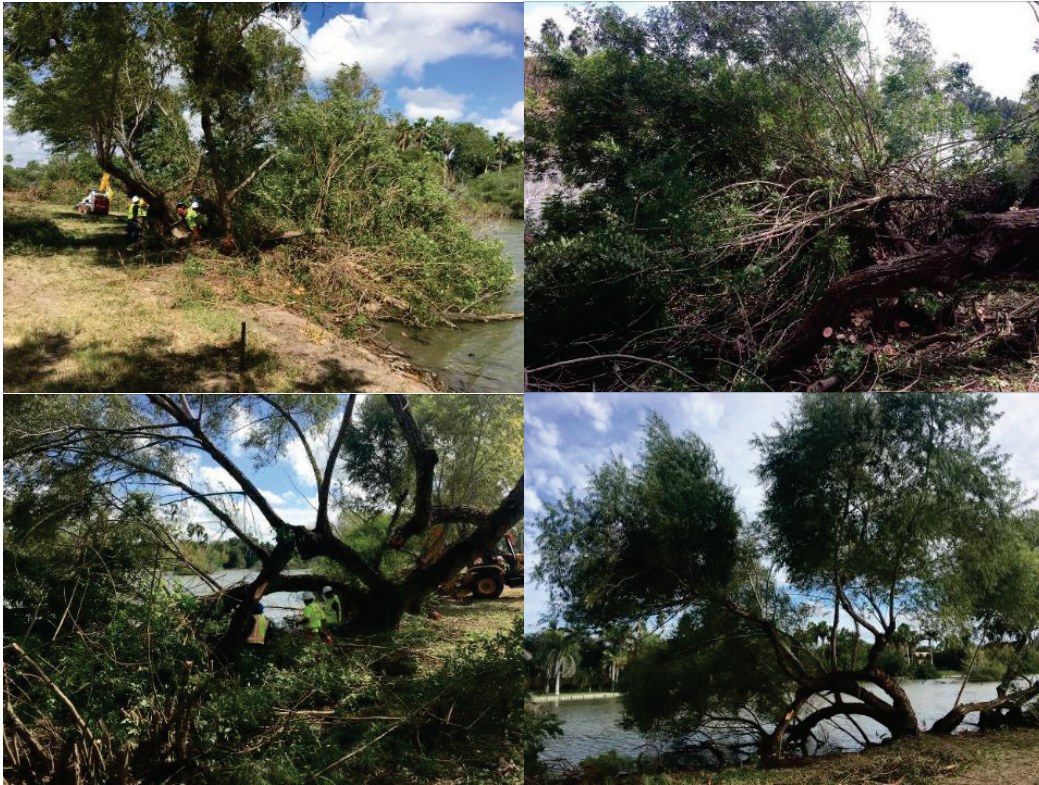
Figure B-5. Example of removing BPT around native vegetation (willows).

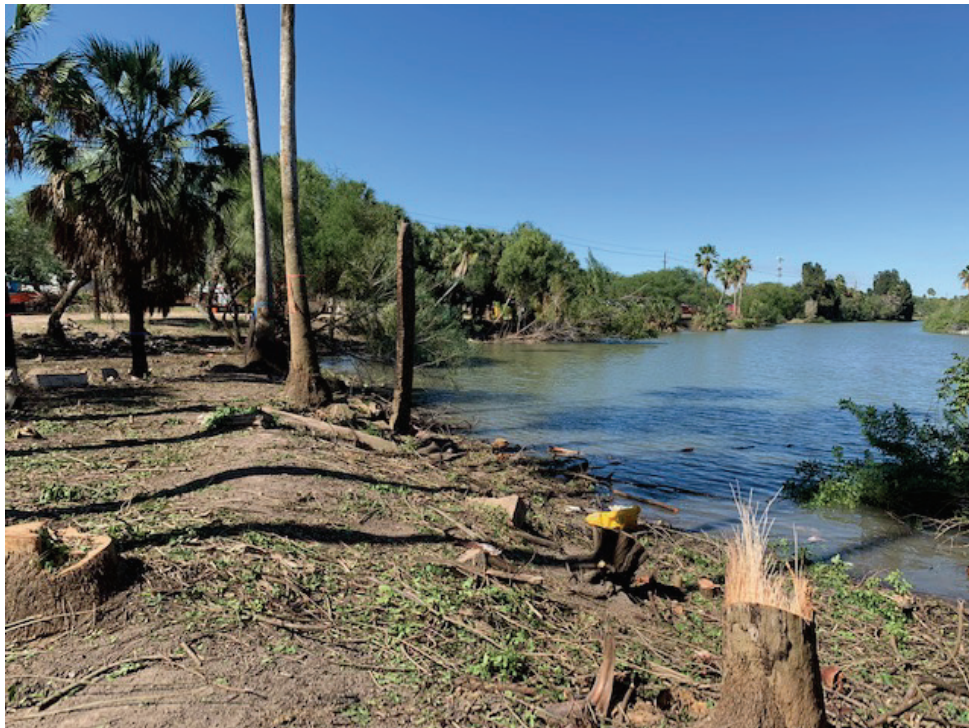
Figure B-6. Project site post-invasive species management and preplanting; looking north from the south end of the project area.

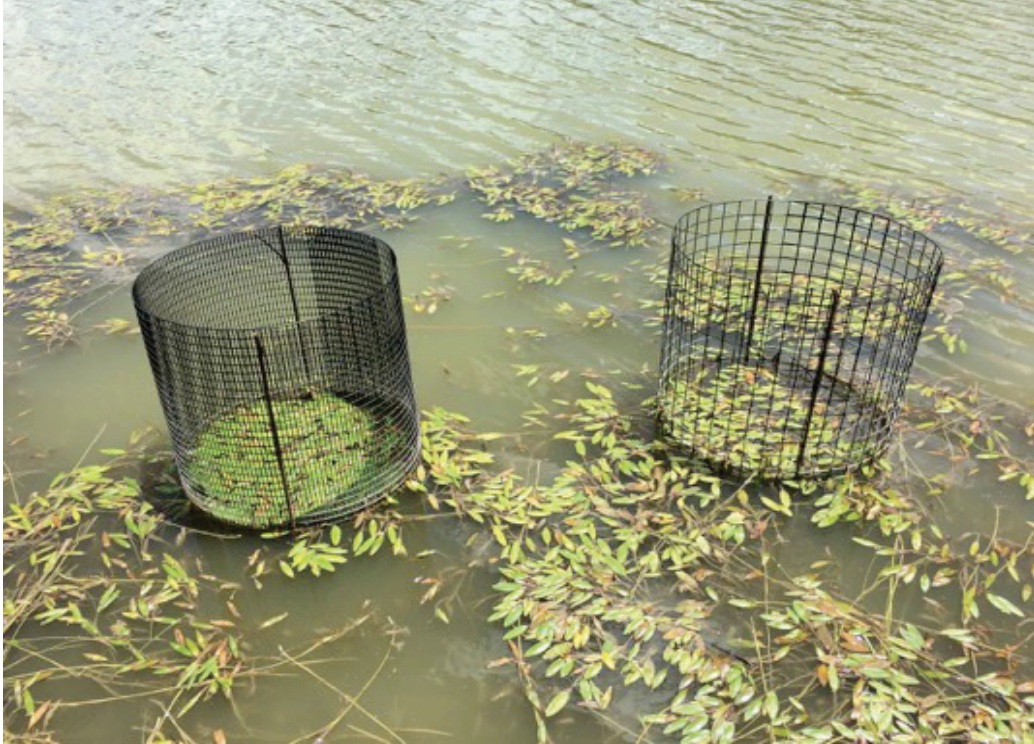
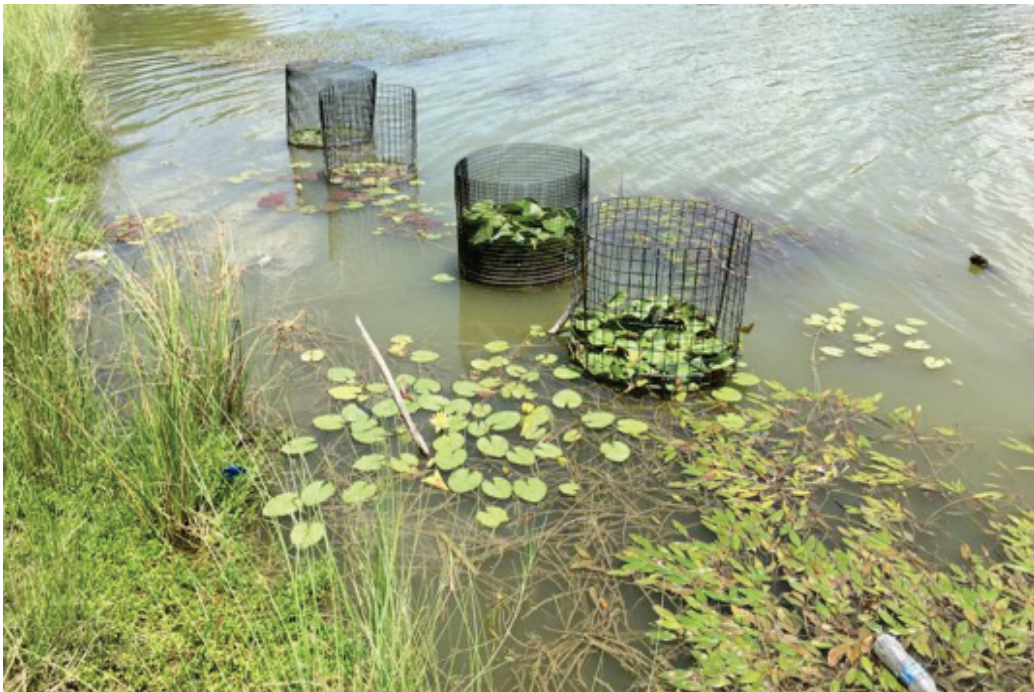
Figure D-1. Native submerged aquatic vegetation established at project site.
