# **Aquatic Ecosystem Restoration in the Texas Western Gulf Coast Plain / Lower Rio Grande Alluvial Floodplain Ecoregion**

Resaca Boulevard Resaca Section 206—Vegetation Community Adaptive Management

Final report

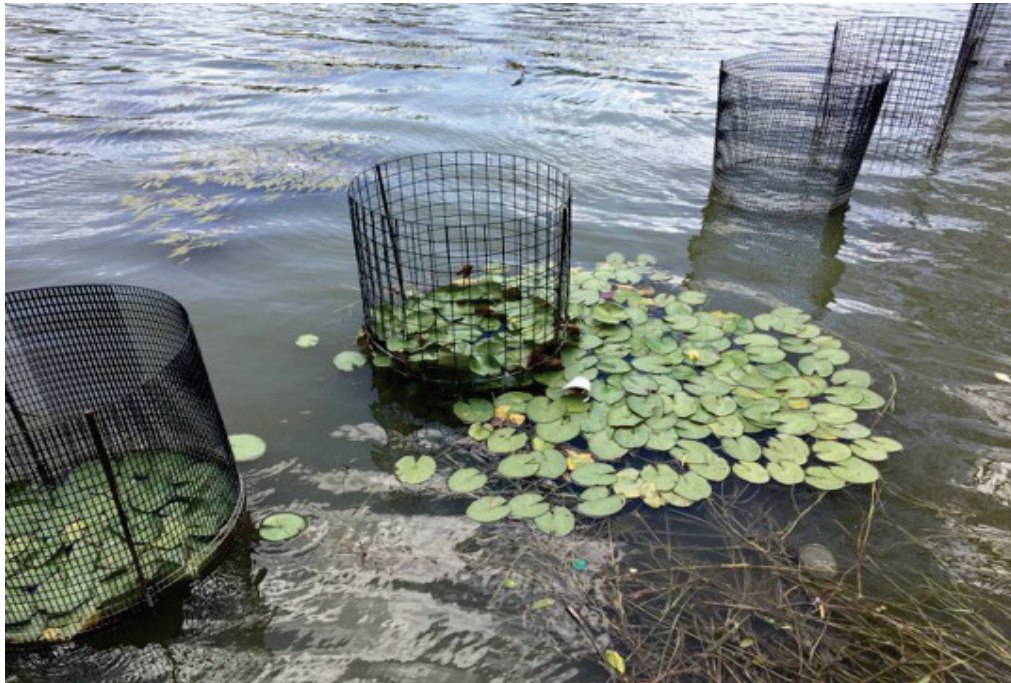
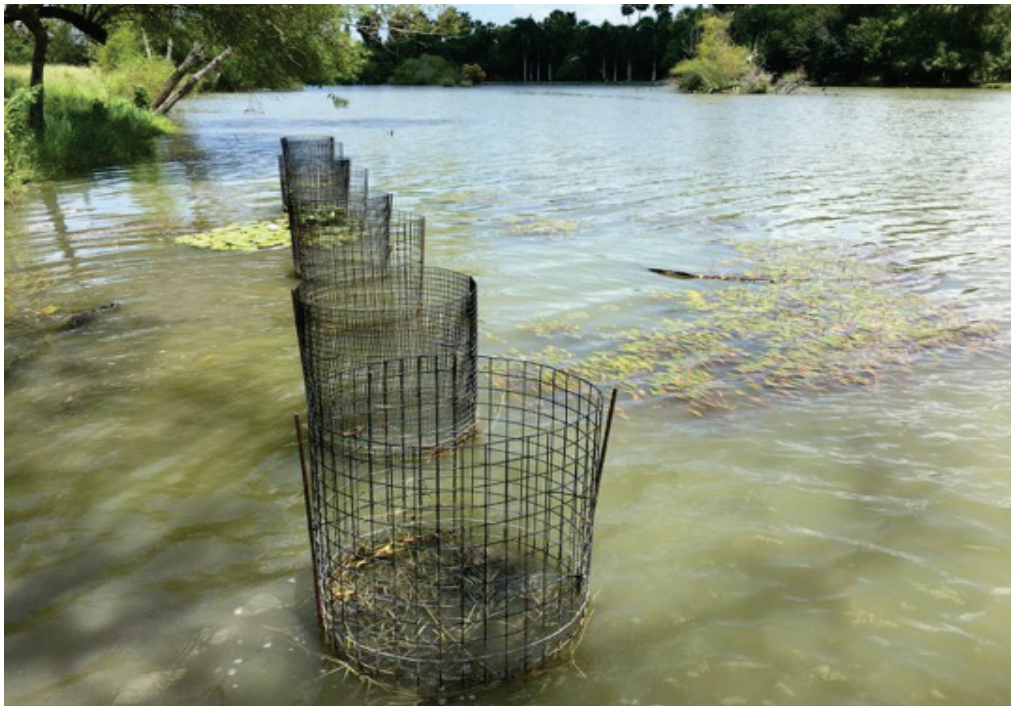
Figure D-2. Native submerged aquatic vegetation established at project site.

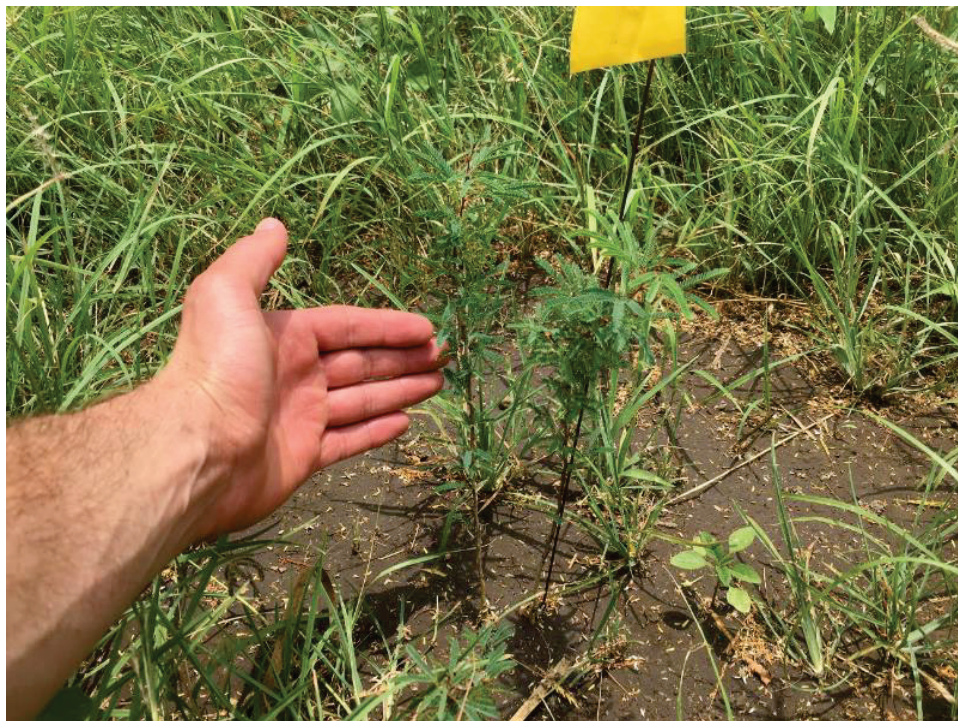
Figure E-1. Planted twisted acacia (*Acacia schaffneri*).

The final ERDC-EL-LAERF planting occurred in November 2020 and involved a site-wide supplemental / adaptive management planting that included installation of 17 plant species totaling 700 plants. Species planted included anacua, Texas lignum-vitae, catclaw acacia, sabal palm, Mexican holdback, milkweeds, whitebrush, lotebush, Mexican olive, blackbrush acacia, spiny hackberry, Texas ebony, Brazilian bluewood, Texas persimmon, Montezuma cypress, and guajillo (Figure 25). During this time, site conditions were also assessed. SAV founder colony sites were functioning as planned and the most successful woody vegetation remained was anacua, Mexican holdback, Montezuma cypress, Mexican olive, Mexican ash, acacias, sabal palms, hackberries, cedar elms, Texas persimmons, and whitebrush (Appendices D and E).

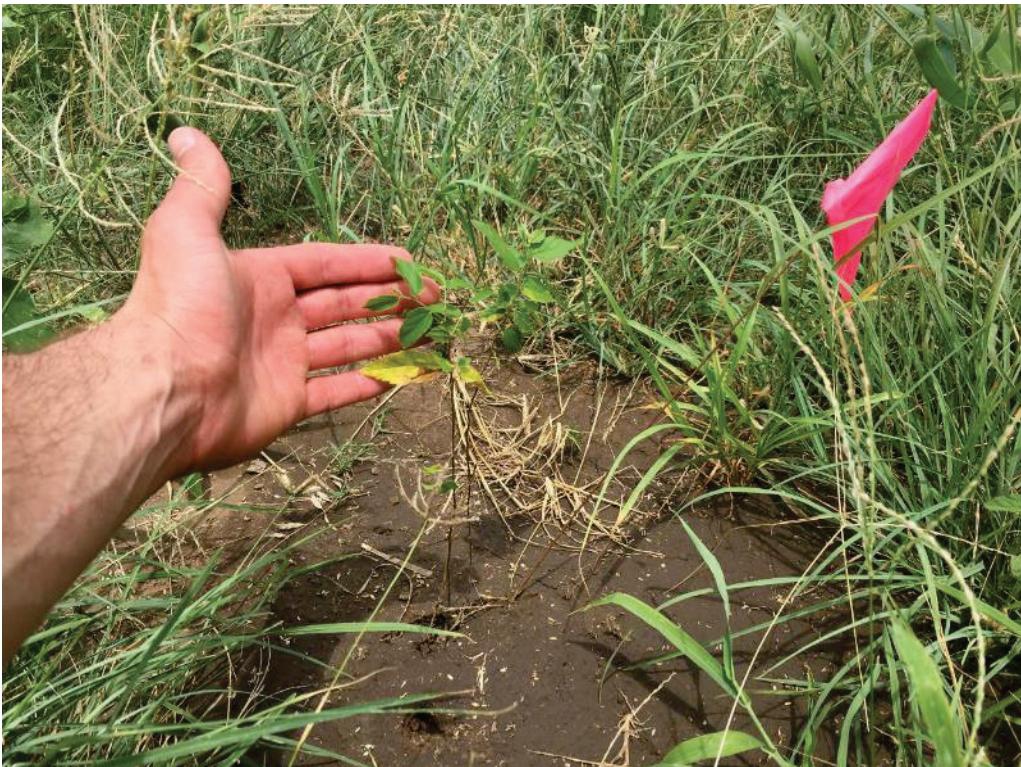
Figure E-4. Planted sugarberry (*Celtis laevigata*).

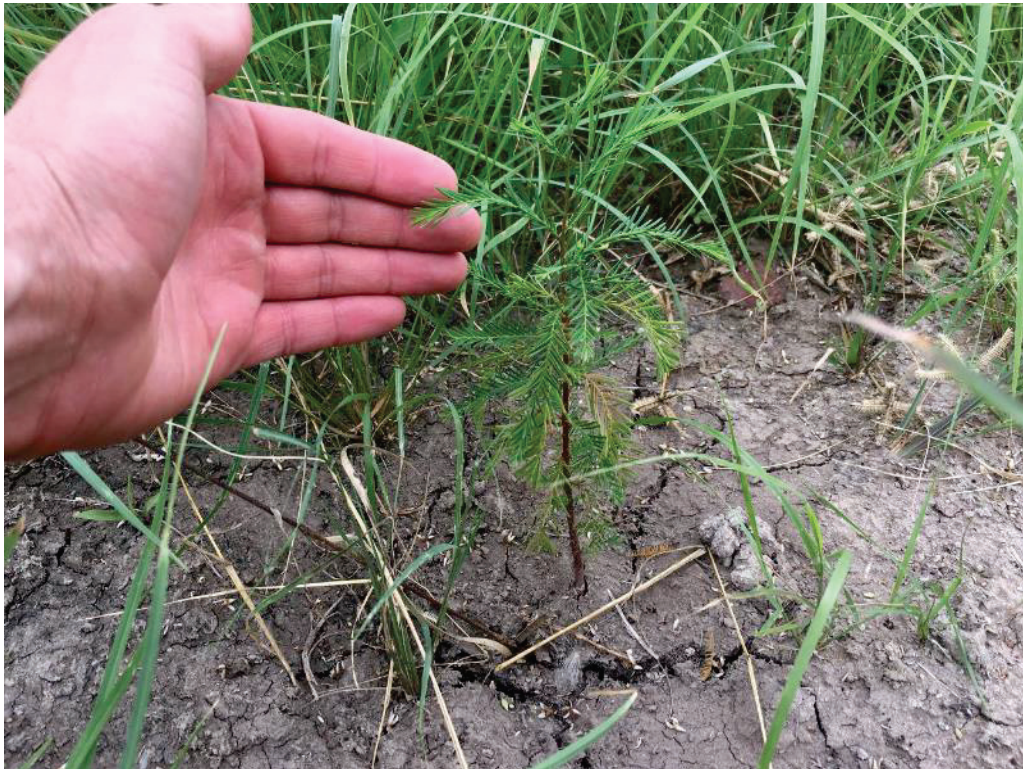
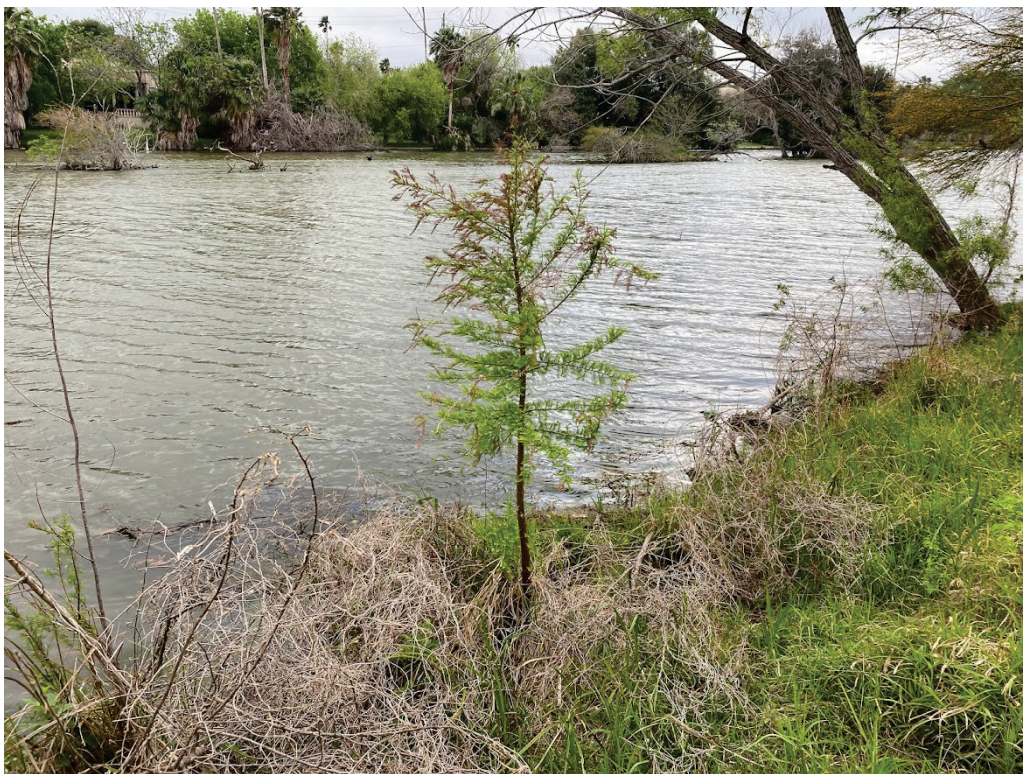
Figure E-5. Planted Montezuma cypress (*Taxodium mucronatum*).

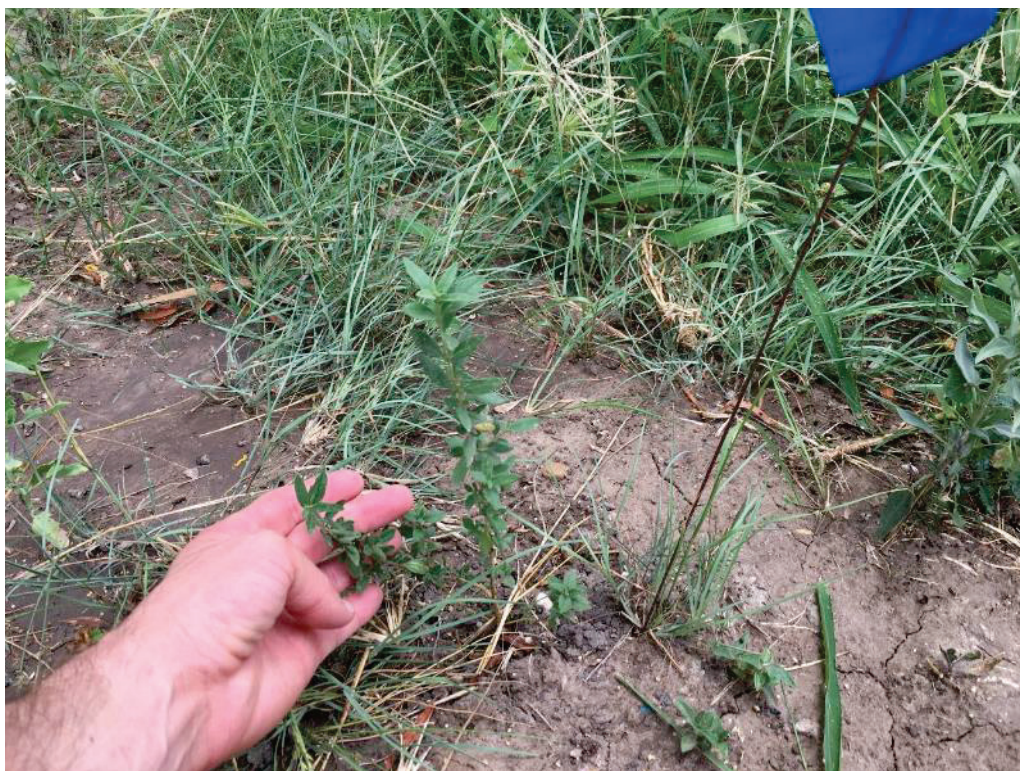
Figure E-9. Planted whitebrush (*Aloysia gratissima*).
