MISCELLANEOUS PAPER S-73-31

# CONDITION SURVEY, MATHER AIR FORCE BASE, CALIFORNIA

P. J. Vedros

May 1973

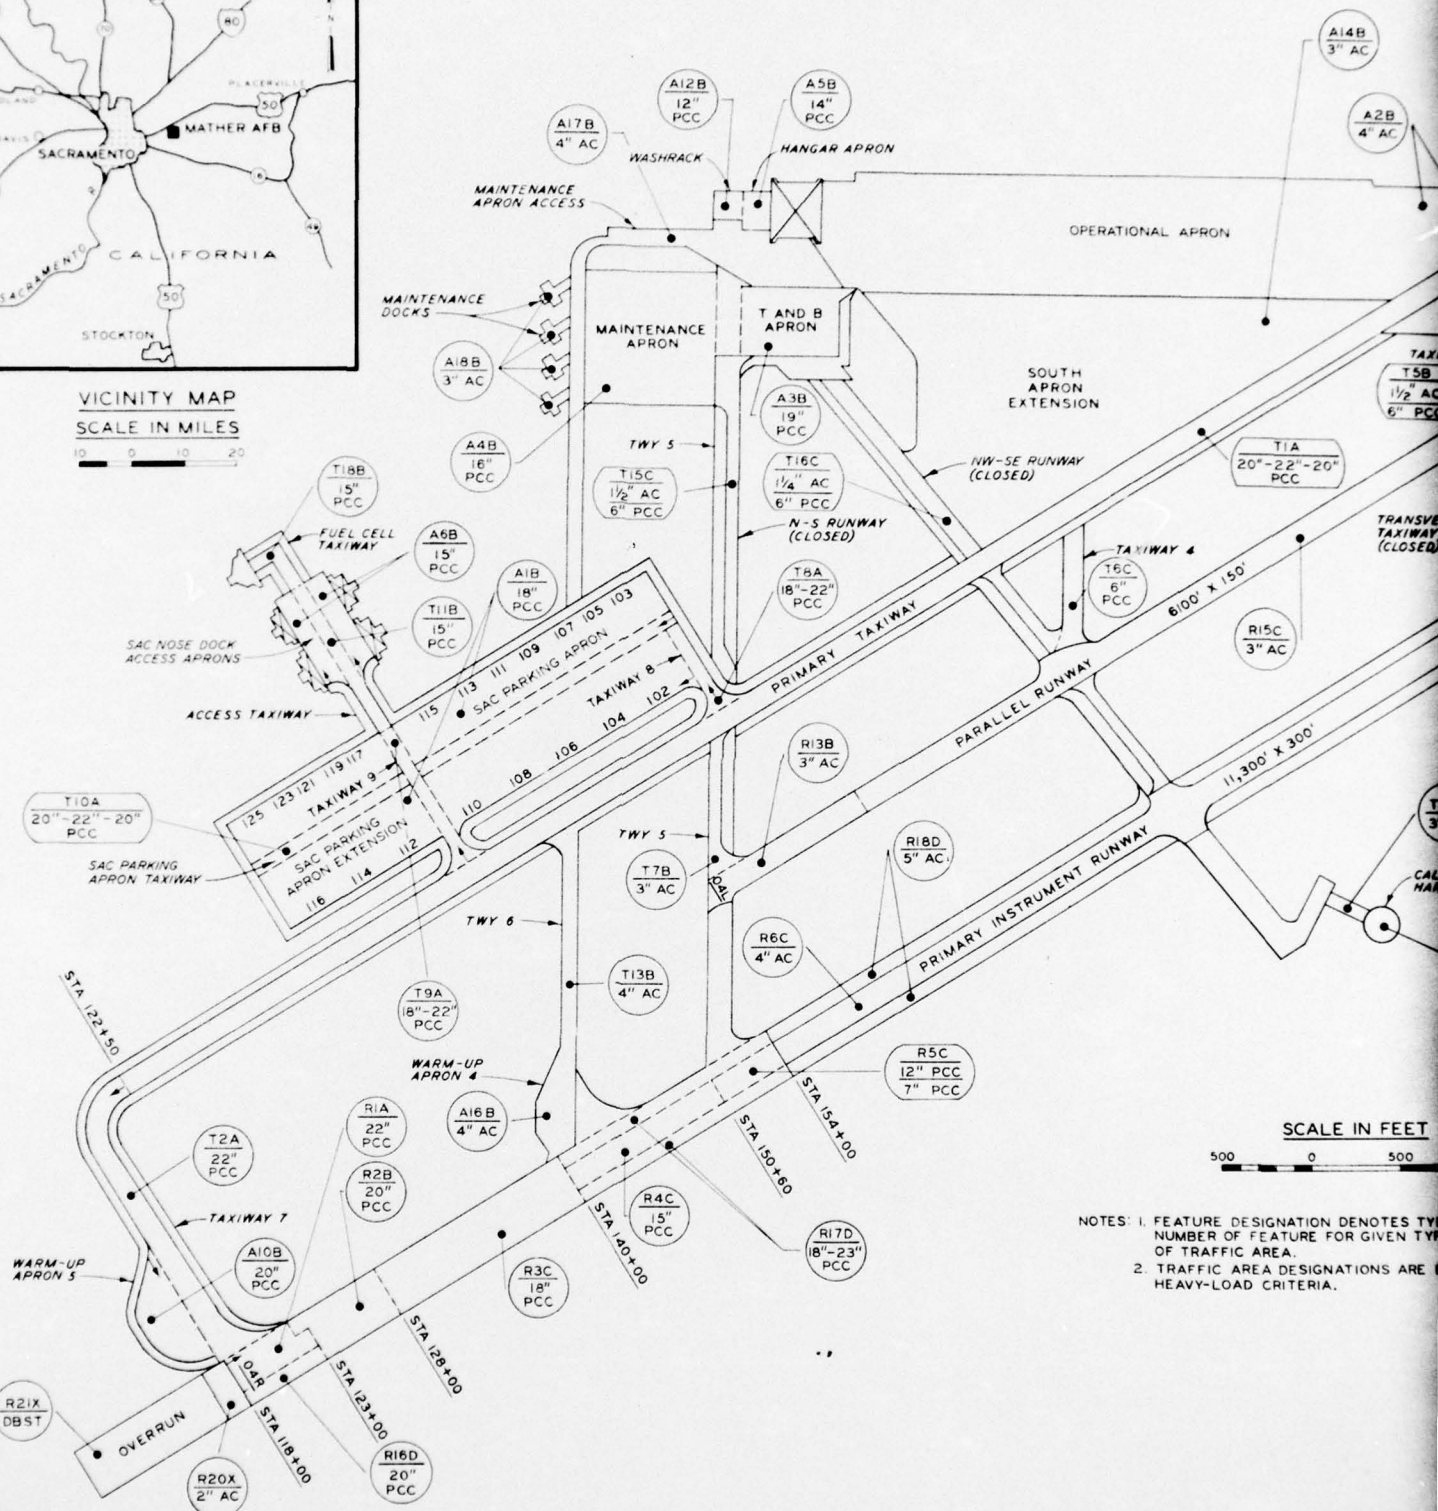
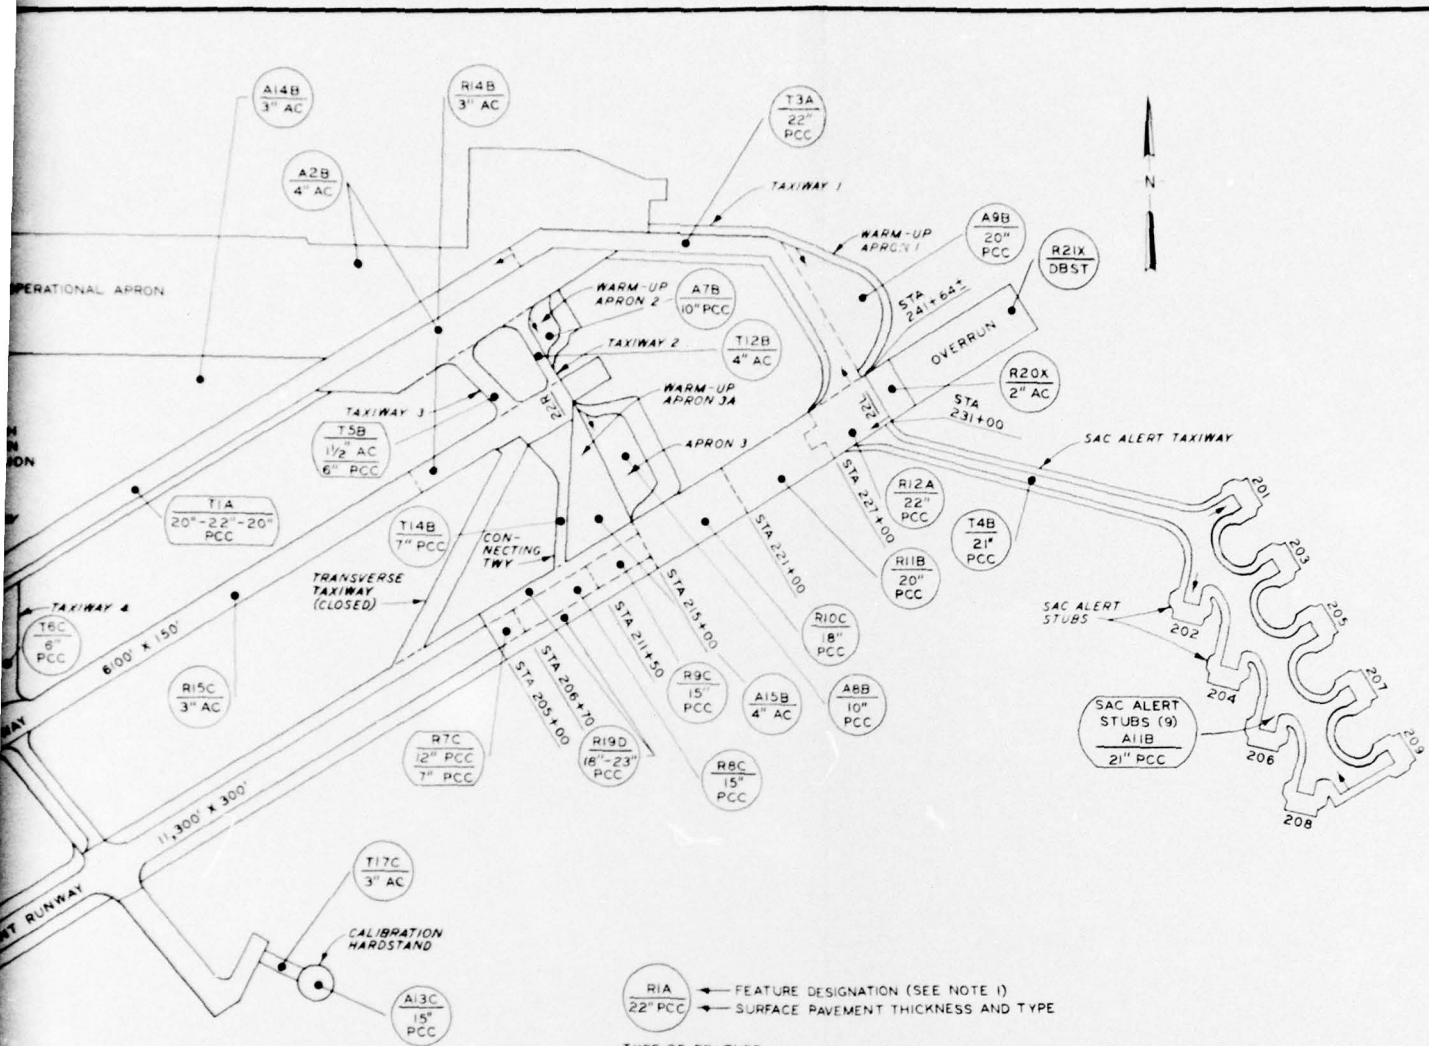
MATHER AFB  
 AIRFIELD LAYOUT

- RIA  
 22" PCC
- ← FEATURE DESIGNATION (SEE NOTE 1)  
 → SURFACE PAVEMENT THICKNESS AND TYPE
- TYPE OF FEATURE  
 R - RUNWAY  
 T - TAXIWAY  
 A - APRON
- TYPE TRAFFIC AREA (SEE NOTE 2)  
 A - A TYPE TRAFFIC  
 B - B TYPE TRAFFIC  
 C - C TYPE TRAFFIC  
 D - D TYPE TRAFFIC  
 X - NO TRAFFIC TYPE ASSIGNED
- AC - ASPHALTIC CONCRETE  
 PCC - PORTLAND CEMENT CONCRETE  
 DBST - DOUBLE BITUMINOUS SURFACE TREATMENT
- DIRECTION OF SURVEY

NOTES: 1. FEATURE DESIGNATION DENOTES TYPE OF FEATURE, NUMBER OF FEATURE FOR GIVEN TYPE, AND TYPE OF TRAFFIC AREA.  
 2. TRAFFIC AREA DESIGNATIONS ARE BASED ON HEAVY-LOAD CRITERIA.

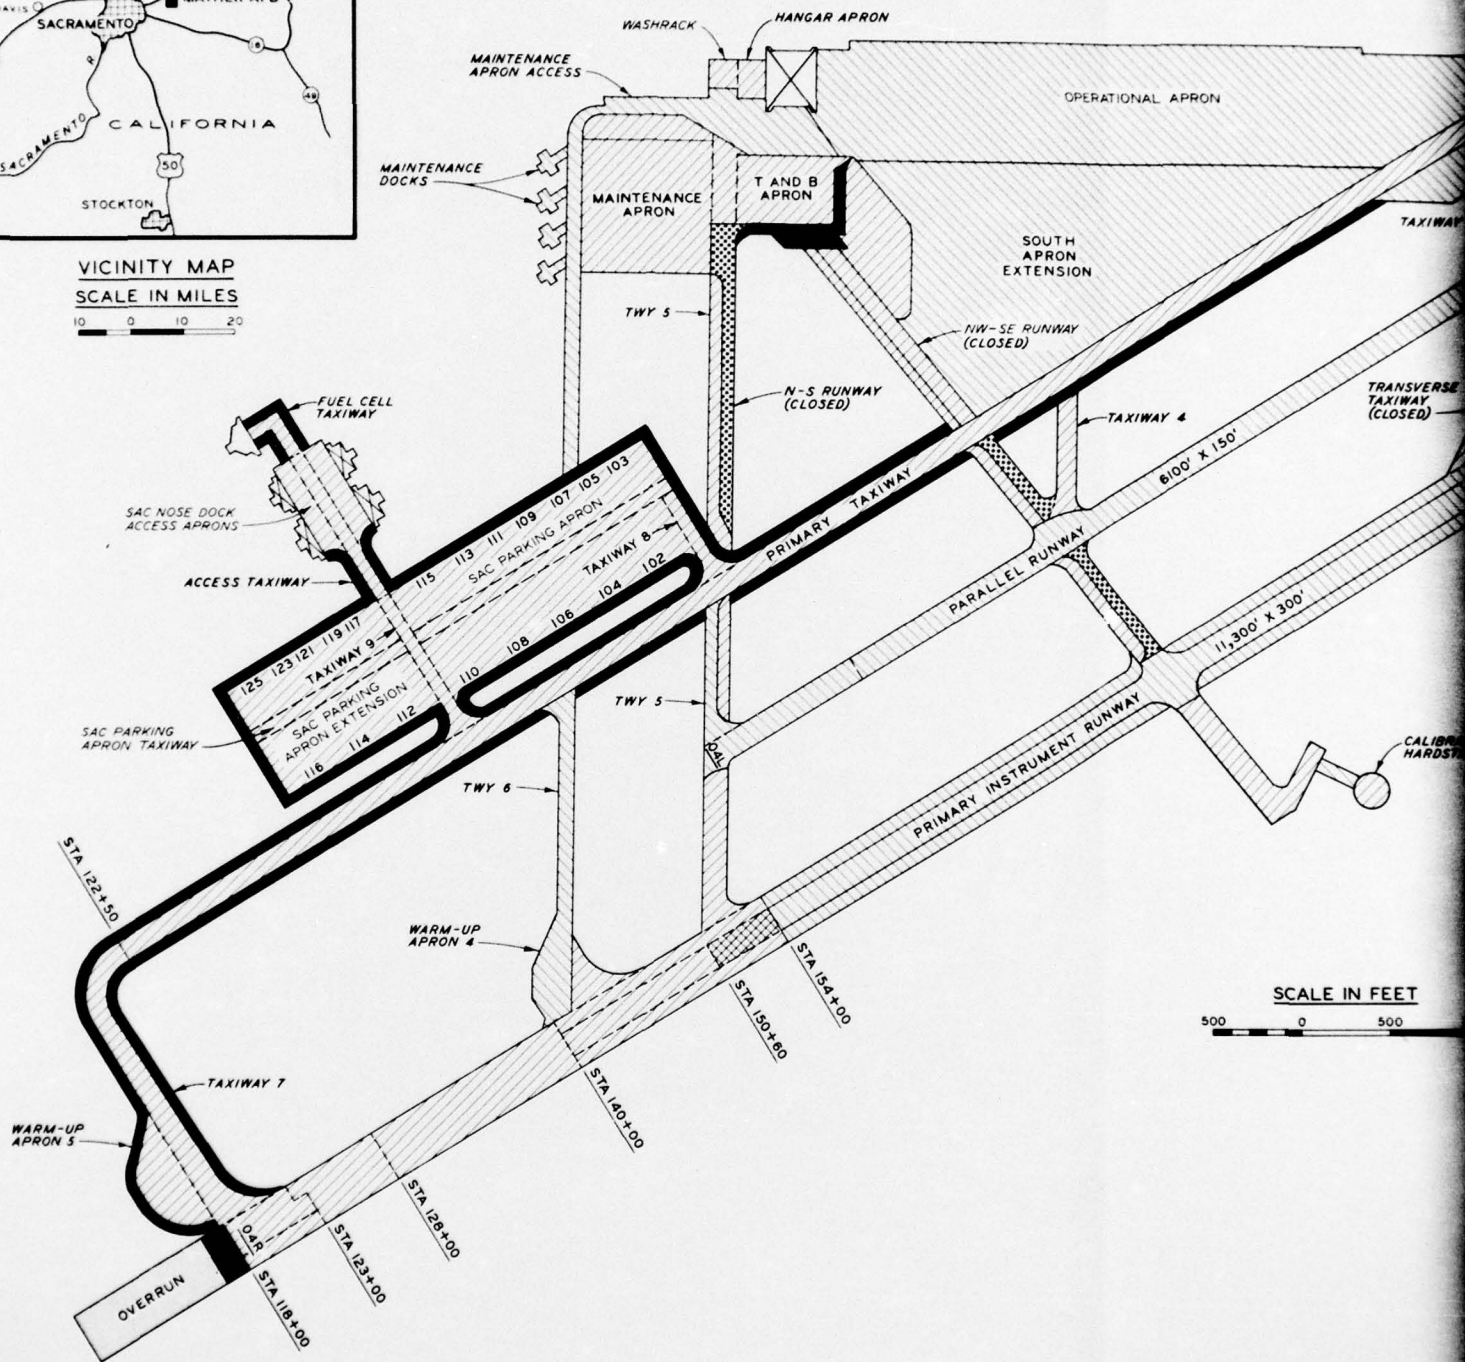
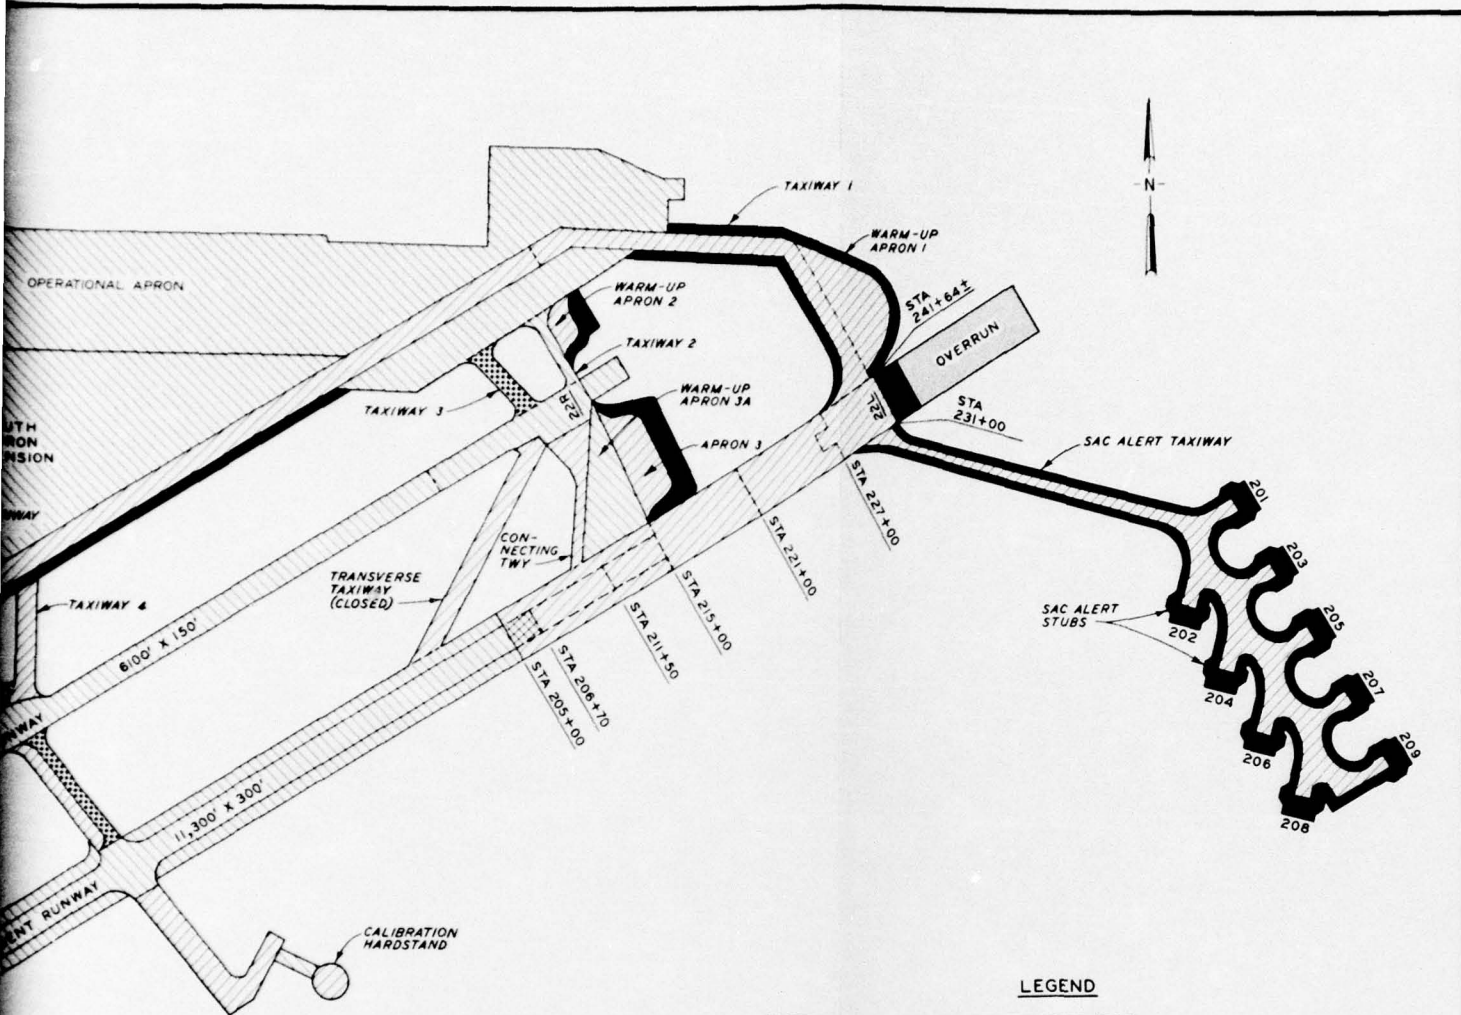
SCALE IN FEET  
500 0 500

#### LEGEND

- PORTLAND CEMENT CONCRETE (PCC)
- ASPHALTIC CONCRETE (AC)
- ASPHALTIC CONCRETE OVER PORTLAND CEMENT CONCRETE
- PORTLAND CEMENT CONCRETE OVER PORTLAND CEMENT CONCRETE
- DOUBLE BITUMINOUS SURFACE TREATMENT (DBST)
- BLAST PAVEMENT (AC-NON TRAFFIC)
