PRATT AND WHITNEY AIRCRAFT EAST HARTFORD CONN  
ADVANCED CERAMIC TURBINE SEAL SYSTEM, PHASES II AND III.(U)  
NOV 76

ADVANCED CERAMIC TURBINE SEAL SYSTEM, PHASES II AND III  
FINAL REPORT  
PWA-5426

9 FINAL REPORT. 1 Mar 74-15 Jun 76.  
PWA-5426

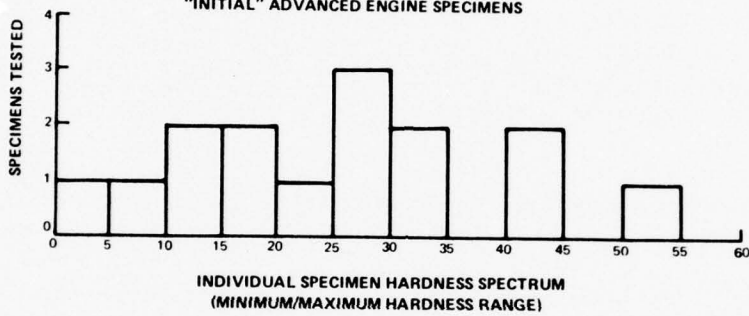
PHASE II - "FIRST" AND "PRELIMINARY"  
ADVANCED ENGINE SPECIMENS

"INITIAL" ADVANCED ENGINE SPECIMENS

Figure 1 Graded Ceramic Hardness Data

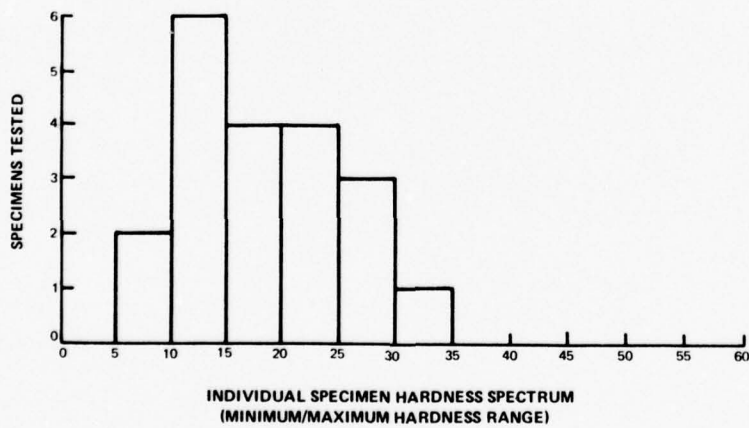
Figure 2 Graded Ceramic Hardness Data for "First Modification" and "Second Modification" Advanced Engine Specimens

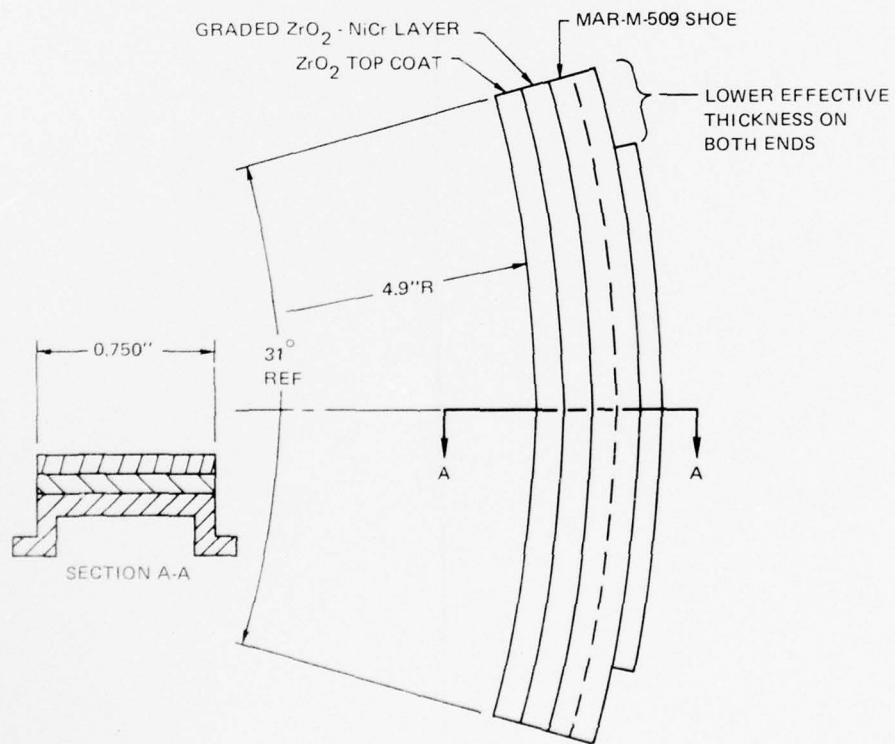
Figure 5 Graded Ceramic-Metal Rub Specimen

The thermal fatigue specimen configuration was modified for the "initial" test phases to be identical with the rub rig specimens (Figure 5) to more closely simulate engine stresses in the graded  $ZrO_2$ -NiCr turbine seal. Analysis performed during Phase II indicated that the 3/4-inch square segment could result in excessively high internal stresses. The rub rig specimen configuration creates stresses in the coating more nearly simulating stress which would be generated throughout a full engine operating cycle.

The "second modification" graded  $ZrO_2$ -NiCr thermal fatigue rig seals fabricated using the improved mixing, forming and bonding techniques were machined to remove the portion of the specimen ends that were of lower effective thickness (Figure 5) prior to test. The results of these tests, shown in Table III, continue to show the significant improvement obtained in the "first modification" testing. During previous tests the rig controls have normally required adjustment in the first 50 to 150 cycles to maintain the desired thermal conditions implying the initiation of cracks. In the test of specimen Number 3, which was the best from NDT evaluation, adjustments were unnecessary for approximately 350-400 cycles demonstrating further improvement in thermal fatigue performance. Figure 6 shows the condition of this specimen during test after 410 cycles. Specimen 1 and 2 which had some low density at the ends in intermediate layer were subjected to over 850 cycles before delamination.

Rub rig test specimen design, shown in Figure 5 for the graded  $ZrO_2$ -NiCr seals, which closely simulates engine seal construction features, was used for all abrasability testing.

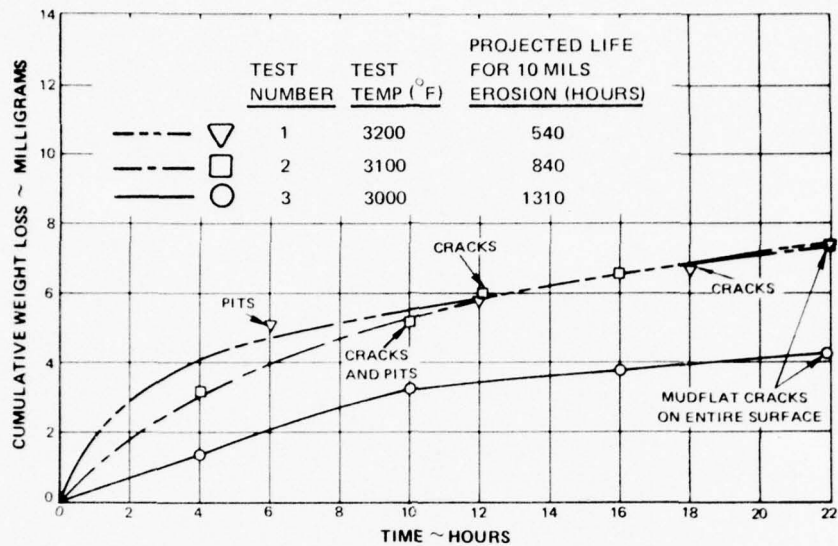
Figure 8 Results of Hot Gas Erosion Testing of the Graded  $ZrO_2$ -NiCr Seal Specimens

Erosion lives determined from the test results (Figure 8) of the "first" advanced engine graded ceramic-metal rig specimens were considered exceptional for this point in the development cycle. Calculations of the erosion rates are based on the steady state portion of the weight-loss curves, the measured impingement area on the specimens, and the density of the  $ZrO_2$  layer of the seal coatings.

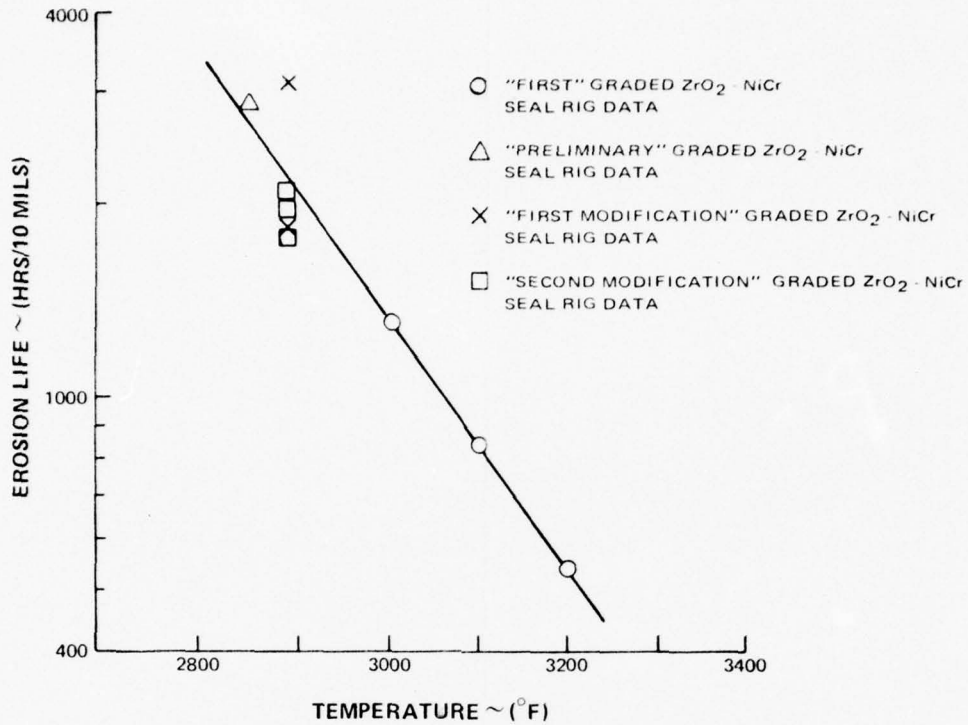
Figure 9 Graded ZrO<sub>2</sub>-NiCr Seal Thermal-Erosion Life Correlation

Hot gas erosion data from the "preliminary" rig tests indicate that erosion is a function of the coating superficial hardness. Hardness dependent erosion lives were obtained (Table IV) for each of the specimens tested at 2850°F. The hardness data presented in Table IV was measured using a Rockwell Rs45Y superficial hardness tester. The erosion life of the hardest specimen correlates well with the results of the "first" graded  $ZrO_2$ -NiCr rig tests as shown in Figure 9.

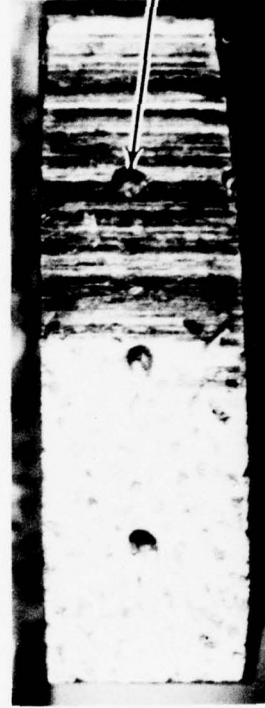
SIMULATED  
BLADE TIP  
COOLING HOLES  
(11 MIL DIA)

PRETEST  
BLADE  
TIP

MINIMAL CLOSURE  
ALTHOUGH BLADE  
MATERIAL SMEARING

POST TEST  
BLADE  
TIP

Figure 14 Rig Blades With Simulated Cooling Holes Showing Minimal Closure

Test No. 1 was run with blade tips with three holes in each simulating engine cooling hole geometry. Closure of the blade tip cooling holes was minimal (10-15%) as indicated in Figure 14. VWF of 0.045 was approximately the same as for tests without holes in the blade tips.

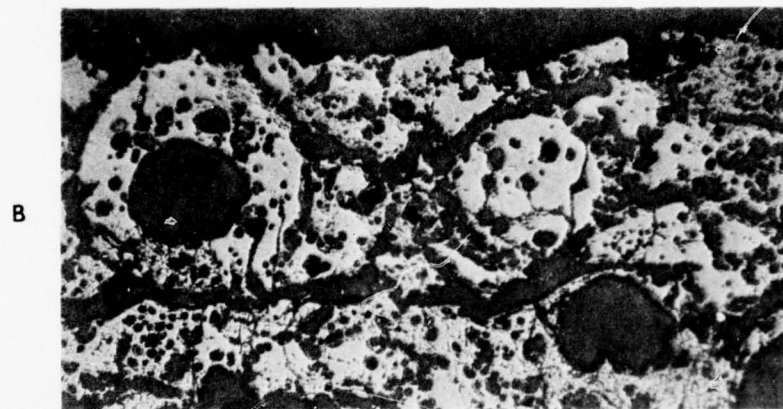
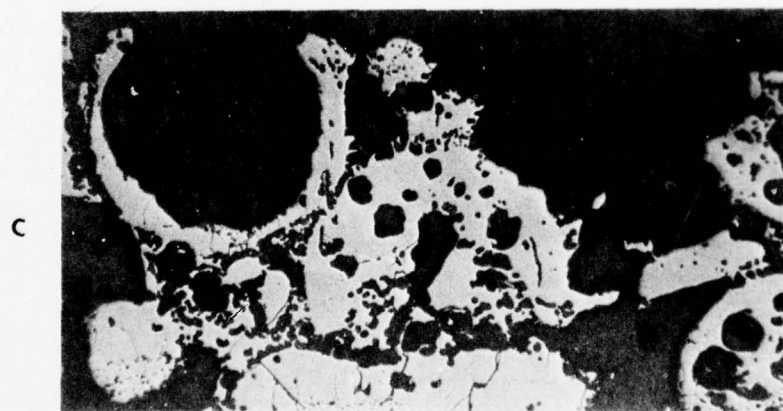
MAG: 100X

Figure 3 Microsections Near Surface of Post-Test Hot Gas Erosion Specimens: (A) 3000°F, (B) 3100°F, (C) 3200°F (M741383, M74182, M74181)

Microscopic examination of the erosion specimens shows that the degree of coalescence of the Y<sub>2</sub>O<sub>3</sub> stabilized ZrO<sub>2</sub> matrix particles and the degradation of the CaO stabilized ZrO<sub>2</sub> spheres progresses with exposure to increasing temperature (Figure 3). As is evident in the post test surface photographs, (Figure 4) the degree of the crack network within the ceramic structure progresses with increasing test temperature. This cracking in the ceramic layer is considered to be caused by a combination of the shrinkage due to sintering and coalescence; and creep and plastic flow of the ZrO<sub>2</sub> at maximum temperature conditions causing mud flat cracks when the specimens are returned to room temperature. The surface cracks observed in the erosion specimens normally arrested in the ZrO<sub>2</sub> layer as seen in the microsection of the specimen tested at 3100°F (Figure 5). It can be seen in Figure 6 that the surface crack networks are mainly encompassed in the ZrO<sub>2</sub> matrix and that the ZrO<sub>2</sub> spheres act as a crack arresting mechanism.

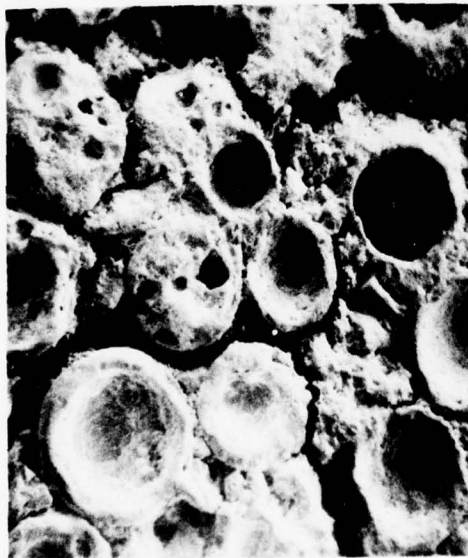
MAG: 60X

Figure 6 Surface of Specimen Erosion Tested at 3200°F

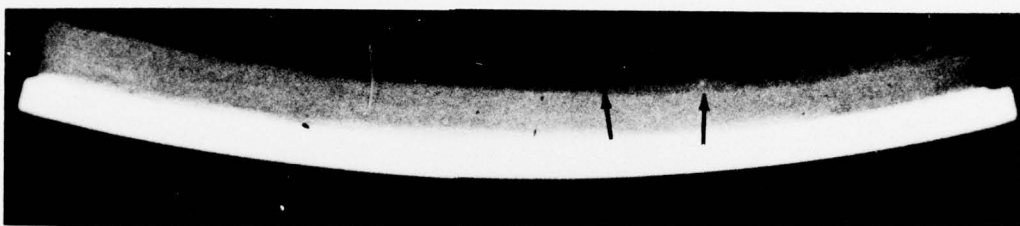
a. CRACKS

b. DEGREE OF THICKNESS UNIFORMITY

c. LOCAL DENSITY

The results of the nondestructive inspection (NDI) testing by x-ray and visual methods are summarized in Table I to Table V for all iterations of the graded ceramic-metal seal design rig specimens. With x-ray inspection it was possible to detect the depths of visual cracks (Figure 1, x-ray a), degree of thickness uniformity of the  $ZrO_2$  layer (x-ray b), local density variation (x-ray c) and layer separation (x-ray d in Figure 1).

Visually observable surface cracks in some of the  $ZrO_2$  layer of the specimen were shown to terminate in the graded  $ZrO_2$ -NiCr layer (Figure 1, x-ray a). These cracks were not considered to be critical.

Local density variations were observed (Figure 1, x-ray c). Areas of lesser density appear slightly darker than adjacent regions in the figure. When this specimen was later sectioned, one of the density variations was found to be associated with a void at the substrate interface and with some porosity within the ZrO<sub>2</sub> layer.

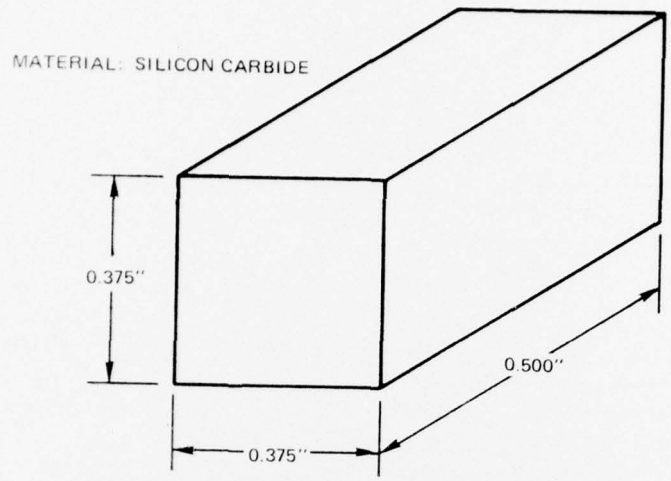
Figure 1 Structural Ceramic Erosion Specimen

Hot gas erosion tests at 2600°F, 2700°F and 2800°F, and Mach 0.8 gas velocity were completed with a predicted erosion life of 7300, 6860 and 6250 hours to 10 mils, respectively.
