UNITED TECHNOLOGIES CORP STRATFORD CONN SIKORSKY AIR--ETC F/G 13/8
FORGE-DIFFUSION BOND TITANIUM ROTOR HUB EVALUATION.(U)

AMMRC-CTR-75-14

**FORGE-DIFFUSION BOND TITANIUM
ROTOR HUB EVALUATION**

Final Report - Contract Number DAAG-46-73-C-0126

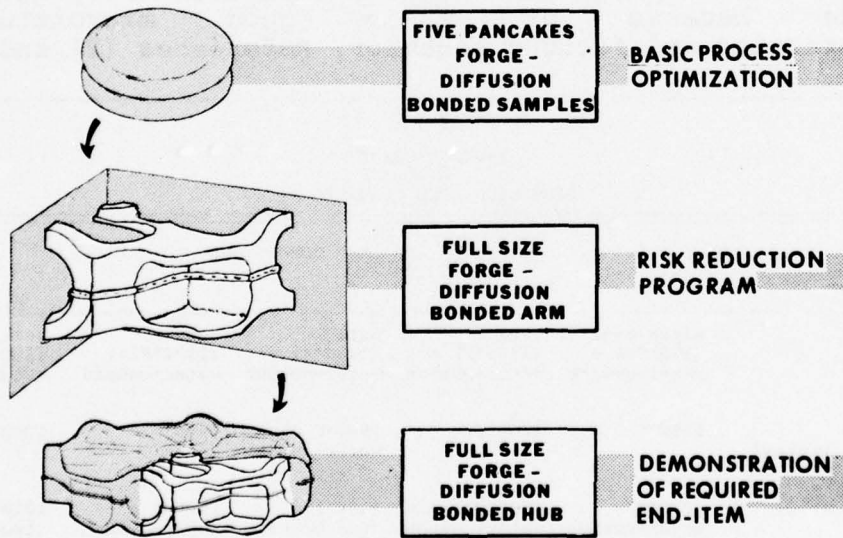
FIGURE 4. PROGRAM CONCEPT.

The program concept involved three phases. The first phase consisted in the selection of an optimum, cost-effective, forge bonding condition by comparing the processing costs and bond strengths of five simple pancake forgings bonded at different combinations of process conditions. A single hub arm was to be fabricated in the second phase as a risk reduction segment. The risk reduction segment was machined from two half-forgings of the main rotor hub and forge bonded at the optimum condition selected in Phase I and tested. Finally, the fabrication of a full-size H-53 Elastomeric Main Rotor Hub was to be fabricated. The program concept is illustrated diagrammatically in Figure 4. The first two phases of the concept have been successfully completed in this contract.

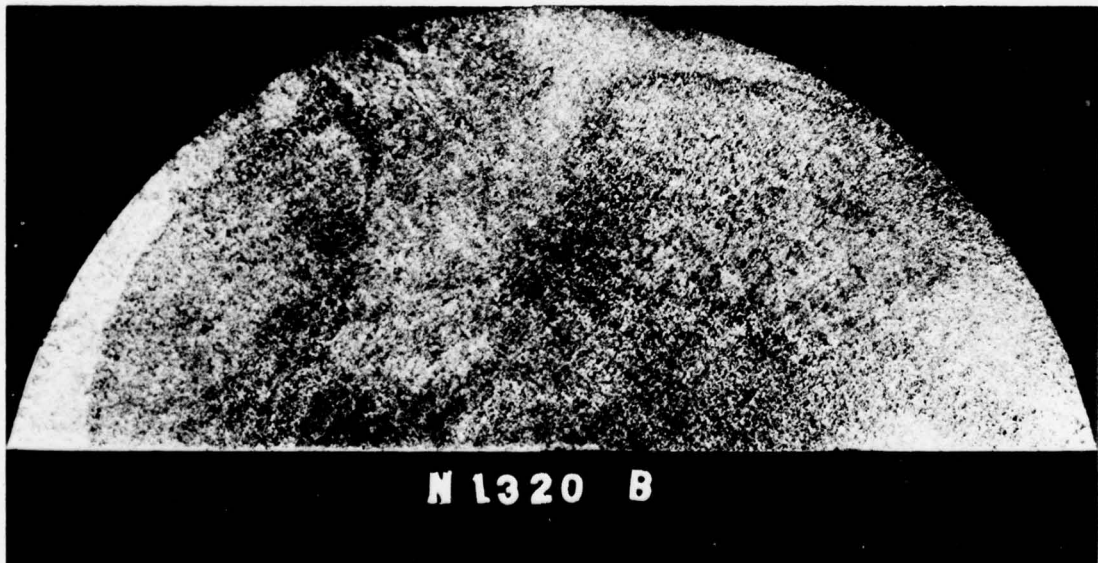
TOP SIDE

BOTTOM SIDE

FIGURE 5. MACROSTRUCTURE OF Ti-6Al-4V FORGING STOCK MATERIAL, FORGE-DIFFUSION BOND OF SIMPLE PANCAKE FORGINGS. .75X

Nine-inch round Ti-6Al-4V alloy forging stock material conforming to the requirements of Sikorsky Standard 8445 Reference (4) was procured from Titanium Metals Corporation of America (TMCA). Chemical analysis of the material is provided in Table II and indicates its acceptability. Metallographic examination of the top and bottom of the forging stock material indicated a material of good quality. The macrostructure was uniform with recrystallized fine beta grains, as shown in Figure 5. The microstructure exhibited a very acceptable alpha particle size for forging stock material, as shown in Figure 6.

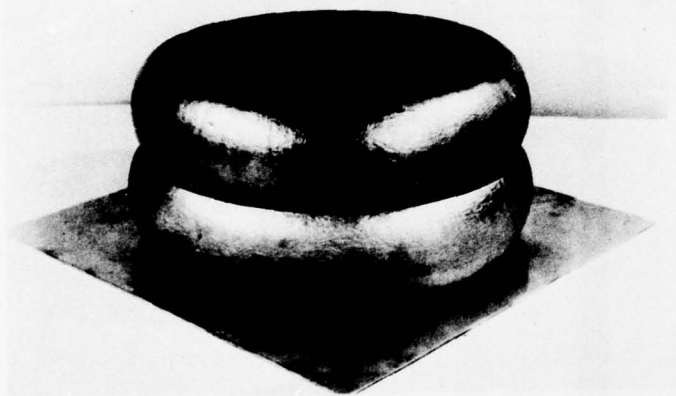
FIGURE 8. PANCAKE ASSEMBLY POSITIONED ON STAINLESS STEEL PLATE.

The pancakes were sandblasted and one forged surface from each pancake was machined to a final thickness of 3.5-inches. The machined pancakes were chemically milled (chem-milled) in a standard hydrofluoric-nitric acid aqueous solution (3% HF, 30% HNO₃) for removal of surface contaminants. Figure 7 depicts two typical machined and chem-milled pancakes. The chem-milled surfaces of two pancake segments were mated and the assembly was placed on a stainless steel plate, Figure 8. A prefabricated expendable stainless steel cover with an air evacuation tube was positioned over the pancake assembly, Figure 9, and the steel container (retort) was sealed by a Tungsten Inert Gas (TIG) weld. This procedure was followed for all five of the assemblies to be bonded.

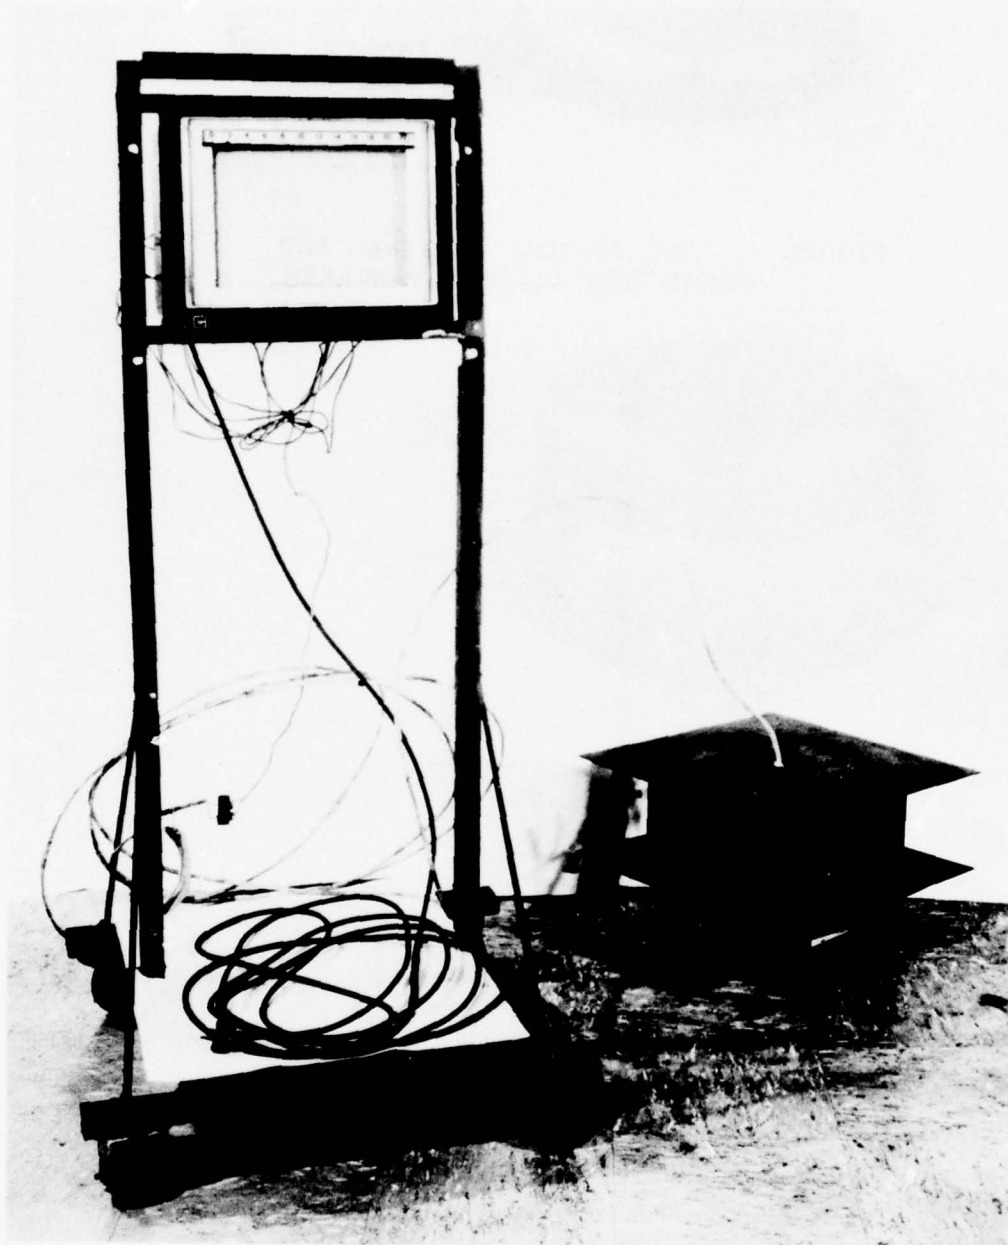
FIGURE 10. TEST RETORT WITH THERMOCOUPLE AND RECORDING INSTRUMENTATION.

In order to establish a heating cycle for an evacuated retort, an additional test retort was fabricated. The same general procedures were used in fabrication of this unit as described for the five pancake assemblies. The only exception was the use of a 6.5-inches thick by 16-inches diameter solid Ti-6Al-4V billet which had a 1/2-inch diameter hole drilled along its longitudinal axis to the center of the 6.5-inches thickness dimension in order to position a thermocouple. A thermocouple was inserted and packed into the stainless steel tube and connected to a recording unit. The assembly was helium leak tested, thermally outgassed and sealed. The assembly was placed in a furnace and a relationship of time versus temperature for the billet was established. This data was subsequently used with the five test retort assemblies. Figure 10 shows the test retort assembly with the thermocouple and recording instrument.

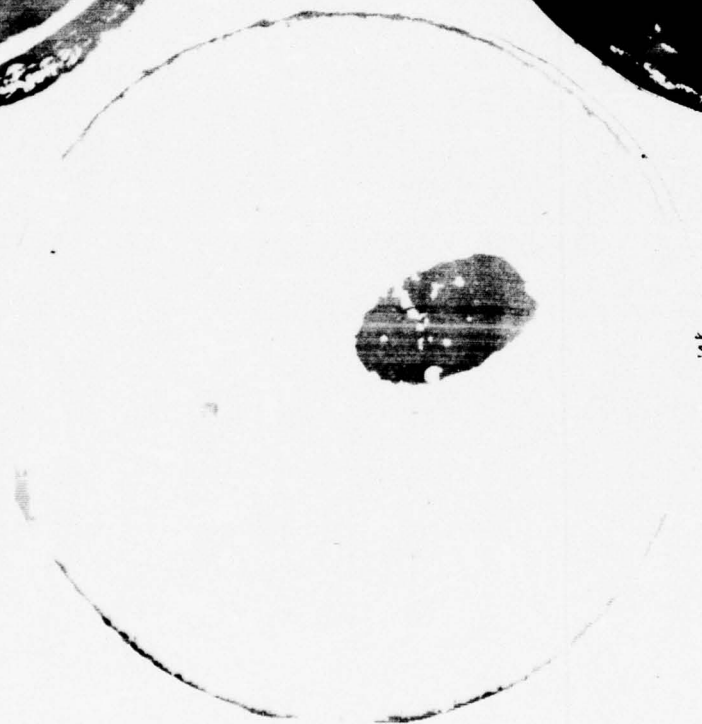
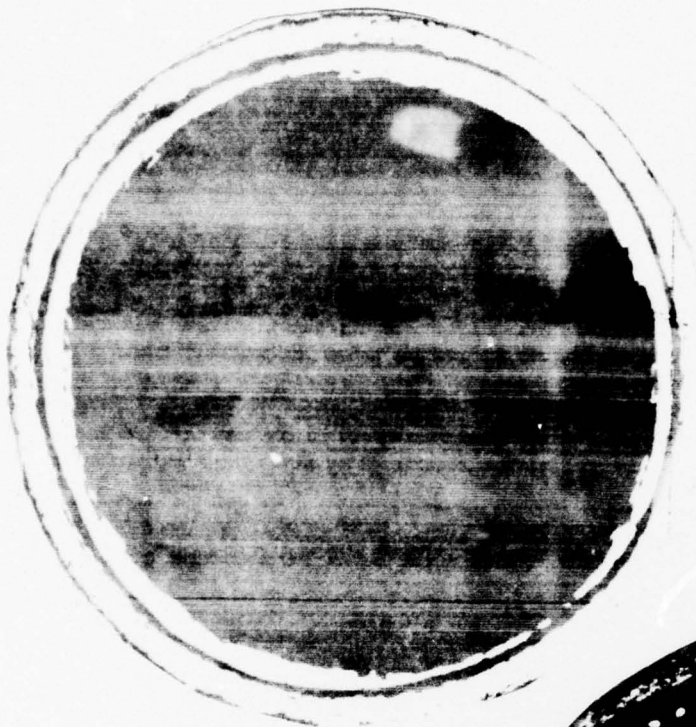
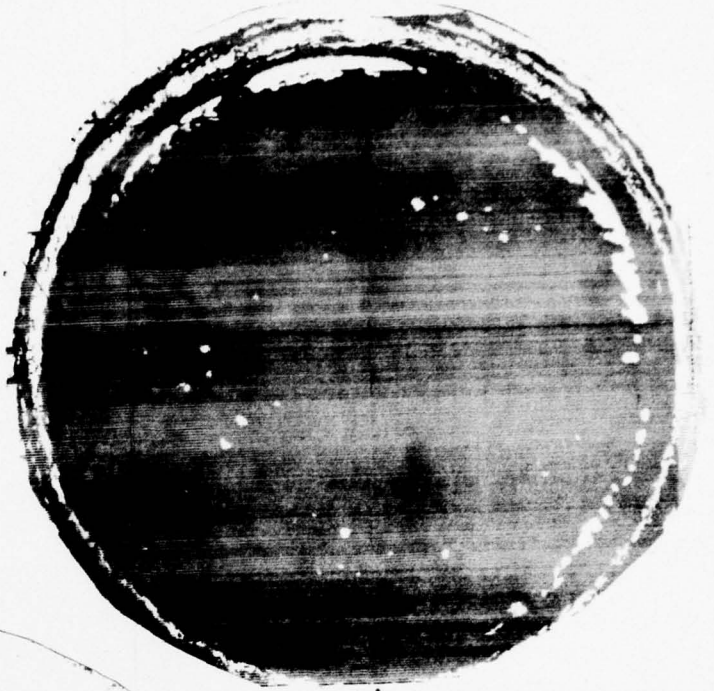
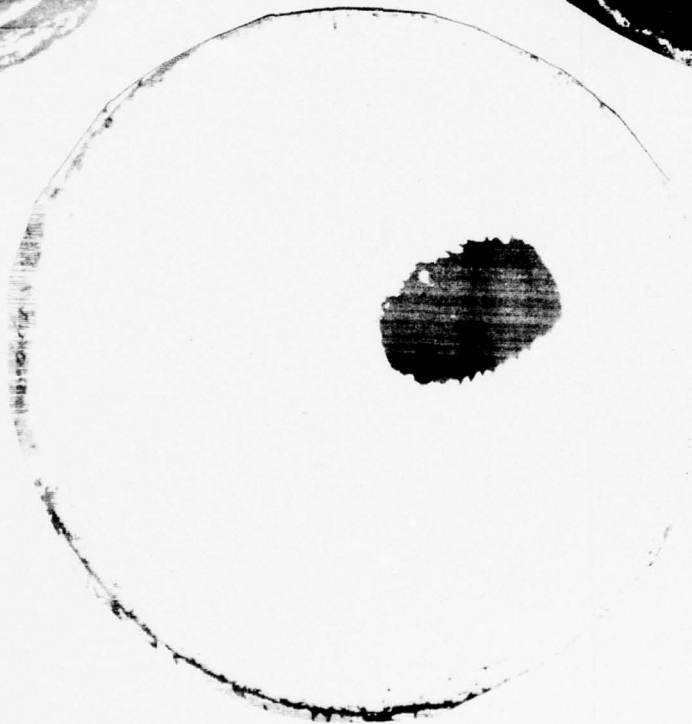
FIGURE 17. C-SCAN RECORDINGS OF FIVE PANCAKE ASSEMBLIES,
ALARM LEVEL 100% OF #3 fbh IN REFERENCE BLOCK.

indications of nonbonded areas were significantly decreased. The indication of nonbonded areas were less than 1% for assemblies Condition 1, and less than 5 to 15% for assemblies Conditions 2, 3, and 4. The most severe condition was Condition 5, the low temperature bonded assembly which exhibited 89% nonbonded area. C-scan recordings of each of the five pancake assemblies at this sensitivity level are provided in Figure 17.

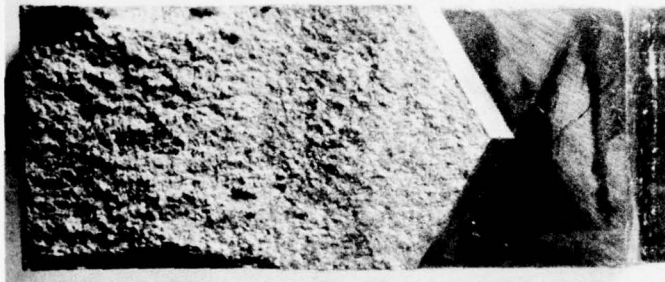
FIGURE 30. FRACTURE TOUGHNESS INTERFACE,
TYPICAL FRACTURE INTERFACE
TRIAL PANCAKE ASSEMBLIES. 1.5X

Fracture Toughness - Fracture toughness results are presented in Table V. Review of the test data discloses valid and nonvalid values, as defined by the requirements in ASTM-E399-72, Reference (7). K_{IC} values which do not meet the requirements of Reference (7) cannot be reported as valid K_{IC} values and are reported as K_Q values. Condition 1 exhibits slightly higher fracture toughness characteristics than Condition 2 and 20% higher than Condition 3. All of the Condition 4 results are invalid. The fracture toughness specimens displayed fracture surfaces with normal flat brittle fatigue precracking followed by overload plane strain cracking. Crack propagation was transgranular in nature exhibiting a fine grain fracture interface for both the precrack and plane strain cracking regions as shown in Figure 30. The only variation was Condition #4 which manifested a relative coarser static fracture surface, as shown in Figure 31. No evidence of voids or contamination was observed on these fracture interfaces that could have generated the different fracture surface texture.

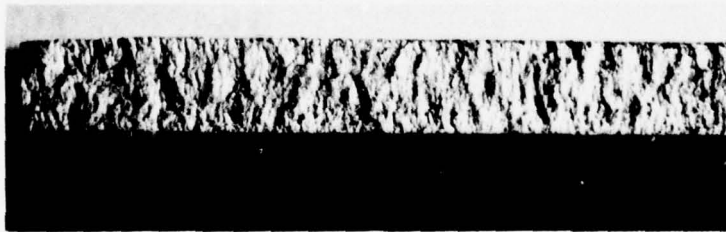
FIGURE 32. IN-LINE SHEAR FRACTURE, TYPICAL STATIC OVERLOAD FRACTURE SURFACE, TRIAL PANCAKE ASSEMBLIES. 4X

Shear - In-line shear test results are provided in Table VI. Comparison of the test data disclosed no significant differences among bonded assemblies 1, 2, 3, and 4. Slightly lower values were manifested by Condition 1, but, it does not appear to be meaningful since this amount of variation could occur within the normal scatter of testing and is typical of that found away from the bondline. In-line shear specimens manifested standard overload fractures as shown in Figure 32. The morphology of these specimens were very similar among the conditions tested with no outstanding deviations or differences. No voids or contamination were detected on the fracture surfaces.

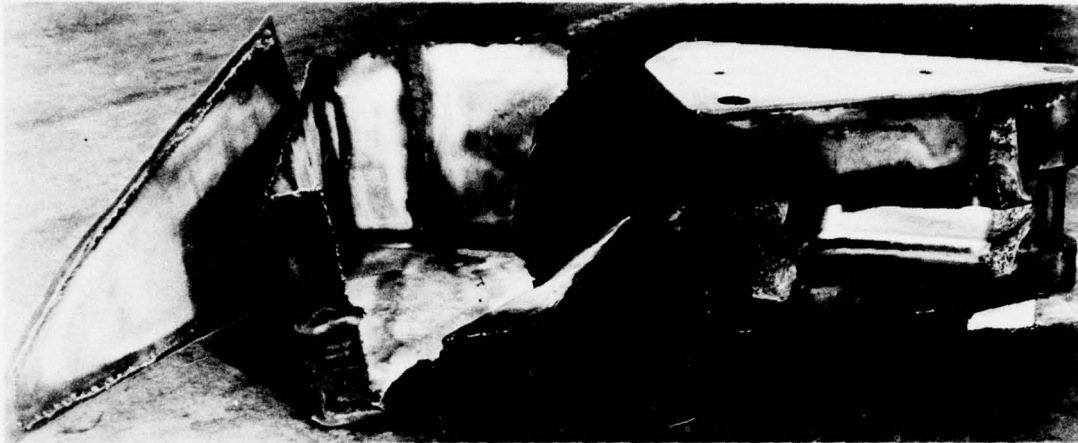
FIGURE 50. RETORT, DIE, AND ARM SEGMENT AFTER THE FORGE-BOND AND POST BOND ANNEAL, THIRD ARM SEGMENT.

The retort was opened for an early evaluation of the arm segment as shown in Figure 50. Details relating to the investigation of the preliminary sonic indication are presented in Section 5.4.2 on Hub Arm Inspection. The arm segment was then thermally treated at 1900°F for one-hour at temperature, water-quenched, annealed at 1300°F for two-hours and air cooled. These operations completed fabrication of the single hub arm risk reduction segment. Inspection and destructive testing were the next major efforts as discussed in Sections 5.4.3 and 5.5.

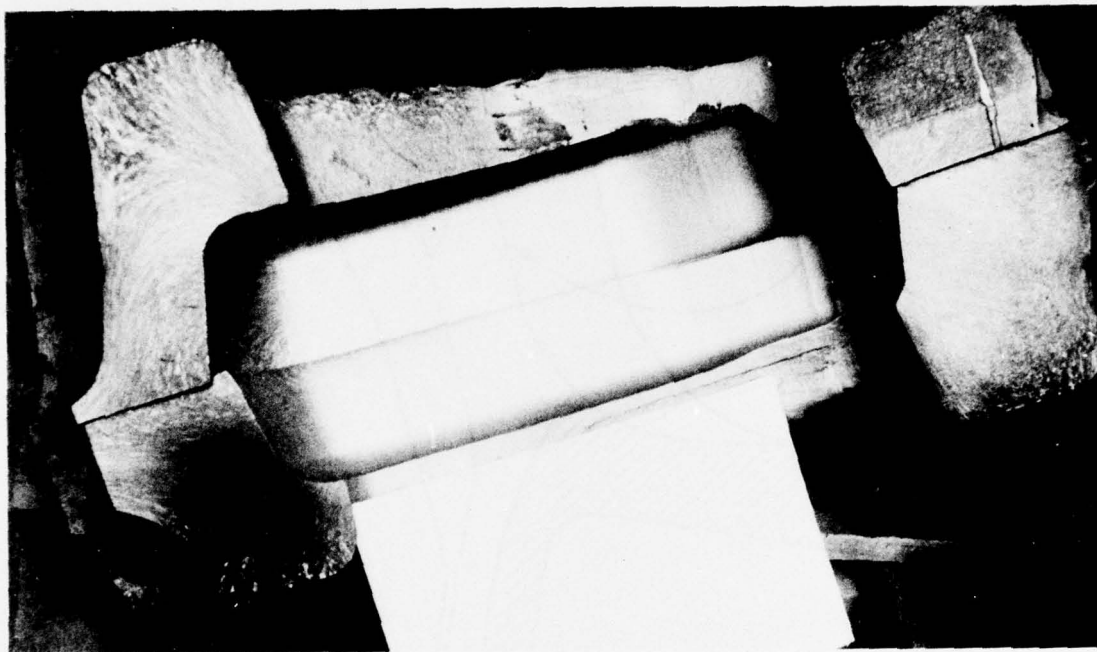
FIGURE 67. THIRD HUB ARM SEGMENT AS REMOVED FROM REPORT.

3rd Hub Arm - After the forge-bond and post-bond thermal treatment at 1750°F, the retort was opened by cutting and the third arm segment was removed from the bonding dies. Generally, the arm segment was bright, manifesting a noncontaminated surface. Only one area on the arm segment disclosed a minute area of possible contamination. Figure 67 shows the arm segment as it was removed from the retort.

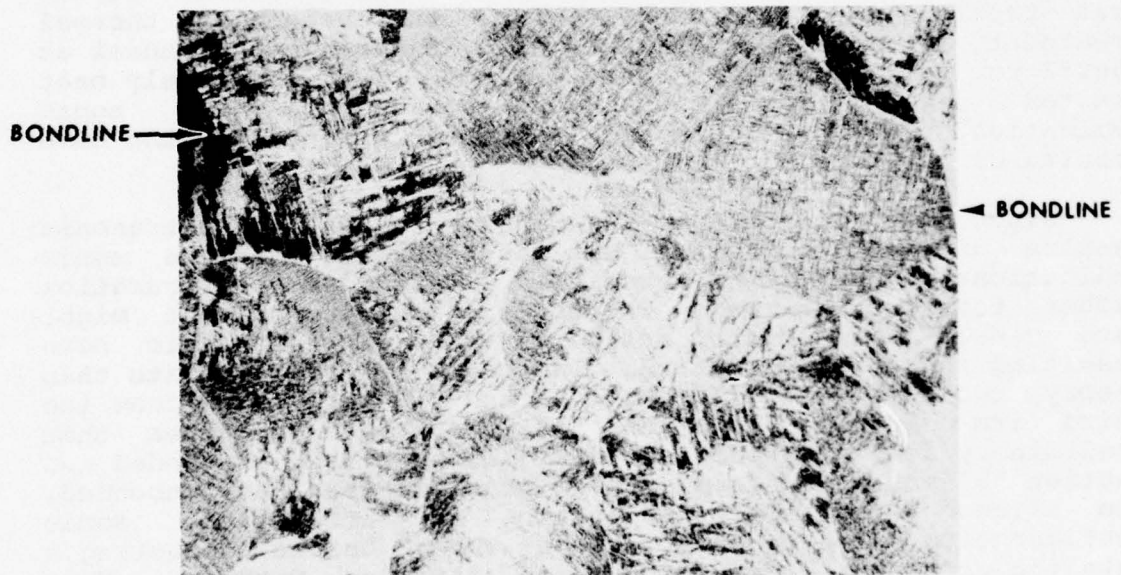
FIGURE 70. MICROSTRUCTURE ACROSS BONDLINE OF THIRD HUB ARM SEGMENT, AFTER FINAL BETA HEAT TREAT AGAIN DISCLOSED NO GROSS LACK OF BOND. 50X

Transverse slices were cut from an area exhibiting some indications of nonbonding. Contrary to the ultrasonic indications, macrostructure examination disclosed an apparent good diffusion bond. The forging flow lines were evident in the alpha-beta macrostructure and tended to bring out the bondline location. Figure 69 depicts the macrostructure across the bondline. Micro-examination of the same area revealed no evidence of cracking, lack of bond, contamination or other discontinuities at the joint interface. In order to examine the bondline in more detail, a segment of the macrospecimen was processed in accordance with the final beta heat treatment. The heat treatment consisted of 1900°F for one-hour, water-quench, anneal at 1300°F for two hours and air cool. Metallurgical examination again disclosed no gross lack of bond in the beta structure which appeared to be homogeneous as shown in Figure 70 with no indication of the bondline location.

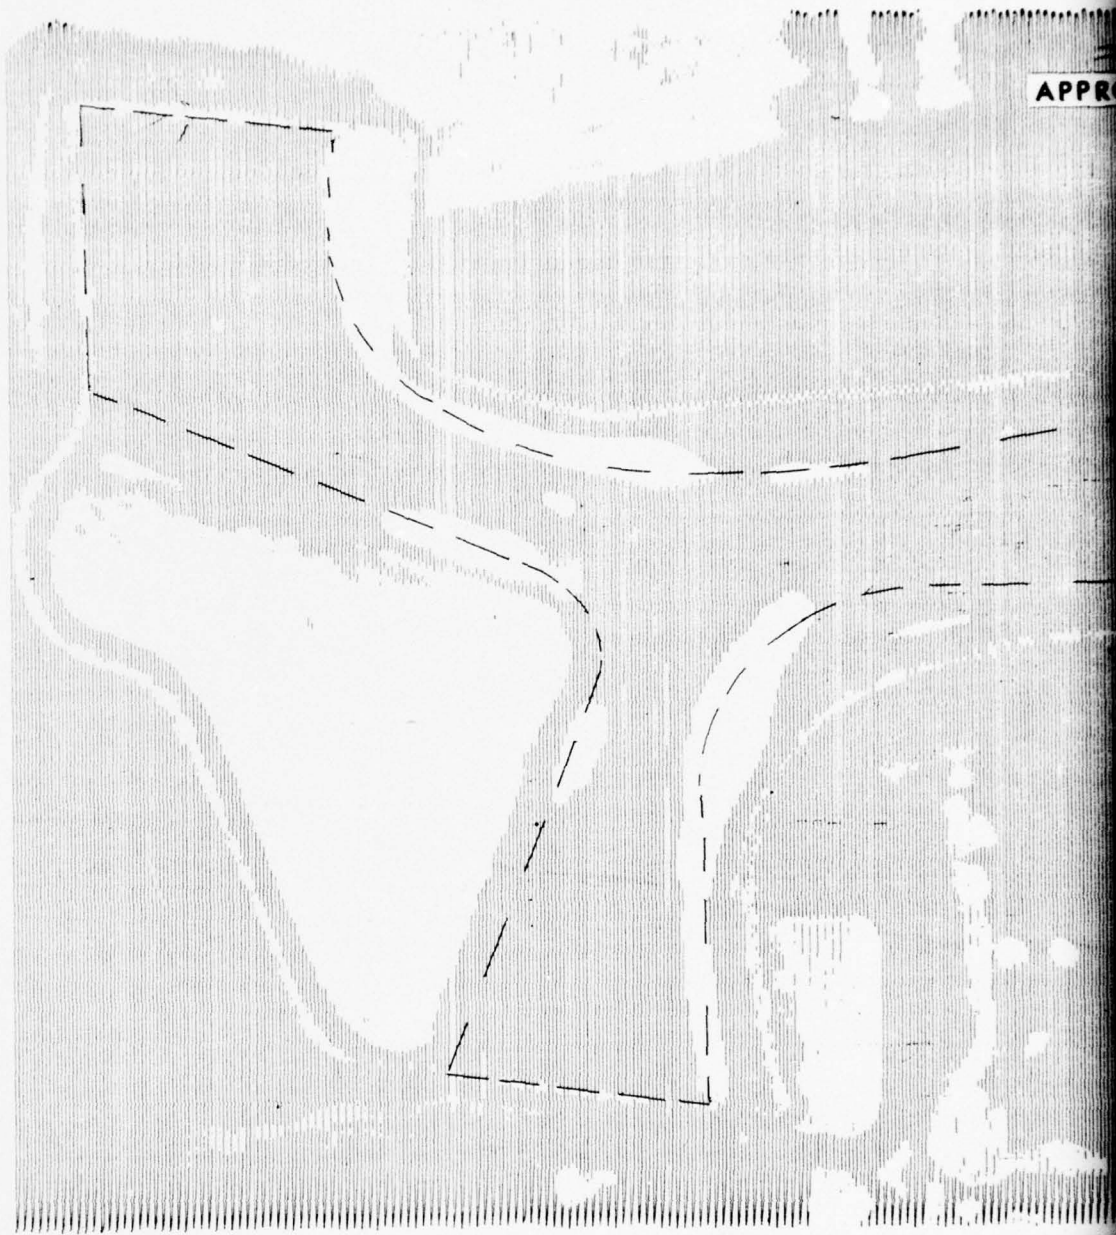
FIGURE 76. C-SCAN RECORDING OF FOURTH HUB ARM SEGMENT,
80% OF #4 fbh IN REFERENCE BLOCK.

4th Hub Arm - Following completion of the fabrication process, the fourth arm segment was machined top and bottom surfaces to an ultrasonic inspection configuration. The technique used in inspection of the fourth arm was the same as employed for the third arm. Results of this inspection disclosed a satisfactory joint with no evidence of gross lack of bond. C-scan recordings portrayed a similar read-out, as obtained previously from the third arm. Figure 76 is a copy of a C-scan recording of the fourth arm segment depicting the familiar anomalies along the periphery.

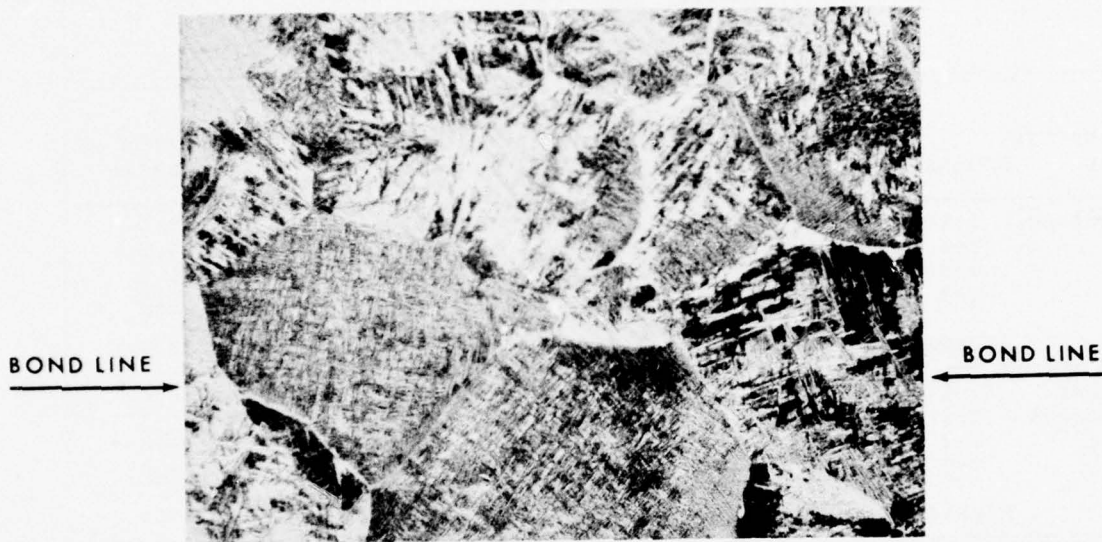
FIGURE 86. TYPICAL CROSS SECTION OF BONDLINE, NO EVIDENCE OF ANY ANOMALIES, BOND JOINT IS NOT DISTINGUISHABLE FROM PARENT MATERIAL. 50X

General - Analysis of the mechanical properties of the parent material and the forge-bond joint revealed no significant differences. The results indicated a high quality diffusion bonded joint had been obtained. A summary of the test results is provided in Figure 85. Visual evaluation of the tested specimens, parent material and bondline revealed that all the specimens failed in the test region and are considered valid tests. The bondline specimens separated within the test section as designed. Fracture examination of the tensile, fracture toughness, in-line shear, and fatigue initiation specimens for the parent material and bondline specimens revealed the mode and mechanism of failure to be typical as related to the particular type of tests conducted. No evidence of any abnormalities were detected on the fracture surface of the bondline specimens that could have caused or contributed to premature failures. Microstructure examination of cross sectional areas of bondline specimens revealed no evidence of failure initiation due to an anomaly at the bondline. No significant differences were observed between the parent material and bondline specimens. Metallographic examination of cross sectional segments of bondline specimens and macroslices disclosed no evidence of voids, contamination, or lack of bond. In most instances, metallographic examination could not distinguish the bond joint from the parent material, as illustrated in Figure 86.

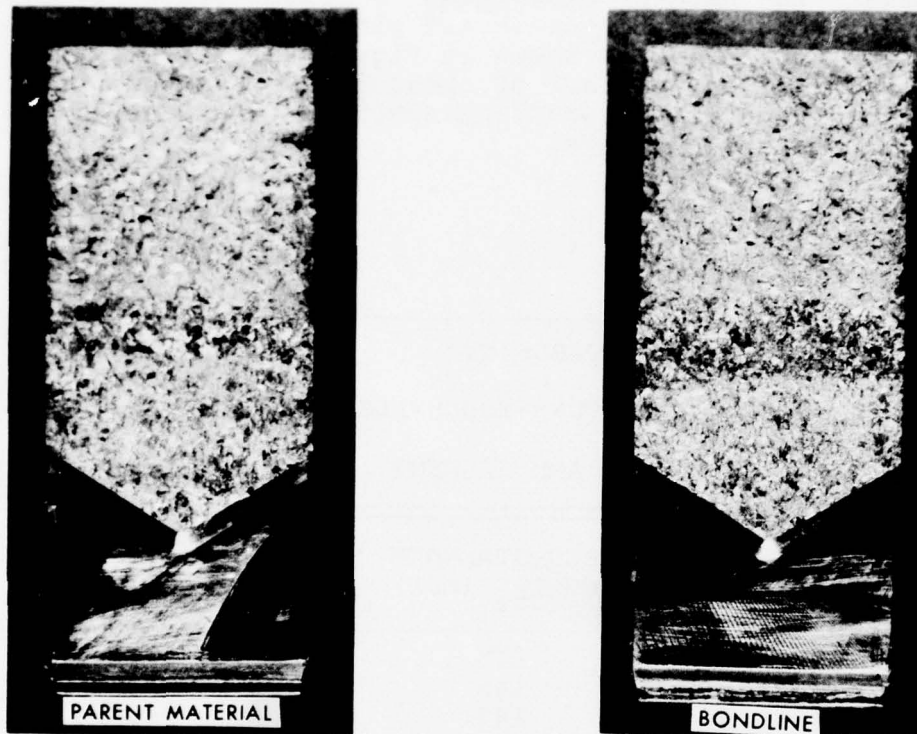
FIGURE 88. FRACTURE TOUGHNESS TYPICAL FRACTURE INTERFACE, HUB ARM SEGMENT. 1.5X

Fracture Toughness - Fracture toughness results are presented in Table XV. Review of the data disclosed no significant differences and all the test values are valid, meeting all criteria for determination of valid K_{IC} measurements described in ASTM-E399-72 (Reference (7)). The specimens displayed fracture surfaces with normal flat brittle fatigue precracking followed by overload, plane strain cracking for both the parent material and bondline specimens. Crack propagation was transgranular in nature exhibiting a fine grain fracture interface for both the precrack and plane strain crack region of both type specimens as shown in Figure 88. No evidence of voids, contamination, or lack of bond was observed on the fracture interface of the bondline specimens that could have generated a premature failure.

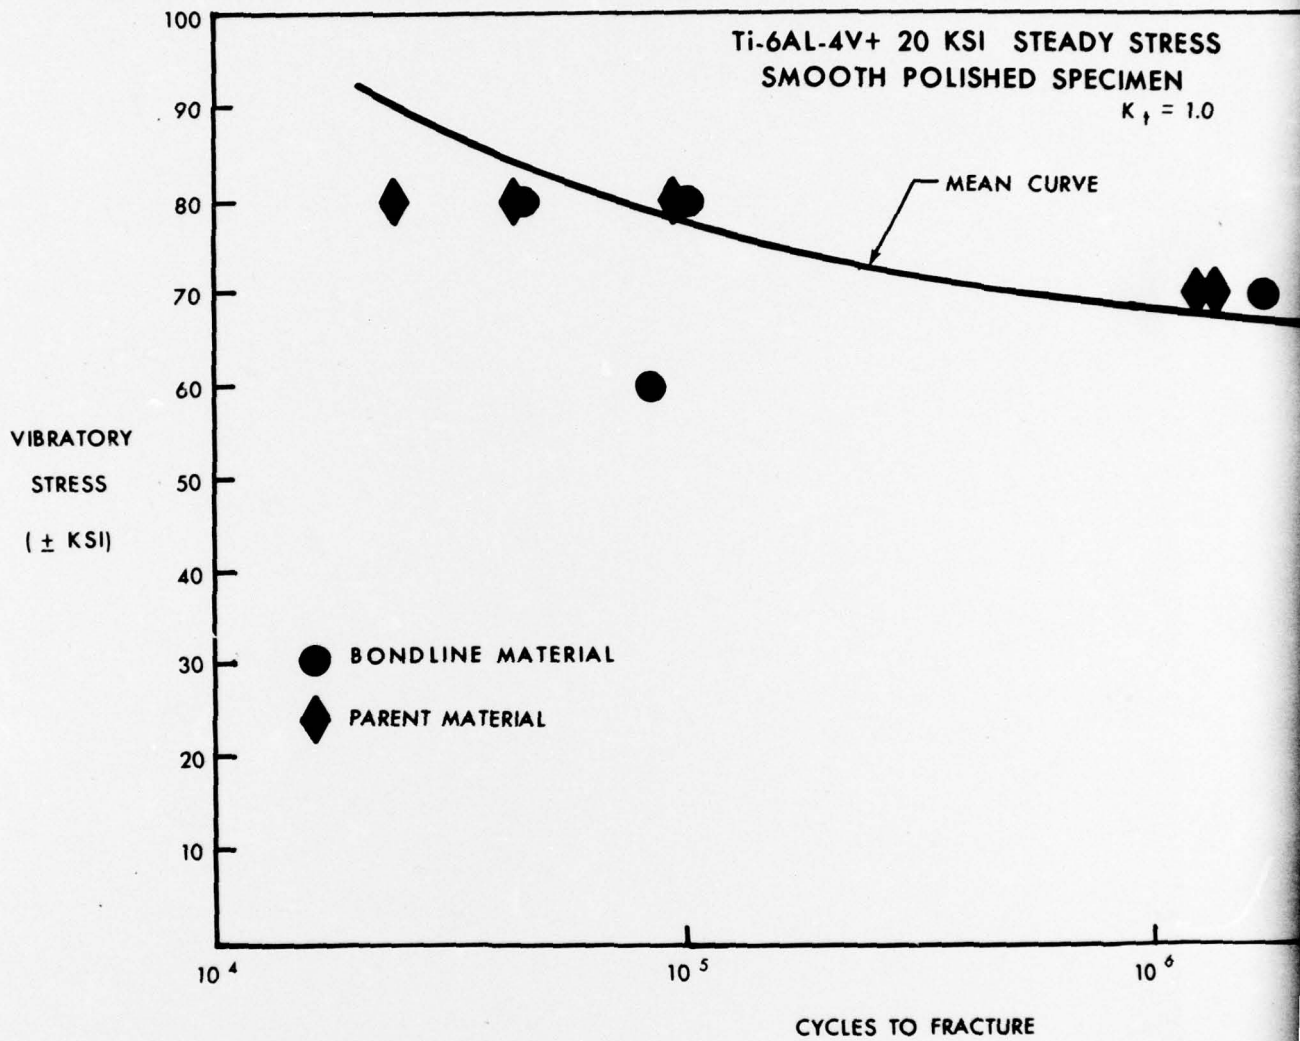
FIGURE 90. MEAN S/N CURVE FOR HUB ARM SEGMENT, BONDLINE MATERIAL AND PARENT MATERIAL.

Ti-6AL-4V+ 20 KSI STEADY STRESS
SMOOTH POLISHED SPECIMEN
 $K_t = 1.0$

Fatigue - Results of the fatigue test data are summarized in Table XVII. This data is also presented on a mean S/N curve, Figure 90. Statistical analysis of the mean fatigue strength at 10^8 cycles for the parent material and bondline specimens plus the results obtained from Condition 1 of the pancake forging initially evaluated revealed no significant differences. The parent material and bondline specimens exhibited origins on the O.D. Cracking propagated in cyclic loading before complete separation of the specimens due to overload. The relationship of cyclic propagation and overload was contingent on the load level of testing. As expected, specimens tested at the higher load level manifested a smaller cyclic region and larger static overload zone. The fracture interfaces of both type specimens were similar with no evidence of abnormalities at the origin site that could have initiated cracking as shown in Figure 91. The fracture interface of the one, slightly lower bondline specimen revealed no discrepancies that could account for the slightly lower test point.

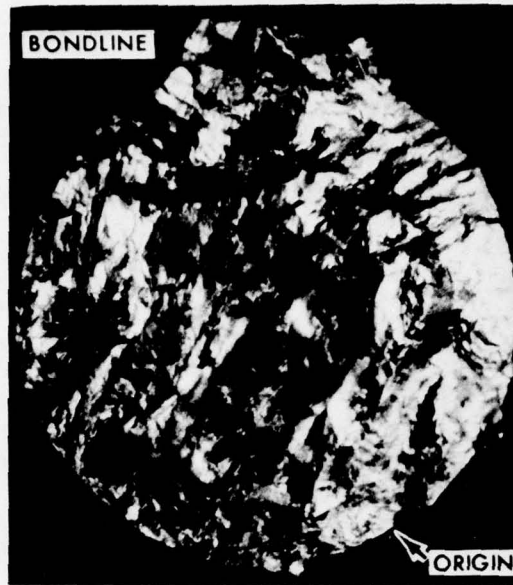
FIGURE 91. FATIGUE FRACTURE, TYPICAL FRACTURE SURFACE WITH ORIGIN ON O.D., HUB ARM SEGMENT. 11X
