construction  
engineering  
research  
laboratory

12  
INTERIM REPORT M-200  
January 1977

FRACTURE CHARACTERISTICS OF TWO HIGH-STRENGTH,  
LOW-ALLOY AND TWO STAINLESS STEELS

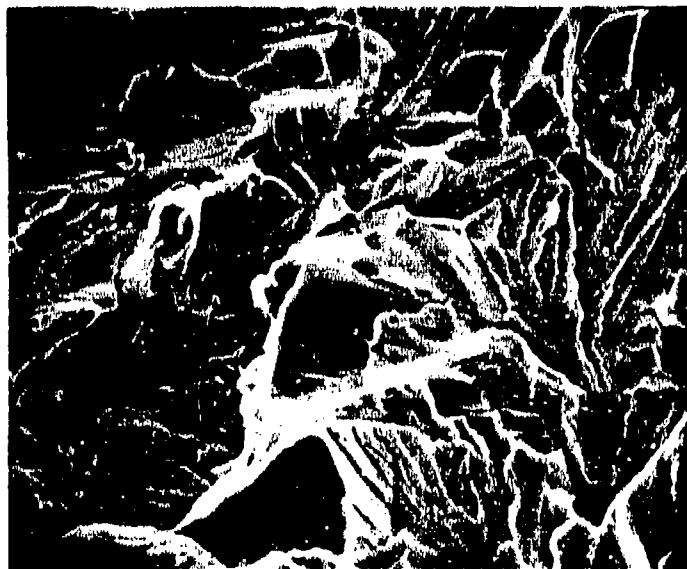
**Figure 23.** Cleavage facets in an A-588 Charpy specimen tested at  $-196^{\circ}\text{C}$ , 1000X.

Figure 22 shows the fracture surface of an A-588 Charpy impact specimen tested to failure at -196°C. A higher magnification of the surface (Figure 23) shows that failure occurred by cleavage. Numerous river patterns are found on the facets. For the Charpy specimen tested at -103°C, the fracture surface consisted primarily of cleavage facets with some interspersed dimpled regions (Figure 24). When fracture occurred at -18°C, the interior surface showed primarily cleavage facets; at the edges, however, regions of mixed cleavage and dimples appeared. At room temperature (23°C), one area in the interior of the surface failed by cleavage; however, most of the specimen had failed by a combination of cleavage and dimple rupture (Figure 25), which gave the surface a fibrous texture (Figure 26).

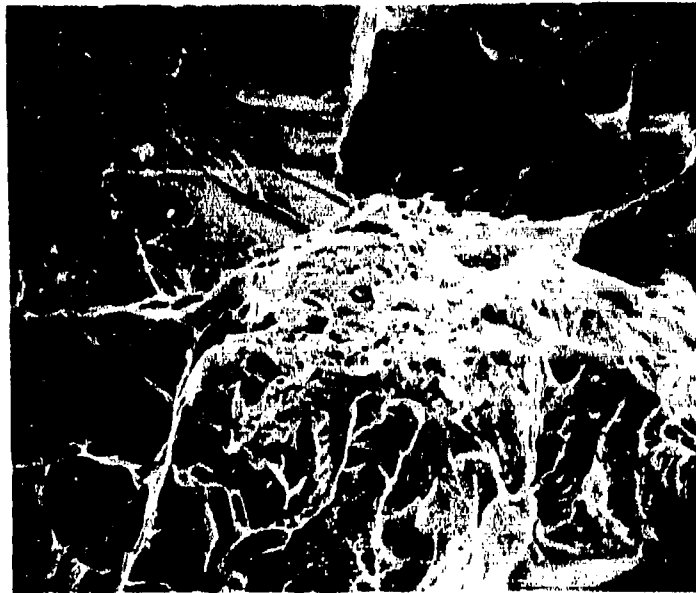
**Figure 24.** Cleavage fracture and dimple rupture in an A-588 Charpy specimen tested at  $-103^{\circ}\text{C}$ , 1000X.
