# EVALUATION OF LUBRICATING COMPOSITES FOR THE M16A1 RIFLE

GEORGE P. MURPHY, JR.  
BERNARD J. BORNONG

FEBRUARY 1976

## TECHNICAL REPORT

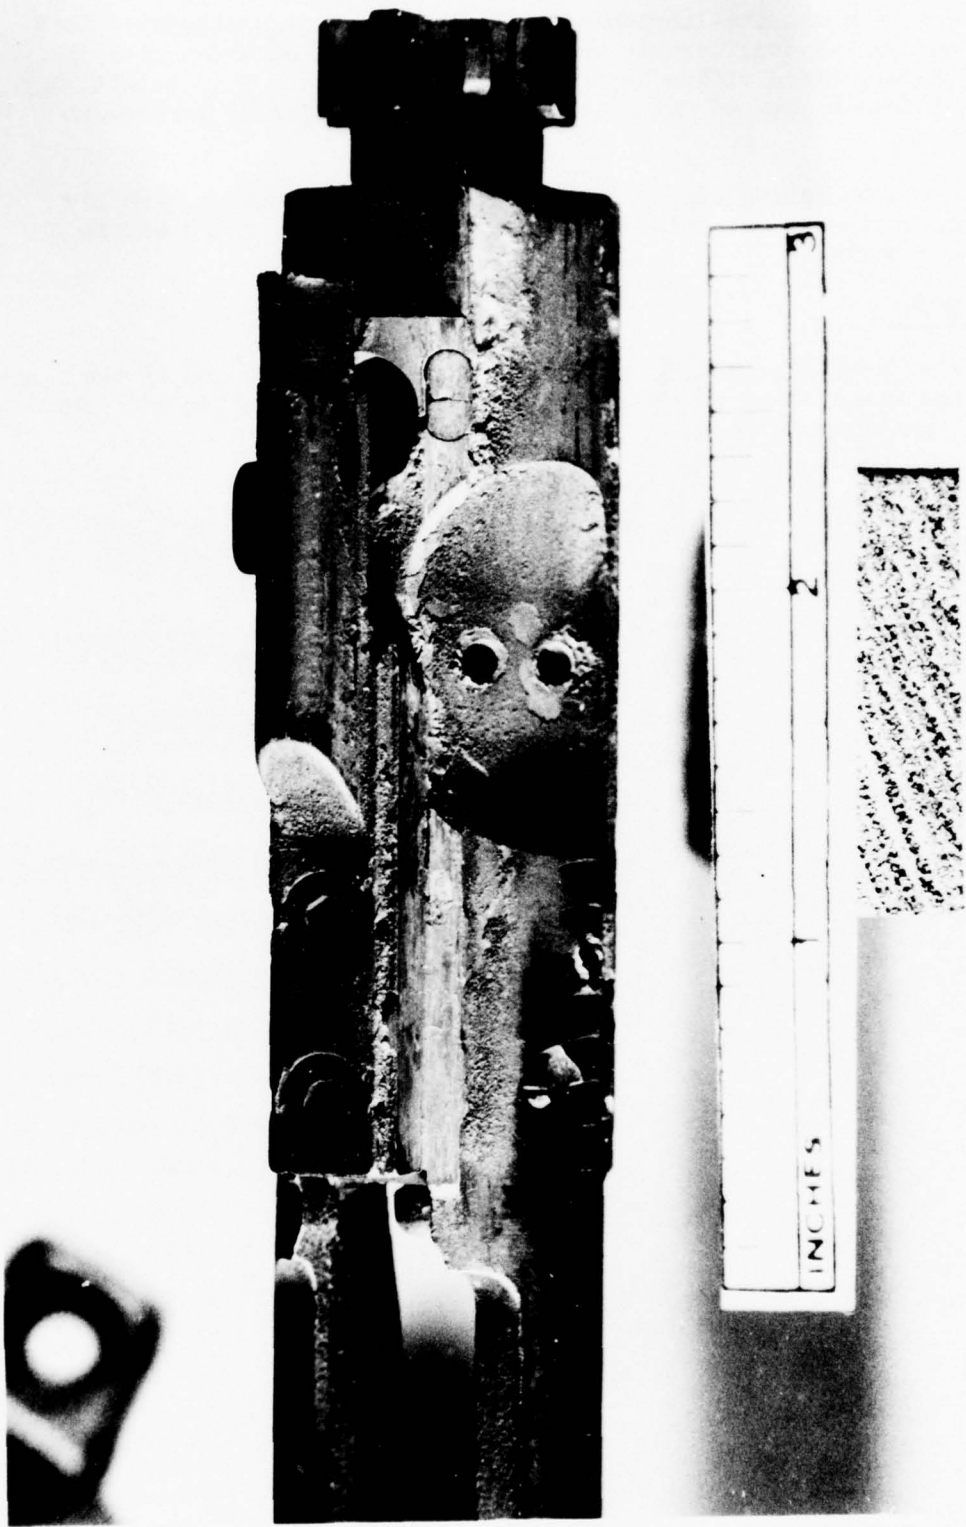
Figure 9. Bolt Carrier after 10,000 Rounds Showing Cracked Insert.

Although Rifles Nos. 2 and 3 completed the 10,000-round test, the composite insert in the cam path area had cracked. In Figure 9, the bolt carrier of Rifle No. 3 is shown at the end of the test with the cracked insert. Therefore, with the exception of Rifle No. 4, which was in the test for only a short time, the composite insert in the cam path area, at which the cam path wall was broken through during machining, either fell out or broke off, or was cracked. The effect of this on the test results is difficult to assess. The exact time at which these inserts cracked could not be determined; however this cracking could have occurred very early in the test. Some malfunctions undoubtedly occurred because of these cracked inserts and not because of any lubrication deficiencies. In spite of the difficulties encountered with the inserts in this one area of the carrier cam, the 6-malfunction rate per composite-lubricated rifle is considered very good.
