DYNAMIC TESTS
ON
WOOD - NAIL JOINTS

INTERIM REPORT NO. 2

MTMC
TRANSPORTATION ENGINEERING
AGENCY
NEWPORT NEWS, VIRGINIA 23606

DARCOM
AMMUNITION CENTER
SAVANNA, ILLINOIS 61074

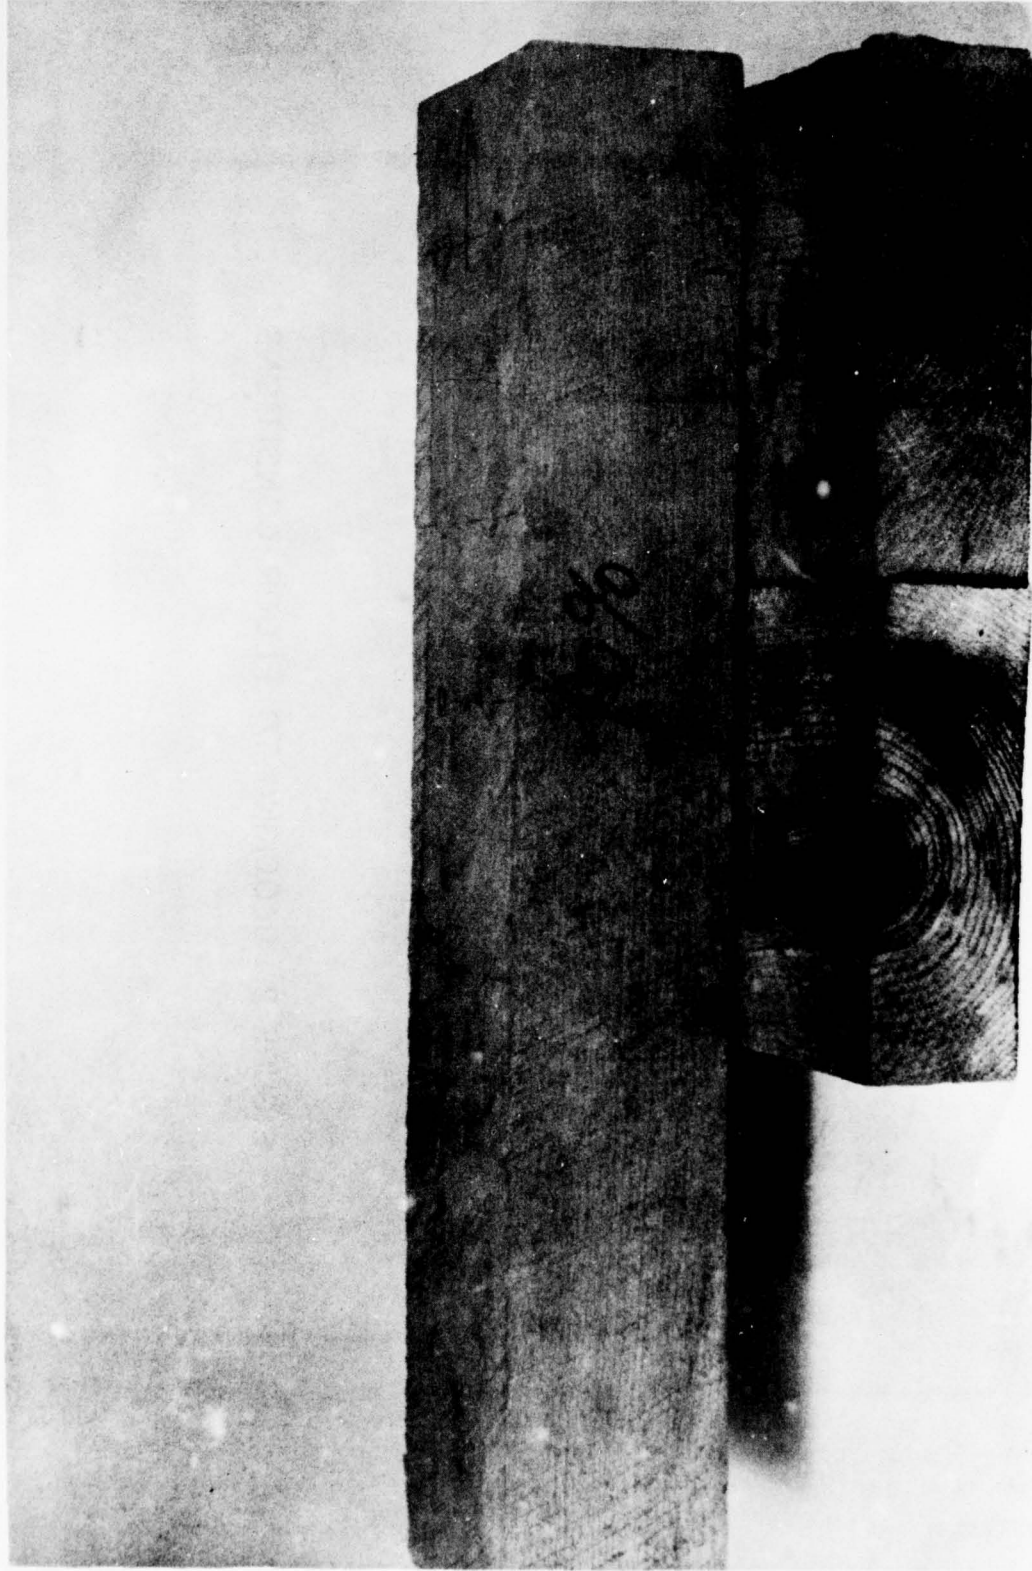
Figure 1

This floor-nail-cleat assembly was used in the X-Ray Test.

The configuration selected for the sequential X-ray test is shown in Figures 1 and 2. Other information is as follows:

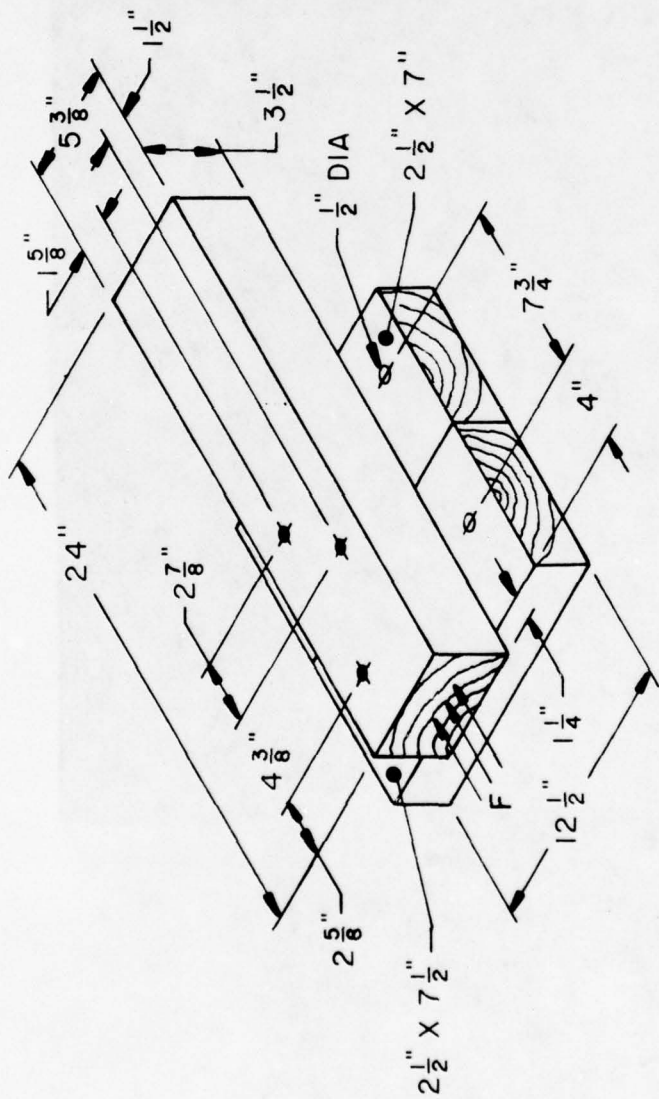
FIGURE 2. BLOCKING TO FLOOR CONDITIONS

The X-Ray photographs of the specimen are shown as Figures 4 through 10. If the X-Rays are to be compared with Figure 2, the specimen in Figure 2 must be oriented so that the longitudinal direction of the simulated floor is vertical and the two nails in the same longitudinal plane of the cleat are above the third nail. The darker portions on the photograph are analogous to the ends of the simulated floor boards. Because the nails are not in the same horizontal plane, the nail that is closer to the film appears to be shorter and smaller than the other two nails. This appearance is due to the shadow effect produced by the X-Rays being emitted in a conical pattern and the nails in horizontal planes between the X-Ray emitter and the film.

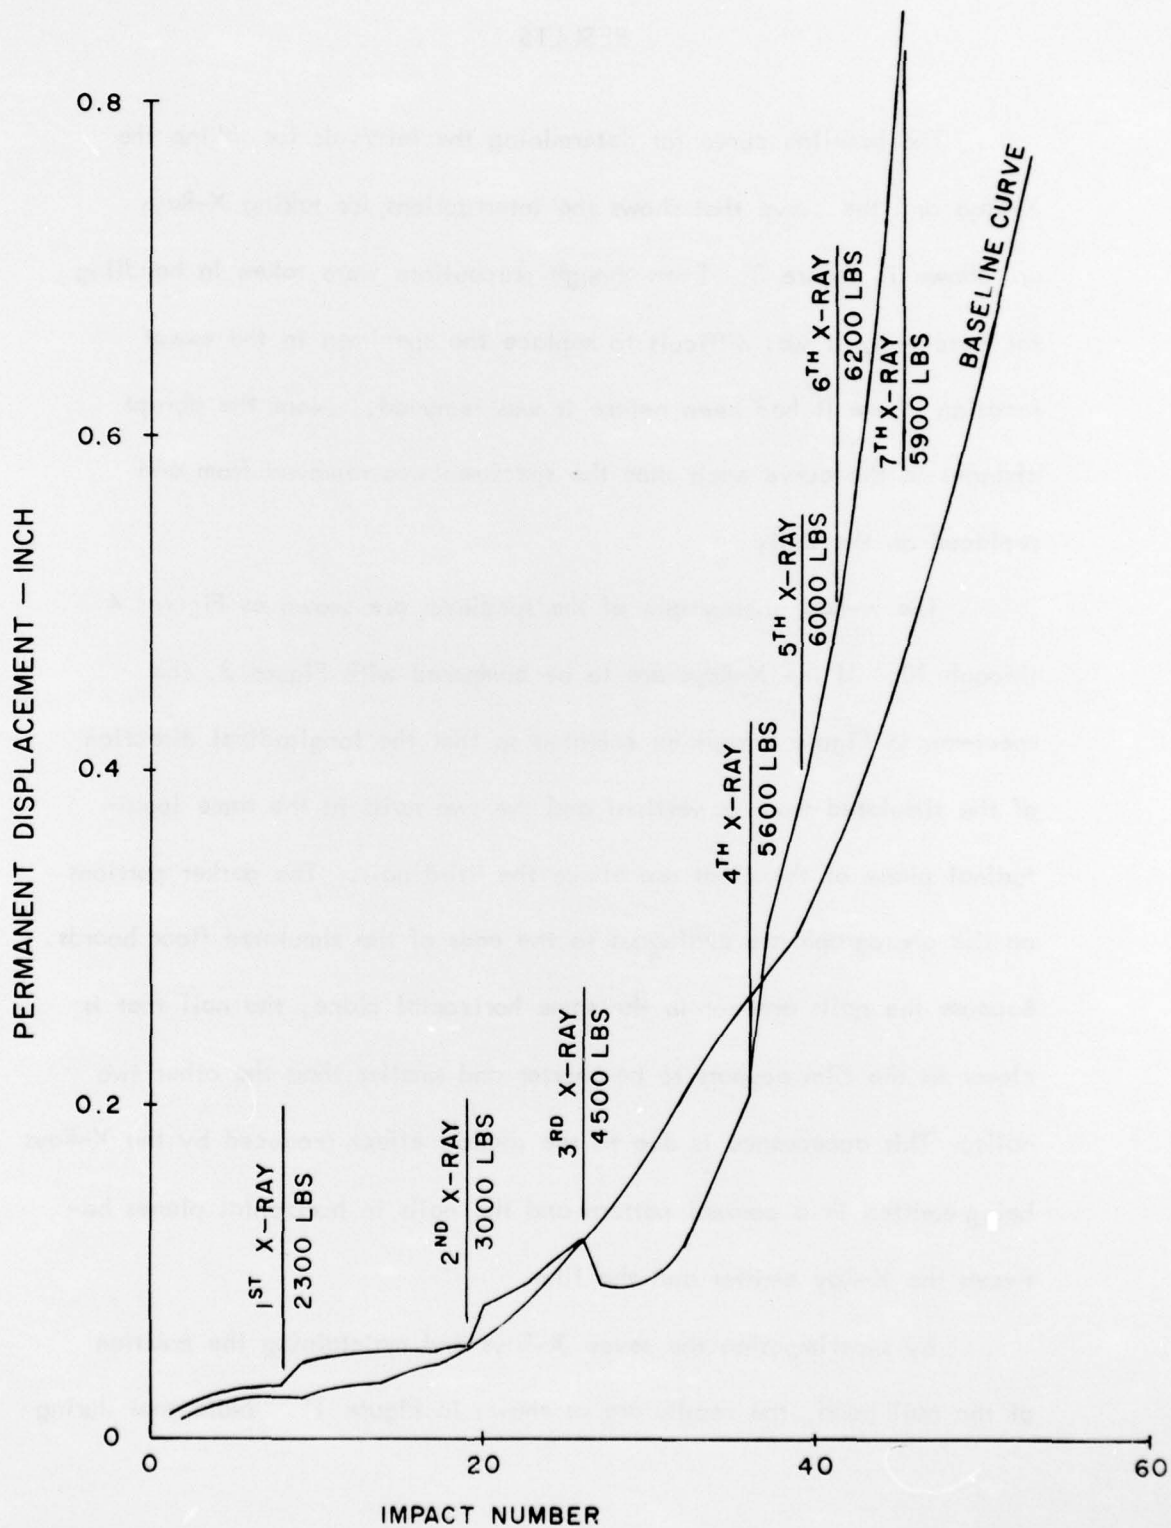
FIGURE 3. DISPLACEMENT AND FORCE SUSTAINED BY SPECIMEN WHEN X-RAY PHOTOGRAPH WAS PRODUCED.

The baseline curve for determining the intervals for taking the X-Rays and the curve that shows the interruptions for taking X-Rays are shown in Figure 3. Even though precautions were taken in handling the specimen, it was difficult to replace the specimen in the exact location where it had been before it was removed. Note the abrupt changes in the curve each time the specimen was removed from and replaced on the dolly.

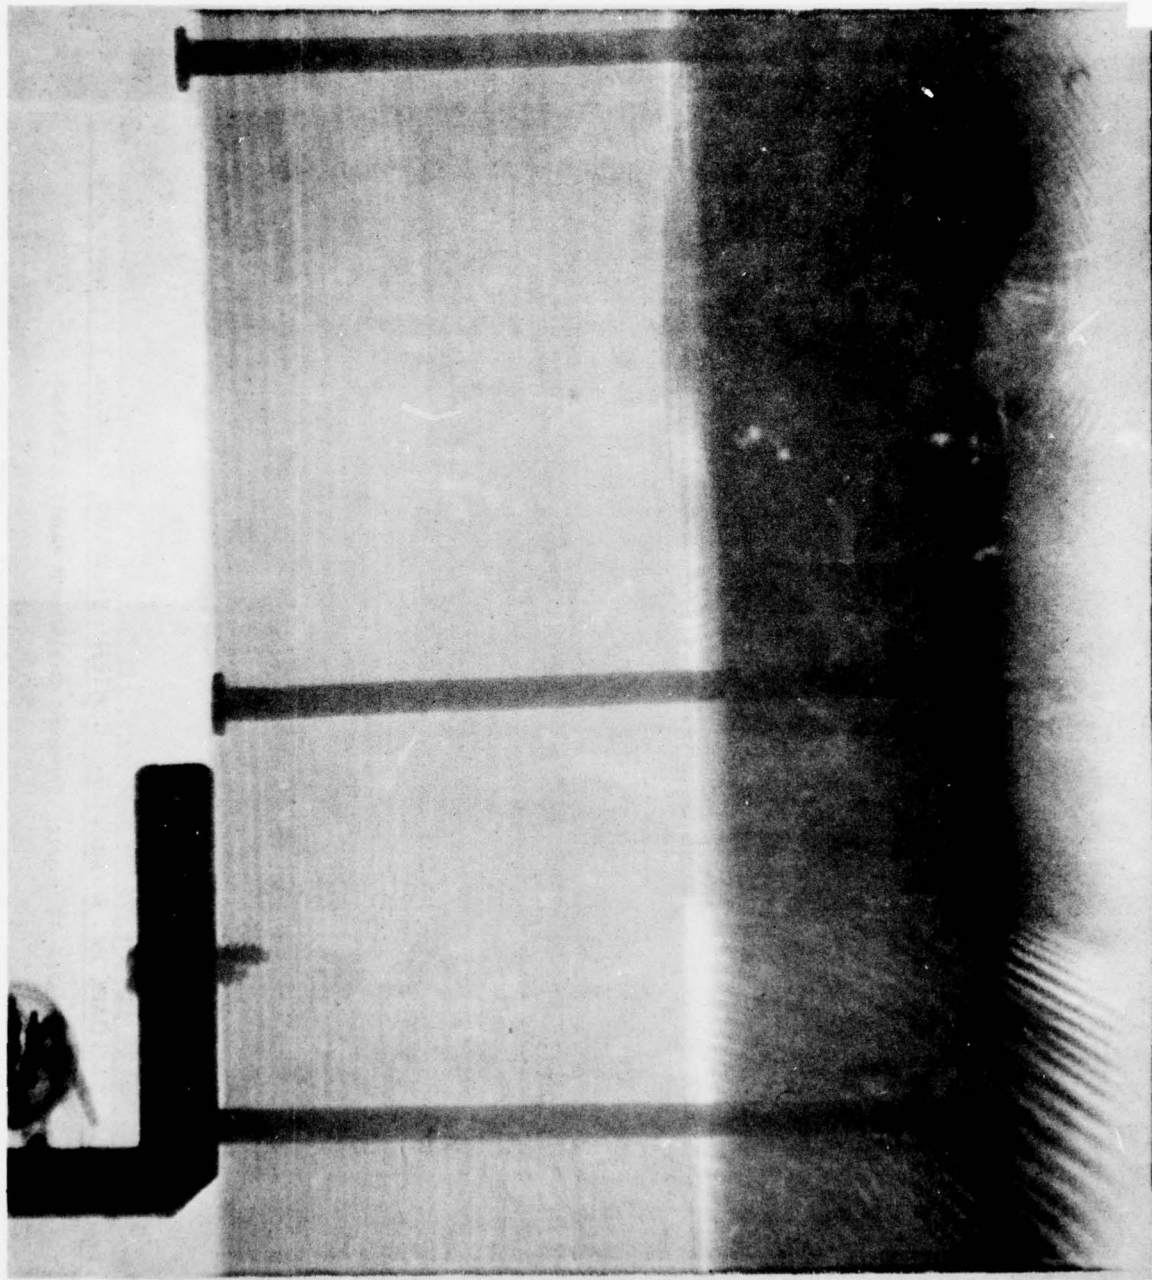
Figure 4 | DARCOM AMMUNITION CENTER - SAVANNA, ILLINOIS | November 1976
Nail distortion after 8 impacts. Permanent displacement equals 0.03 inch.

Observe the distortion of the nails shown in Figures 4, 5, and 6. There is no observable distortion in the nails in Figures 4 and 5 but there is some distortion in the nails in Figure 6. As stated in Part II, the yield point corresponds to 0.05 inch displacement. Figure 5 represents the nail distortion at the yield point. Based on this information it appears that the yield point corresponds with the force required to bend the low carbon nail. (At this point the observation must be considered an hypothesis).

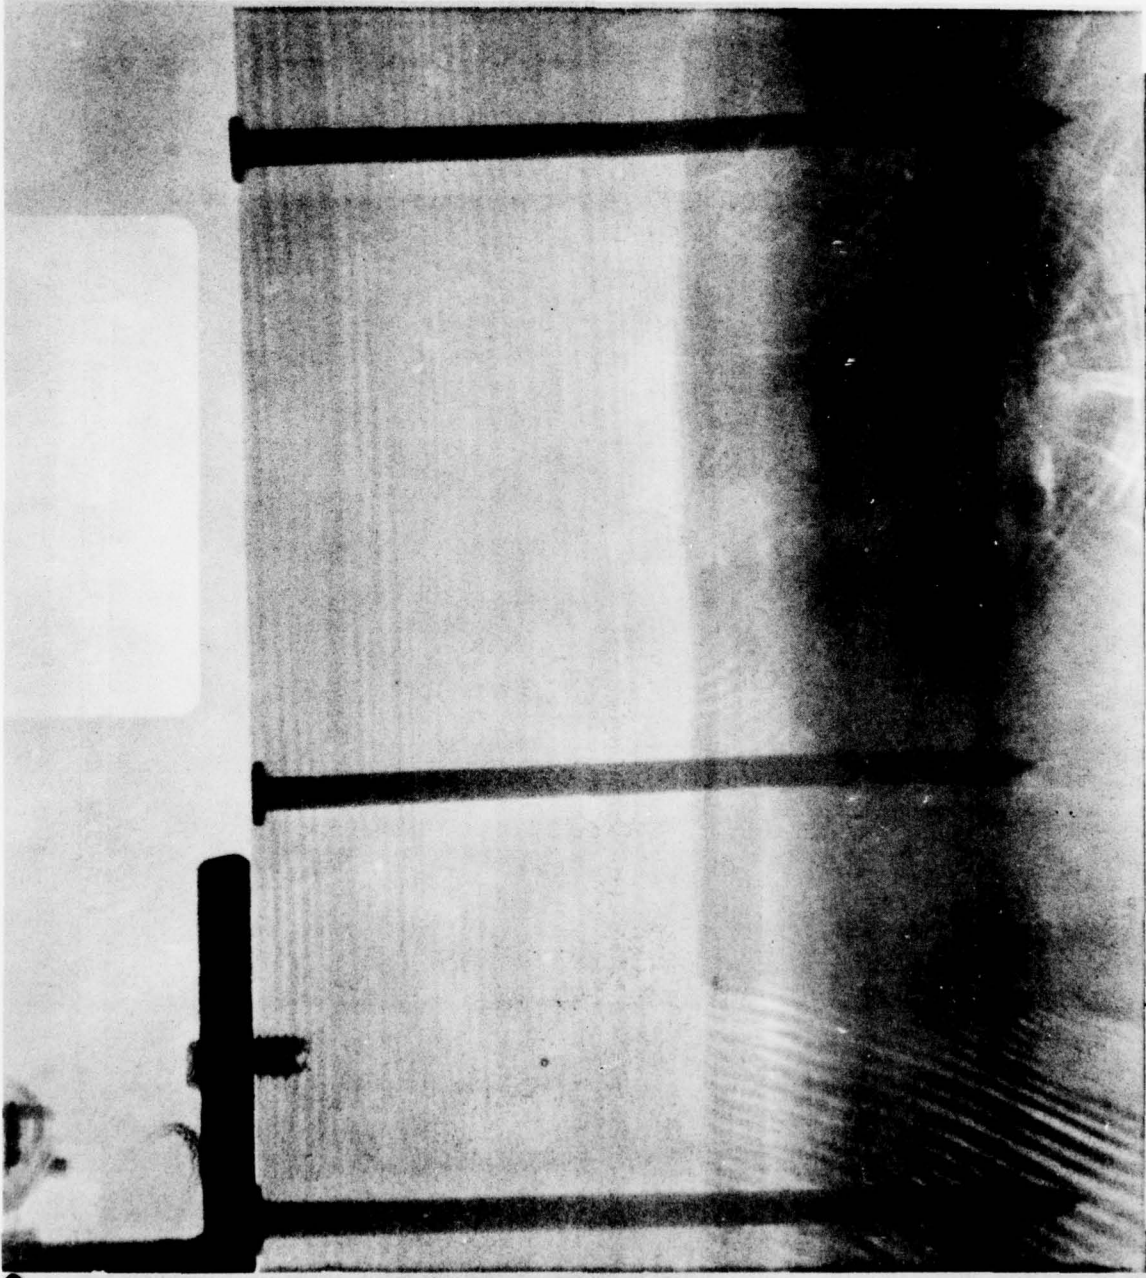
Figure 5

Nail distortion after 19 impacts. Permanent displacement equals 0.053 inch.

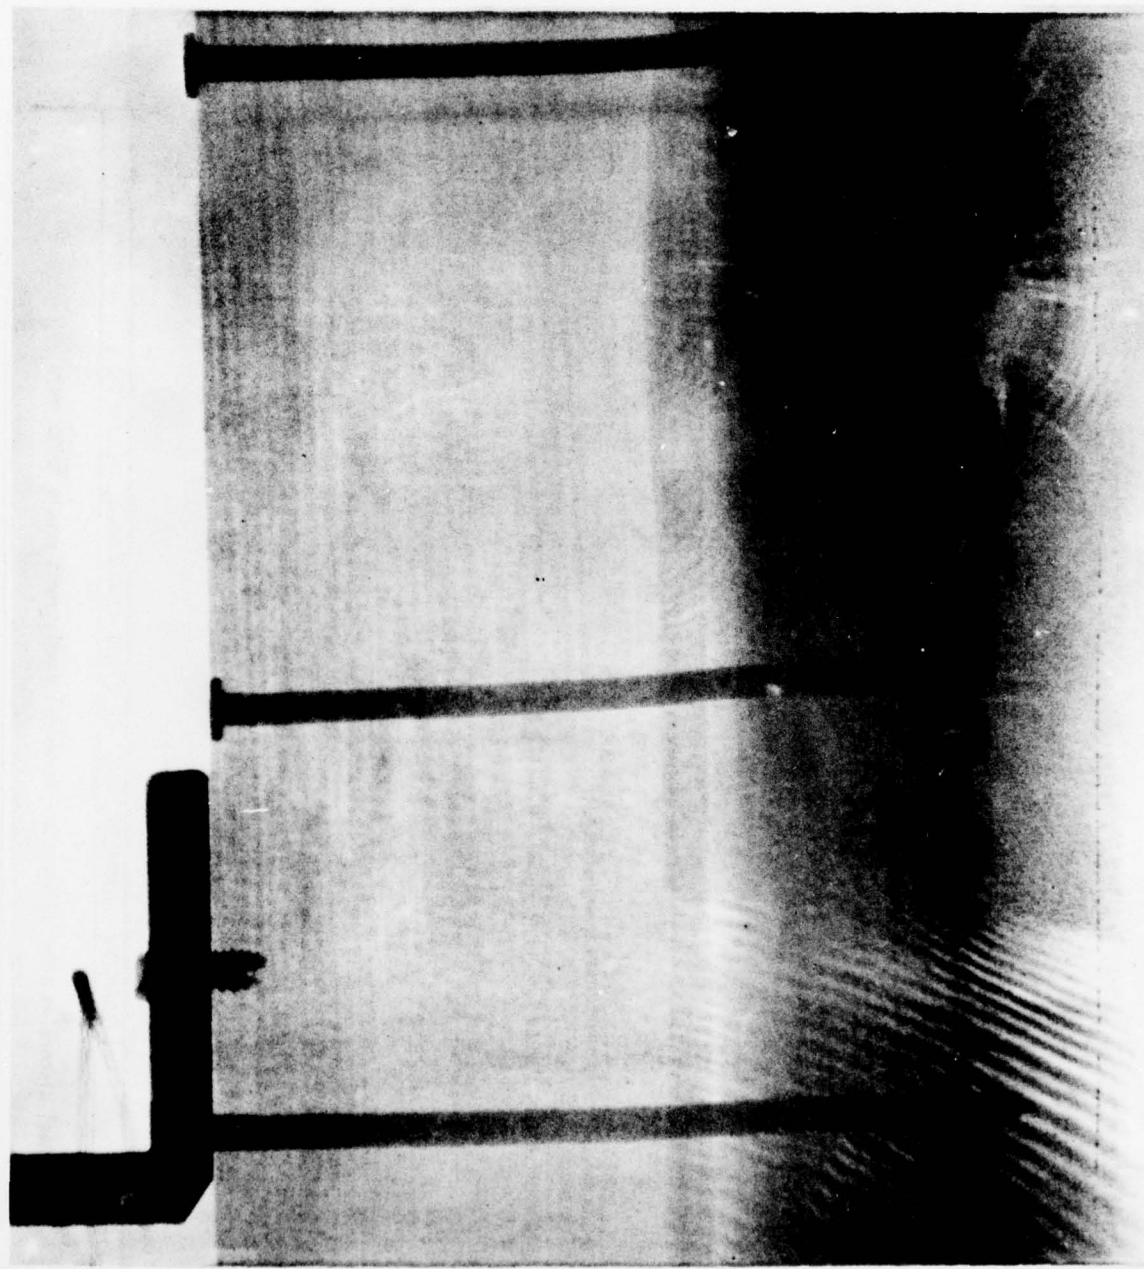
Figure 6

Nail distortion after 26 impacts. Permanent displacement equals 0.109 inch.

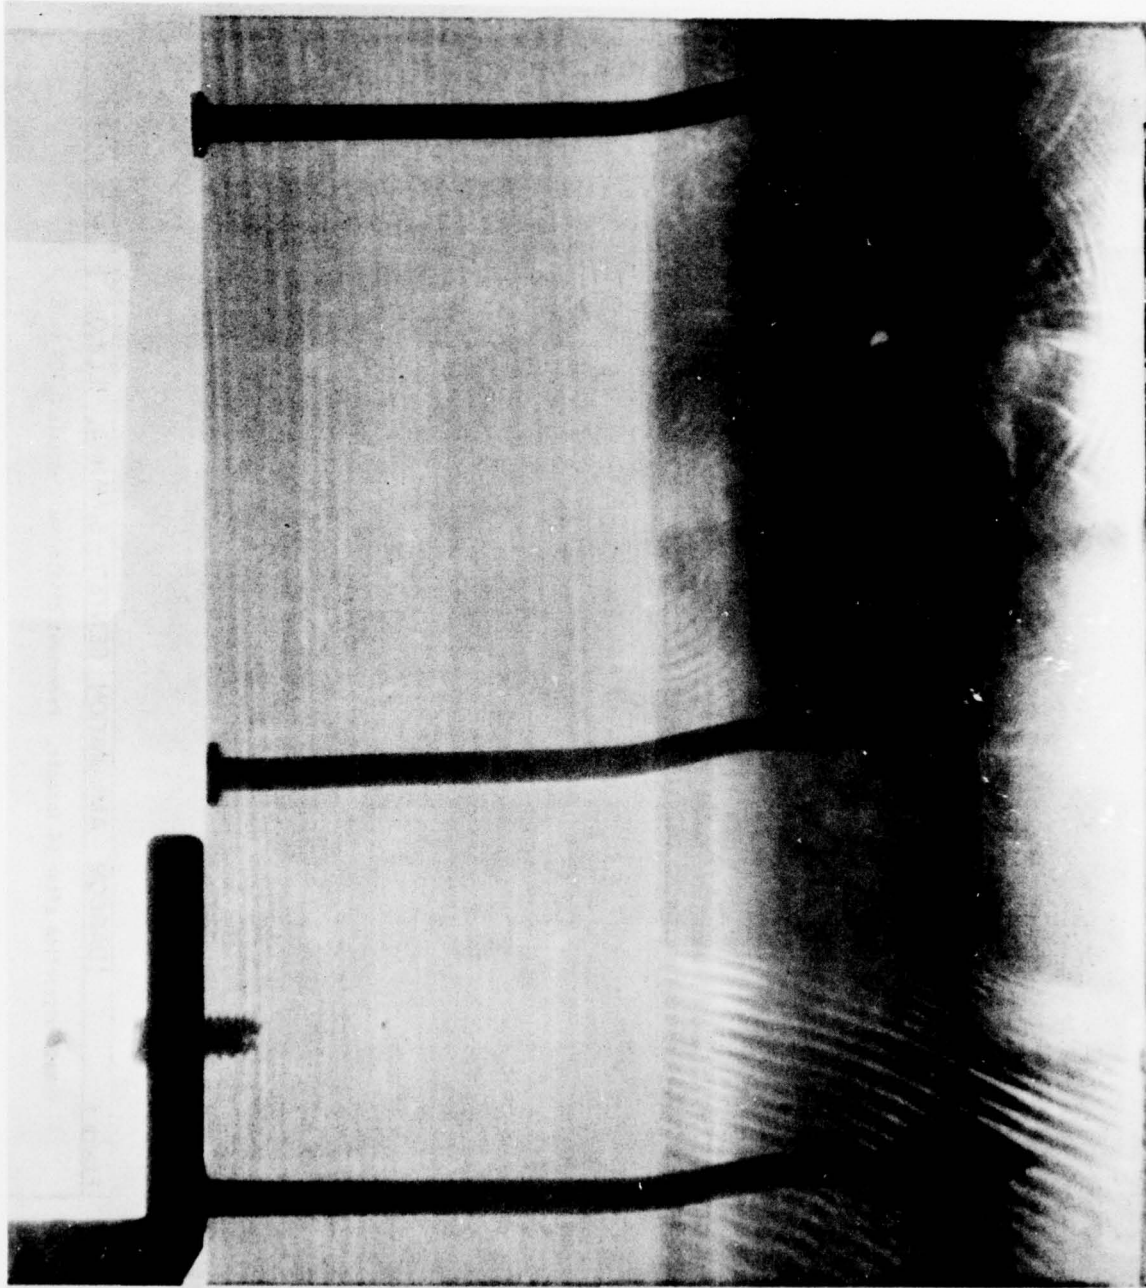
Figure 7

Nail distortion after 36 impacts. Permanent displacement equals 0.196 inch.

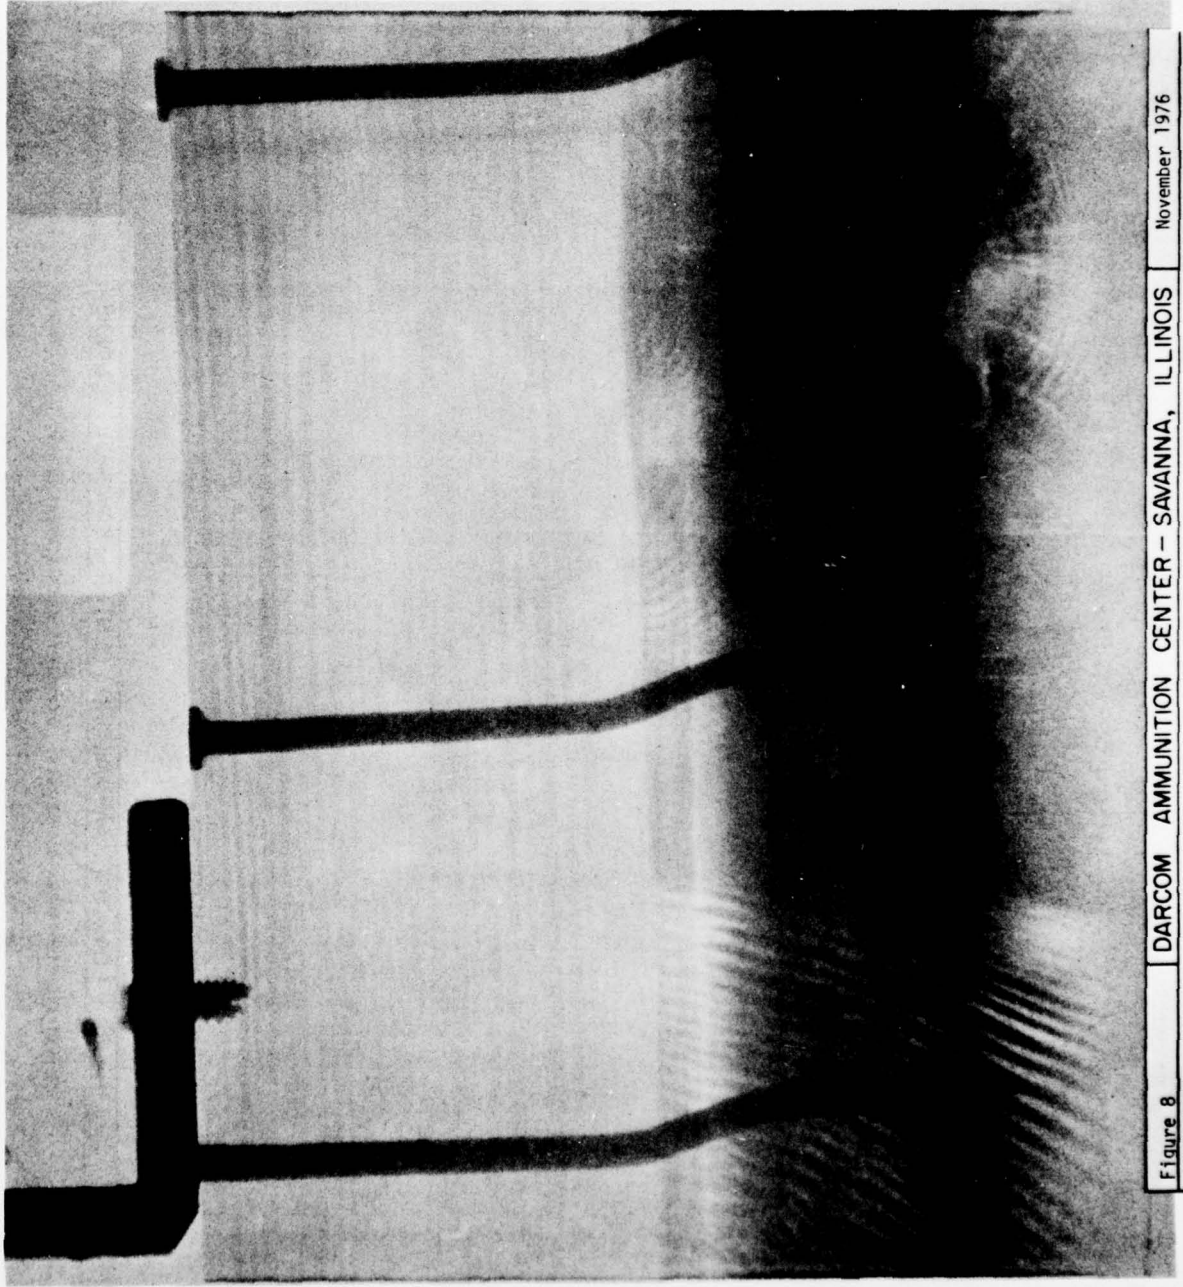
Figure 8

Nail distortion after 39 impacts. Permanent displacement equals 0.366 inch.

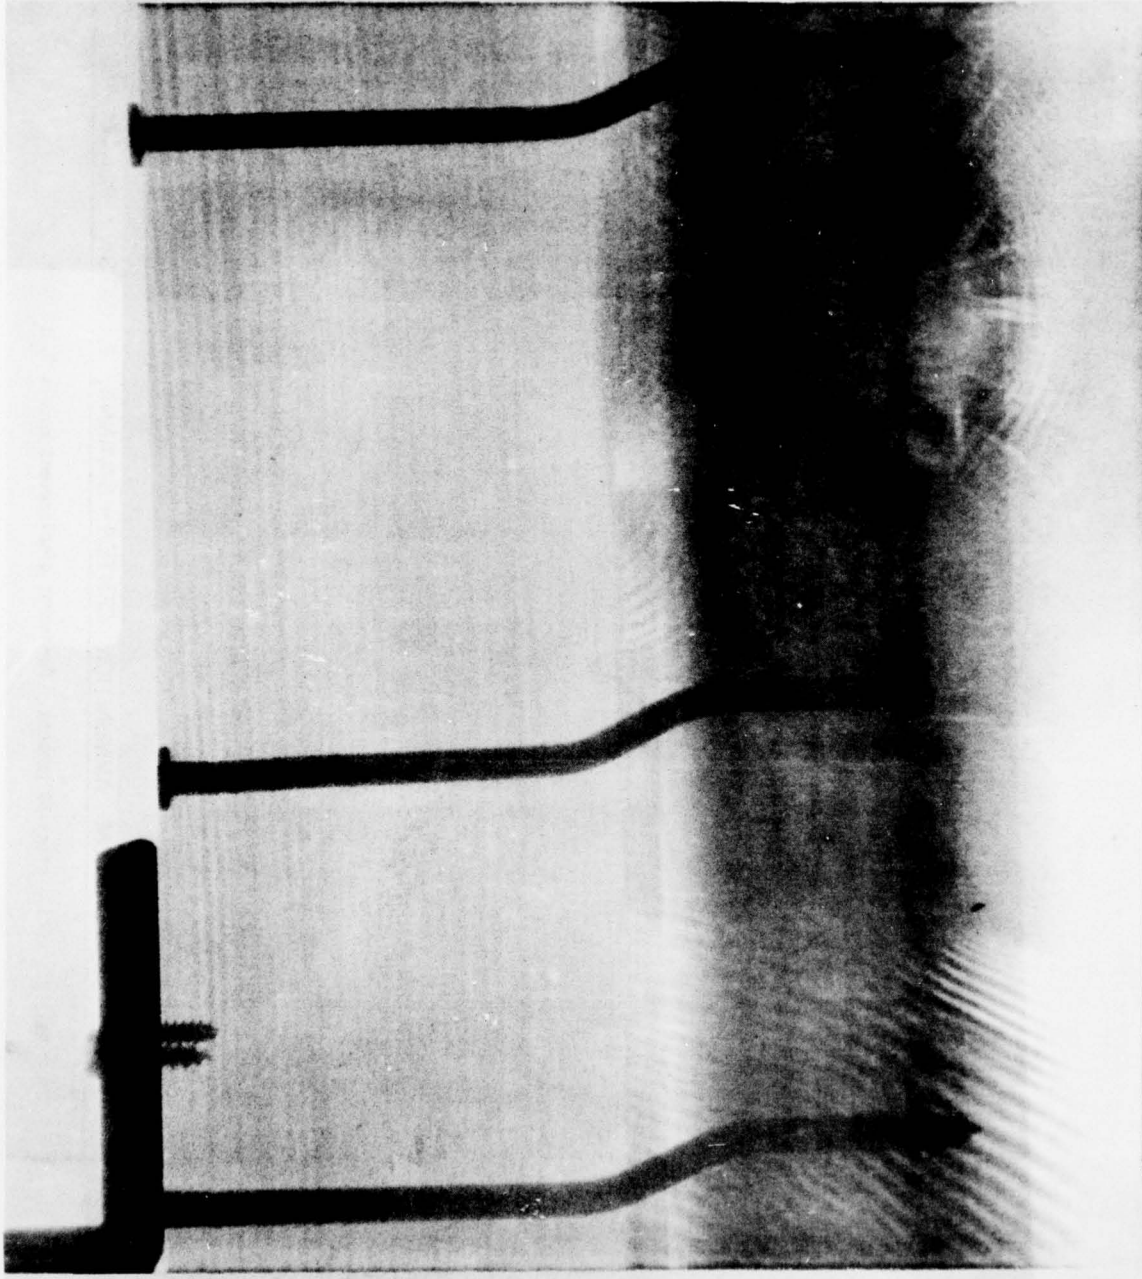
Figure 2	DARCOM AMMUNITION CENTER - SAVANNAH, ILLINOIS	November 1976
Nail distortion after 41 impacts. Permanent displacement equals 0.467 inch.

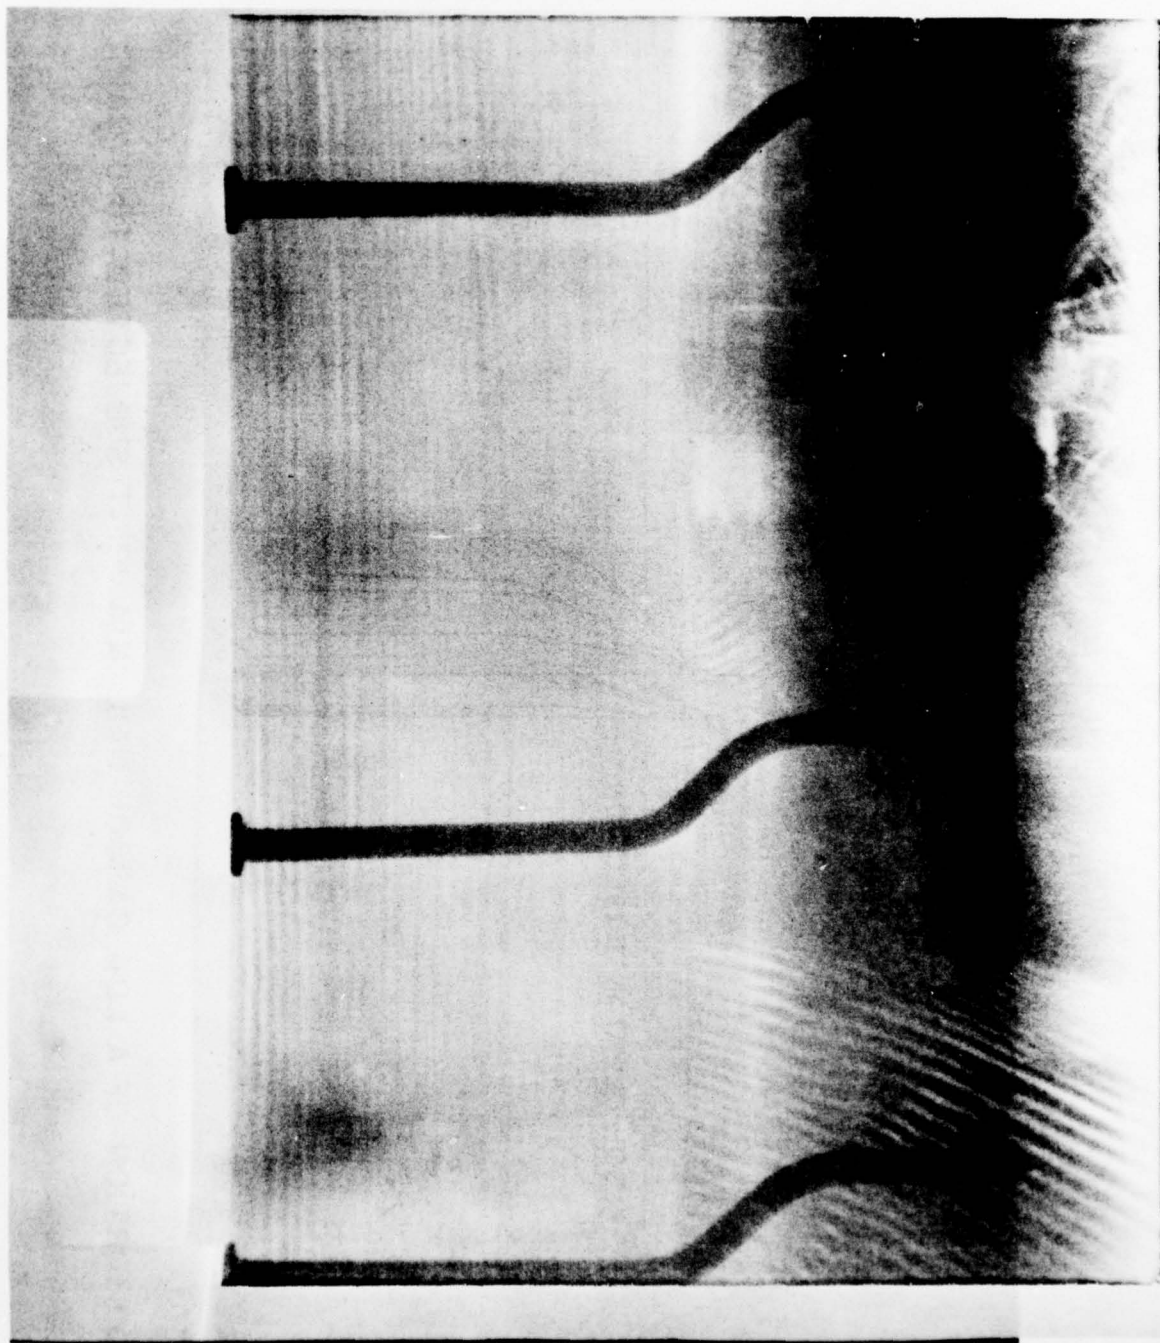
Figure 10 DARCUM AMMUNITION CENTER - SAVANNA, ILLINOIS November 1976

Nail distortion after 45 impacts. Permanent displacement equals 0.841 inch.

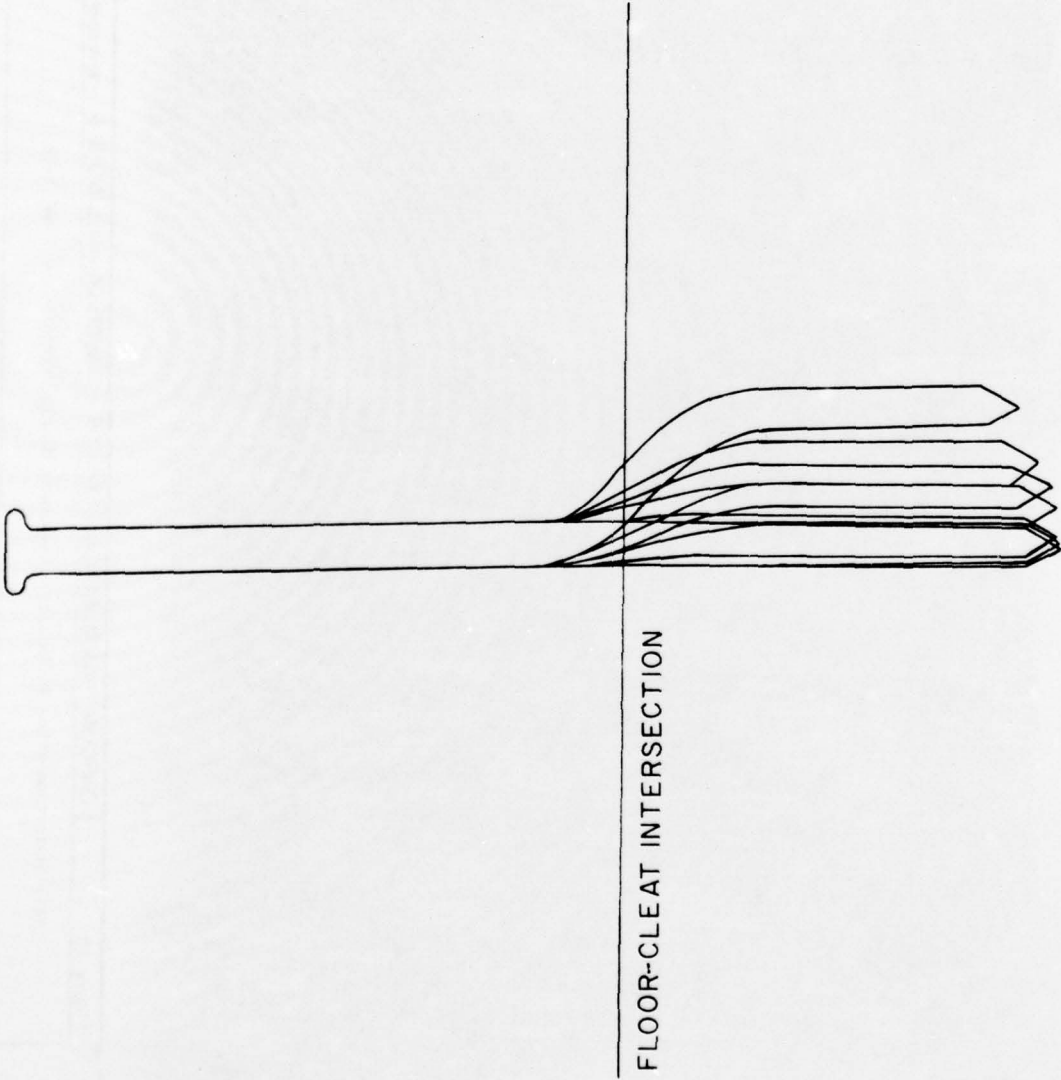
FIGURE II. DISTORTION OF A LOW CARBON NAIL IN A JOINT SUBJECTED TO DYNAMIC FORCES

the test the top board or cleat moved and not the floor as indicated in this Figure. However this arrangement has the advantage of showing the nail distortion and change in depth of penetration with the increase in permanent displacement.

By superimposing the seven X-Rays and maintaining the position of the nail head, the results are as shown in Figure 11. Note that during
