TECHNICAL REPORT ARCSL-TR-77022  
(EP-TR-77028)

**NONDESTRUCTIVE TESTING OF STRUCTURAL DEFICIENCIES  
IN PROTECTIVE FILTERS**

Ponce D. Dixon

May 1977

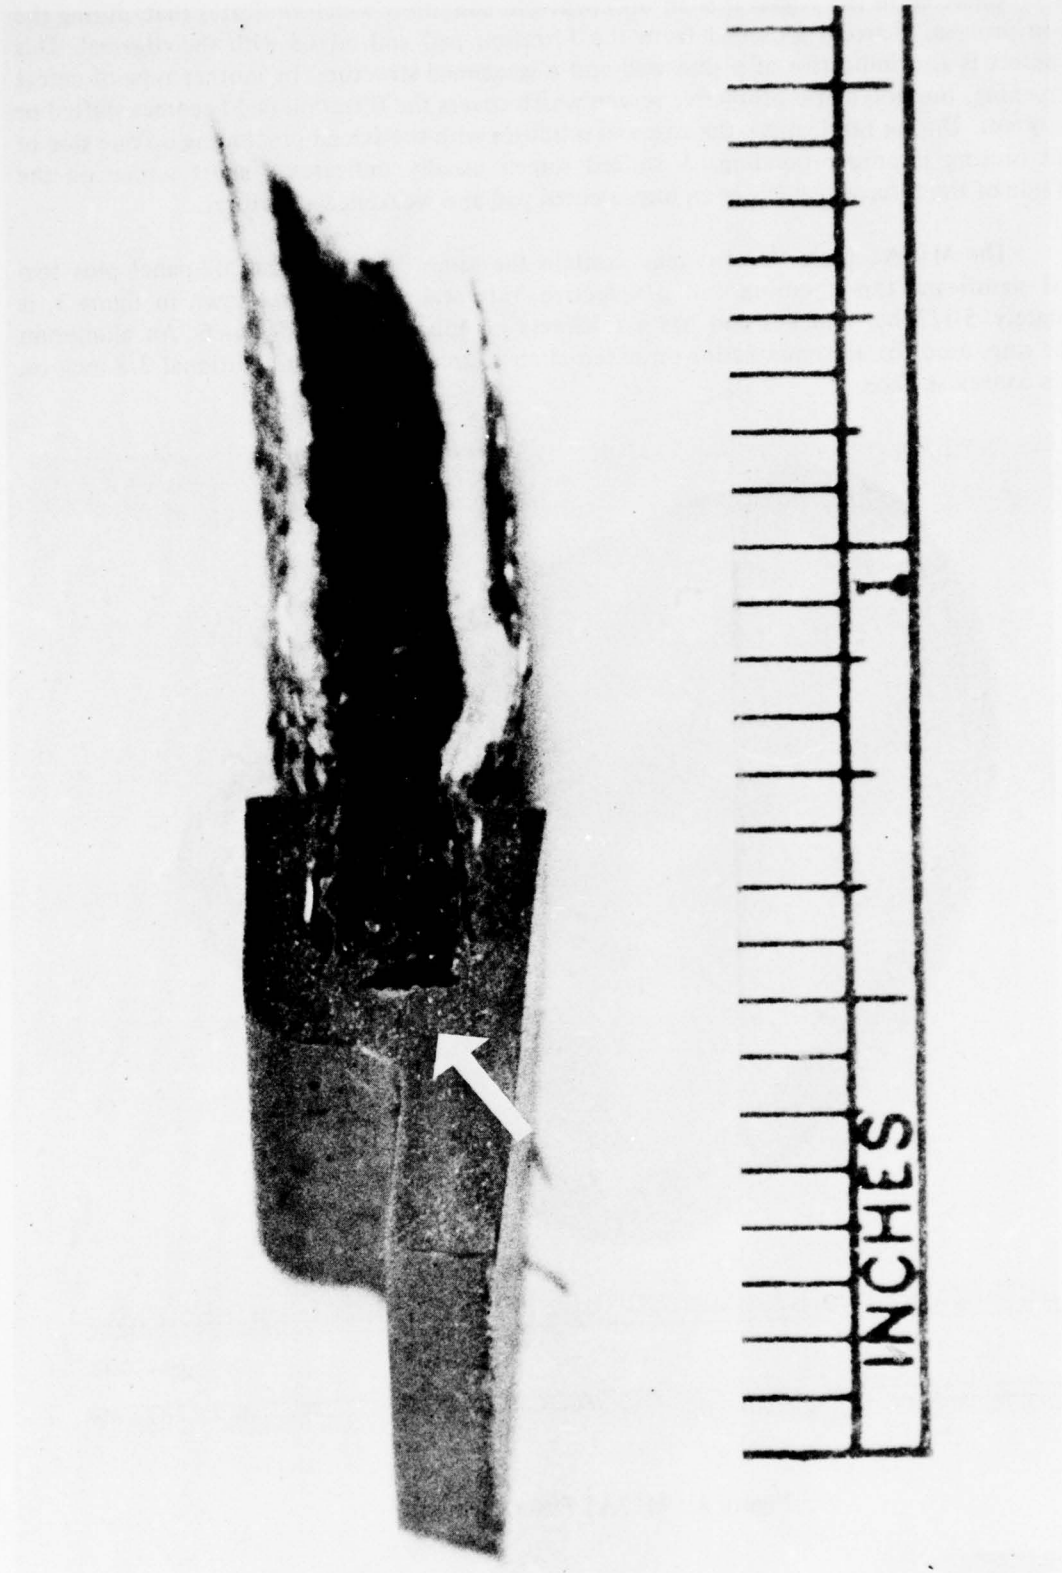
Figure 2. Section of M2 Filter Panel Showing Open Channel Void

Nearly all of the defects in the filter panel occur in the edgeseal area where charcoal-impregnated pads are bound by a plasticized compound called edgeseal which solidifies under heat and pressure to form a rigid border. Figure 2 shows a cutaway view of the M2 panel.

Voids, comprised of cracks, porosity, blisters, and open channels are the most frequently occurring defects in this filter. They may significantly weaken the filter's structure as well as present an incipient path bypassing the neutralizing element of the filter. Figure 2 shows an open-channel-type void in the edgeseal. Voids comprise one of the more serious, subtle defects and they cannot usually be detected by visual inspection. In some cases, wherein voids extend close to the surface, they can be detected visually by flexing the edgeseal while watching for bubble-like appearances.

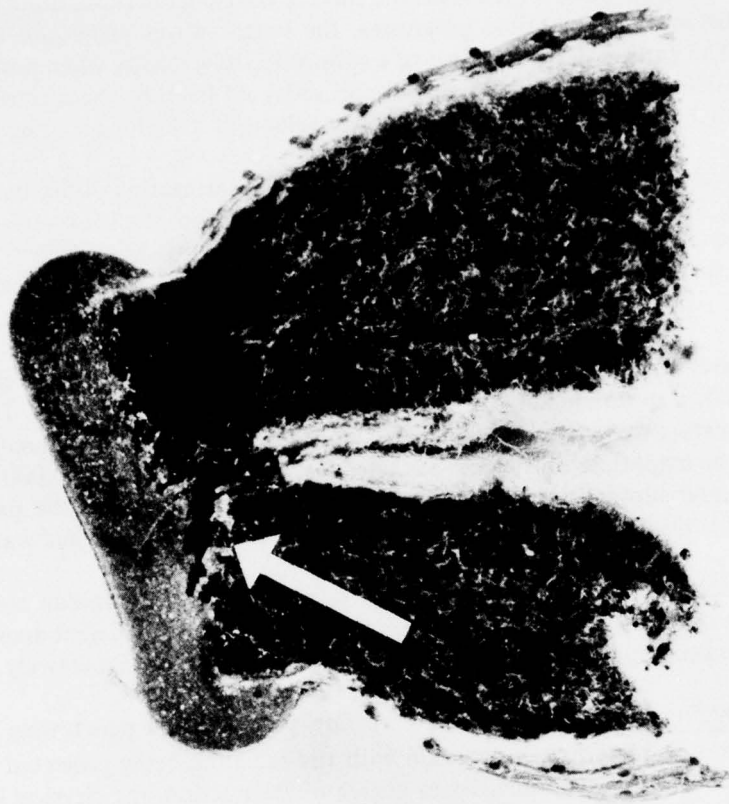
Figure 5. Defective Butt Seal

The defective butt seal can originate from a variety of causes such as a shifted pad, improper mold temperature, dirty or dusty padding. This defect causes a weakened structure in the edgeseal area and often results in a thin wall, a void, or a separation of the filtration pads. Unless severe, a defective butt seal cannot be detected visually without sectionalizing the filter. Figure 5 shows a defective butt seal.

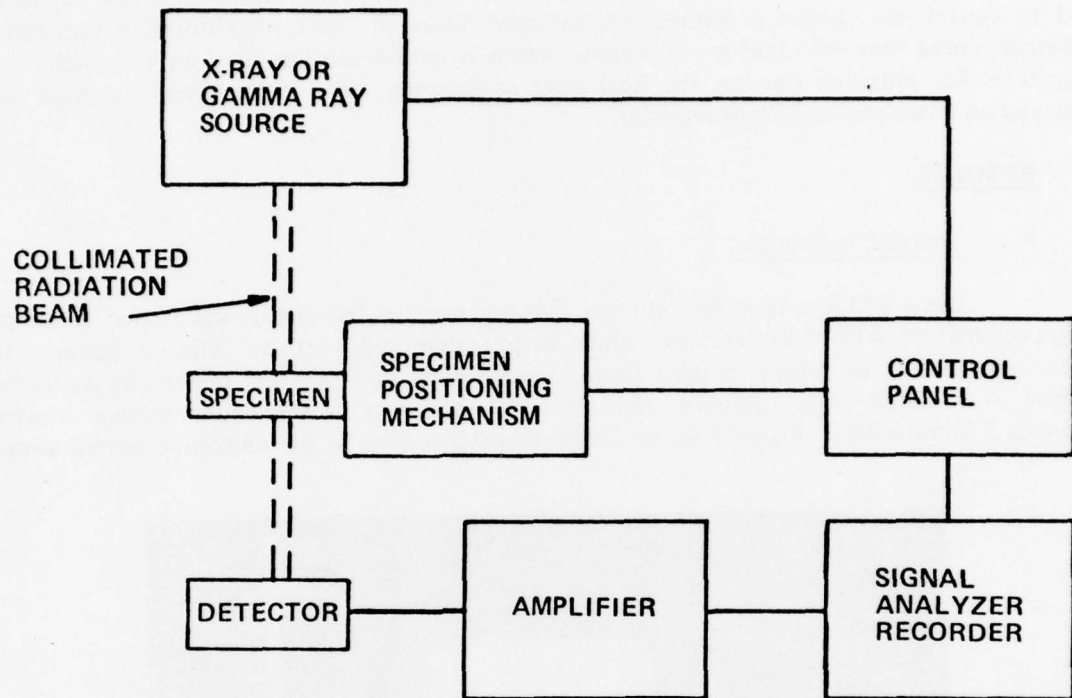
Figure 6. Block Diagram of Radiation Gauging System

3. Radiation Gauging. This NDT technique involves real-time monitoring of the attenuated radiation as affected by flaws in the beam's path. Basic components of the gauging system consist of a radiation source, a detector, and a readout device or signal analyzer as shown in figure 6.

In order to attain optimum sensitivity in gauging, the type and energy of radiation must be selected to match the mass attenuation coefficient of the edgeseal material. The applied cathode potential best suited for inspecting approximately 1/3 inch of edgeseal, as found in the M2 protective panel, is approximately 50 to 70 kv. At this potential, most of the radiation in the beam has an energy range of approximately 20 to 35 kv.

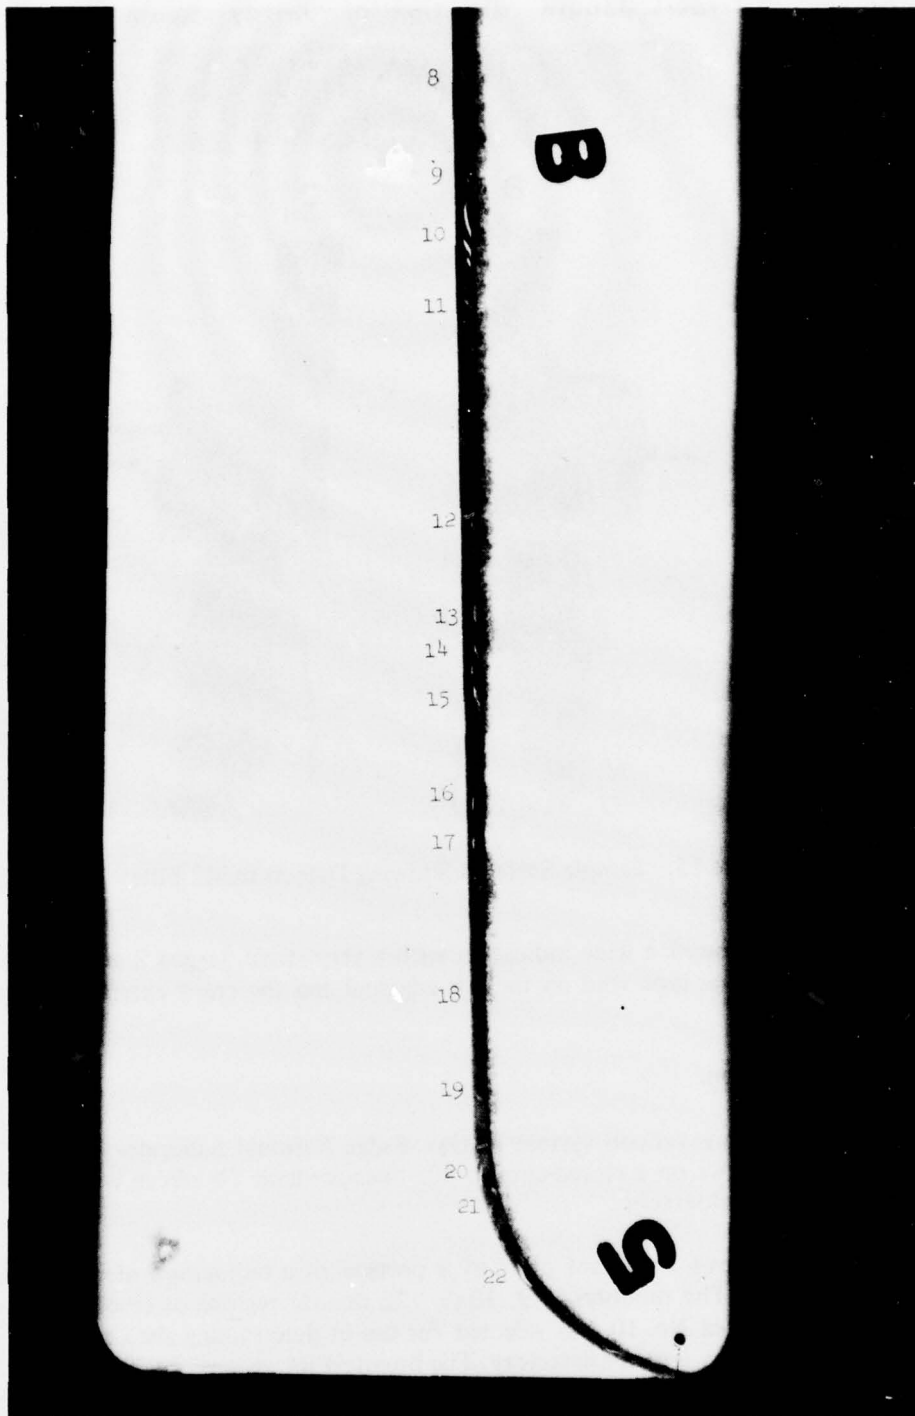
Figure 16. Radiograph of Edgesal with Numerous Voids

Figure 16 shows a contact print of a portion of a radiograph of an infant protector filter selected for study. The numbers 8, 9, 10 . . . 22 denote regions of cracking or voids (light areas) in the edgeseal. Area No. 10 was selected for use in determining the optimum conditions. X-ray energies below 120 kv are unsatisfactory. The brightest image was obtained at 140 kv, 30 ma, with the filter located 5-1/2 inch from the X-ray target; however, geometric unsharpness was rather severe. Better resolution, although the image was not as bright, was obtained using the same X-ray energy and current but increasing the filter-to-X-ray target distance to 10 inches. There is a left-to-right reversal of the monitor screen photos as compared to the contact print. This is because conventional viewing of a radiograph is from the X-ray source side while, with the X-ray sensitive vidicon, viewing is from the detector side of the sample.

Figure 17 shows two different selected regions (No. 10 and No. 20, respectively) of the filter, as imaged on the monitor screen, using the established optimum conditions of X-ray energy, current distances, and system gain. The white spots seen on the photos are caused by defects in the selenium target of the X-ray sensitive vidicon and would be nonexistent in a new vidicon. The 15 regions denoted in figure 16 were visible on the monitor screen in the static mode.

Dynamic tests were conducted to determine the maximum practical speed that the filter could be moved through the X-ray beam and still permit observation of the filter flaws on the monitor screen. The maximum speed was approximately 52 inches per minute. All 15 regions denoted in figure 16 were visible. In fact, the smaller regions (e.g., No. 18 and No. 20) were more easily seen in this dynamic mode than under in the static conditions.
