TECHNICAL REPORT H-77-22

BREAKWATER STABILITY STUDY IMPERIAL BEACH, CALIFORNIA

Hydraulic Model Investigation

U. S. Army Engineer Waterways Experiment Station
P. O. Box 631, Vicksburg, Miss. 39180

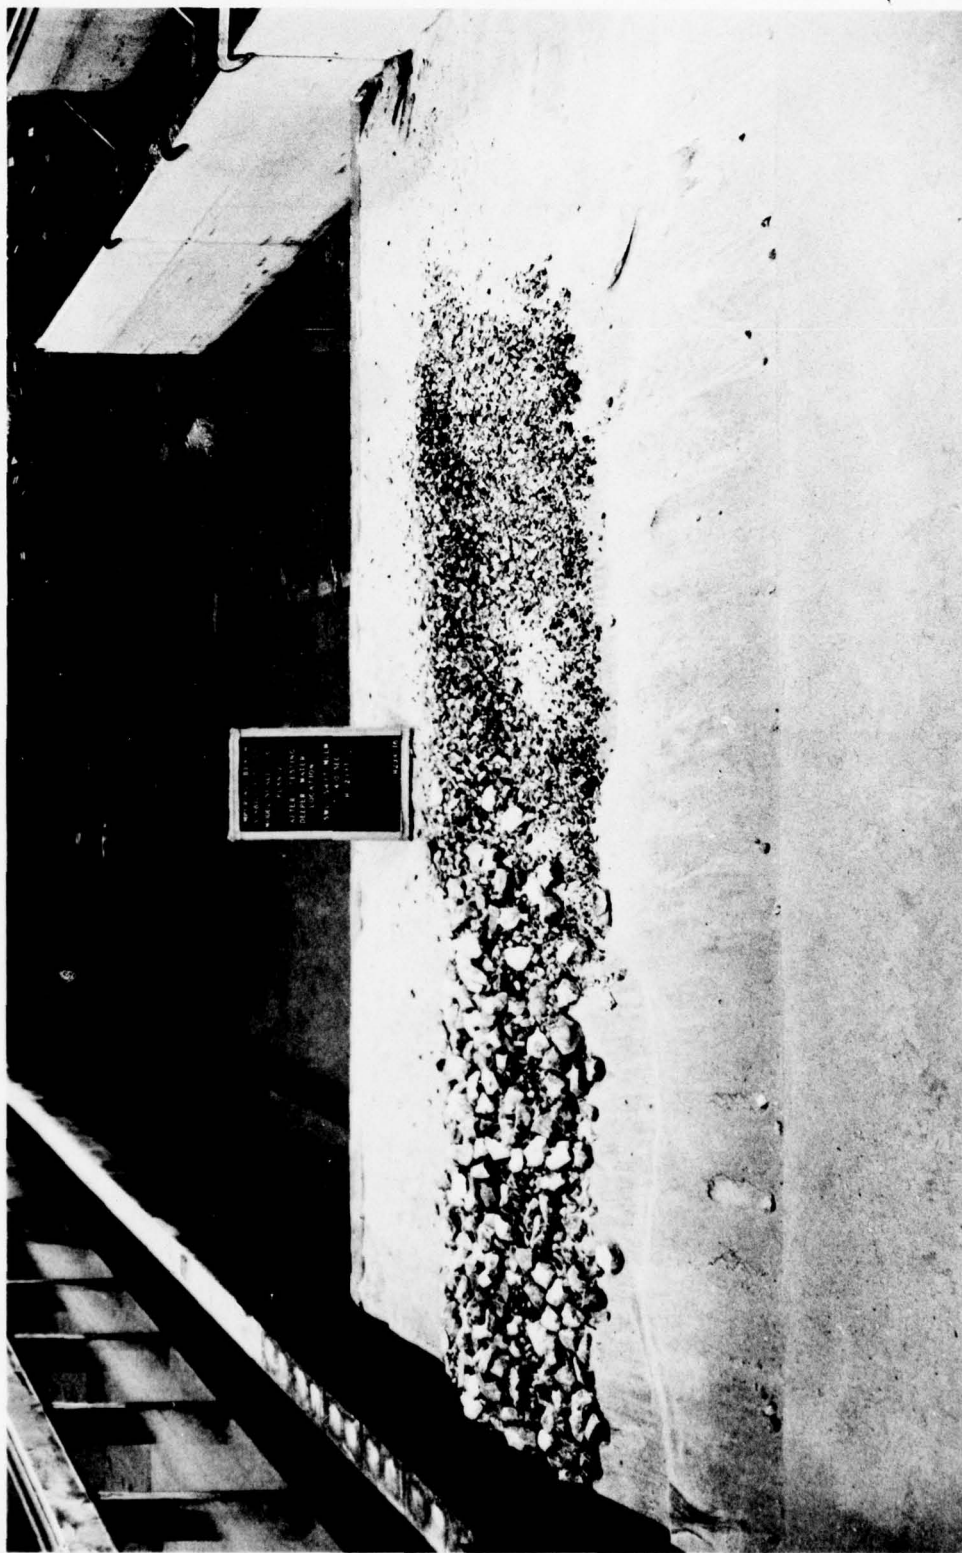
Photo 6. Sea-side view of Plan 2 in the deeper water location after 1.0 hr of 14.0-sec, 12.1-ft waves at an swl of +5.4 ft mllw

13. Plan 2 (Plate 2 and Photo 4) was similar to Plan 1 except a 2.0-ft-thick blanket of 25-lb filter material was added to the bottom of the structure. Crown elevations of +2.4 and -5.2 ft mllw were used for the deeper water location. Attack of 14.0-sec, 8.3-ft waves at an swl of 0.0 ft mllw for 1.5 hr produced moderate damage to both the low- and high-sill sections of the breakwater (Photo 5). Attack of 14.0-sec, 12.1-ft waves at an swl of +5.4 ft mllw for 1.0 hr produced extensive damage to all portions of the breakwater (Photo 6).

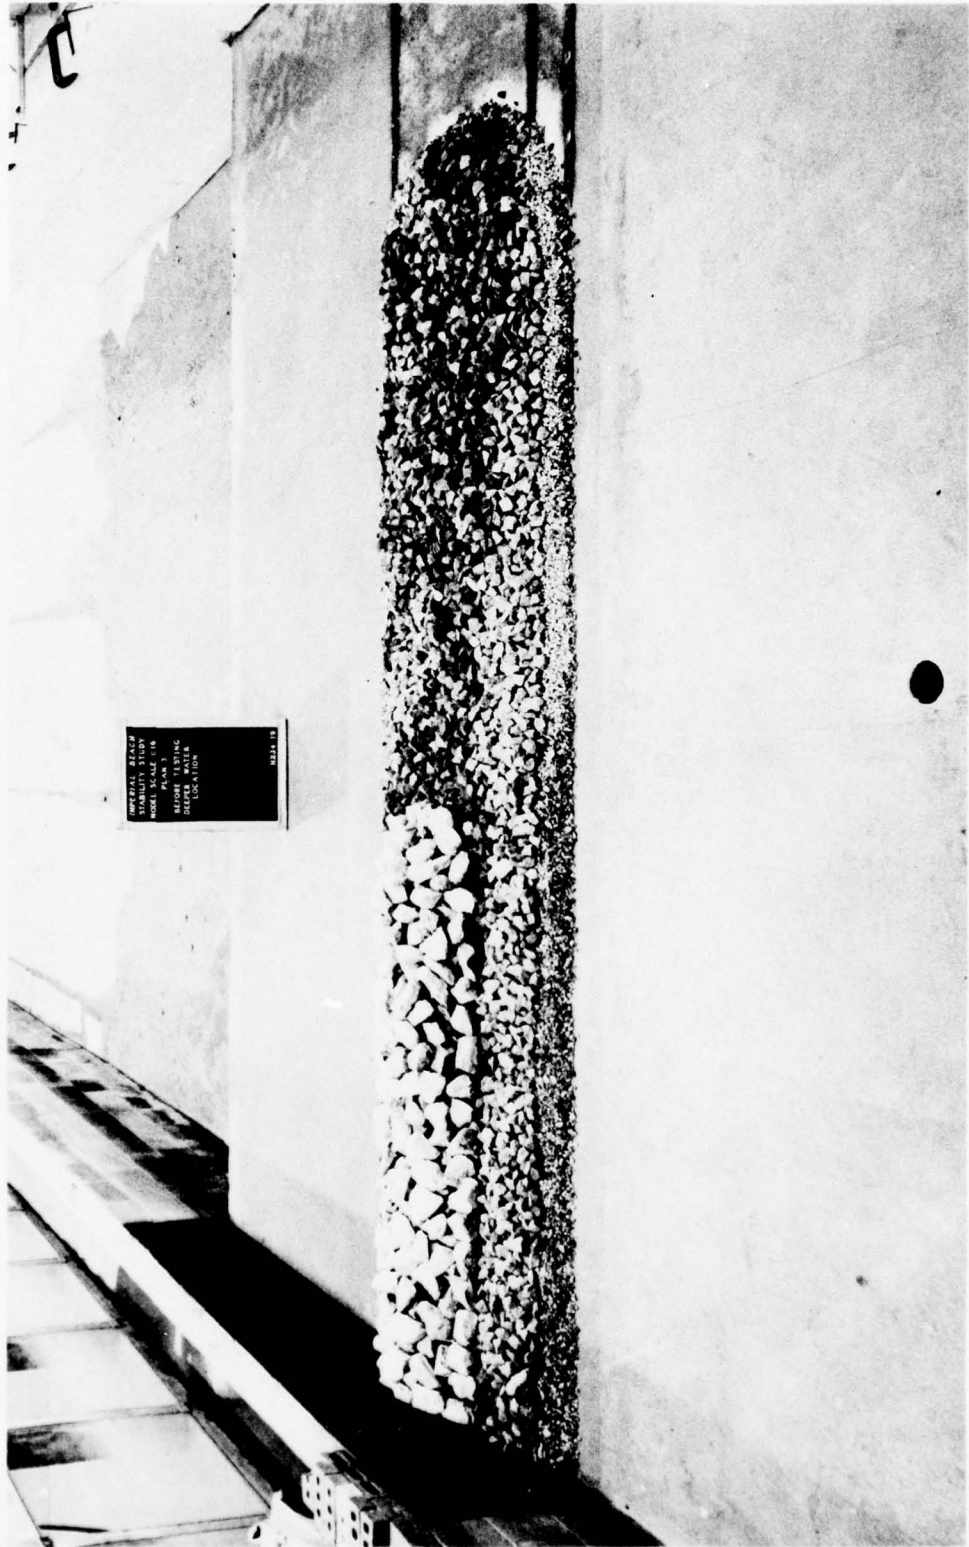
Photo 7. Sea-side view of Plan 3 before wave attack

14. Plan 3 (Plate 3 and Photo 7) used 5.0-ton stone on the high sill and 0.5-ton stone on the low sill and was tested in both the deeper water and shallow-water locations. Armor slopes of 1V on 1.5H were used both sea side and beach side. The high-sill section of the structure was constructed to a crown elevation of +5.2 ft mllw in the deeper water location (equivalent to +10.2 ft mllw in the shallow-water location). The low-sill section of the structure was constructed to a crown

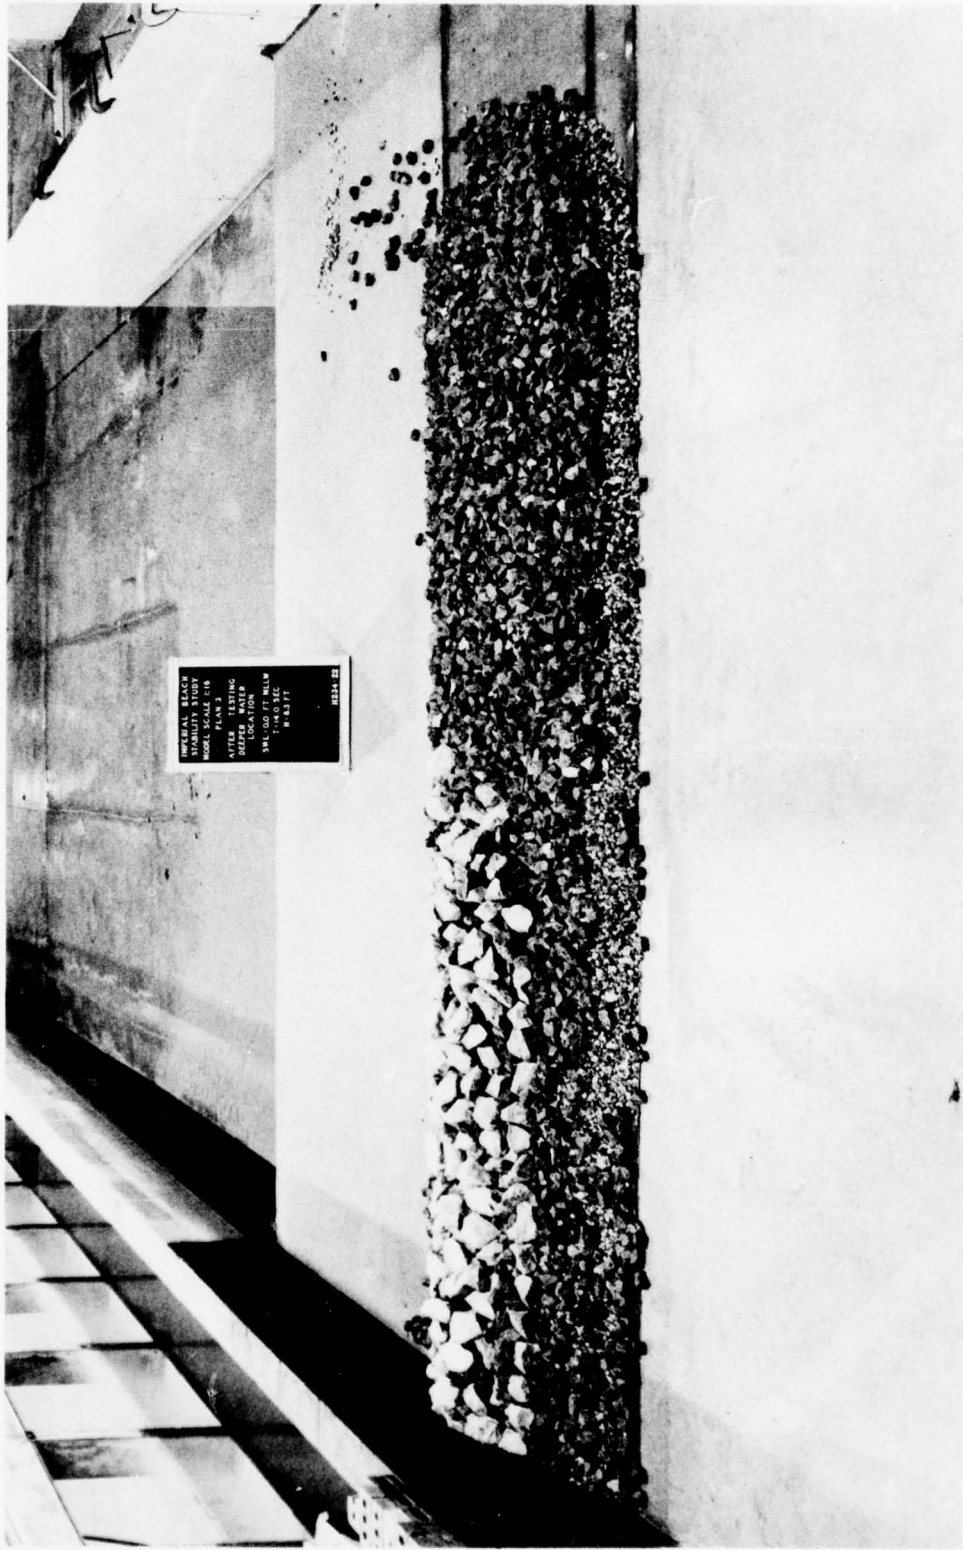
Photo 8. Sea-side view of Plan 3 in the deeper water location after 2.0 hr of 14.0-sec, 8.3-ft waves at an swl of 0.0 ft mllw

elevation of -3.8 ft mllw in the deeper water location (equivalent to +1.2 ft mllw in the shallow-water location). Testing in the deeper water location with 14.0-sec, 8.3-ft waves at an swl of 0.0 ft mllw for 2.0 hr produced only minor damage (Photo 8); however, 2.0 hr of attack by 14.0-sec, 12.1-ft waves at an swl of +5.4 ft mllw produced extensive damage (Photo 9). The breakwater was rebuilt in the shallow-water location and 2.0 hr of 14.0-sec, 4.5-ft waves at an swl of 0.0 ft mllw and 2.0 hr of 14.0-sec, 8.5-ft waves at an swl of -5.4 ft mllw produced only minor damage (Photos 10-13).

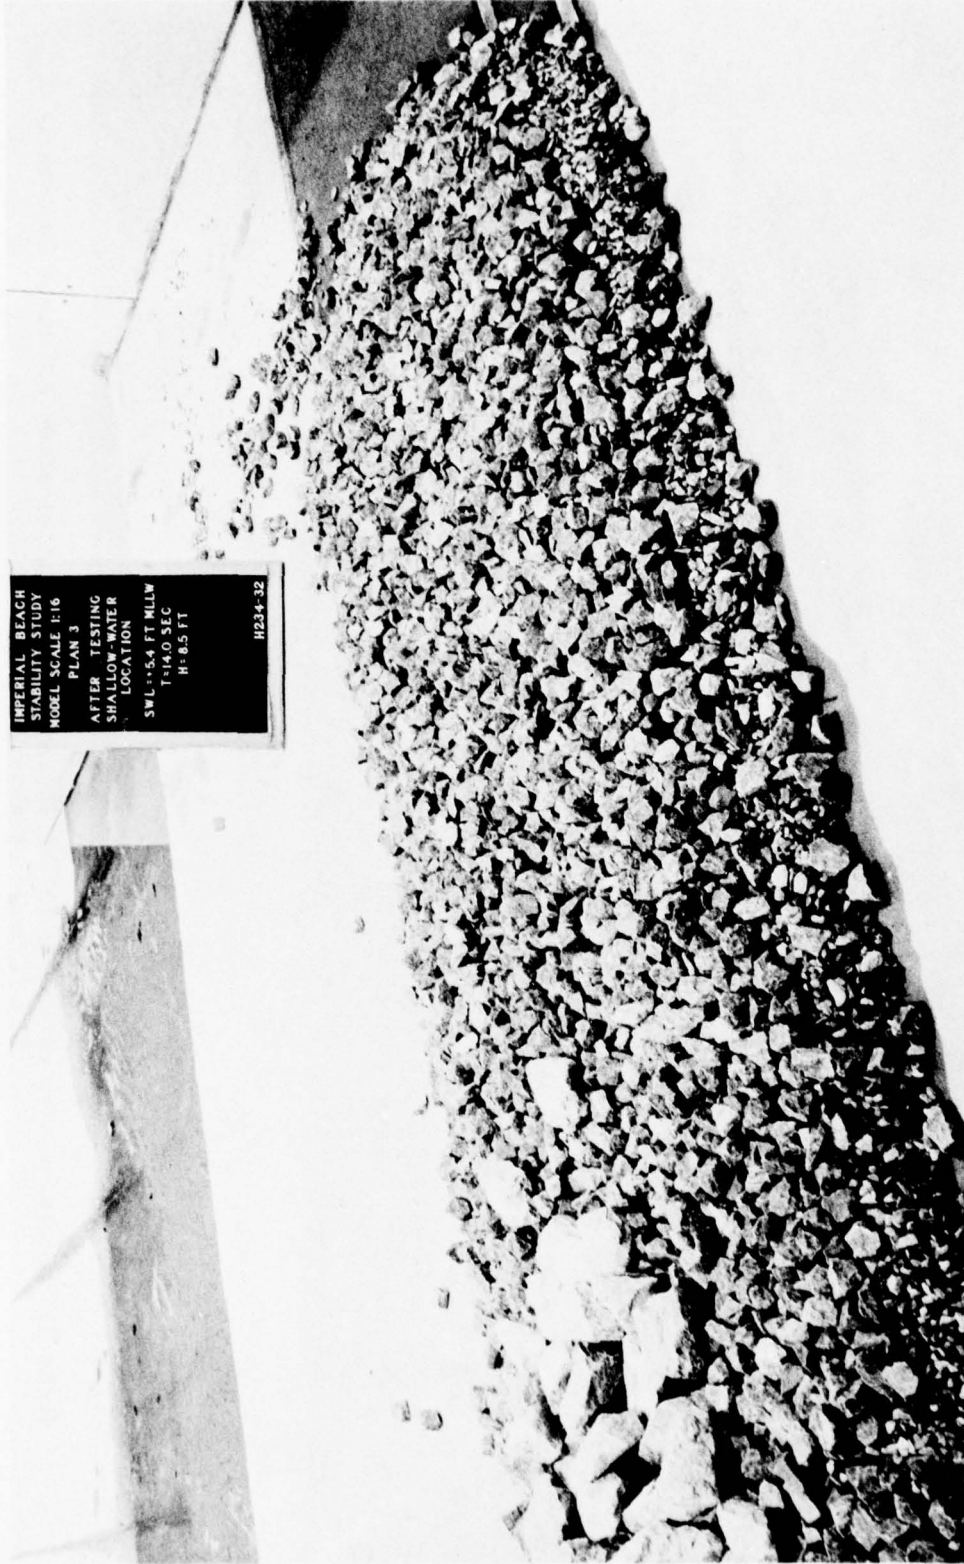
IMPERIAL BEACH
STABILITY STUDY
MODEL SCALE 1:16
PLAN 3
AFTER TESTING
SHALLOW-WATER
LOCATION
SWL - 1.54 FT MLLW
T - 14.0 SEC
H - 8.5 FT
H234-32

Photo 12. Sea-side view of low-sill section of Plan 3 in the shallow-water location after 2.0 hr of 14.0-sec, 8.5-ft waves at an swl of +5.4 ft mllw

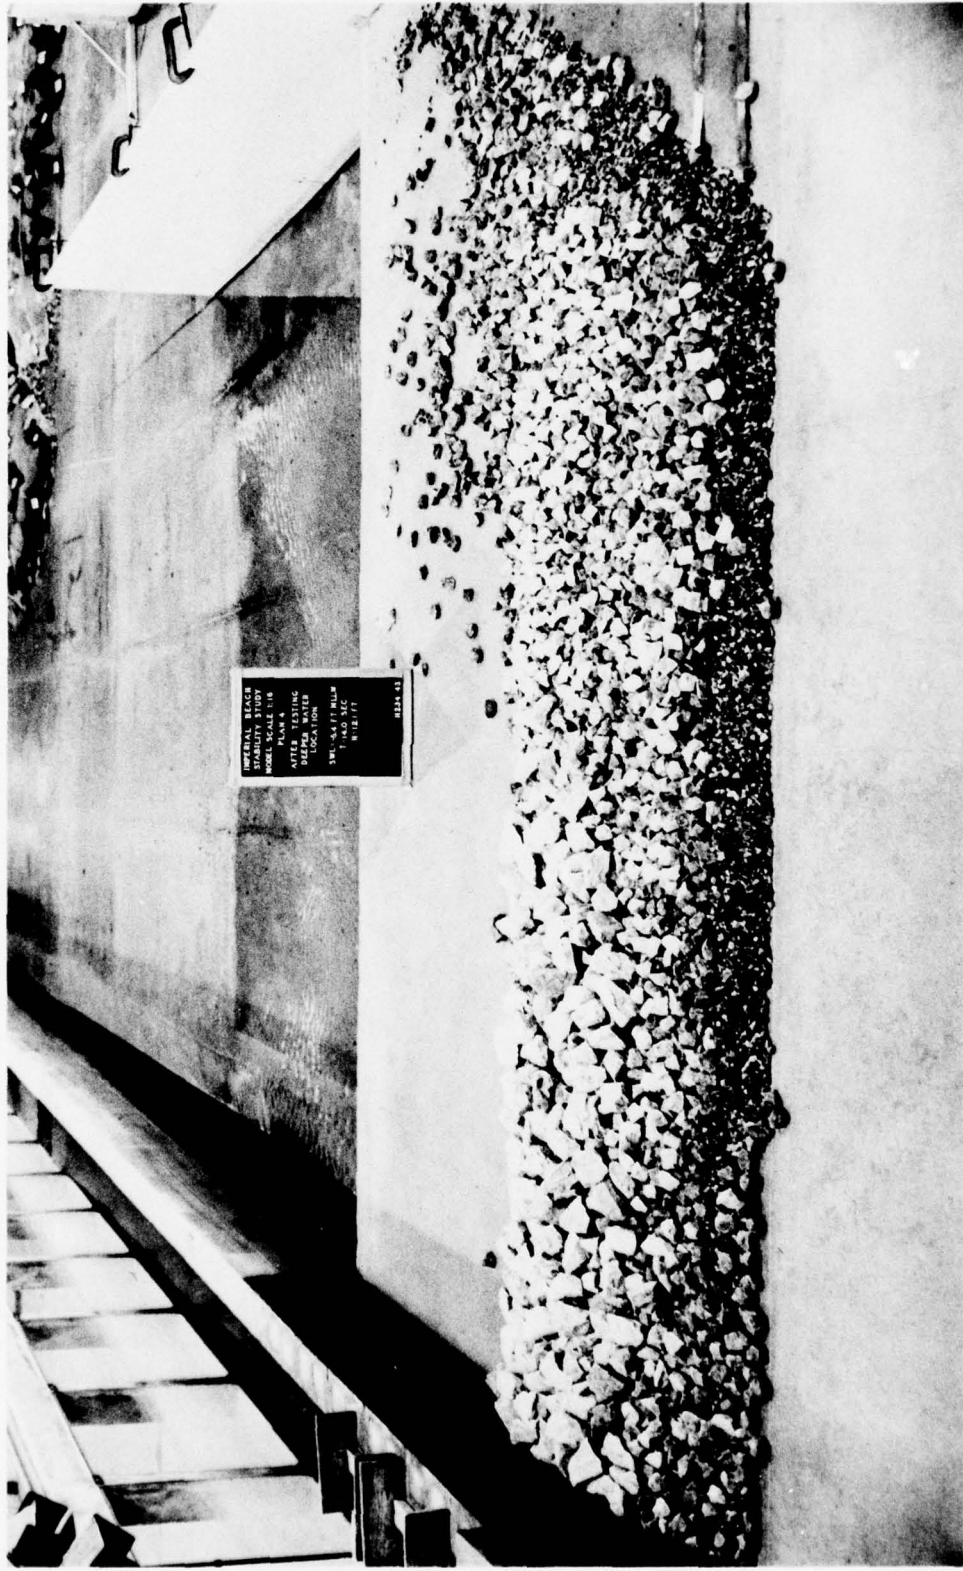
Photo 16. Sea-side view of Plan 4 in the deeper water location after 2.0 hr of 14.0-sec, 12.1-ft waves at an swl of +5.4 ft mllw

15. Plan 4 (Plate 4 and Photo 14) was constructed in the deeper water location to high- and low-sill elevations of +6.0 ft and -3.0 ft mllw, respectively. The high sill was armored with 5.0-ton stone and the low sill used 1750-lb stone. The 5.0-ton and 1750-lb stone were built to slopes of 1V on 2H and 1V on 1.5H, respectively. Attack of 14.0-sec, 8.3-ft waves at an swl of 0.0 ft mllw for 1.5 hr produced only minor damage (Photo 15); however, test conditions were changed to 14.0-sec, 12.1-ft waves at an swl of +5.4 ft mllw and 2.0 hr of wave attack produced extensive damage to both the low- and high-sill sections of the structure (Photo 16).

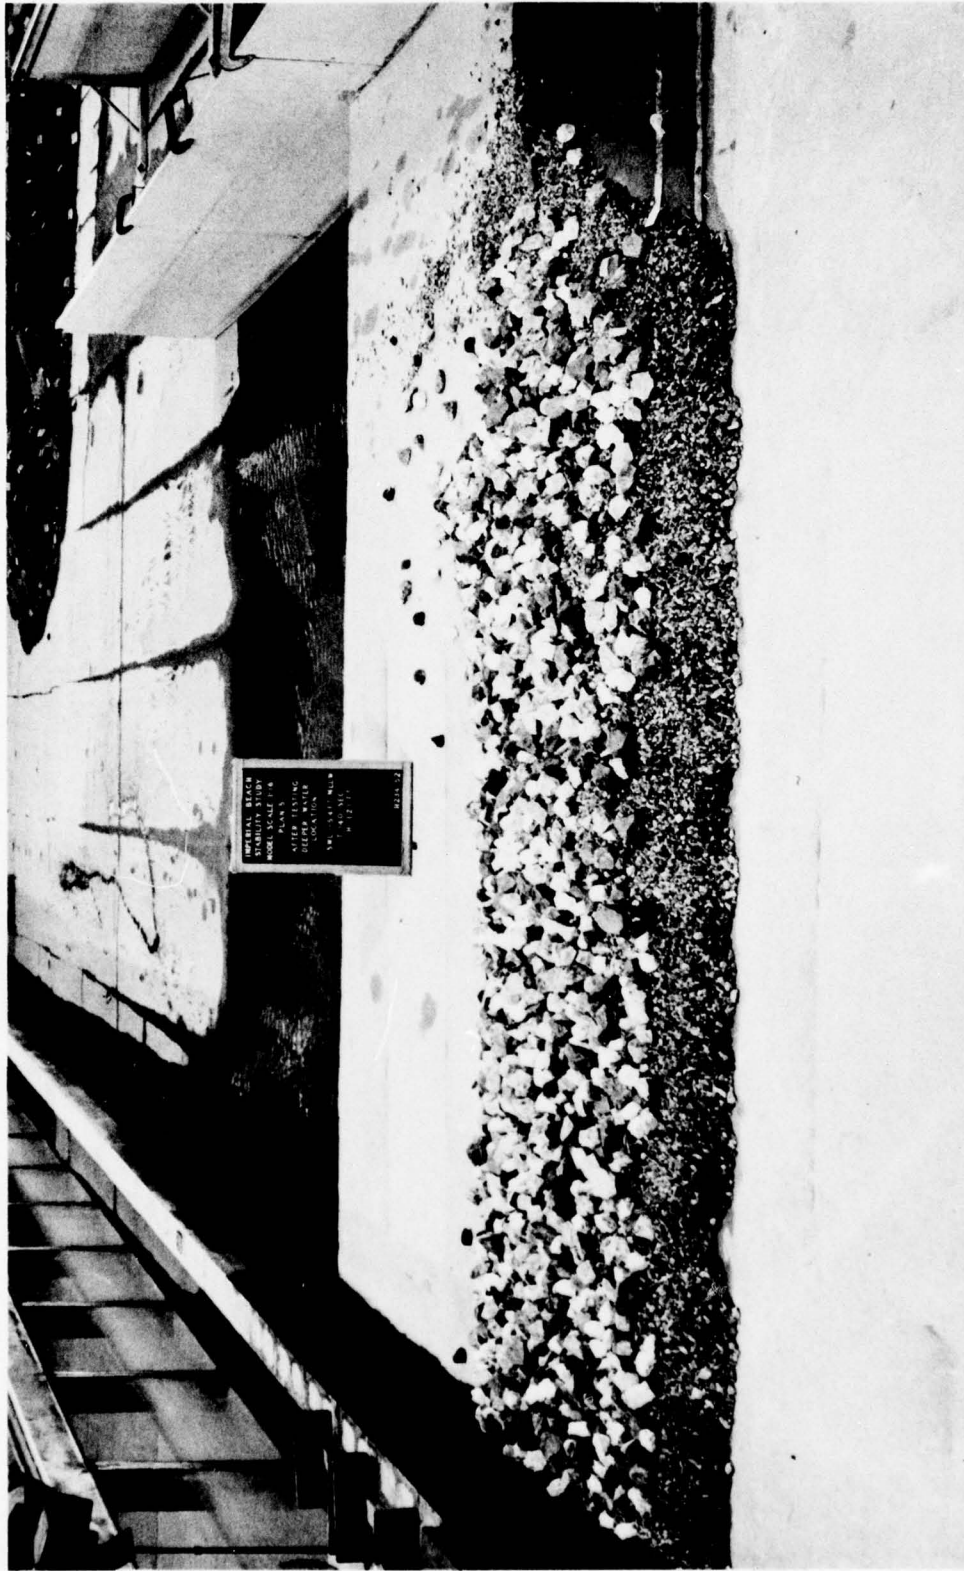
Photo 19. Sea-side view of Plan 5 in the deeper water location after 2.0 hr of 14.0-sec, 12.1-ft waves at an swl of +5.4 ft mllw

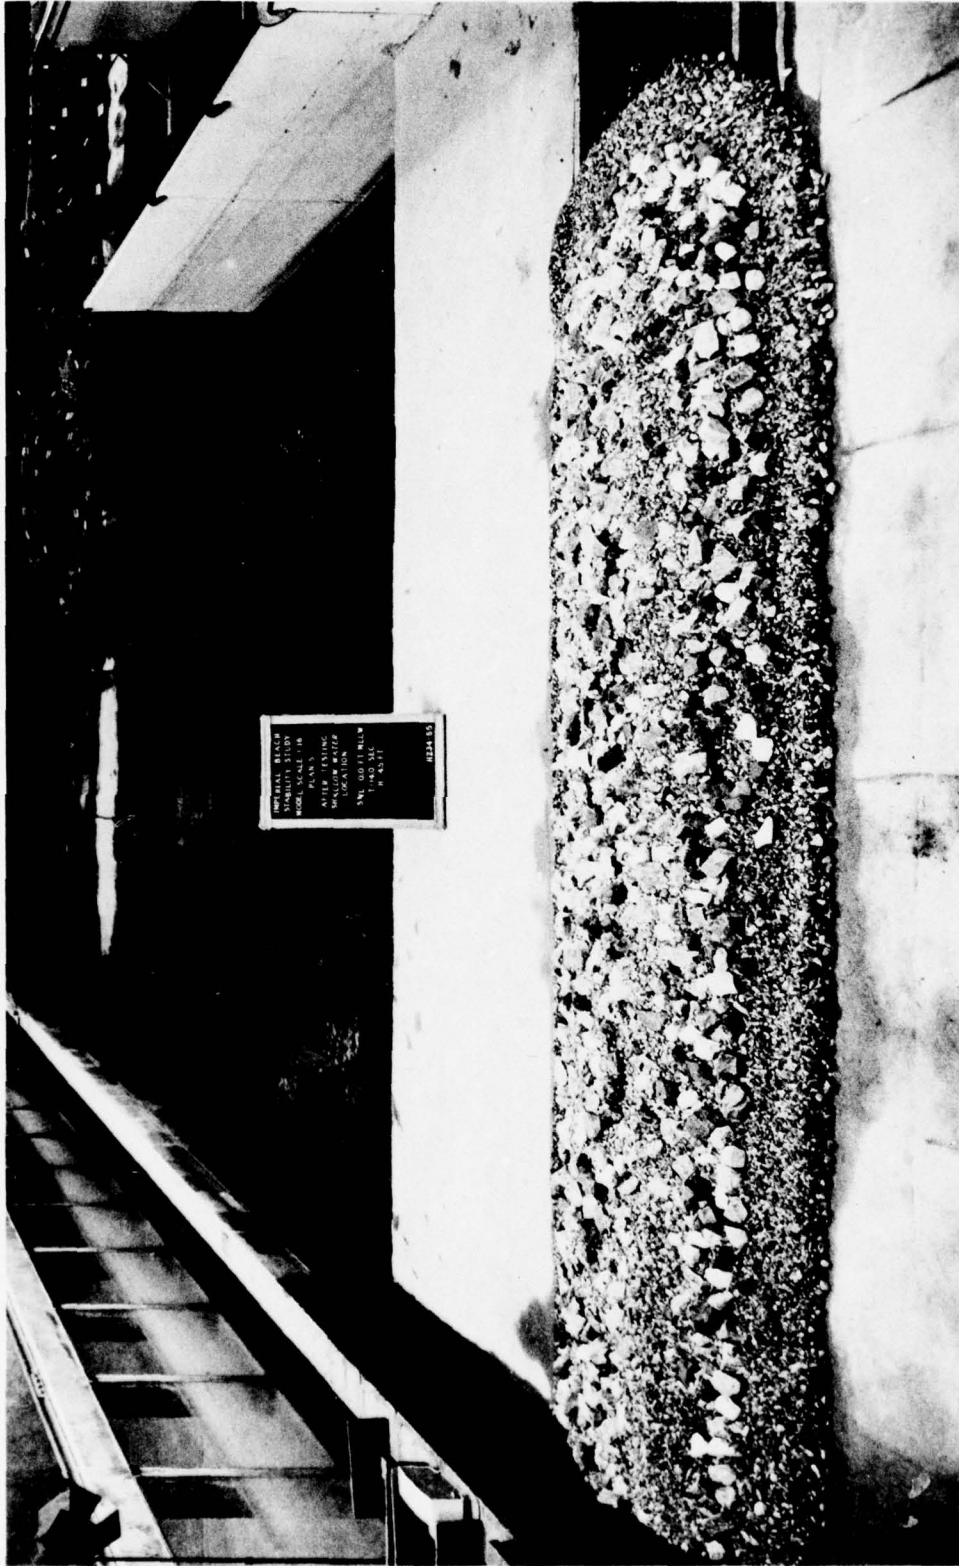
Photo 20. Sea-side view of Plan 5 in the shallow-water location after 1.5 hr of 14.0-sec, 4.5-ft waves at an swl of 0.0 ft mllw

0.0 ft mllw produced significant toe stone movement, but only minor damage to the primary armor mix (Photo 20). Wave attack was continued for 2.0 hr using 14.0-sec, 8.5-ft waves at an swl of +5.4 ft mllw and this resulted in minor to moderate damage to all sections of the breakwater (Photo 21).

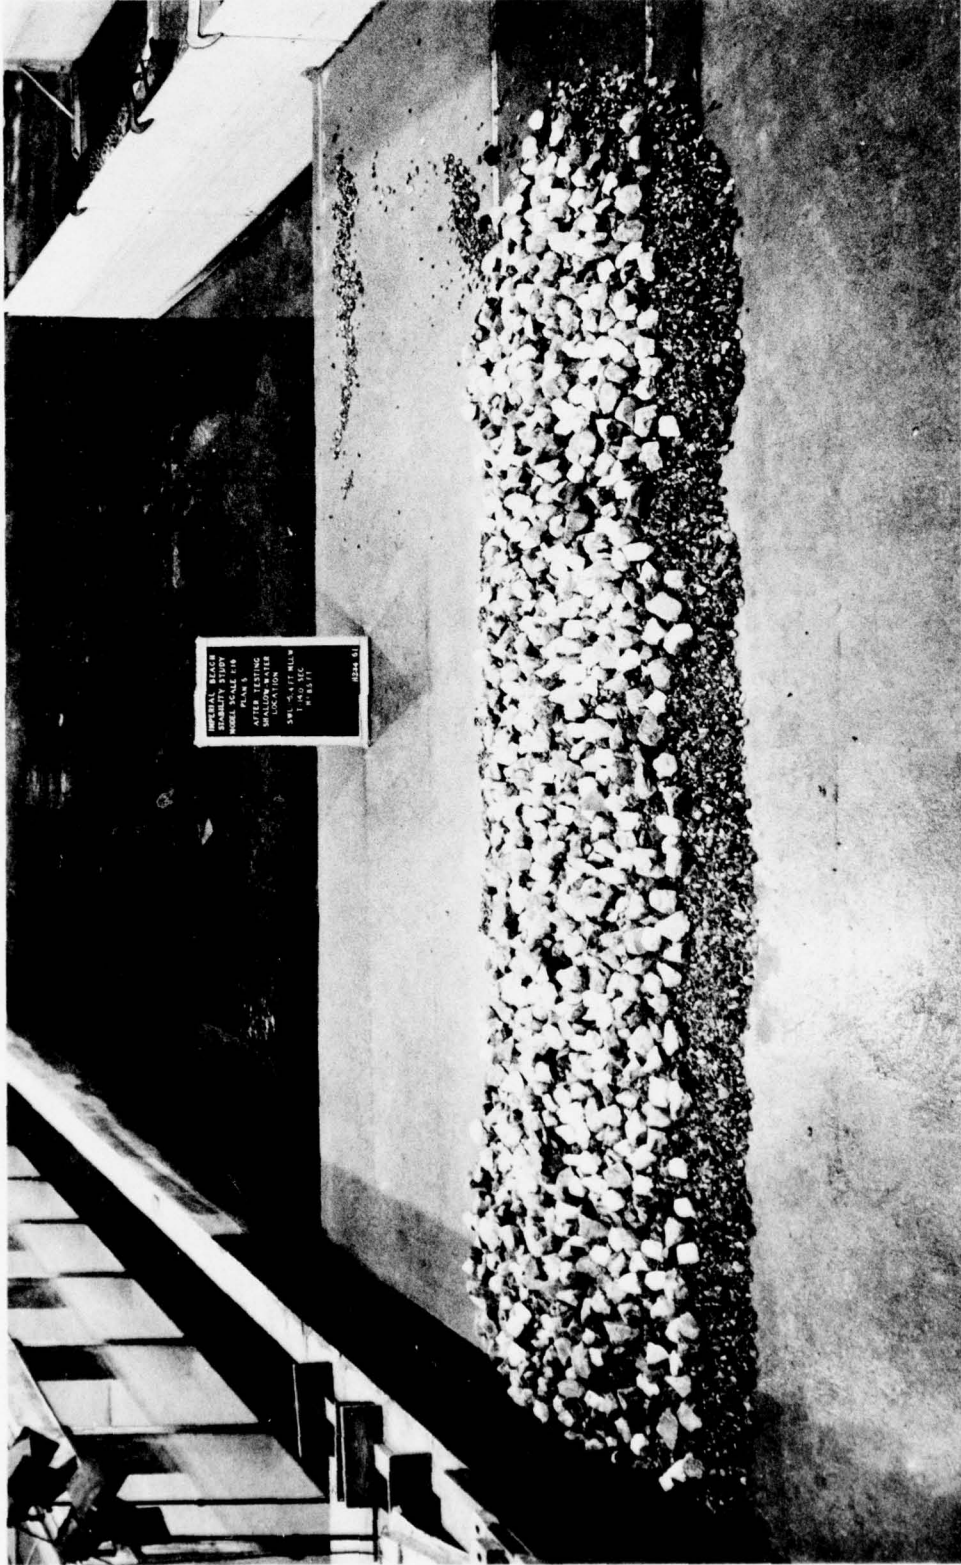
Photo 21. Sea-side view of Plan 5 in the shallow-water location after 2.0 hr of 14.0-sec, 8.5-ft waves at an swl of +5.4 ft mllw

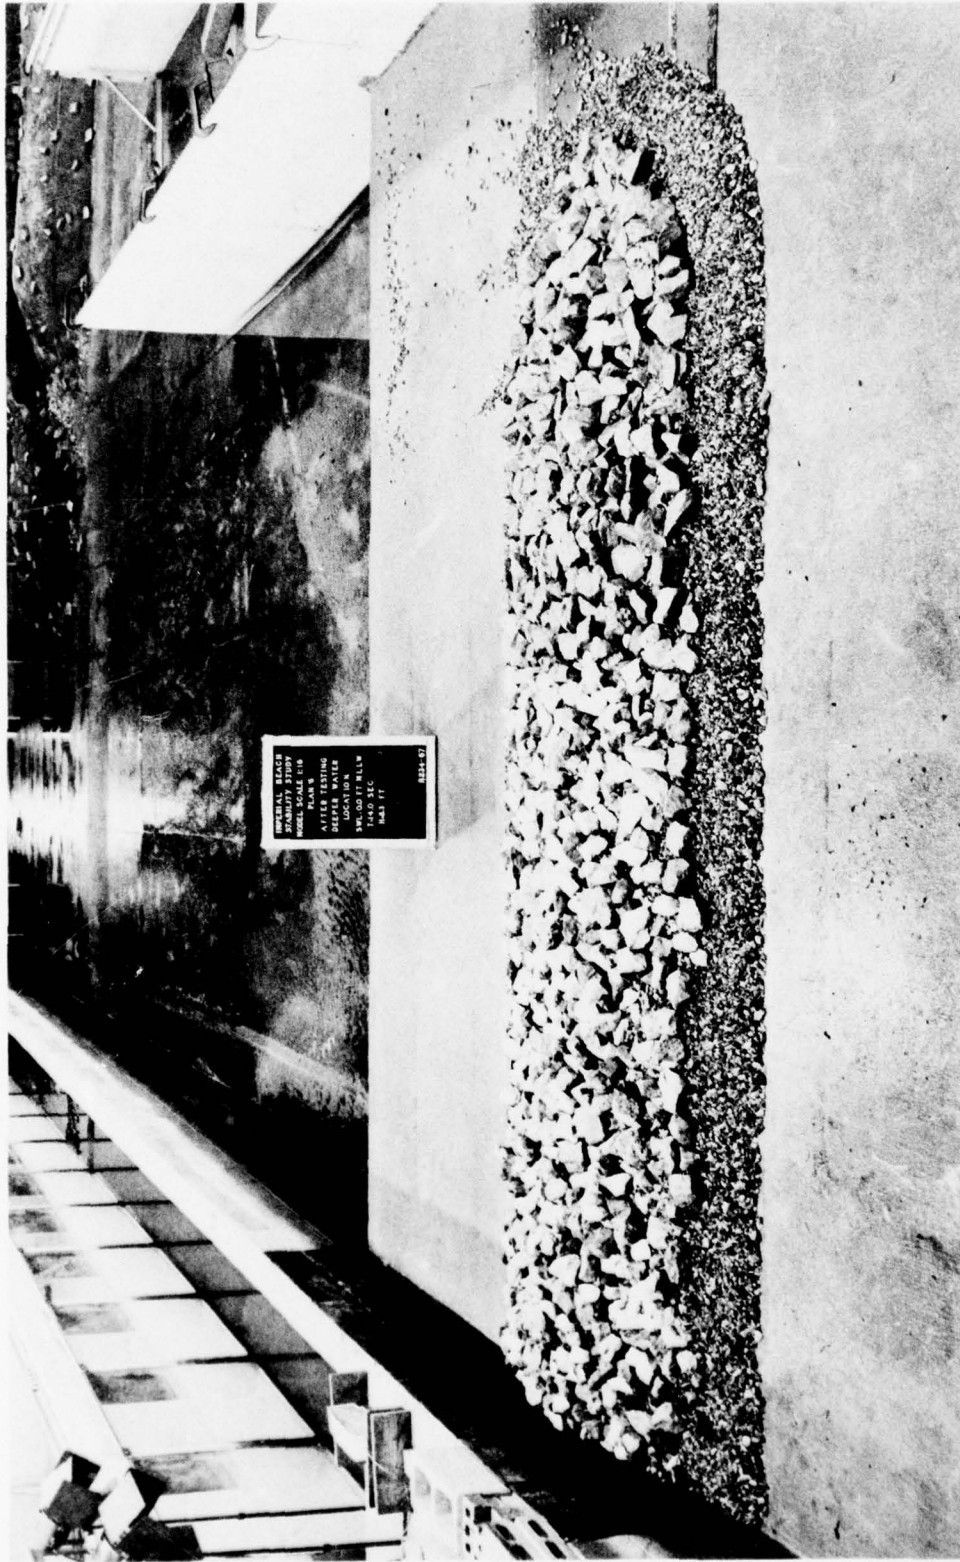
Photo 23. Sea-side view of Plan 6 in the deeper water location after 1.5 hr of 14.0-sec, 8.3-ft waves at an swl of 0.0 ft mllw

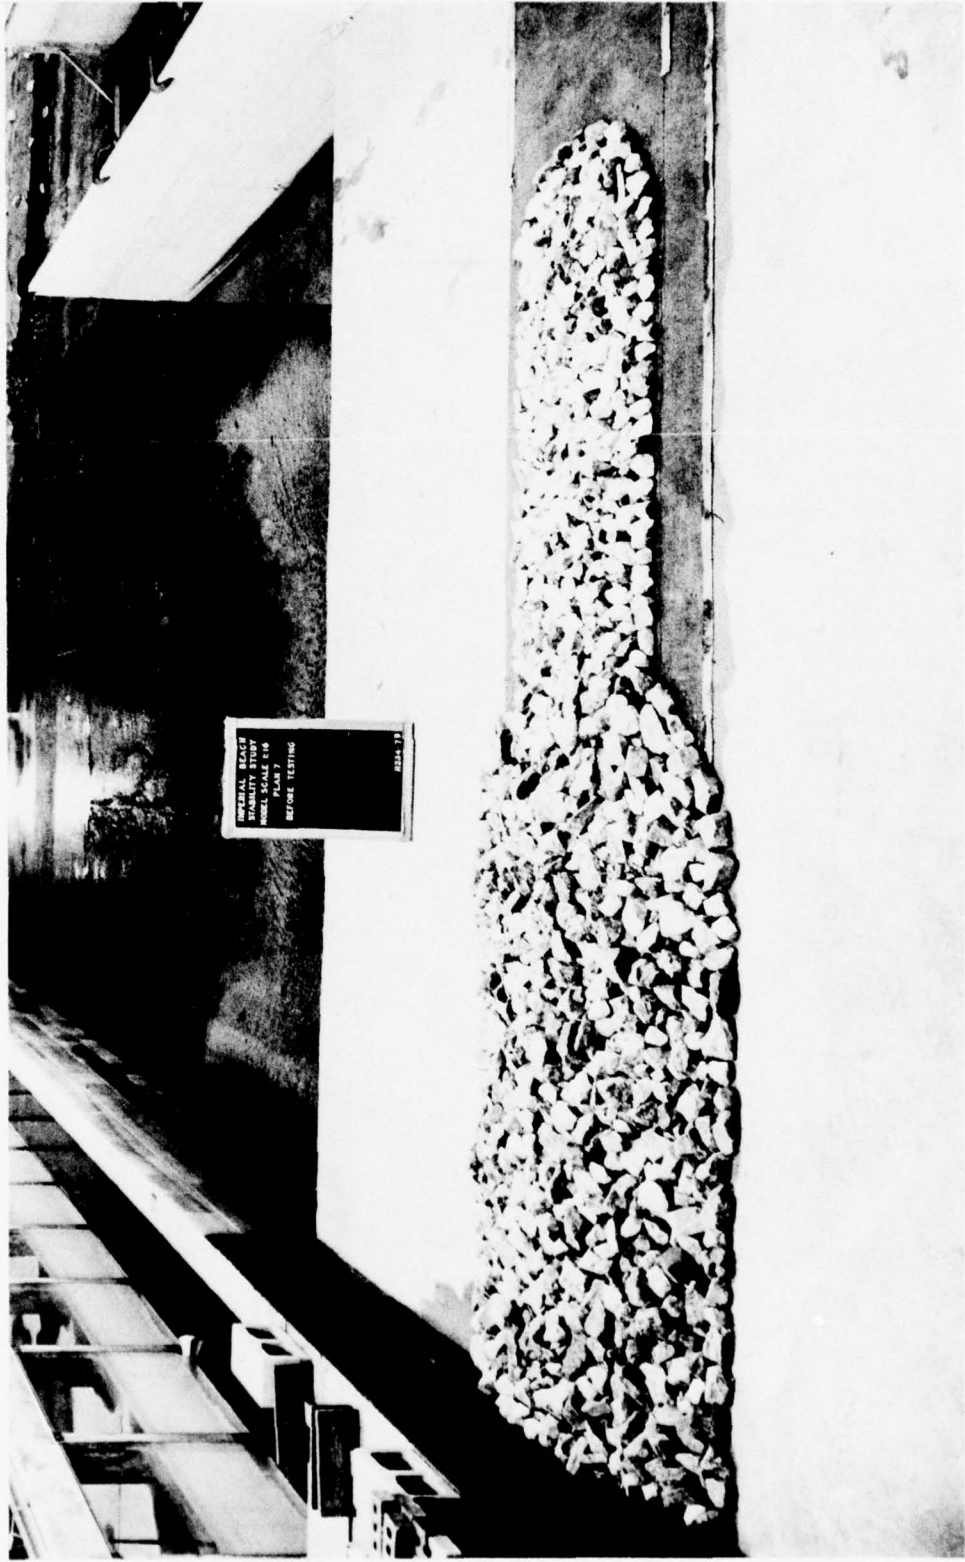
Photo 27. Sea-side view of Plan 7 before wave attack

18. Plan 7 (Plate 7 and Photo 27) returned to the alternating high- and low-sill concept for the deeper water location, but removed the 25-lb stone filter layer with the assumption that the rock filter would be replaced with filter cloth. The high sill was constructed with 1V-on-3H slopes to a crown elevation of 0.0 ft mllw using 5.0-ton graded armor stone. Using 3.0-ton graded armor stone, the low sill was constructed with 1V-on-3H slopes to a crown elevation of -5.0 ft mllw. After experiencing 1.5 hr of attack by 14.0-sec, 8.3-ft waves at an swl of 0.0 ft mllw, the structure had sustained very minor damage (Photo 28) and was considered stabilized for this test condition. The test

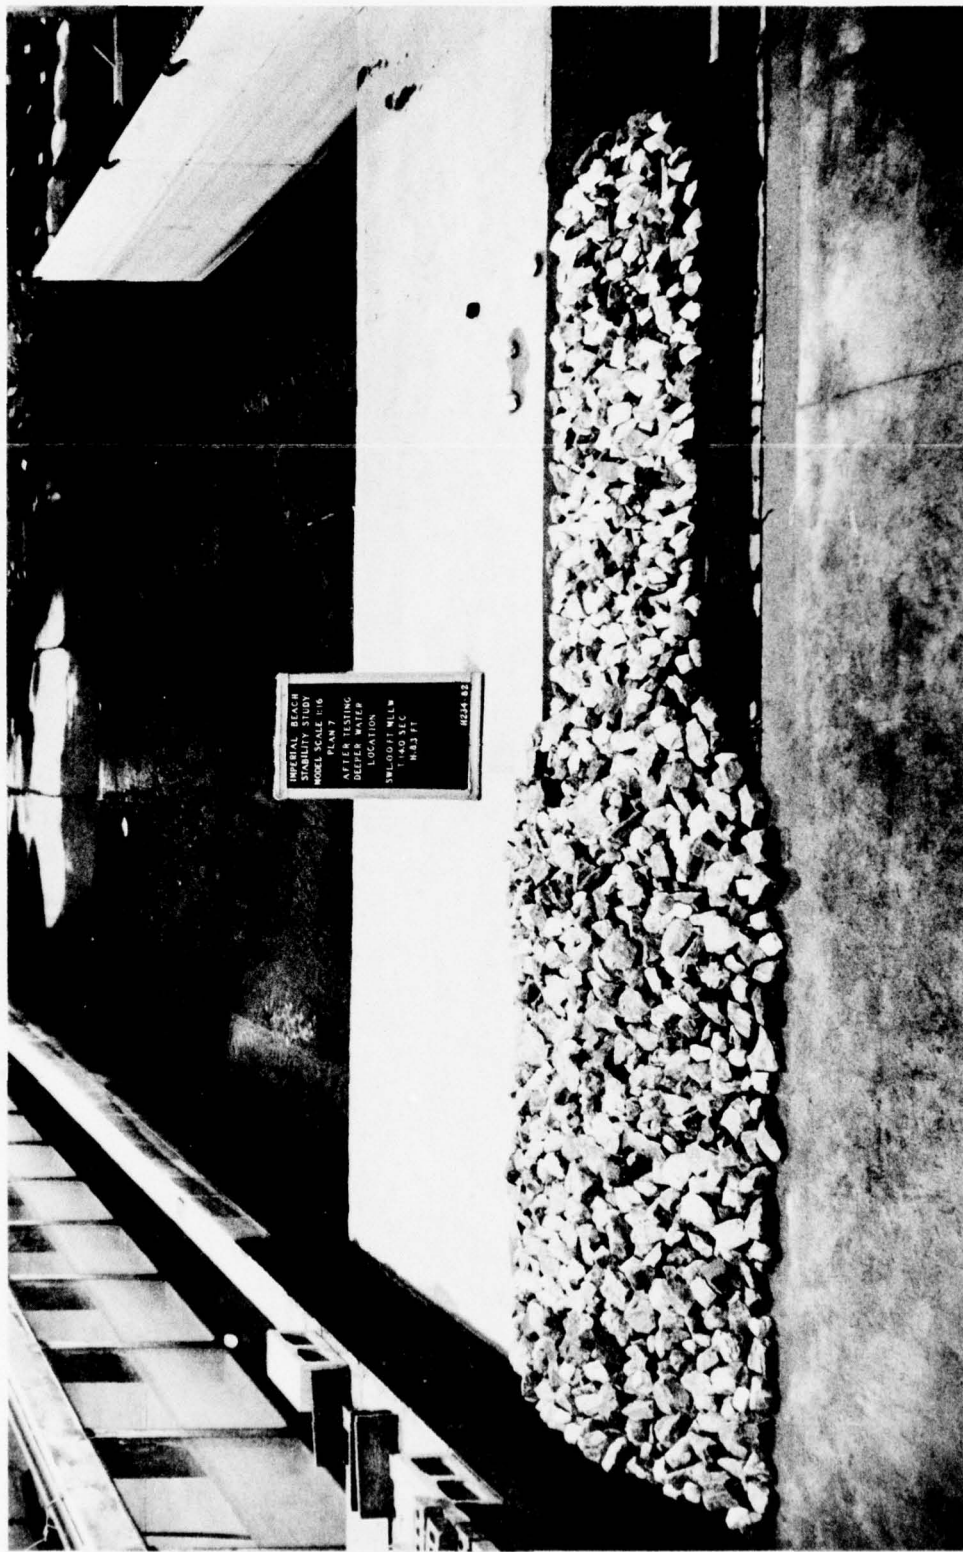
Photo 28. Sea-side view of Plan 7 in the deeper water location after 1.5 hr of 14.0-sec, 8.3-ft waves at an swl of 0.0 ft mllw

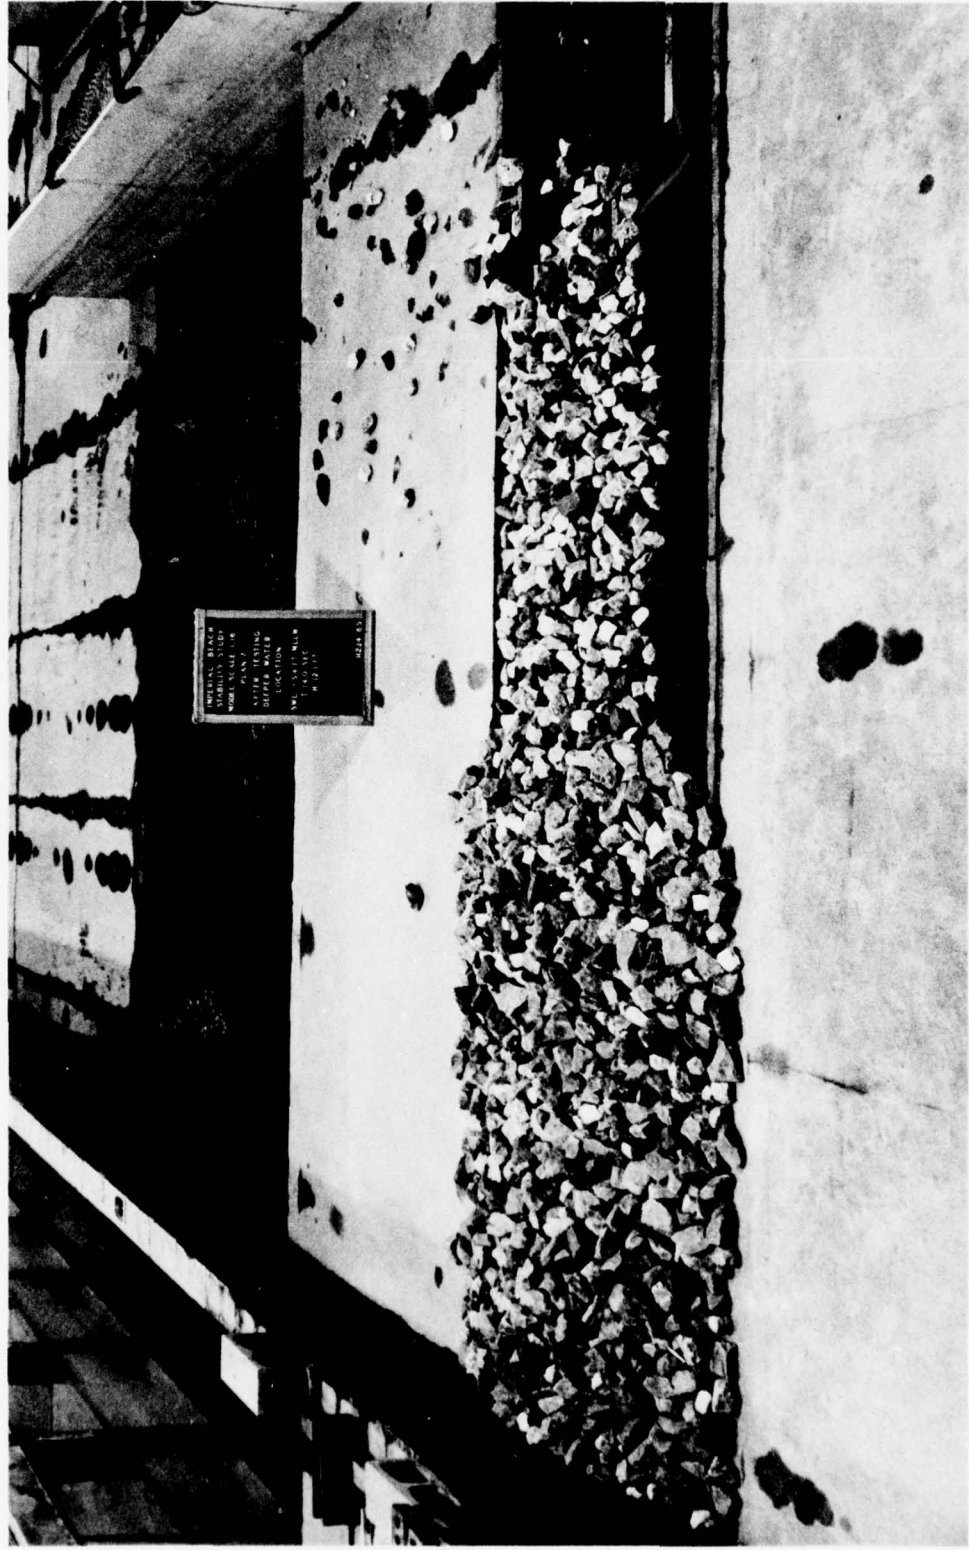
Photo 29. Sea-side view of Plan 7 in the deeper water location after 2.0 hr of 14.0-sec, 12.1-ft waves at an swl of +5.4 ft mllw

condition was changed to 14.0-sec, 12.1-ft waves at an swl of +5.4 ft mllw. After 2.0 hr of exposure to this wave condition, the high-sill and low-sill trunk had experienced very little displacement; however, the low-sill head section showed significant damage (Photo 29) and had not stabilized.

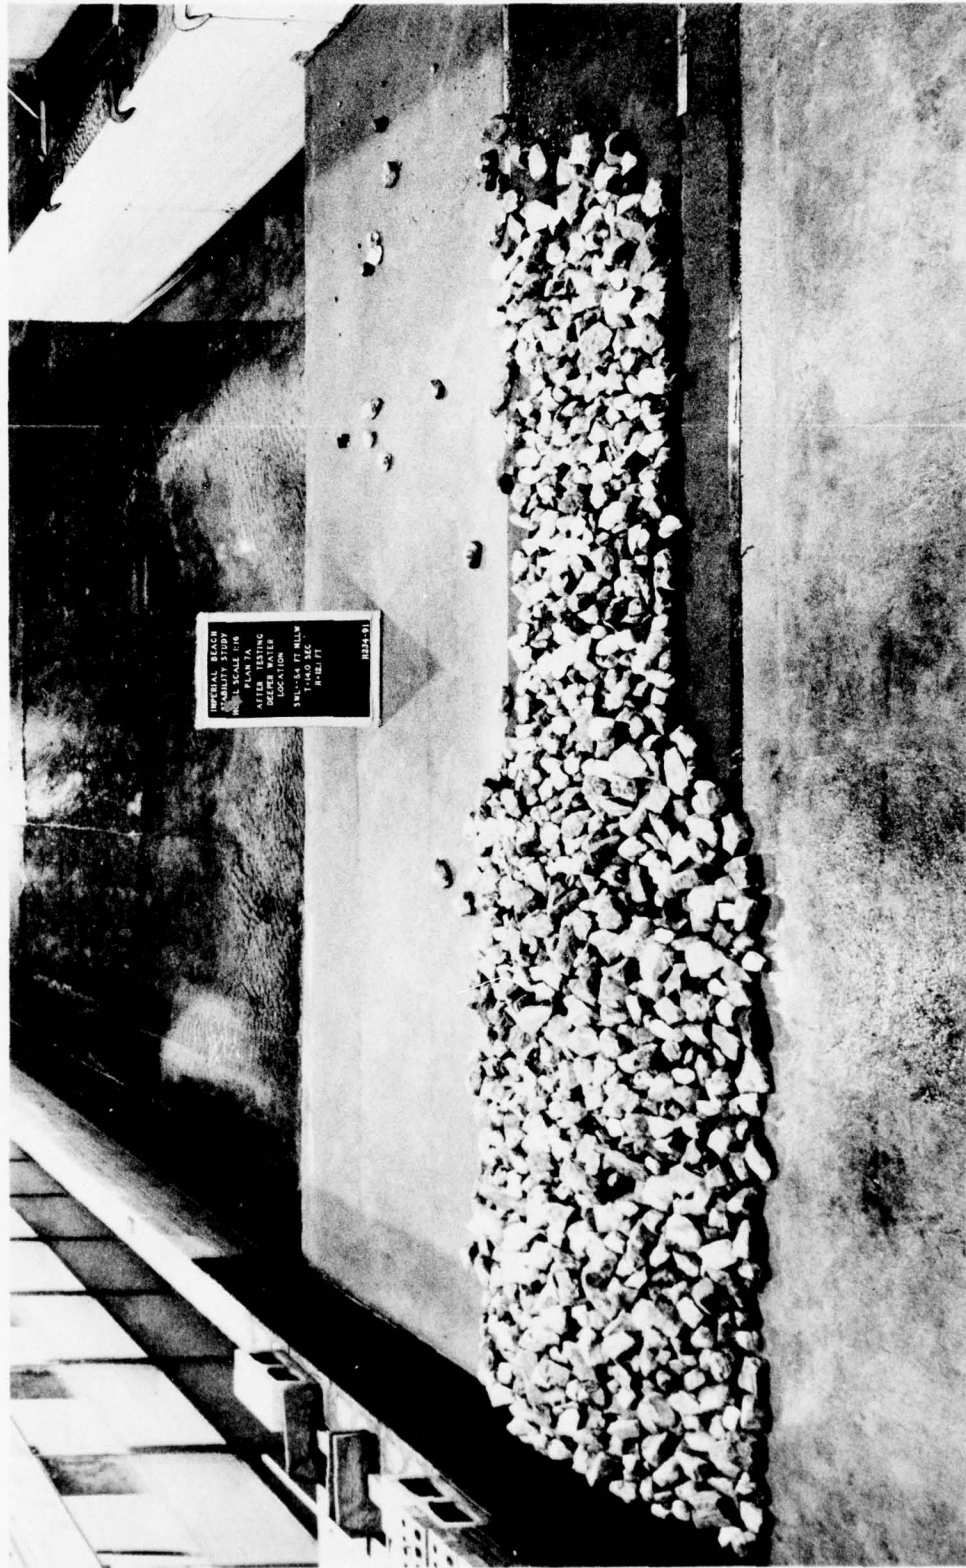
Photo 31. Sea-side view of Plan 7A in the deeper water location after 2.0 hr on the low sill and 4.0 hr on the high sill of 14.0-sec, 12.1-ft waves at an swl of +5.4 ft mllw

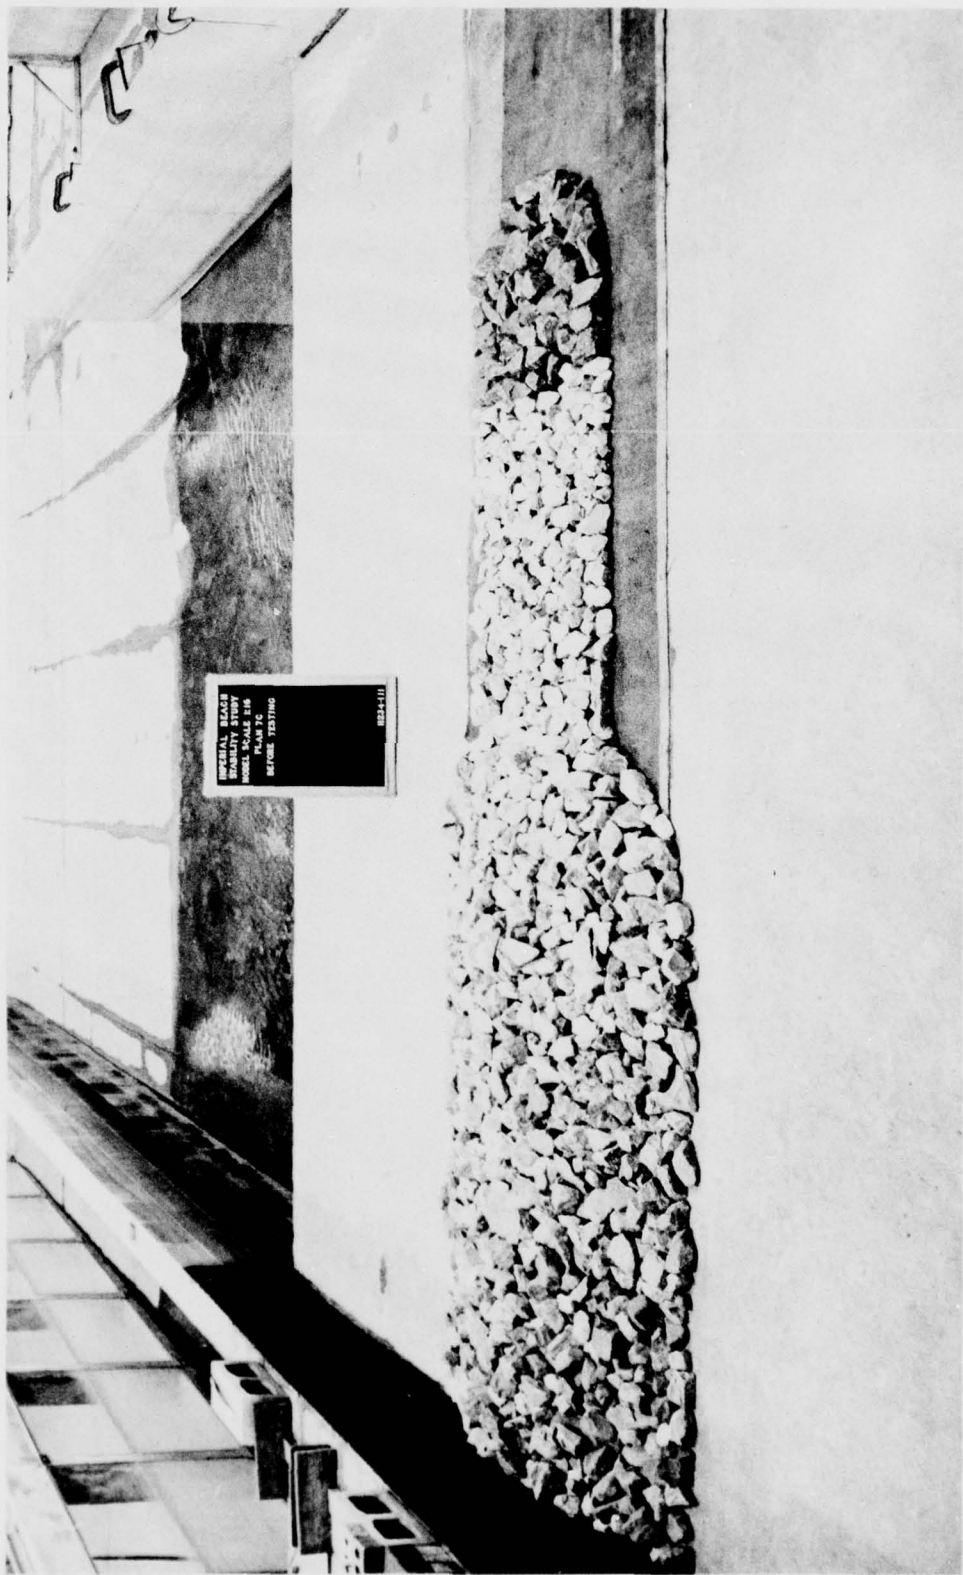
Photo 35. Sea-side view of Plan 7C before wave attack
