TECHNICAL REPORT H-77-22

BREAKWATER STABILITY STUDY IMPERIAL BEACH, CALIFORNIA

Hydraulic Model Investigation

U. S. Army Engineer Waterways Experiment Station
P. O. Box 631, Vicksburg, Miss. 39180

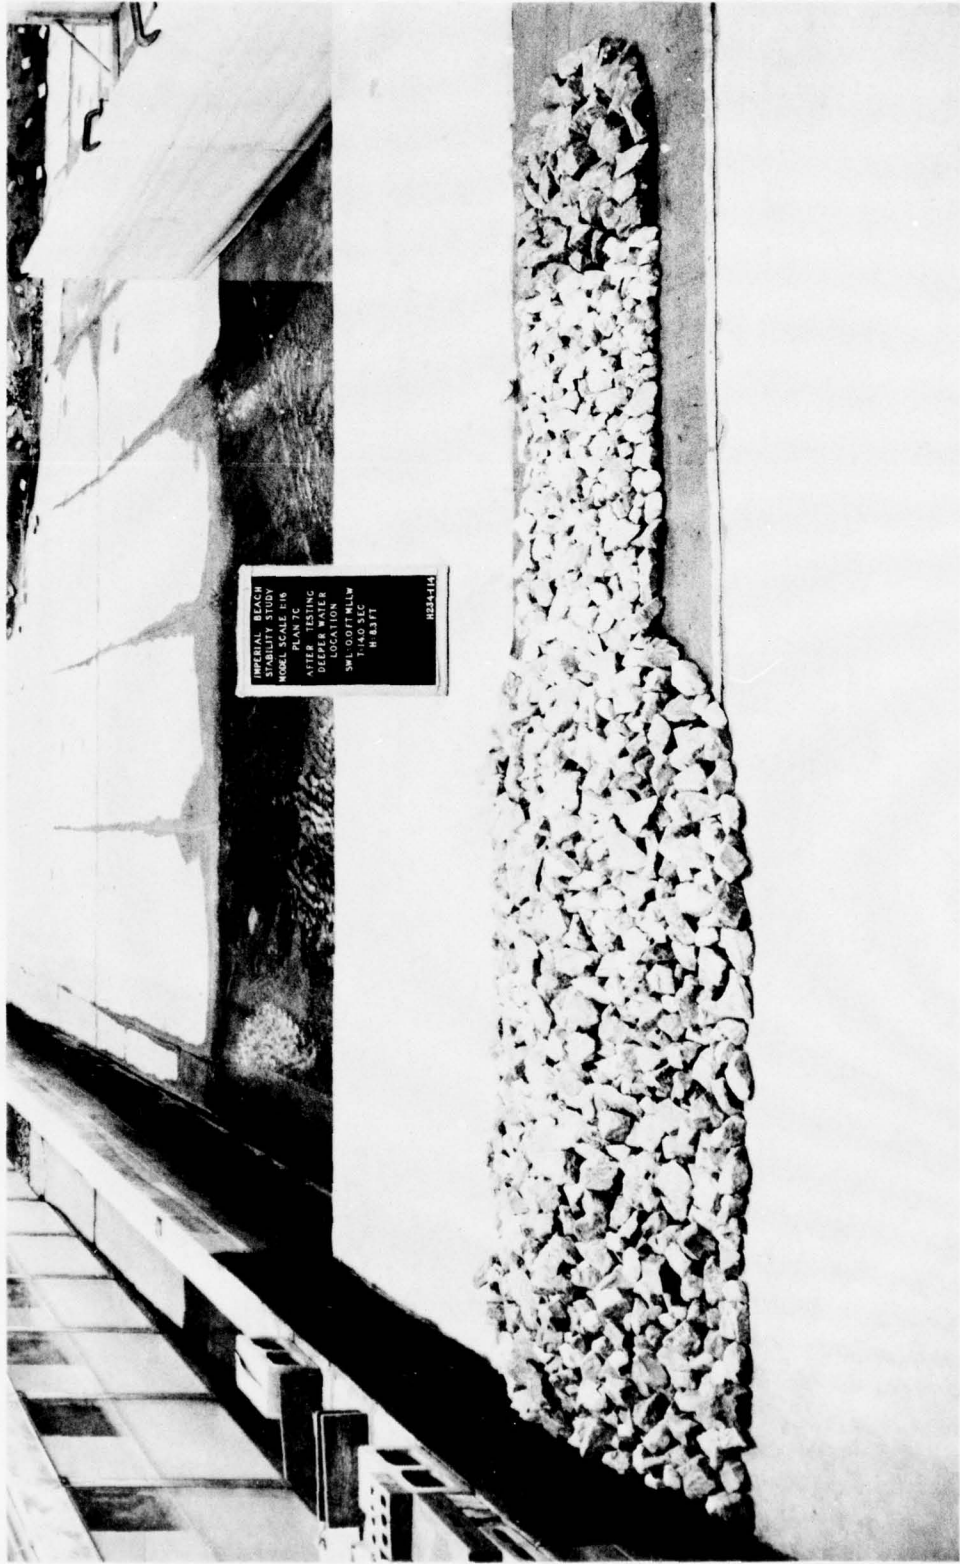
Photo 36. Sea-side view of Plan 7C in the deeper water location after 1.0 hr of 14.0-sec, 8.3-ft waves at an swl of 0.0 ft mllw

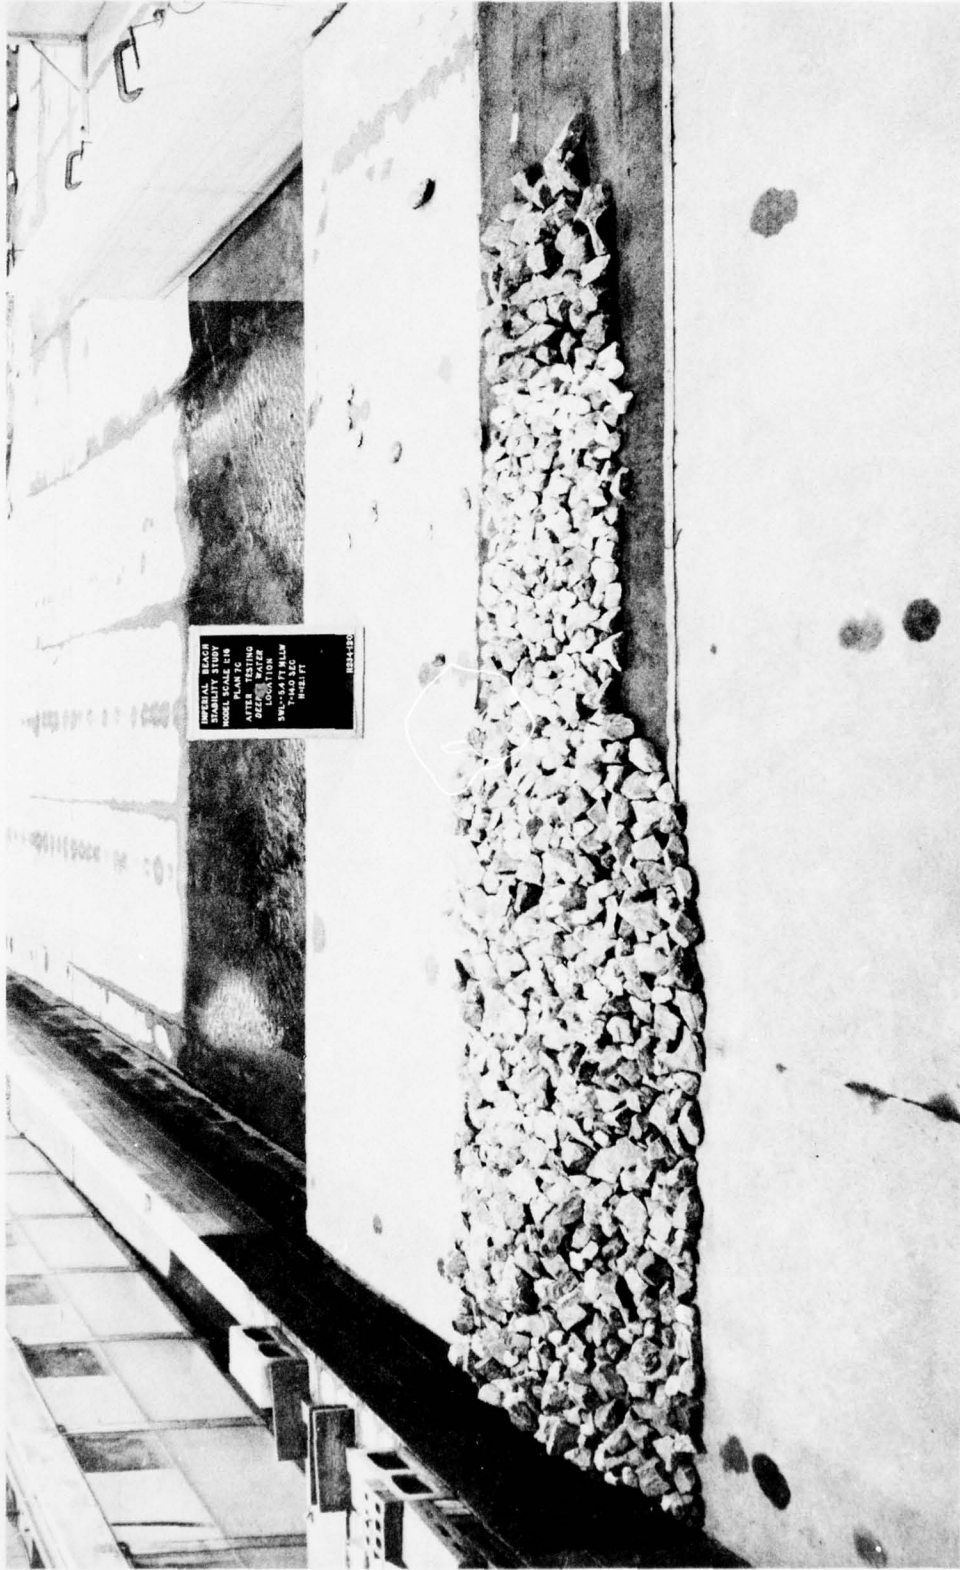
Photo 38. Sea-side view of Plan 7C in the deeper water location after 4.0 hr of 14.0-sec, 12.1-ft waves at an swl of +5.4 ft mllw

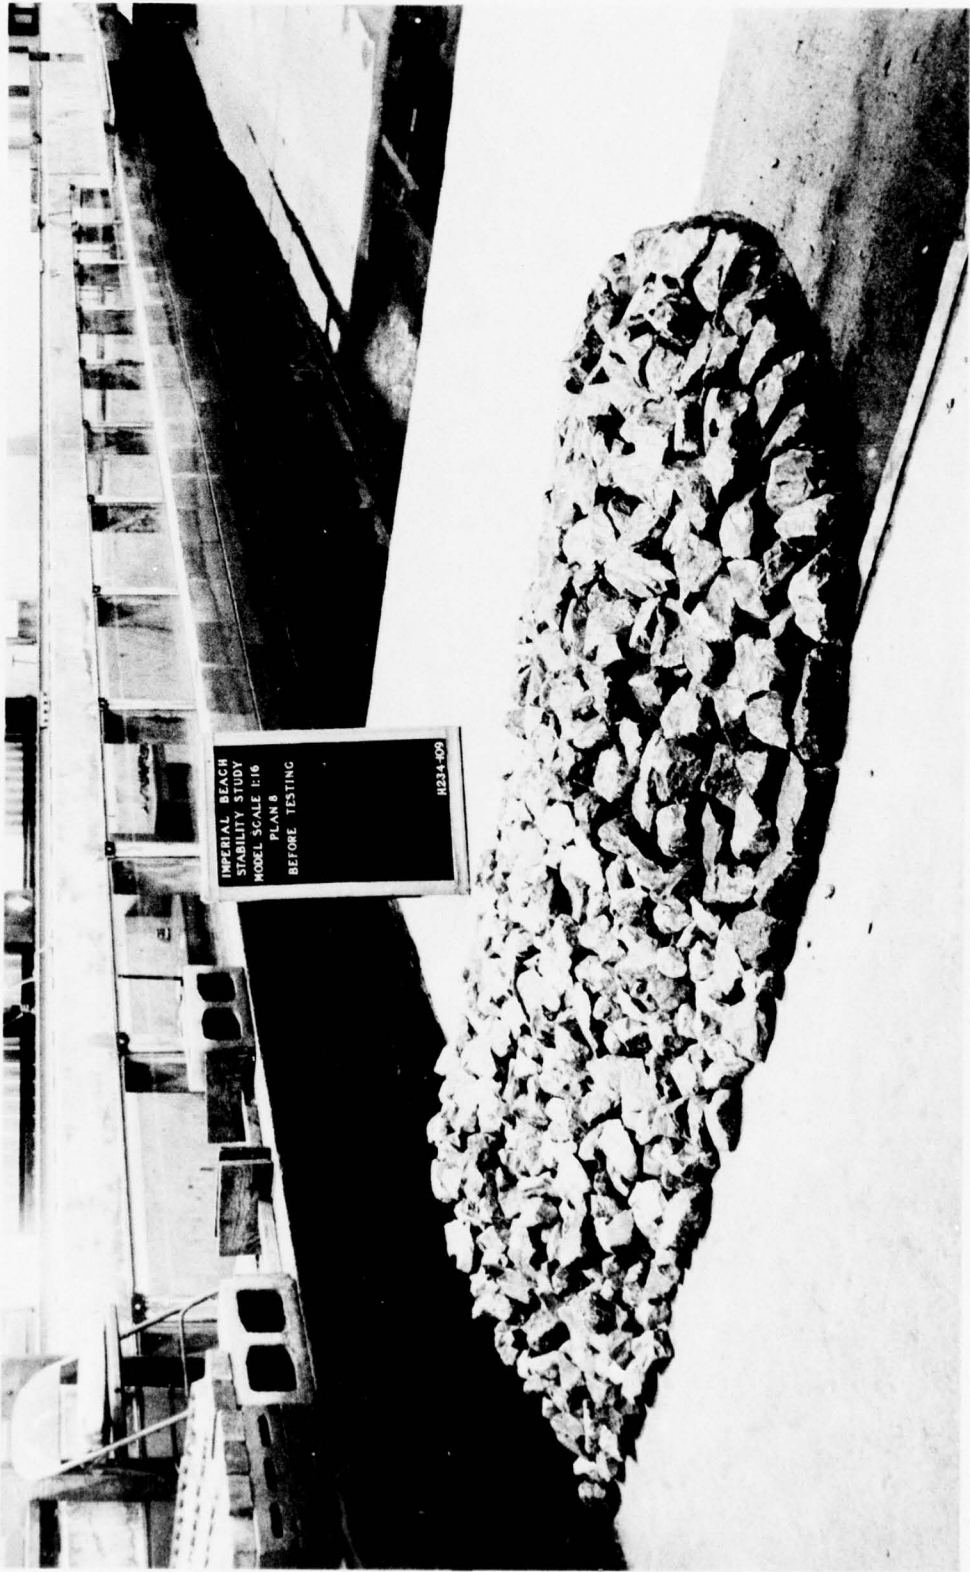
Photo 41. Sea-side view of Plan 8 before wave attack

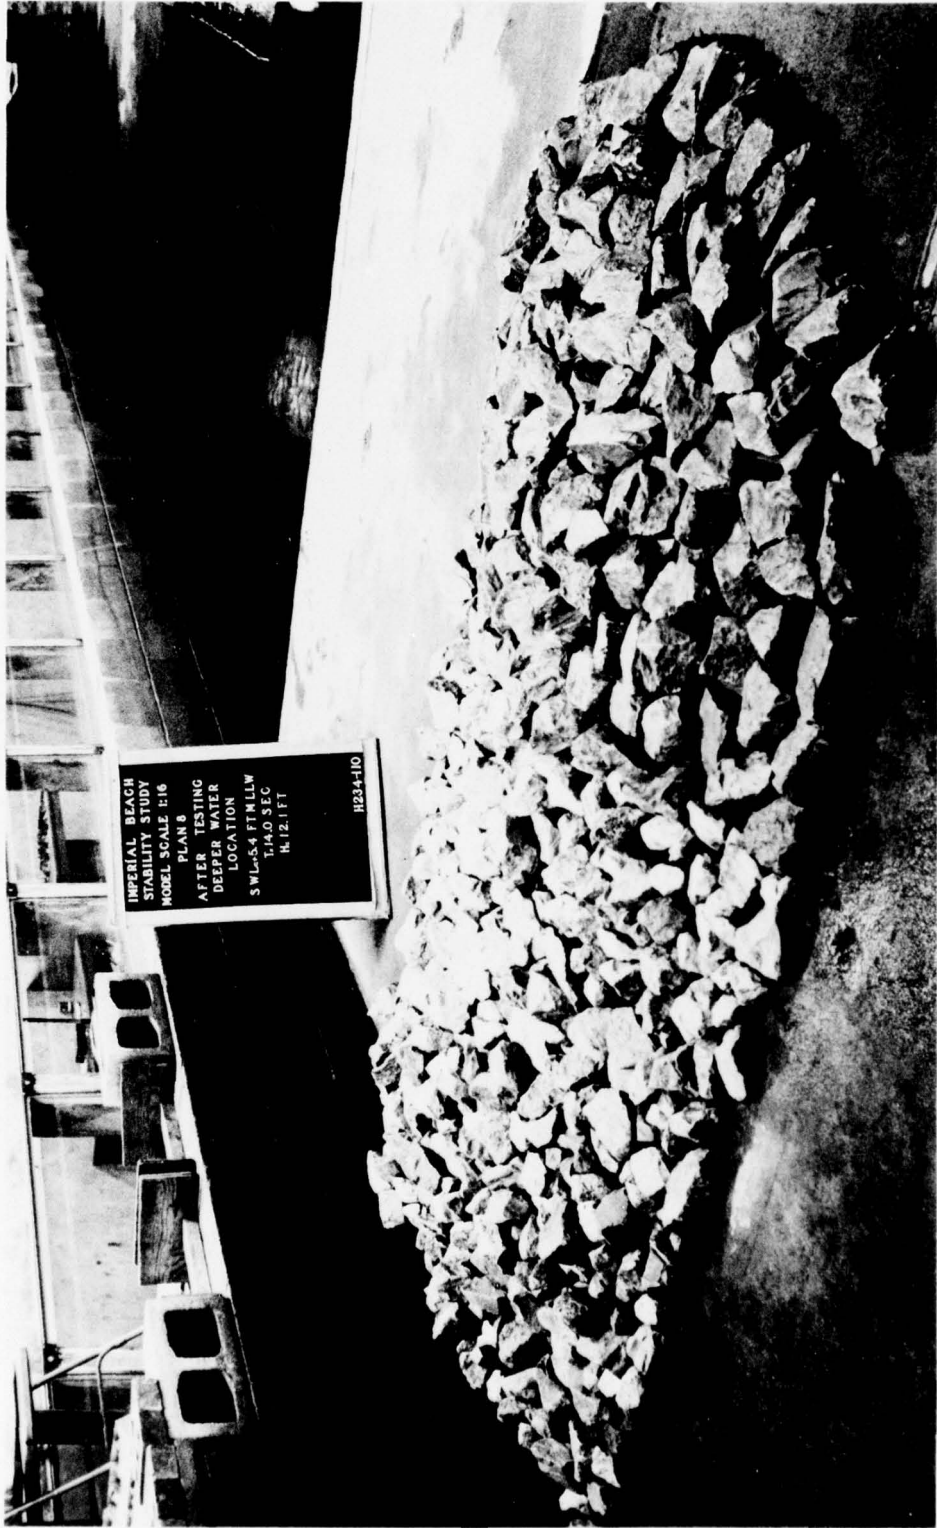
Photo 42. Sea-side view of Plan 8 in the deeper water location after 2.0 hr of 14.0-sec, 12.1-ft waves at an swl of +5.4 ft mllw

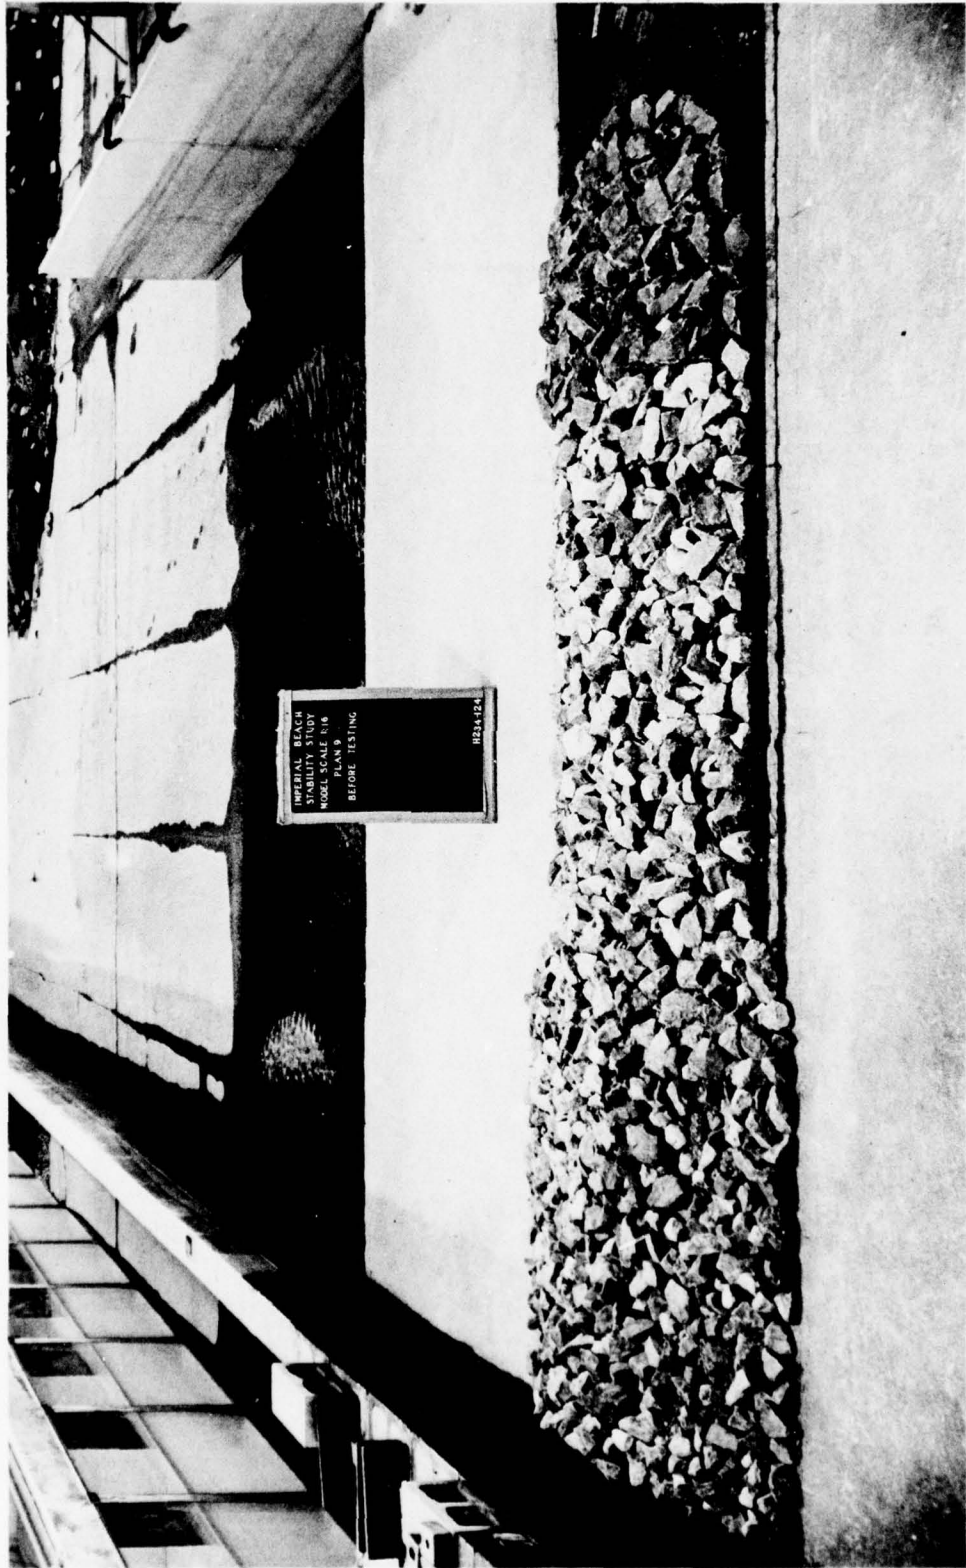
Photo 43. Sea-side view of Plan 9 before wave attack

23. Plan 9 (Plate 12 and Photo 43) was run in an effort to steepen the breakwater slopes and thus reduce construction costs by

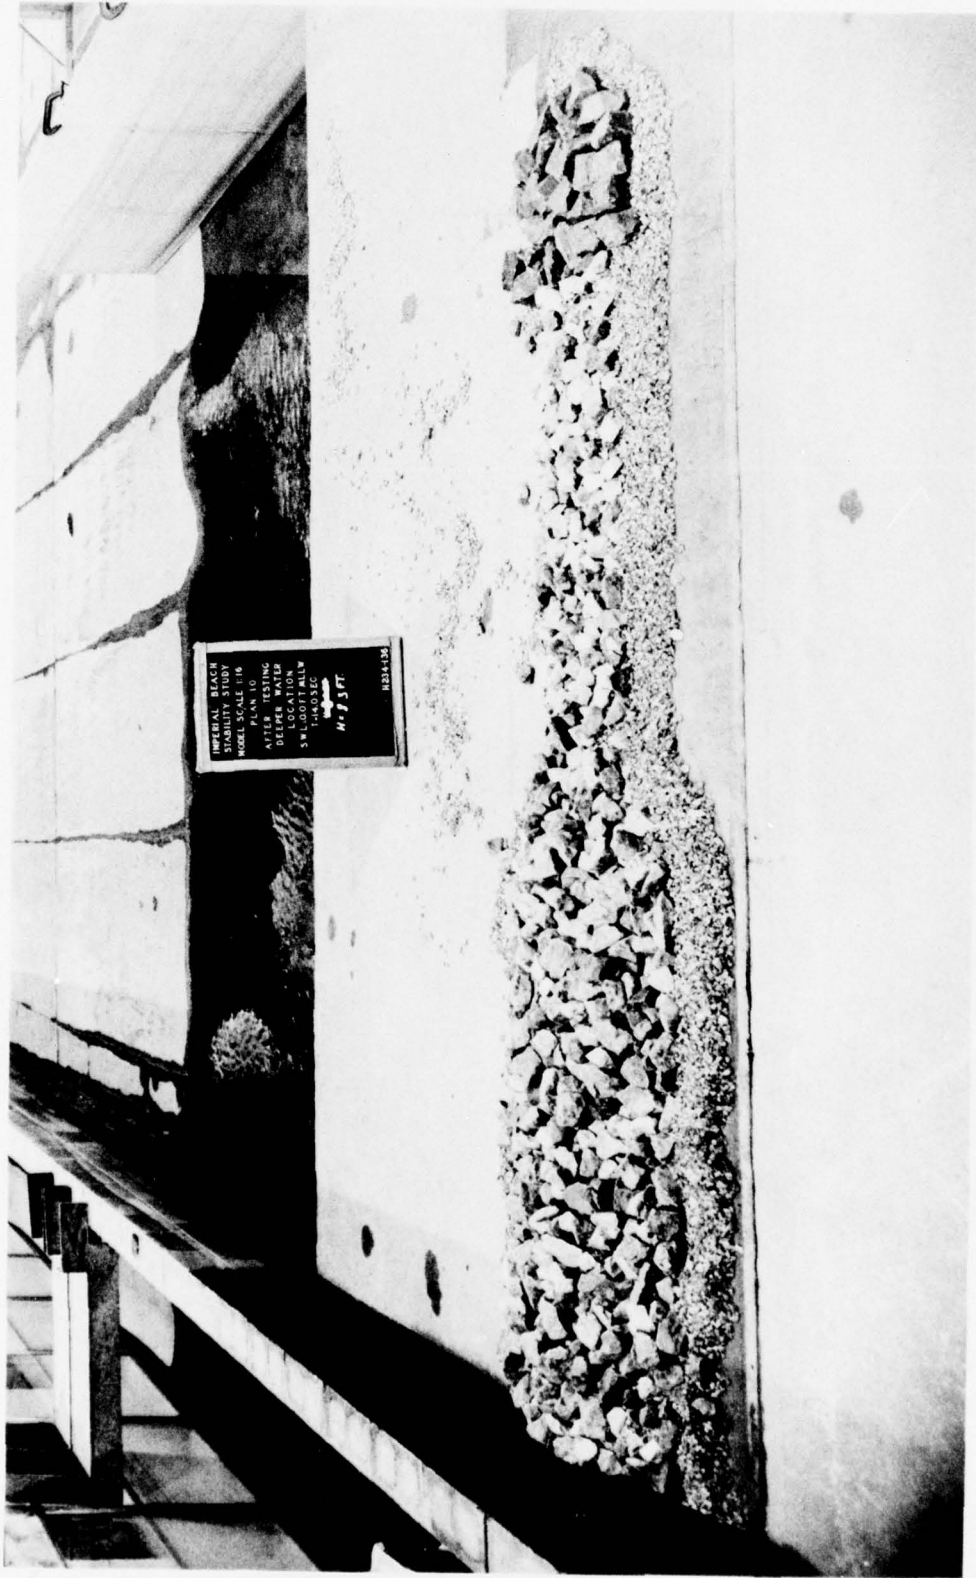
Photo 46. Sea-side view of Plan 10 in the deeper water location after 2.0 hr of 14.0-sec, 8.3-ft waves at an swl of 0.0 ft mllw

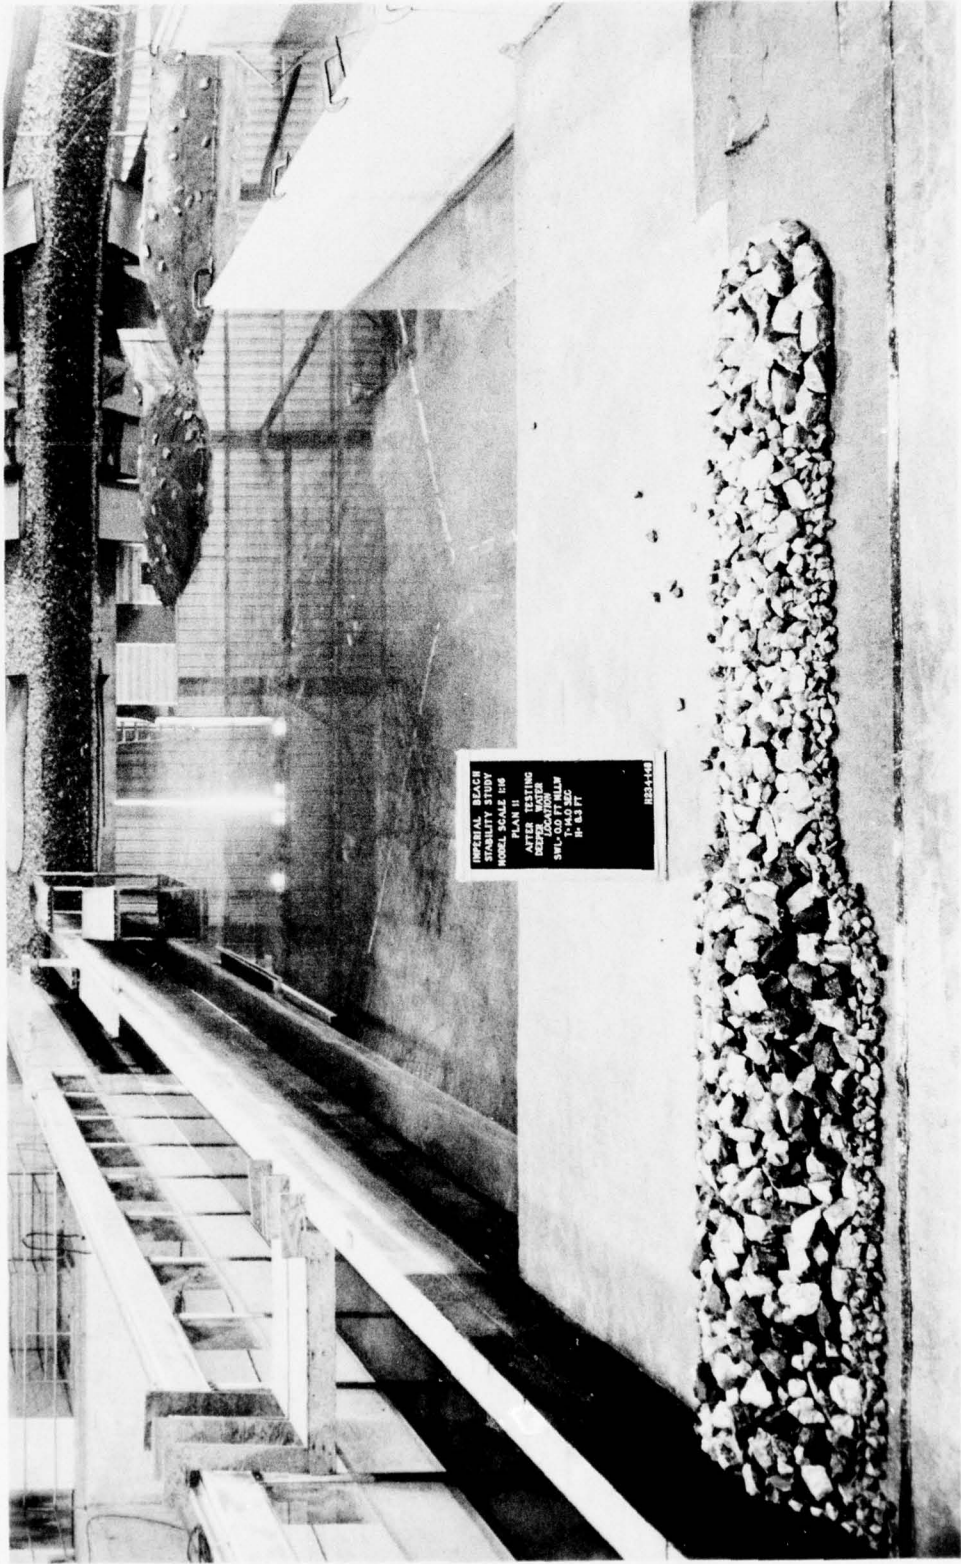
Photo 150. Sea-side view of Plan 11 in the deeper water location after 1.0 hr of 14.0-sec, 8.3-ft waves at an swl of 0.0 ft mllw

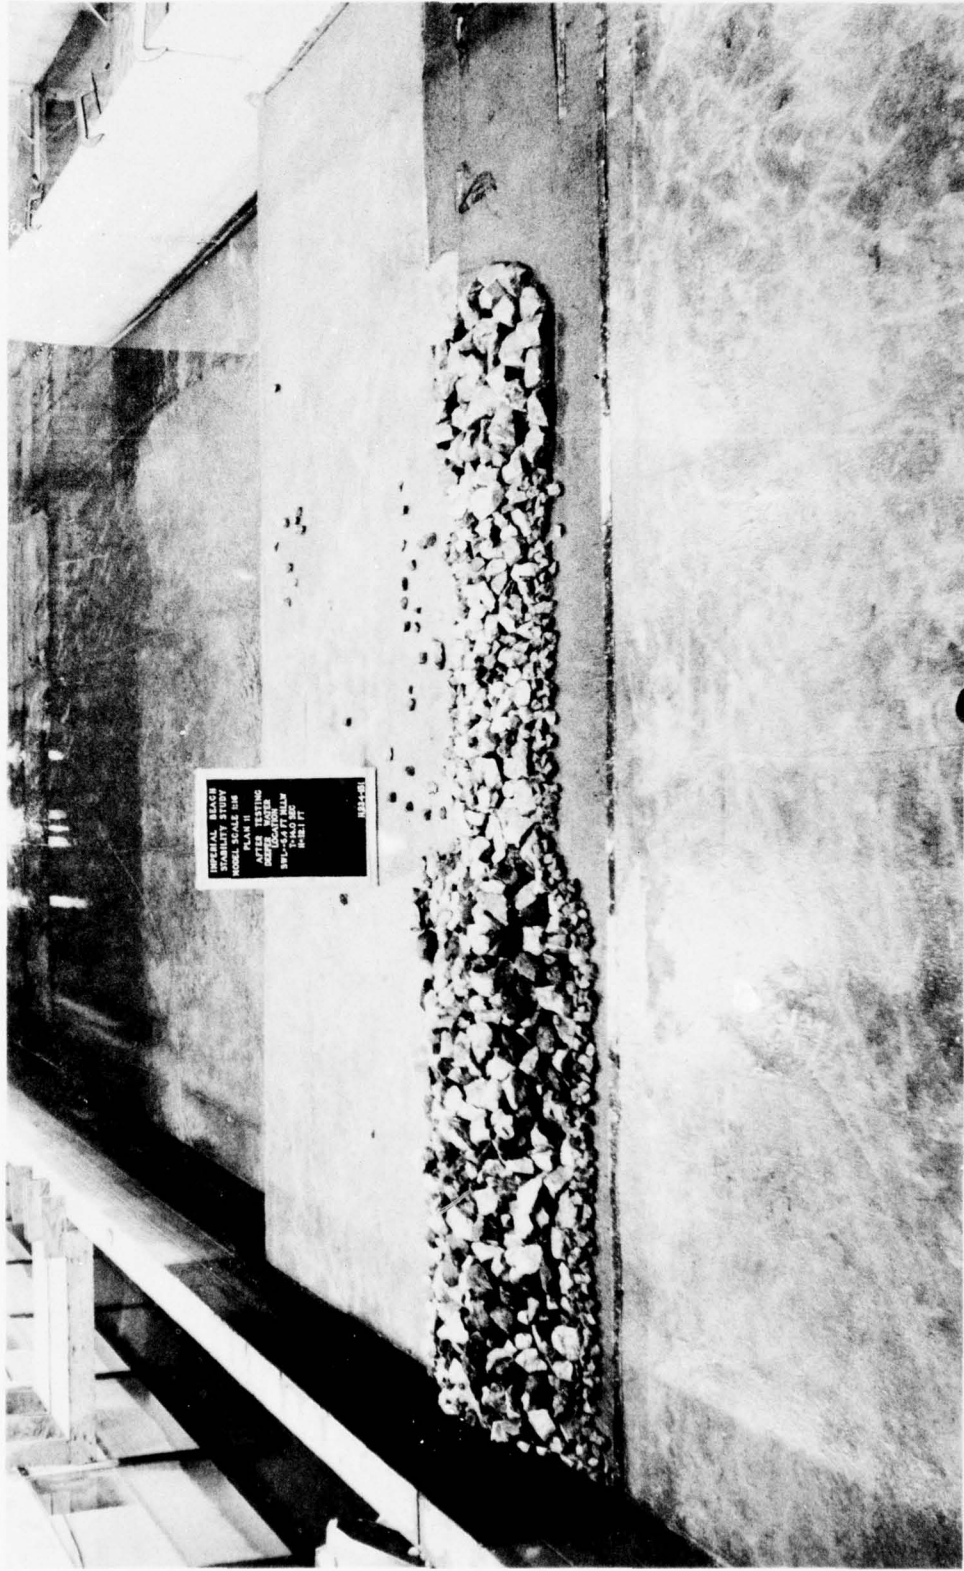
Photo 51. Sea-side view of Plan 11 in the deeper water location after 2.0 hr of 14.0-sec, 12.1-ft waves at an swl of +5.4 ft mllw

displacement of this stone on a prototype sand bottom would not be as severe as shown in the model. The remainder of the structure suffered minor damage (Photo 51). The identical wave attack was extended for 2.0 hr more, resulting in very little change to the breakwater (Photos 52-54). Moderate damage had occurred on the low-sill head and minor damage on the remainder of the structure after a total of 6.0 hr of 14.0-sec, 12.1-ft waves at an swl of +5.4 ft mllw (Photos 55-57).

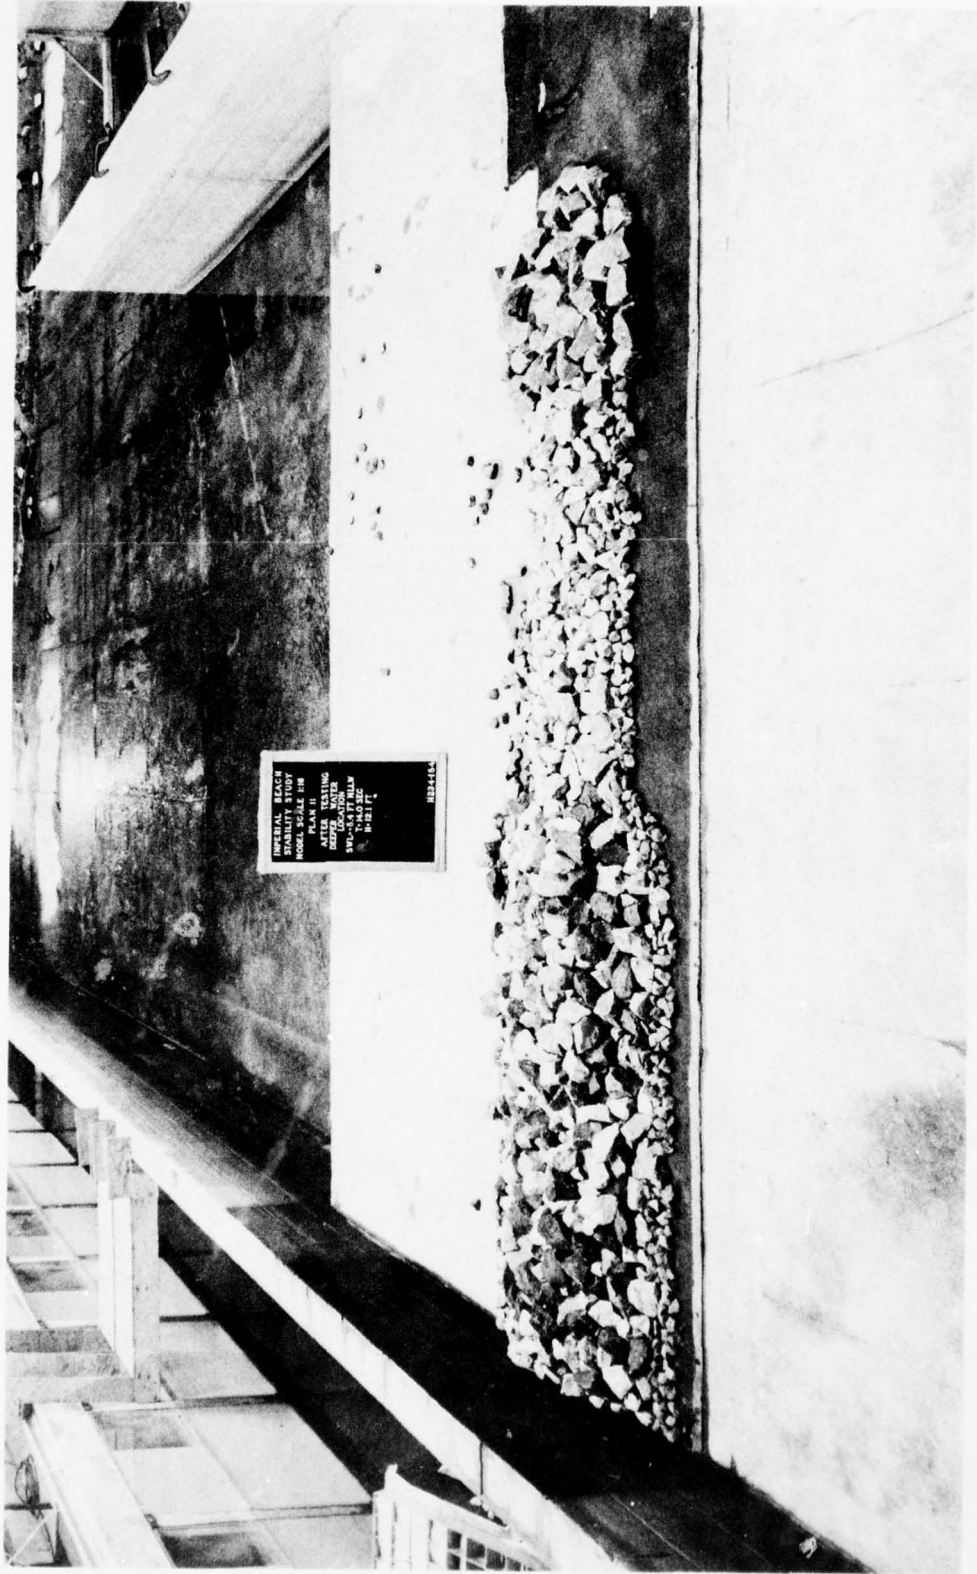
Photo 52. Sea-side view of Plan 11 in the deeper water location after 4.0 hr of 14.0-sec, 12.1-ft waves at an swl of +5.4 ft mllw

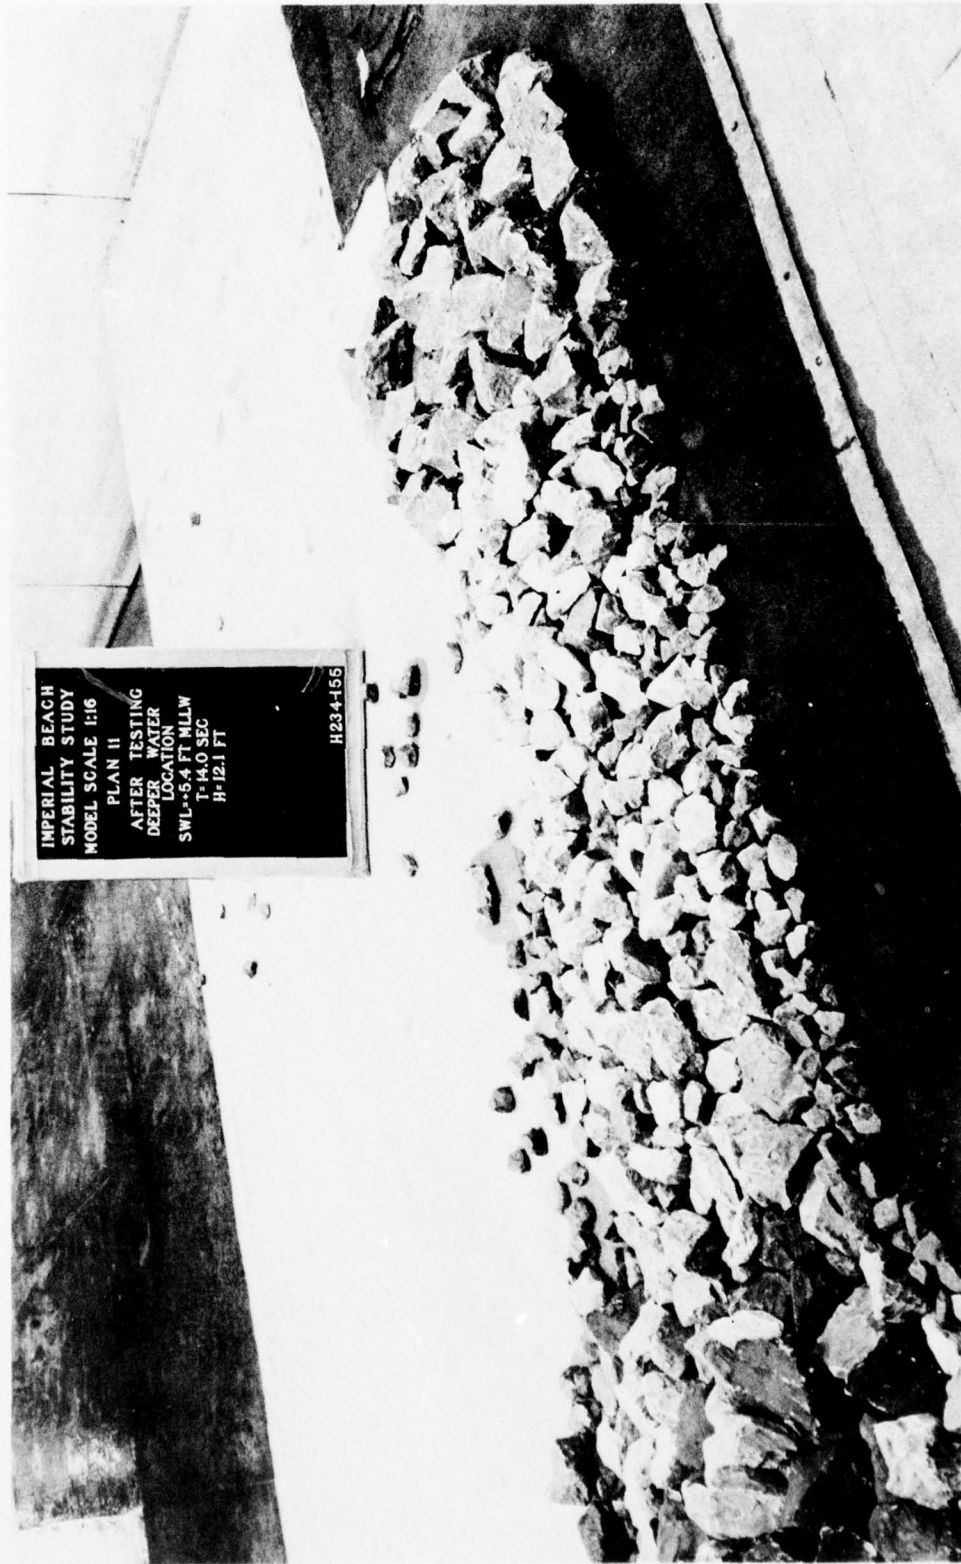
Photo 53. Sea-side view of low-sill section of Plan 11 in the deeper water location after 4.0 hr of 14.0-sec, 12.1-ft waves at an swl of +5.4 ft mllw

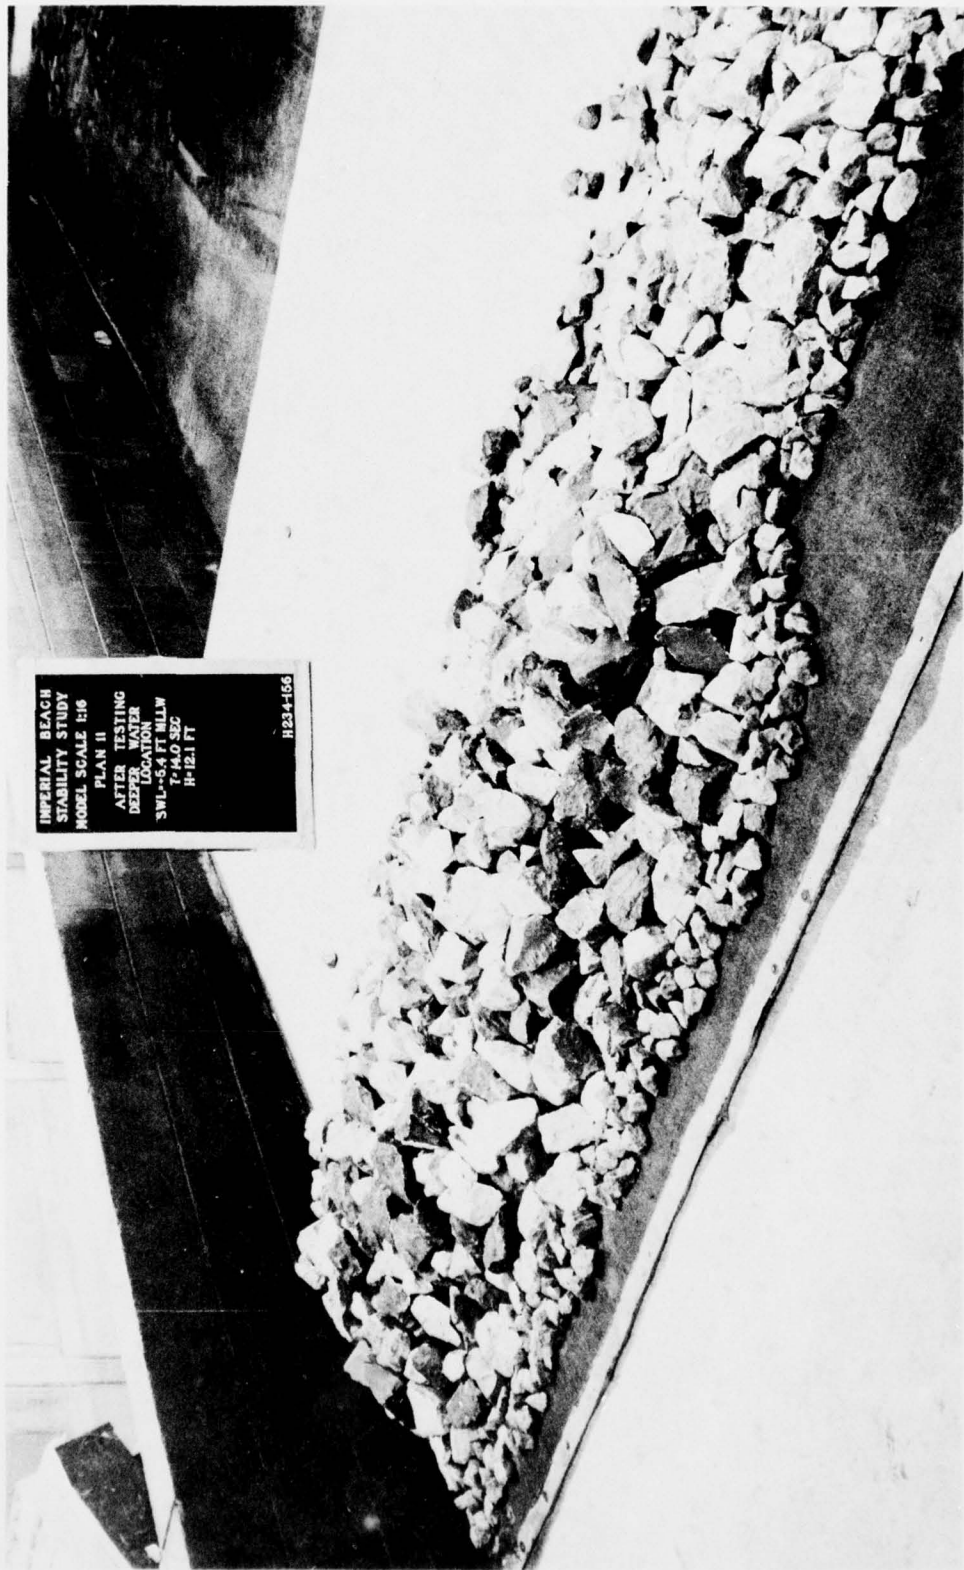
Photo 54. Sea-side view of high-sill section of Plan II in the deeper water location after 4.0 hr of 14.0-sec, 12.1-ft waves at an swl of +5.4 ft mllw

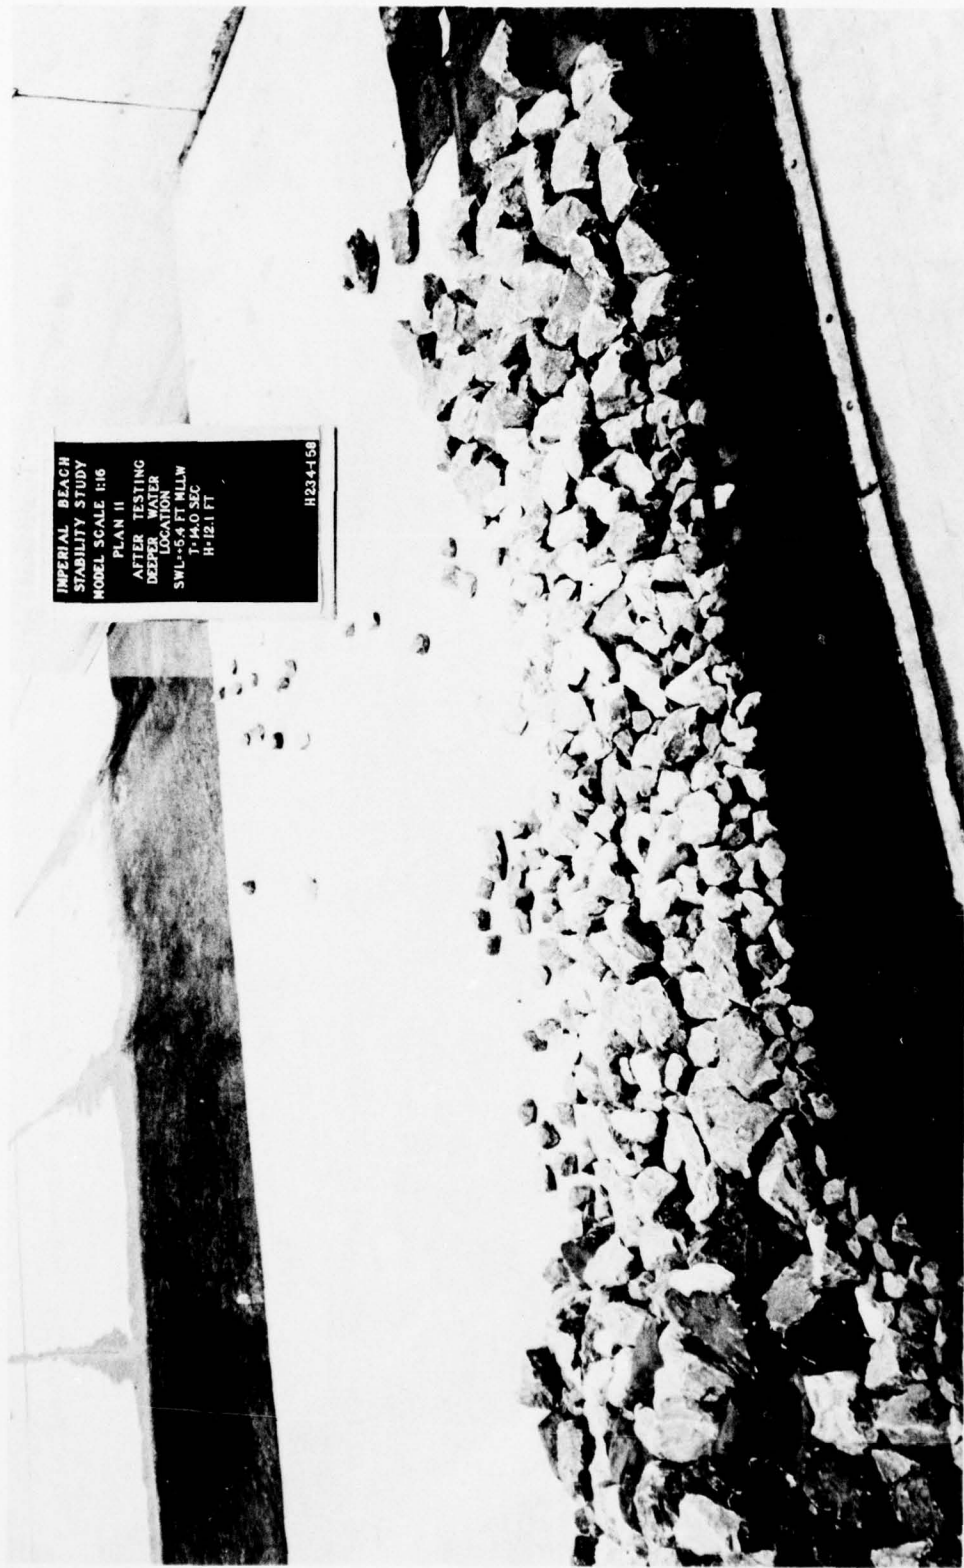
Photo 56. Sea-side view of low-sill section of Plan II in the deeper water location after 6.0 hr of 14.0-sec, 12.1-ft waves at an swl of +5.4 ft mllw

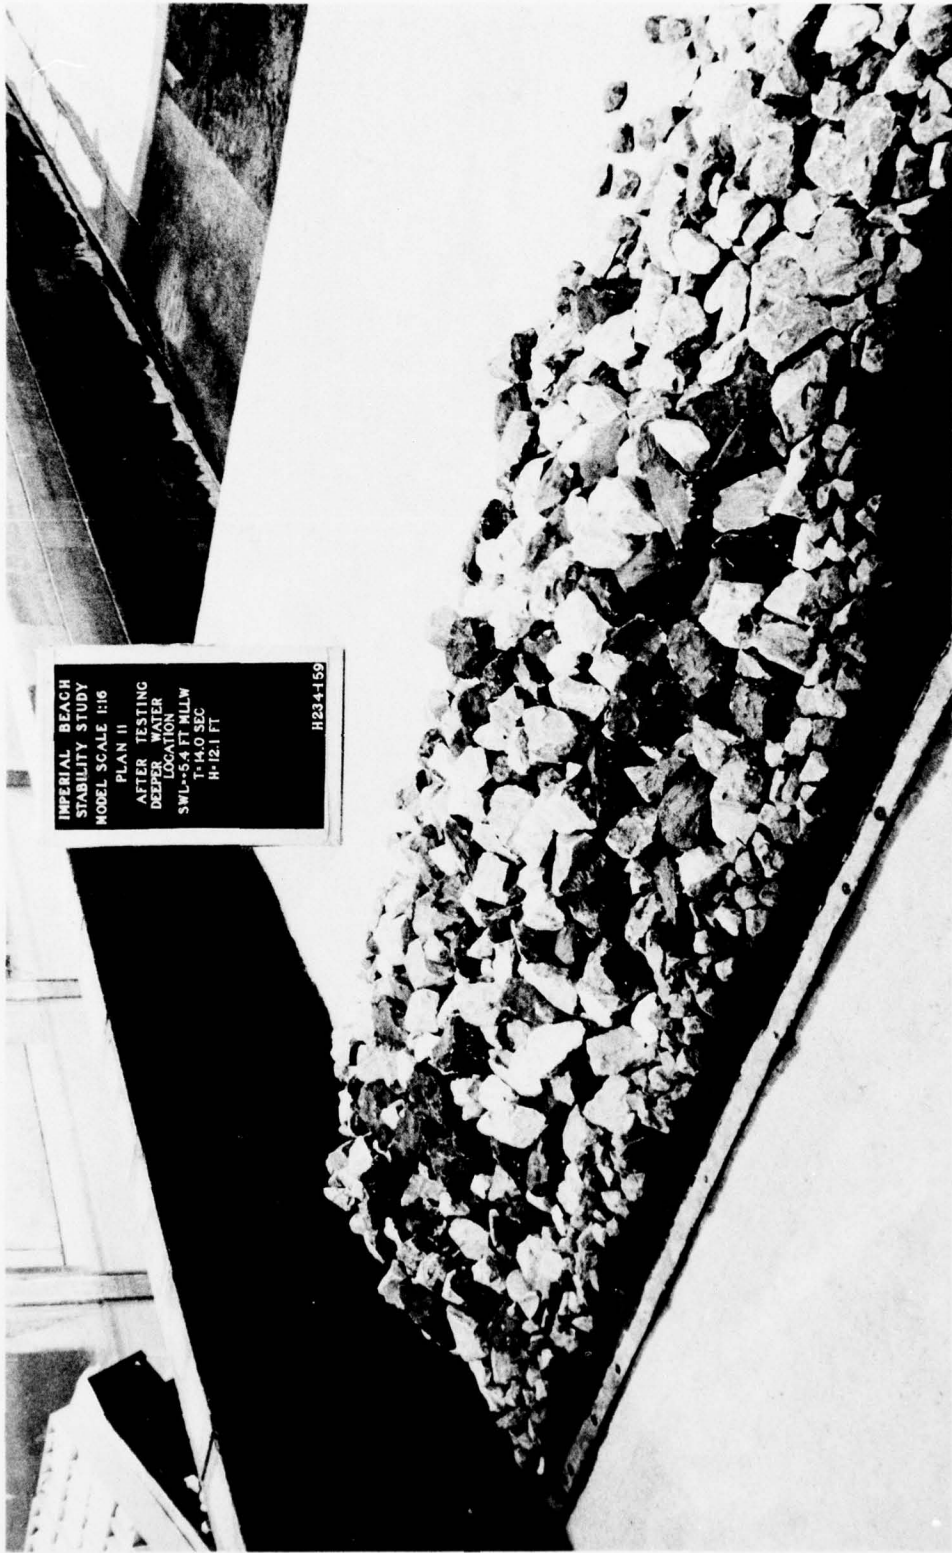
Photo 57. Sea-side view of high-sill section of Plan 11 in the deeper water location after 6.0 hr of 14.0-sec, 12.1-ft waves at an swl of +5.4 ft mllw

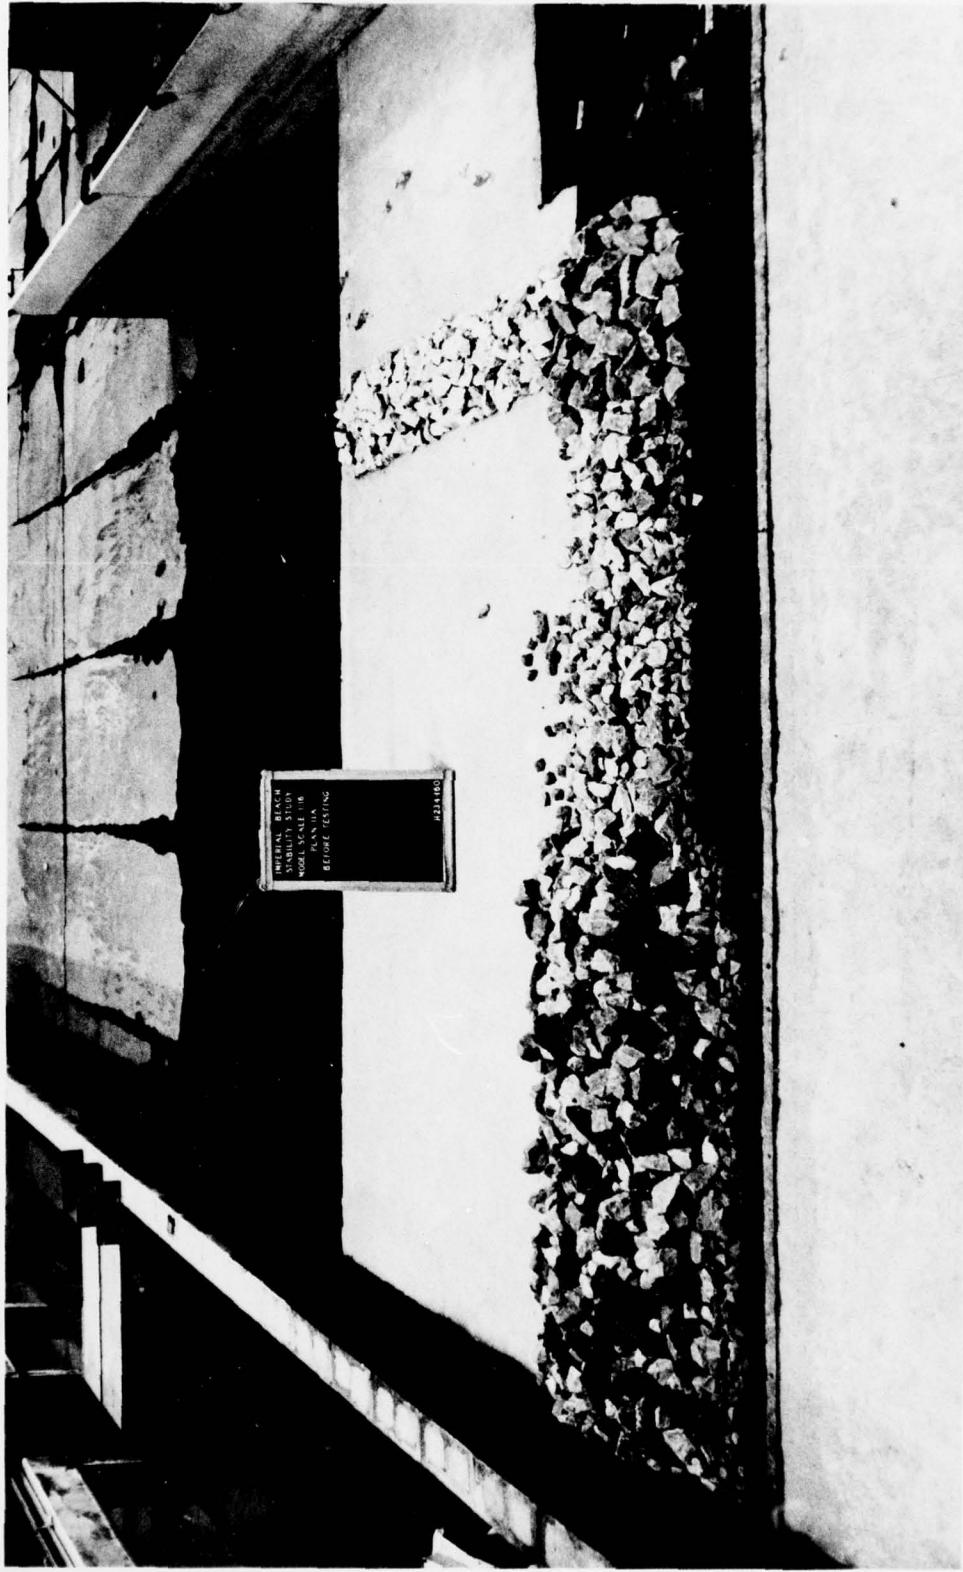
Photo 58. Sea-side view of Plan 11A before wave attack

27. Plan 11A (Plate 16 and Photo 58) was identical with Plan 11 (paragraph 26) except for the addition of the 5-ft-high beach-connected groin, constructed at a 90° angle to and connected to the low-sill head. The 5-ton graded armor stone mix, identical with that used on the low-sill trunk, was placed on 1V-on-2H slopes with a constant crown width of 10 ft. The groin crown elevation was not held constant but instead the structure height was maintained at 5 ft. In changing from Plan 11 to Plan 11A, only the low-sill head was rebuilt. In order to observe the result of extended wave attack, the remaining sections of the breakwater were not rebuilt during the change to Plan 11A. After 1.0 hr of attack by 14.0-sec, 12.1-ft waves at an swl of +5.4 ft mllw, the entire breakwater showed only minor damage which had stabilized before conclusion of the test (Photo 59).
