TECHNICAL REPORT H-77-22

BREAKWATER STABILITY STUDY IMPERIAL BEACH, CALIFORNIA

Hydraulic Model Investigation

U. S. Army Engineer Waterways Experiment Station
P. O. Box 631, Vicksburg, Miss. 39180

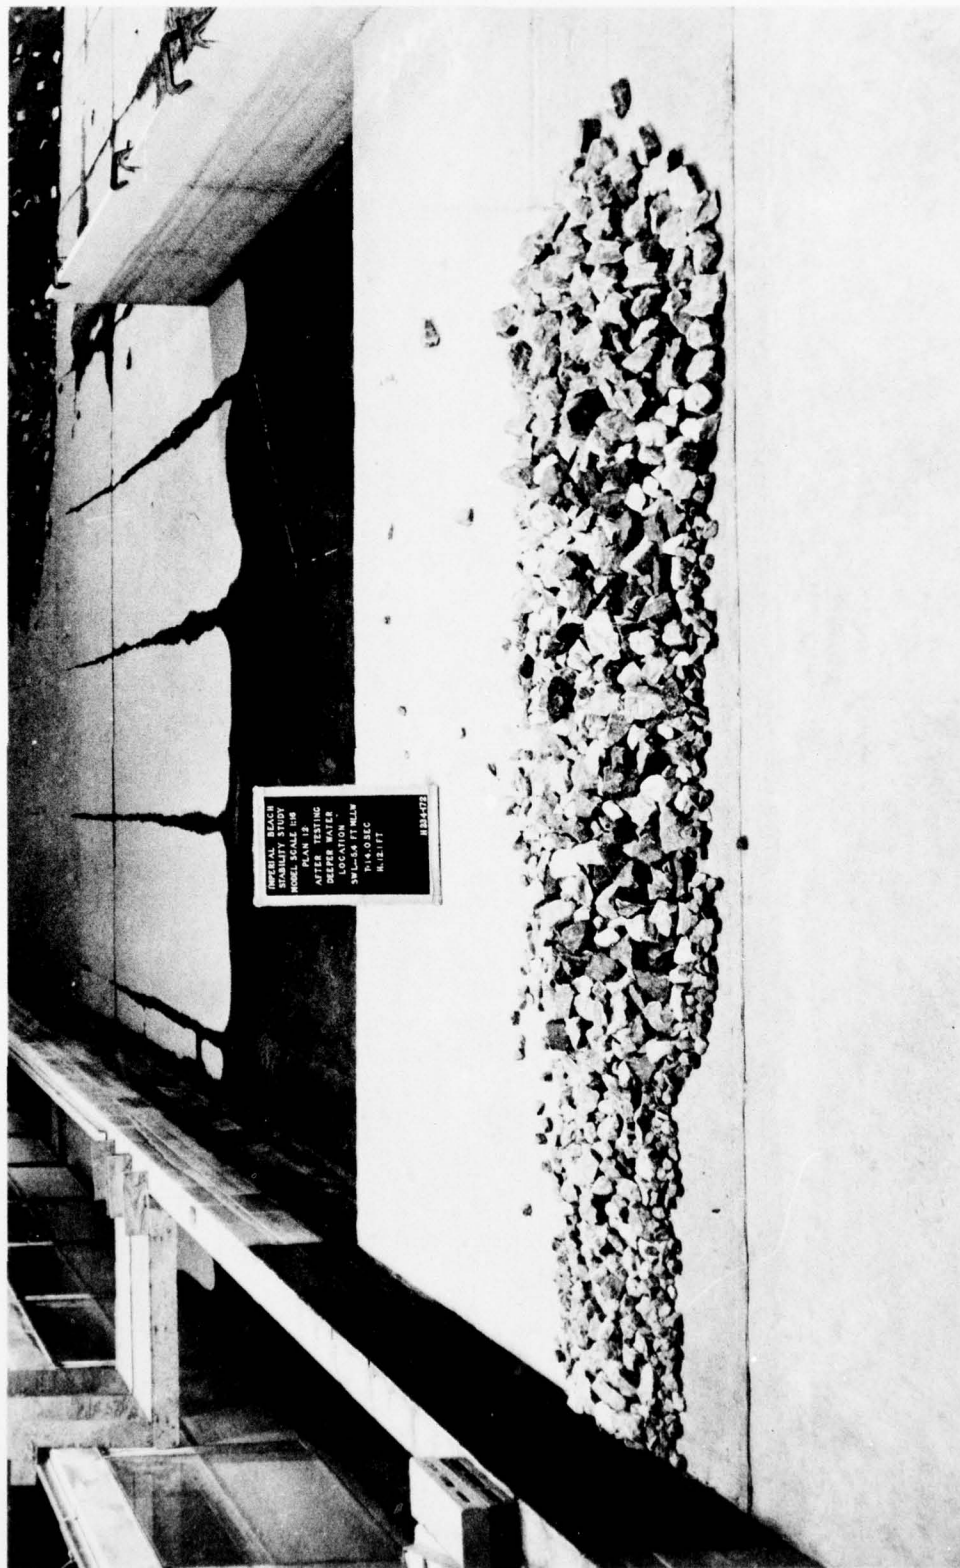
Photo 62. Sea-side view of Plan 12 in the deeper water location after 2.0 hr of 14.0-sec, 12.1-ft waves at an swl of +5.4 ft mllw

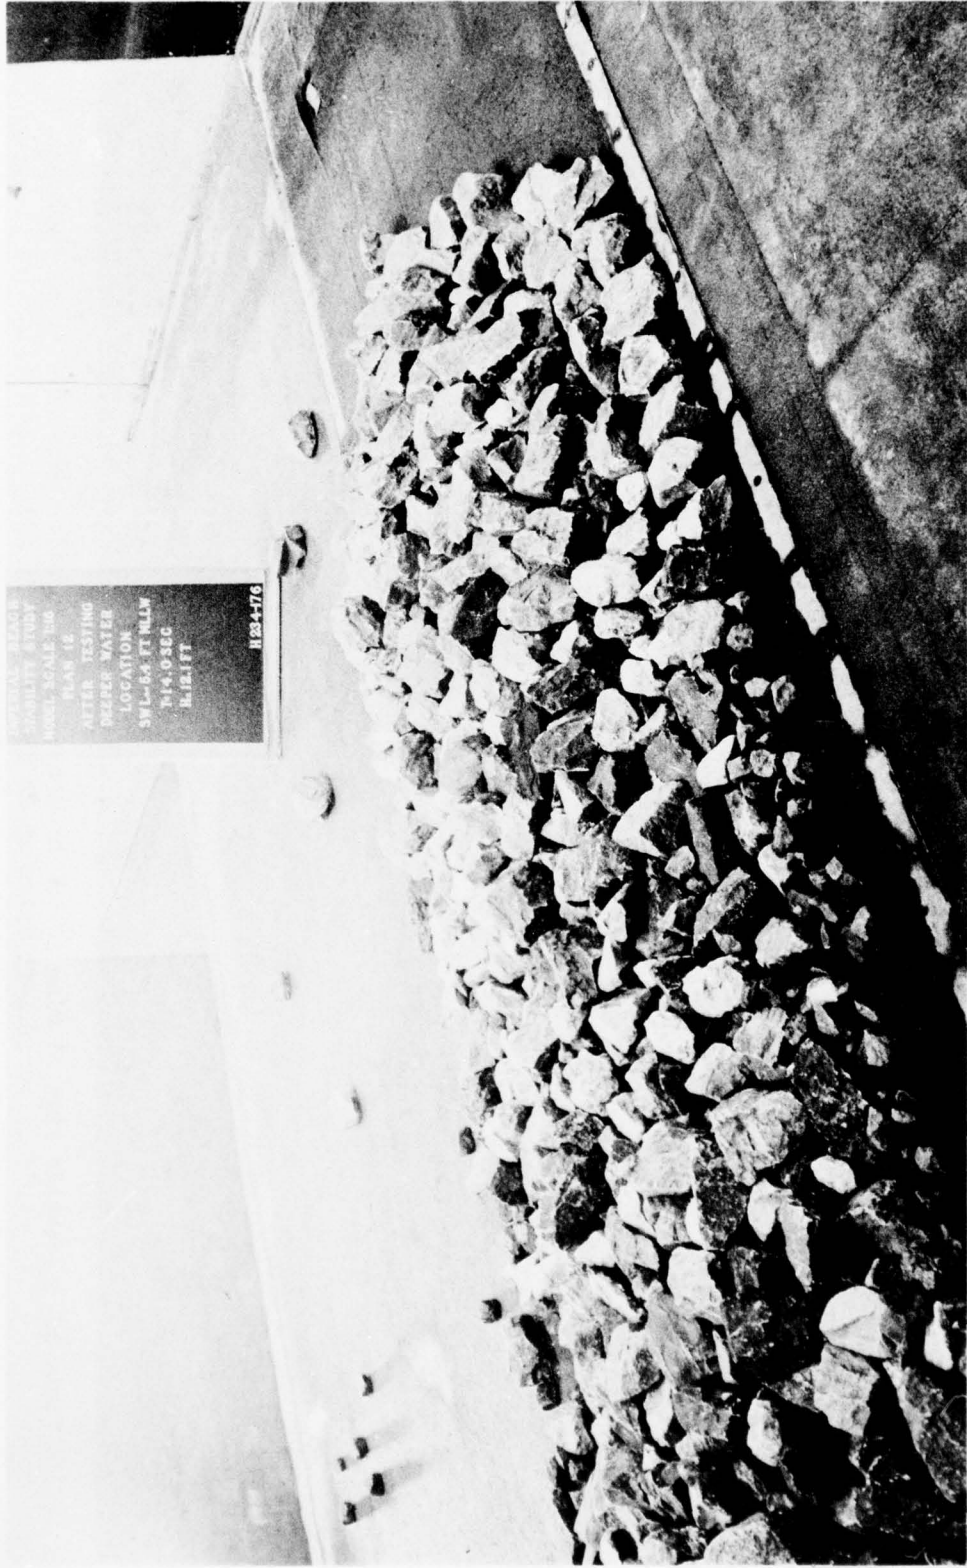
Photo 64. Sea-side view of high-sill section of Plan 12 in the deeper water location after 4.0 hr of 14.0-sec, 12.1-ft waves at an swl of +5.4 ft mllw

28. Plan 12 (Plate 17 and Photo 60) was a repeat test for the high-sill section and low-sill trunk of Plan 11. The alternating high and low sills of Plan 11 were reversed during construction of Plan 12 so that a 1V-on-3H slope high-sill head could be constructed at the end of the 1V-on-2H slope high-sill trunk. Construction of the high-sill head was identical with Plan 8 (paragraph 22) except that in Plan 8 the head had been attached to a high-sill trunk with 1V-on-3H slopes. Crown elevations were identical with those of Plan 11. After 1.0 hr of exposure to 14.0-sec, 8.3-ft waves at an swl of 0.0 ft mllw, the structure had experienced very minor damage (Photo 61). The test condition was changed to 14.0-sec, 12.1-ft waves at an swl of +5.4 ft mllw and after 2.0 hr of wave attack, only minor damage was observed (Photo 62). The identical test conditions were extended and after a total of 4.0 hr of wave attack the breakwater had accrued minor to moderate damage (Photos 63-65).

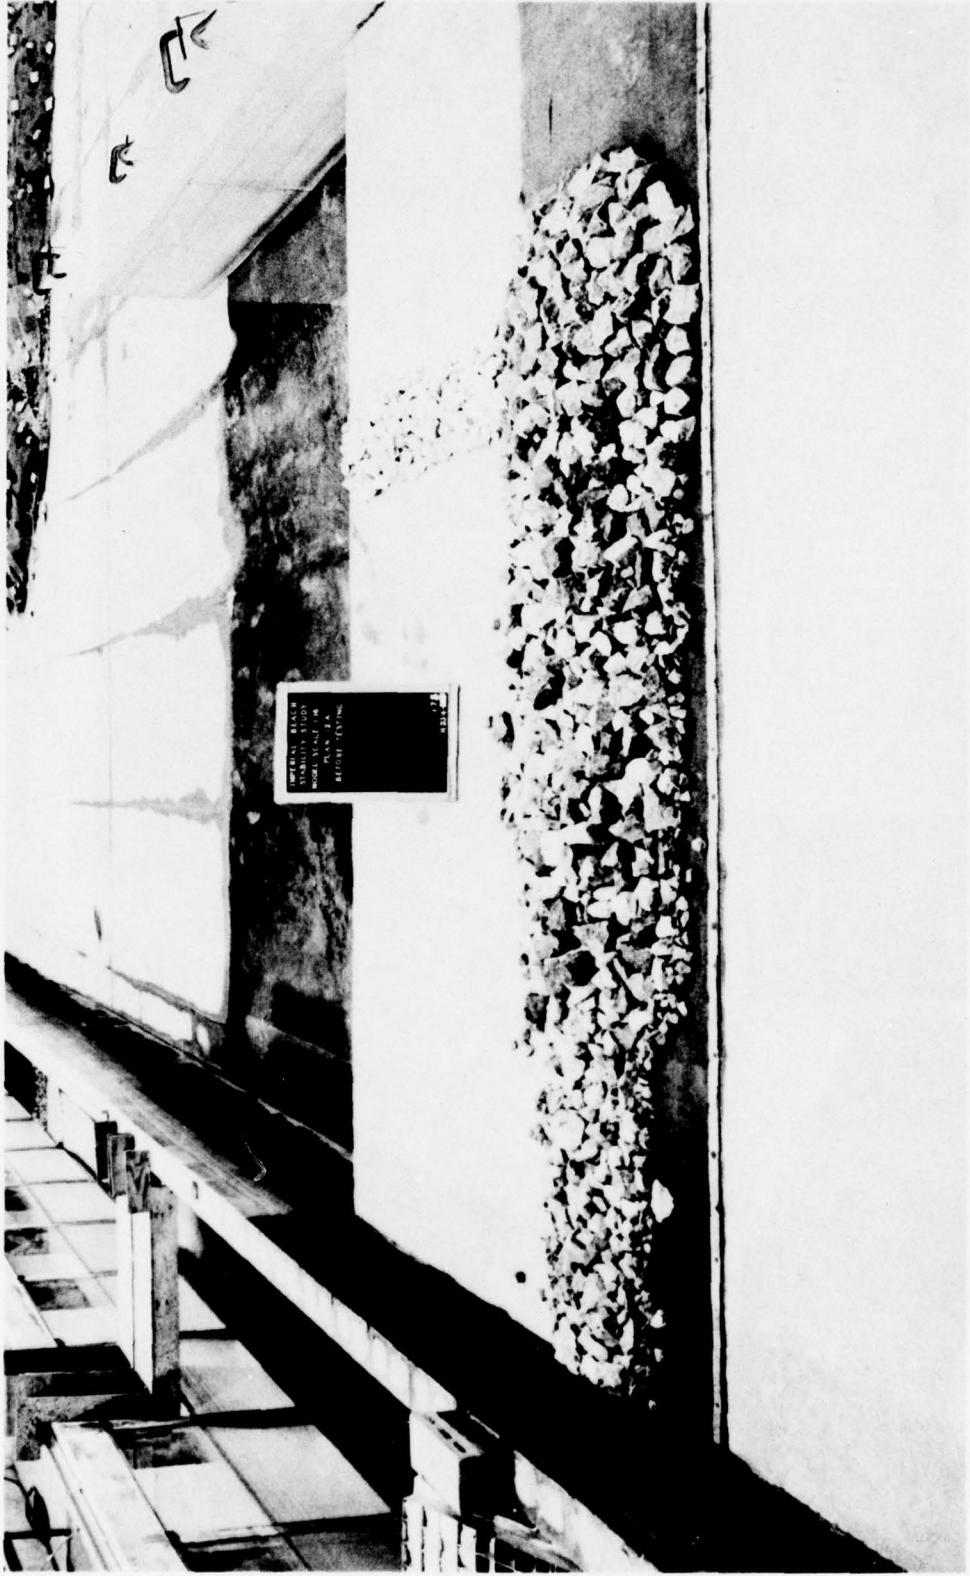
Photo 66. Sea-side view of Plan 12A before wave attack

29. Plan 12A (Plate 18 and Photo 66) consisted of rebuilding the high-sill head and adding a 5-ft-high, beach-connected groin to Plan 12. The groin was constructed with 1V-on-2H slopes using 5.0-ton graded armor stone and connected at a 90° angle to the beach side of the high-sill head. In order to observe the effect of extended wave attack on the high-sill and low-sill trunk, these sections of the Plan 12 breakwater were not rebuilt before testing was initiated on Plan 12A. After 2.0 hr of attack by 14.0-sec, 12.1-ft waves at an swl of +5.4 ft mllw caused minor damage on the high-sill head and groin. Little change occurred to those portions of the structure which were not rebuilt after testing Plan 12 (Photos 67-69). The breakwater was then exposed to 1.0 hr of 14.0-sec, 8.3-ft waves at an swl of 0.0 ft mllw to check for any possible stability problems on the 5-ft-high groin when exposed to this low-water wave attack. No instability was observed on the groin and the remainder of the breakwater showed very little change.

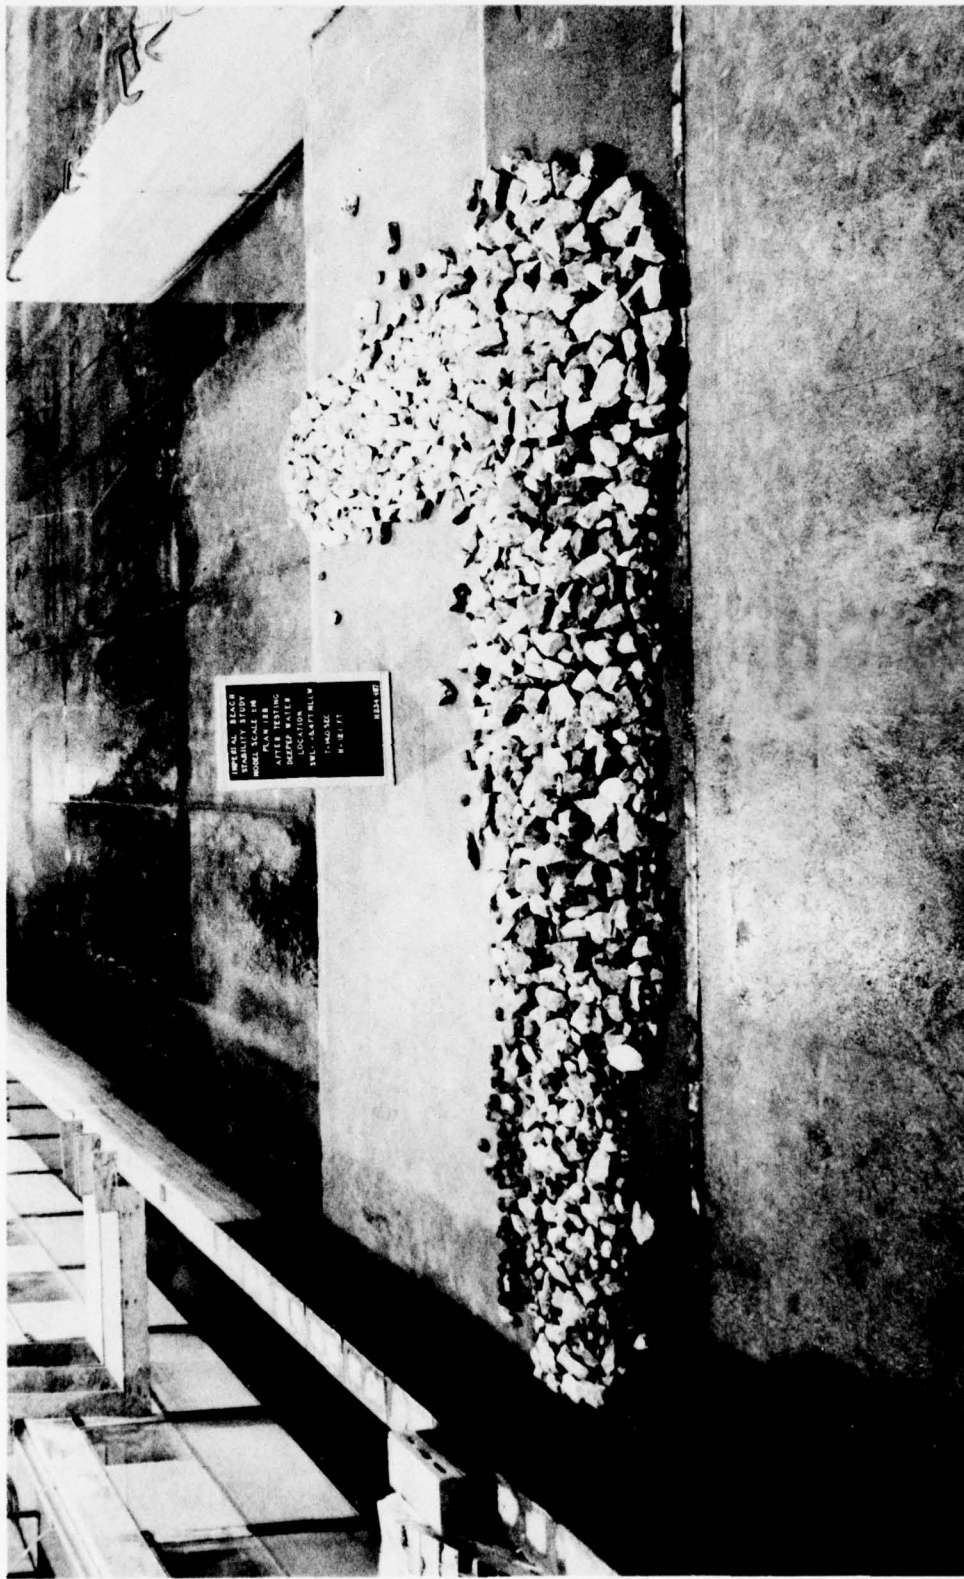
Photo 71. Sea-side view of Plan 12B in the deeper water location after 2.0 hr on high-sill head and 10-ft-high groin and 8.0 hr on remainder of breakwater of 14.0-sec, 12.1-ft waves at an swl of +5.4 ft mllw

30. Plan 12B (Plate 19 and Photo 70) consisted of the addition of a 10-ft-high, 5.0-ton graded armor stone, beach-connected groin and rebuilding of the high-sill head on Plan 12A. The remainder of the breakwater, the high- and low-sill trunks, was once again not rebuilt in order to observe the results of extended wave attack. After 2.0 hr of exposure to 14.0-sec, 12.1-ft waves at an swl of +5.4 ft mllw, the intersection between the high-sill head and groin showed significant damage and the remainder of the breakwater showed minor to moderate damage (Photos 71-73).

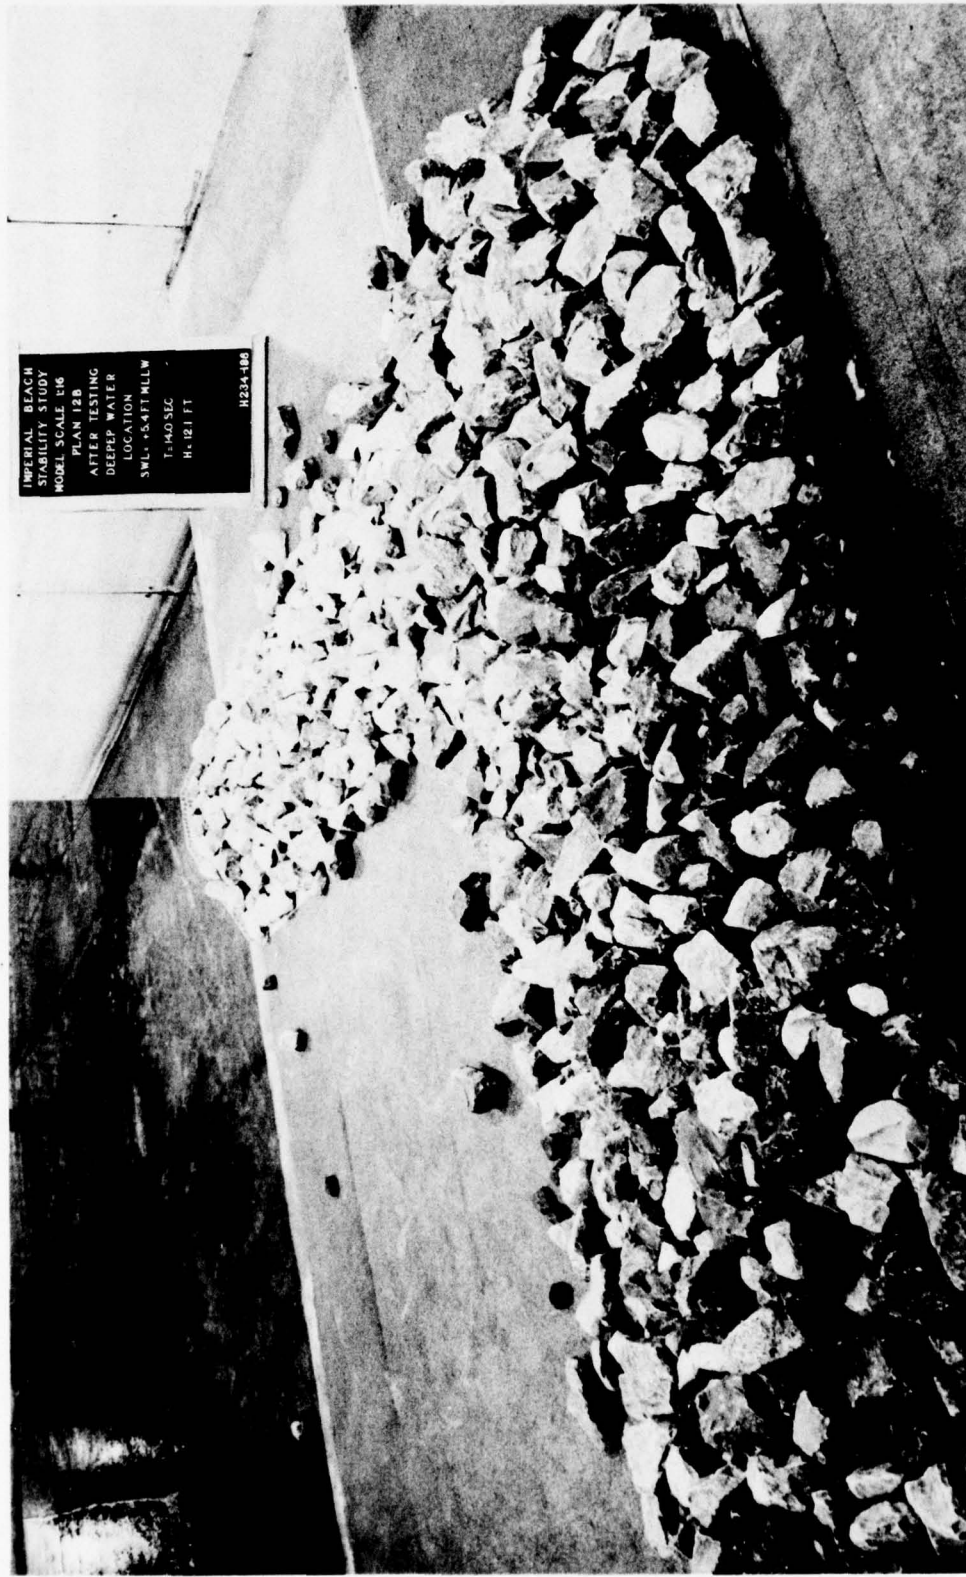
Photo 72. Sea-side view of high-sill section and 10-ft-high groin of Plan 12B in the deeper water location after 2.0 hr on high-sill head and groin and 8.0 hr on remainder of high-sill of 14.0-sec, 12.1-ft waves at an swl of +5.4 ft mllw

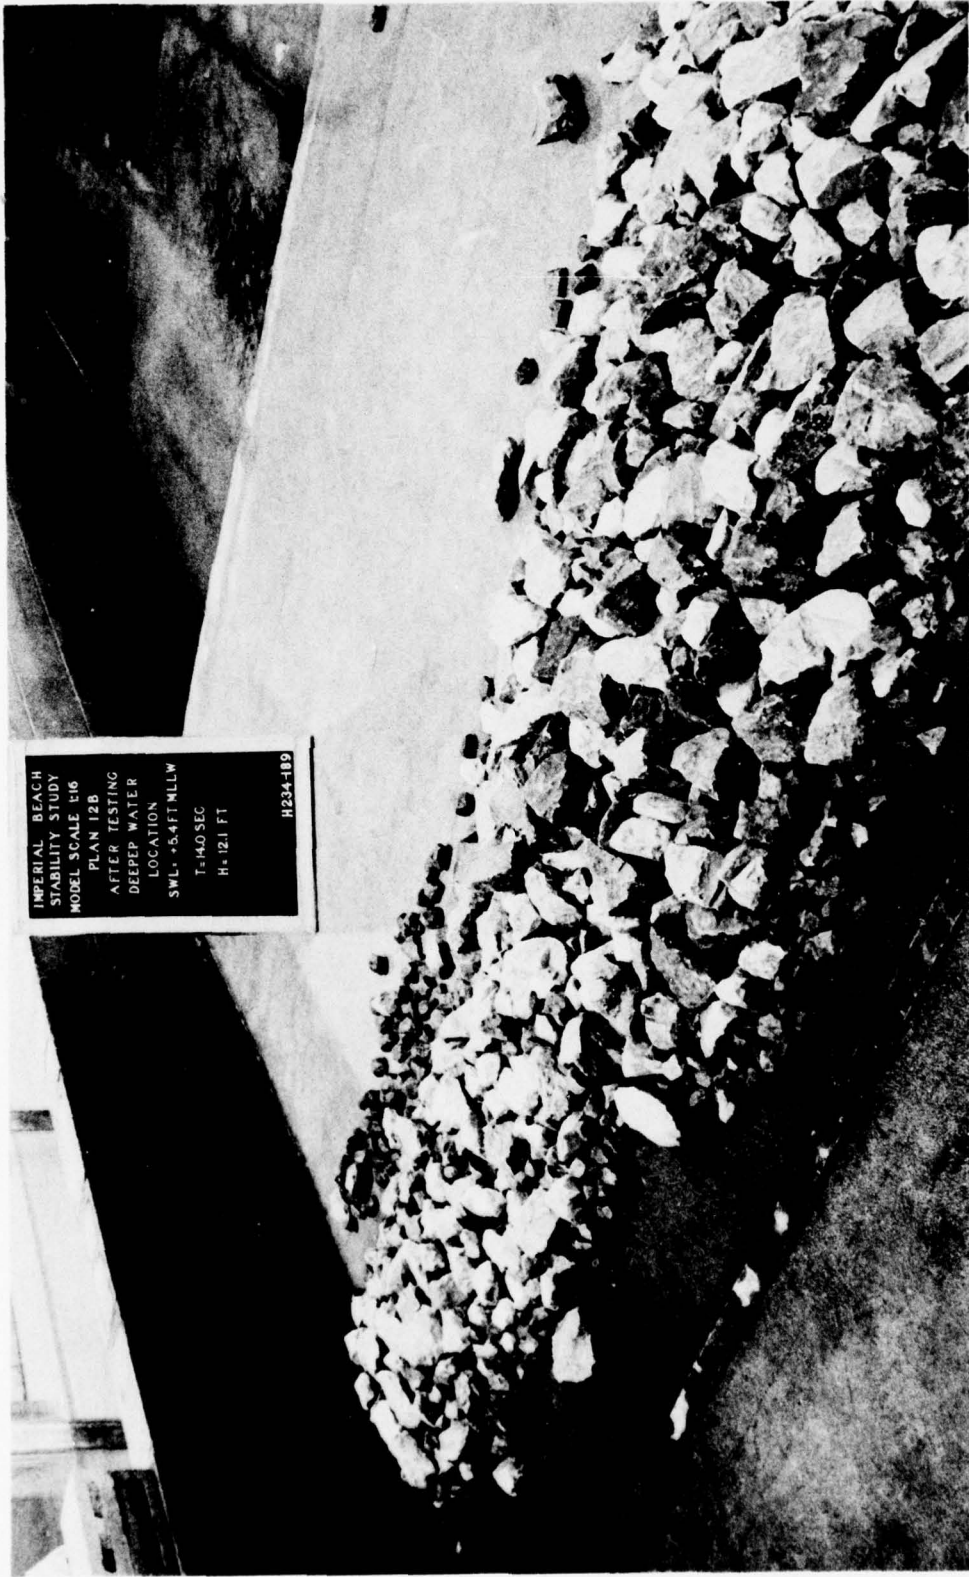
Photo 73. Sea-side view of low-sill section of Plan 12B in the deeper water location after 8.0 hr of 14.0-sec, 12.1-ft waves at an swl of +5.4 ft mllw

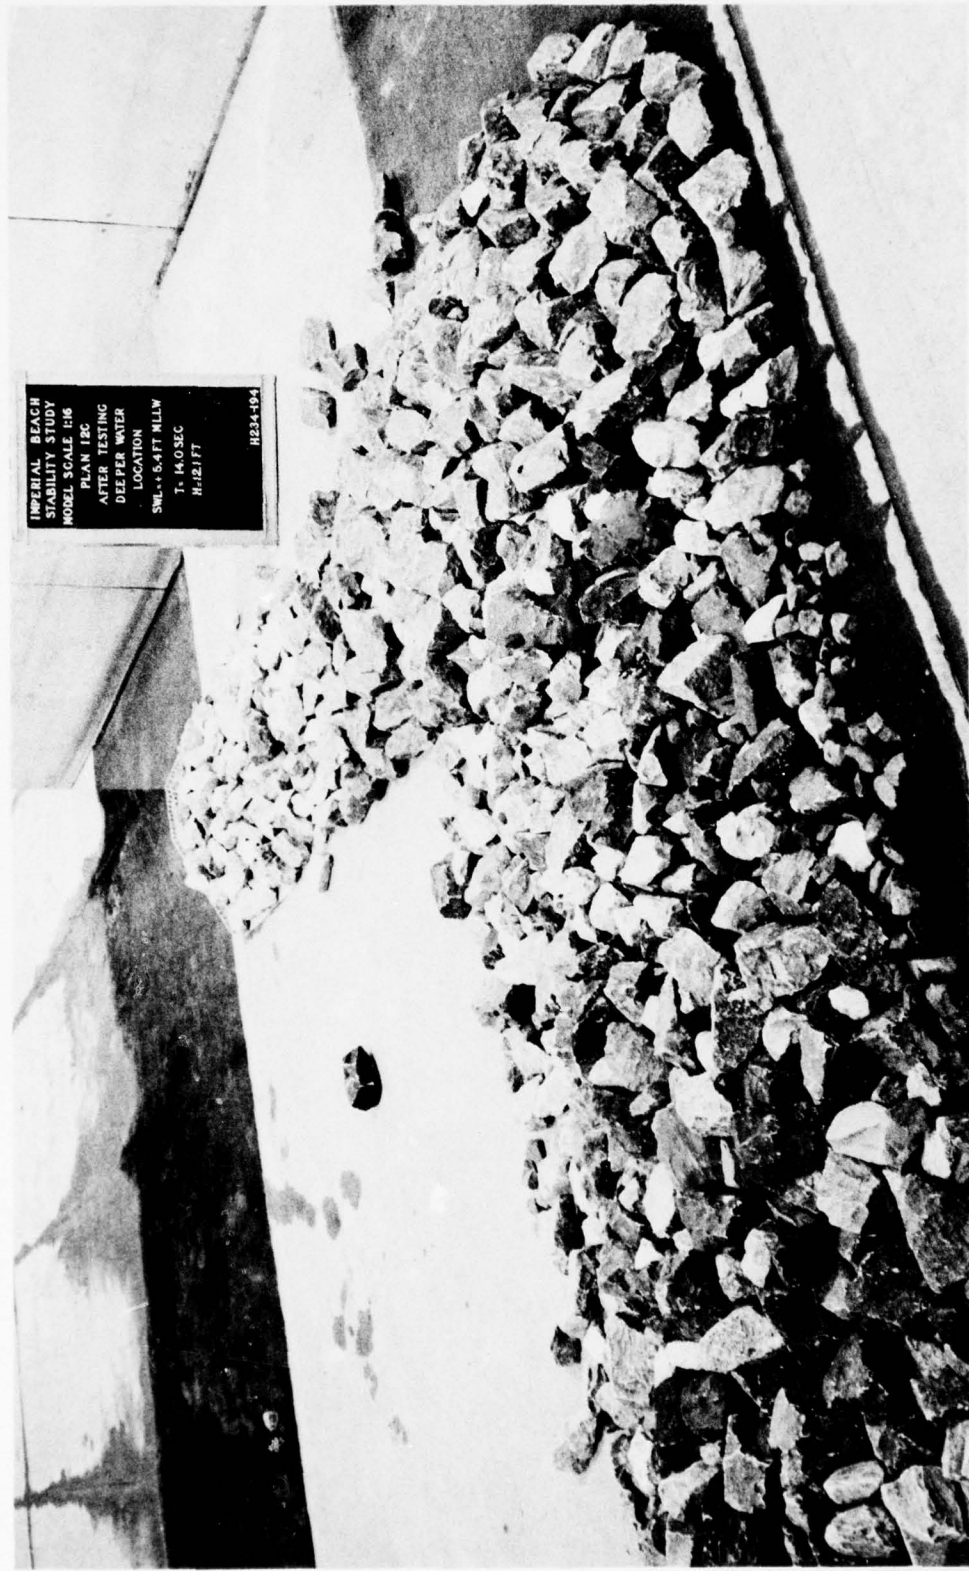
Photo 77. Sea-side view of high-sill section and 10-ft-high groin of Plan 12C in the deeper water location after 2.0 hr on high-sill head and groin and 10.0 hr on remainder of high-sill of 14.0-sec, 12.1-ft waves at an swl of +5.4 ft mllw

of +5.4 ft mllw since its initial building and had sustained minor to moderate damage (Photos 76-78).

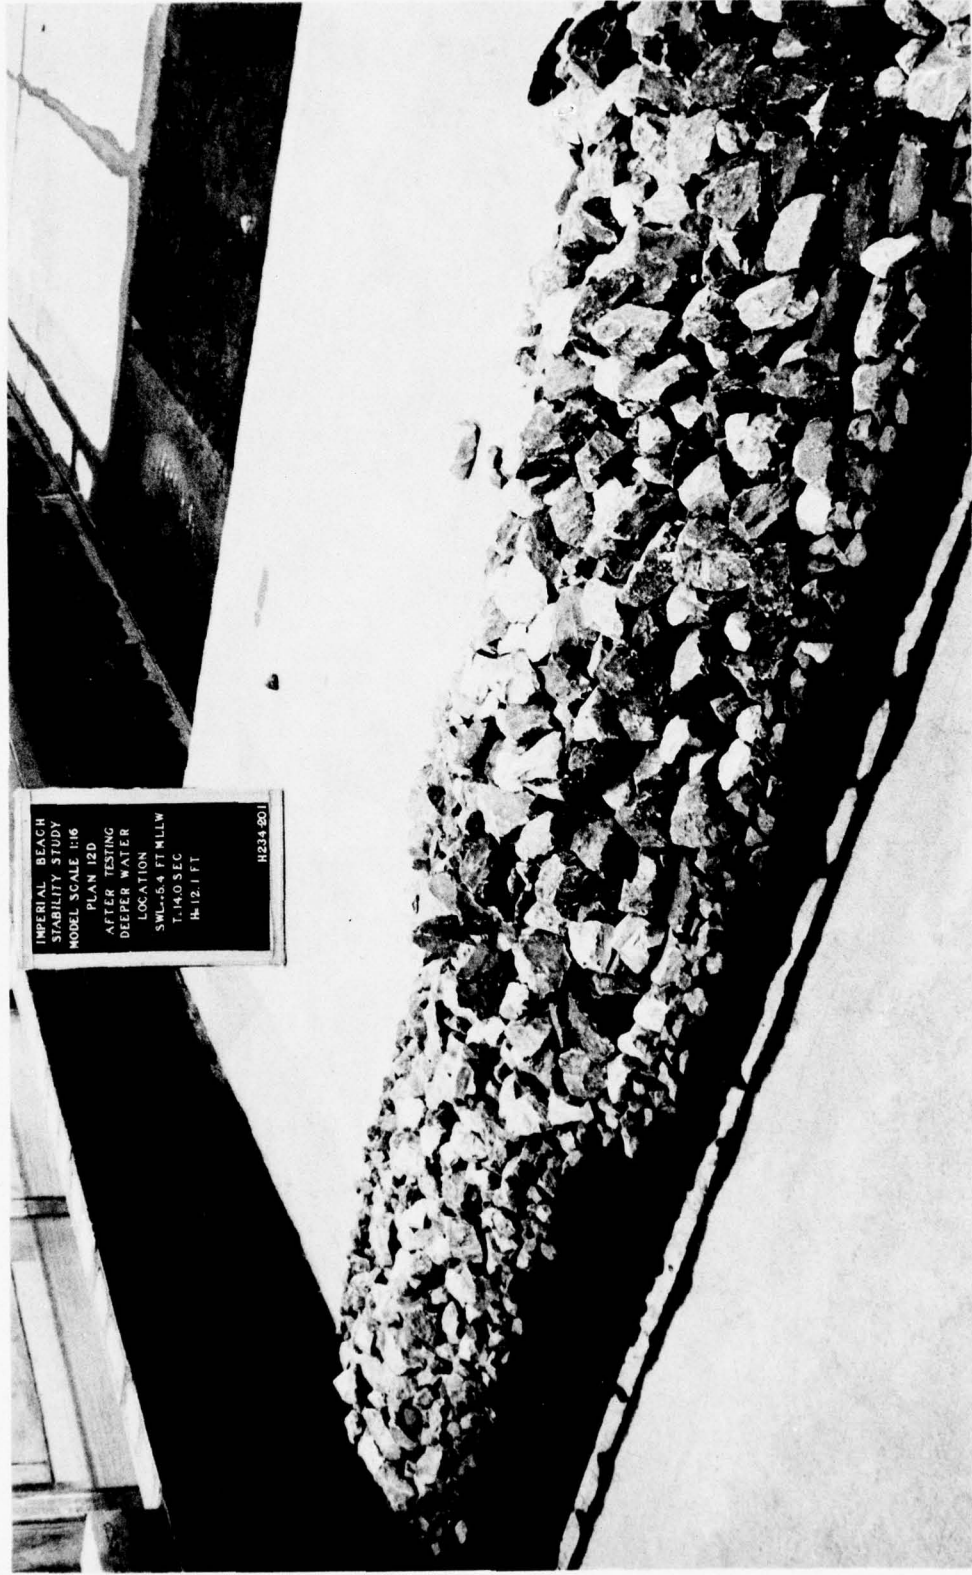
Photo 82. Sea-side view of low-sill section of Plan 12D in the deeper water location after 2.0 hr of 14.0-sec, 12.1-ft waves at an swl of +5.4 ft mllw

32. Plan 12D (Plate 21 and Photo 79) consisted of rebuilding a breakwater identical with Plan 12B except that 7.0-ton graded armor stone was used in the 10-ft-high groin instead of 5.0-ton graded armor stone. This plan was tested to determine if larger graded armor stone could be used as an alternative to capping the first 40 ft of the groin with 7.0-ton armor stone as was done in Plan 12C. After 2.0 hr of exposure to 14.0-sec, 12.1-ft waves at an swl of +5.4 ft mllw, the high-sill and low-sill trunk had accrued minor damage. The high-sill head had sustained moderate damage, very similar to previous test results. The connecting area between the high-sill head and the 10-ft-high groin showed moderate damage at the conclusion of the test (Photos 80-82). Damage in this area was somewhat less than that of Plan 12B but more than that sustained by Plan 12C when exposed to the identical test conditions.
