MISCELLANEOUS PAPER H-78-4

STABILITY TESTS OF NAWILIWILI BREAKWATER REPAIR

Hydraulics Laboratory

Final Report

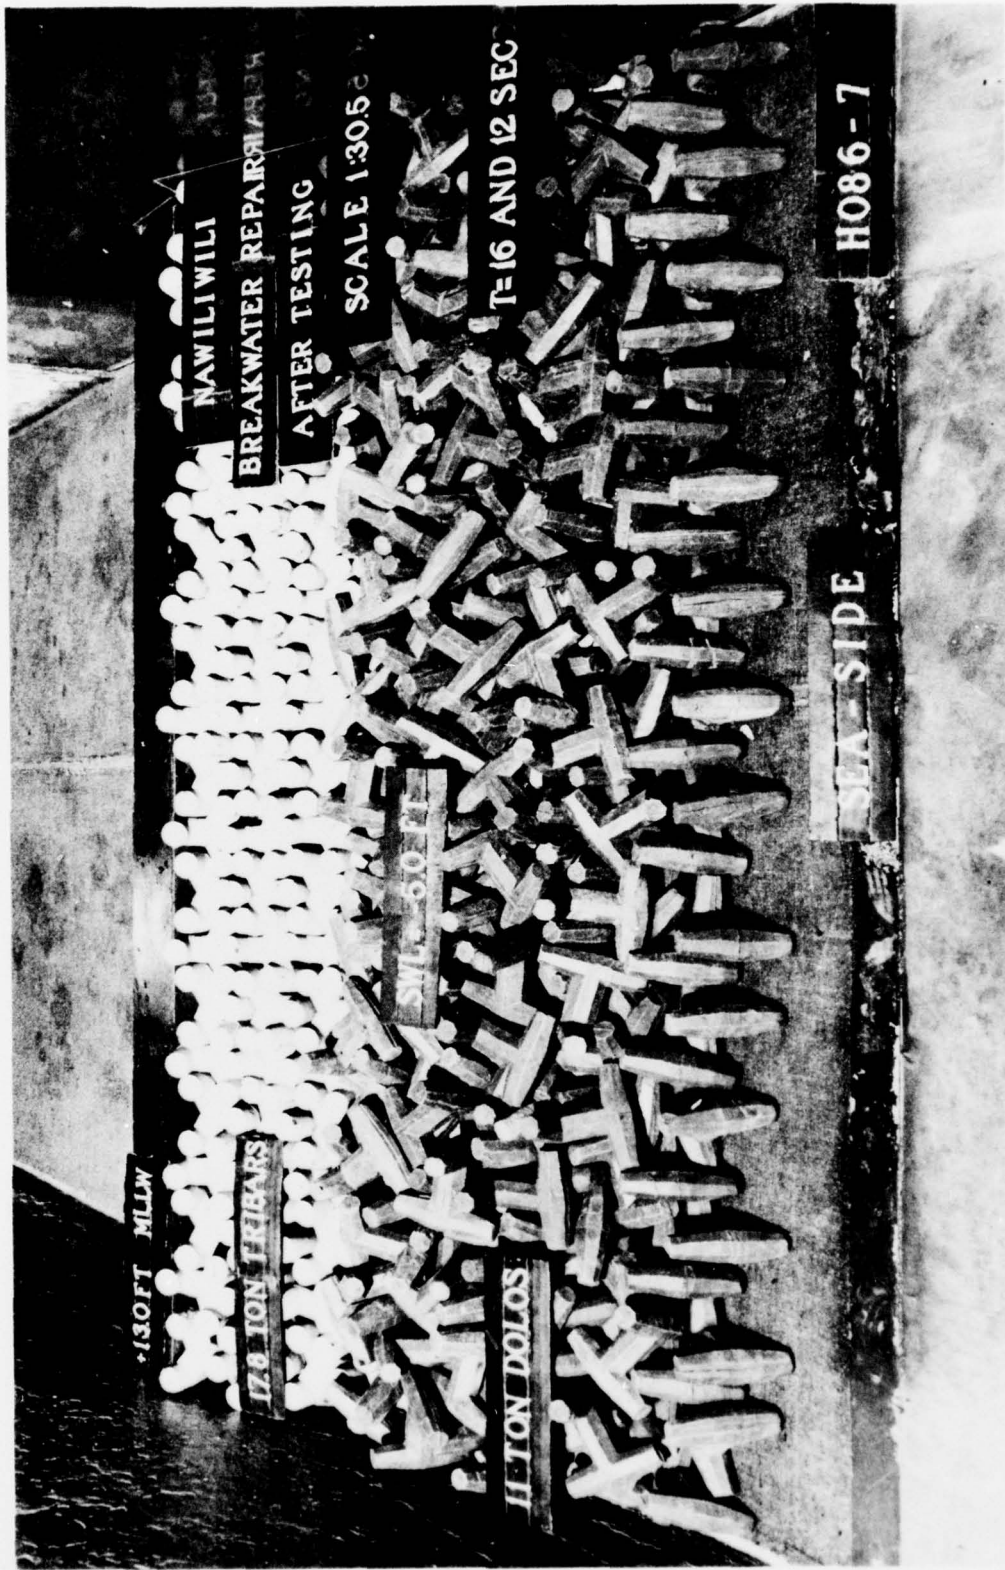
Photo 5. Sea-side view of test section 1 after testing with 16-sec, 8.9-ft and 12-sec, 8.4-ft waves at -5 ft mllw swl
