RADC-TR-77-431, Volume II (of three)
Final Technical Report
January 1978

ATEC DIGITAL ADAPTATION STUDY, Development and Field
Evaluation - Digital Automated Technical Control

Honeywell Inc.

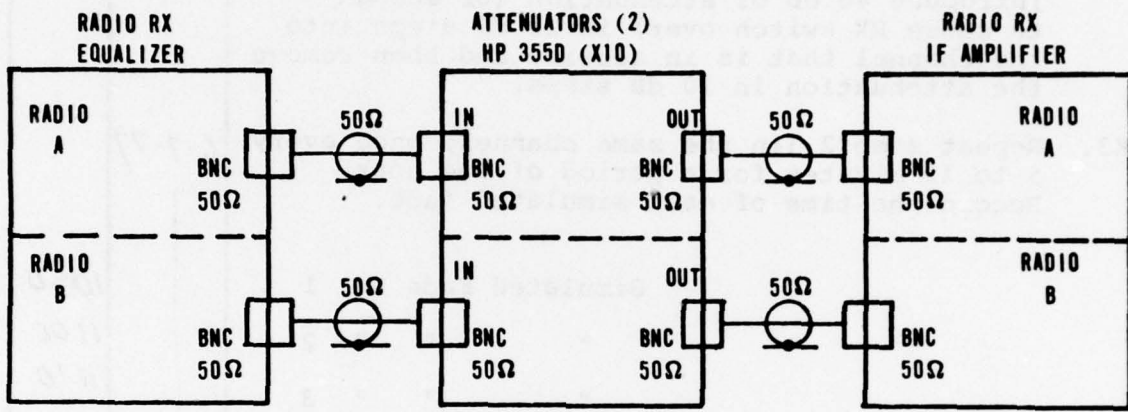
Figure K-1. Test Configuration, Link RF Fading

* Alternate attenuators which may be used:
Weinschel Engineering, Model 933

PROCEDURE	DATE	TIME
<p>K1. At HUA, connect attenuators (X10) between Equalizer and IF in RX A and RX B as shown in Figure K-1.</p> <p><u>Single Receiver Fade: -</u></p>	6-7-77	
<p>K2. In period of approximately 4 seconds: Introduce 40 dB of attenuation (or enough to cause RX switch over) in 10 dB steps into the channel that is in service and then remove the attenuation in 10 dB steps.</p>	6-7-77	
<p>K3. Repeat step 2 (In the same channel) once every 5 to 10 minutes for a period of one hour. Record the time of each simulated fade.</p>	6-7-77	
<p>Simulated Fade No. 1</p>		1050
<p>" " " 2</p>		1100
<p>" " " 3</p>		1110
<p>" " " 4</p>		1120
<p>" " " 5</p>		1130
<p>" " " 6</p>		1240
<p>" " " 7</p>		1250
<p>" " " 8</p>		1300
<p>" " " 9</p>		1310
<p>" " " 10</p>		1320
<p>" " " 11</p>		1330
<p>" " " 12</p>		1340
<p>BREAK FOR LUNCH MAINT. ADVISED TO CHECK A RX @ HUA</p>	<p>→</p>	
<p>CONDUCTED BY <u>C. L. Christy</u> 6-7-77</p> <p>OBSERVED BY _____</p>		<p>Y</p>

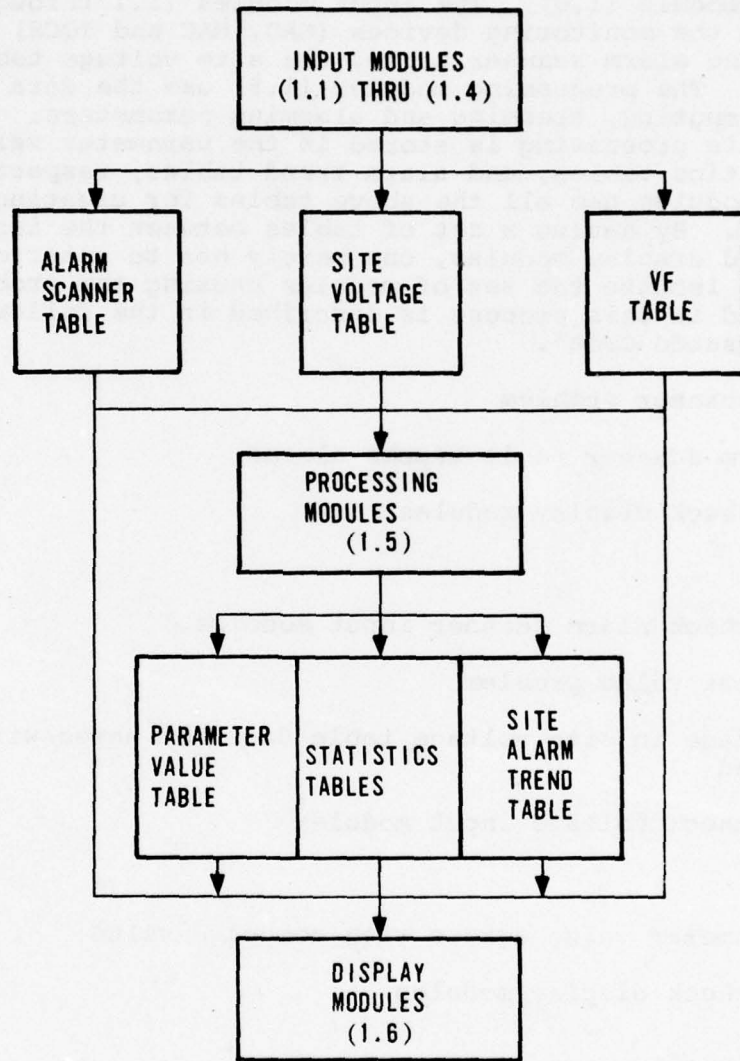
FIGURE 6-17. NODAL CONTROL SCAN MODULE

The software and data structure described in the hierarchy and HIPO diagrams allow for quick isolation of software problems. As an example, Figure 6-17 summarizes the HIPOs for the nodal control scan module (1.0). The input modules (1.1 through 1.4) get data from the monitoring devices (MAD, MAC and IQCS) and store it in the alarm scanner table, the site voltage table and the VF table. The processing modules (1.5) use the data in these tables for computing, trending and alarming parameters. The results of this processing is stored in the parameter value table, statistics tables, and alarm trend tables, respectively. The display modules use all the above tables for creating display presentations. By having a set of tables between the input, processing and display modules, one merely has to interrogate the tables to isolate the set of modules causing the problem. The logic used in this process is described in the following example of "Pseudo Code".

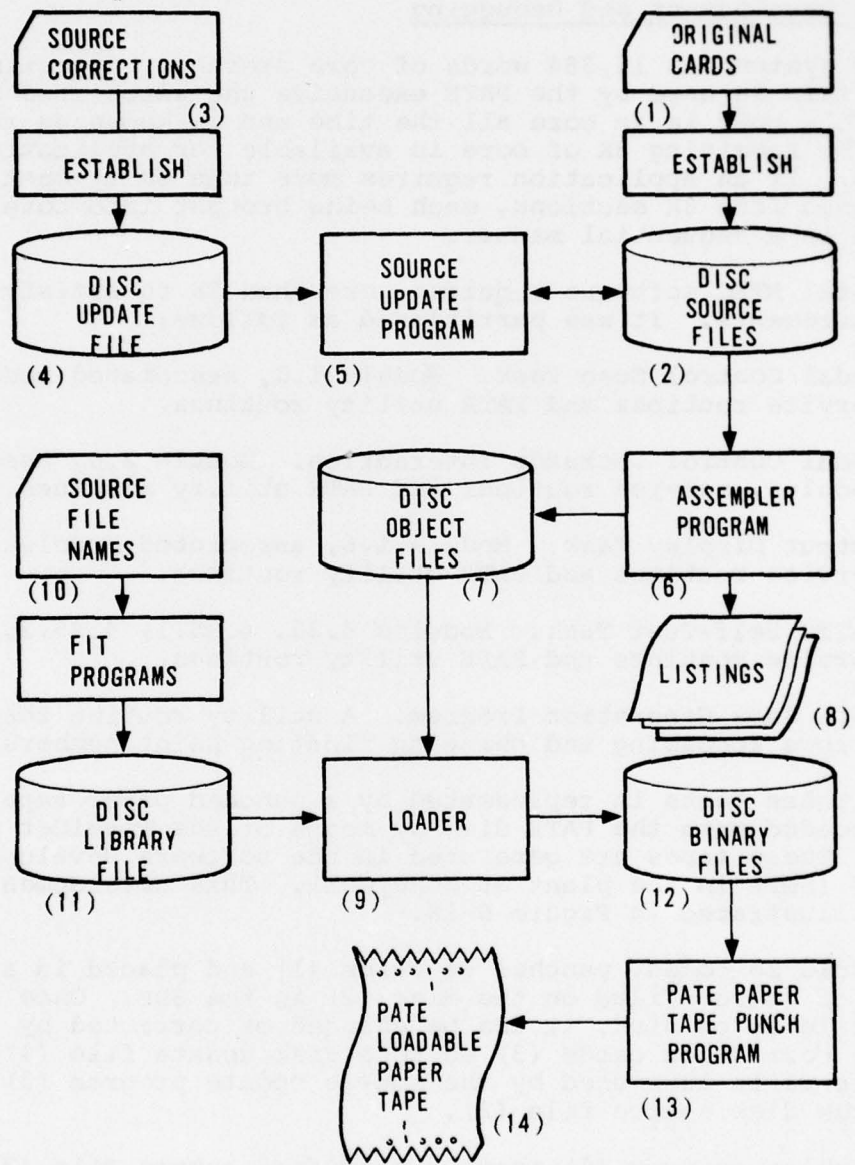
FIGURE 6-18. SOFTWARE DEVELOPMENT PROCESS

Each of these tasks is represented by a punched paper tape which can be loaded onto the PATE disk by means of the TermiNet tape reader. These tapes are generated in the software development facility (SDF) in the plant at Honeywell. This development process is illustrated in Figure 6-18.

The assembler program (6) reads a specified source file (2) and generates an object file (7) which can be read by the loader. It also generates a program listing of the specified module which is kept in a binder for reference purposes.

After all modules making up a task are in the object file state, a paper tape can be generated. This is done by entering a card deck (10) of source file names making up the task. The

fit programs search all source files in this list to determine their respective sizes and generates a disk library file (11) consisting of the object file names in the order that they are to be loaded. This file is ordered by the fit programs so as to minimize cross sector linkages. The loader program (9) loads the object files (7) as specified by the disk library file (11). The output of this loading process is a binary file (12) placed on the disk. The data in this file is in core image format which can now be read by the PATE paper tape punch program.

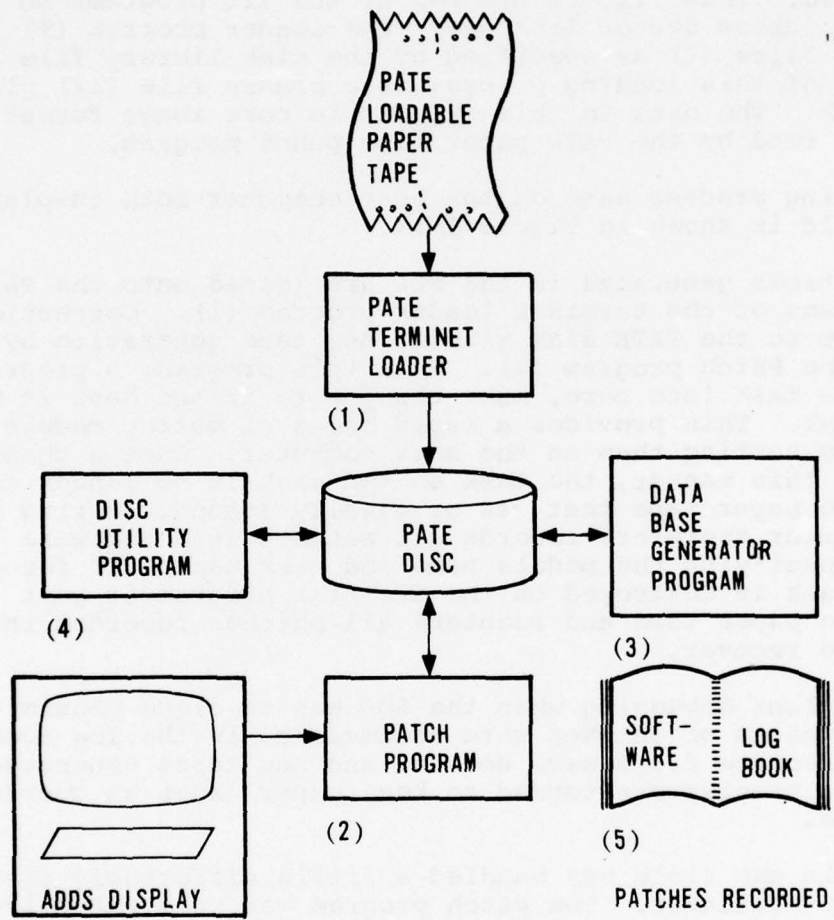
FIGURE 6-19. IN-PLANT AND FIELD CHECKOUT PROCESS

The debugging process used on the host computer both in-plant and in the field is shown in Figure 6-19.

Debugging in the field was handled a little differently since the SDF was not available. The patch program was used extensively to make corrections and modifications. These were carefully recorded in the software log book. In addition, a disk backup system was used. The PATE disk has a fixed disk and a removable disk. These two packs contain the same information. When a task is patched it is written to both the fixed and removable disks. A three disk cycle was used to save information and provide backup capability. After patching a task the removable disk is taken off the drive and replaced by the oldest disk in the cycle. The disk utility program (4) is then used to copy the fixed to the removable. If the disk was ever destroyed, the latest backup could be used to restore the system.

The software development and debugging procedures described were quite effective in both in-plant and field checkout. They were simple to use and learned in a minimum amount of time by new programmers. The many software improvements, some quite
