REPORT OF GOVERNMENTAL OPERATIONAL VERIFICATION TEST ON A/S 32 P-15 FIRE FIGHTING TRUCK

DIRECTORATE OF FIRE PROTECTION

FEBRUARY 1978

AIR FORCE CIVIL ENGINEERING CENTER
(AIR FORCE ENGINEERING AND SERVICES AGENCY)

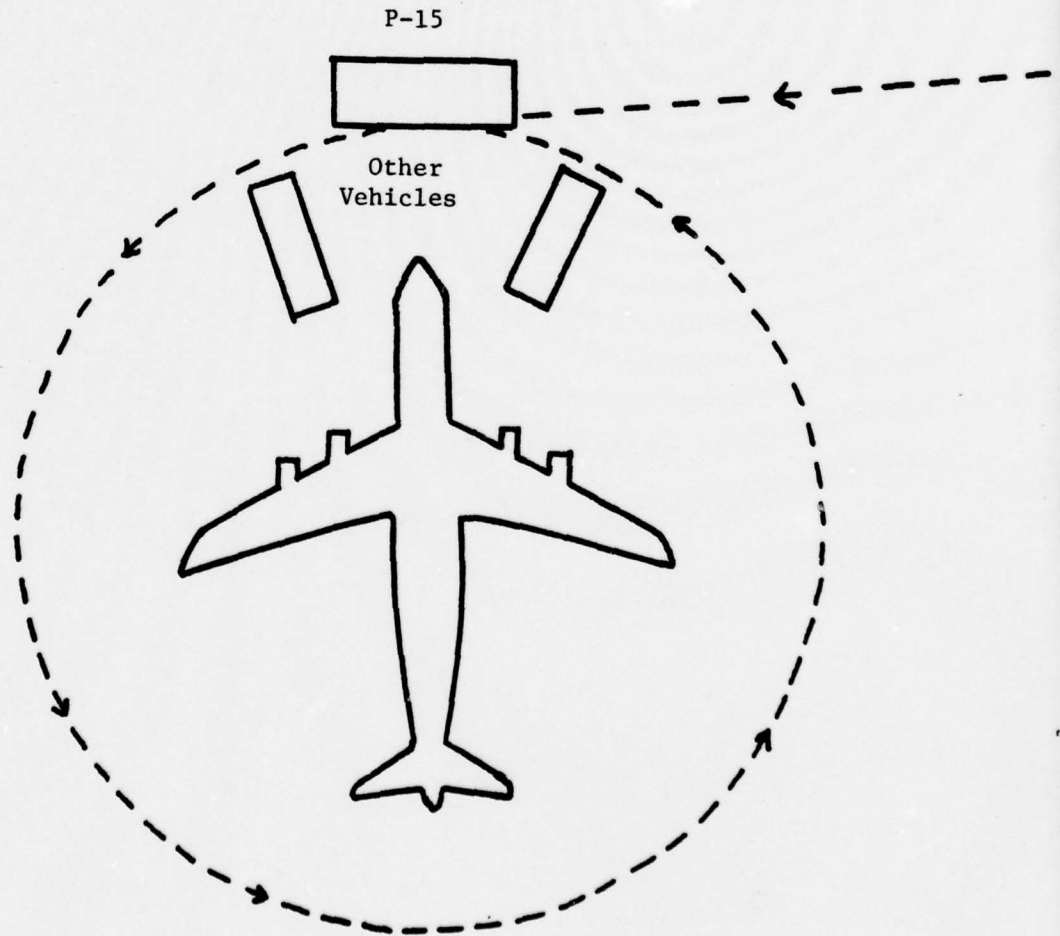
IDEAL P-15 APPROACH TO FIRE

5.1 Several factors affecting the employment of the P-15 are its size, maneuverability, and crew proficiency. The size of the vehicle will constrain its use in narrow or confined spaces, as well as create a potential traffic hazard. Overhead power and telephone lines may restrict the routes available for response to the fire scene and for trips to vehicle maintenance facilities. The vehicle's 75 foot (22.875M) turning radius may restrict its use in POL and ammunition areas, in addition to limiting its use in mutual aid of other firefighting organizations. The dimensions of the fire station stall will preclude turret operators from assuming their firefighting positions before leaving the fire station. The proficiency of the crew will depend on proper training, adequate communication, and sound teamwork with other firefighting vehicles.
