TECHNICAL REPORT H-78-3

MODEL STUDIES OF THE PORTUGUES AND BUCANA RIVERS CHANNELIZATION PUERTO RICO

Hydraulic Model Investigation

Noel R. Oswalt

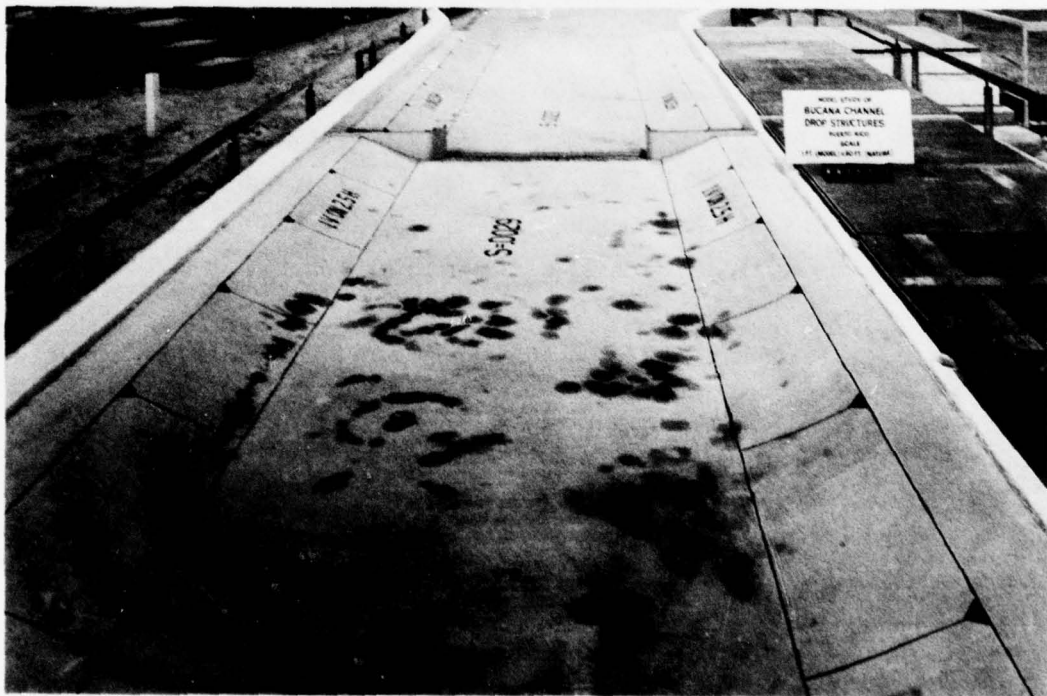
a. 3300-ft test channel

b. Drop structures

Figure 2. Bucana Channel test facility

7. A 1:30-scale model (Figure 2a) reproduced 3300 ft (prototype) of test channel including both trapezoidal and rectangular sections. Initially, this model represented the Bucana Channel between sta 131+20 and 164+00 (Plate 1); and later it was used as a typical channel reach to study the transitions and stilling basins, including riprap stability downstream from the basins.

8. The second model (Figure 2b) was also constructed to a 1:30 scale and reproduced about 1200 ft of the 150-ft-wide Bucana Channel for studying the drop structures and the adjacent riprap protection requirements (Plate 2). The trapezoidal sections of both models were molded in sand and cement mortar to sheet-metal templates initially to test the original structures within the channel. All transitions, stilling basins, rectangular channel sections, and drop structures were made of plastic-coated plywood and some sheet metal. Riprap replaced the cement mortar in later tests to determine the riprap protection requirements with the recommended structures. Filter cloth was placed between the sand and the graded riprap for all riprap tests. The gradations of riprap simulated and tested in the model compare with those based on Engineer Technical Letter 1110-2-120* for 165 lb/cu ft riprap placed in the dry with a $1.0 D_{100}$ maximum thickness.

12. Tests to determine the adequacy of the Bucana Channel drop structures 1-4 (Plate 2) were conducted in the facility shown in Plate 3 and Figure 2b. For expediency, the initial test channel was covered with grout in lieu of riprap. The channel riprap requirements were determined in later tests after the optimum drop structure design had been developed.

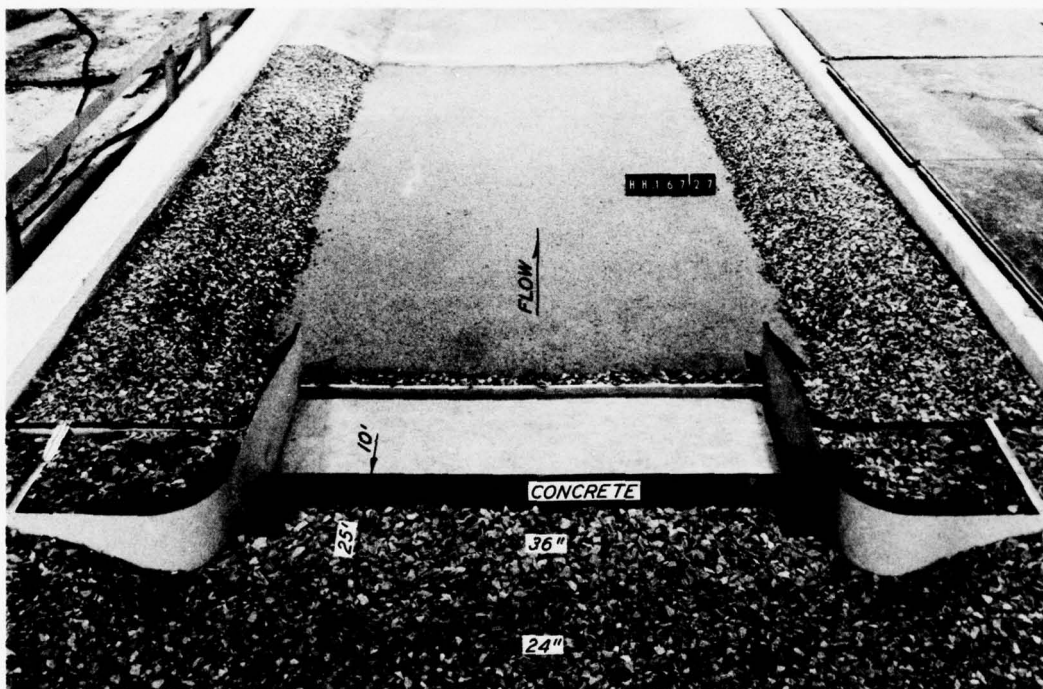
Figure 4. Drop structure 4, design 4, type 1 riprap plan (looking downstream)

20. Unfortunately, the design 4 structure increased hydraulic capacity and approach velocities relative to those with the original drop structure 4, and would require costly additional protection upstream (Figure 4). Therefore the original basin design was favored and recommended for the prototype.

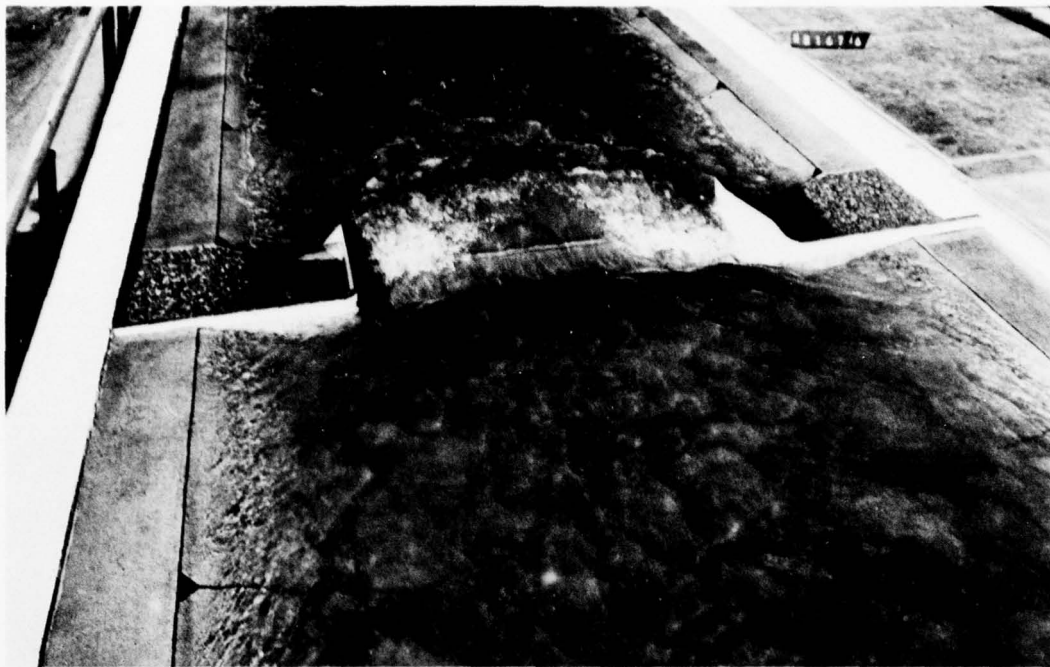
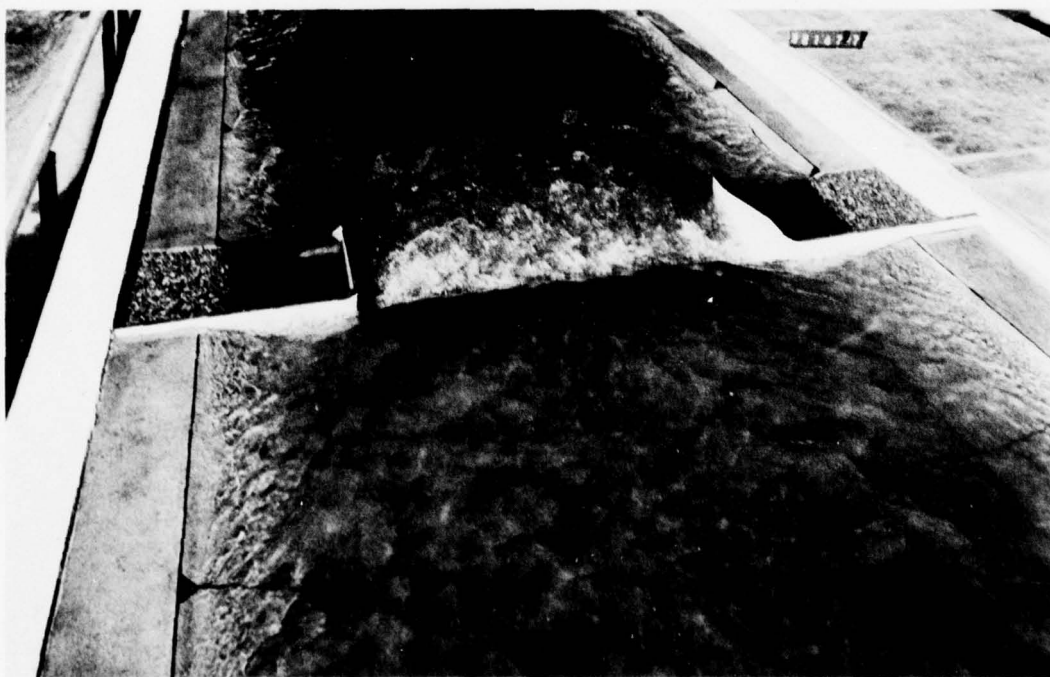
a. Tailwater el 81.2 (1.8 ft below rating curve); hydraulic jump is sweeping out of drop structure

b. Tailwater el 82.1 (0.9 ft below rating curve); forced hydraulic jump

Photo 3. Drop structure 1 (original design), design flow 27,800 cfs
(sheet 1 of 2)

c. Tailwater el 83.7 (0.7 ft above rating curve);
good hydraulic jump

d. Tailwater el 84.5 (1.6 ft above rating curve);
mild eddy on each side of drop structure

14. Performance curves obtained for drop structure 1 throughout the range of expected operation (Plate 7) indicated that the original design structure would provide a satisfactory drop in water surface without increasing downstream velocities or creating adverse flow patterns. Photographs of the flow conditions observed with the design flow of 27,800 cfs and a range of tailwaters beyond those expected are provided in Photo 3. Both upstream and downstream velocities for the original design are provided in Plates 8 and 9.

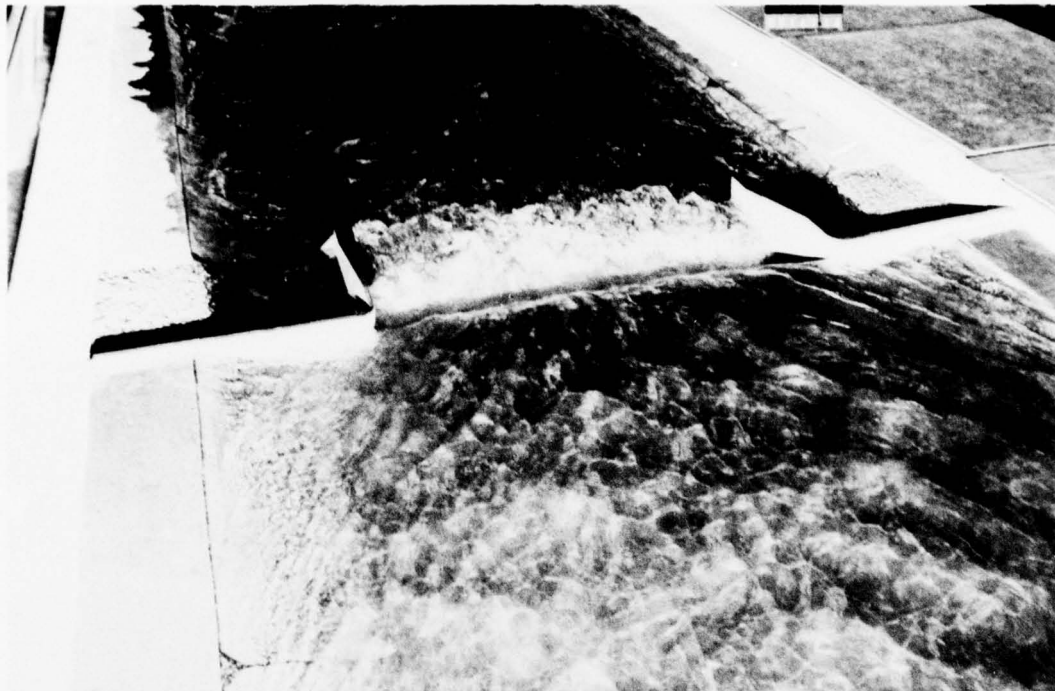
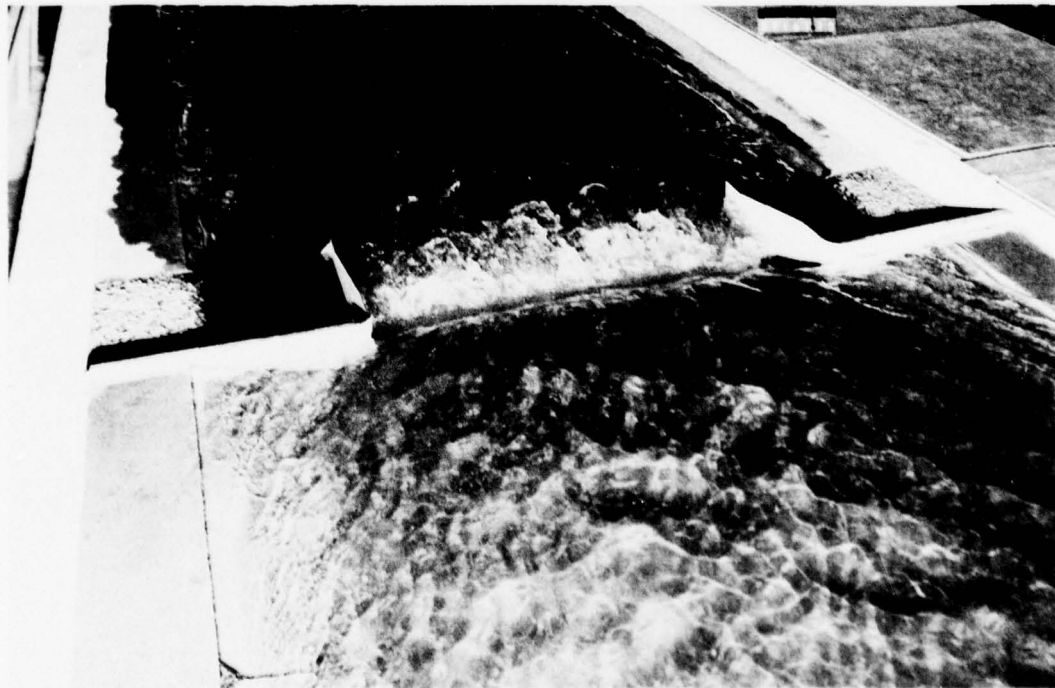
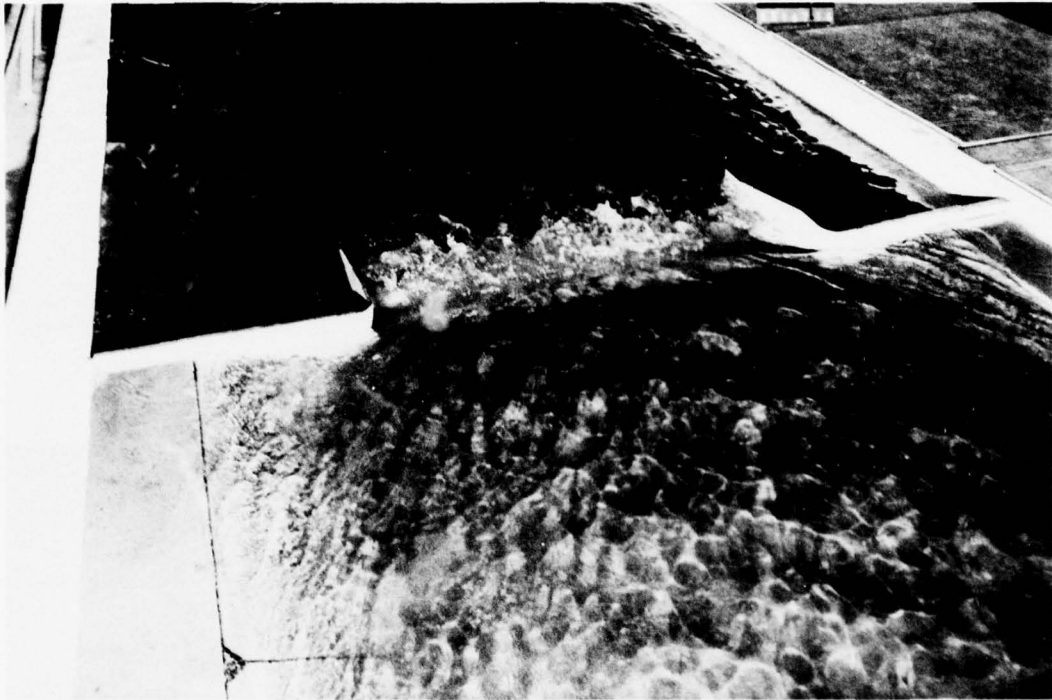
a. Tailwater el 103.2, forced jump

b. Tailwater el 104.5, good jump

Photo 5. Drop structure 3, design flow 24,700 cfs (sheet 1 of 2)

c. Tailwater el 108.6, submerged jump

Photo 5. (sheet 2 of 2)

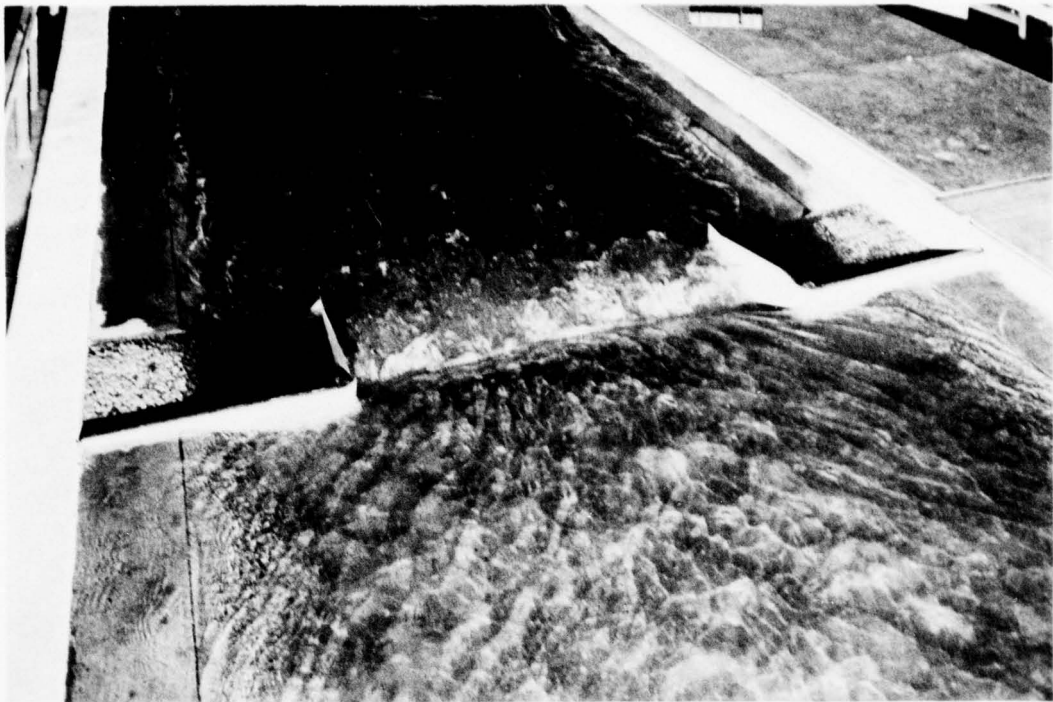
a. Tailwater el 116.8, good jump

b. Tailwater el, 119.2, eddies

Photo 6. Drop structure b (original design), design flow 24,700 cfs

18. Performance curves on drop structure 4 (Plate 16) for the full range of expected flows up to 24,700 cfs indicated that the original design would provide a satisfactory drop in water surface without creating a significant increase in downstream velocities. However, a mild eddy did develop with the normal tailwater and reduced velocities in each side of the drop structure. This intermittent eddy occurred on each side of drop structure 4 as sketched in Figure 3 with tailwaters 0.5 ft or more above the normal tailwater. This created reverse flow, reduced the effective width of drop structure, and created higher velocities in the remaining width of structure. Photographs of good and bad flow conditions with the original design and a discharge of 24,700 cfs are shown in Photo 6.

19. The eddies observed at tailwater elevations of 0.5 ft or more above normal with drop structure 4 (Photo 6b) were attributed to the abrupt approach walls and the related tailwater elevation. Therefore modifications to the original approach walls were tested to prevent occurrence of these eddies. Various semicircular, curved, and straight walls were tested. Design 4, shown in Plate 17, consists of a 35-ft upstream extension of the approach walls on each side with a 15-ft radius at the abutments. This design prevented the eddies and reduced the maximum downstream velocities. A comparison of the original design and design 4 velocities (Plate 18) shows the improved flow distribution and reduced velocities near the invert with design 4. Walls shorter than 35 ft were not as effective in improving flow conditions. Water-surface profiles of the original design and design 4 are shown in Plates 19 and 20, respectively. Photographs of flow conditions with

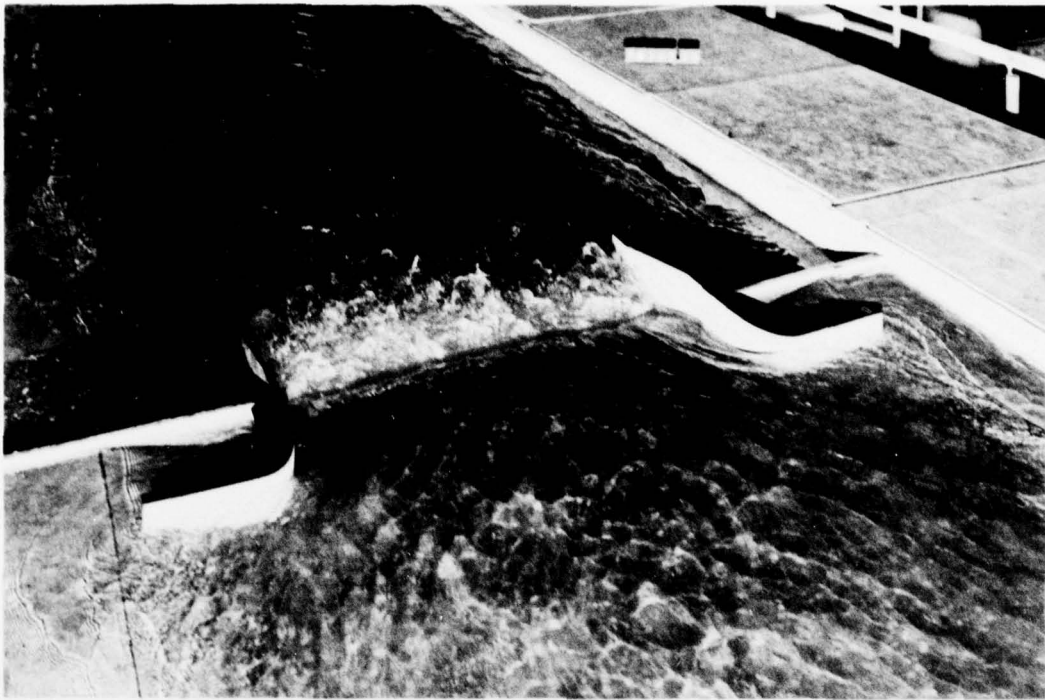
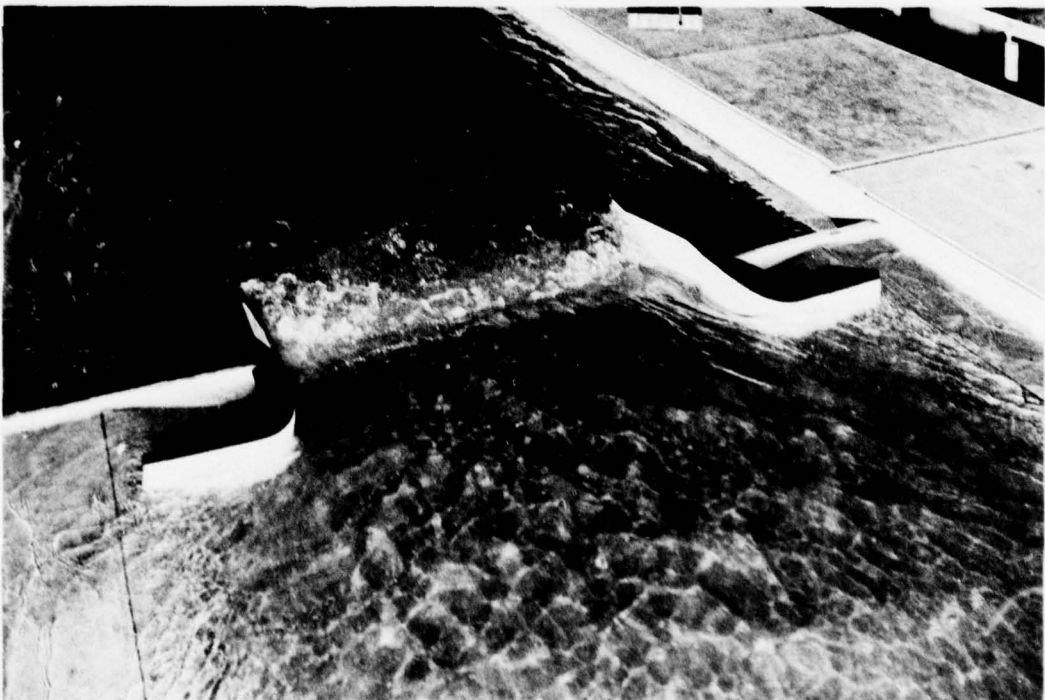
a. Tailwater el 116.8, good jump

b. Tailwater el 119.2, good jump

Photo 7. Drop structure h (design h), design flow 24,700 cfs

design 4, a 24,700-cfs design flow, and tailwaters of 116.8 and 119.2 are shown in Photo 7.

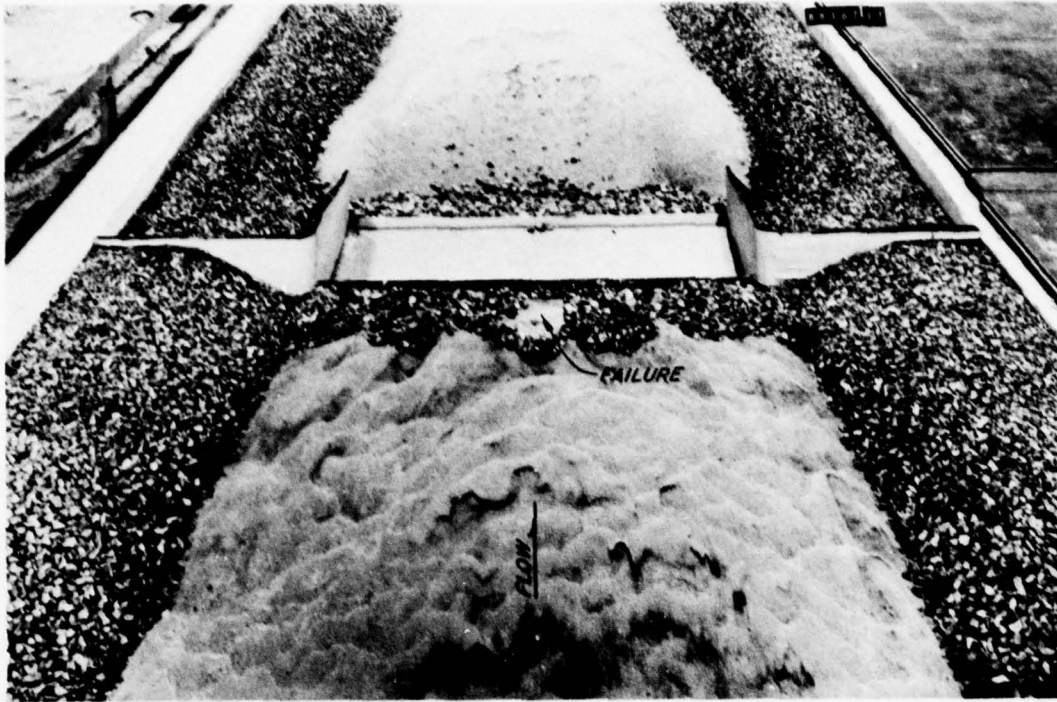
a. Looking downstream

b. Looking upstream

Photo 8. Drop structure 1 (original design); failure of type 8 riprap plan after 30-min (prototype) operation with 27,800-cfs flow

22. The type 8 riprap plan recommended for drop structures 2, 3, and 4 was not recommended for drop structure 1 because the 24-in. riprap upstream of the structure failed as shown in Photo 8. Any appreciable movement of riprap in model tests was considered failure. Some 36-in. riprap upstream of the structure moved after the 24-in. riprap had failed in a previous test; however, a 20-ft-long horizontal blanket of 36-in. riprap plan 10) of the structure was stable (Photo 9). Deposition of model sand and riprap downstream of the upper sill resulted after each test and indicated that maintenance will probably be required after the larger floods for all four drop structures. The deposition of sand and loose stone in the structure downstream of the upper sill (Figure 5)

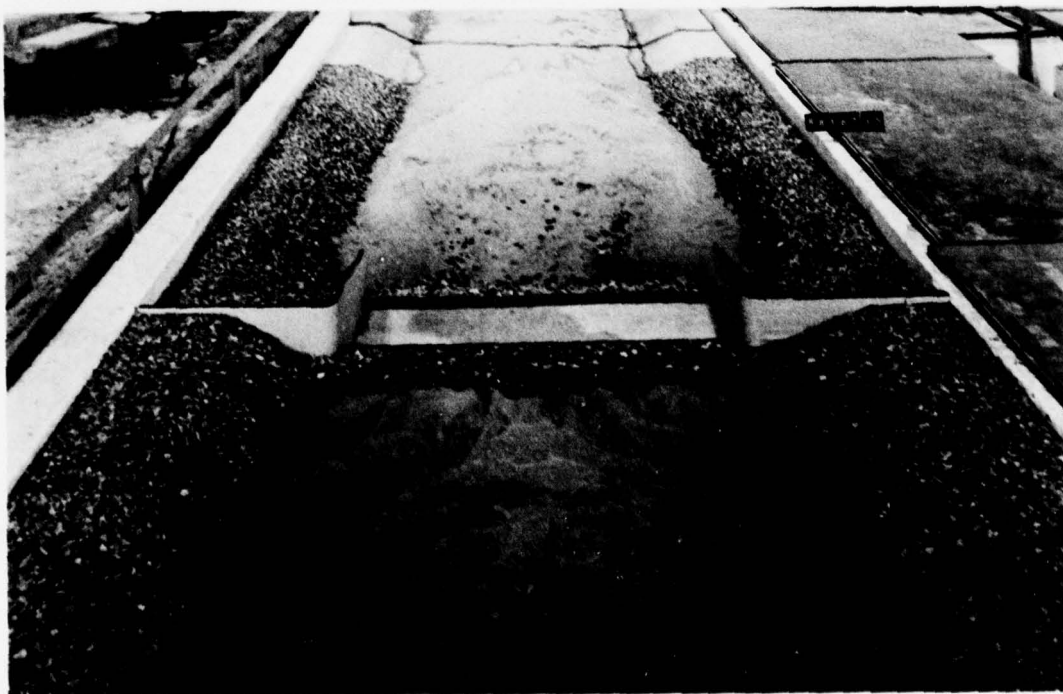
Photo 10. Drop structure 4 (design 4); type 8 riprap plan (recommended) after 1-hr (prototype) operation with 24,700-cfs flow

23. Photo 10 shows the recommended riprap design 8 for drop

structure 4 taken after the design flow. This condition is typical of that expected at drop structures 2, 3, and 4.

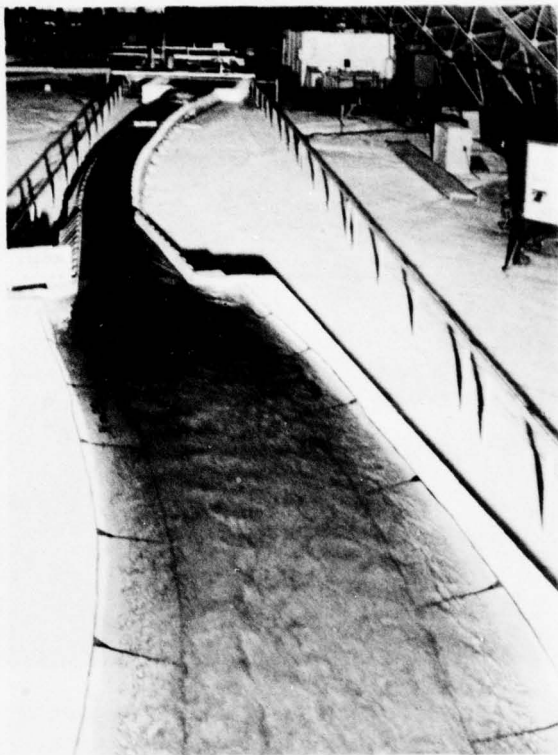
Photo 11. Overall view of
model (Bucana Channel, orig-
inal design); design flow
28,900 cfs

24. Tests in the high-velocity reach of Bucana Channel between sta 164+00 and 131+00 were conducted to determine the adequacy of the original design channel alignment, transition, and stilling basin. Although the original channel retained the design flow of 28,900 cfs within the vertical walls as shown in Photo 11, the turbulence and standing waves generated in the original transition (Photo 12) were improved by design 2 (Plate 23). This modification shortened the transition, remained within the original channel right-of-way, streamlined the flow, and lowered the water surface. A water-surface profile obtained along the center line of the original channel is provided in Plate 24. Tests with the design 2 transition between sta 157+48 and 154+20 indicated improved flow conditions. The entire Bucana Channel water surface between sta 139+00 and 154+00 was lowered an average of 2 ft, and the surface reflected waves were greatly reduced as shown in Photo 13. However, an increase in water level of 2 to 3 ft resulted upstream of the design 2 transition. Modifications to the transition shown in Plate 25, design 3, lowered the water surface upstream and retained the improved flow conditions. Flow conditions with the design 3 transition are shown in Photo 14 and a water-surface profile is provided in Plate 26. The design 3 transition is recommended for the prototype.

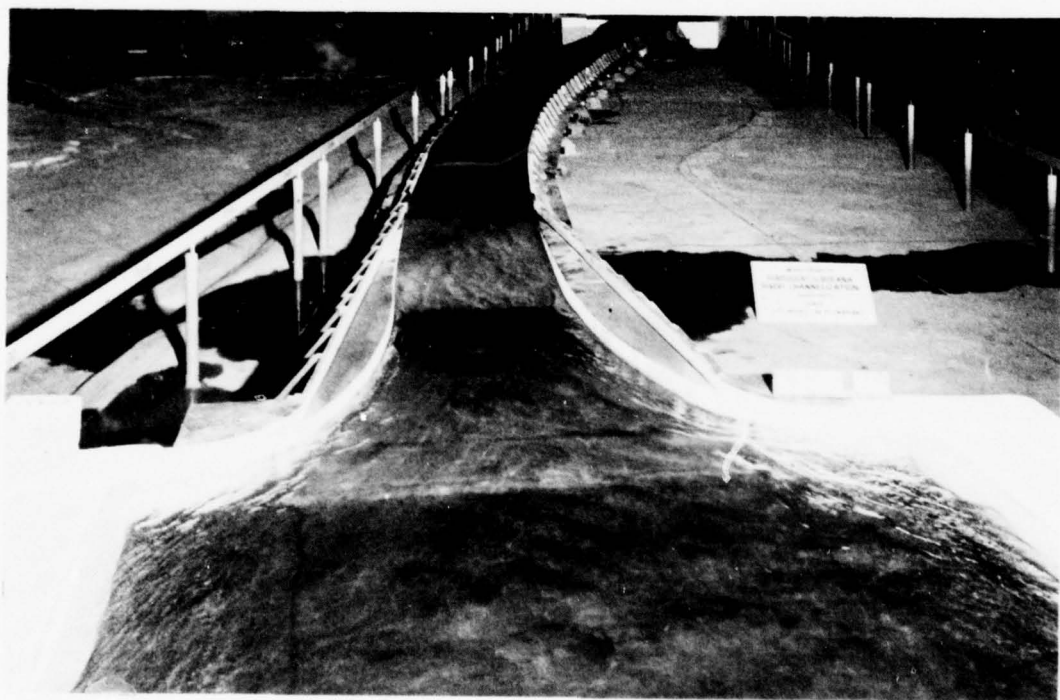
Photo 14. Bucana Channel design 3 transition at sta 157+81; design flow 28,900 cfs, bottom slope 0.0514

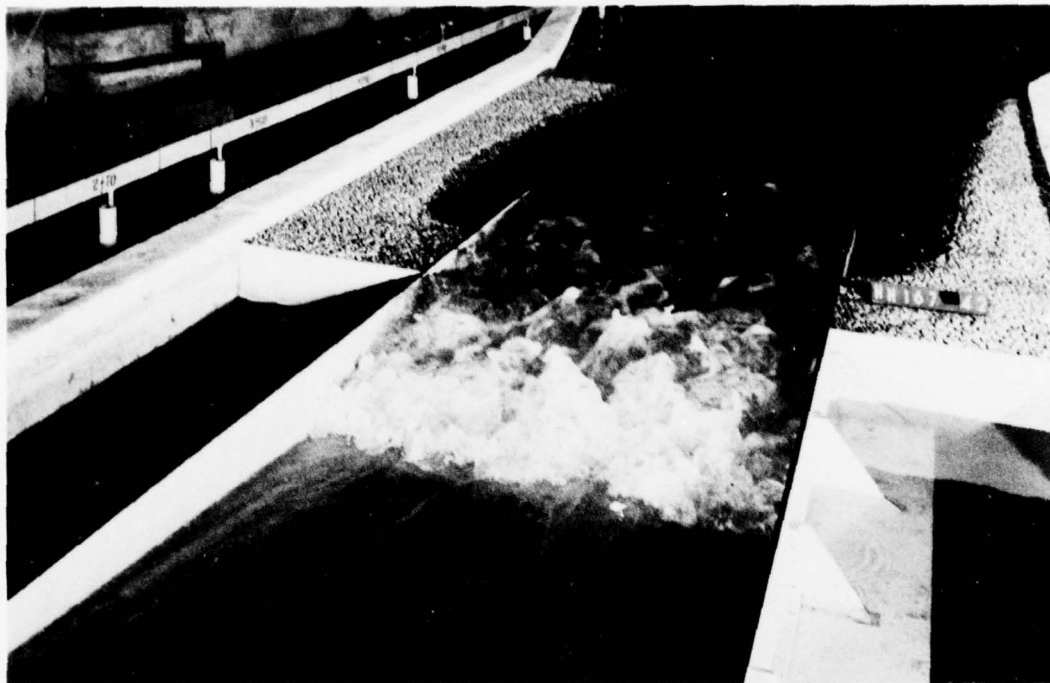
Photo 17. Stilling basin B-2 (original design); design flow 28,400 cfs, tailwater el 56.3

operating the model and Photo 17 shows the basin with the design flow of 28,400 cfs. Failure of the original design 24-in. riprap is shown in Photo 18. Lowering the end sill and exit channel as discussed in paragraph 32 prevented movement of the 24-in. riprap. A weak hydraulic jump formed in the basin, although velocities downstream were not equally distributed across the channel (Plate 31). Also, there was a considerable drawdown of the water surface immediately downstream from the end sill (Plate 32). The unequal distribution of velocities was attributed to the transition upstream between sta 188+92.8 and 187+66, and the drawdown in water surface was attributed to the high end sill.

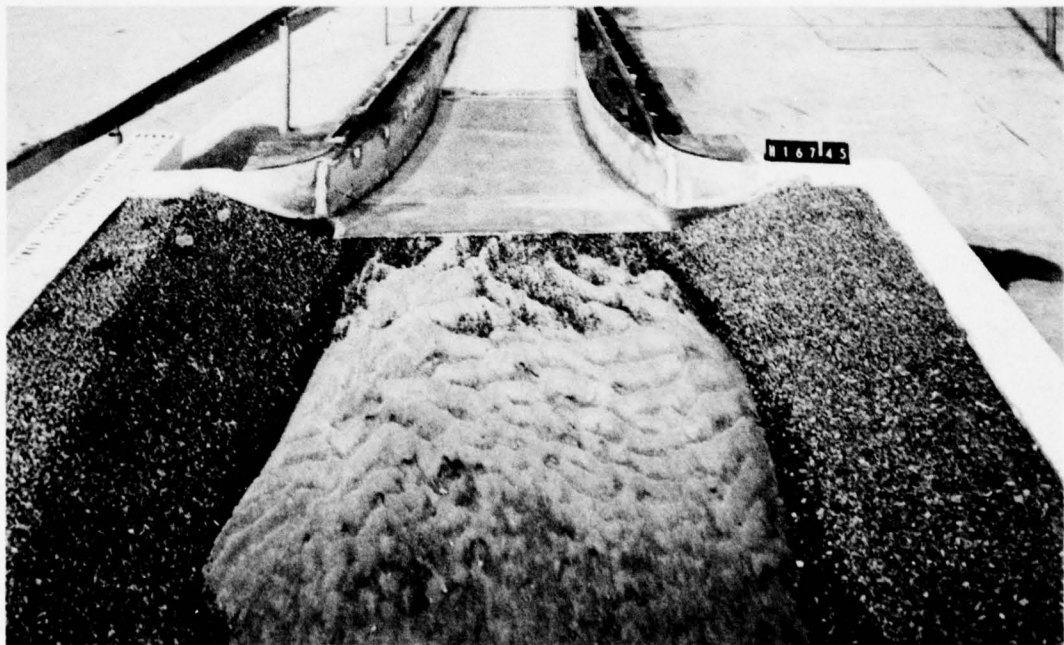
Photo 23. Original riprap plan after 30-min (prototype) operation with design flow 28,900 cfs, Bucana transition design 3

37. The original riprap protection upstream of transition design 3 (Plate 44 and Photo 22) was exposed to the design flow for 2 hr (prototype), causing some movement of the sand bottom and loose stone without actual failure or damage to the 18-in. riprap bottom or slopes (Photo 23). The original riprap protection plan (Plate 44) withstood 9-hr additional exposure with 28,900 cfs without damage and is therefore recommended for the prototype.
