MISCELLANEOUS PAPER C-78-16

TESTS OF BRICK-VENEER WALLS AND CLOSURES FOR RESISTANCE TO FLOODWATERS

U. S. Army Engineer Waterways Experiment Station
P. O. Box 631, Vicksburg, Miss. 39180

December 1978

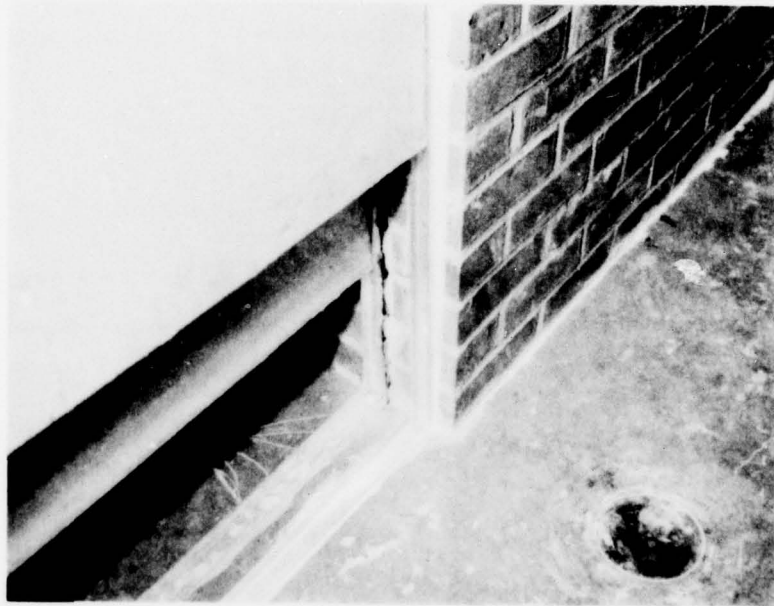
Figure 15. Two sheets of plywood used to form a closure

- d. Channels were attached to the brick sides of the door opening and angles were fixed at the base to hold a piece of plastic-coated plywood as a closure (Figure 14). Two sheets of plywood (Figure 15) were used in order to check the penetration of water to the barrier, along it and out between the two layers of brick at the closure into the space between the two sheets of plywood. In other words, we knew the closure should be on the opposite side of the water barrier from where the water was applied but the second sheet of plywood was placed on the same side of the barrier as the water was applied. The criticalness of the closure location could be checked by how fast the space between the two sheets of plywood filled up with water. The summary of tests on Wall 2 is as follows:
