PAINT AS A VAPOR BARRIER FOR WALLS OF OLDER HOMES

RESEARCH
PAPER
FPL 319

FOREST PRODUCTS LABORATORY
FOREST SERVICE
U.S. DEPARTMENT OF AGRICULTURE
MADISON, WIS.

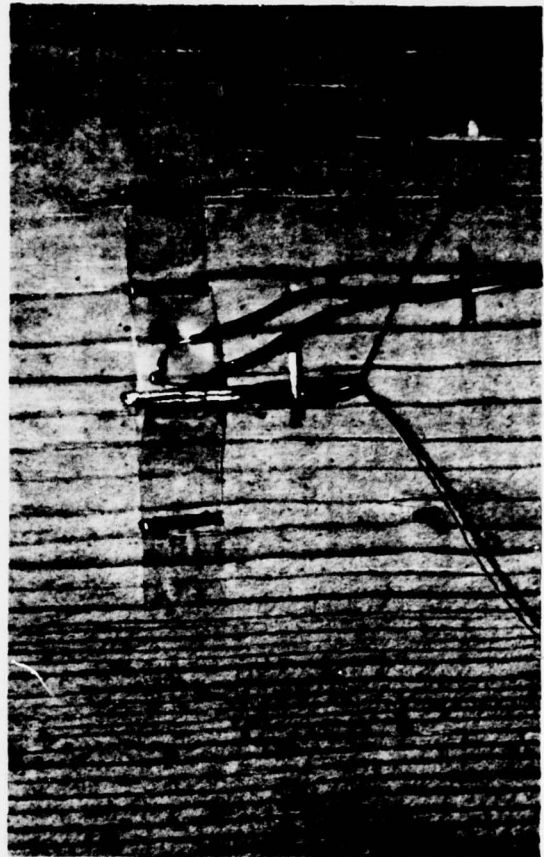
Figure 5. - - Moisture probe and thermocouple attached to interior surface of sheathing board. (M 144 309)

changes of 10° F or more. Inside room temperature was used for correcting the moisture probes located immediately adjacent to the interior wall lining. Outside air temperature was used to correct the probes immediately beneath the siding. For moisture probes within the wall between the insulation and sheathing, actual thermocouple measurements were made for each probe. Placement of a probe and its associated thermocouple for temperature is shown in figure 5.

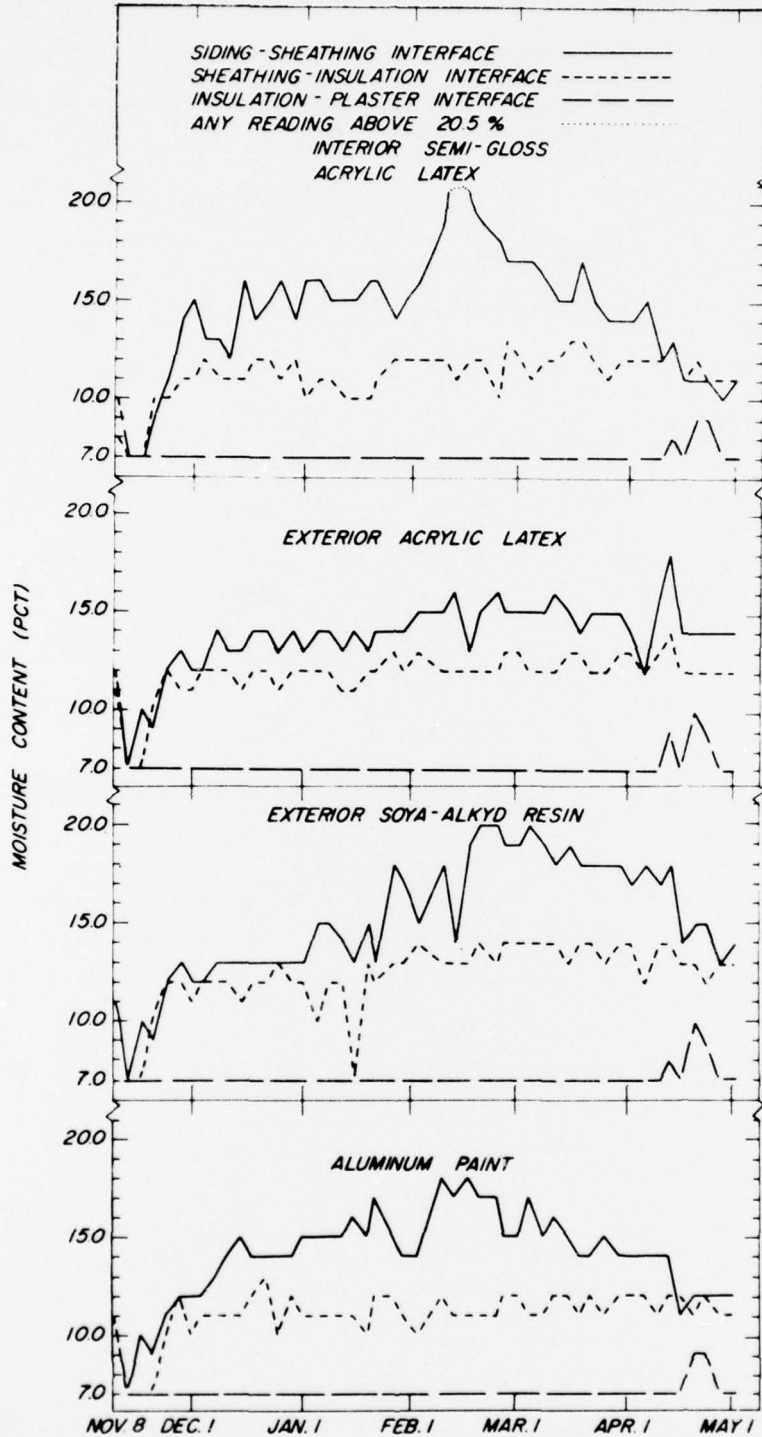
Figure 8. - - Moisture conditions through typical wall sections with paint applied to plaster for vapor resistance. (M 146 535)

Representative plots for walls with no remedial treatment, for each type of paint, and for both vented systems are presented in figures 7, 8, and 9. Plots shown are from north walls where condensation is most severe. A discussion of these figures is given in the sections which follow.

The MC in four wall sections — each with a different type of paint, applied in two coats to reduce permeability — is shown in figure 8. All of these walls had an MC at the siding-sheathing interface well below 20 percent during the test period with one exception. The wall section with interior semigloss acrylic latex had an MC above 20 percent for a brief period during the coldest weather.
